Archaeological building recording
and desk-based assessment at
18-20 Benefield Road, Oundle,
Northamptonshire
November 2008

Report 08/187

**ARCHAEOLOGICAL BUILDING RECORDING AND DESK-BASED
ASSESSMENT AT 18-20 BENEFIELD ROAD, OUNDLE
NORTHAMPTONSHIRE
SEPTEMBER 2008**

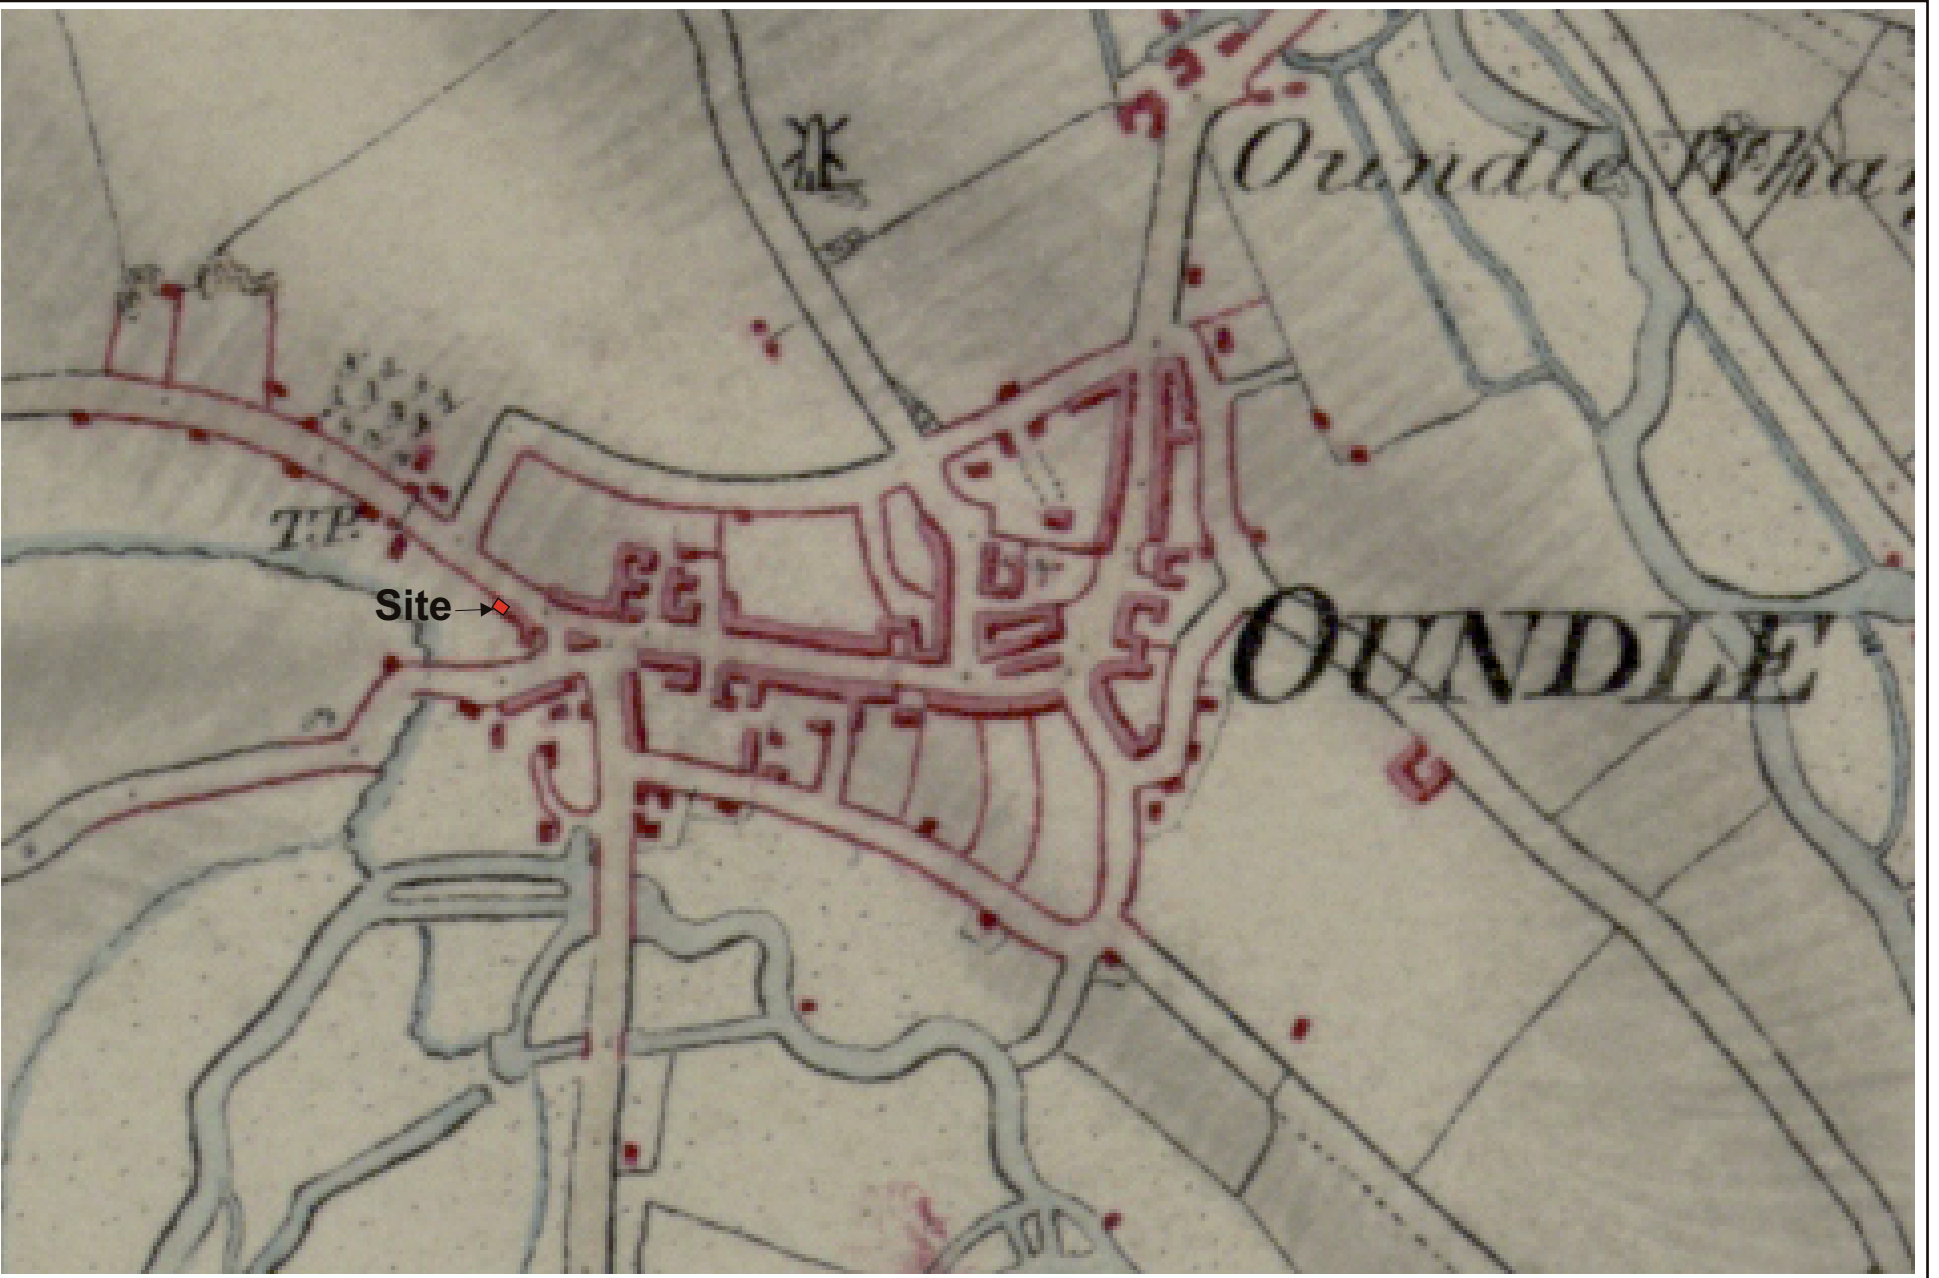
1810 Ordnance Survey preparatory map Fig 2

- 3.3 The Extensive Urban Survey does not describe individual domestic buildings and apart from the brief listing description, nothing is known of the two cottages which are the subject of this report. They appear to be present on the 1810 Ordnance Survey preparatory map (Fig 2). They lie at the very western edge of the town at that time, but the detail of the map is such that little else can be said of them. On the 1880 Ordnance Survey map they are depicted essentially as they remain today, but without the rear extensions, at the edge of the town and with their respective garden plots shown (Fig 3). They are subsequently present on all later maps which again show them in outline only.
- 3.4 No previous building recording or archaeological investigation is known to have been undertaken at, or near to, the cottages.

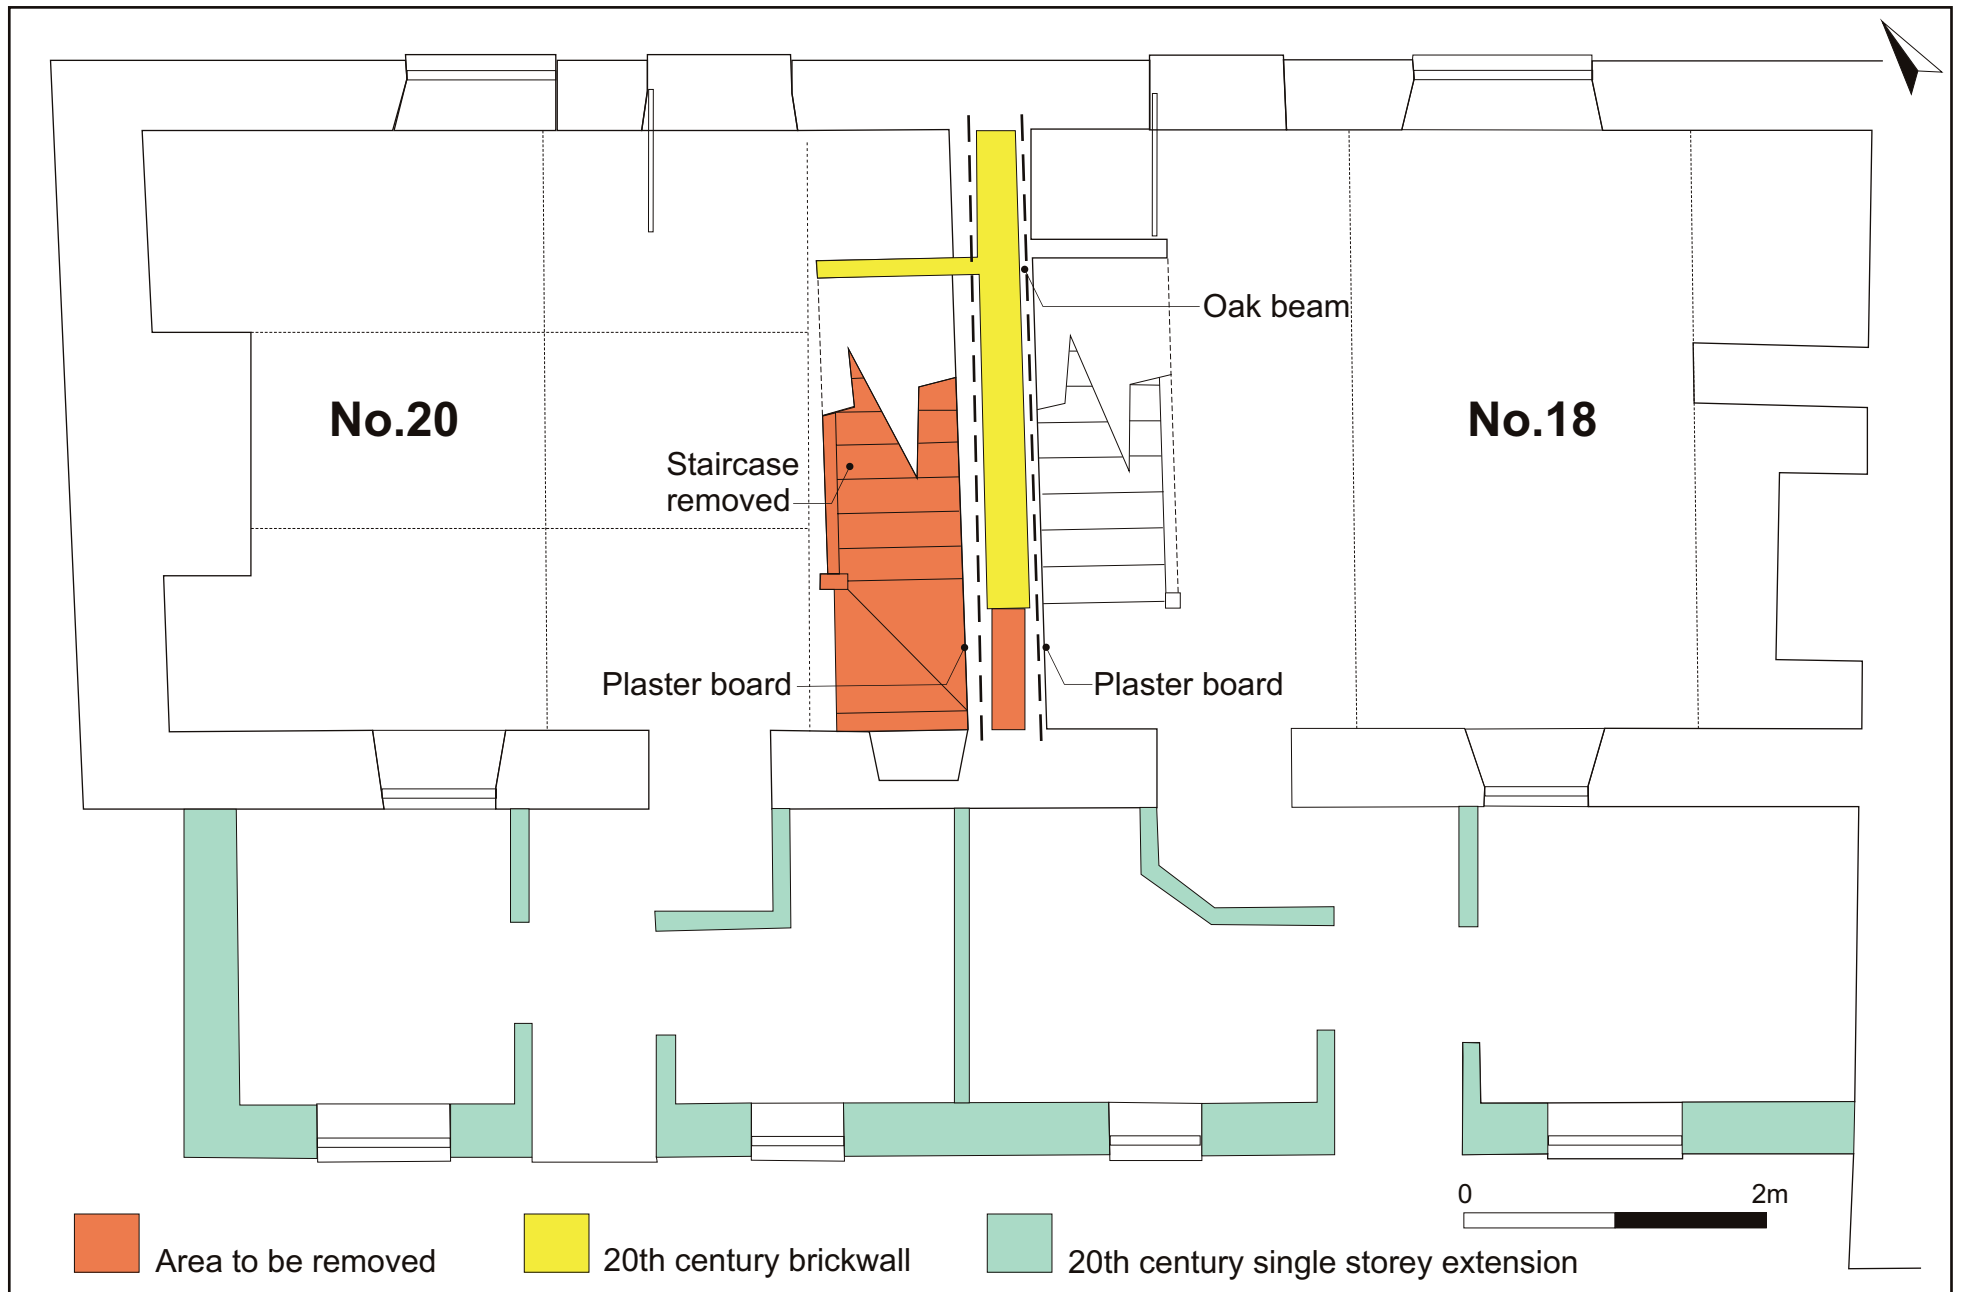
Ground floor plan, 18 and 20 Benefield Road, Oundle Fig 4

blocks to make the understair cupboard adjacent to the front door. The brick wall sits beneath an oak beam lying north-south between the north and south stone exterior walls of the building (Fig 4). It was not possible to examine the underside of the beam to see if it retained sockets for upright timbers, which may have been present if there had previously been a studwork partition, perhaps with a doorway if the cottages had previously been connected. One side of the beam was roughly chamfered, the other retained a waney edge. The beam retains whitewash indicating that it was exposed within the ground floor room at some stage, and also retains empty sockets along the top edge for joists.

- 4.3 ***Internal description; first floor.*** The new opening was to be made at the top of the staircases, and in doing so would make one of them obsolete (Figs 4 and 5). That within number 20 was removed and was revealed to be modern, probably dating to the 1970s, and was constructed of pine. Both internal wall surfaces between the two cottages were covered at first floor level with plaster on the removal of which the partition wall was shown to be of nineteenth-century red brick (230mm x 110mm x 70mm) bonded in lime mortar (Plates 6 and 7). At the top of the staircase in number 18 a brick pier had been constructed in the angle of the dividing and front walls of the cottage and was constructed of twentieth-century brick bonded in cement (Fig 5, Plate 6). It appears that this pier was inserted when the front wall of the cottage was rebuilt and it tidies the change from existing stonework to the new, narrower rendered brick front wall which remains today.

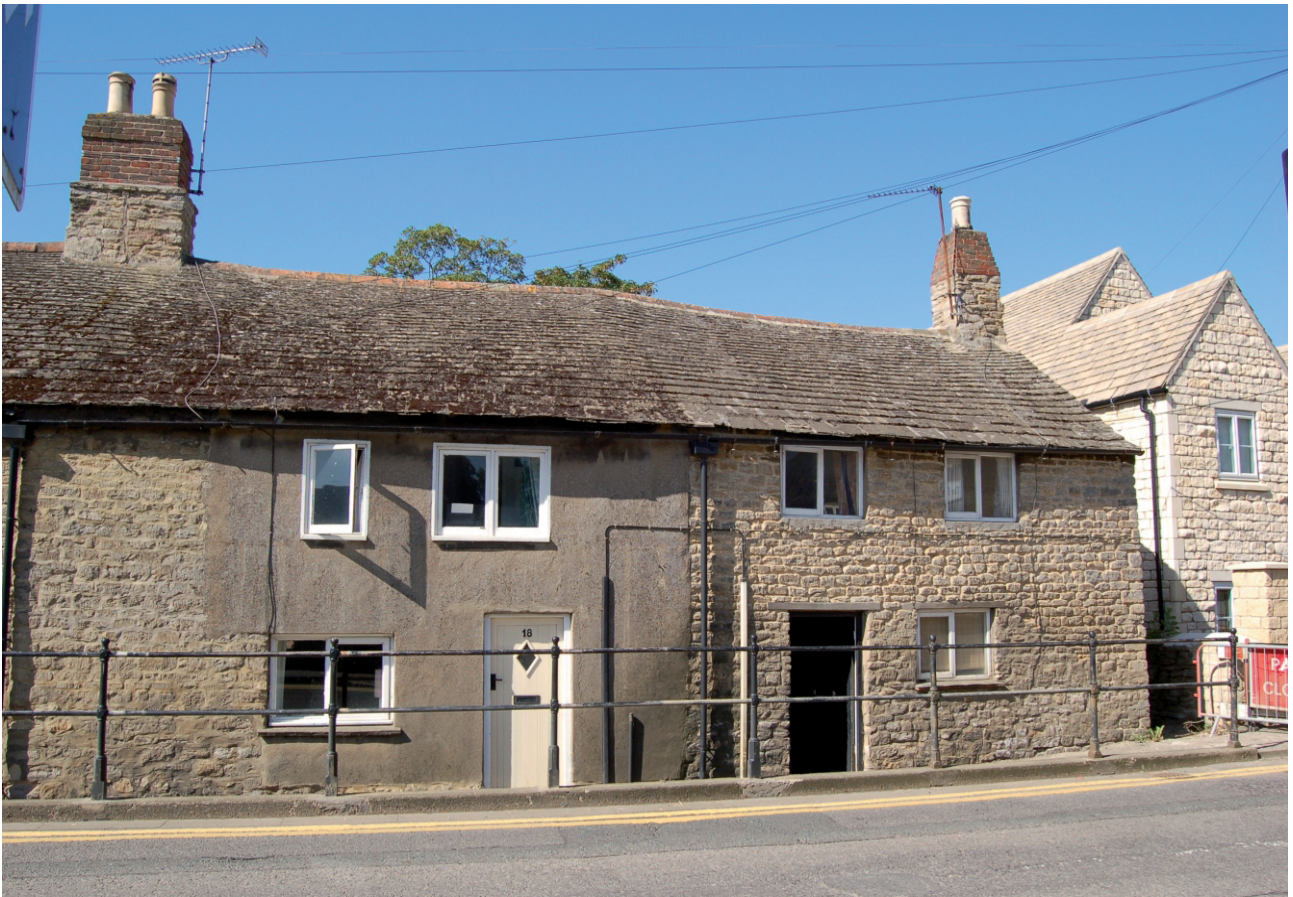
- 4.1 **External description.** The two cottages face onto Benefield Road which is aligned roughly north-west to south-east. For the sake of ease, the street frontage will be described as being the north side, number 18 lies to the east, number 20 at the far western end of the terrace row (Fig 1, Plate 1). Number 18 has a doorway and window on the ground floor with two windows to the first floor. The majority of the façade is cement rendered, apparently the result of much of the front wall collapsing and having been re-built in brick during the twentieth century (D Stone pers comm). The eastern end of this façade retains some dressed, coursed limestone, re-pointed with cement. The roof is covered with Collyweston stone slates and the property shares a stone chimney stack with its neighbour to the east, topped with more recent brickwork and supporting two chimney pots of yellow clay (the western one serves number 18).

Plate 1 Street frontage (north side) on Benefield Road

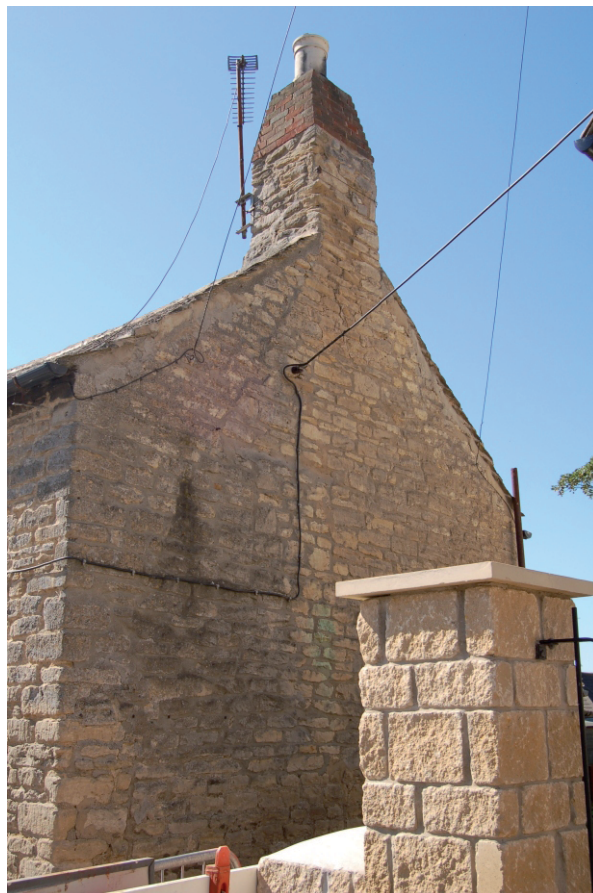
The west gable end shows clearly that the cottages were originally a single storey with a room in the eaves, which have subsequently been raised (Plate 2). The original pitch of the roof line suggests that at this stage they were probably thatched, and there was a small window to the north of the chimney stack, now blocked with stone. The south façade of the cottages is obscured on the ground floor by a modern single storey extension, but where the original cottage wall can be seen it is of coursed limestone rubble (Plate 3). There was a door and window on the ground floor of each cottage, opposite those in the north façade, and just one window to each building on the first floor. The east end of each cottage is the partition wall between it and the next building; only that between numbers 18 and 20 was observed during this project.

Plate 2 West gable end showing former roof line

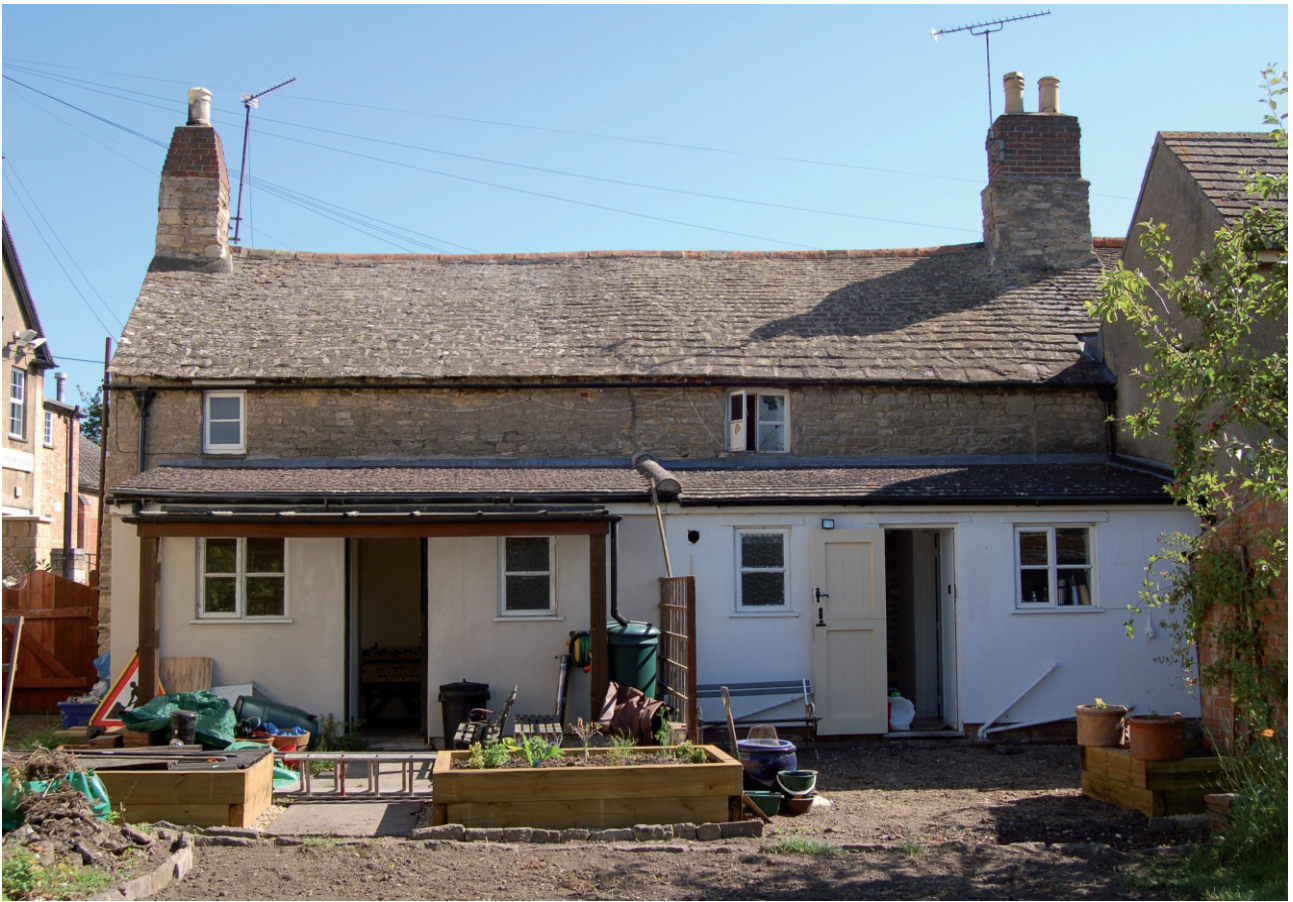
Plate 3 Garden frontage (south side) with later single storey additions

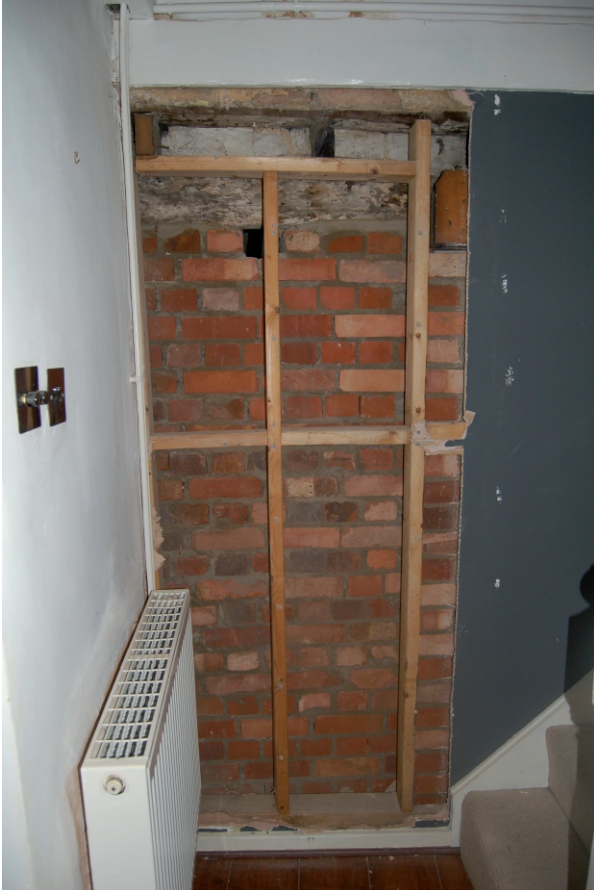
- 4.2 **Internal description; ground floor.** Internally both cottages have been modernised to varying degrees, and all interior wall surfaces (which were the subject of this survey) were covered with either plaster or plasterboard. These were recorded prior to any alterations by photography. Floor coverings were modern. The current owner then removed the modern wall covering in those areas on the ground and first floors where the new openings were to be made (Figs 4 and 5). On the ground floor of both cottages this was found to be plasterboard with a void behind, and the wall between the two cottages was found to be of twentieth-century red brick (210mm x 100mm x 60mm), two bricks thick bonded in cement (Plates 4 and 5). At the northern end of this wall there was also some use of breeze

Plate 4 Dividing wall between cottages; ground floor, east side (No 18) looking west

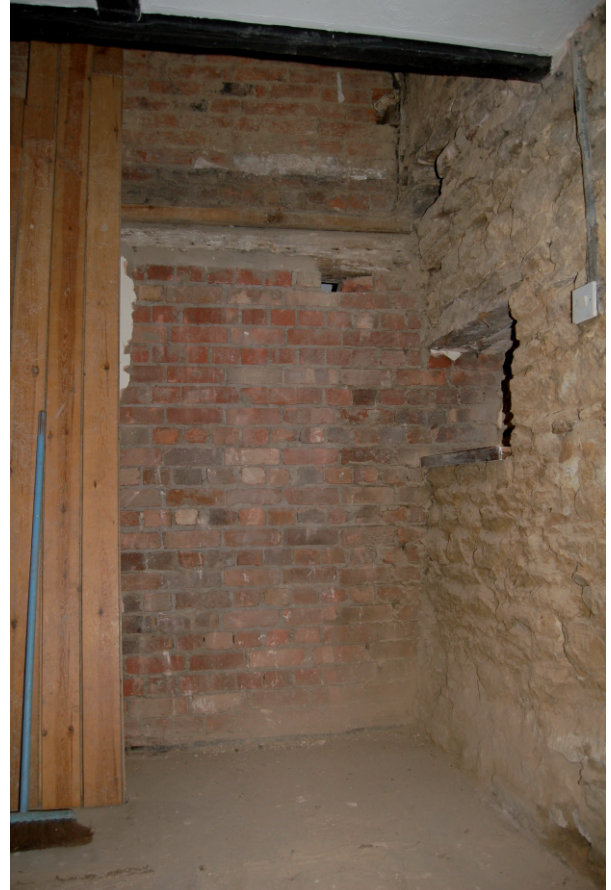
Plate 5 Dividing wall between cottages; ground floor, west side (No 20) looking east

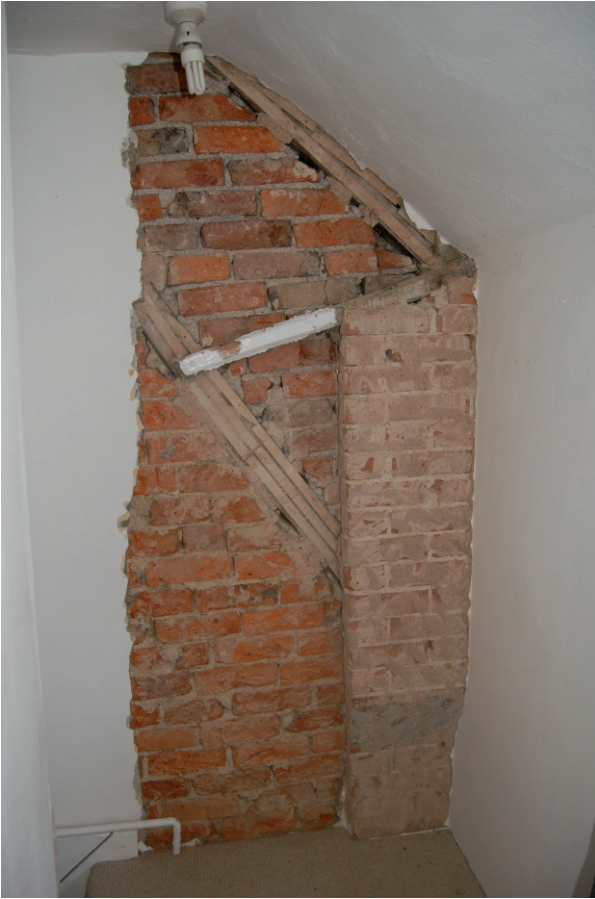
Plate 6 Dividing wall between cottages; first floor, east side (No 18) looking west

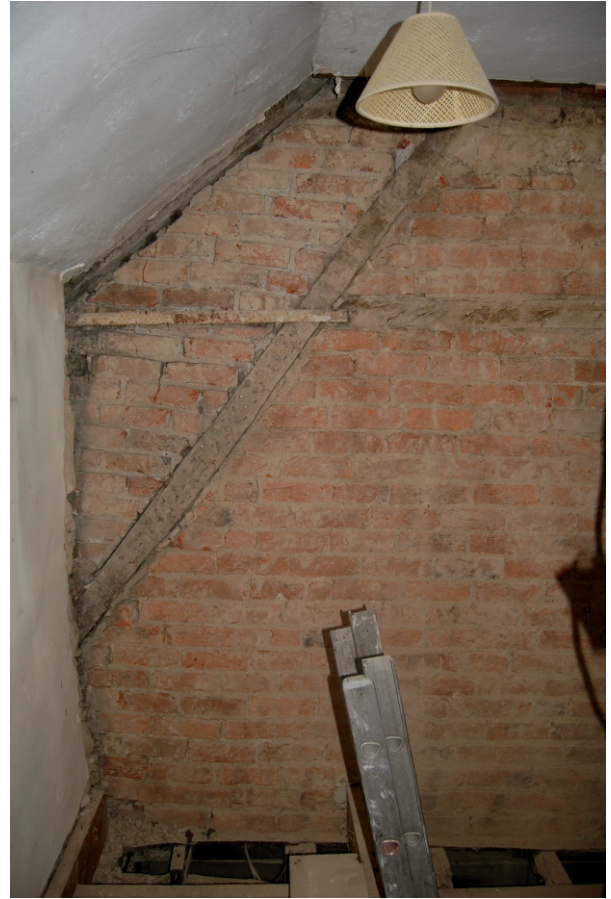
Plate 7 Dividing wall between cottages; first floor, west side (No 20) looking east

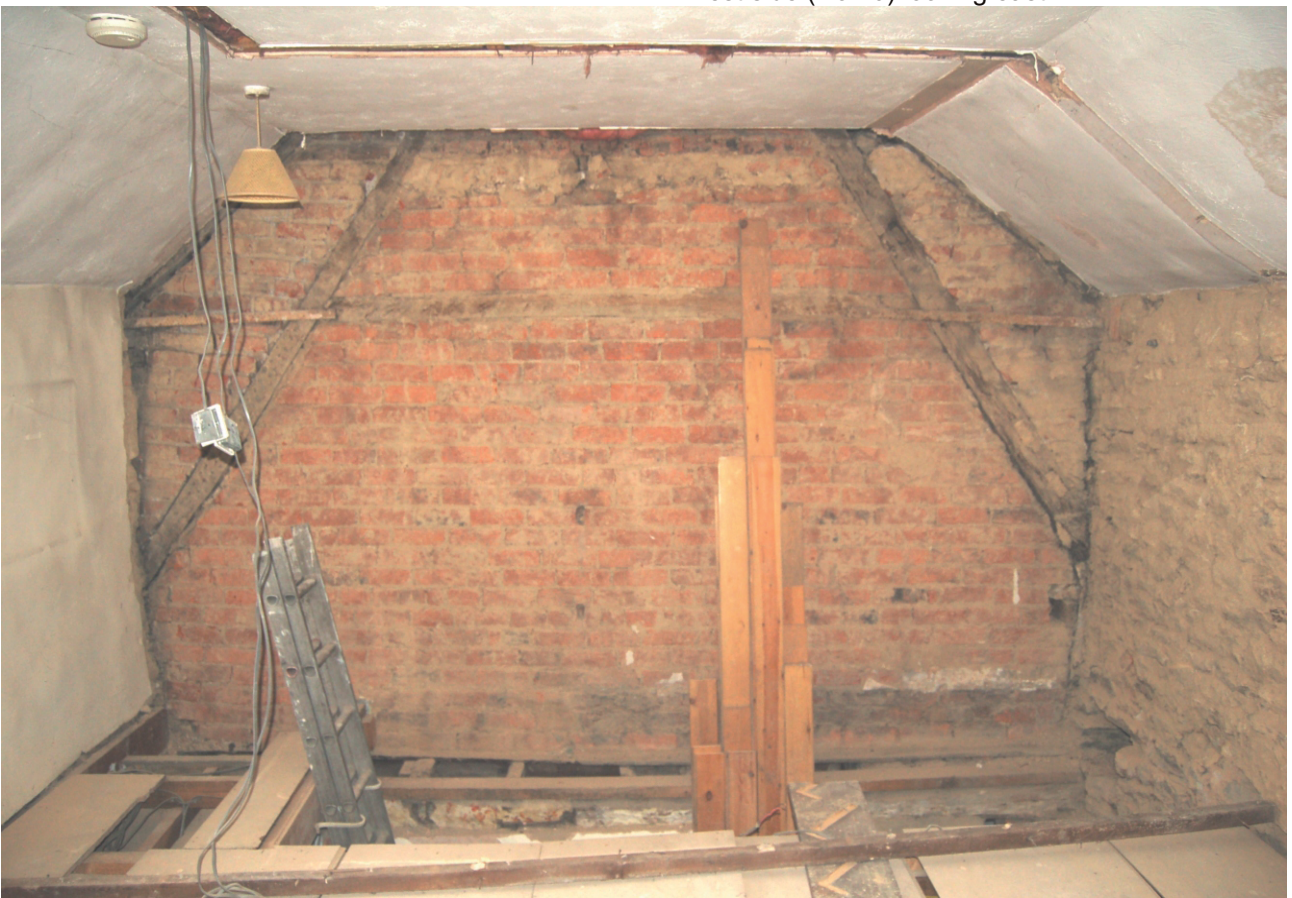
- 4.4 Due to the proposed new works associated with the creation of the new doorways and staircase removal, the owner had also removed the plaster from the whole covering of the west wall of cottage number 20 which revealed that the rafters of the original roof survived *in situ* (Plate 8). The angle of the rafters supports the theory that the roof was originally thatched and shows that the first floor room had little head room; a collar survives which is very low, but the room was apparently used for accommodation as indicated by the presence of plaster on the underside of the rafters. Rather oddly, the rafters do not lie directly above the oak beam, but slightly to the west of it, this means that the brick infill wall at first floor level does not rest on top of the first floor principal beam but on the floor boards to one side. This also indicates that the brick partition wall is secondary. Unfortunately the upper surface of the principal beam is covered by a later length of pine which obscures the surface, thus hiding any potential evidence of sockets which might indicate a timber frame, perhaps covered with lath and plaster. It appears that when the north and south (front and back) stone walls were heightened, the brick partition wall was introduced as the same type of brick is used both above and below the original rafters. This lifting of the walls and heightening of the roof gave extra headroom and allowed the small windows to be inserted in the north and south facades. At some stage metal straps have been added between the north and south walls and the original rafters, presumably to act as ties.

Plate 8 Dividing wall between cottages at first floor level showing original rafters and brick infill looking east from No 20
