An archaeological watching brief
at The Church of St Nicholas,
Bringhurst, Leicestershire
July 2007

Report 08/108

**AN ARCHAEOLOGICAL WATCHING BRIEF AT
THE CHURCH OF ST NICHOLAS, BRINGHURST,
LEICESTERSHIRE
JULY 2007**

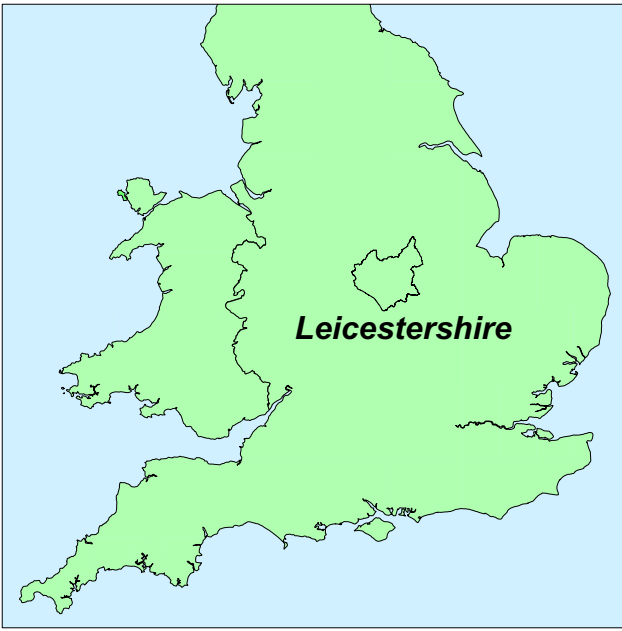
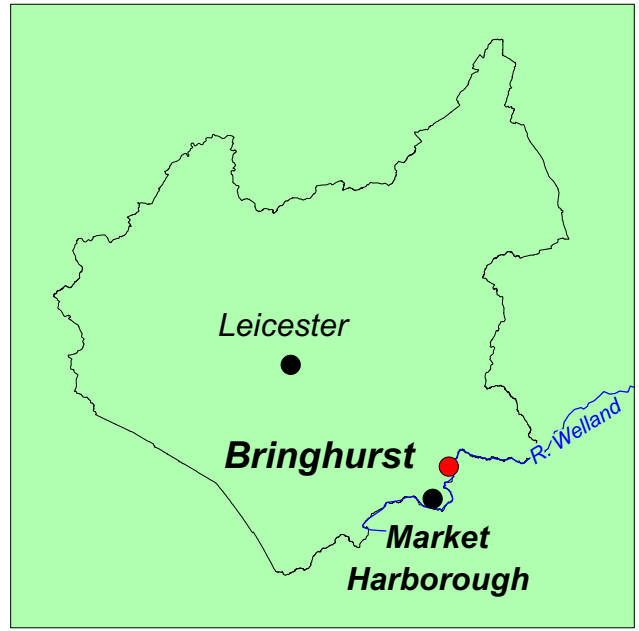
Site location Fig 1

Scale 1:25,000

An archaeological watching brief was undertaken by Northamptonshire Archaeology in July 2007 during groundworks associated with the dismantling and re-building of the churchyard retaining wall at The Church of St Nicholas, Bringhurst, Leicestershire (NGR SP 8412 9214: Fig 1; Plate 1). The work was carried out on behalf of Harborough District Council following a specification submitted to the Diocesan Archaeological Consultant by Northamptonshire Archaeology (Leigh, 2007) and approved on the 6th July 2007.

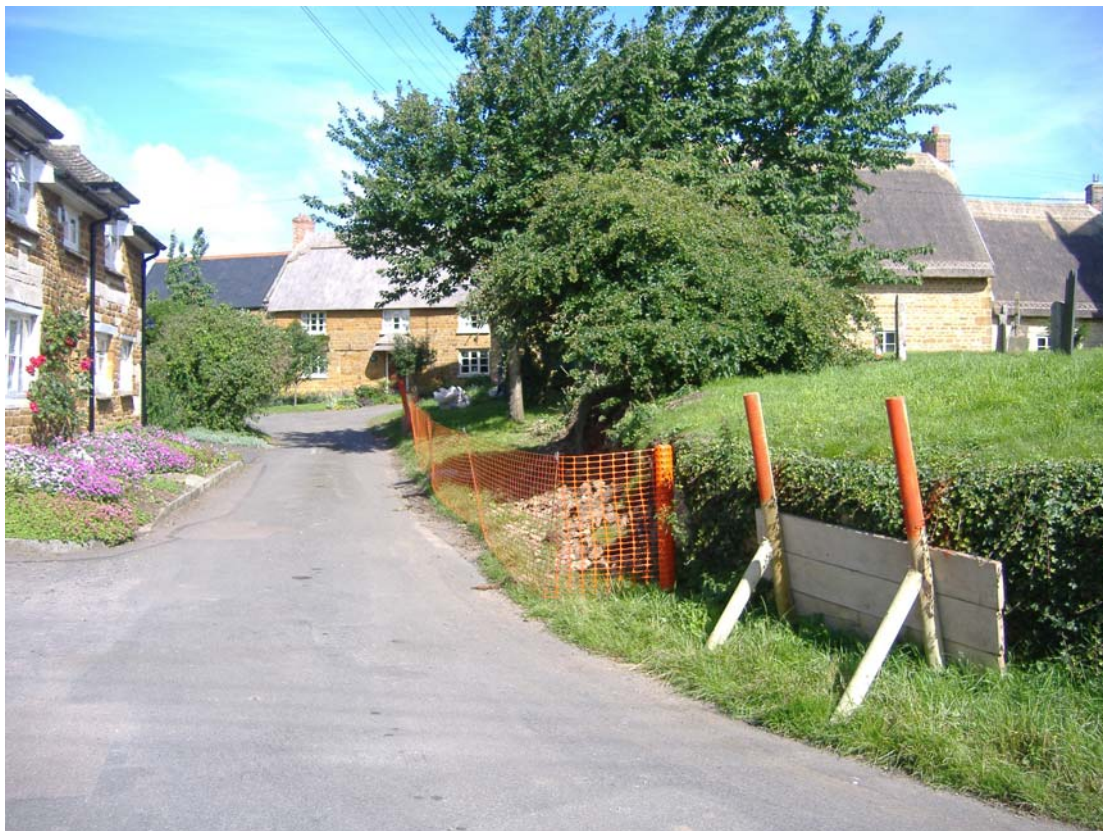
The retaining wall was constructed of rough stone fragments bonded together with white/cream coloured mortar. Behind the wall a consistent stratigraphy was revealed along all the dismantled section.

This comprised grey/black silt loam, which extended the full depth of the section, and contained occasional irregular stones with numerous small fragments of modern ceramic building material. This was sealed by a topsoil/turf layer, up to 0.08m thick.

Plate 2: General view of the churchyard retaining wall

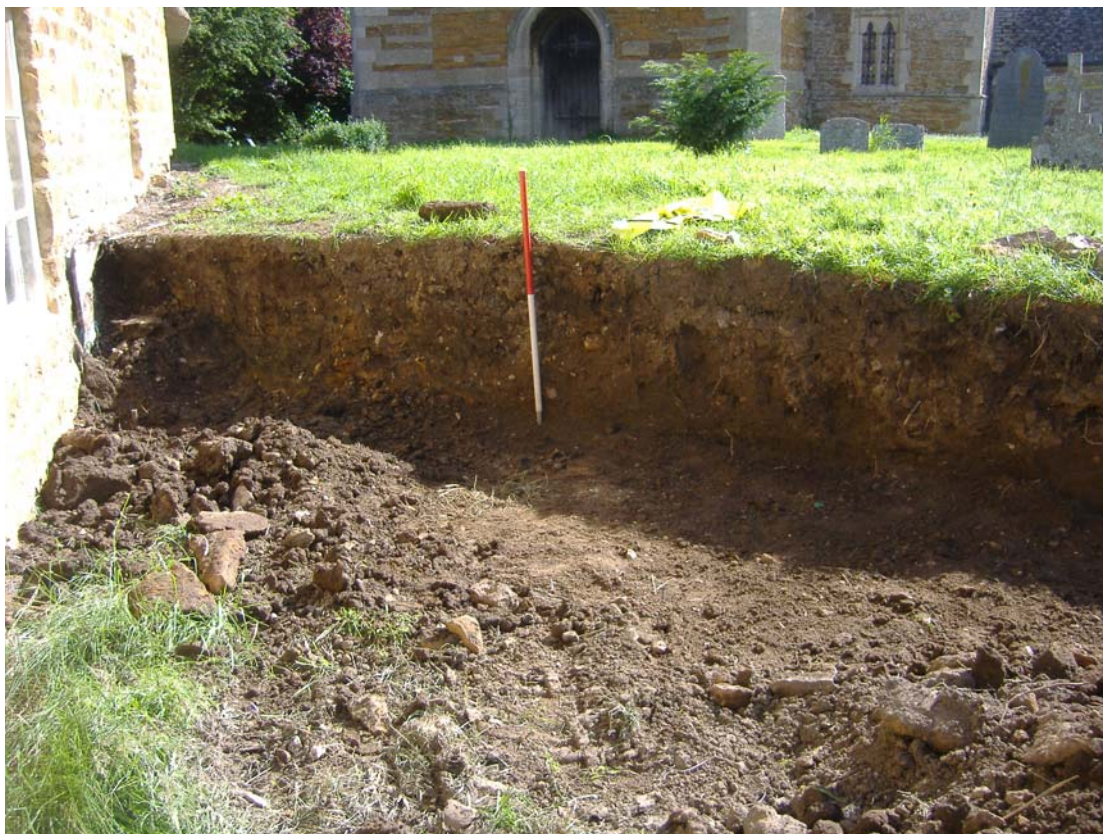
Plate 3: General view after removal of the retaining wall

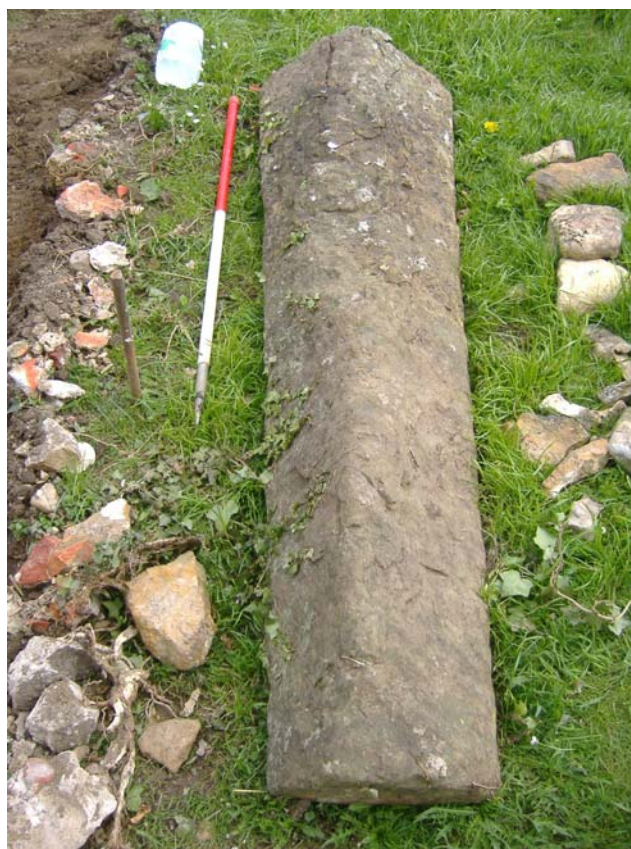
At the southern entrance to the churchyard a ridged stone grave slab had been re-used as a capstone (Plate 4). This was removed during dismantling with its future location still to be decided.

Two ridged grave slabs were noted on the top of the wall which had been re-used as capstones. No date can be assigned to these, however stylistically it is possible that they are of medieval date.

Plate 4: The grave slab

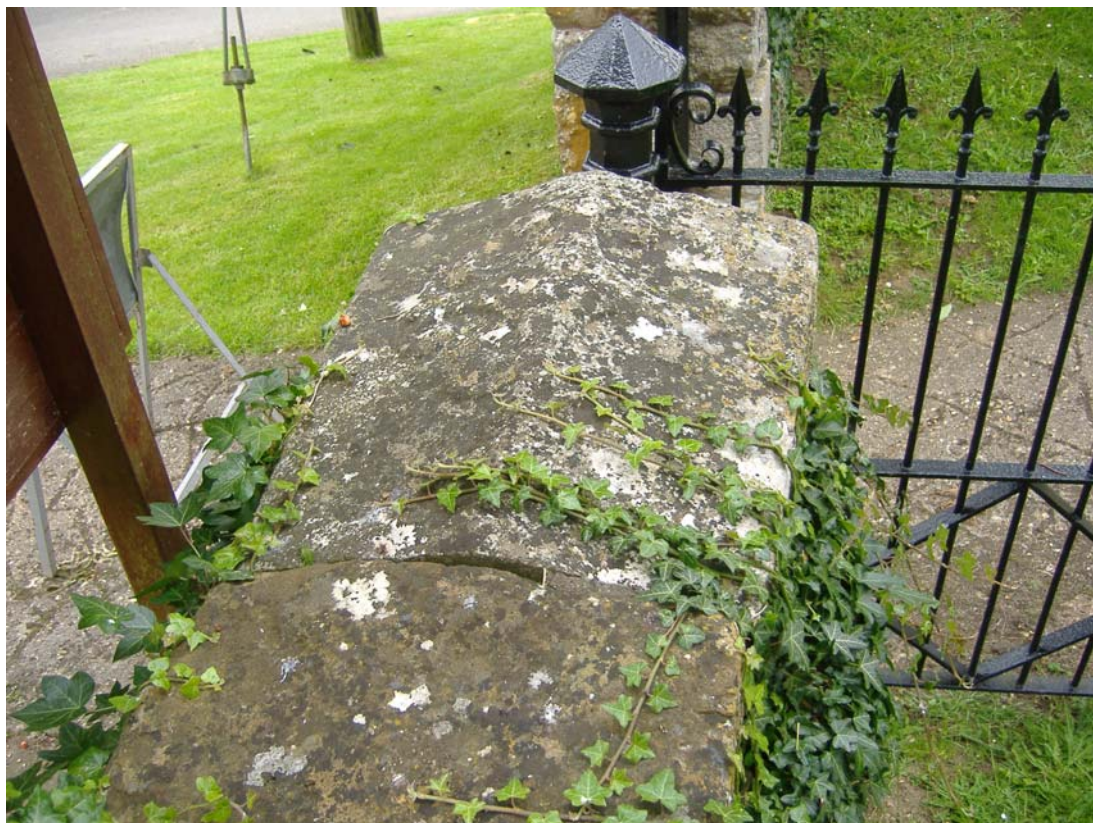
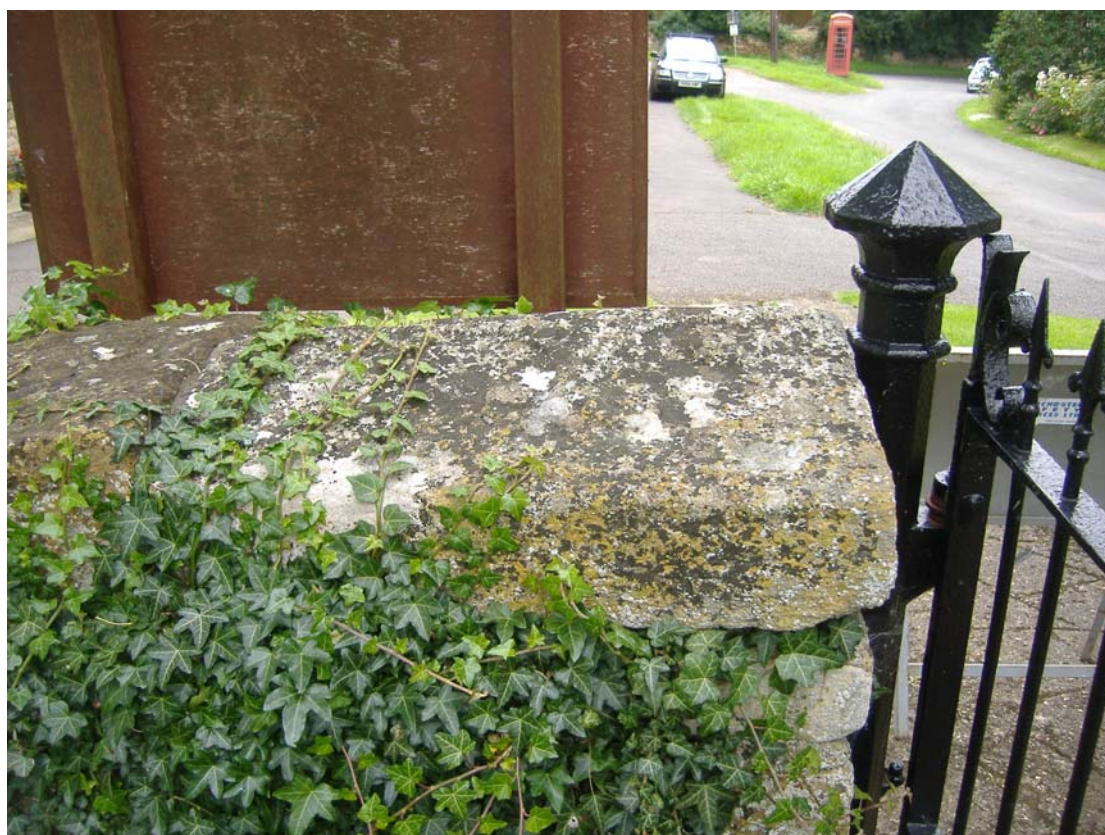
At the northern entrance to the churchyard another ridged grave slab was noted (Plates 5 & 6), this section of the wall was not disturbed during the current works and therefore only a cursory examination was made. The slab had been broken in half and used as a capstone either side of

the gateway. Some evidence of inscription was noted, however the slab is in poor condition and no interpretation could be made.

Plate 5: The grave slab at the northern entrance to the churchyard

Plate 6: The grave slab at the northern entrance to the churchyard
