Archaeological excavation at  
Holy Trinity Church, Orton Longueville  
Peterborough  
November 2009

Report 09/180

**ARCHAEOLOGICAL EXCAVATION  
ON LAND AT HOLY TRINITY CHURCH  
ORTON LONGUEVILLE, PETERBOROUGH  
SEPTEMBER 2009**

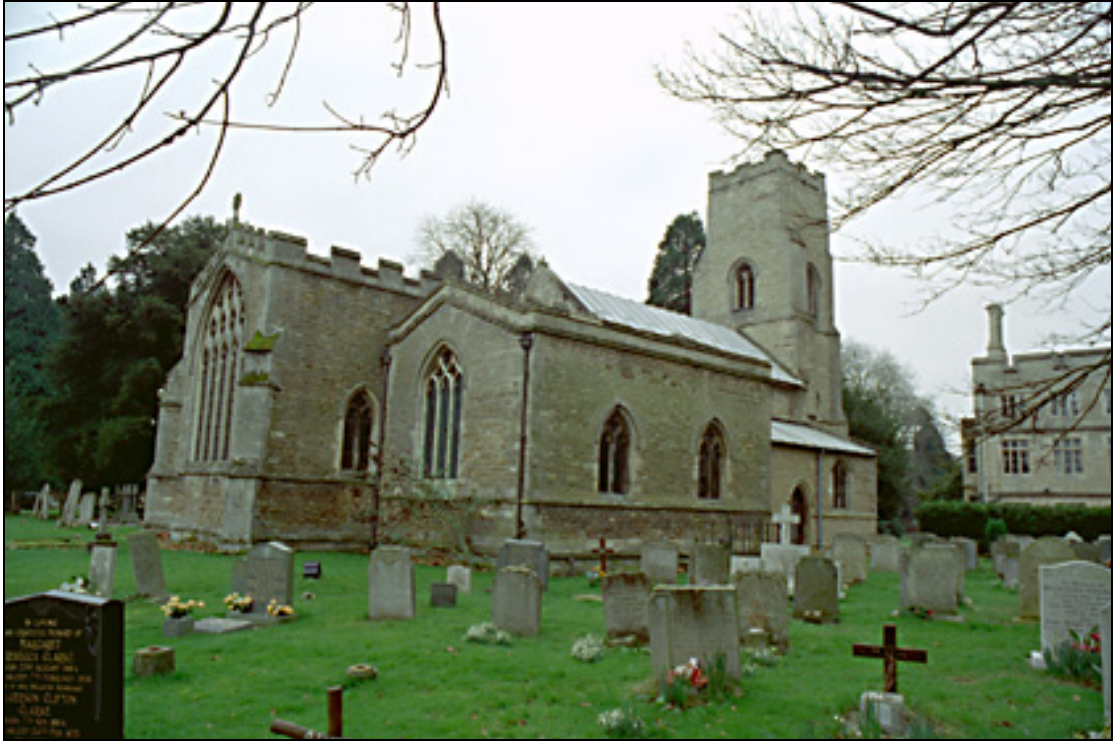
Fig 5

Holy Trinity Church, looking south-west

The site is located within the historic settlement of Orton Longueville, Peterborough (NGR: TL 16825 96525; Fig 1). The development will provide disabled toilet facilities and a general purpose room for parish use. The extension will cross part of the church graveyard bounded to the south and east by walls of the existing church with new walls to the west and north. Access will be via the existing north door of the north aisle (Figs 2 and 5).

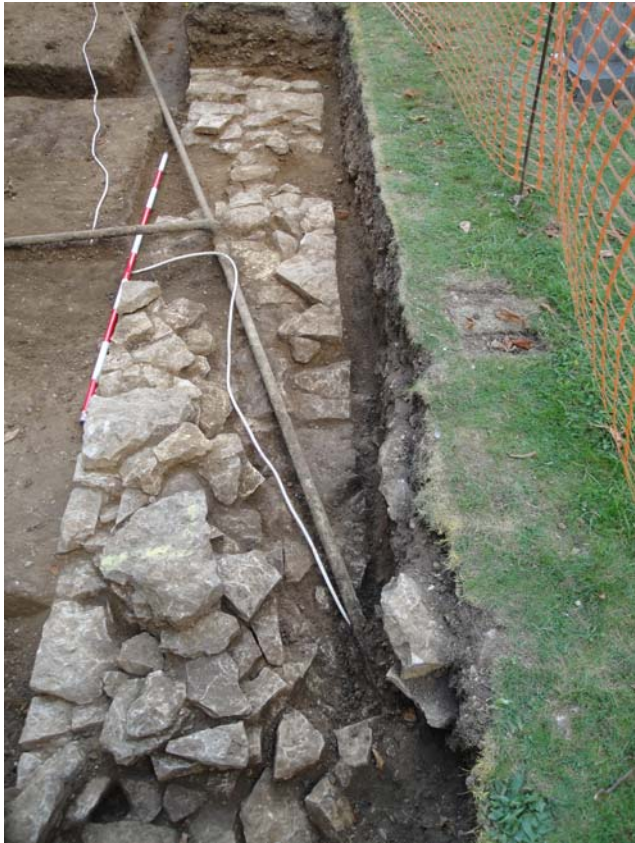
Fig 11

Wall (120), looking west

At the north of the trench, there was vestigial evidence for a probable foundation trench [121] aligned roughly east to west and parallel with the existing north wall of the church (Fig 3, Sections 3 & 4). It was 0.80m wide by 0.65m deep, with vertical sides and a flat base. It contained a limestone wall (120) built of irregularly split and roughly faced limestone fragments bonded with decayed coarse, sandy, yellow lime mortar (Fig 2 and Fig 3, Sections 3 & 4). Although roughly coursed, the wall had a good straight face to north and south (Figs 11 & 12).

At the east the wall survived up to 0.65m high with at least six courses of stonework. At the west the wall survived as a single course of stonework only 0.15m thick, and bedded on a layer of coarse sandy gravel and lime mortar up to 0.2m deep.

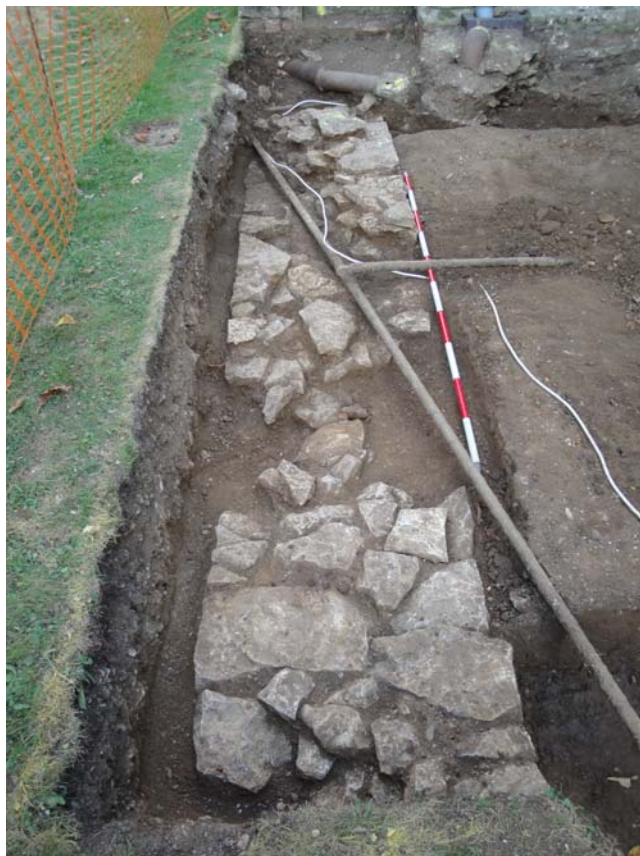
Wall (120), looking east, note damage from service trench excavation

At the east, layer (104) was cut through by service trench [116], 0.30m wide and 0.30m deep, filled with the redeposited upcast from its excavation (117) and a 4" salt glaze surface water drain pipe. This was connected to the rainwater down pipe (139) at the junction of the church and the north chapel to the south and to a similar down pipe (119) at the north-west corner of the chapel. The trench and rain water drain then extended north east, removing the east end of wall (120) extending beyond the present limit of excavation (Fig 2, Fig 12 (top of photograph) and Fig14).

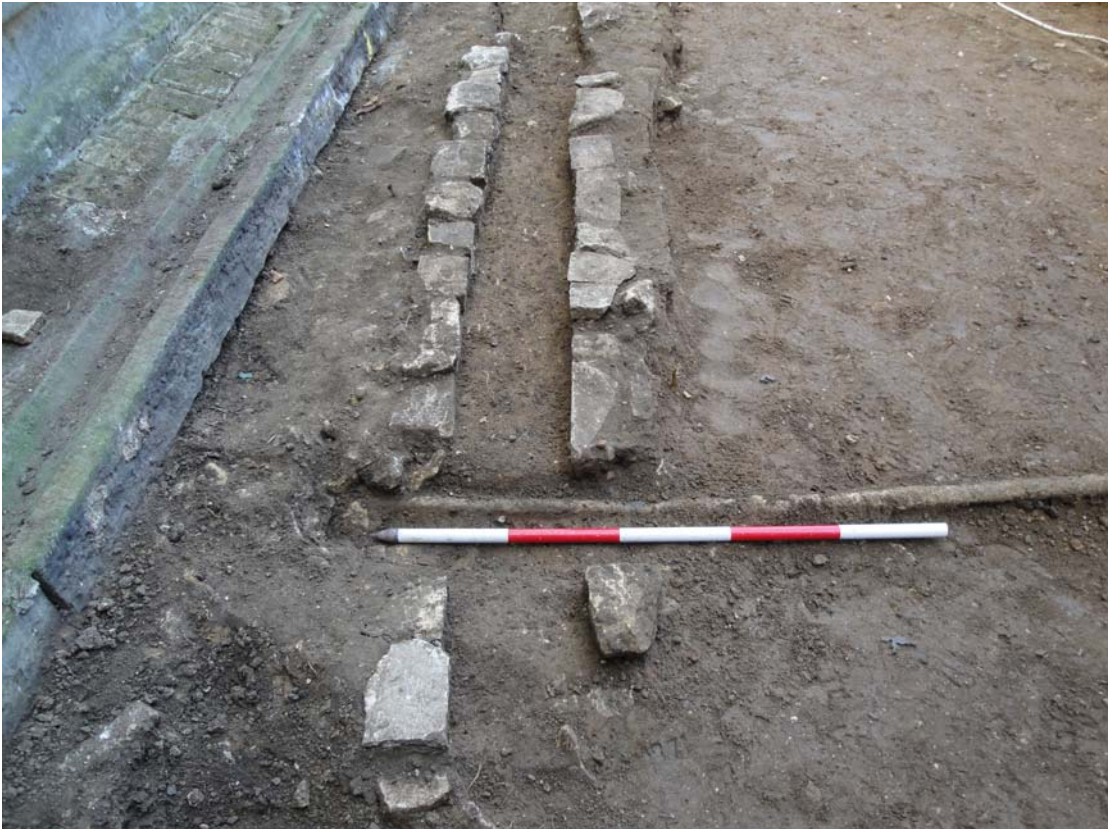
Drain (107) and stone lined drain (110), looking west Fig 13  
(Note carved stone immediately above 1m scale)

It was filled with two parallel rows of limestone fragments (110), set about 0.2m apart (Figs 2 & 13). Each row contained handmade bricks and occasional fragments of worked limestone. The two rows formed a stone-lined channel or drain filled with brown silty clay (111) which completely filled the drainage channel.

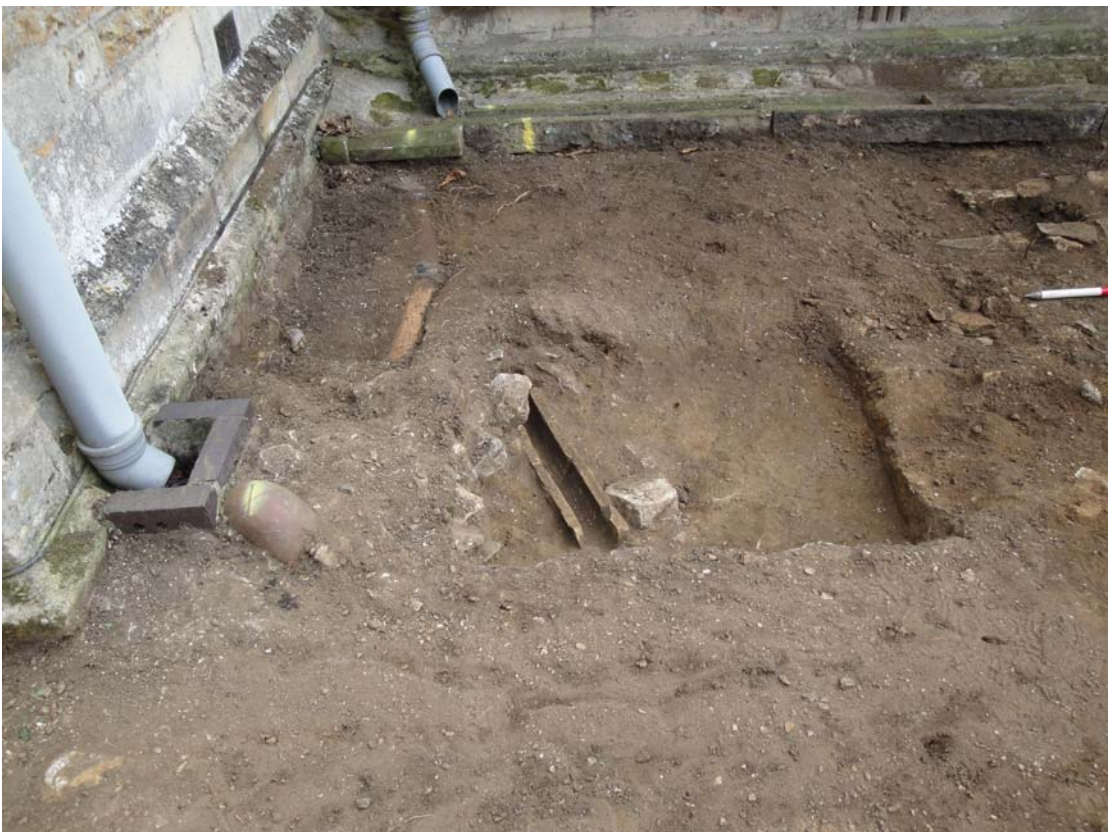
Drain (107), salt glaze pipes (117) and field drain (115), looking south Fig 14

Cutting layer (104) about 0.4m to the west was trench [114] aligned roughly north-west to south-east across the excavated area. It was 0.30m wide and 0.35m deep with vertical sides and a flat base. It contained 12" sections of white terracotta land drains laid upside down in the trench forming an open drain aligned on the down pipe at the corner of the church and main chapel (Figs 2 and 14).

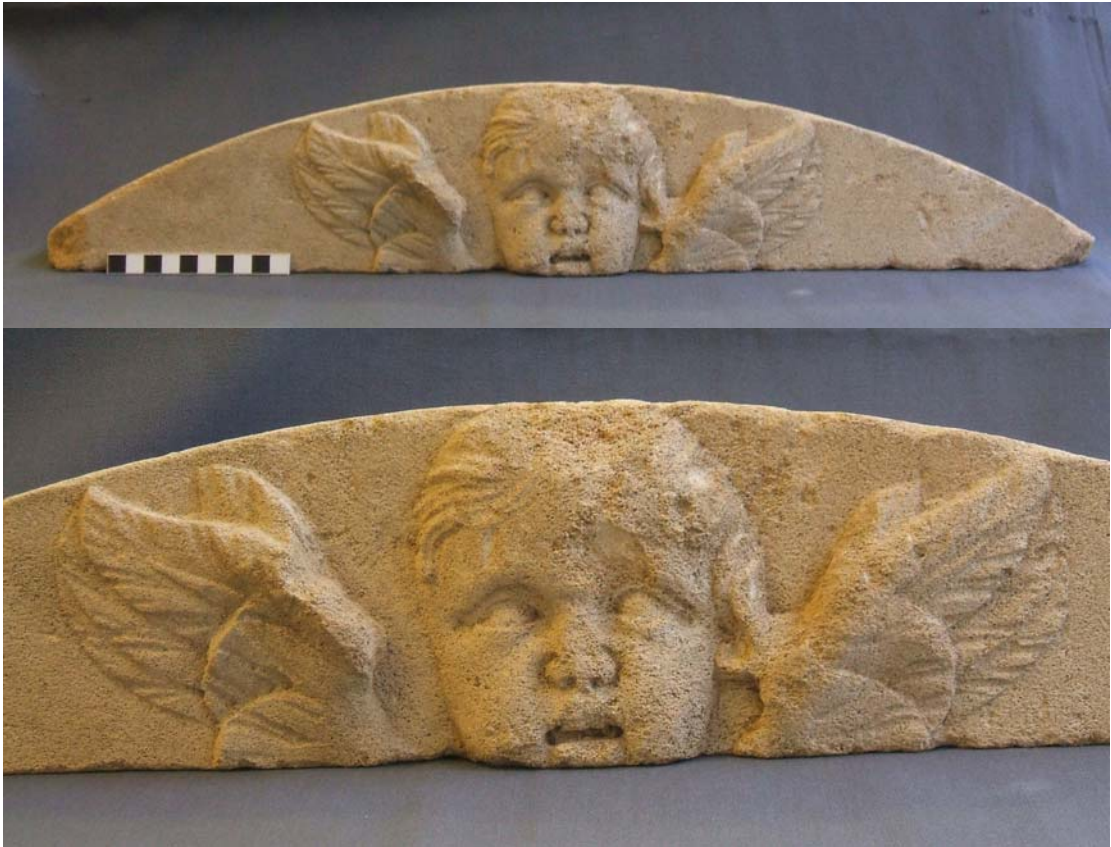
Part of possible wall monument or chest tomb, cherub head (Scale 100mm) Fig 15

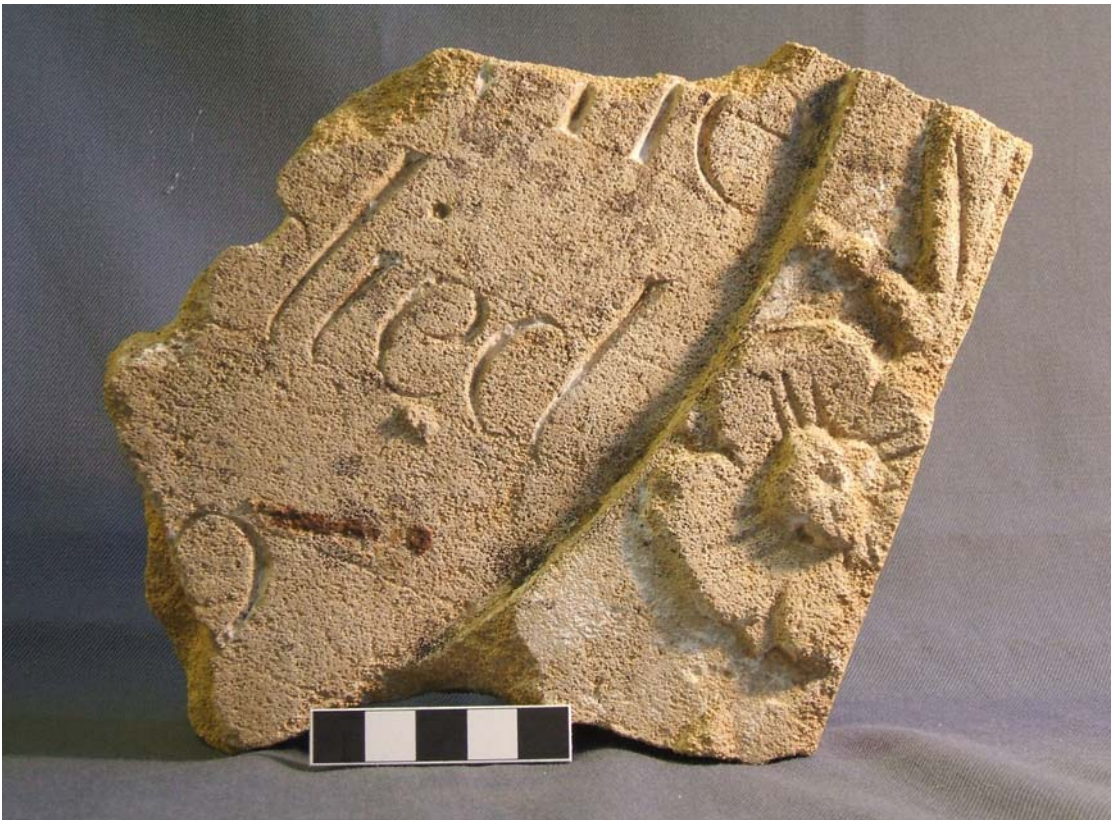
Fragment of memorial inscription, part of possible wall monument (Scale 50mm) Fig 16

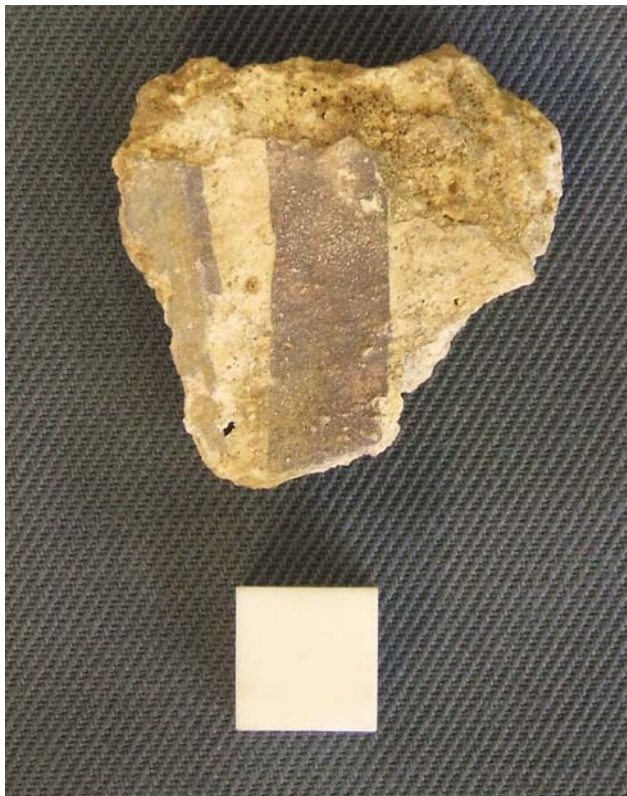
Painted wall plaster (Scale 10mm) Fig 17

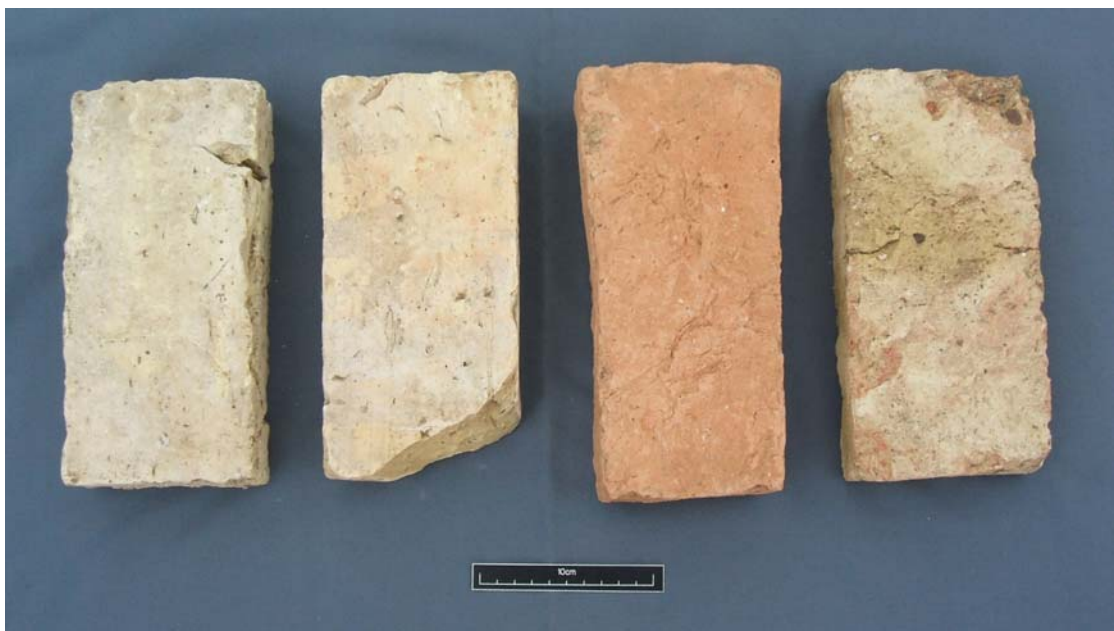
Examples of 17th to 19th-century bricks recovered from excavations (Scale 100mm) Fig 18

Context and type	Dimensions mm & (inches)	Comment
104 – disturbed layer (related to 19th-20th century repairs and alterations )	218 x 105 x 57 (8½ x 4¼ x 2¼)	Yellow
110 - stone-lined drain	227 x 110 x 43 (8⅞ x 4⅜ x 1¾)	pale pinkish brown covered in thin skin of mortar
110 - stone-lined drain	219 x 102 x 57 (8⅝ x 4 x 2¼)	Yellow
110 - stone-lined drain	234 x 108 to 95 x 65 (9¼ x 4¼ to 3¾ x 2½)	pale pinkish brown, tapering slightly
