Archaeological assessment of
The Chantry Chapel, Buckingham
and its documentary resource

Iain Soden and Charlotte Walker

March 2009

Report 09/27

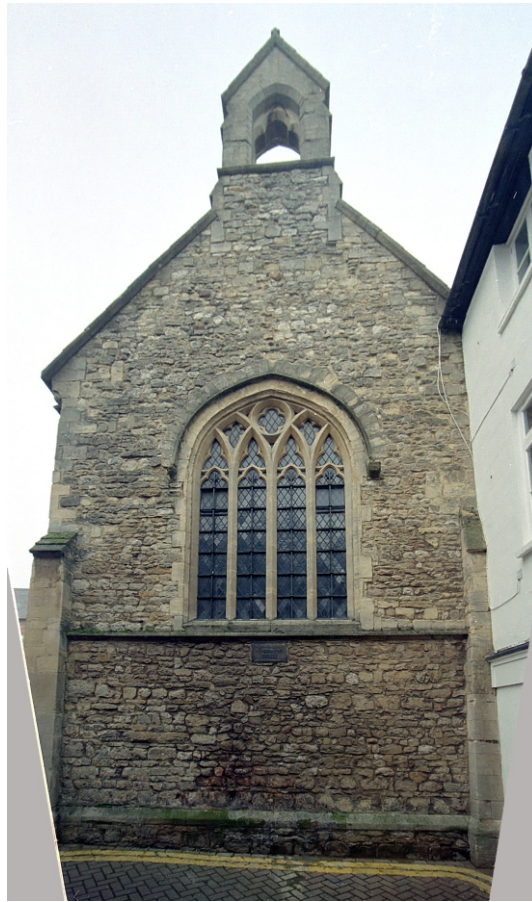
Fig 3: Elevation of south gable

The south gable exterior (Fig 3)

The south gable fronts onto a narrow road, a confined space in which it was not possible to make fully rectifiable images. Consequently, although some attempt to rectify the view has been made, this has not been fully achieved and photographs of this gable show converging verticals. The gable wall surmounts a chamfered plinth which is not present on the long axis. At a height of about 2m above the present ground level is a drip-moulding string course, above which is a tall gothic window with flowing tracery around four ogee-headed lights and a hood-mould. The stonework of the tracery is not medieval although it employs a standard medieval cavetto cross-section in its mullion form. It is likely to be of the nineteenth century. The corners of the gable have buttresses which also extend outwards the chamfer of the wall plinth. Above these the quoins are stressed in ashlar stonework up to eaves level. To the east (right) of the window embrasure, directly adjacent to the buttress-head, is a reused fragment of an architectural fragment, probably a very worn thirteenth-century dog-tooth (Fig 4). Its location suggests that it surmounts a blocked put-log hole. Although the equivalent stone is not of architectural origin, a comparable arrangement lies at exactly the same location adjacent to the other buttress head. Together they do seem to indicate a pair of blocked put-log holes. A bell-cote surmounts the apex of the gable. It is an addition (documents attest of Scott, 1879), while on top of the roof pitch is a stone coping, secondary to the bell-cote.

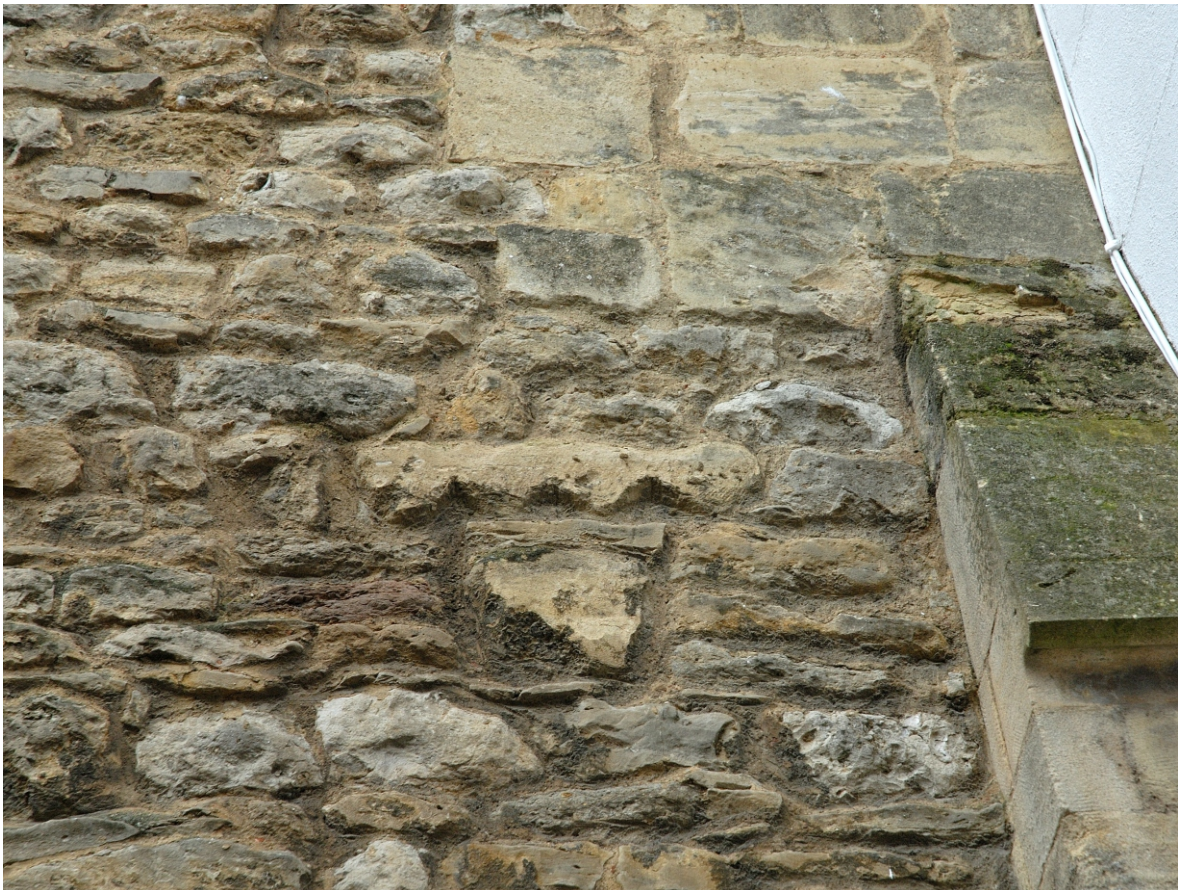
Fig 4: Re-used architectural fragment and possible put-log hole

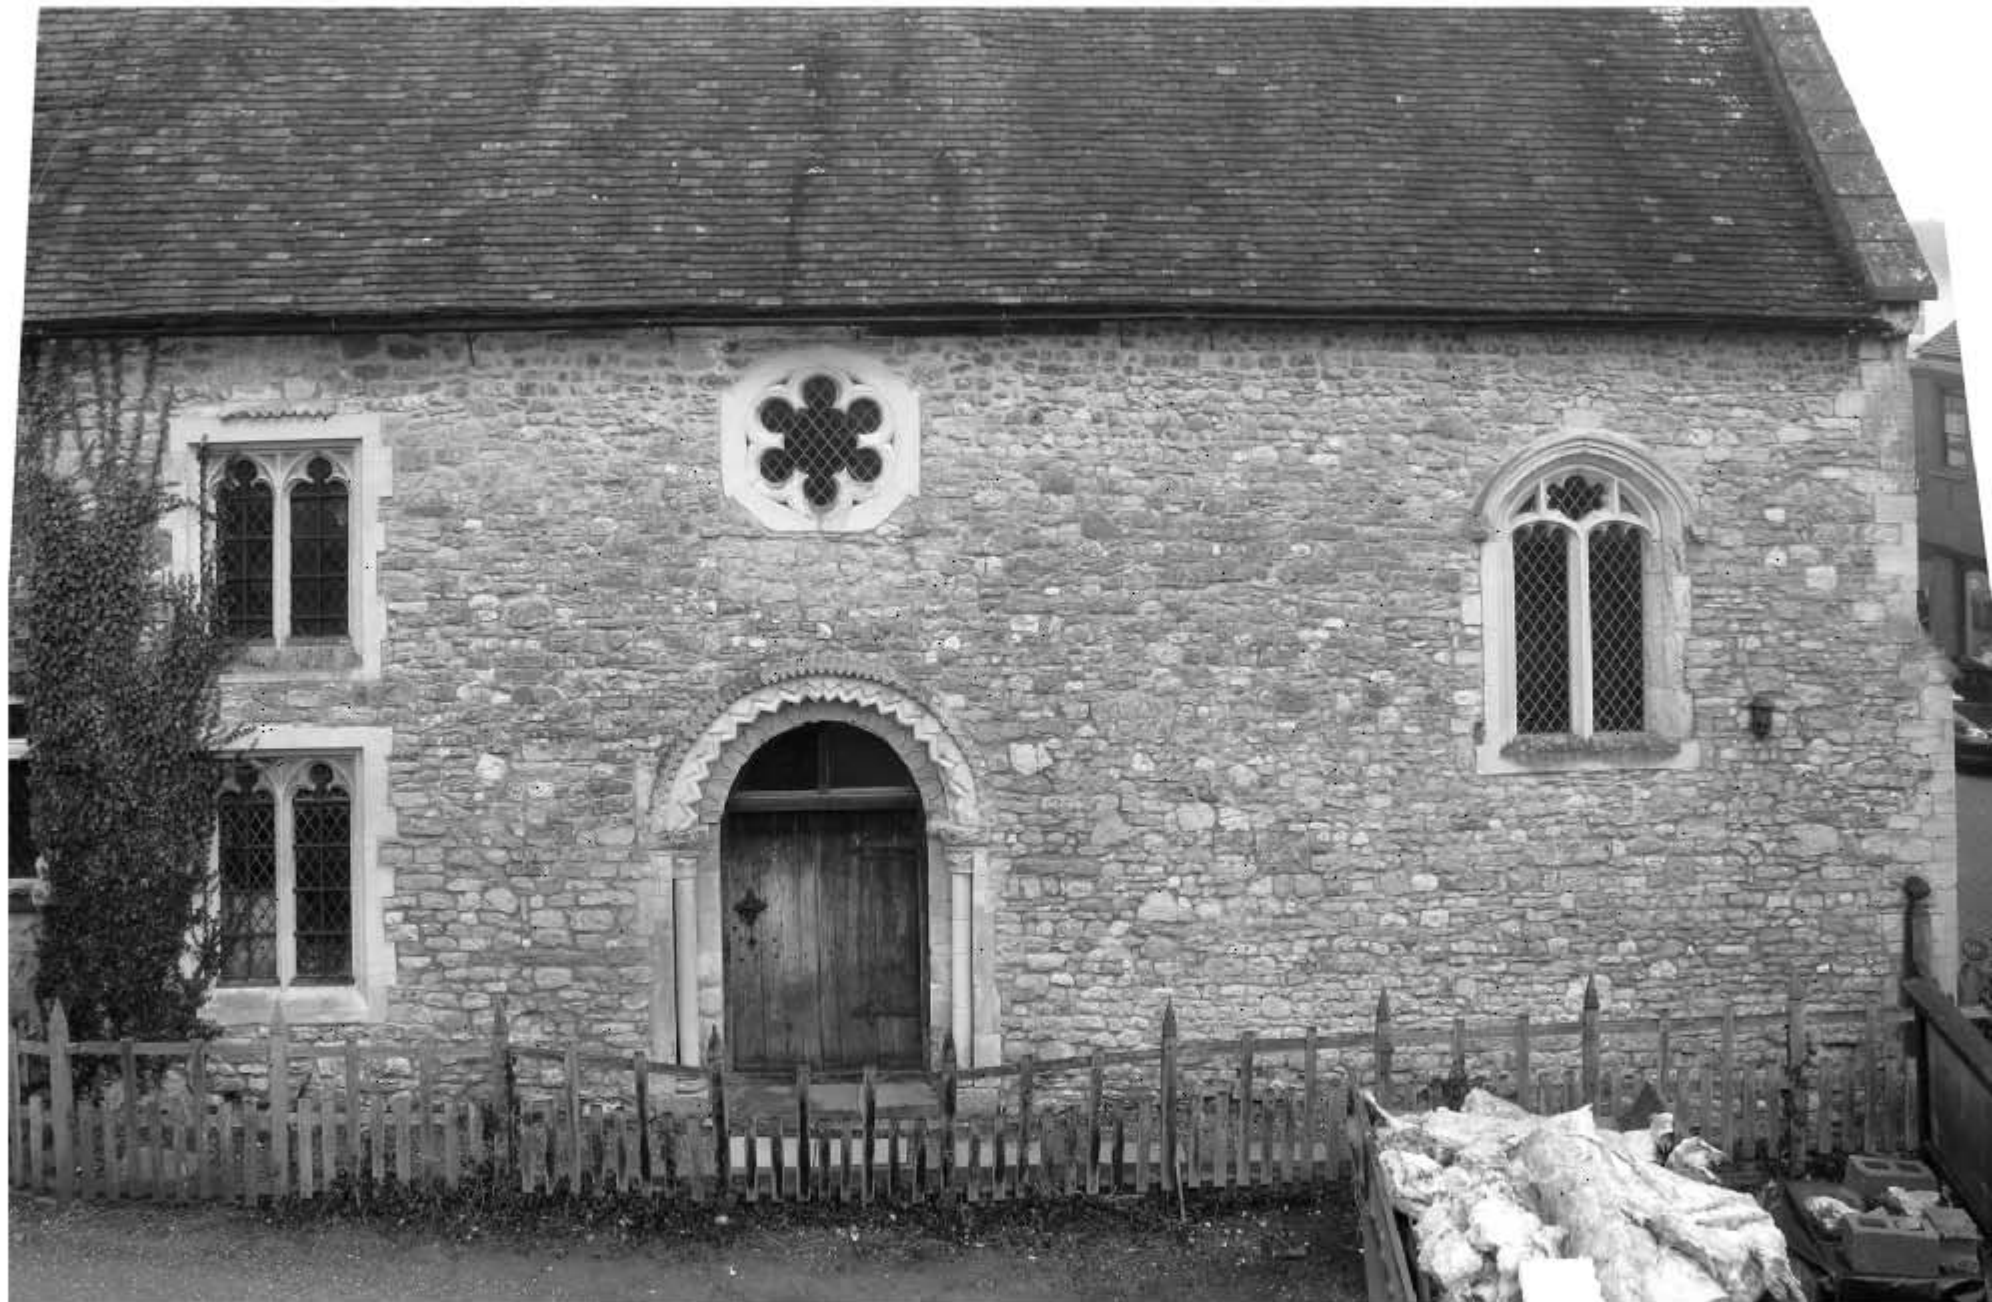
Rectified photo-evaluation of the chapel west wall exterior Fig 5

The west wall exterior (Figs 5 and 6)

Access to this elevation was such that rectified photographic images could be taken for later rectification. Thus Figure 5 is a rectified black and white image of the west wall, printed at a scale of 1:50 to show the wall stone-for stone, while Figure 6 shows the same view in colour with interpretative detail added in relation to changes in build. Such interpretative detail would likely increase if the same approach were taken should the mortar of the wall ever be raked out.

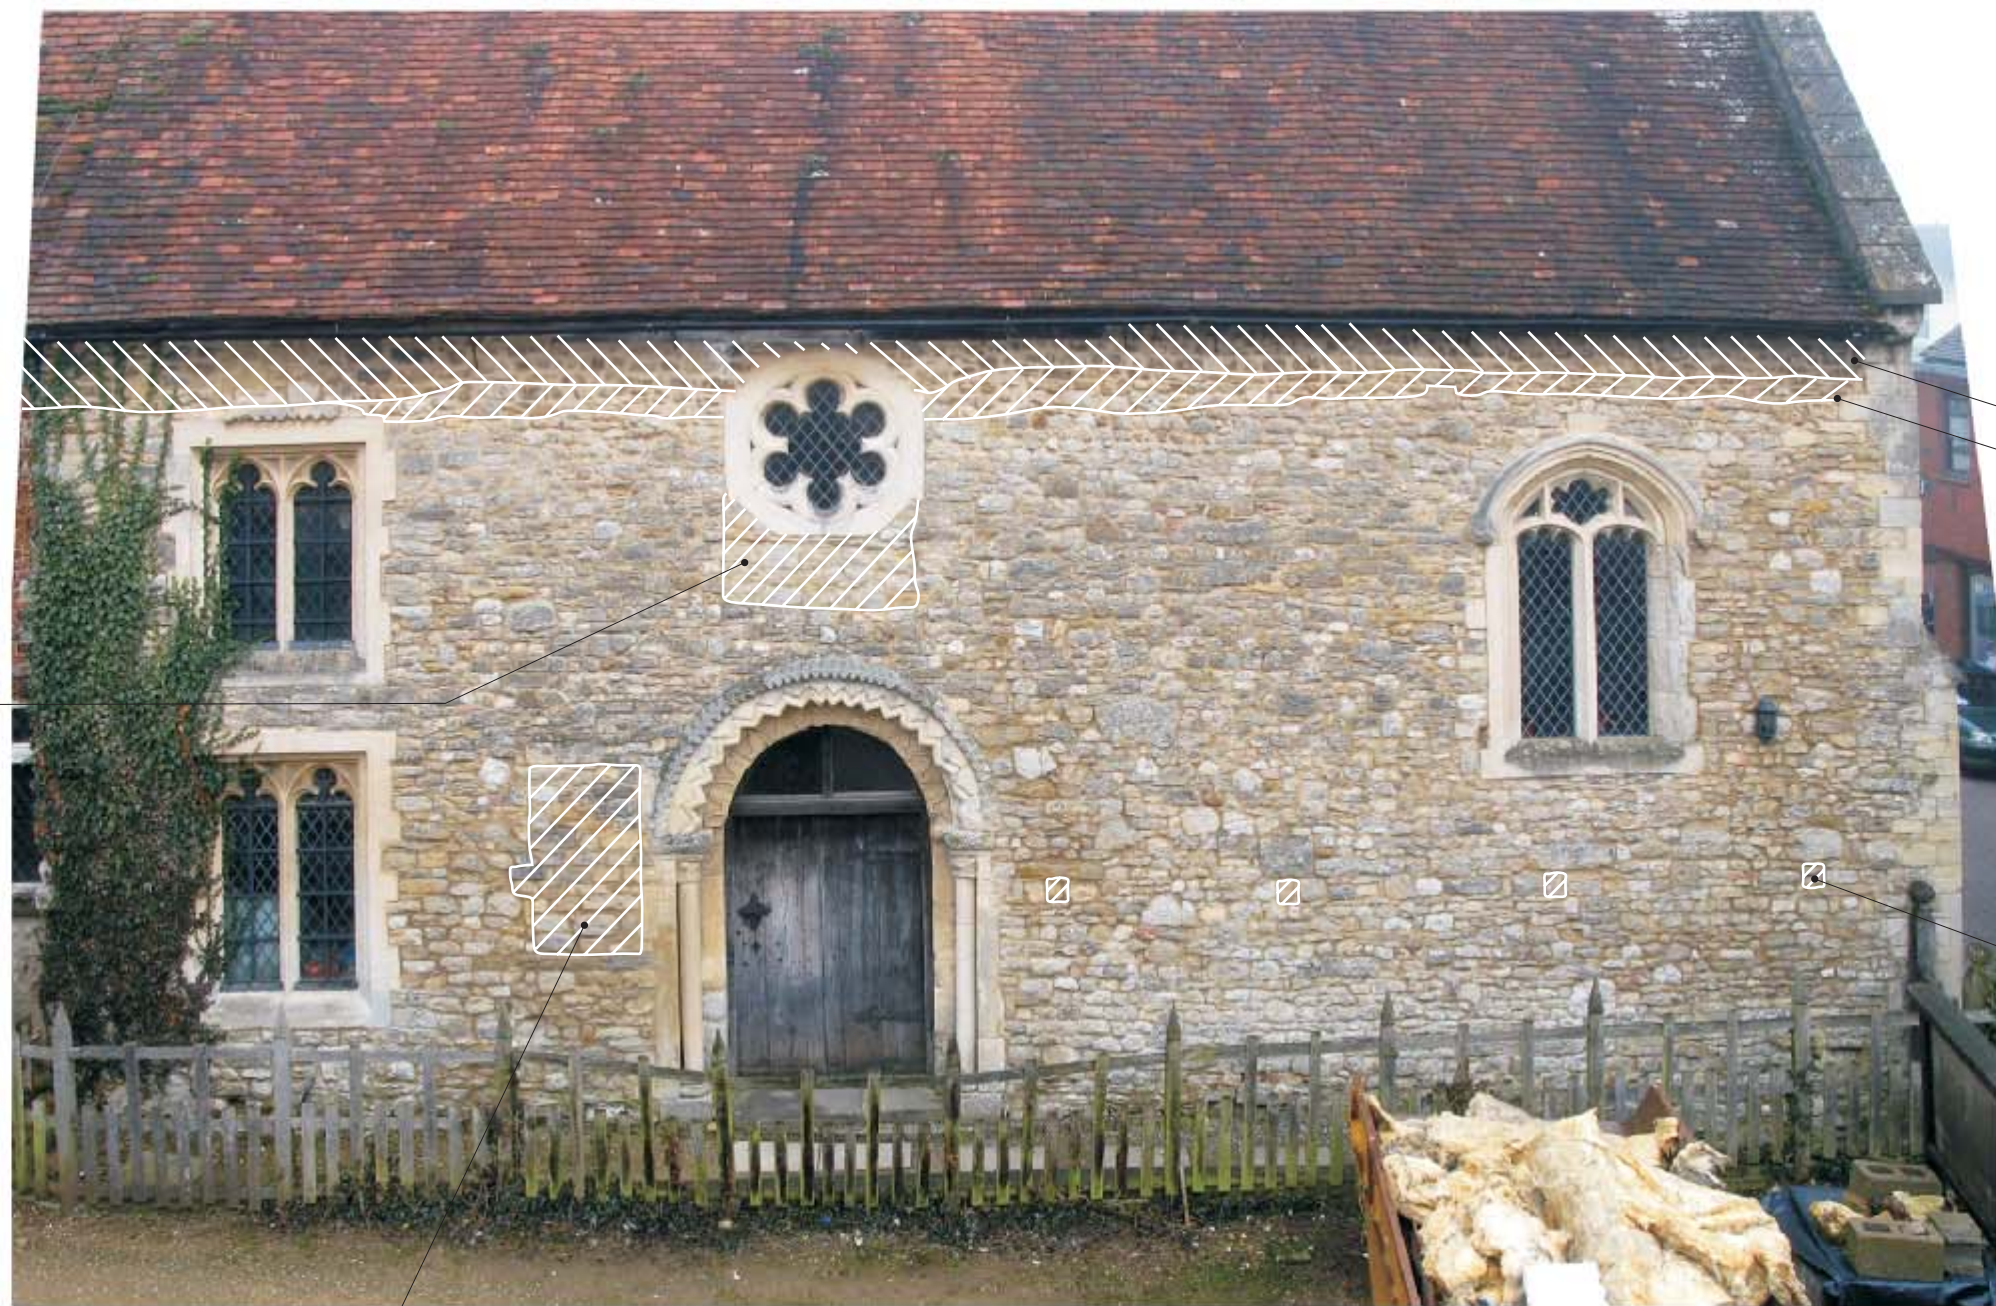
Interpretative rectified photo-evaluation of west wall elevation Fig 6

Blocked window

Re-set
Stonework

Putlog
holes

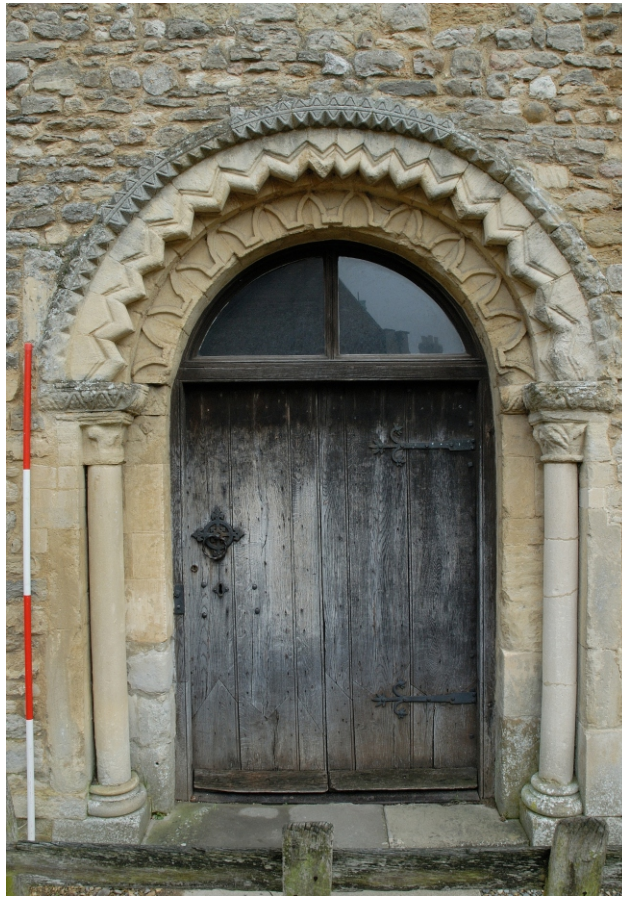
Fig 7: Detail of west entrance

The single entrance to the building lies at about the midpoint of the south wall (Fig 7). It comprises a high, wide oak door with a simple but fully developed Romanesque arch over, displaying three aspects of the order's decoration:

- A projecting outer string or hood of dog-teeth
- A middle row of chevrons
- An inner row of a simple repeating ogee motif in relief

Jambs and reveals are plain and enclose free-standing column shafts on cushion bases, surmounted by capitals with worn, indistinct (and therefore unclear) foliate decoration, possibly forming simple volutes. Both bases and capitals are fully engaged. On both sides the abacus forms impostes supporting the arch which have foliated chevron decoration (Figs 8 and 9).

The inner reveal and jambs are re-set and renovated. The innermost reveal has a groove in its underside suggesting it once held either glazing or, just conceivably formed part of a key for a tympanum. The chevrons of the central row of decoration are integral to each voussoir. Although they are distinctively inexpert in their carving, they are undamaged where they lie. Individual examples are slightly smaller toward the apex, where the two smallest lie in the position of a key, but cannot otherwise be distinguished. For these reasons it is suggested that the arch is as originally intended and is not a re-build in this position.

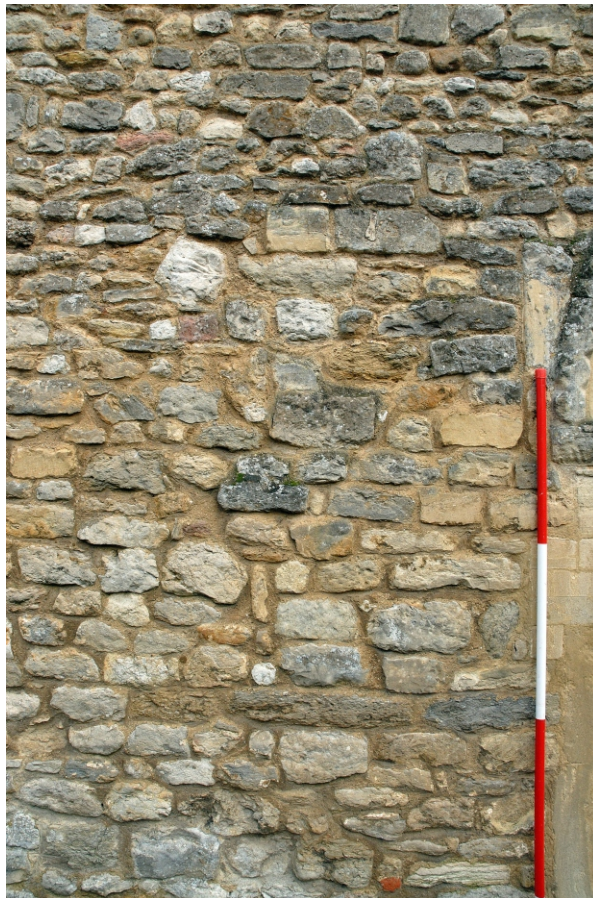
Fig 10: Blocked window

There are a number of variations in the wall-face. To the immediate left of the entrance is a blocked rectangular window embrasure (Figs 5, 6 and 10). Above the door and below the cusped round window is a patch of weathered roughly-coursed ashlar, blocking for the lower part of an earlier window (Figs 5 and 6). Two variations in stonework beneath the eaves attest two alterations or restorations, possibly affecting the roof (Figs 5 and 6). At about six feet above the ground a possible masonry lift is suggested by a distinctive arrangement of stonework which is probably built around, and subsequently filled, put-log holes from scaffolding (Figs 5, 6 and 11). This is a similar arrangement to those seen in the road-side gable but here forms a line of four.

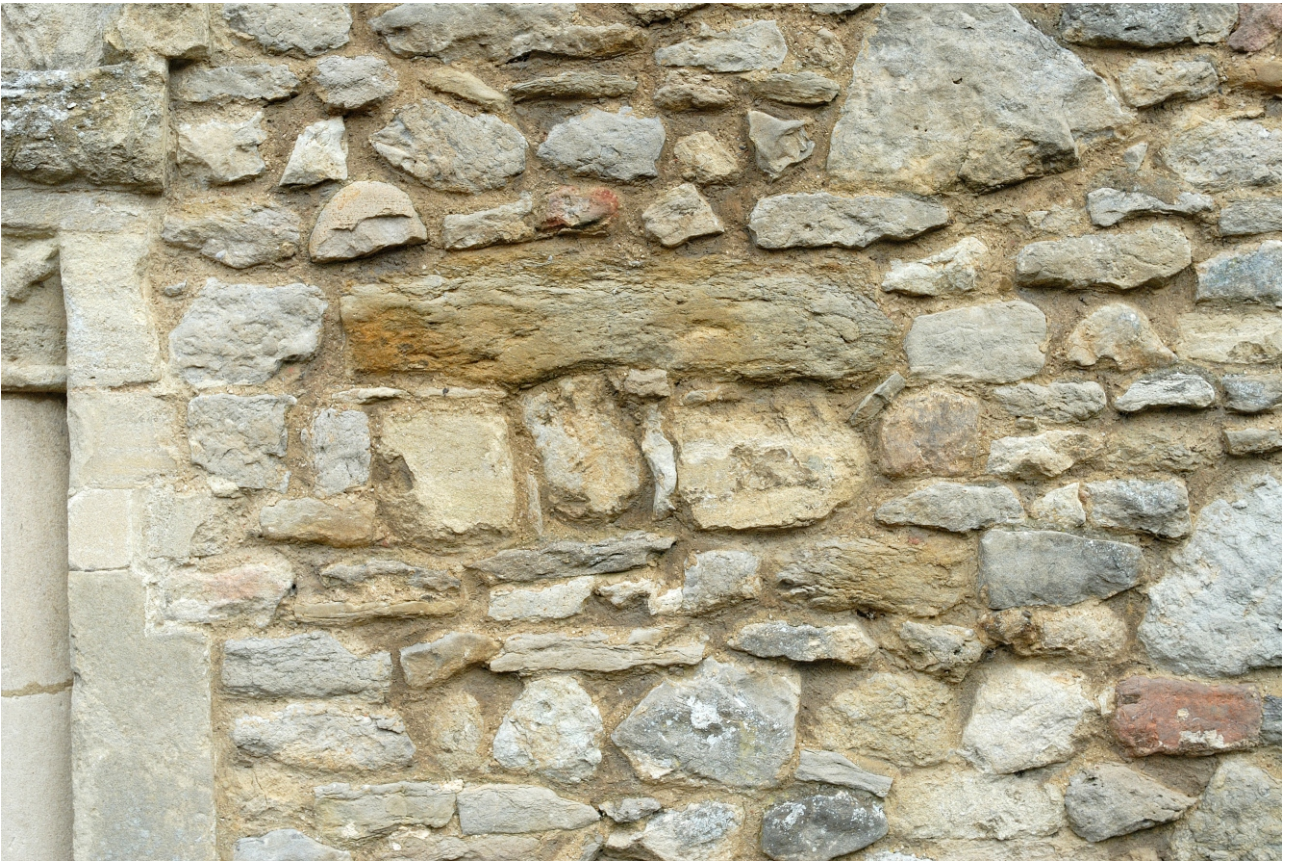
Fig 11: Blocked put-log hole

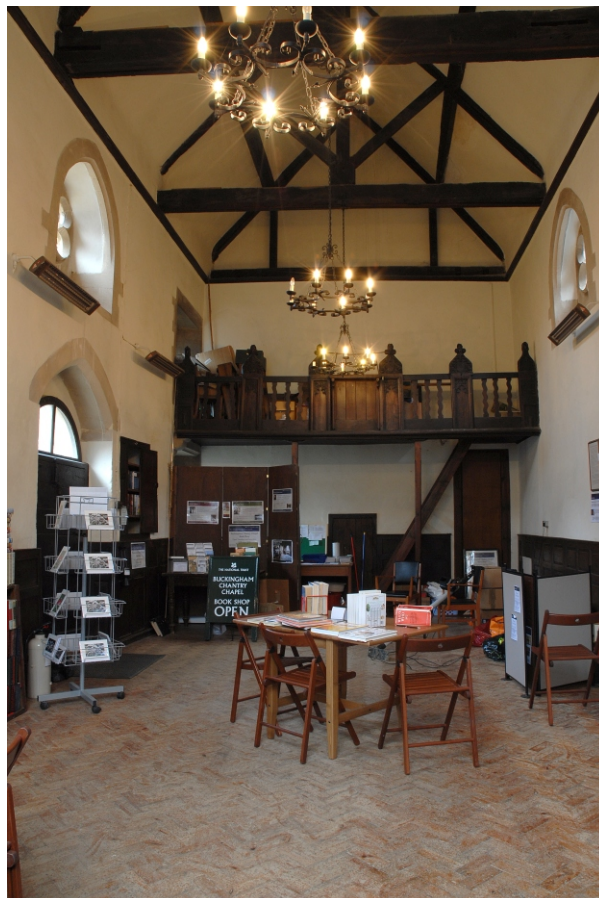
Fig 12: Interior, looking north

The interior is comprised of a single room measuring 11.5m x 5.1m, with a first-floor balcony at the north end and a deep window splay from floor to ceiling at the south end (Figs 12 and 13). The east wall, whose exact thickness is not known, steps in towards the south end. The reason for this is unclear. The floor is parquet woodwork throughout. All of the interior wall surfaces are plastered and painted, except for the arrises of embrasures. This means that no evidence of alteration in the stonework is visible on the inside.

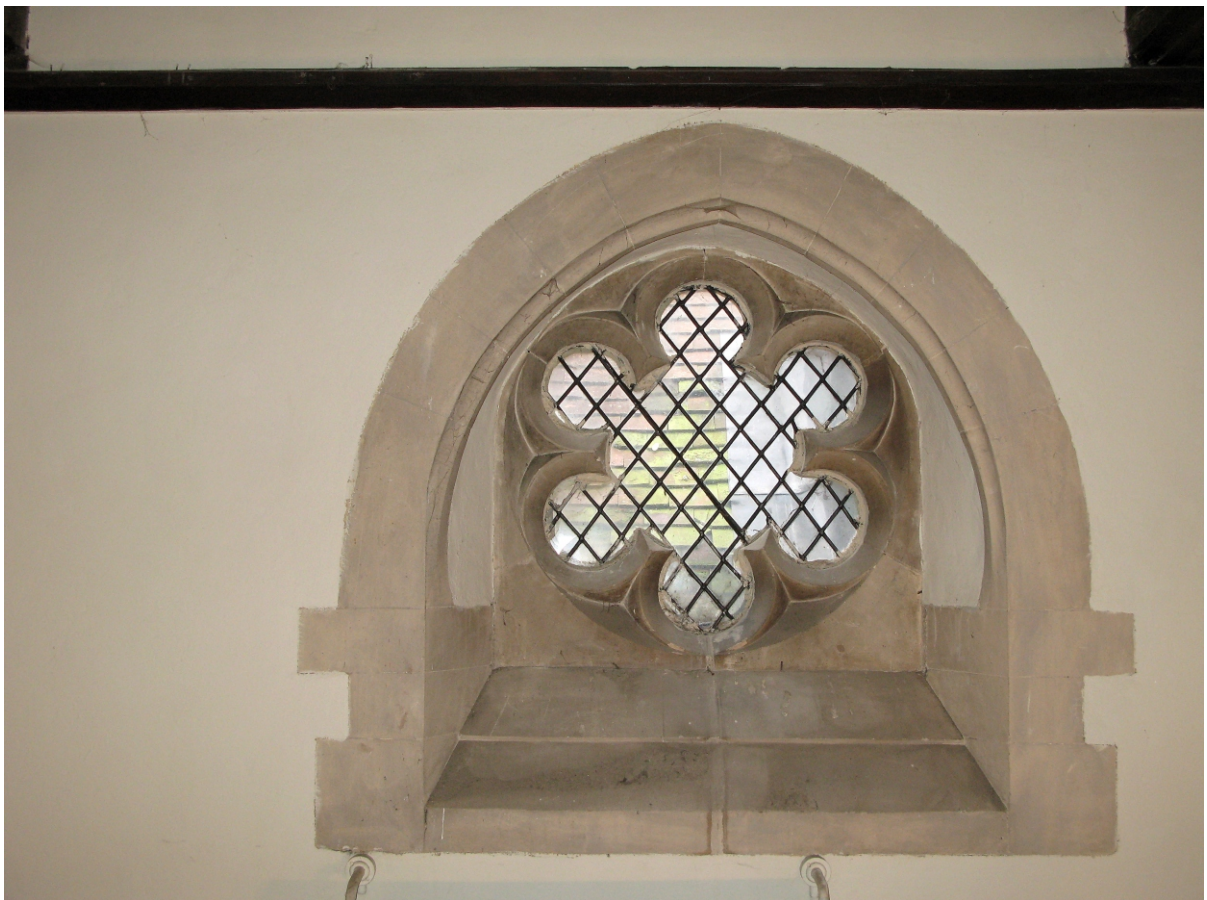
Fig 16: Clerestory window and cornice

Of the extant windows, all but one jamb (as noted on the exterior) are of nineteenth-century work. The view of the interior indicates that the three cusped round windows of the clerestorey, all set within deep embrasures, are nineteenth-century in date and are of a suite (Fig 16).

An oak cornice marks the location of a former suspended ceiling, now lost, at a height of 5.45m above the floor (Fig 16). In the roof there are a total of five trusses creating four

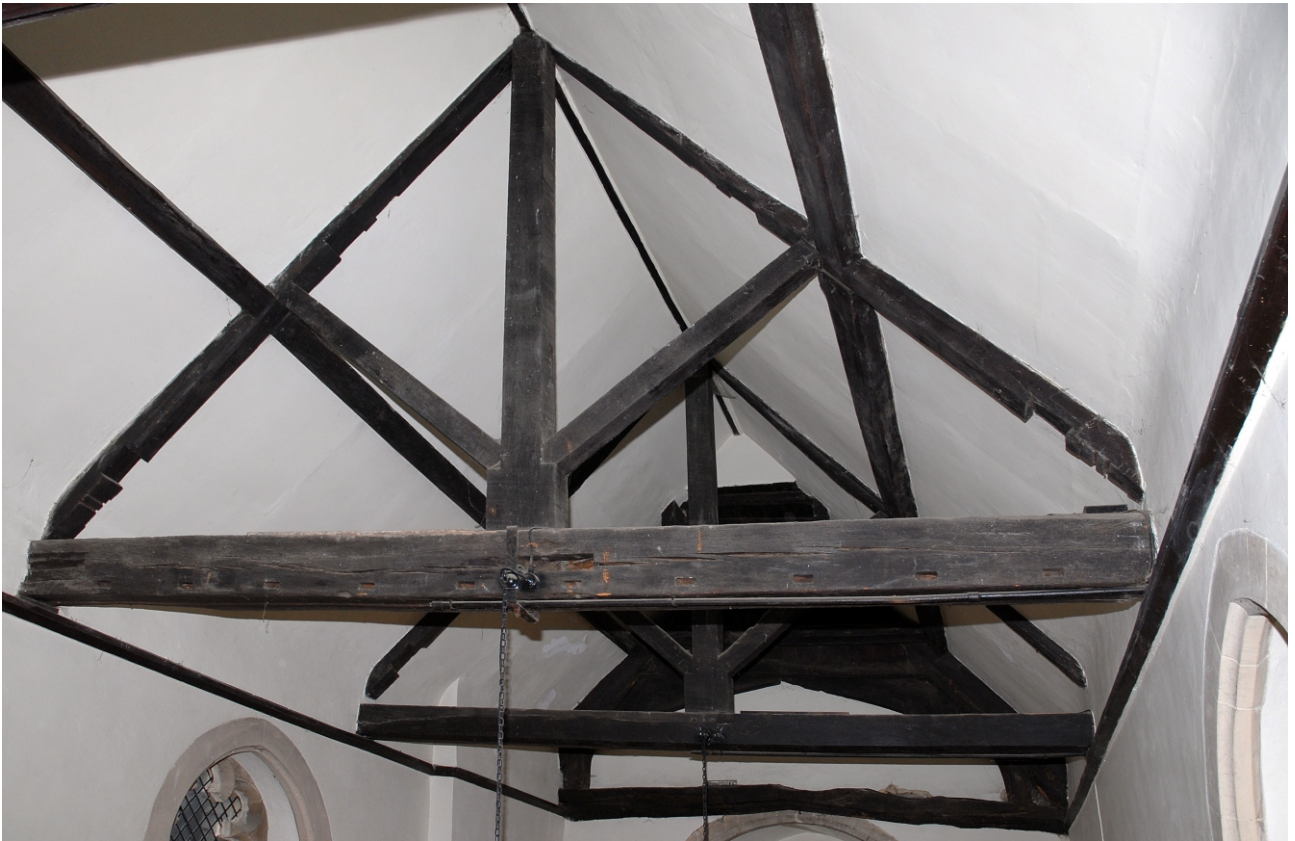
Fig 17: Roof interior, looking south

bays (Fig 17). The three middle trusses are of nearly identical layout, comprising king posts. However, the two gable end trusses differ. That on the north gable comprises simple tie and collar beams, but that to the south comprises a canted tie beam with moulded underside while above this is a separate collar supported by spere trusses (Fig 18). Fully within the room and adjacent to this collar, supported across the roof purlins, lies a substantial beam on which a bell-pulley is mounted. In the apex of the roof above are the timber vestiges of a former bell cupola, now lost and roofed over (Fig 18). It is not clear whether the bell pulley relates to the former cupola or the surviving bell-cote of 1879.

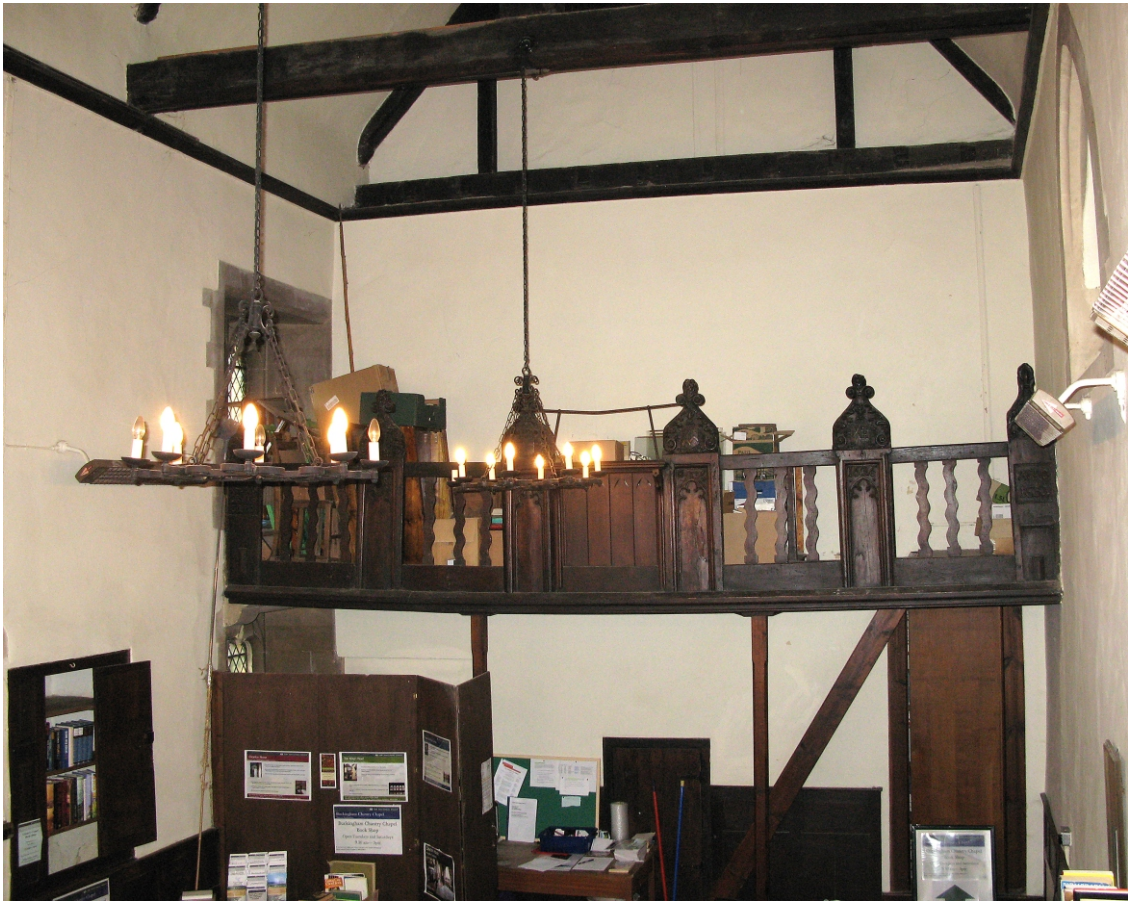
Fig 19: Balcony

At the north end of the room in the west wall, the higher of the two northern windows lights a wooden balcony accessed by a simple fixed timber stair (Fig 19). The front rail of the balcony comprises six re-used, seventeenth-century, highly decorative church pew-ends separated by a rail and wavy splat balusters re-used from a former staircase (Fig 20). All are of oak.

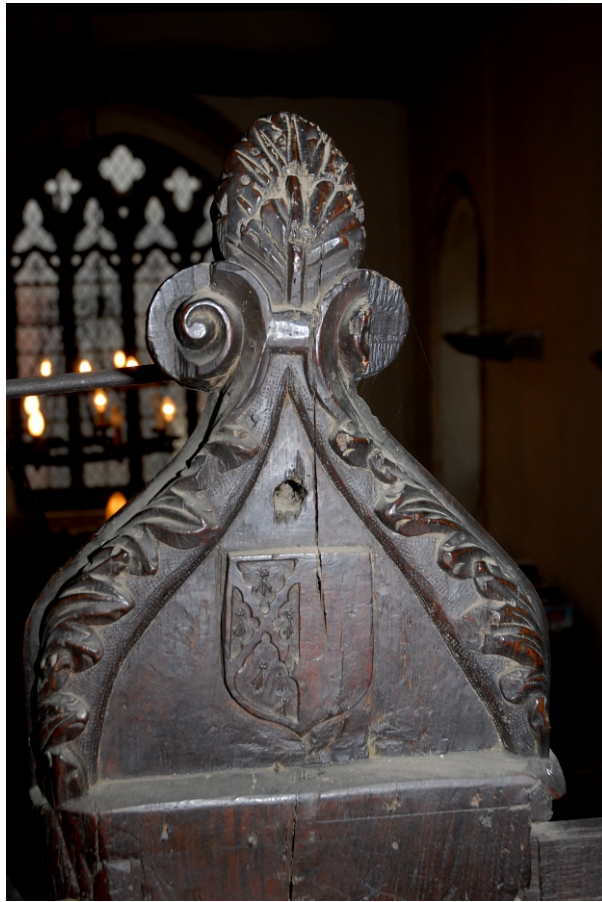
Fig 21: Pew-end (rear)

The pew ends are decorated with different schemes. The main body of the plank is carved into a cusped ogee head with flowers filling the spandrels, while the upper superstructure bears coats of arms on front and/or rear and acanthus foliage (Fig 21) with Jacobean strapwork and classical volutes surmounted by acanthus flowers with their petals curling back to form stylised fleurs-de-lys. Others bear the dates 1626 (Fig 22) and ANNO 1650 (both N's reversed). Another bears a panel with the words THOMAS GROVE GENT, the letter N of gent(leman) being reversed (Fig 23). On the rear is carved a love-heart with the initials A and G. All the decoration is carved in relief.
