An archaeological watching brief at

Sutton House, Hackney

Report 09/15

**AN ARCHAEOLOGICAL WATCHING BRIEF AT SUTTON HOUSE,
HACKNEY**

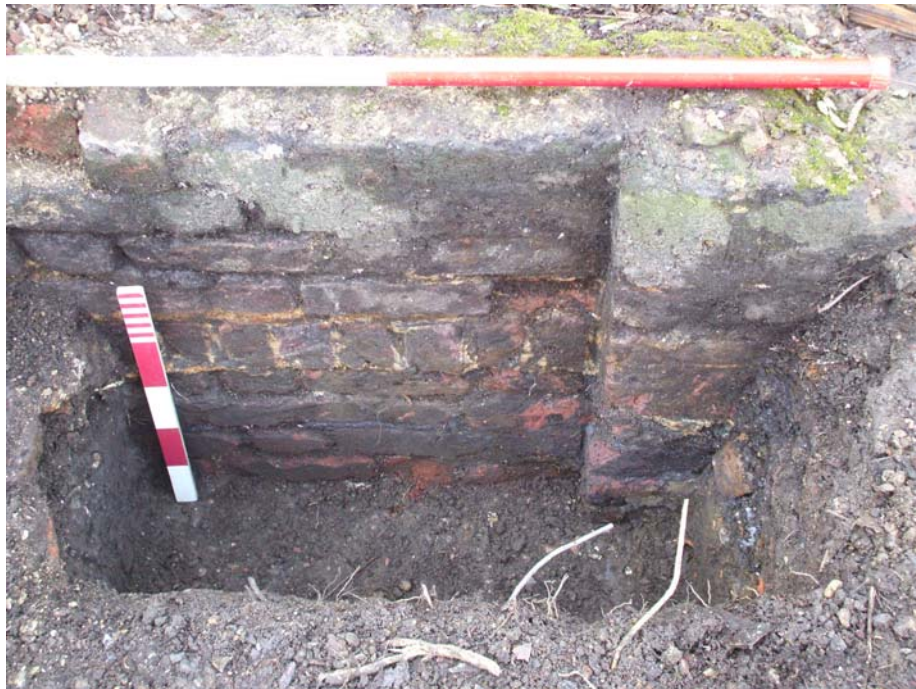
Plate 2: Test pit 1, looking west

The wall was strengthened by slightly-built brick buttresses [6], [8], [10] that were spaced at regular intervals of *c* 3.8m (22 feet 4 inches) centre to centre. These were visible in TPs 1,4,6 (Fig 3, Section 1; Plates 2, 5 and 7). They were *c* 0.40m wide and projected from the face of the wall by only a brick's width (100mm). Based upon the observed spacing another buttress was probably obscured by the soil baulk left in between TPs 8 and 9. This conjecture would leave a gap of *c* 1m between this and another, northernmost buttress [12] which corresponded with the position of a small recess [14] between the upper and second course of both the wall and the buttress that bore traces of timber (Fig 3, Section 1; Plate 10). This may be related to the position of a former aperture in the wall, perhaps a sill or step for a gateway or window. Perhaps co-incidentally, an aperture appears in roughly the same location in the reconstructed plan of the Tanhouse by Mike Gray that is reproduced in the MoLAS evaluation report (2007, fig 9). Alternatively, the timber could simply have been used to level up prior to the construction of the second phase of walling (see below). A larger recess [13], measuring 0.12m deep was observed in the upper course of the wall in TP8 (Fig 3, Section 1; Plate 9); its function remains unknown.

In TPs 1-3 the face of wall [2] was flush with the underlying fabric (Plates 2-4); to the north, in TPs 4-9 (Plates 5-10), it overhung it by up to 0.06m; perhaps the result of subsidence.

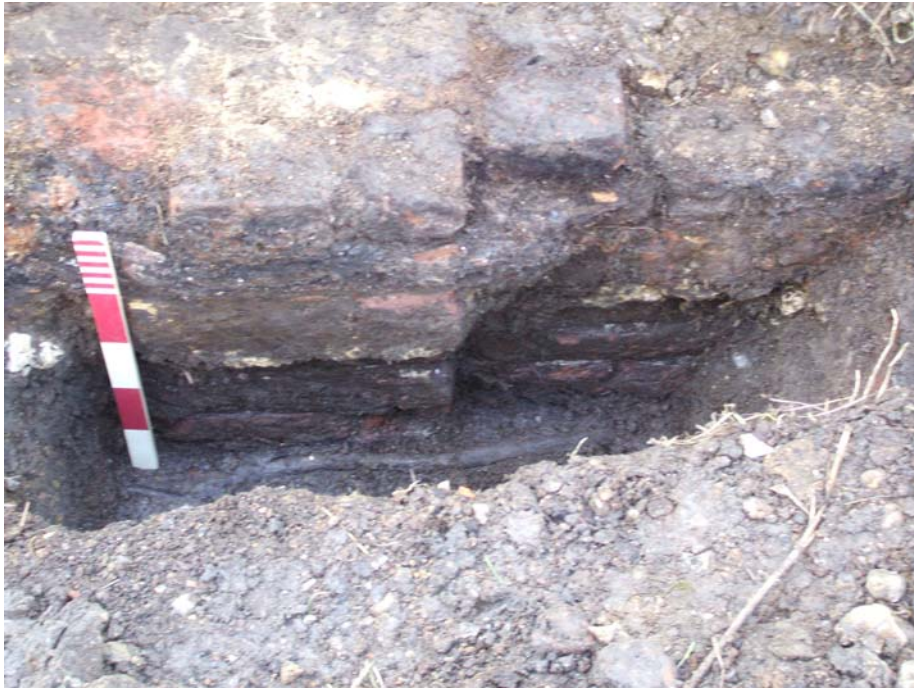
Plate 5: Test pit 4, looking west

designed as a direct copy of the original. The presence of corresponding buttresses on the west face of the wall was suggested by a right angled return observed in the brickwork of the buttress revealed in TP4. A similar arrangement was present to the north where the trial trench exposed the wall's west face (MoLAS 2007, fig 6).

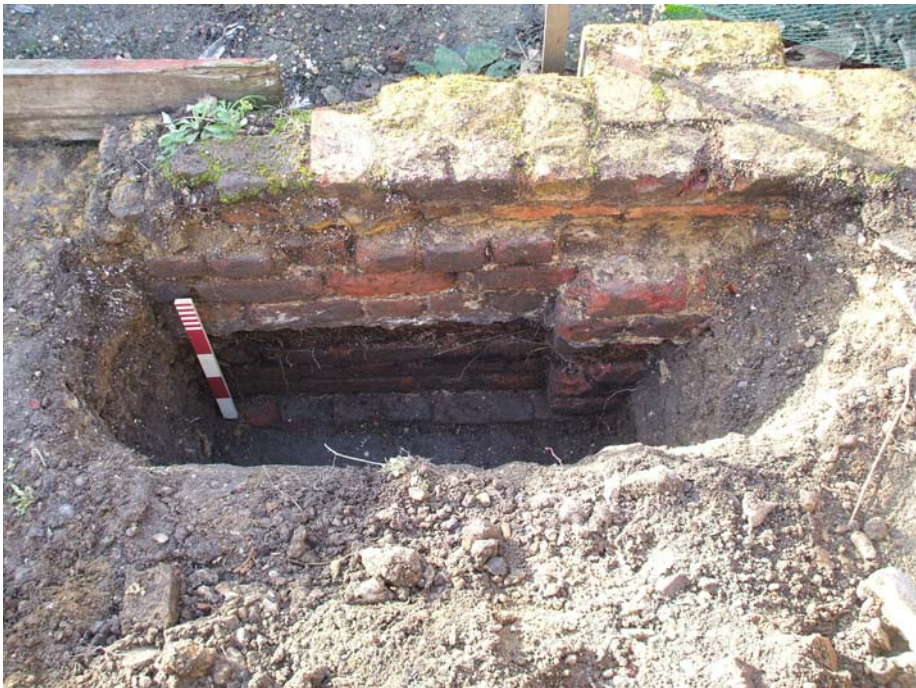
Plate 10: Test pit 9, looking west

The earliest wall [3] had previously been recorded during the evaluation of the site and subsequently identified a possible remnant of the complex of buildings known as the Tanhouse (MoLAS 2007, 9). The top of this wall lay at 15.36-15.46mOD and comprised four, even courses of irregular brickwork bonded with a loose off-white lime mortar (Fig 3, Section 1; Plates 2-10). The individual bricks were handmade and date to the 18th century. They measured 228 x 100 x 60mm (9 x 3 ⁵/₈ x 2³/₈ inches) and were lain over a footing of 'headers' [15] that projected *c* 0.06m from the face of the wall at 14.96-15.08mOD (this footing was only visible at the base of TPs 6-9 which were deeper than those to the south; see Plate 10; the MoLAS trial trench showed this footing to be four courses deep (MoLAS 2007, fig 5)).

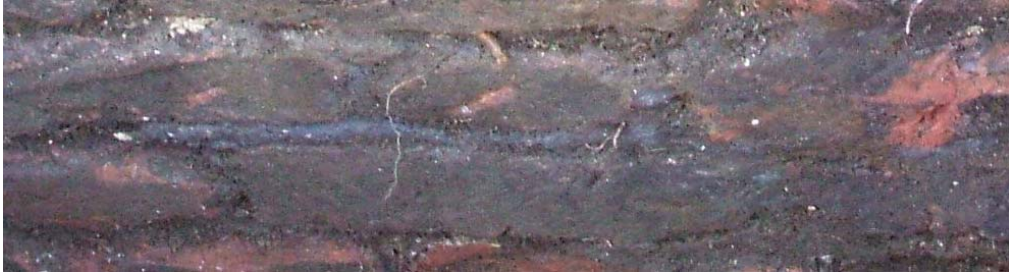
Along its length, localised patches of the wall had been re-pointed with a mid-grey to charcoal grey mortar (Plate 11).

Plate 11: Re-pointing in 18th (?) century wall [3]

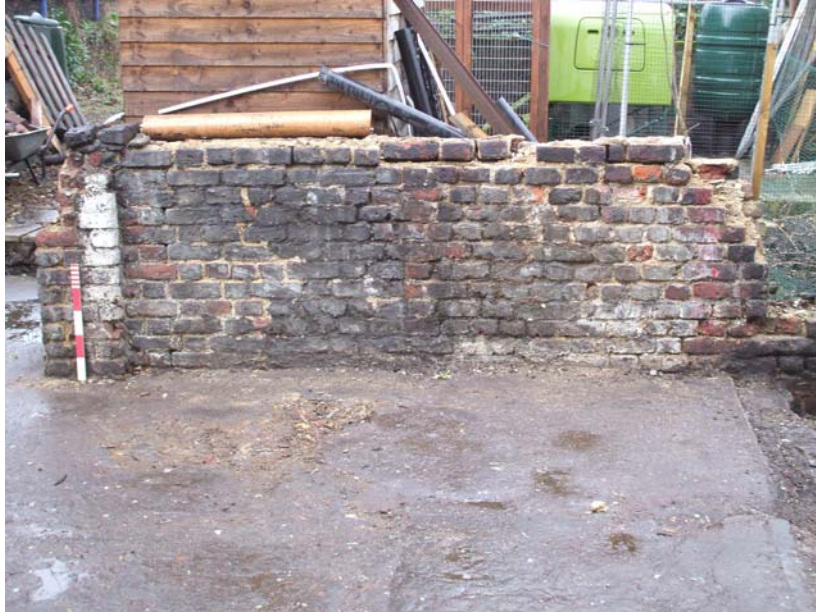
A second wall [2] was bonded to the top of the earlier with a thick application of very hard off-white lime mortar. At the southern end of the site, beyond the area investigated by the test pits, this wall stood to a height of *c* 1m (to *c* 16.50mOD; Plate 12). Where observed within the pits themselves it had been reduced to only two or three courses (surviving on average to only *c* 15.60m OD). It was constructed from bricks measuring 215 x 100 x 60mm (8½ x 3 ⅝ x 2⅜ inches), laid in even, but irregular, courses over a single course of 'headers'. It was bonded with a medium hard yellow mortar.

Plate 12: Upstanding fabric of 19th (?) century wall [2]

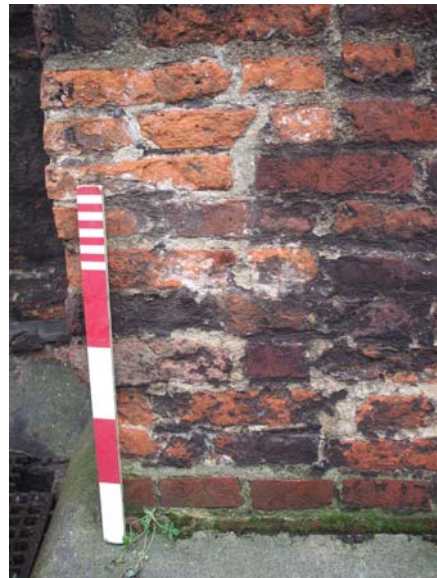
Further indications that the wall is not related to the Tanhouse are offered by the size of the bricks used in its construction which probably date to the 18th century. The early bricks used in the fabric of Sutton House, where observed in the patched-up west chimney breast (Plate 13) were a different fabric and much slighter measuring 220mm x 90mm x 40mm (8½ x 3½ x 1½ inches). Further doubt is introduced by the quality of the wall's construction, including its irregular bond and poor quality mortar; neither seems in keeping with a respectable dwelling such as the Tanhouse. The patchy, poorly executed re-pointing in a dark grey mortar is incongruous in this respect as it is usually employed on buildings of reasonable status – but in a far more carefully applied manner. Perhaps it was used opportunistically as a 'left-over' from another building. Neither does the slight size of the buttresses, and their correspondence with the positions of the later property boundary wall, convince. Finally, no finds pre-dating the 19th century were retrieved from the soils that had accumulated against the

Plate 13: Early bricks used in exterior of Sutton House's western chimney breast
