Archaeological Buildings Recording  
of a Wall at 4 High Street Wootton

Northamptonshire

January 2009

Report 09/10

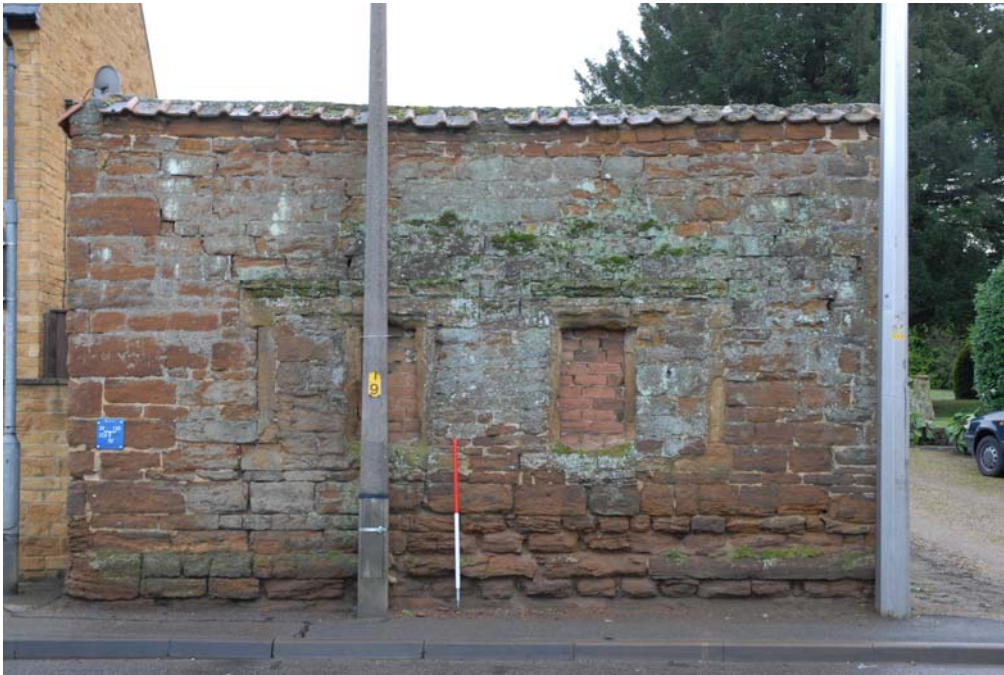
The windows had undergone two phases of blocking, the first with dressed stone blocking the opposite half of each window (Fig 4, Plate 1). The second phase of blocking was with machine-made bricks, these measured 9 inches x 4 ¼ inches x 2 ⅞ inches, which would indicate a 19th-century date. The wall also had a plinth, which possibly had a moulded top, although again this was much eroded (Fig 4, Plate 1).

Plate 1: West facing elevation

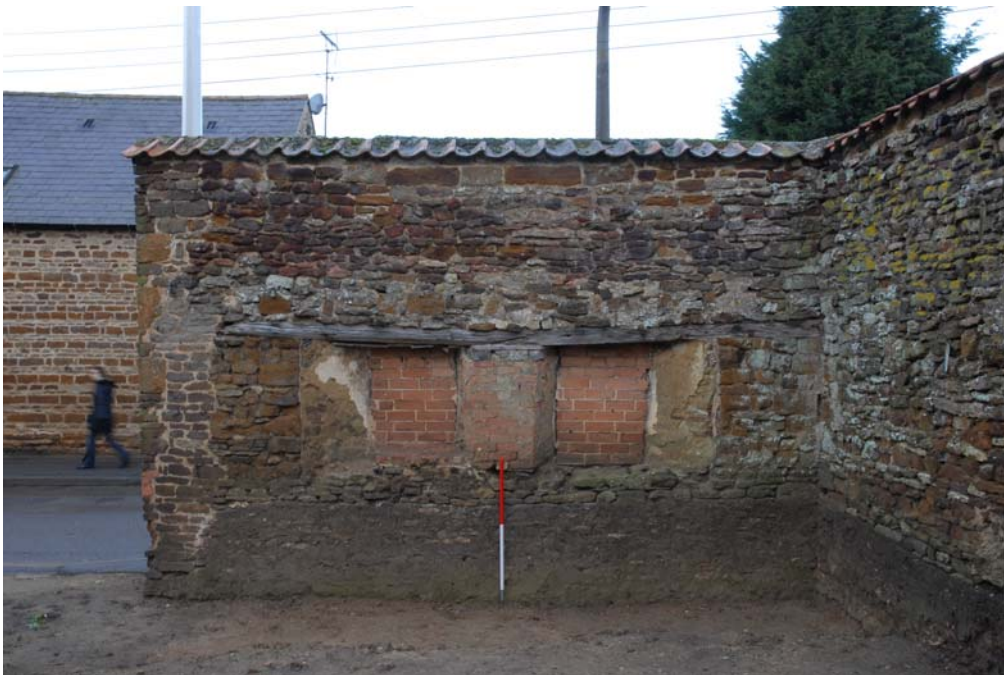
The east facing (former interior) elevation of the wall measured 5.2m long by 3.6m high and was constructed in very roughly coursed Northamptonshire Sand Ironstone rubble, bonded with a buff lime mortar. The upper two courses below the pantile capping were in dressed stone which would suggest that the upper part of the wall had been rebuilt, perhaps when the wall no longer functioned as part of a building.

Plate 2: East facing elevation

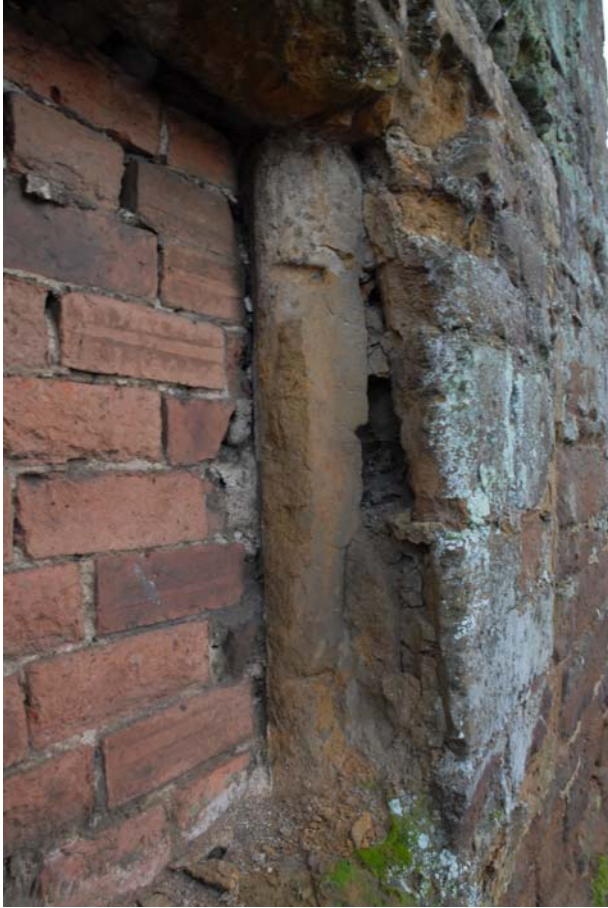
The mullions, although in a very poor eroded condition, showed remnants of a cavetto moulding (Plate 3). There was no evidence for glazing grooves, although sockets for horizontal iron bars did survive (Plate 3). An iron hinge also survived (Plate 4) which may be a fitting for internal shutters which were common with unglazed mullioned windows. Above both windows there was a very badly eroded hood mould.

Plate 3: Detail of window bar slot

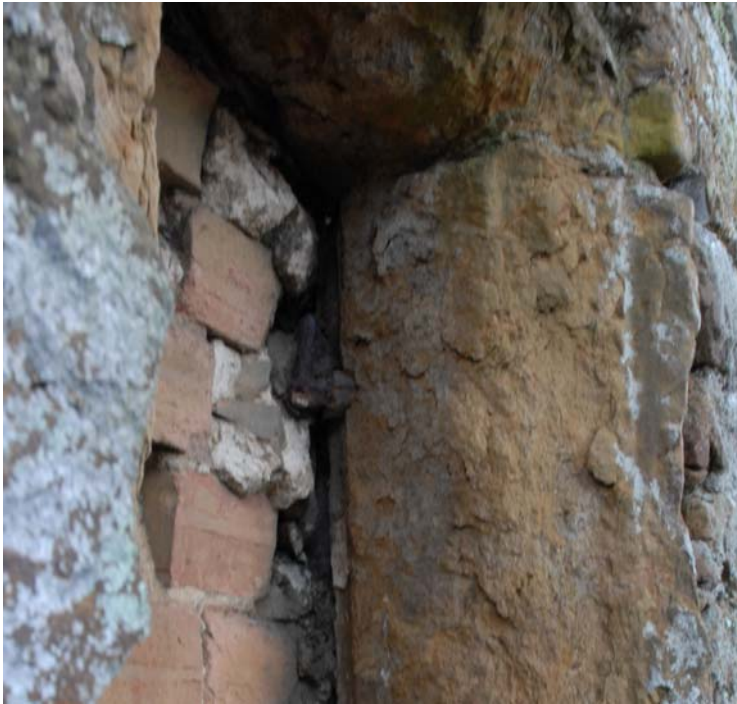
Plate 4: Detail of iron hinge

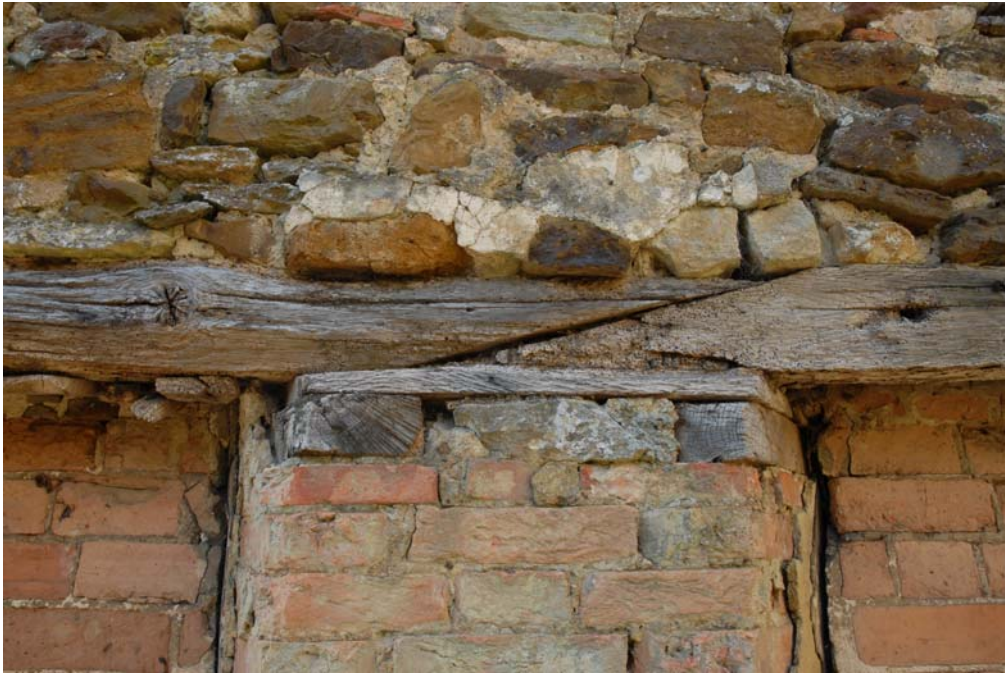
On this face of the wall the windows had a wooden lintel with a central scarf joint (Plate 5). The first phase blocking of each window was less visible on this elevation. Each jamb was originally splayed; when one half of each window was infilled the blocking formed a wider splay from the edge of the original window to the central mullion (Fig 5, Plate 2). This blocking was given a plaster finish which presumably matched the remainder of the original wall surface, though here it has been lost.

The section of the wall between the windows had been rebuilt in hand made brick at a later date, probably during the eighteenth century. Where this brick pier had been inserted beneath the wooden lintel, wooden blocks and a section of plank were used as packing (Fig 5, Plate 5). Planking also survived beneath the lintel in the southern window opening which may be the remnant of original finishing (Plate 6). No complete internal window sills had survived although there was the remnant of a plank beneath the central brickwork; also there were a series of wooden blocks set into the wall below where the original sill would have been. These may have been fixing points for a wooden sill.

Plate 5: Detail of scarf joint and wooden blocks

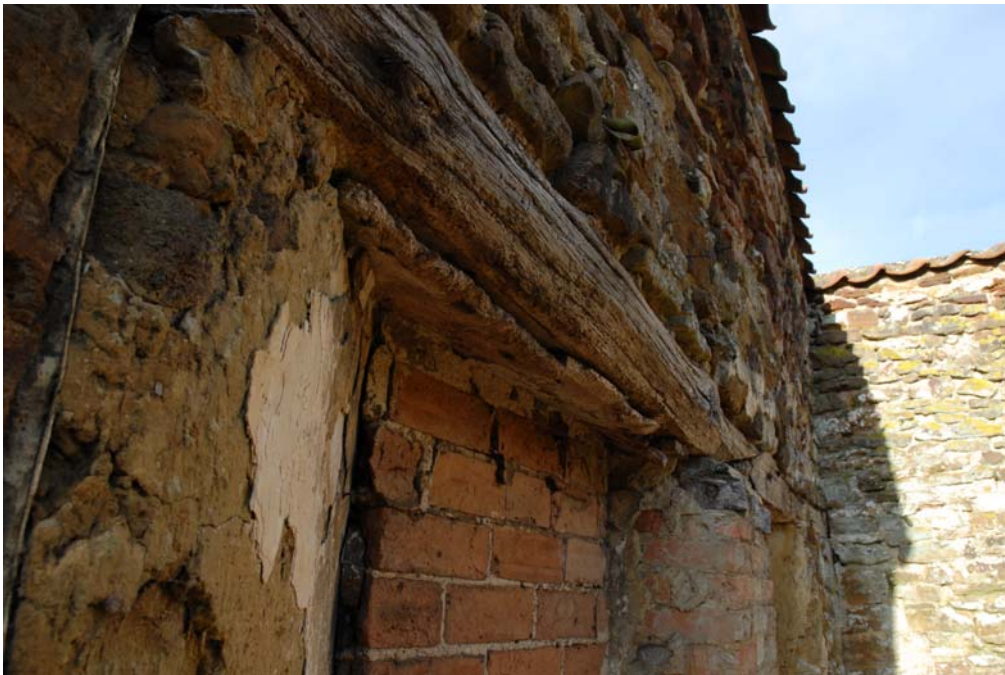
Plate 6: Detail of planking below lintel
