Archaeological Watching Brief at
Home Wood Medieval Fishery and Warren
(SM29423), Northill
Bedfordshire
February 2009

Report 09/44

**AN ARCHAEOLOGICAL WATCHING BRIEF AT
HOME WOOD MEDIEVAL FISHERY AND WARREN (SAM29423),
NORTHILL, BEDFORDSHIRE**

BEDFM.2009.22

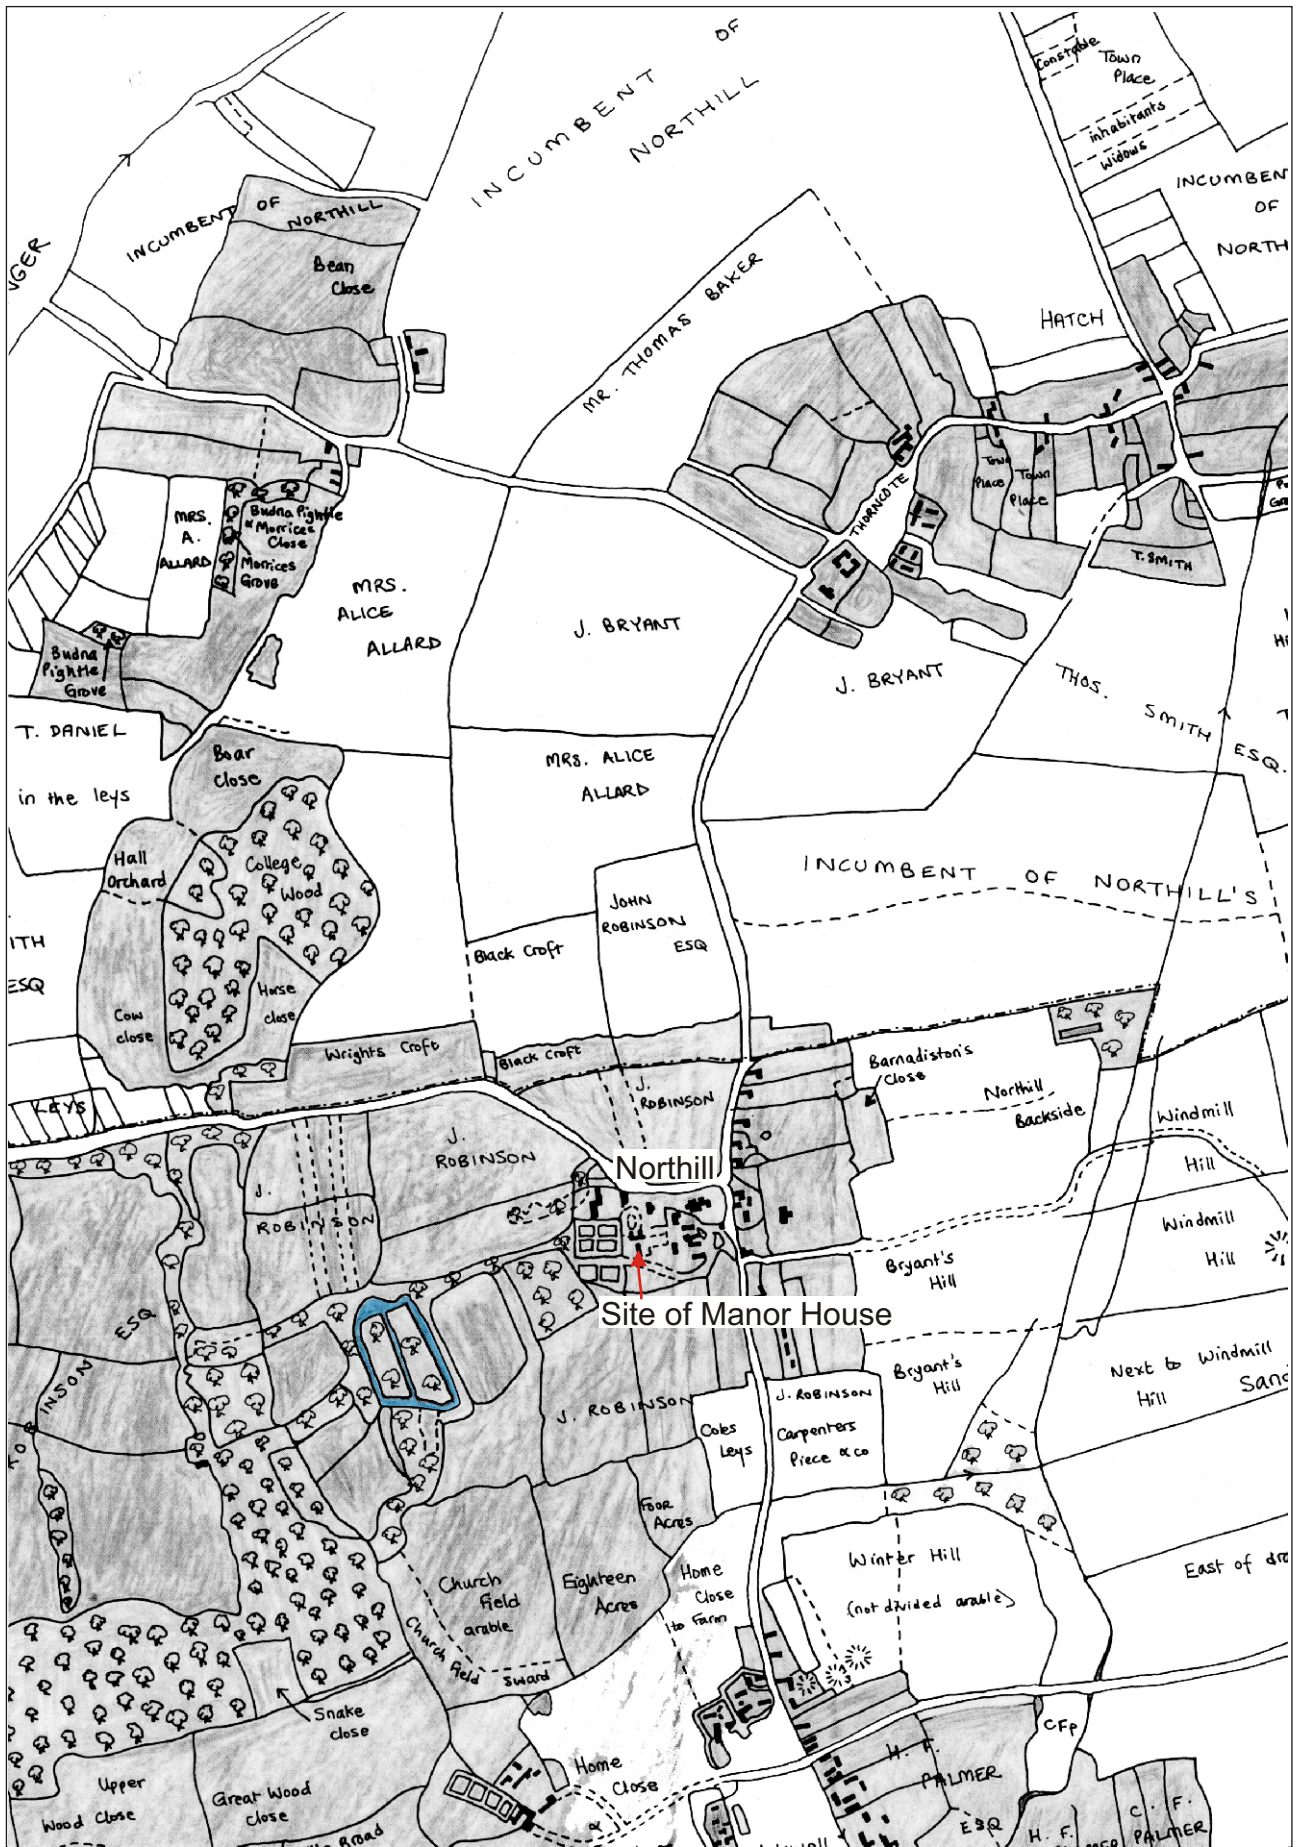
Northhill Enclosure map, 1781 (transcript) Fig 3

As regards the fishpond and warren complex, there are very limited historical references to the site. The principal source is a map of 1781 (Fig 3) indicating that the fishpond complex belonged to Northill Manor, which stood on the crest of a slope immediately to the west of the Northill Church. The map shows a building or buildings

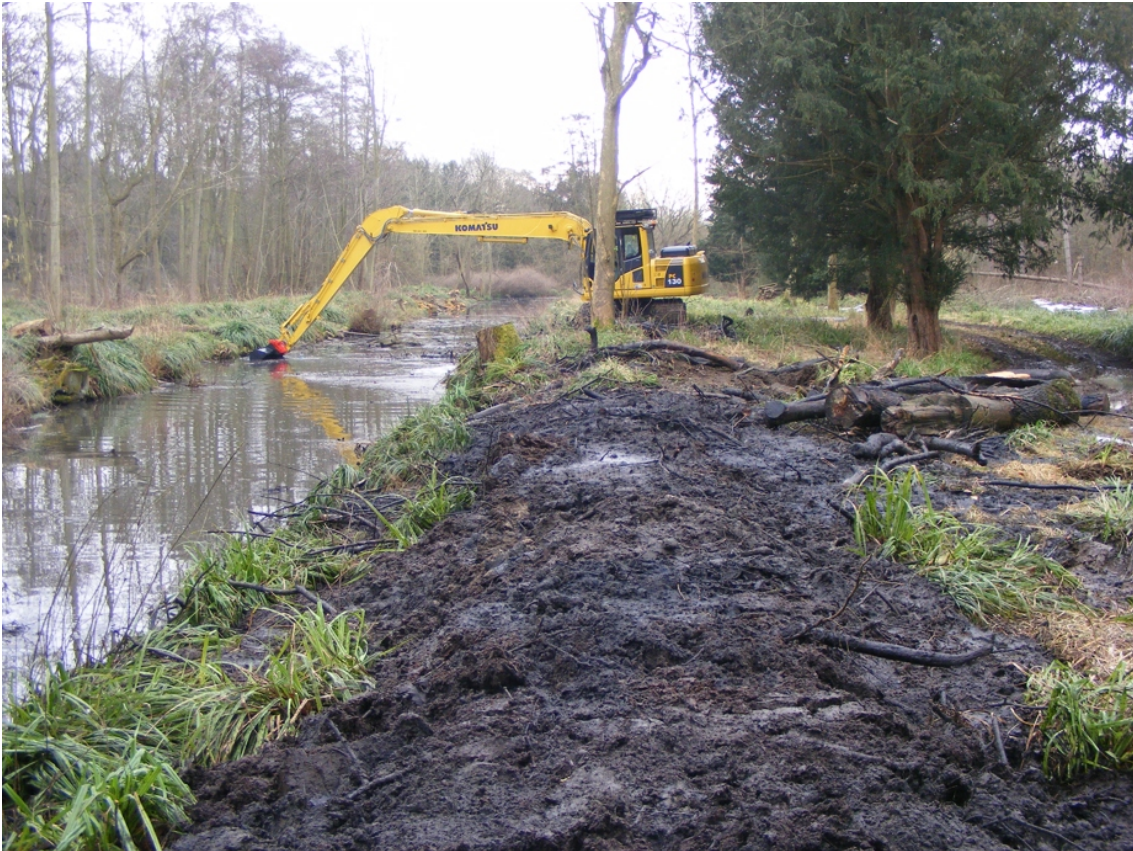
Plate 1: West moat arm [3], looking south

Machine excavation by a 360° excavator fitted with a long reach toothless ditching blade was undertaken working north to south for approximately 110m to the intersection with the southern moat arm and the outlet adjacent to the dam (Fig 4, Cover, Plates 1 and 2). The dredged material was stacked adjacent to the moat arm where it was scanned for any archaeological ecofacts and or remains.

Two tertiary layers were recovered during the observation works, however as the moat was water filled at the time of their removal only an approximate description of their depth can be given. The two layers (1 and 2) seemed to extend across the entire c10-12m width of the moat [3] and were similar in composition, comprising waterlogged dark brown to black silts. The earliest layer (2) was c0.2m thick at the northern end and up to 0.3m thick at the southern end and contained decayed tree litter, fragmentary brush wood and a single residual floor tile fragment, possibly of Roman date. This was overlain by (1) which was c0.2m thick at the northern end and up to 0.6m thick at the southern end at the junction with the southern moat arm. It contained a large number of logs, (either felled, wind blown or decayed), frequent brush wood, leaf matter, occasional plastic sheeting and a number of spent gun shot cartridges, which were recovered by metal detecting, but not retained.

- The western moat arm (part of) situated close to the western margin of the scheduled area (Cover and Plates 1 and 2), the area of observation extending approximately north to south to the intersection with the southern moat and dam, ceasing circa 40m short of the intersection with the northern moat arm due the presence of standing trees, where lack of funds excluded their removal.
- Repairs to a crossing access point into the warren interior via causeway within the northern moat arm and replacement/insertion of a culvert (Plates 3 and 4).
- Repairs to an existing dam in the south west corner of the monument, where a temporary cofferdam was inserted to allow for drainage operations and recording of the dam prior to its repair and consolidation (Plates 5-10).

The ground works were carried out using tracked 360° excavators fitted with a variety of toothless ditching buckets, (Plates 1 and 2). A photographic record in both black and white negative and colour slide was kept, with supplementary photographs in digital format. The written record comprised Northamptonshire Archaeology pro-forma sheets. The watching brief was carried out in accordance with the *Standards and guidance for archaeological watching brief* (1994, revised 2001 and 2008) and the *Code of Conduct of the Institute of Field Archaeologists* (1985, revised 2006). Additionally, all works complied with the guidelines detailed in *Standards for Field Archaeology in the East of England* (Gurney 2003).

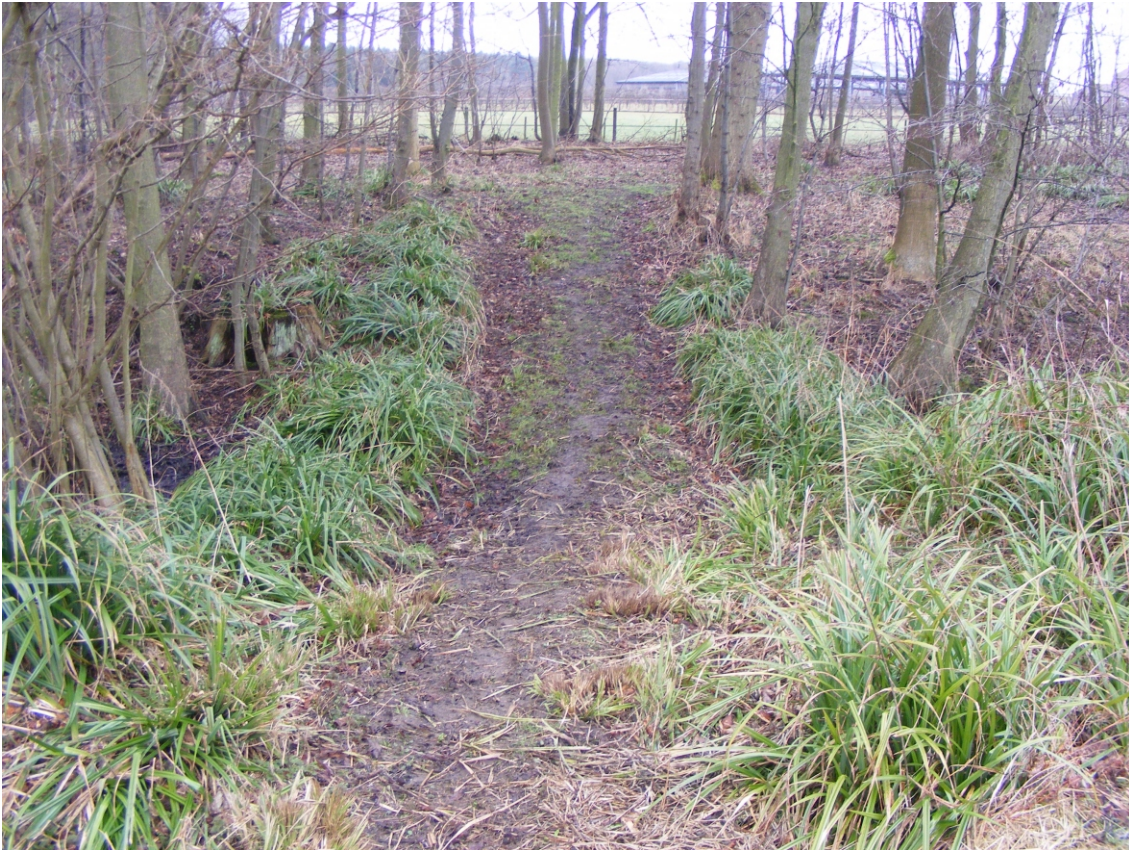
Plate 3: North moat arm/culvert [5], looking north pre-excitation

Machine excavation in this area was minimal (Plates 3 and 4), with only limited impact upon the northern moat arm [5] and access causeway, which at this point measured circa 6m wide. A mixed topsoil/subsoil deposit (4) comprising a mid grey brown silt clay, containing metal sheeting was removed to a depth of 0.15m to allow for insertion of two 6m long plastic culvert pipes to facilitate water flow. These were then sealed by a 0.6m thick deposit of hogging material prior to levelling and covering with the removed topsoil. Apart from two fragments of medieval/post medieval tile, no other finds or features of archaeological significance were found.
