**DELAPRE ABBEY**

**NORTHAMPTON**

**GEOPHYSICAL, TOPOGRAPHIC**

Report 09/059

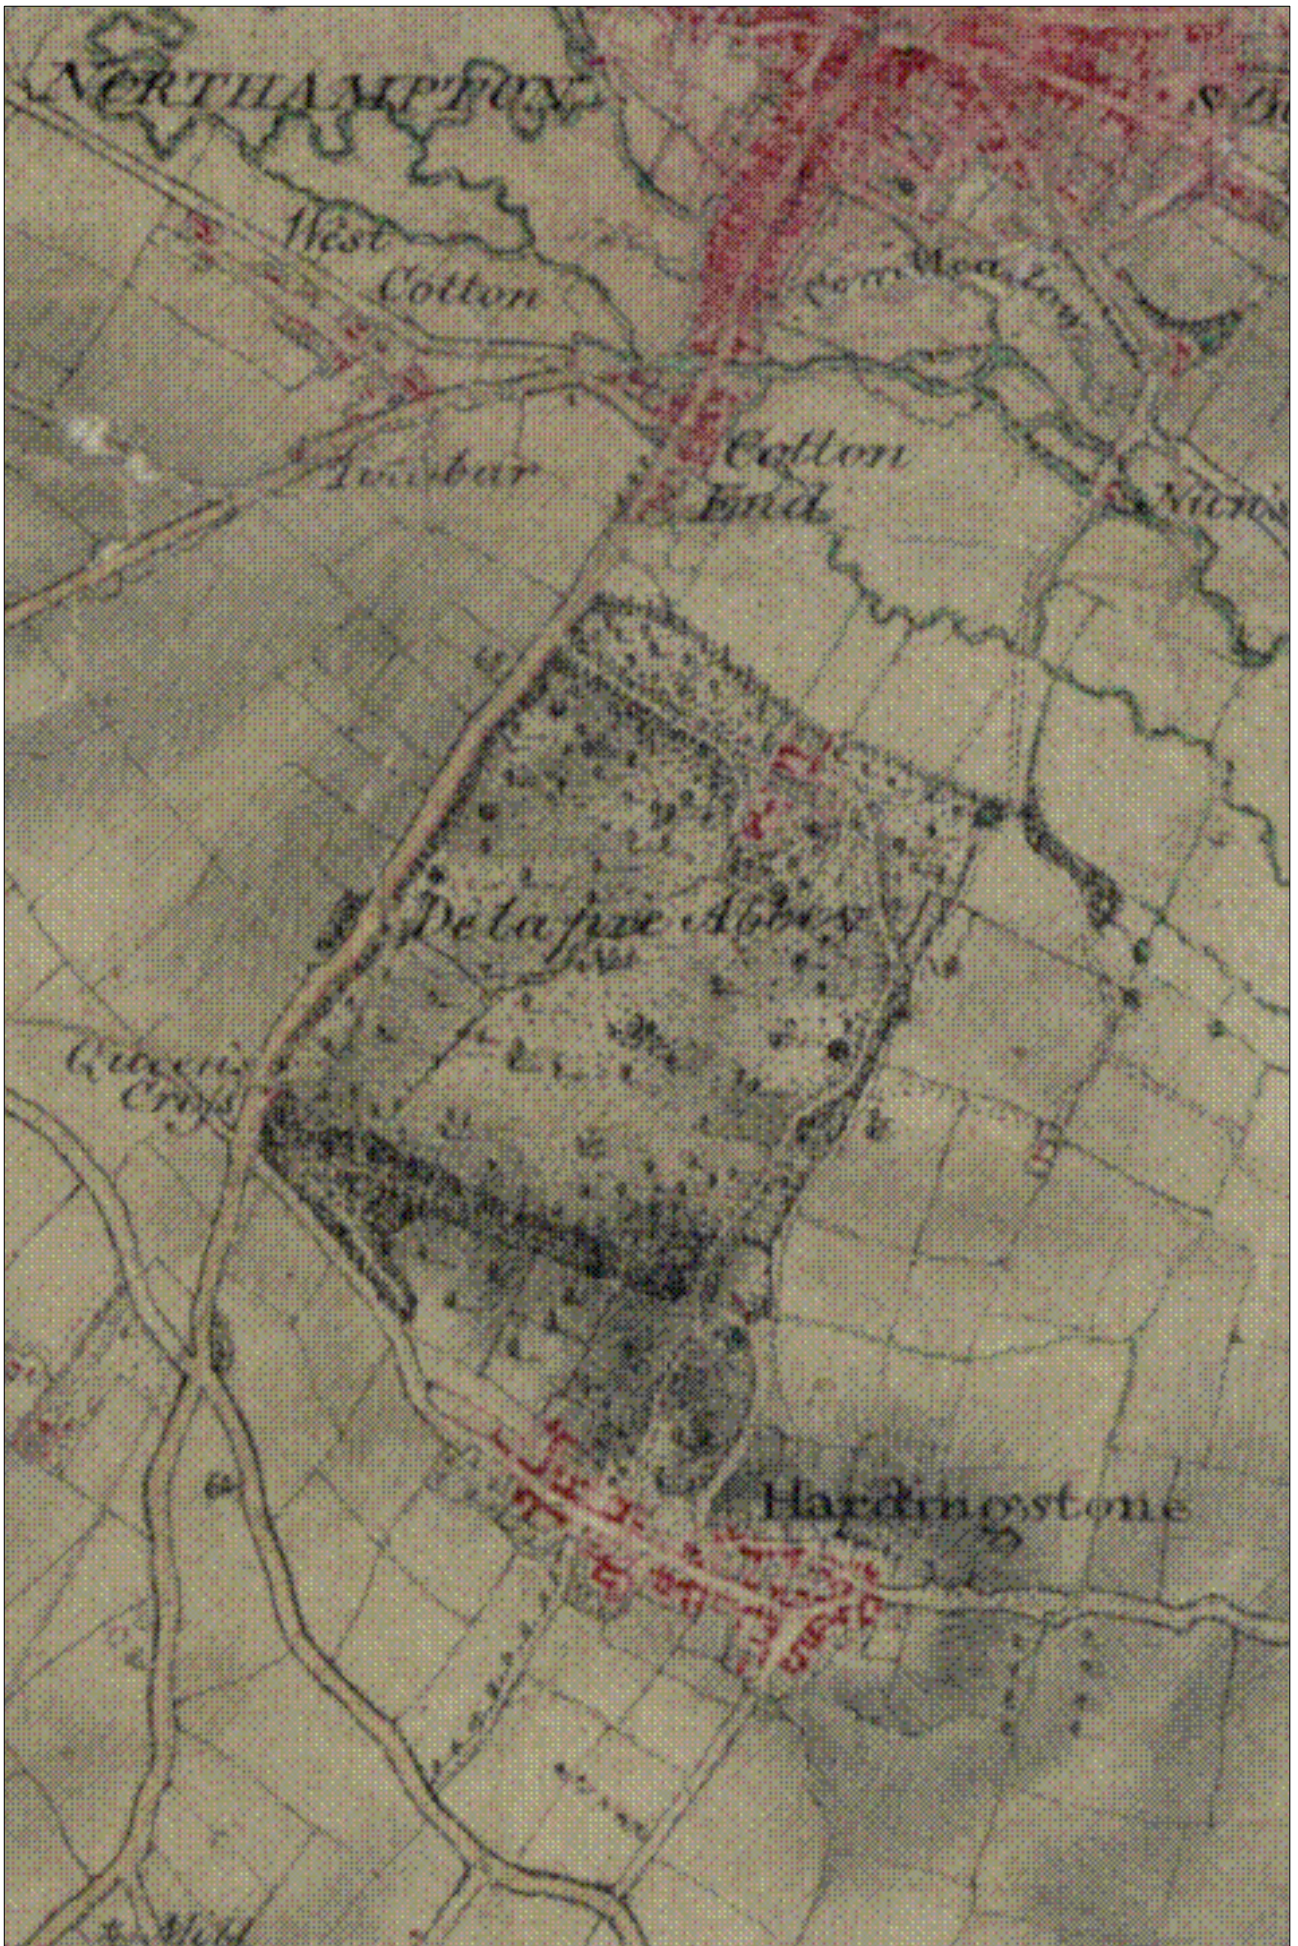
1810 Ordnance Survey map Fig 3

The 1810 Ordnance Survey surveyor's (Fig 3) map depicts many of the features recognisable today. The Gardens to the south of the Abbey have been contained within the Ha-ha. Principal access is via a drive from the west, leading past the Abbey, before continuing to Hardingstone along the eastern bounds of the Park. The Park itself is open, only sub-divided by streams and one boundary. The southern limit is marked by a belt of woodland through which wind several paths.

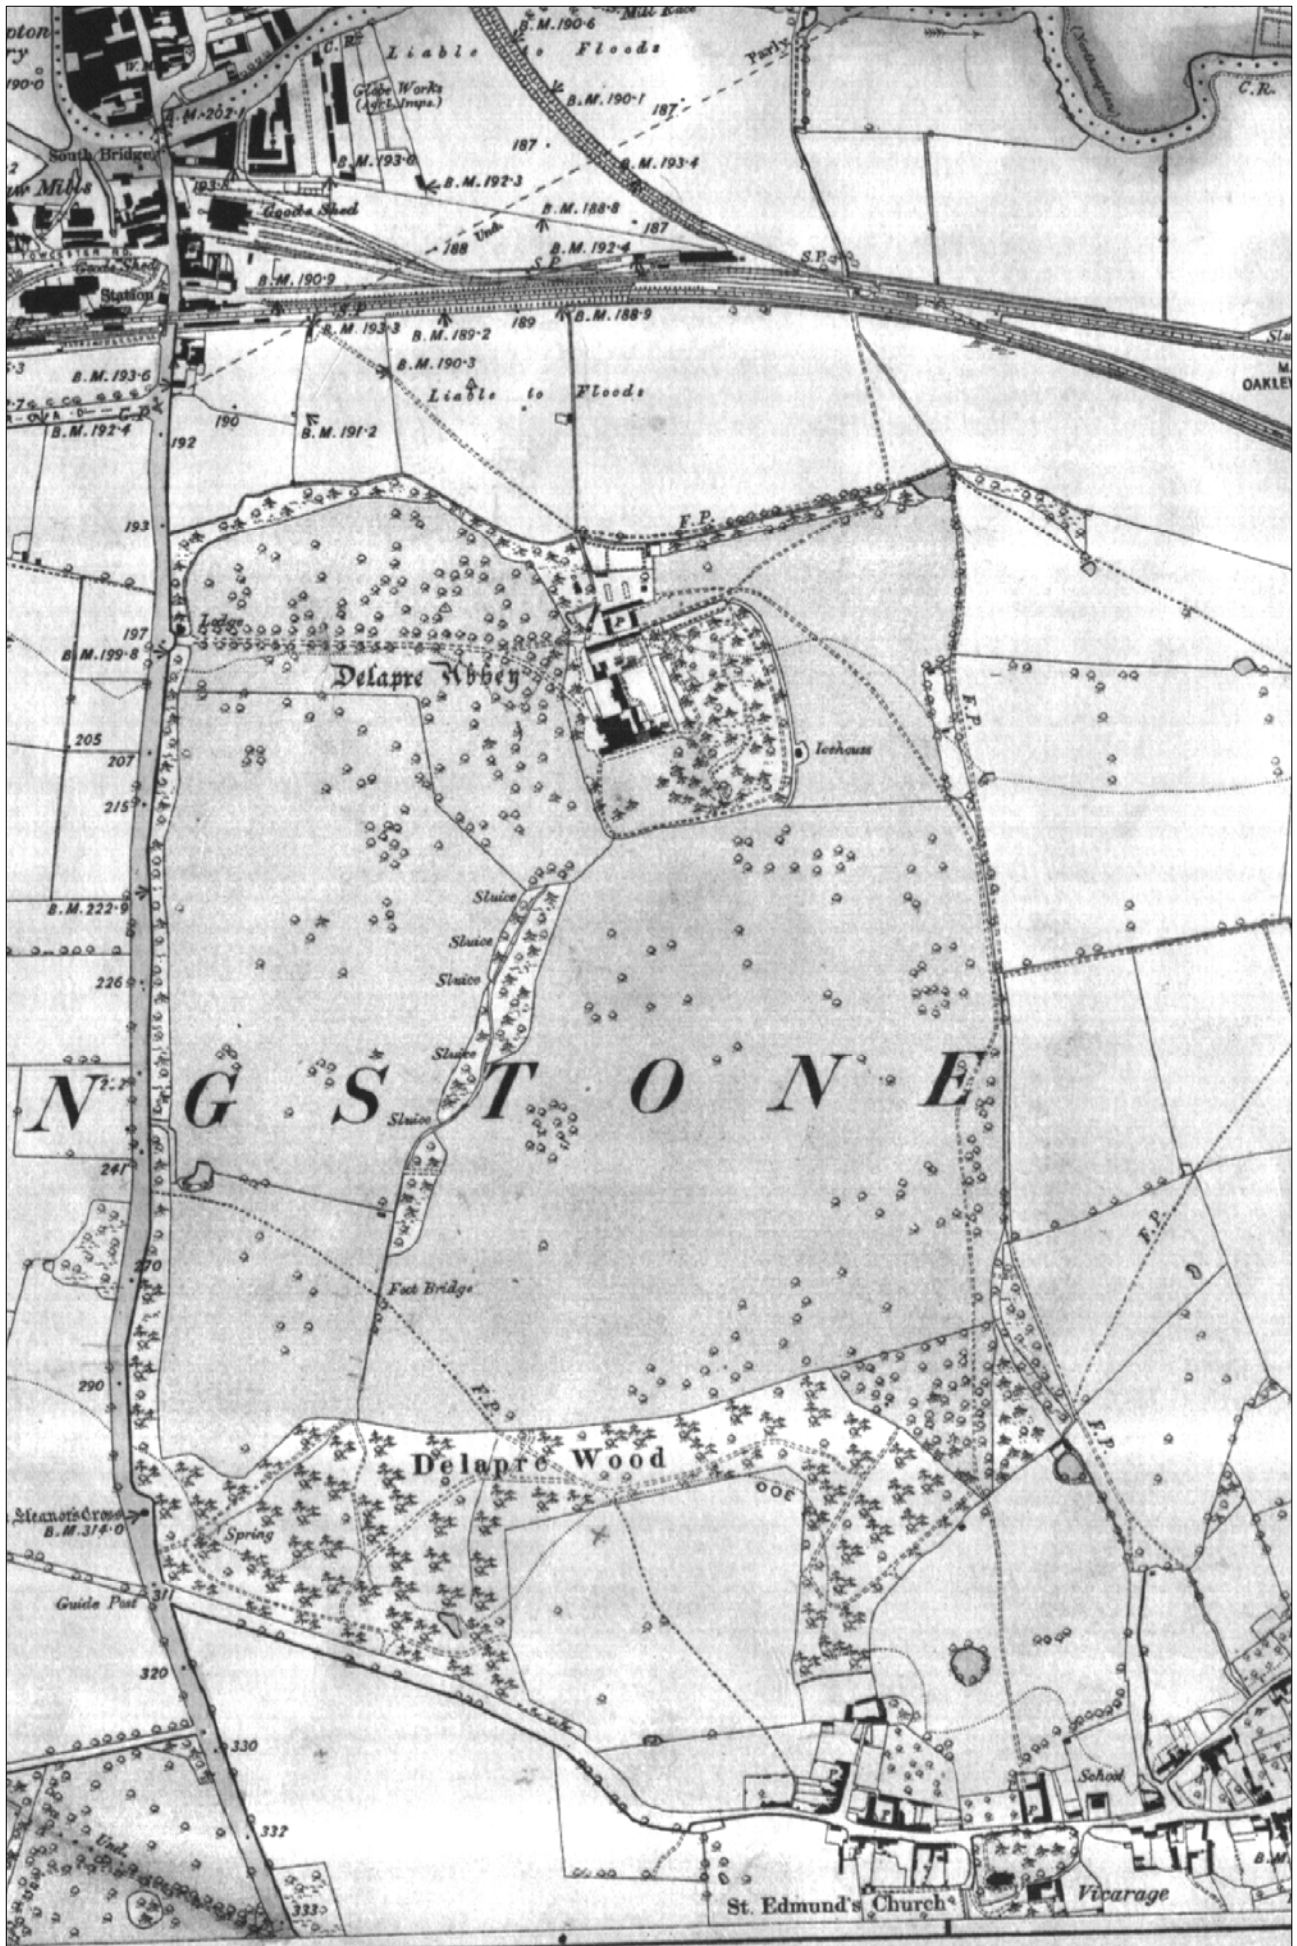
1880 1st Edition Ordnance Survey map Fig 4

There is little change from this picture on the 1<sup>st</sup> Edition Ordnance Survey plan of 1880 (Fig 4). The South Lawn is shown as open space with an informal wooded garden threaded through

with winding paths to the east. An Icehouse has been constructed in the south-east corner of the garden. The Park is largely open, although a few divisions have been added. A series of sluices are depicted on the stream running through the park. The belt of woodland to the south is much expanded, and is referred to as Delapre Wood.

Paths D004 and D005 are both shown on the 1st Edition Ordnance Survey plan of 1880 (Fig 4). These are both substantial features, and path D004 may follow the line of a former medieval headland.

Ditches D002 and D008 may again both preserve alignments retained from the medieval period of former headlands or furrows. Ditch D008 also serves as a drain from pond D009 into a small stream. The pond itself is a substantial features, again shown on the 1<sup>st</sup> Edition Ordnance Survey of 1880 of uncertain function (Fig 4).

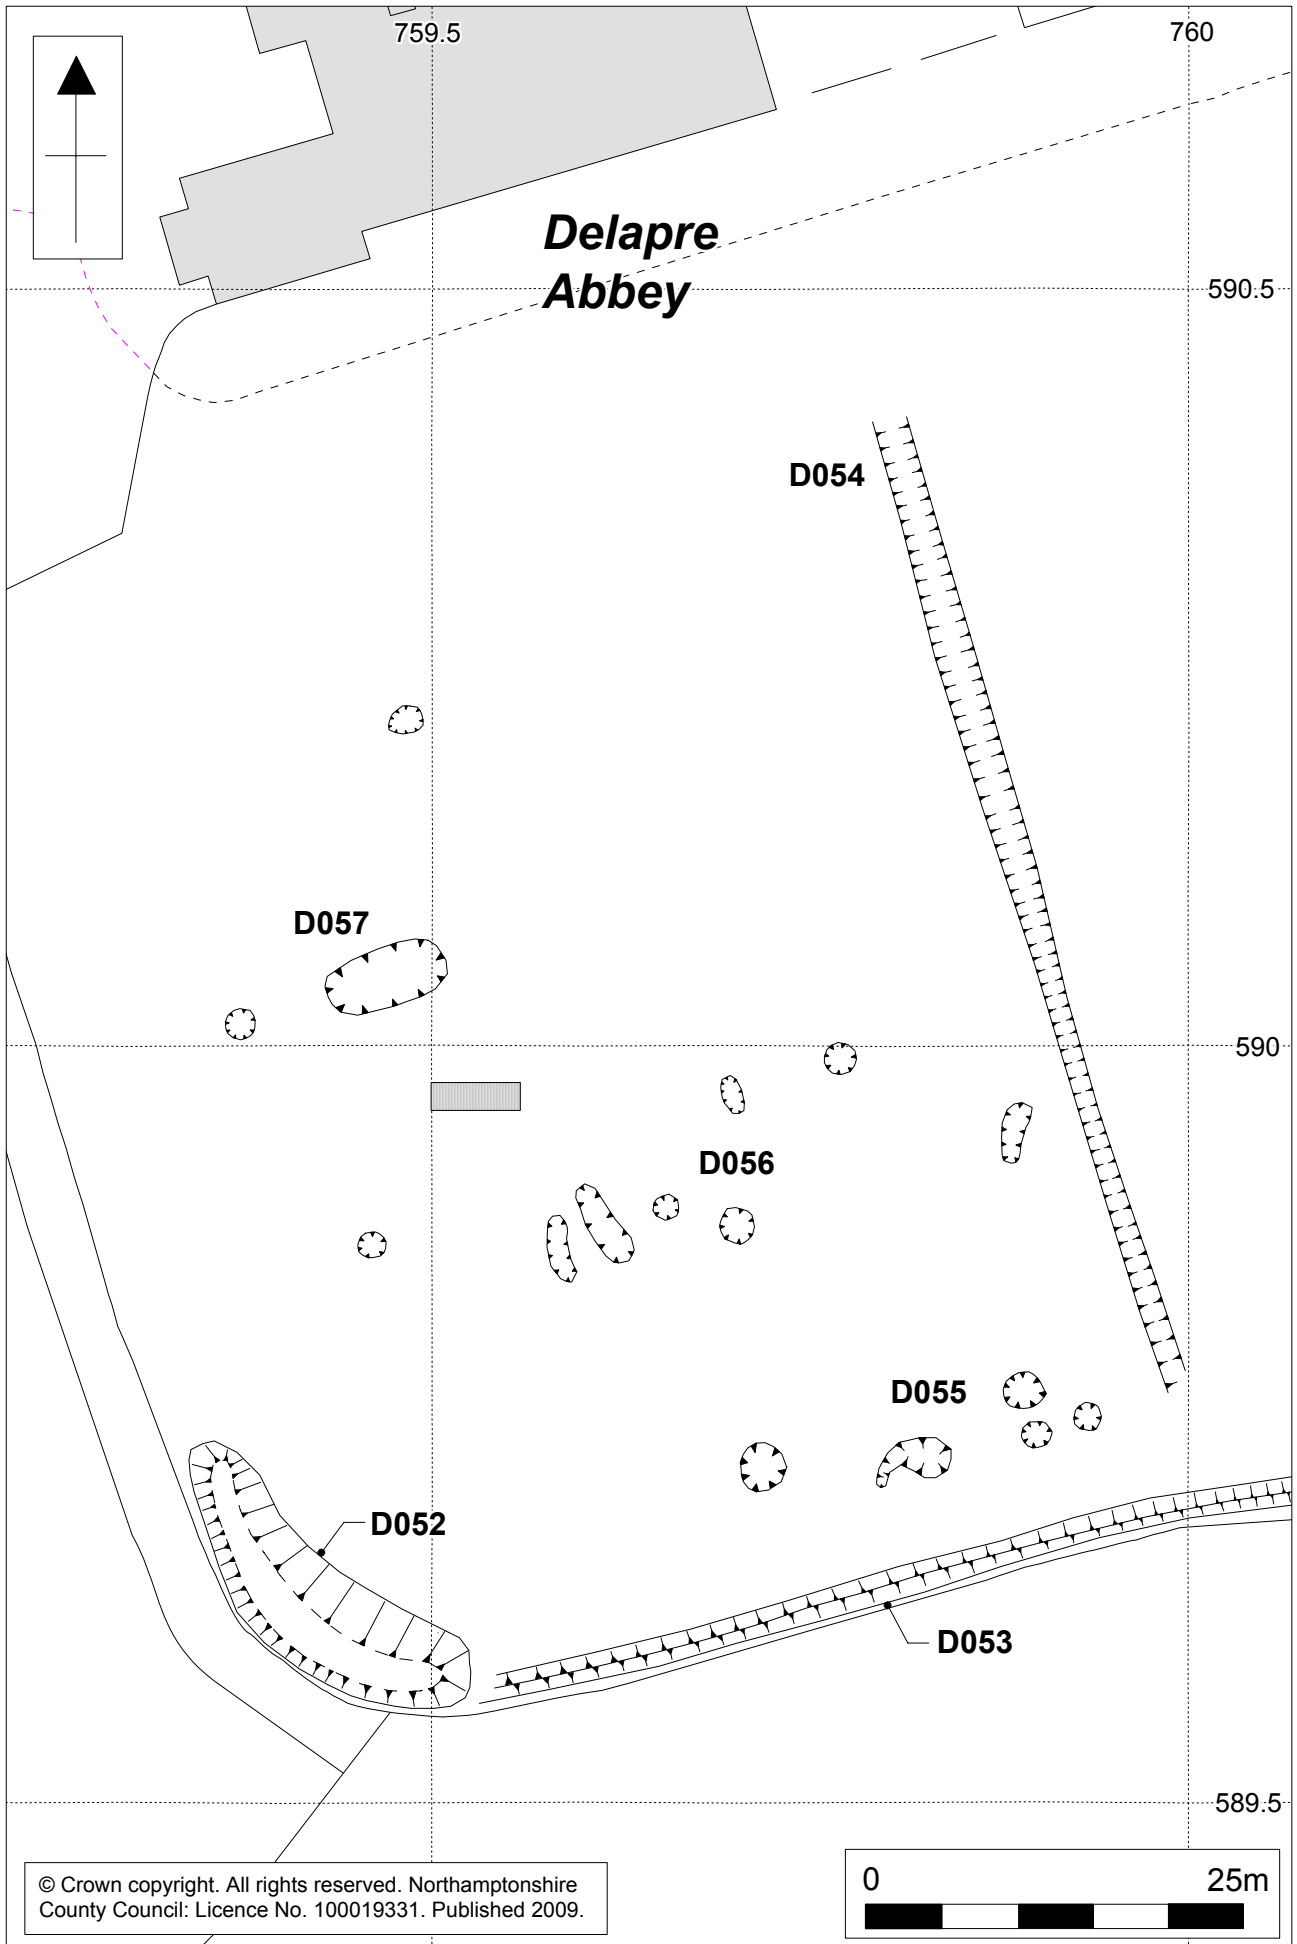
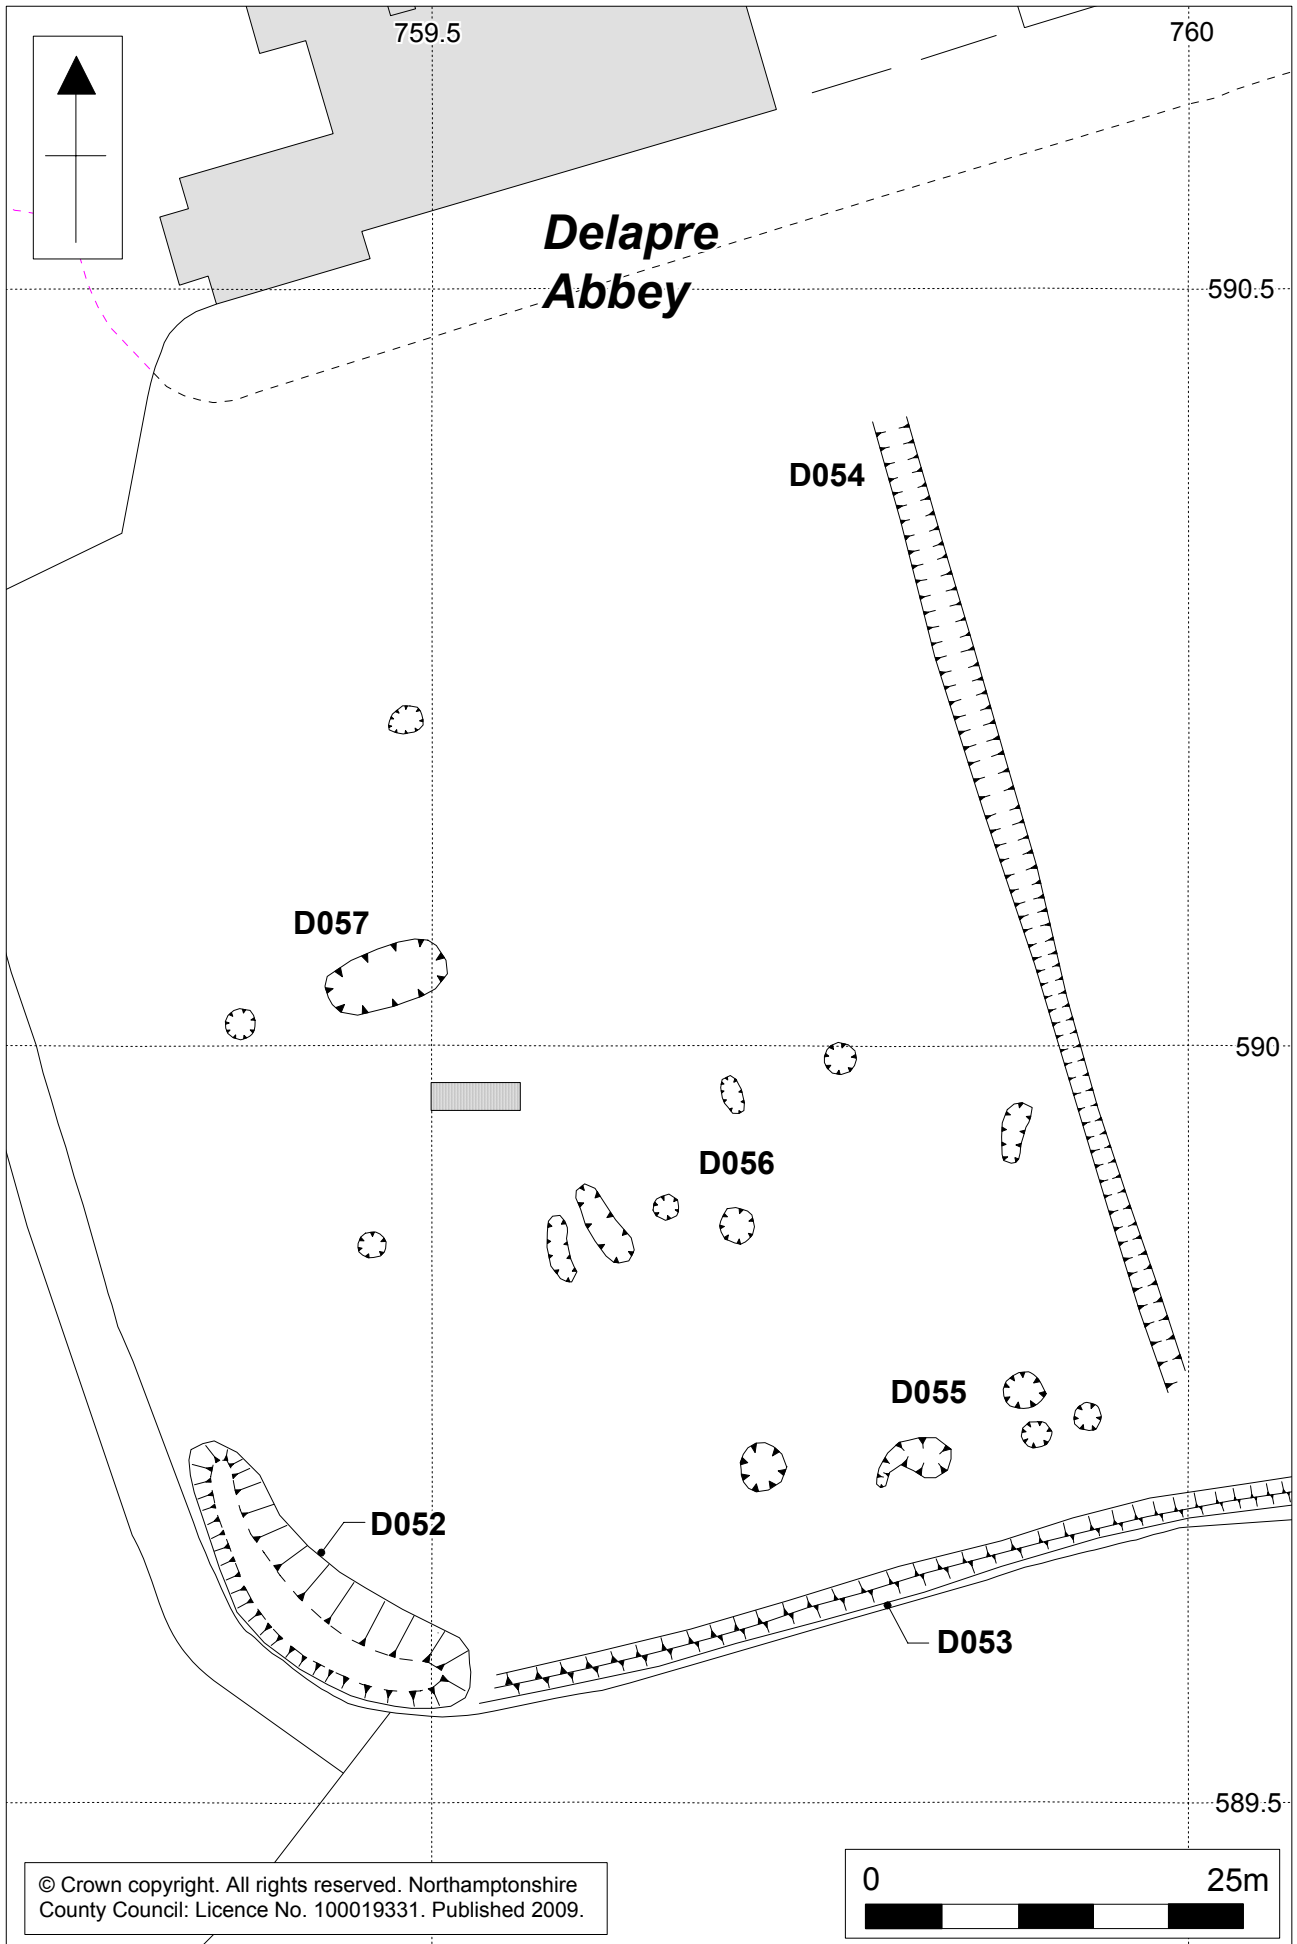
Topographic survey of South Lawn Fig 6

The South Lawn is generally uneven and is much disturbed by moles. The survey identified discrete features within this general unevenness. Survey was carried out using Leica System 1200 Differential GPS. Individual features were plotted to an accuracy of +/-0.05m to Ordnance Survey National Grid and Datum. Individual features were assigned numbers following on from those identified during the walkover survey. These were then described and photographed in the field. A full gazetteer can be found in Appendix 2.

aligned with the south-east corner of the main house and corresponds with a low resistance anomaly.

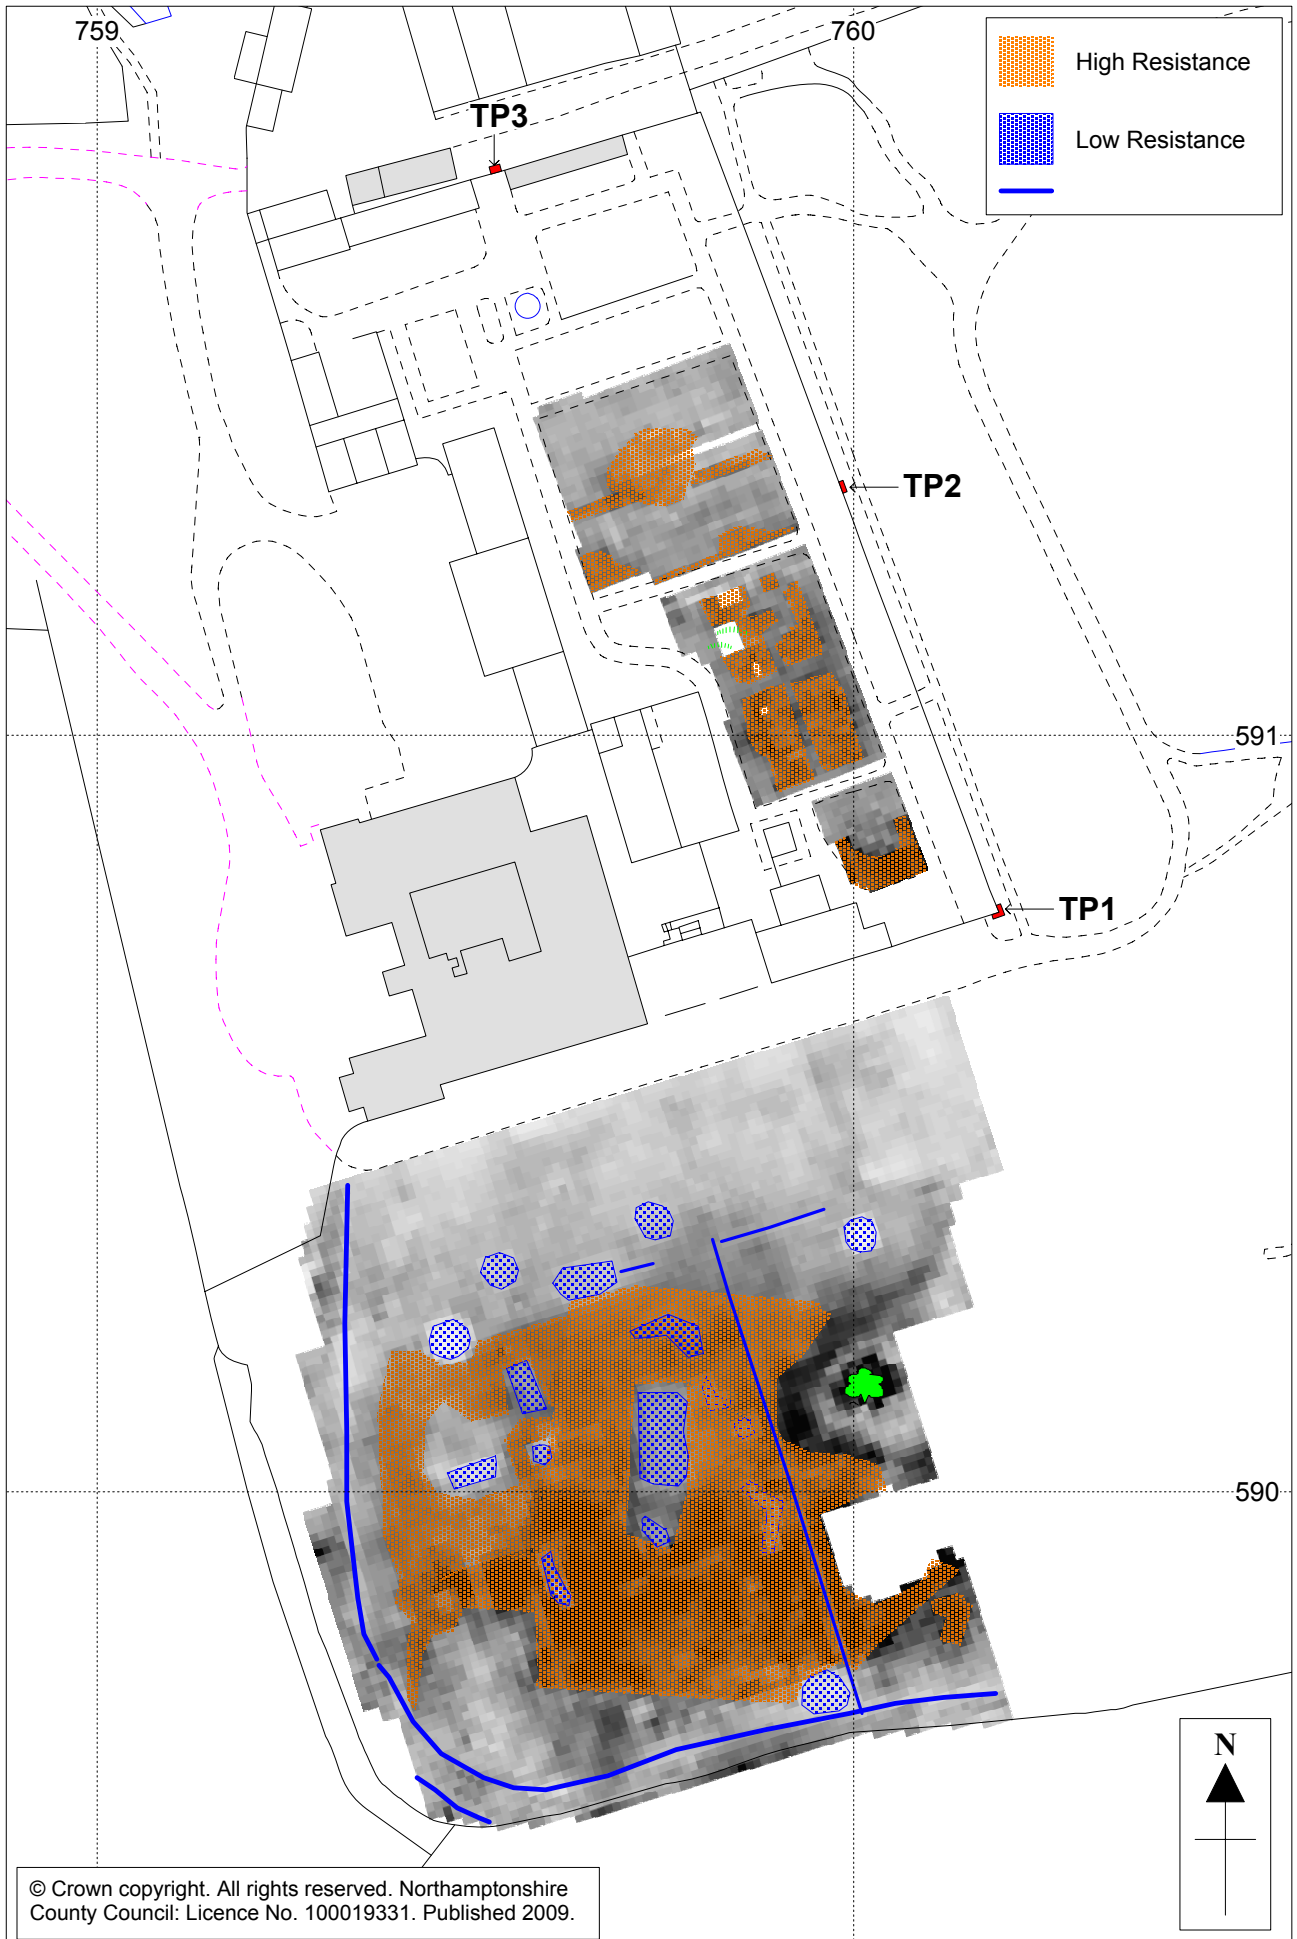
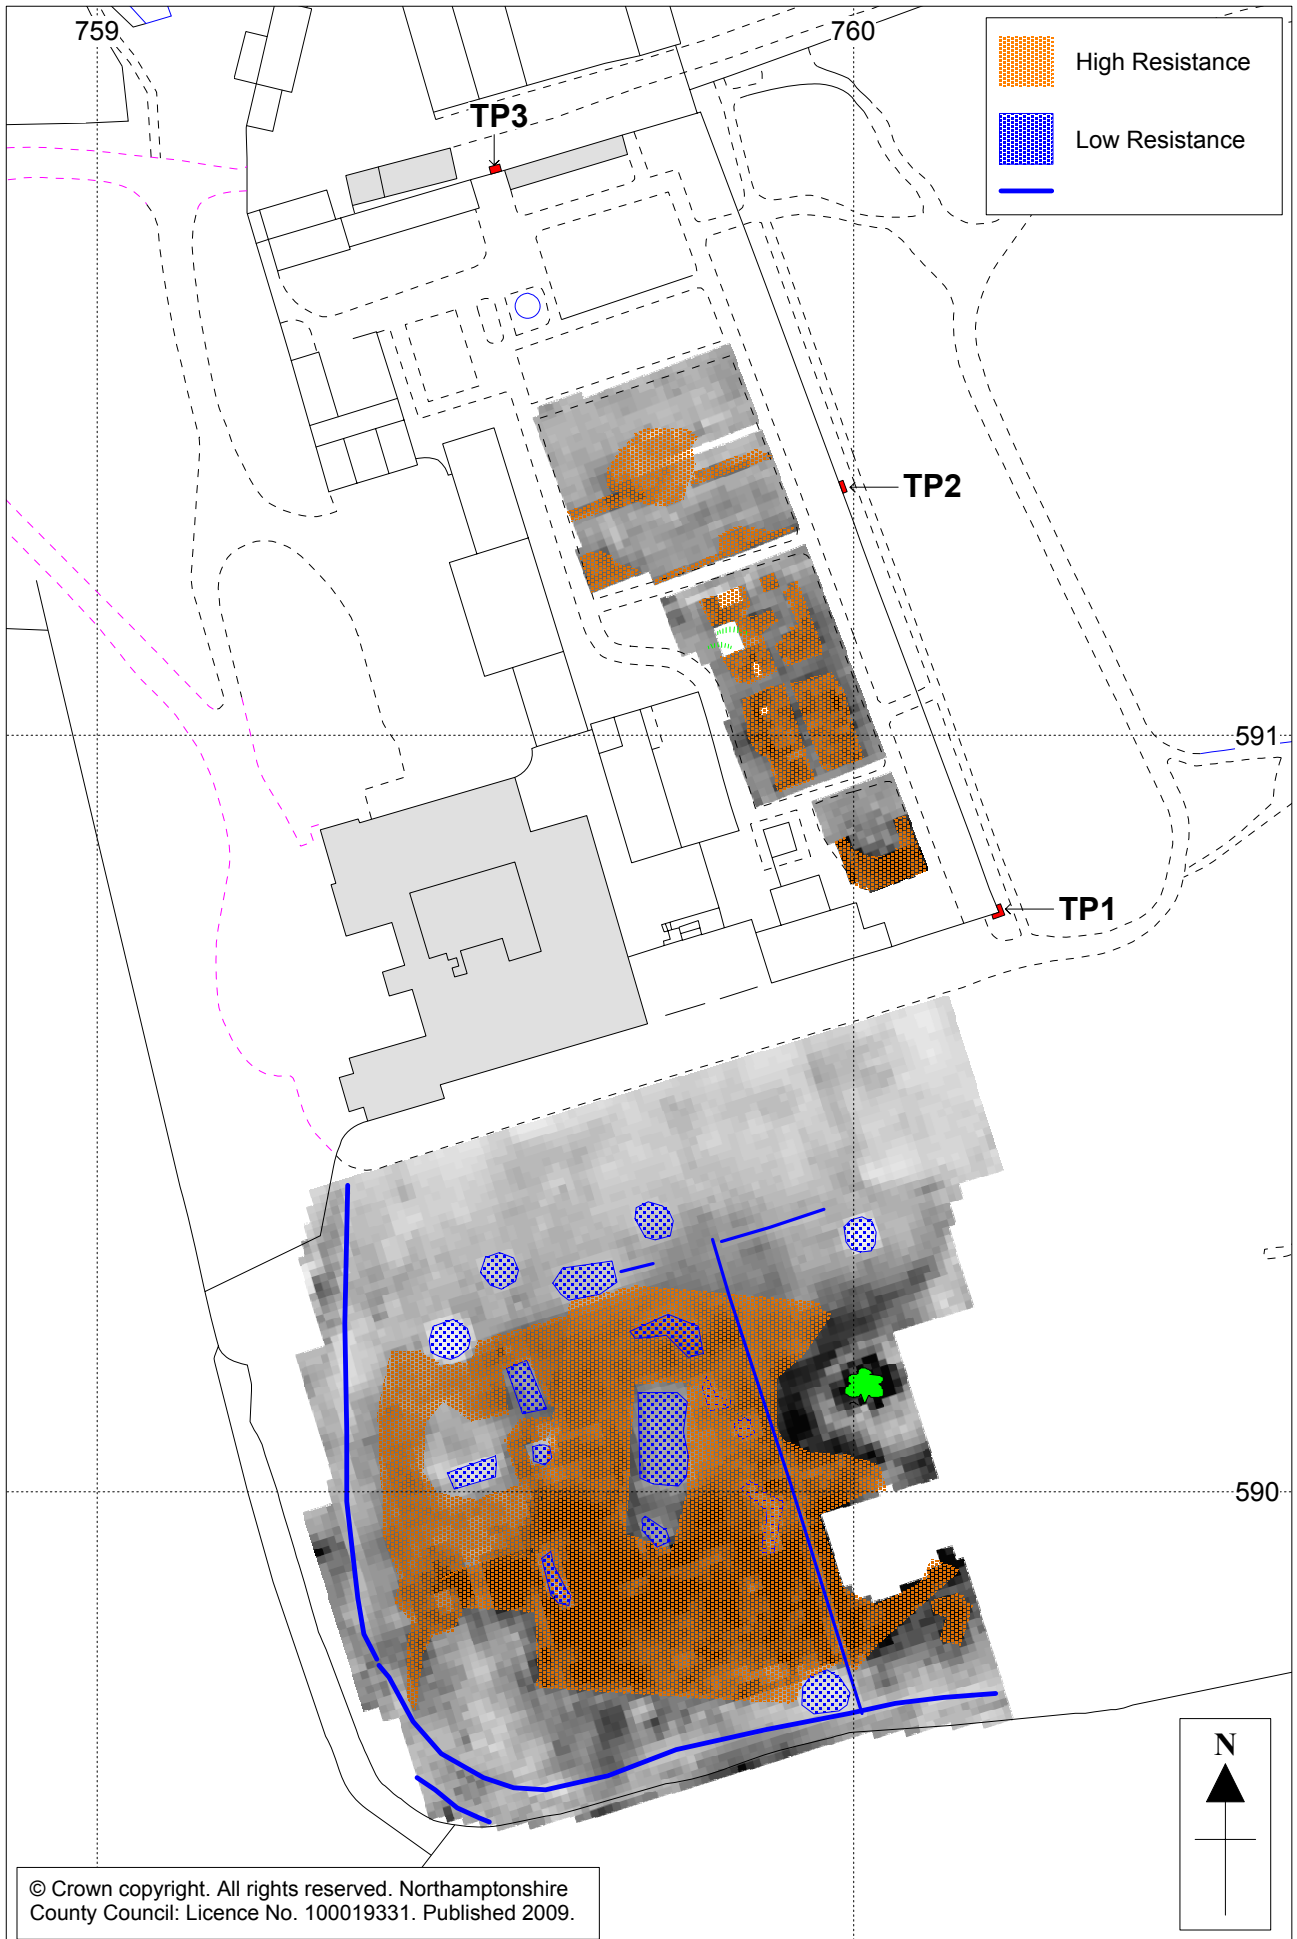
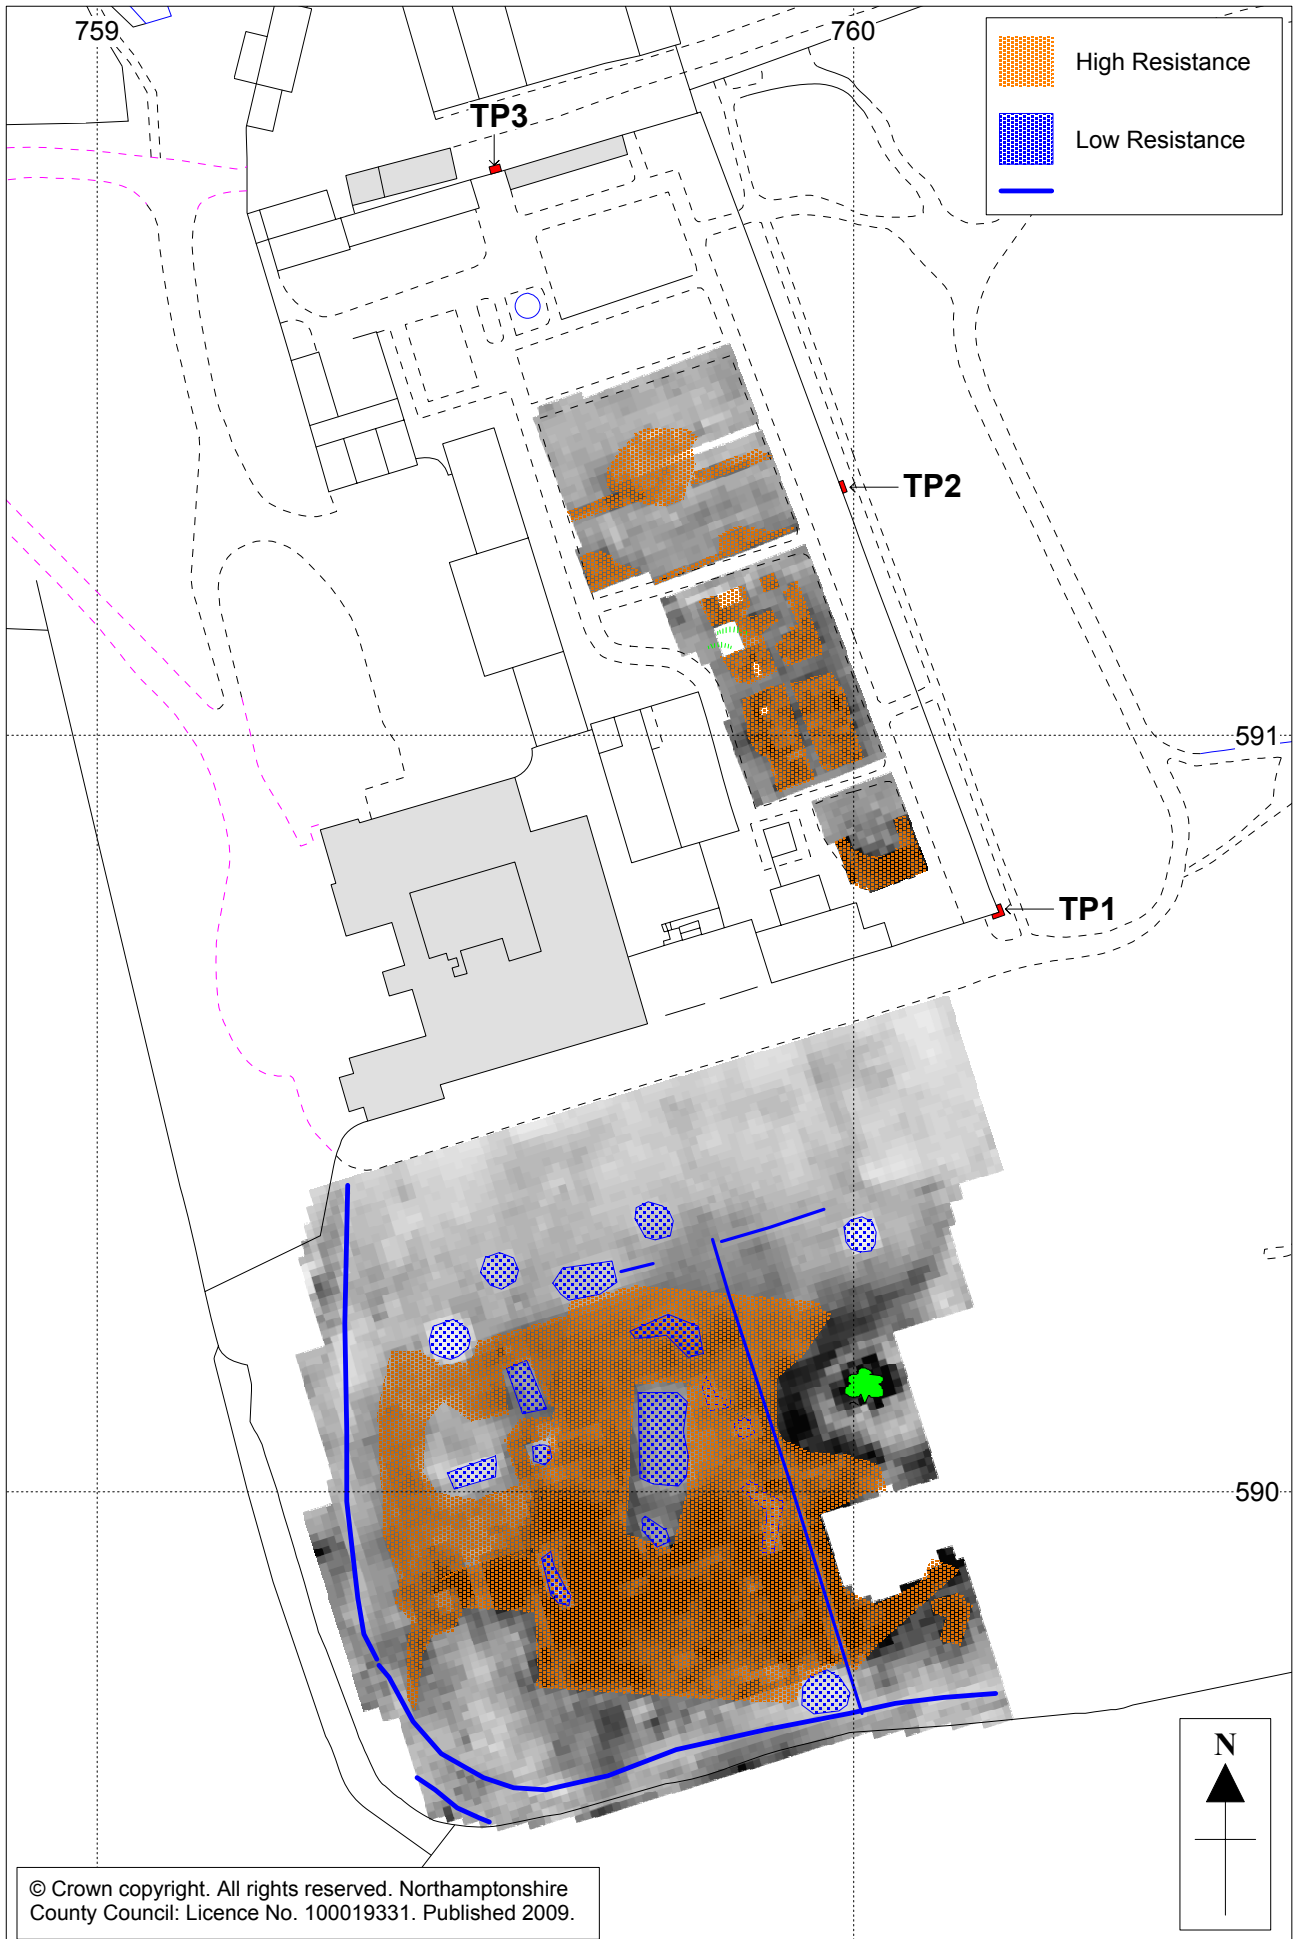
Fig 8

The data was combined and displayed using Geoplot 3.00s software. The only processing required was an edge match function, which removed a slight grid bias caused by repositioning of the remote probes. The processed data is presented in this report in the form of a greyscale plot (Fig 7). As the data from each areas were statistically different, they have been displayed to different anomaly scales: South Garden scale 30 $\Omega$  to 120 $\Omega$  black ~ white; Kitchen Garden scale 28 $\Omega$  to 68 $\Omega$  black ~ white. An interpretative plot has been generated from the results and is referred to in the following results section (Fig 8).
