Archaeological buildings assessment of

71-75 High Street, Thrapston

Northamptonshire

Report 09/75

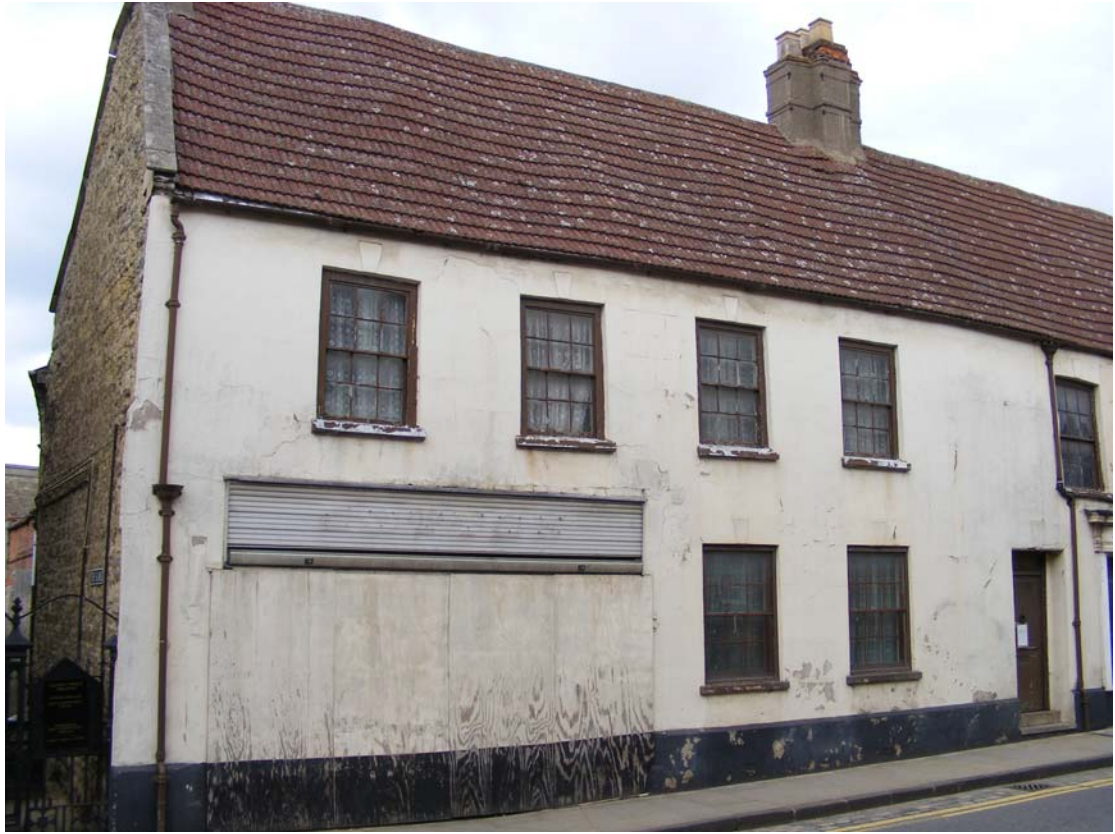
Fig 7: General view of frontage

The buildings are mainly of coursed or roughly-coursed limestone beneath a roof of either pantiles (to the rear face) or modern interlocking concrete tiles (to the front face). The chimney stacks are of brick, as are some of the outbuildings and many alterations or additions to the original building. The gables have stone parapets and kneelers (Figs 7 and 8).

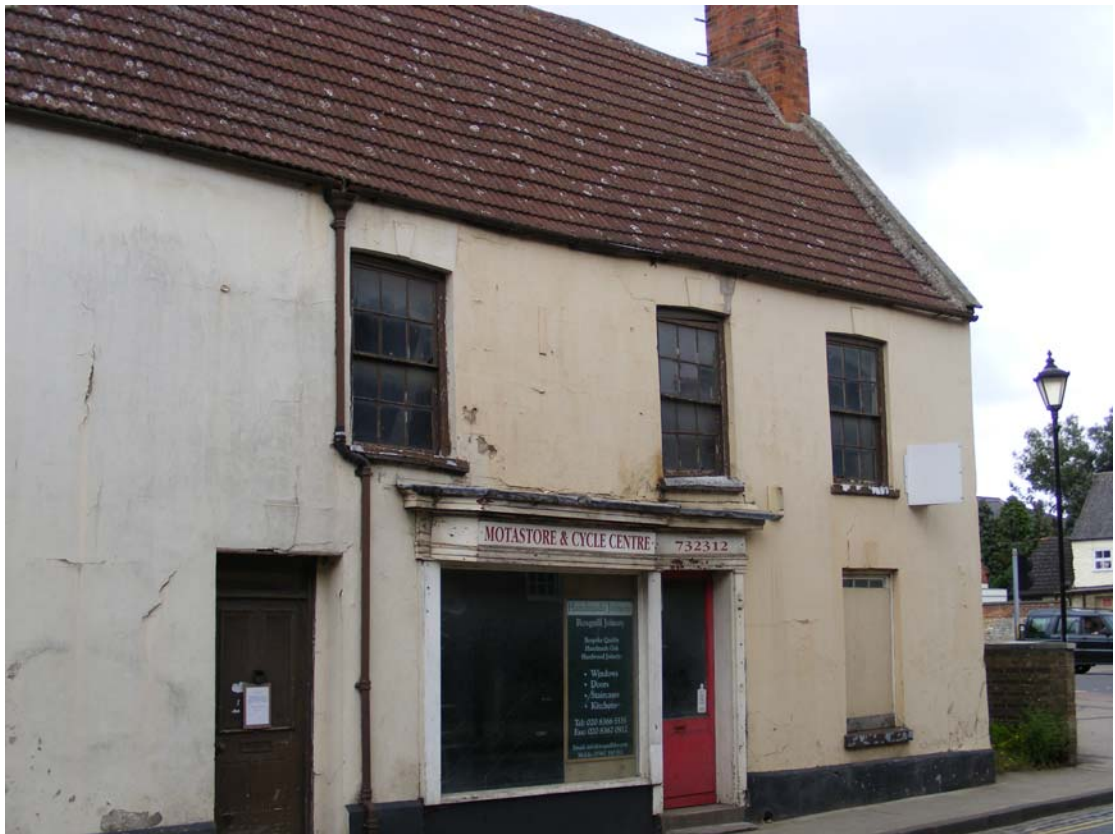
Fig 8: General view of frontage

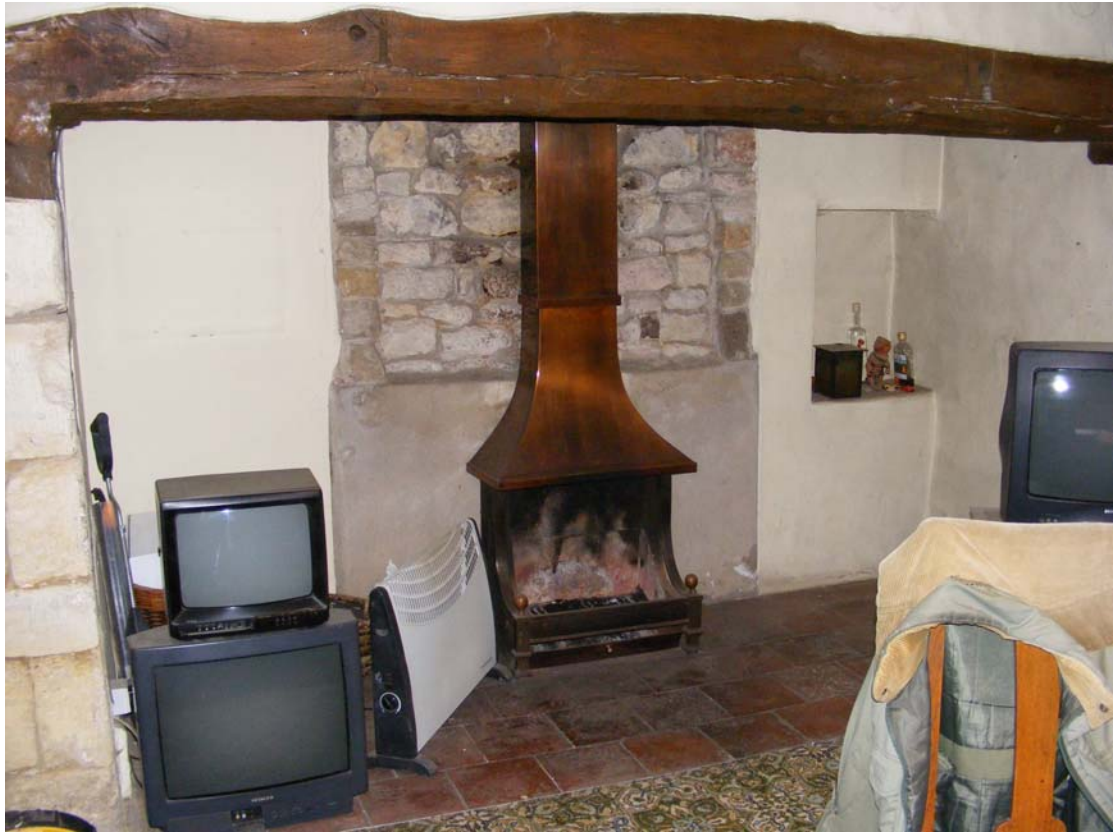
The building began as a simple, two-cell plan fronting south onto the High Street. In its eastern bay (G1) lies a large inglenook fireplace with a plain oak bressumer, simply chamfered on its arris (Fig 9). To its south side lies the recess of a small salt cupboard, while to the north another cupboard has been blocked, but its remains are visible from the back, where a haphazard modern recess has been cut from the front entrance passage (Fig 10). A brick lining suggests this second recess may have been a small oven.

Fig 9: Inglenook fireplace in G1

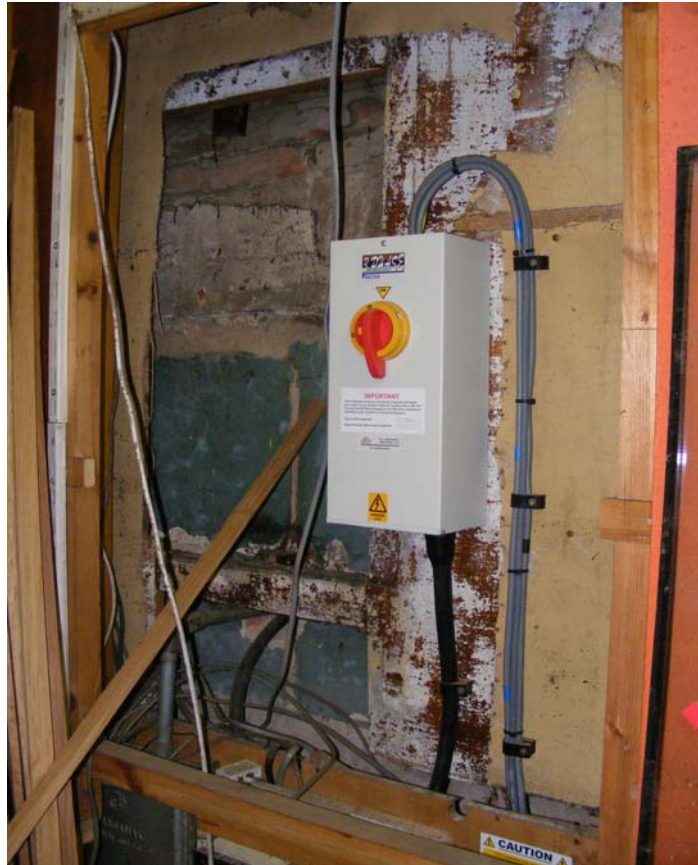
The western bay has been much altered at ground level (G2). A 1970s or 1980s aluminium and glass shop-front has removed the front wall entirely. However, behind this some remains of the bay survive, comprising an axial beam and traces of 19th-century décor on the west gable wall behind an electrical cupboard

(Fig 11). Extensive use of two phases of dry-lining for the former shoe shop means that more of this décor may survive.

Fig 11: Former décor in west wall of G2

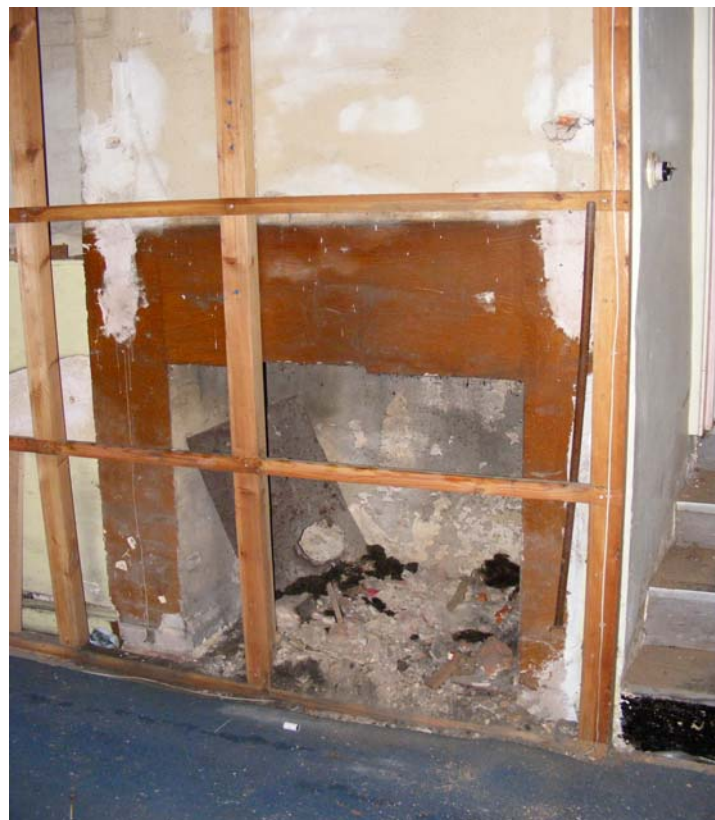
In the rear wall of G4 there is a fireplace and flue (removed in the upper floor) (Fig 14). It has been plastered and the plaster painted and varnished to look wood-grained. It appears contemporary with the floor lowering and the skirting. At ground floor level this rear wing can be seen to contain blocked embrasures to the west and east (windows) and to the north, adjacent to the fireplace (doorway) (Figs 15, 16 and 17).

Fig 14: Obscured fireplace in G4

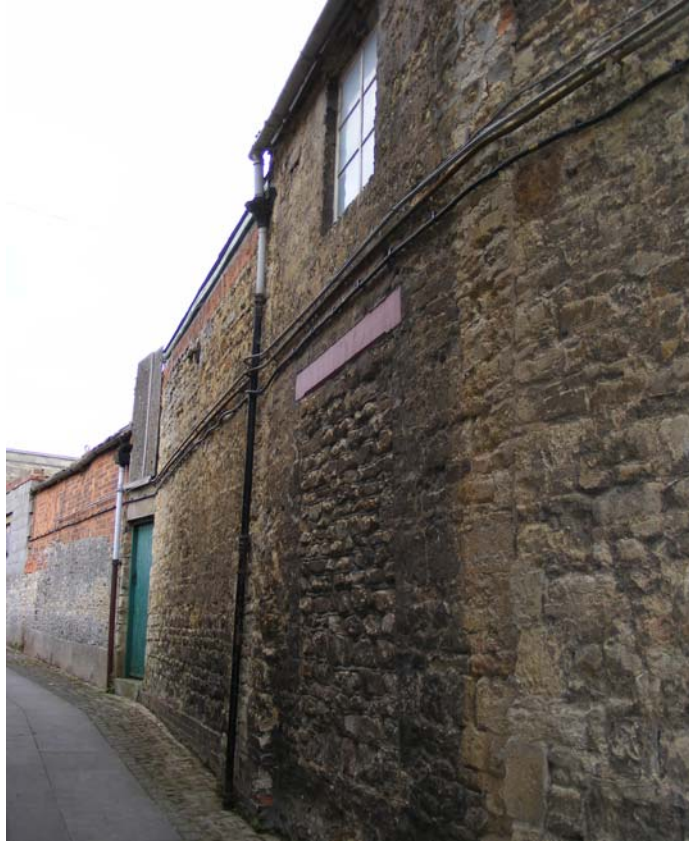
Fig 15: Blocked window in west wall of G4 (exterior)

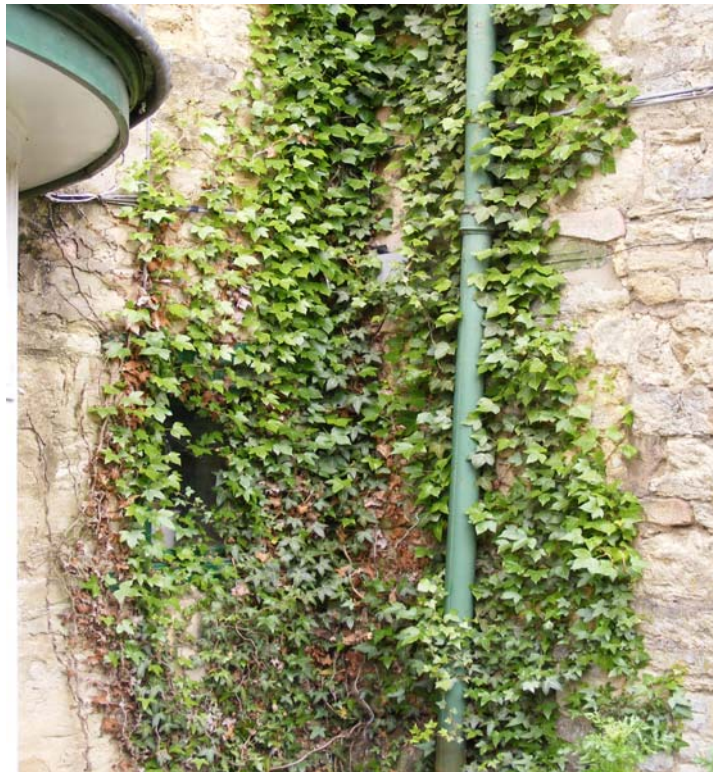
Fig 16: Blocked window in east wall of G4 (exterior)

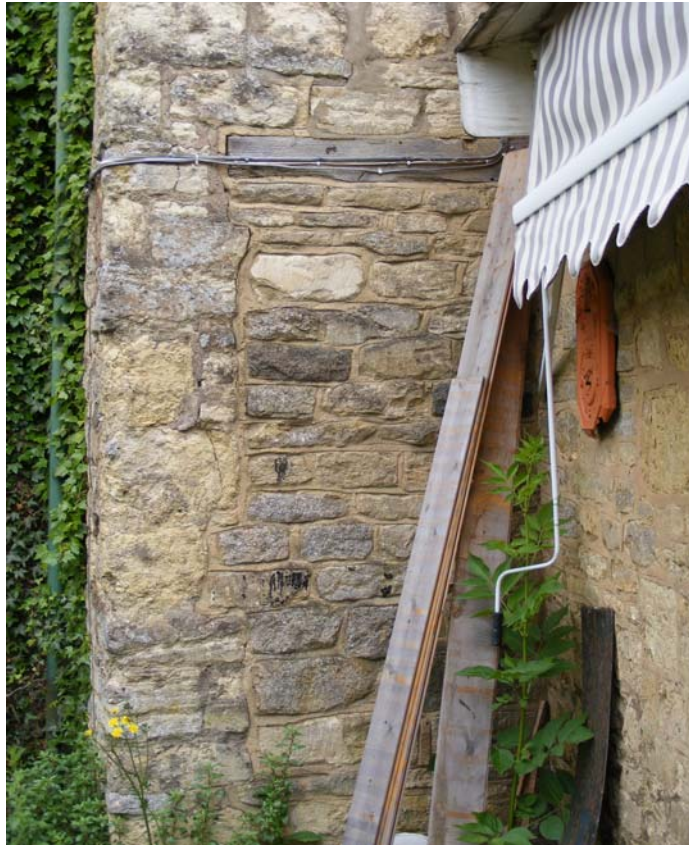
Fig 17: Blocked doorway in north wall of G4 (exterior)

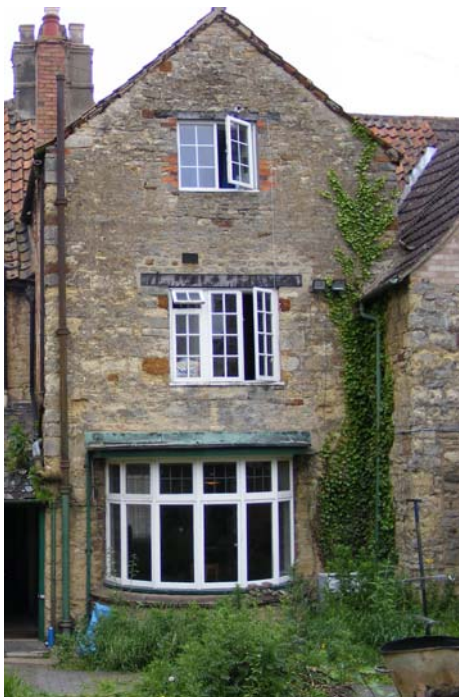
In the angle between the original building and the first extension was constructed a second extension over three floors, which houses the current staircase (Fig 18). It is not clear where the original staircase lay, but it probably led up from G2,

Fig 18: Extension built for the current staircase

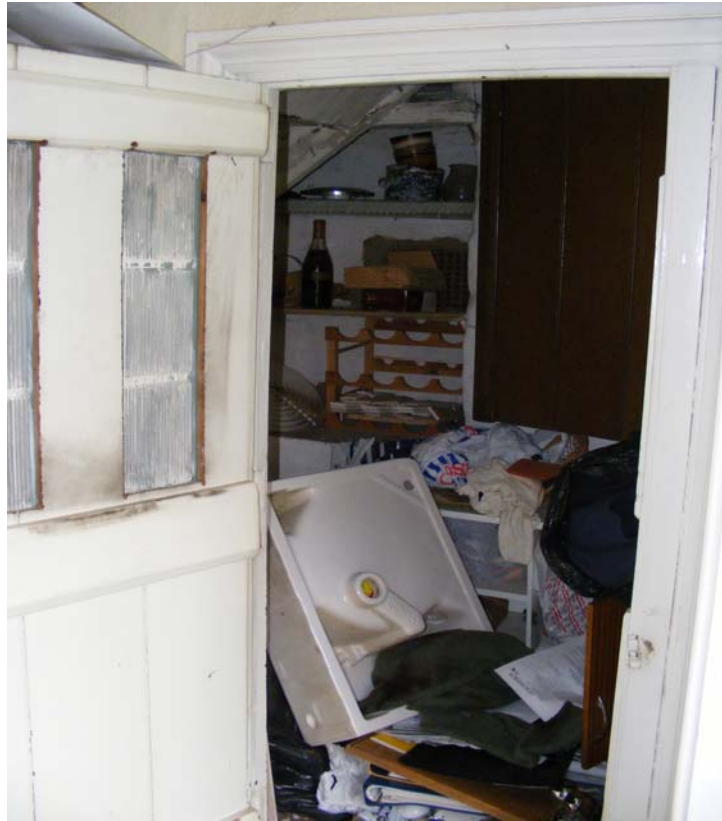
The ground floor room (G3) may originally have served as a kitchen, since beneath the stairs it has direct access to a walk-in pantry with quarry-tiled floor and which still contains a 19th-century wooden cupboard (Fig 19). It has a fireplace in its eastern wall, the flue of which has had to be repaired in brick at higher levels. At Ground Floor level its construction has led to the removal of the former rear wall of the original property. This is probably not an original alteration but is likely to be a modern change, connected with the introduction of a 1950s bay window and the need to introduce higher light levels into G3 and lend additional light to G1.

Fig 19: Cupboard within walk-in pantry off G3 (under stairs)

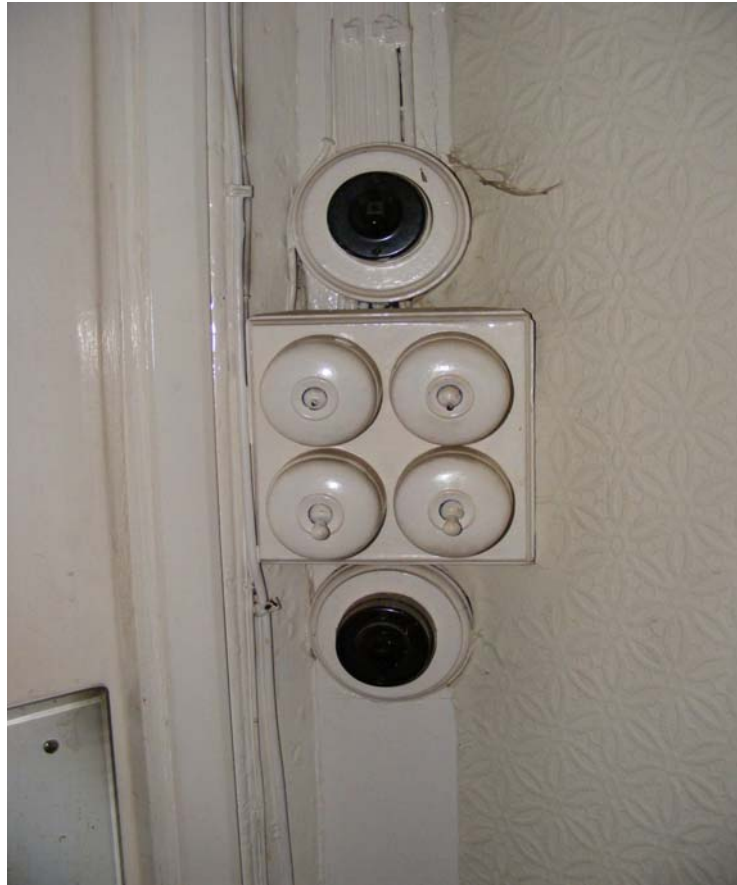
At this level the new extension has been used to introduce the bathroom and an adjacent but separate WC into the building (F3). Neither is remarkable but dating is provided by Bakelite light switches of 1930s vintage. A cupboard in the corner of the bathroom may be significant since it possibly lies adjacent to a fireplace, now lost or obscured behind the bath and current tiling decor. On the landing outside the banister rail has distinctive very individually turned balusters (ie not uniform and steam-turned), suggestive of a date for the stairs (and by inference the extension) in the later 18th or early 19th centuries (Hall 2005, 112; Fig 20). At this level the doors from the landing to the bedrooms are of a suite, but are relatively basic, almost inexpert carpentry, and finished off with Bakelite fittings of the 1930s. Most early light fittings are concentrated around the staircase and these too are of Bakelite, suggesting that the house as a whole came onto electrical mains and received an overhaul before the Second World War (Fig 21).

Fig 21: 1930s Bakelite light fittings (foot of stairs)

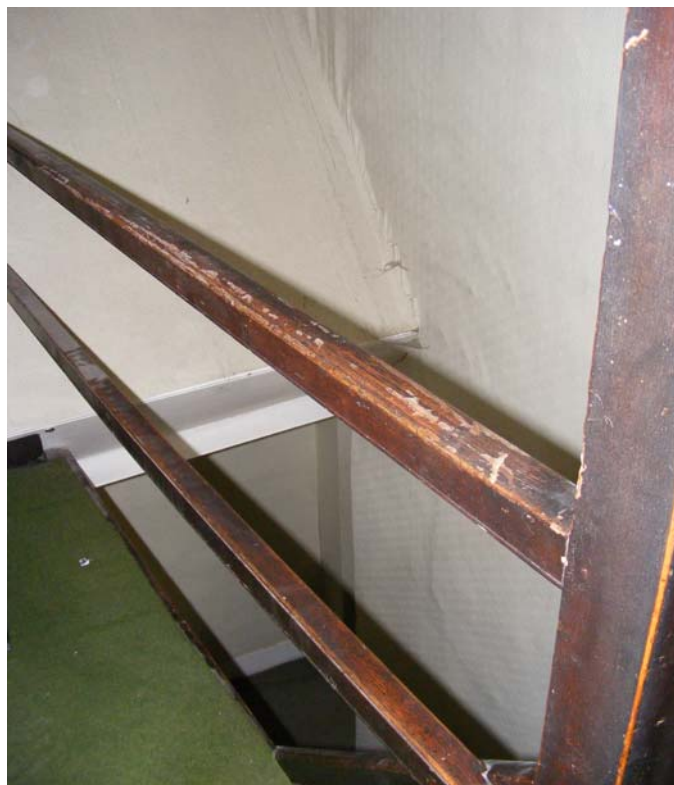
At this level the area off the landing comprises a small bedroom with no historic features visible. The pitched roof above is of pan-tiles over simple, unremarkable roof carpentry. The landing, devoid of all but the simplest handrails, gives direct access to the attic rooms of the main frontage (the cinema, above) (Fig 22).

Fig 22: Landing at second floor, simple handrail

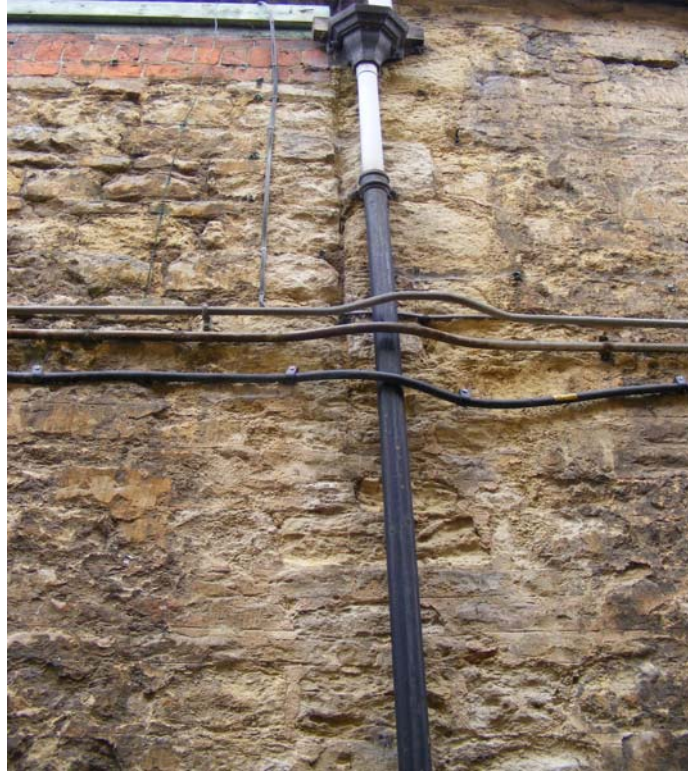
Fig 23: Butt joint between G4 and G5, viewed from The Slabs

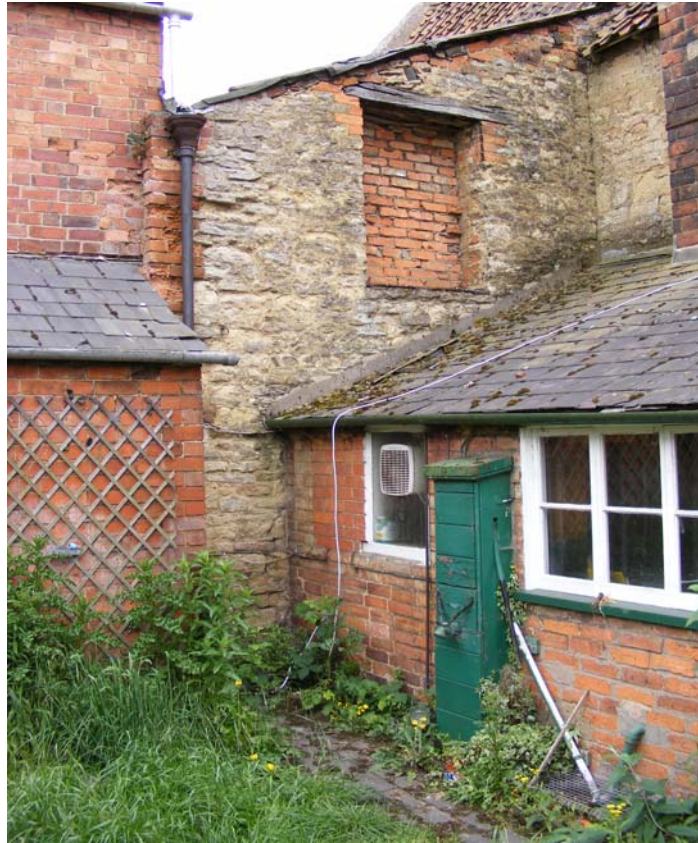
Probably during the 1920s the former kitchen in G3 was taken out of use. It was replaced by another in what may already have been an existing single-storey extension formed by G7. Attached to the back of the eastern property, it actually served the western one and its assumption of the role of kitchen may denote the period at which no 73 was created as a separate entity from 71. The brickwork of its northern wall is 19th-century brick, as is the flue which served its former fireplace added to the back wall (now covered over). Its windows have been altered. Nothing of its early interior survives, having been fully upgraded with built-in units in the 1980s. A water pump stands against its outer wall. It is probably of 19th-century origin and probably marking the location of a well

beneath. It may have been free-standing before G7 was built (Fig 27). An outside WC stands close to the pump, up against the adjacent property. It is of brick with a Welsh slate roof and contains possibly its original high-level cast-iron cistern and ceramic bowl.

Fig 27: Pump and rear wall of kitchen G7

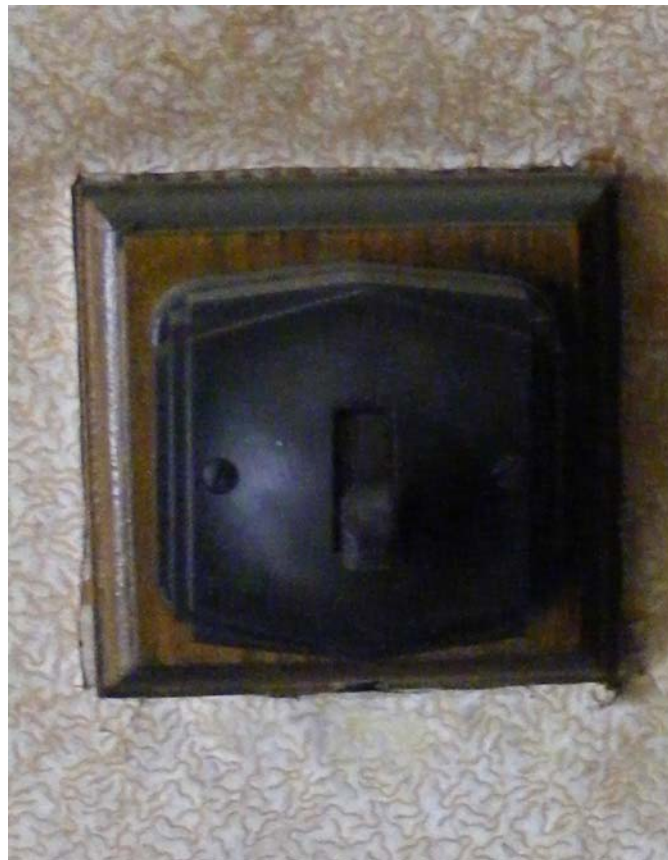
Three simple but, by contrast, well-lit bedrooms lie above the shop space at this level, each entered from the landing. All are characterised by dark-stained wide elm floorboards with 1930s linoleum or oilcloth as a covering. The woodwork retains original 1930s painting, while the walls are covered in F6 and F7 with plain wallpapers with distinctive period friezes (Figs 30 and 31, respectively). The light fittings are equally distinctive 1930s bakelite designs on a stained wooden back-board (Fig 32).

Fig 32: 1930s Bakelite Art Deco-detailed light fitting

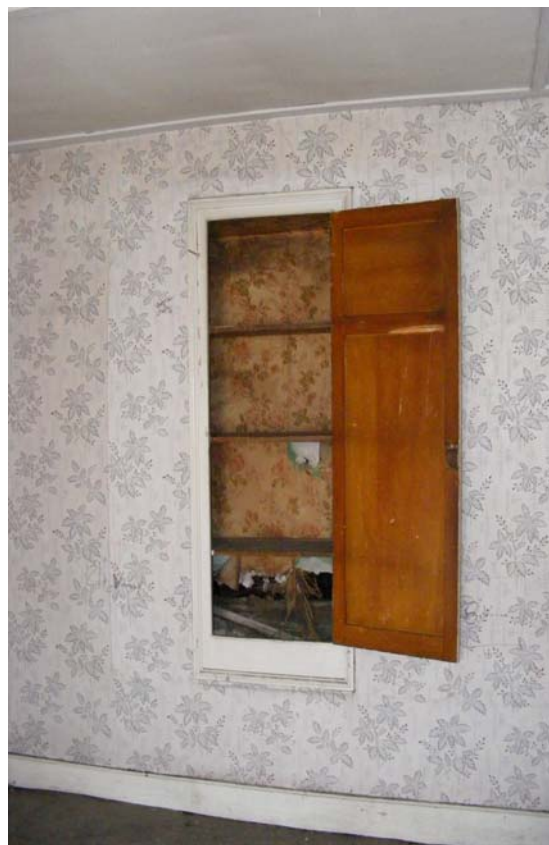
Fig 34: Cupboard in north wall of F5 – possibly a blocked doorway or window

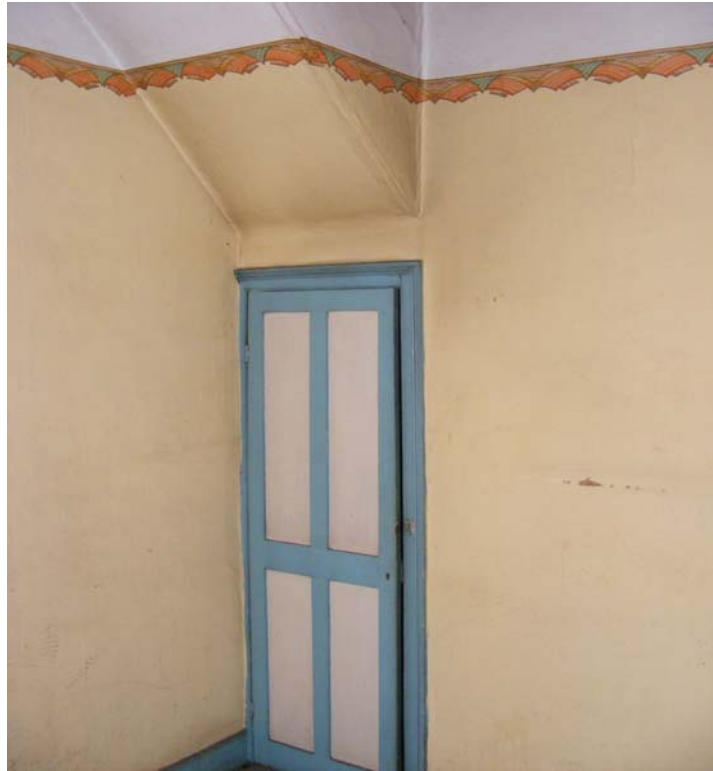
Bedroom F7 contains a built-in wardrobe utilising the under-stairs space and a cupboard adjacent to a former fireplace, the latter long-since disused and plastered over. Above the cupboard, however, the angle of wall to ceiling is spanned by what appears to be the soffit of a stair (Fig 35). Together with the above-mentioned studwork in the adjacent property bedroom F1, this appears to indicate a narrow, now closed-off stair which once linked the two properties between F1 and S6. The evidence is equivocal; however an alternative explanation is lacking.

Fig 35: Possible former stair soffit in F7

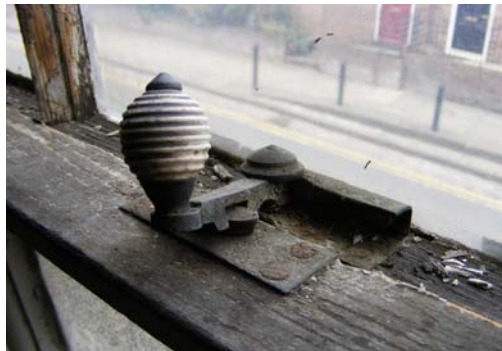
In the windows of F6 and F7 lie distinctive sash window catches which appear to be original to the windows. They are of brass and date from c1875-c1910. (Figs 36 and 37; Calloway (1991), 245 and 362). They may date the surviving fenestration scheme, perhaps better than the usual dating of un-horned/horning of sashes which traditionally falls around 1850.

Fig 36: Window catch in F5

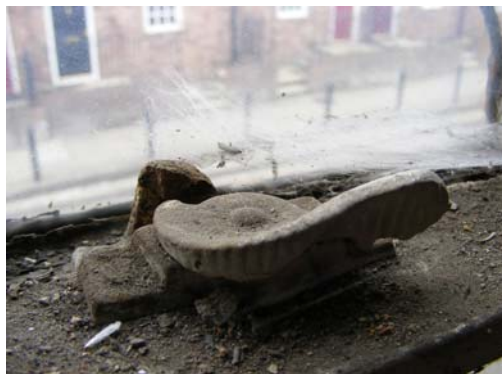
Fig 37: Window catch in F6

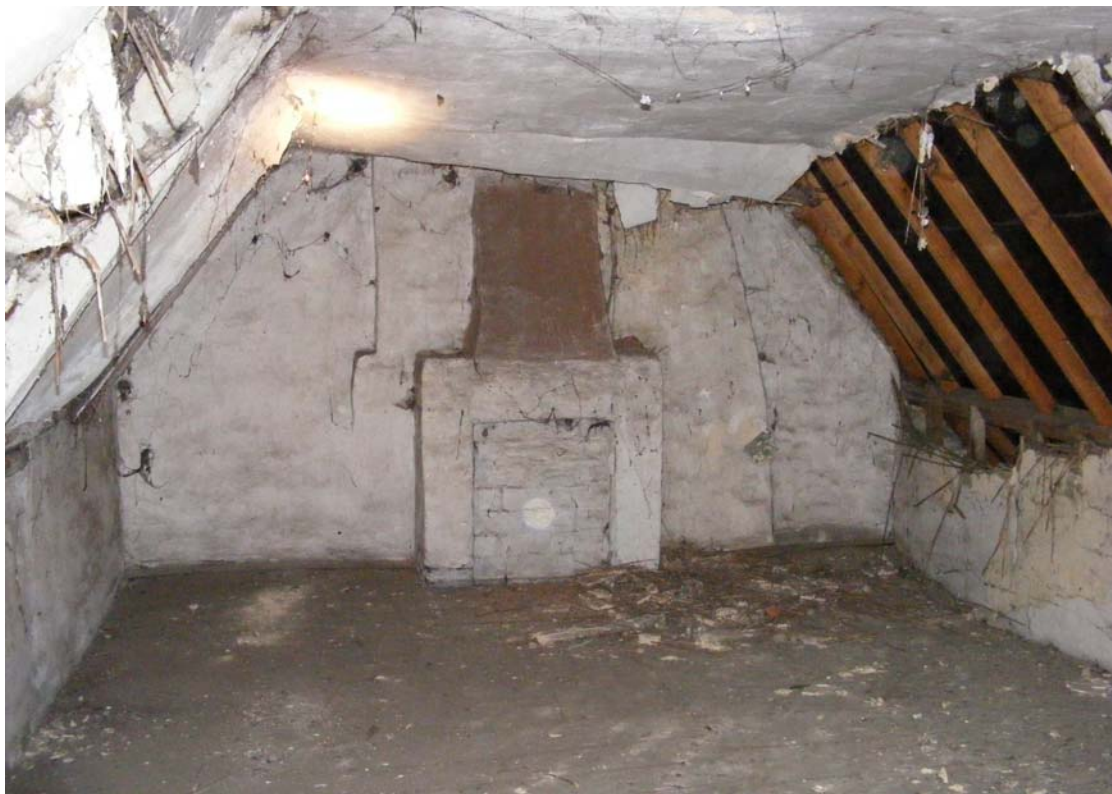
Fig 39: Room S7; note dormer removed at front (right)

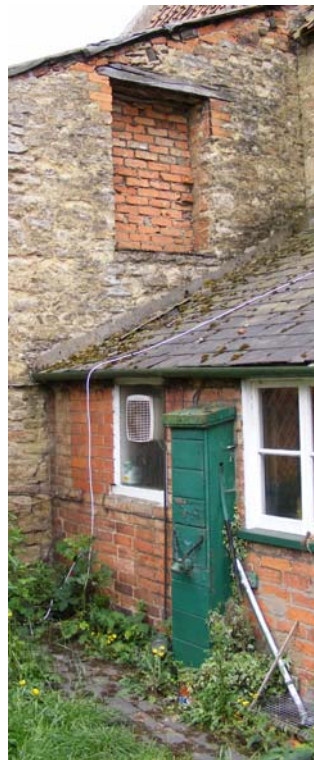
Above G9 lay the inaccessible room F8. It has a boarded-up window in the east wall, a blocked window in the west wall (Fig 41) and maybe a blocked former access from bedroom F5. It may have a fireplace in the north wall. The roof covering is pan-tile.

Fig 41: Blocked window in west wall of F8

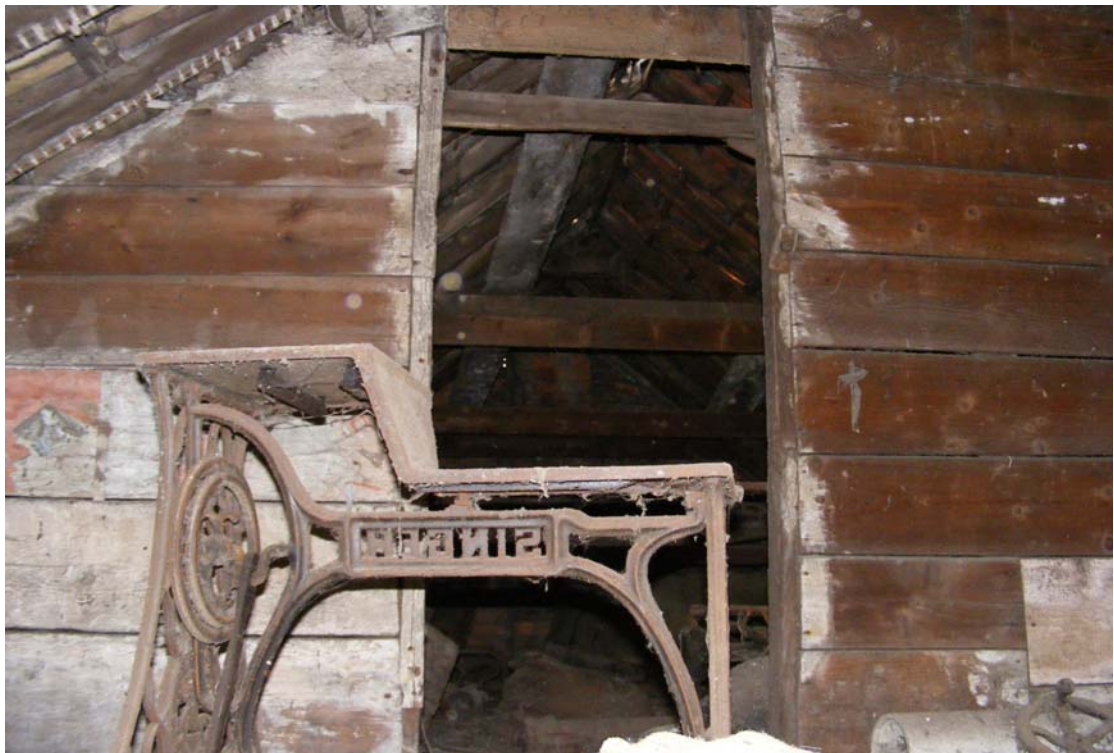
Fig 49: Cottage, first floor; note evidence for plastering at left
