A BUILDING ASSESSMENT OF THE SOUTH
WING AT
BURLEY ON THE HILL HOUSE, BURLEY
RUTLAND

March 2009

Report 09/38

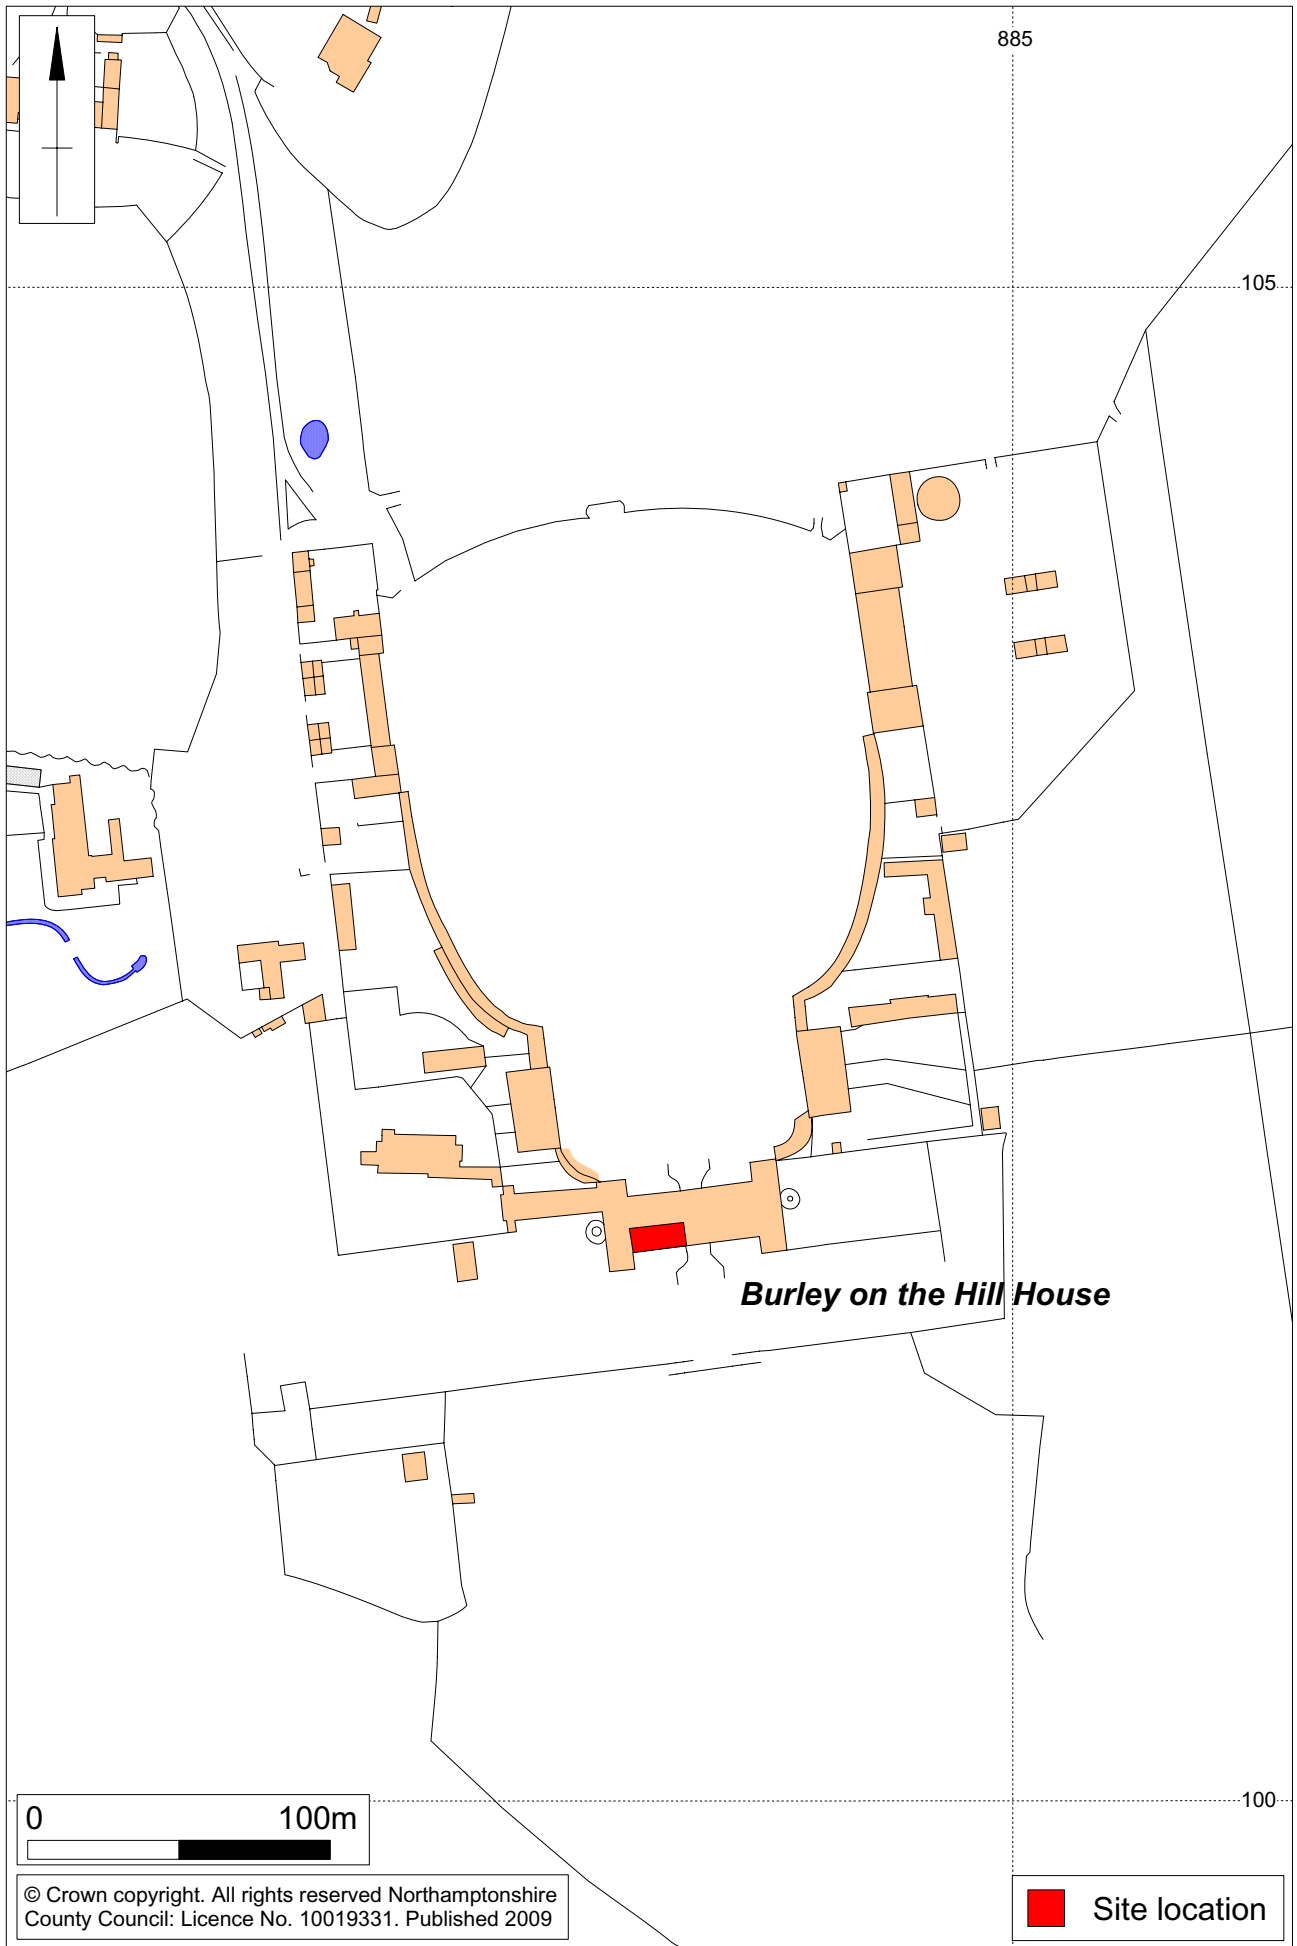
Burley on the Hill House Fig 2

Only the south wing of the house fell within the scope of the survey (Fig 2).
