Archaeological evaluation

The Orchard, Leigh Court, Abbots Leigh

Report 09/083

**ARCHAEOLOGICAL EVALUATION OF LAND AT
THE ORCHARD, LEIGH COURT, ABBOTS LEIGH
NORTH SOMERSET
JUNE 2009**

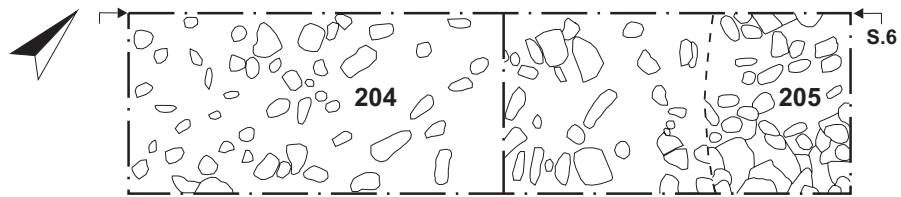
Trench 2

Overlying the rubble surface at the south-west end of the trench was a 0.1m thick deposit of loose stones [203] extending for 1.5m, thinning to the north-east. The stones ranged from small fragments up to pieces 0.15 x 0.15 x 0.10m in size. The deposit was perhaps either from the construction of the pond bank revetting wall or from its subsequent slighting. As no direct stratigraphic link with the wall was present any interpretation is supposition.

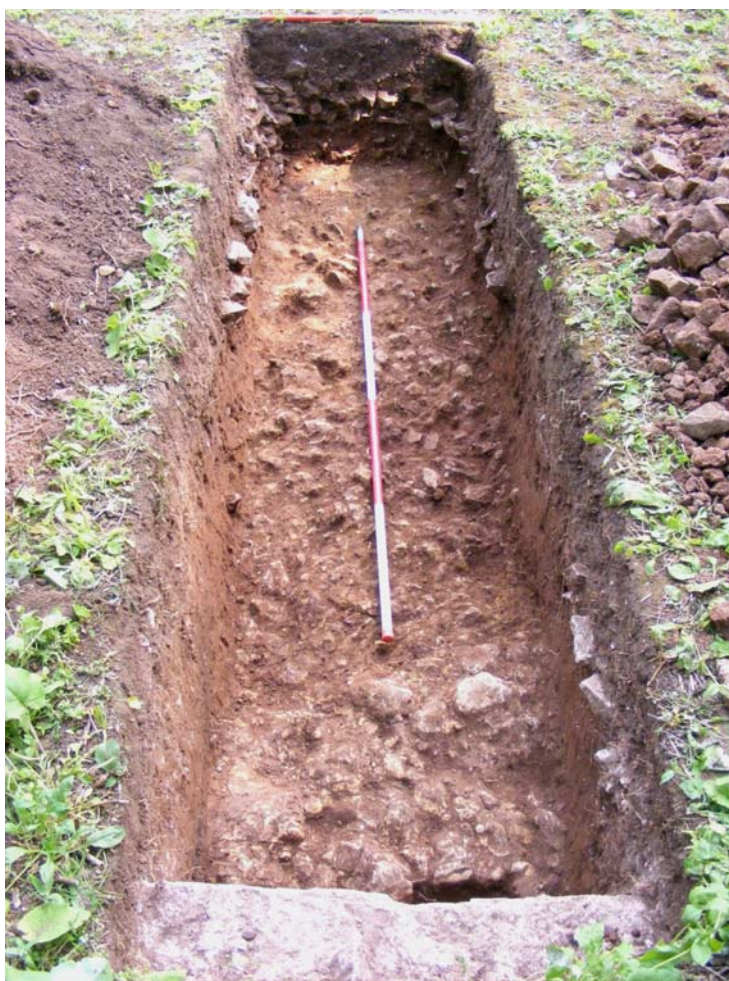
Plate 2: Trench 1, showing wall [106] (foreground) and limestone [107], looking north-east

This trench was positioned to intercept the line of the possible pond bank retaining wall (Plates 1-3). At a depth of 0.7m there was a layer of loosely compacted limestone [107], which had presumably formed a surface or sub-base for loose gravel (Fig 3, Trench 1; Fig 4, Section 2). Excavation stopped on this horizon so its thickness is unknown. It was cut at its south-western end by an irregular, partially exposed pit [109], at least 0.2m in diameter and 0.14m deep. This pit contained a firm reddish-brown sandy clay [108] which contained pottery of medieval date. From its form and stratigraphic position it was interpreted as a possible planting hole from an earlier garden layout.

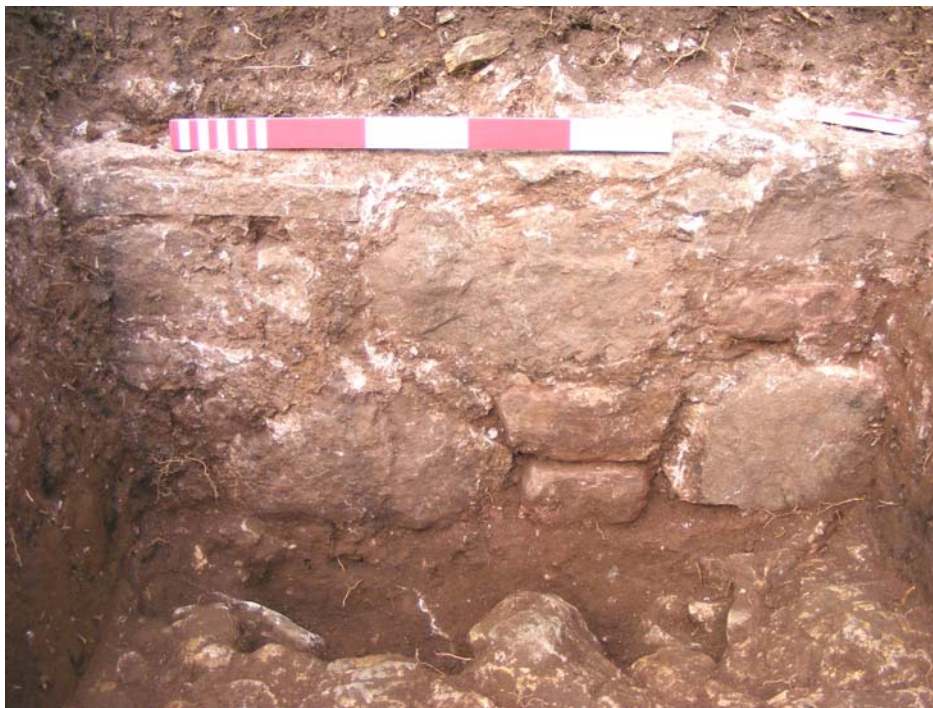
Plate 3: Trench 1, showing exposed face of wall [106]

Part of the top truncated upper surface and north-east face of the stone wall [106] were exposed, it had a maximum surviving height of 0.5m (Plate 3). It comprised an irregularly-coursed wall incorporating roughly-squared blocks 0.3m x 0.2m and thinner smaller pieces, 0.35m x 0.05m, set in strong cement. Some of the stones showed signs of scorching and may have been re-used from elsewhere. The wall had presumably been originally constructed to form a low revetment to the face of the raised plot containing the pond.

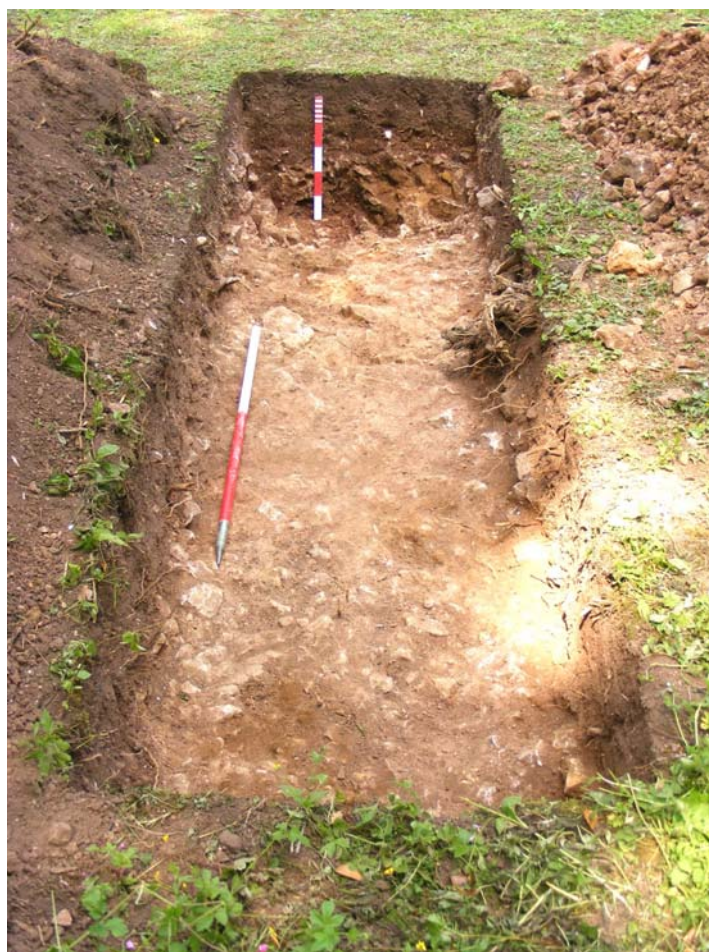
Plate 4: Trench 2 showing limestone 204, looking north-east

This trench was positioned a short distance from the bottom of the slope to the pond. It was excavated to explore the possible presence of rubble collapse or demolition material from the postulated retaining wall and to explore the presence or absence of a robber trench. At 0.25m deep, a layer of limestone [204] containing hardly any soil, extended across the entire length of the trench (Plate 4); what matrix was present comprised clean reddish clay (Fig 3, Trench 2; Fig 4, Section 6). The deposit had a thickness in excess of 0.3m, the limit of excavation of a 1m-long sondage at the north-eastern end of the trench. The stones ranged in size from 0.07 x 0.07 x 0.05m up to 0.3 x 0.2 x 0.2m.

The stones appeared to form a compacted surface, such as a courtyard or roadway, and the upper surface of many of the stones were rounded, the stones lower down in the horizon had a more sub-angular form, further supporting this premise. The

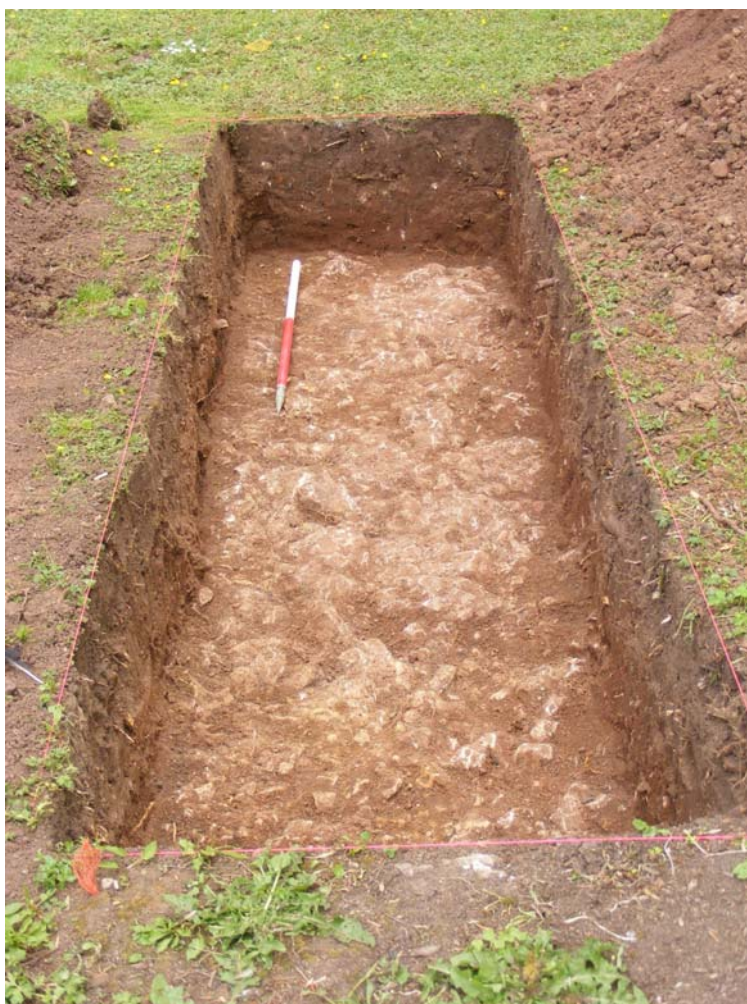
Plate 5: Trench 3, showing dense limestone [305]

This trench was sited to cross a linear anomaly identified in the geophysical survey. The trench was excavated to a depth of 0.5m, at which point an irregular and uneven limestone horizon was encountered [305] (Fig 3, Trench 3). The upper surfaces of the stones were generally rounded and sub-angular, possibly reflecting some degree of wear. The stones were very tightly set together and had presumably originally constituted some surface or a sub base for one (Plate 5). This deposit was not further excavated.

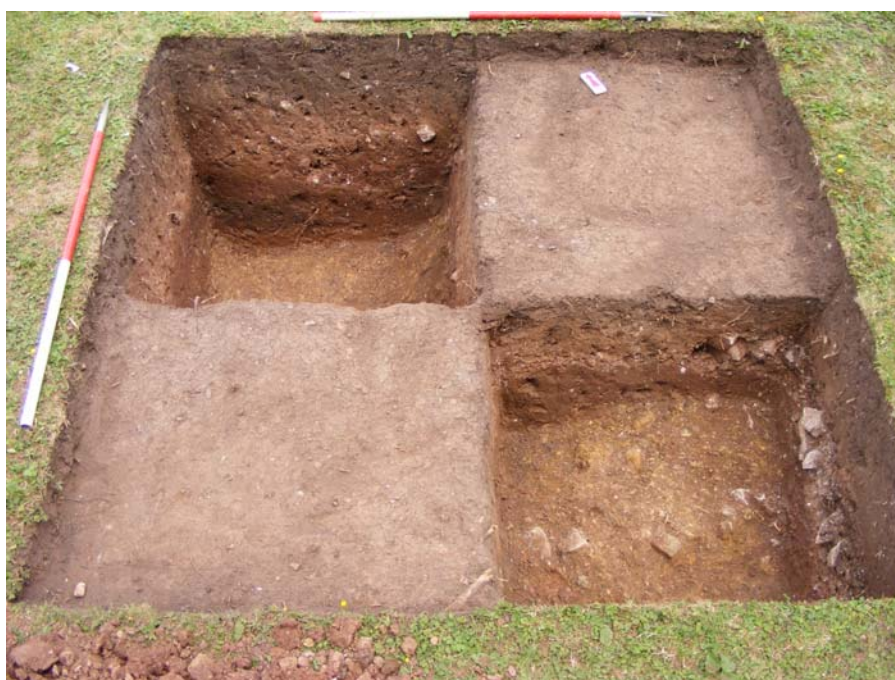
Plate 6: Trench 5, showing excavated quadrants, looking north-east

Trench 5 was positioned in an area of no geophysical anomalies and measured 2m x 2m. The trench was divided into quadrants with the opposing quarters excavated (Plate 6). Between 0.4m and 0.9m deep an uneven limestone horizon [511] was encountered comprising small stones up to a maximum of 0.2m across (Fig 3, Trench 5). This layer formed a trough on the western side of the trench and a shallow bowl on the eastern side. The basal infill of the trough comprised a thin, 0.07m thick, clean gravel deposit [507] comprising small angular and sub angular grit up to 10mm across (Fig 4, Sections 3 and 4). It was uncertain whether this was a deliberate addition in the hollow or if it reflected a gravel horizon higher up (now absent) through which the hollow had been dug.

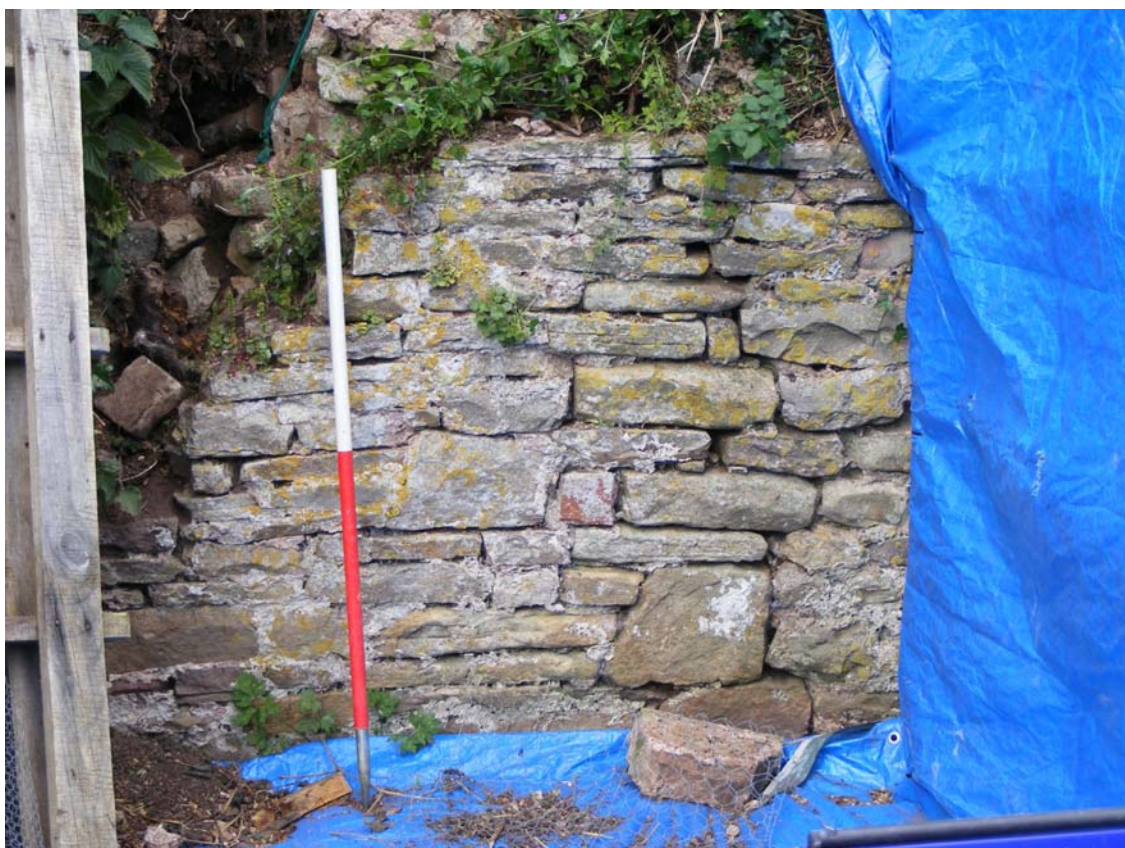
Plates 7 and 8: Showing possible joggle joints perhaps derived from the removed of quoins at the infilling of a gateway at the centre of the south-western wall

Consideration of the site, bearing in mind that it was probably the main approach to the original hall raised a series of interesting problems. It is normal that the approach to lesser great houses is such that the front façade is fully in view to gain maximum impact, clearly the use of a road that by passes this plot is therefore unlikely to be the original access. If, therefore, the approach to the hall crossed the study area then, assuming the south-west wall was contemporary, some sort of gateway through it might reasonably be expected. Examination of the outer face of the wall in an area currently used for growing Bonzai trees did indeed produce evidence for one definite and one probable joggle joint (Plates 7 and 8) such as might occur when quoining has been removed and a gap infilled with further masonry. The distance between the two joggles was of the order of 5.5m, sufficient to afford access for most carriages and the location was at approximately the mid point in the wall's length.
