Archaeological strip, map and sample

exercise on land at

Home Farm, Highfield Lane

St Albans, Hertfordshire

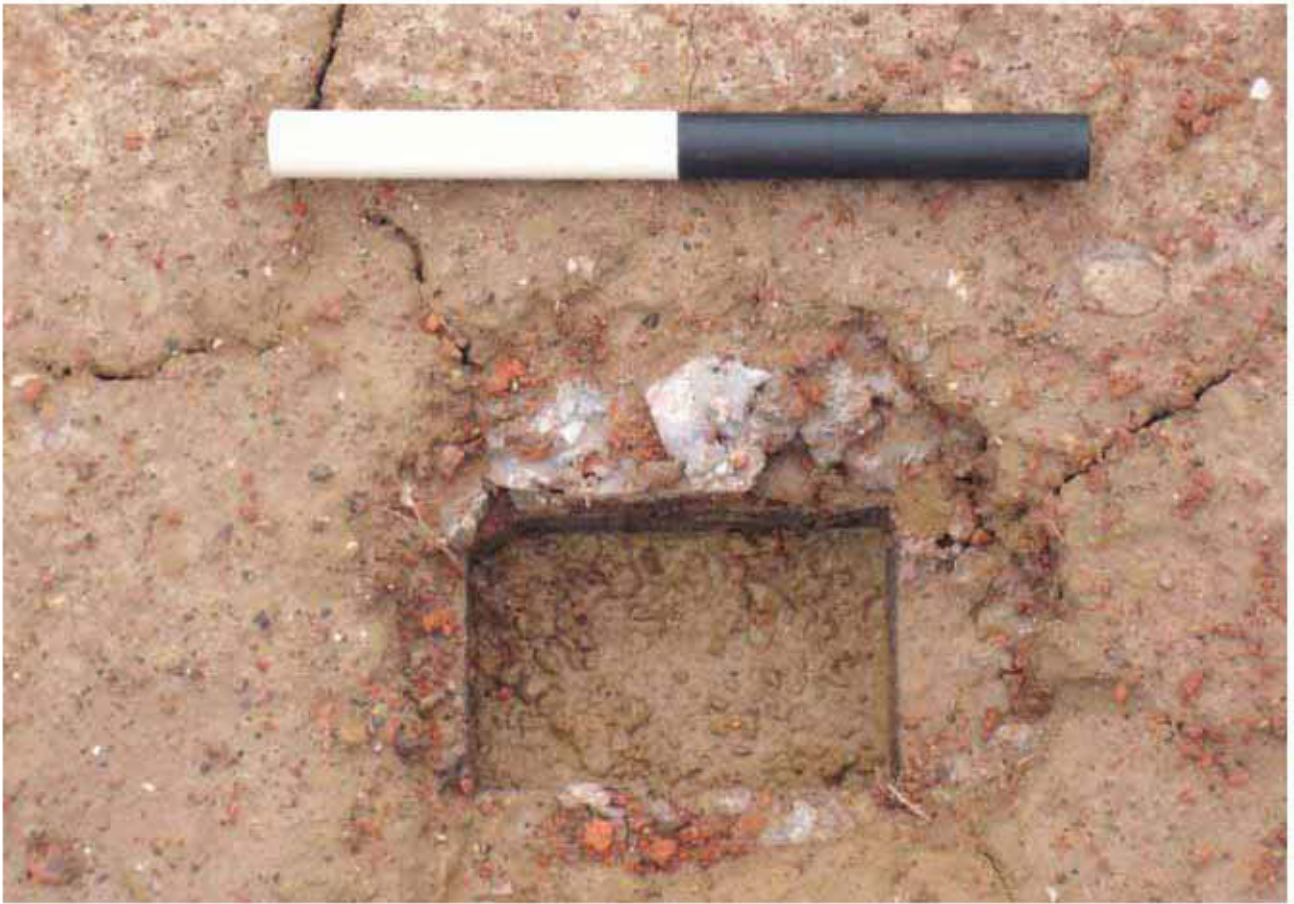
Fig 4 Pre-piggery posthole [9]

Cut into the natural in the north-east of the site was a square posthole [9] with straight sides and a flat base measuring 0.16m x 0.14m and 0.07m deep (Figs 3 and 4). It contained a concrete post-pipe, making the original post size 0.11m x 0.08m. It was infilled with the overlying make-up layers from the piggery floor (7). Another four small sub-circular cuts spaced roughly equidistantly were laid out in a north-west to south-east orientated line. These were more amorphous shallow cuts, which contained no concrete but may have been the remnants of post settings. The features may represent a pre-building fence line or are possibly connected with the construction of the piggery itself.

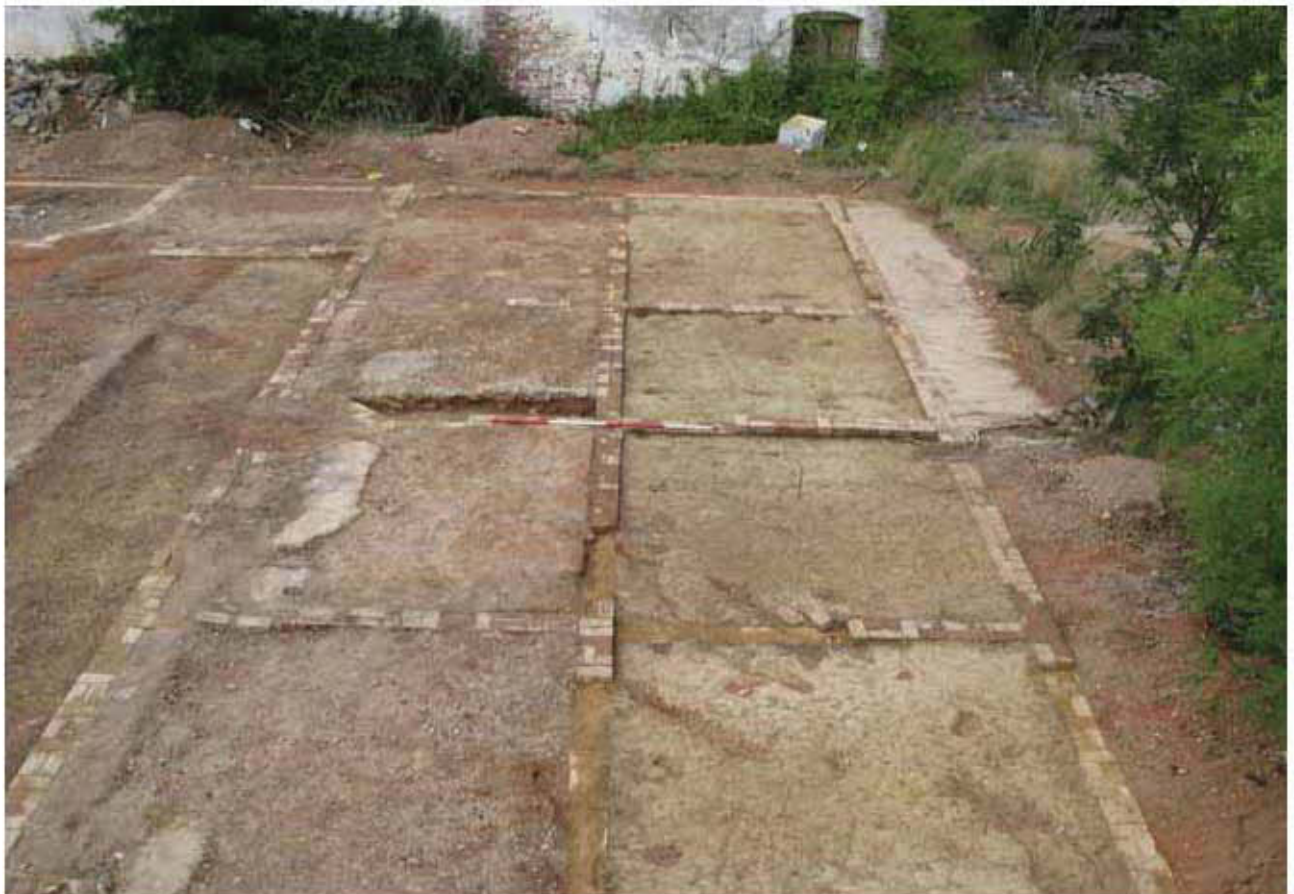
Fig 5 North-eastern range [4], looking north-west

The north-eastern side of the structure comprised a double row of six rectangular bays, formed by a series of brick foundation walls (Fig 5). The sixth bay continued beyond south-eastern edge of the excavation. The bays are thought to be individual pigsties and pens. The walls were constructed from red frogged bricks marked "Hicks Gardener & Co" and laid in Flemish bond with a light yellow sandy mortar (Figs 6 and 7). The bays each measured 3.05m (10') by 2.75m (9') internally, save for the larger bays in the northern corner which were 4.88m (16') by 2.75m (9').

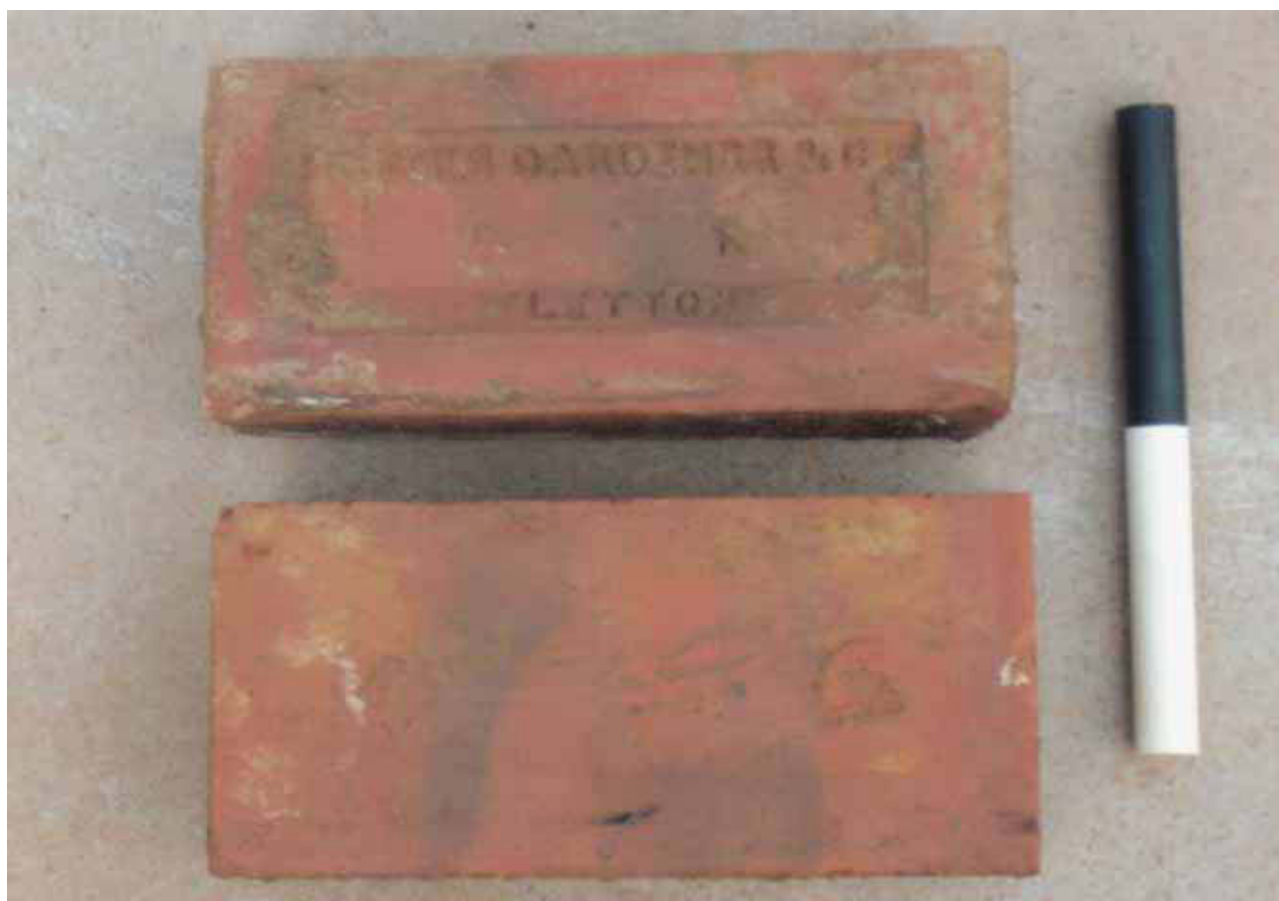
Fig 6 Brick used in construction throughout the piggery

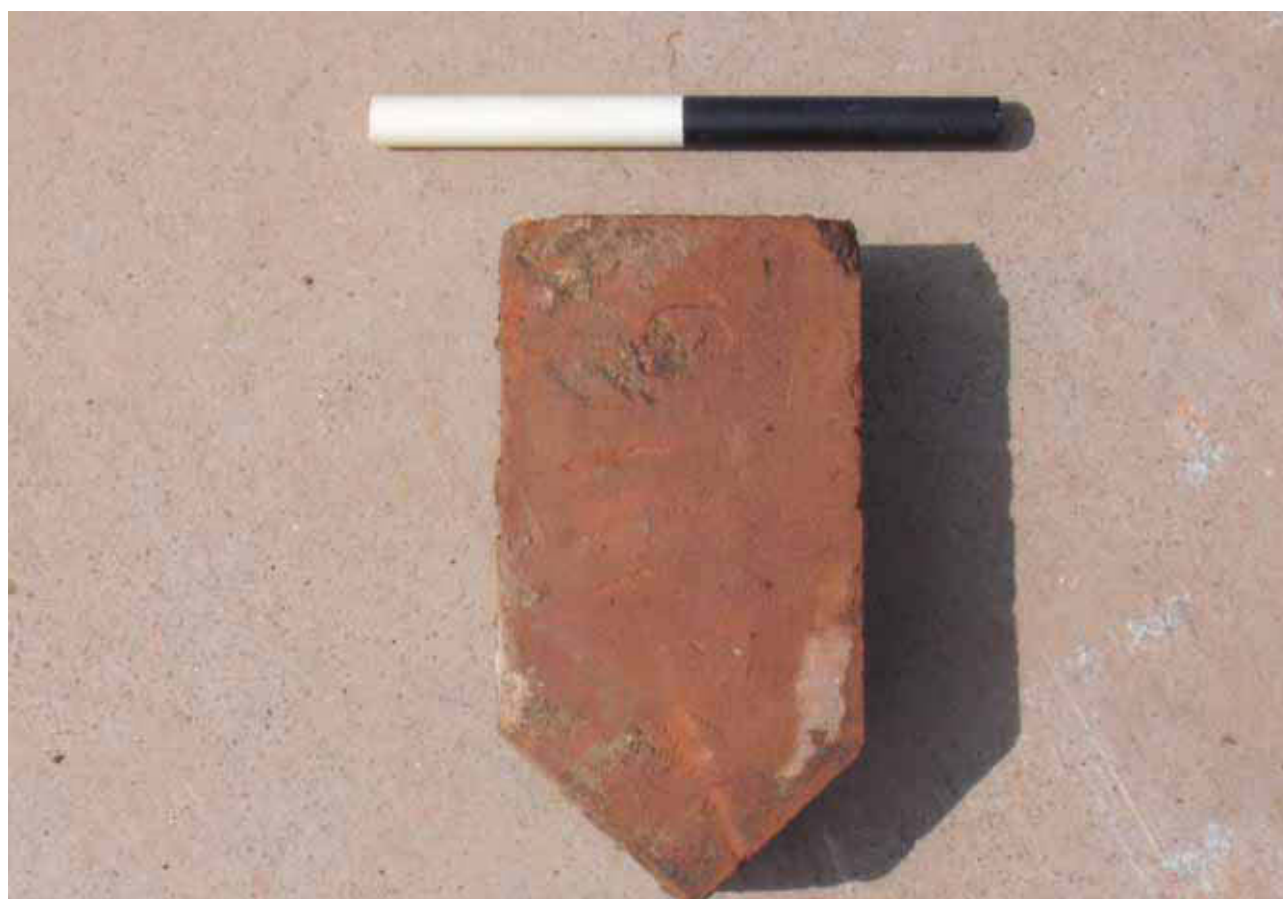
Fig 7 Shaped bricks used in the chevron-shaped sty entrance

On the south-western side of the range, the junctions between each sty were defined by foundations set in a chevron shape. This may have formed an entrance into each bay.

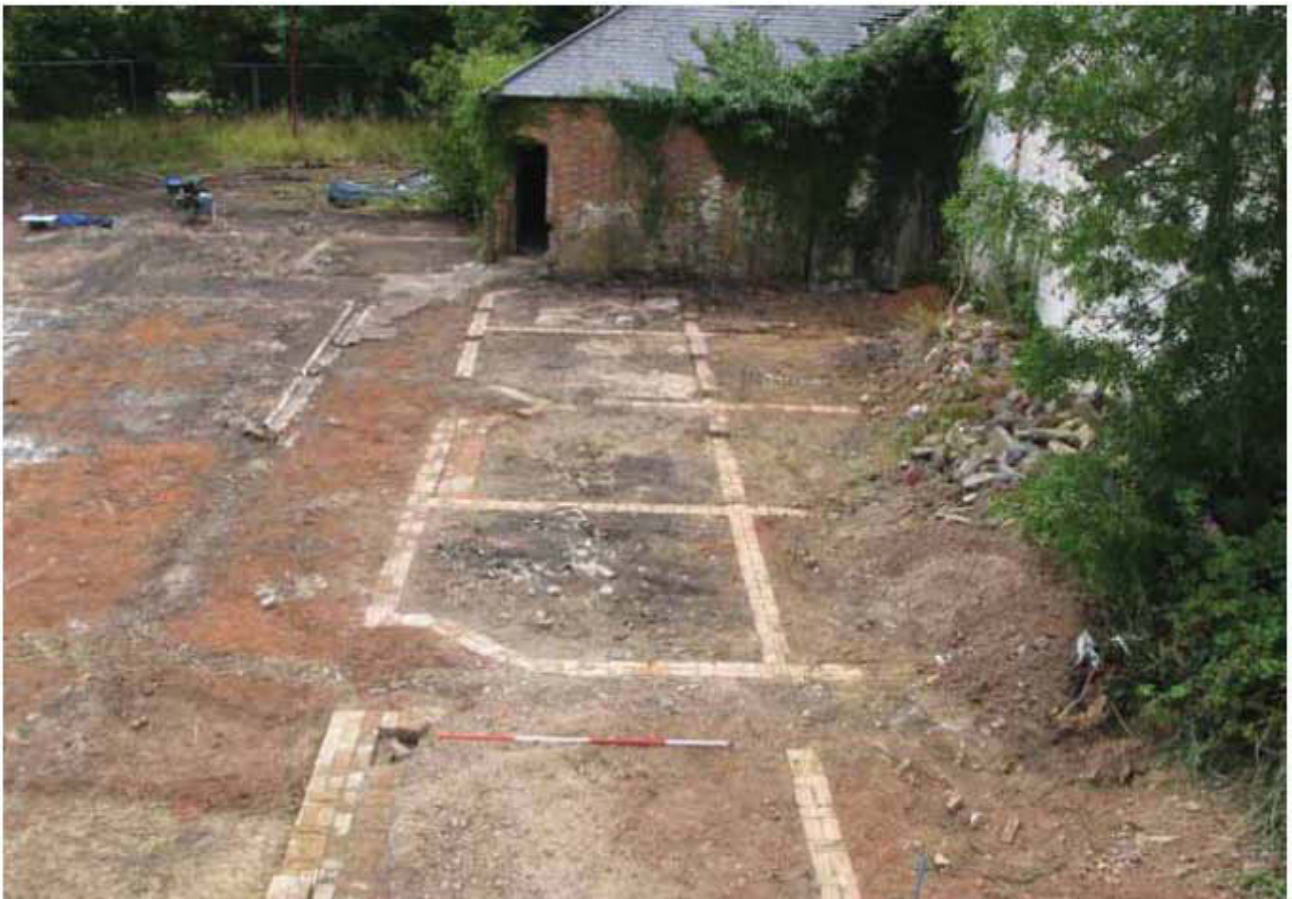
Fig 9 North-western range [17], looking south-west

The north-western range appeared generally identical in plan to north-eastern range, although the rear of the bays, adjacent to the standing farm building, lay beyond the edge of excavation (Fig 9). Two of the sties had a second row of bricks added internally along their southern side but the purpose of this was unclear (Fig 10). The floor levels of the two northern sties of the north-western range had been removed or affected by modern disturbance (18).

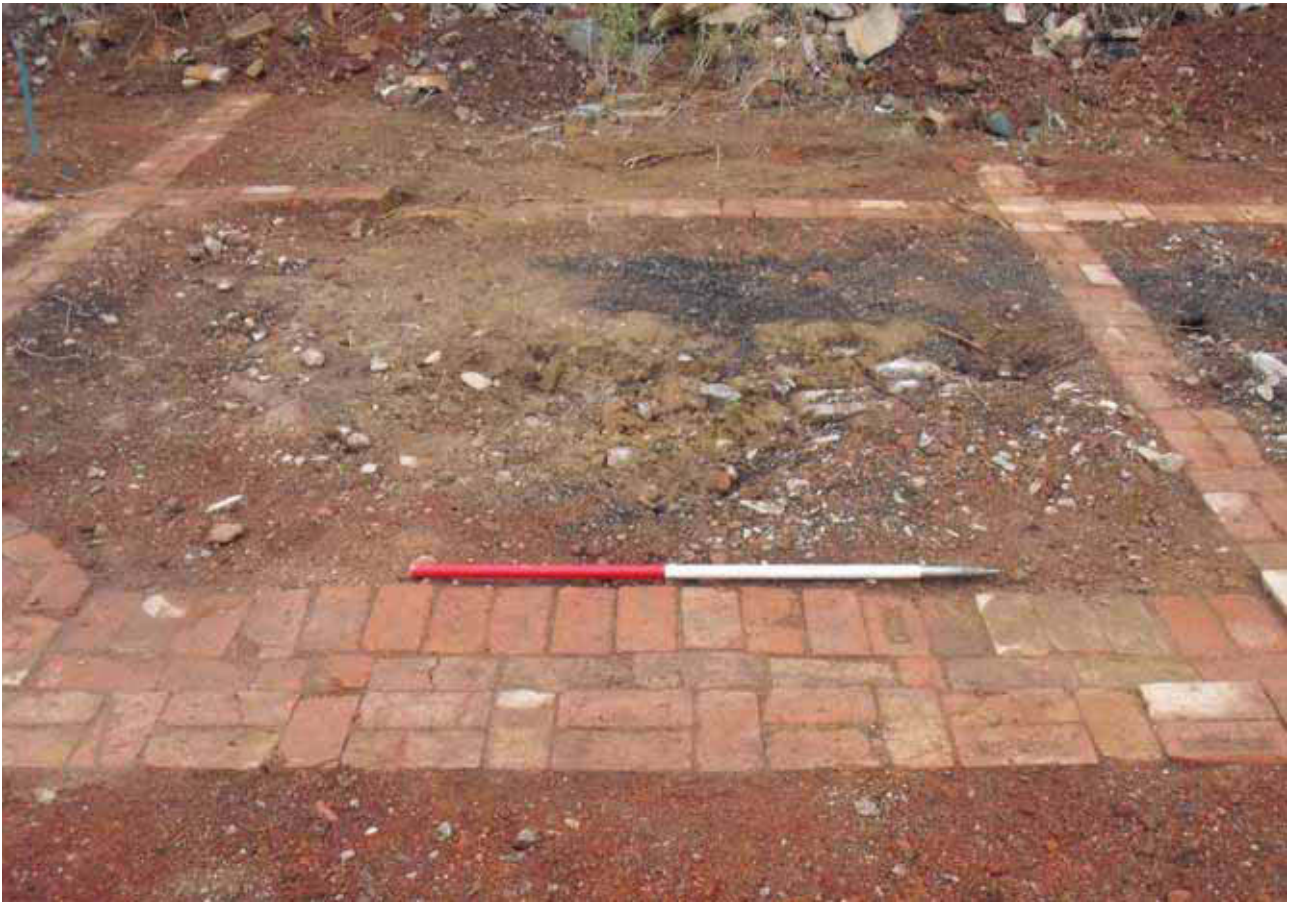
Fig 10 Additional brick foundations within sty in range [17], looking north-west

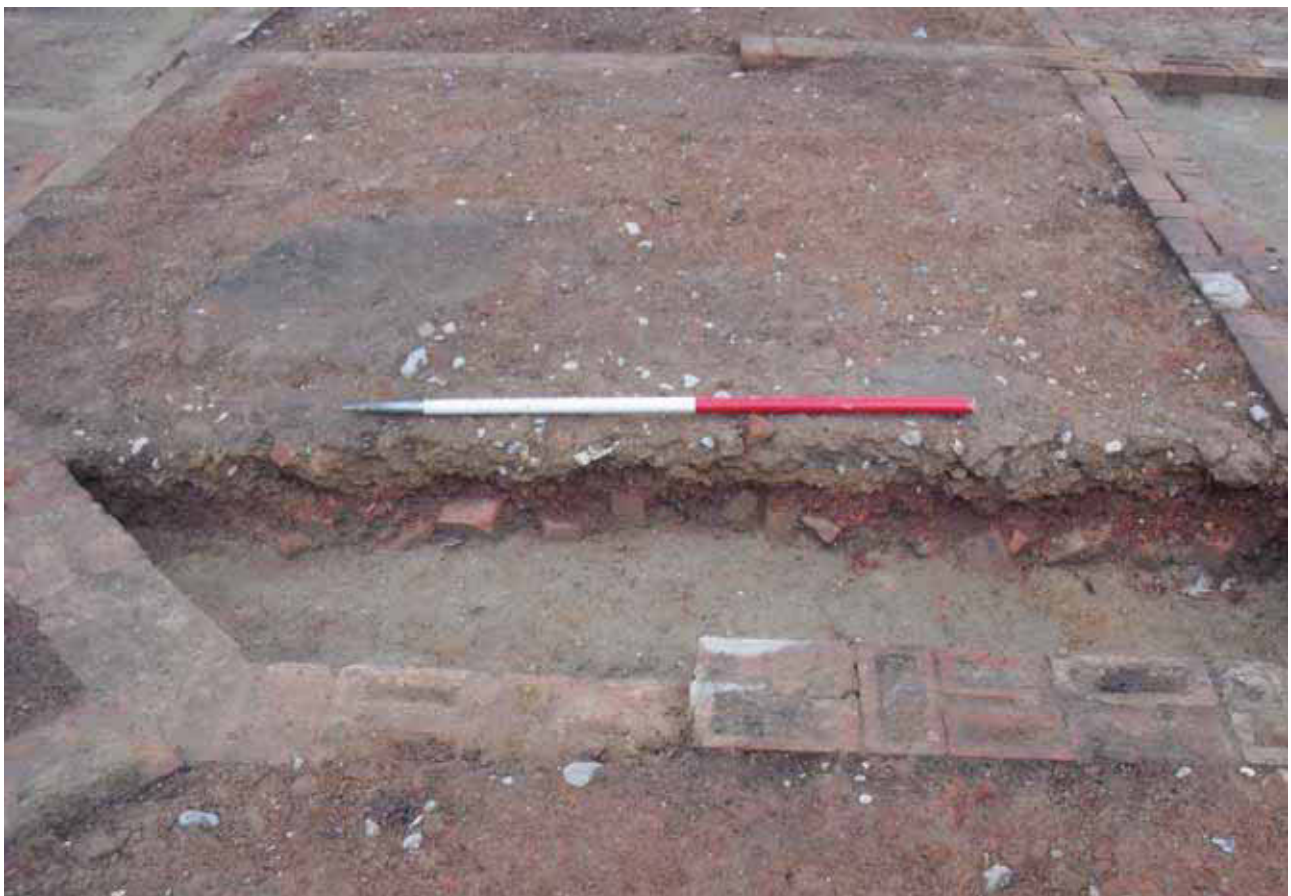
Fig 11 Section through floor make-up layers (6) and (7)

Within all the bays were the remnants of underlying make-up layers and floor surfaces (Fig 11). The make-up layers comprised a compacted layer of crushed red brick 0.12m thick (7). Within the larger northern bay, this layer also included a large quantity of broken slate roof tiles. This was overlain by a compacted greyish-yellow sandy mortar, 0.11m thick, containing very frequent small stones and occasional brick fragments (6)(20). On top of this were the remains of a probable floor surface comprising very compact crushed brick set in a hard white mortar (5) (Fig 12). This survived sporadically throughout the north-eastern range but was better preserved in the north-western range (Fig 13). In places, more modern concrete was present suggesting later patching of the surfaces. The one sty in the south-western side of the piggery [22] contained the vestiges of a tiled floor (24).

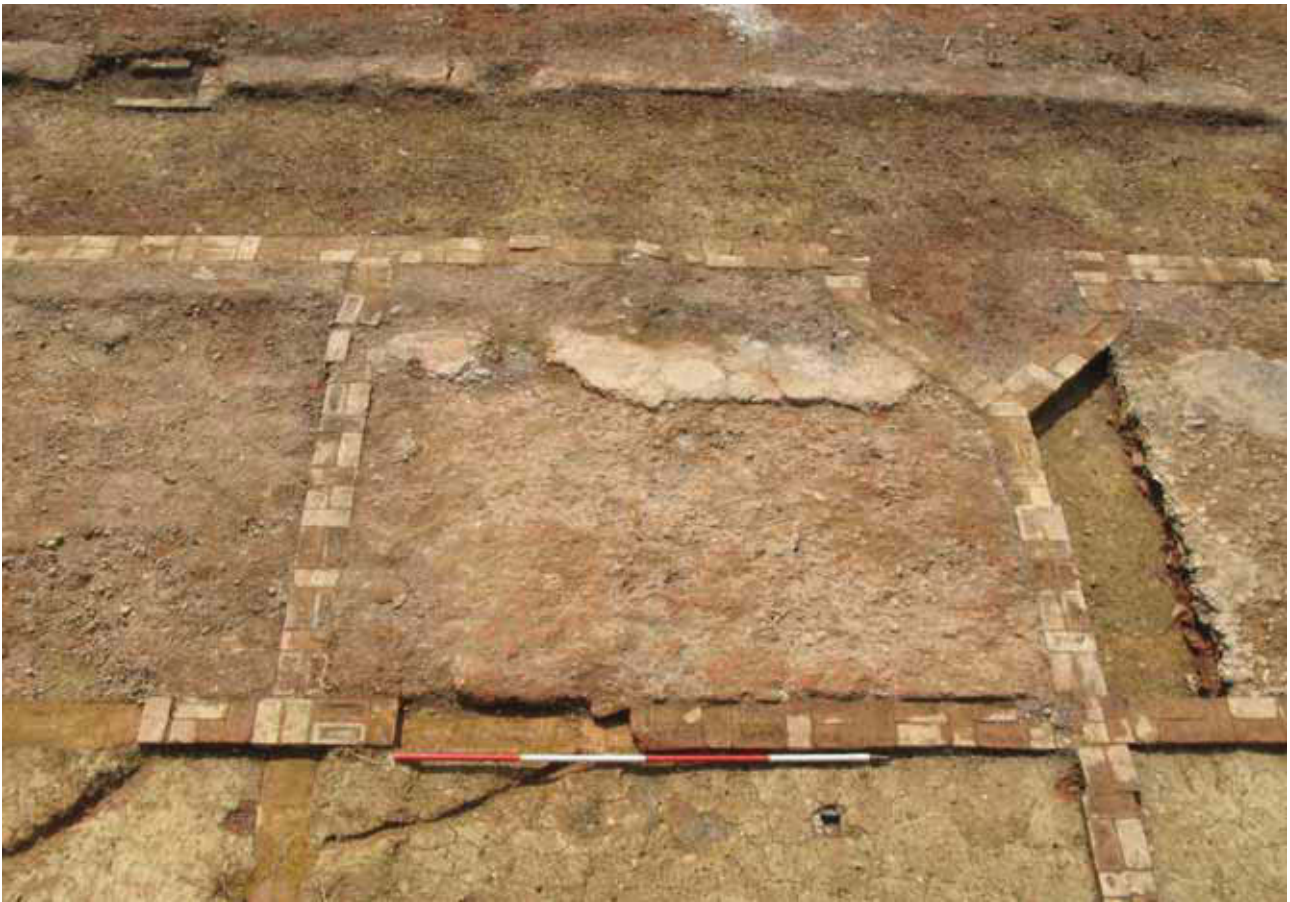
Fig 12 Remains of concrete floor level (5) in north-east range [4] looking south- west. Drain [12] and concrete bedding [11] can be seen at the top of the photograph immediately above robbed out path [25].

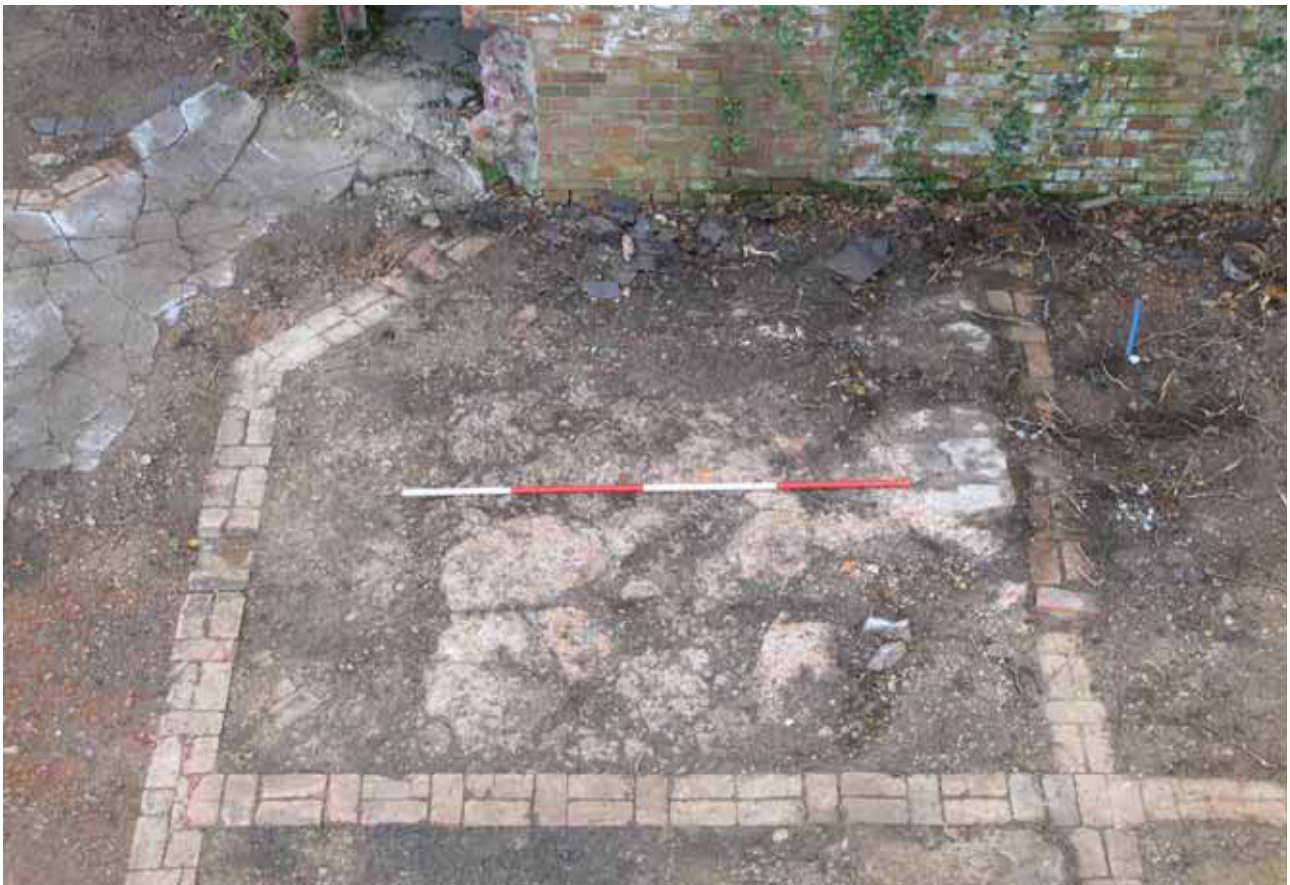
Fig 13 Concrete floor level (19) running in north-west range [17]. Path [25] is shown in the corner of the photograph, leading to building entrance

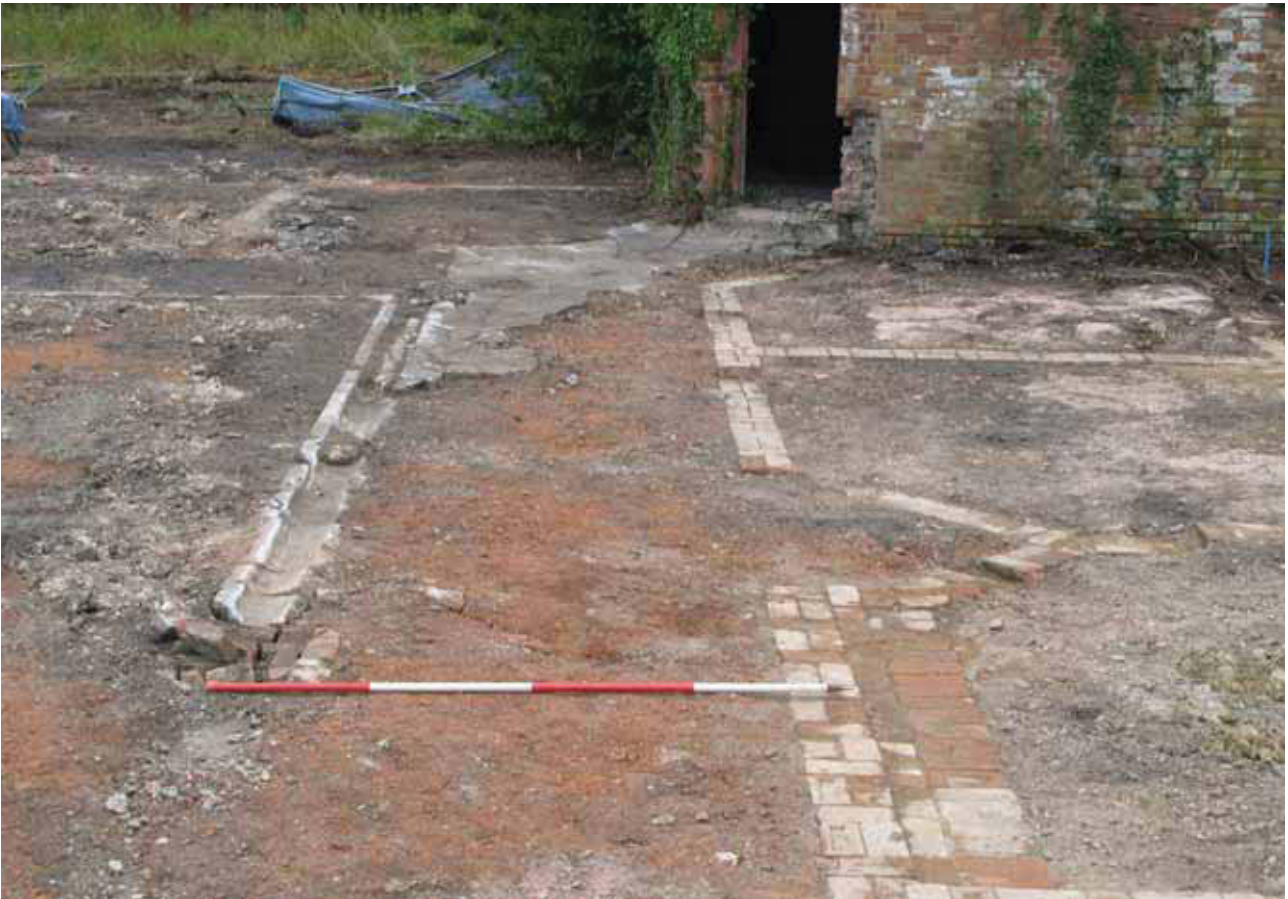
Fig 14 Path [25] and concrete kerb and gully [13], looking south-west

The yard enclosed by the pigsties was defined by edging formed from moulded concrete kerbing which included a channel that would have acted as a gully (Fig 14). The channels fed into drain holes set in the centre of each side of the yard [12][26] (Fig 15). The kerbing sat on a bed of concrete (11) which presumably overlay a soakaway or possibly a deeper lying drain (Fig 12). The kerbing only survived in the western half of the site but the underlying concrete survived throughout.

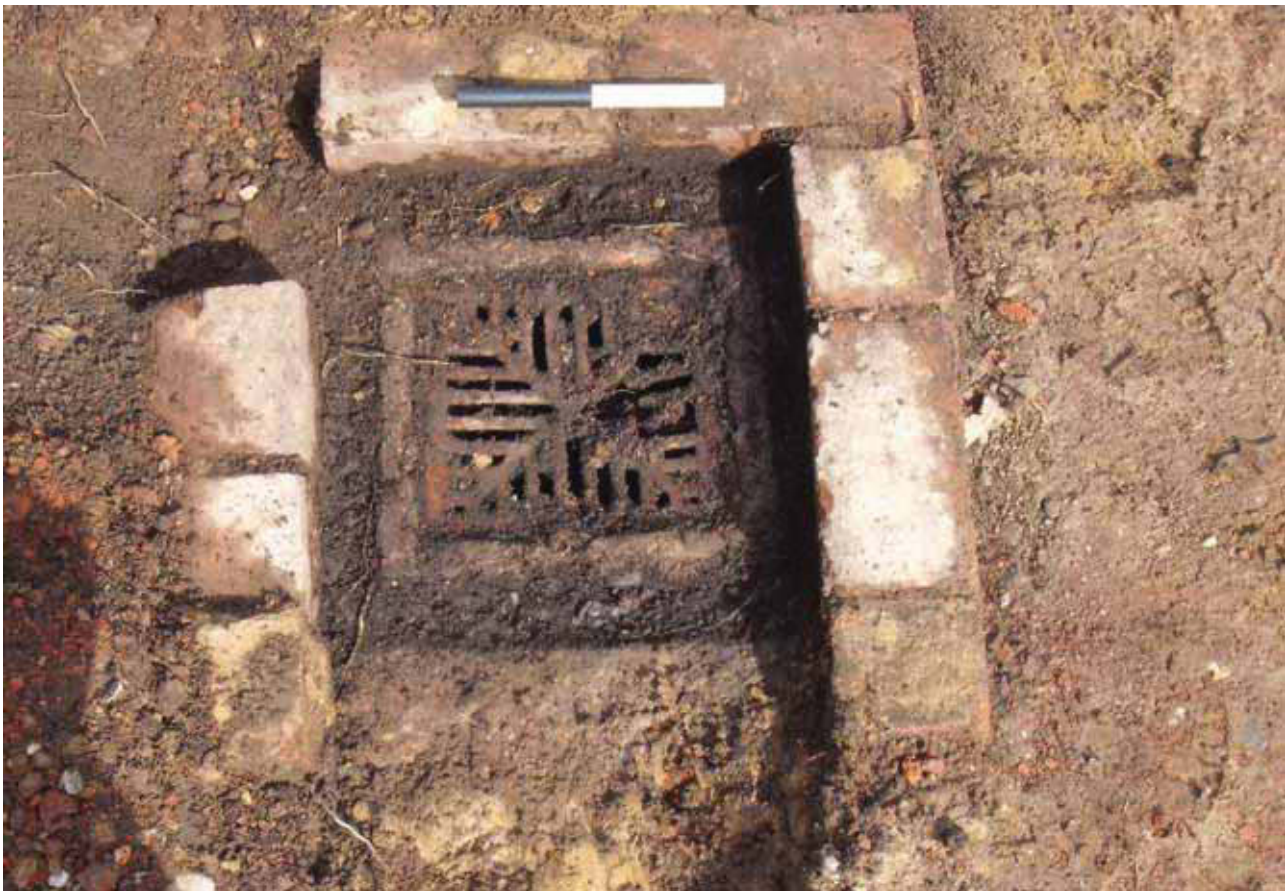
Fig 15 Drain [12], set into the concrete bedding [11] on the south-east side of the courtyard, looking north-west

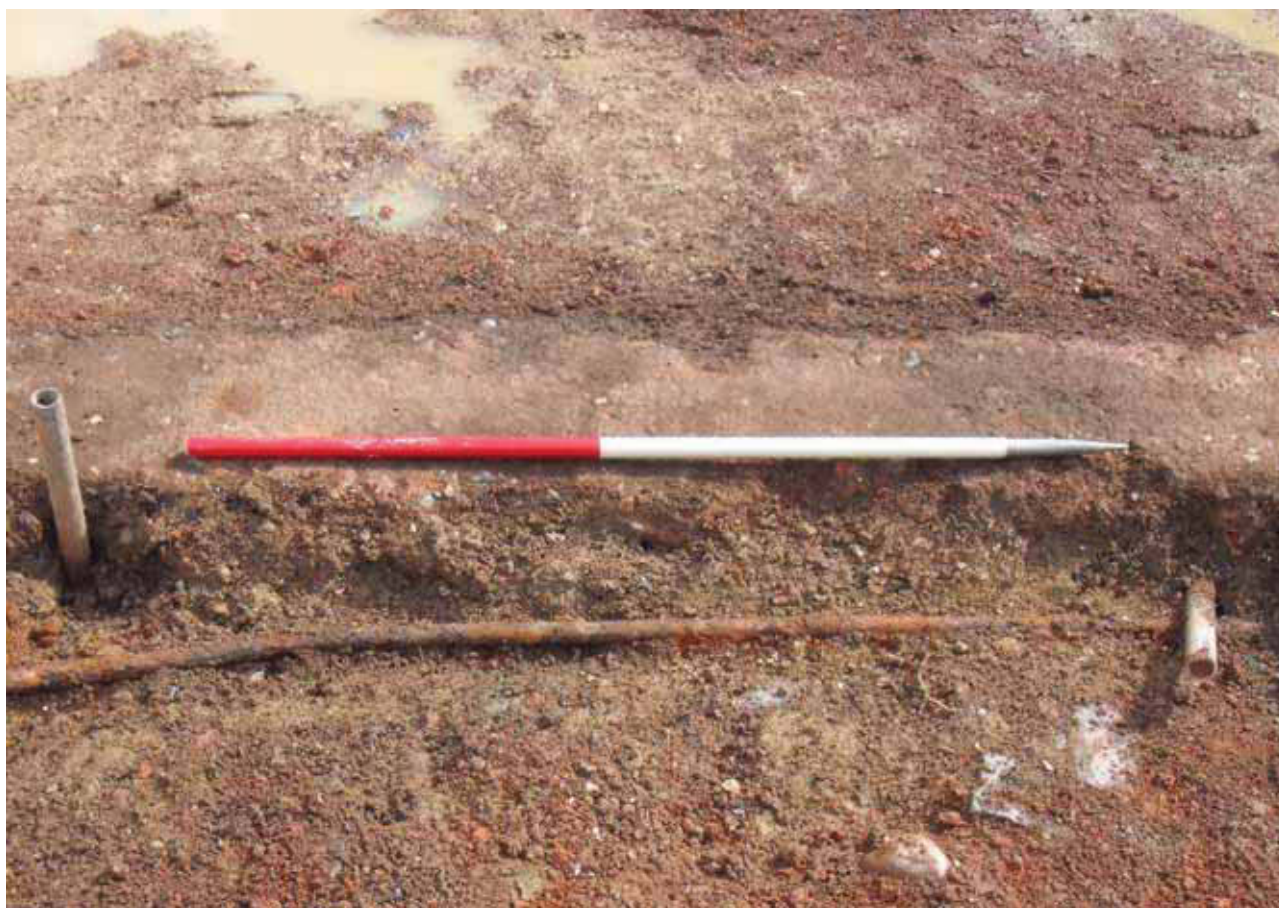
Fig 16 Metal pipes in trench [34] adjacent to concrete bedding [11], looking north east

Adjacent and parallel to the concrete bedding on the eastern side of the courtyard was a shallow cut [34], 0.45m wide, containing a brown sandy clay soil (35). Within the cut were remnants of metal pipes set both horizontally and vertically at relatively regular intervals along the length of the courtyard edge (Fig 16). At first it was thought that these provided a water supply system but none of the pipes appeared connected and it was not possible to ascertain how they would have originally operated or whether they were actually *in situ*.

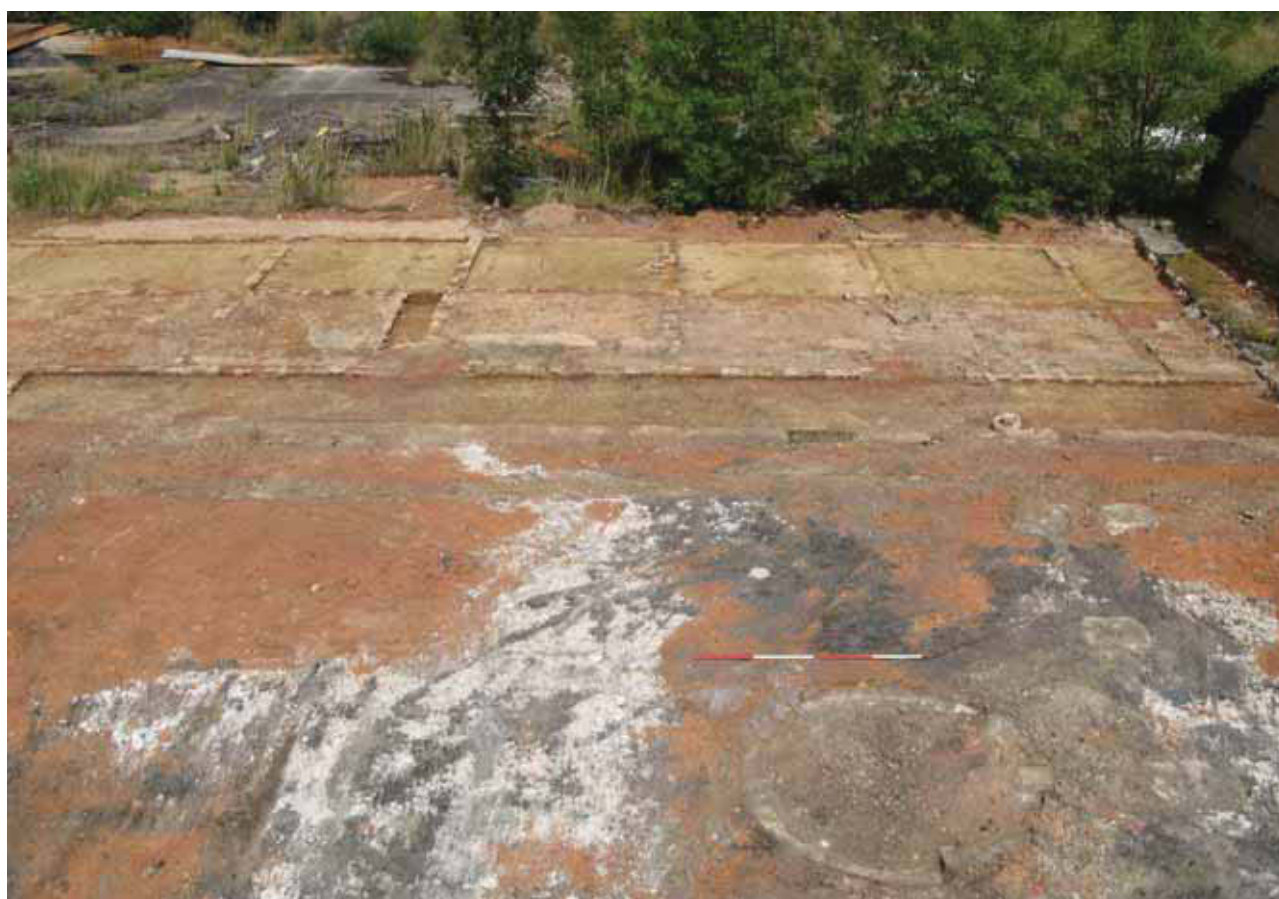
Fig 17 Yard surface (16) and well [15], looking north east

The yard surface itself comprised the same crushed brick makeup layer seen elsewhere on site (7) overlain by compacted chalk and tarmac (16) (Fig 17). A brick-

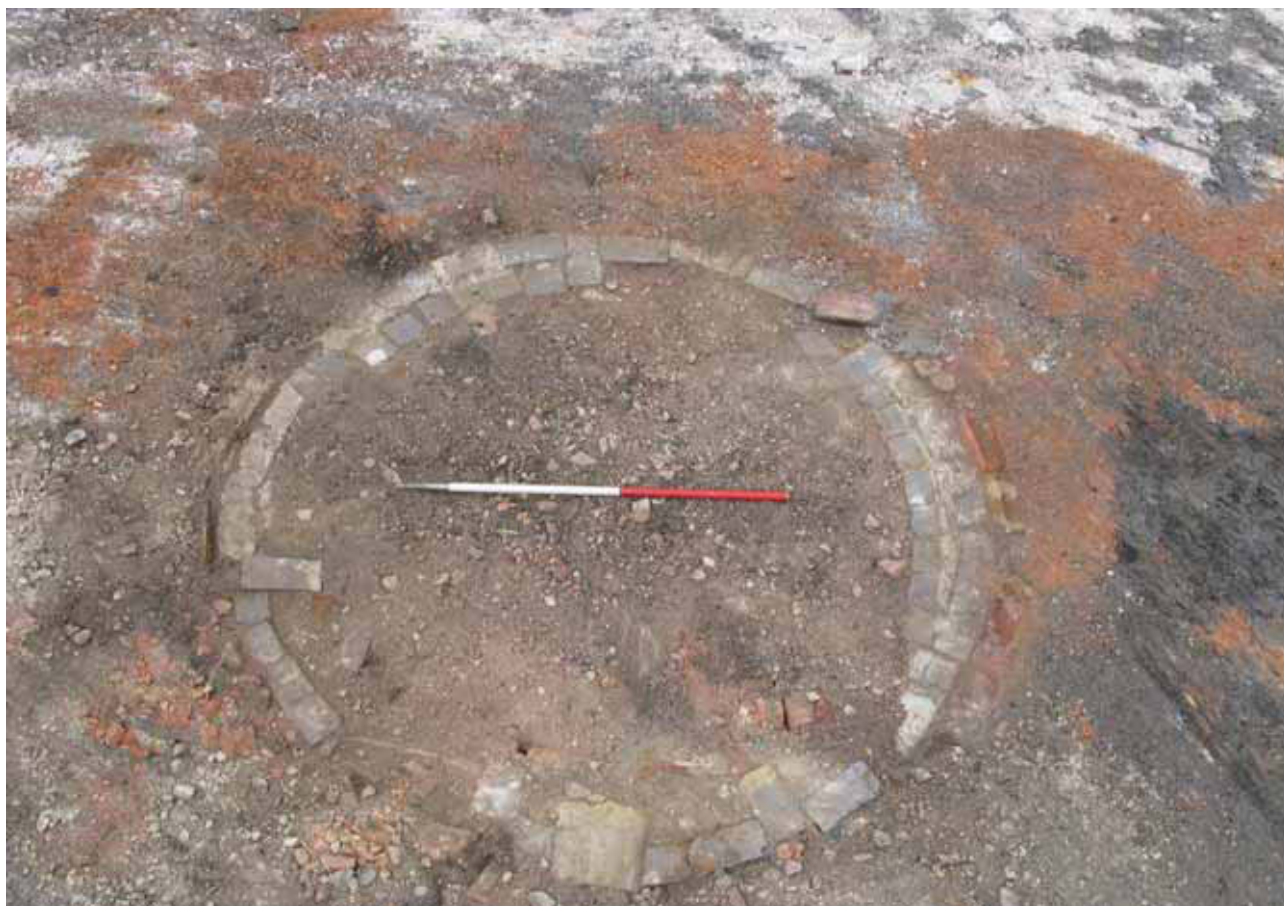
Fig 18 Brick-lined well [15], looking west

lined well [15] had been set into the yard. This was 2.60m in diameter and comprised an inner two courses of blue engineering bricks surrounded by an outer course of red brick. A small stone slab was set into one side. The well had been backfilled with bricks and other demolition debris (Fig 18).

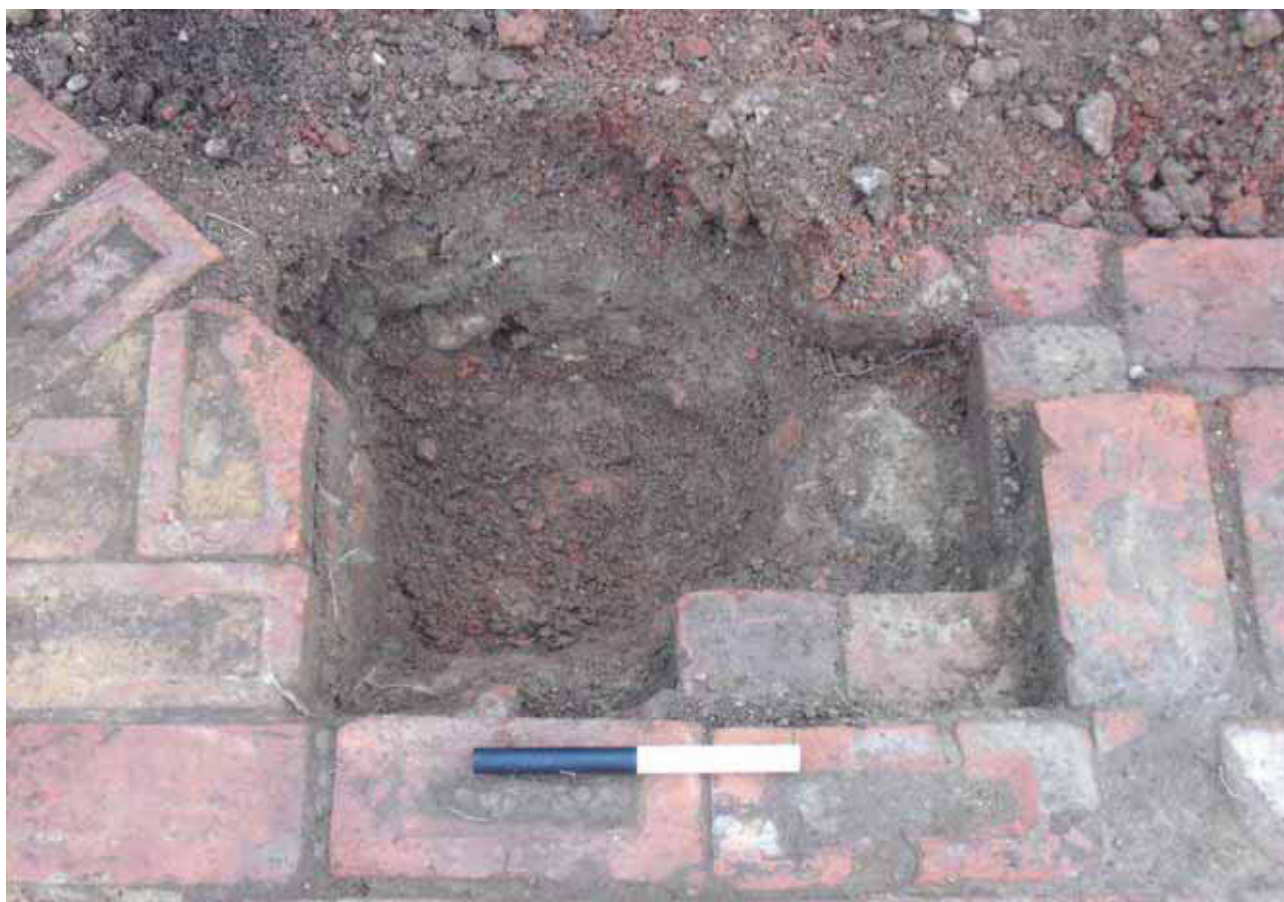
Fig 19 Post pit [28] in corner of sty in north-west range [17], looking north-west

A post-pit [28] had been dug through the entrance of the northernmost sty in the north-west range (Fig 19). This feature had a diameter of 0.35m and was 0.35m deep. It had steep sides and an uneven base and had been cut partially through the brick foundations. It was filled with brick and other demolition debris but did not appear to relate to any other features.

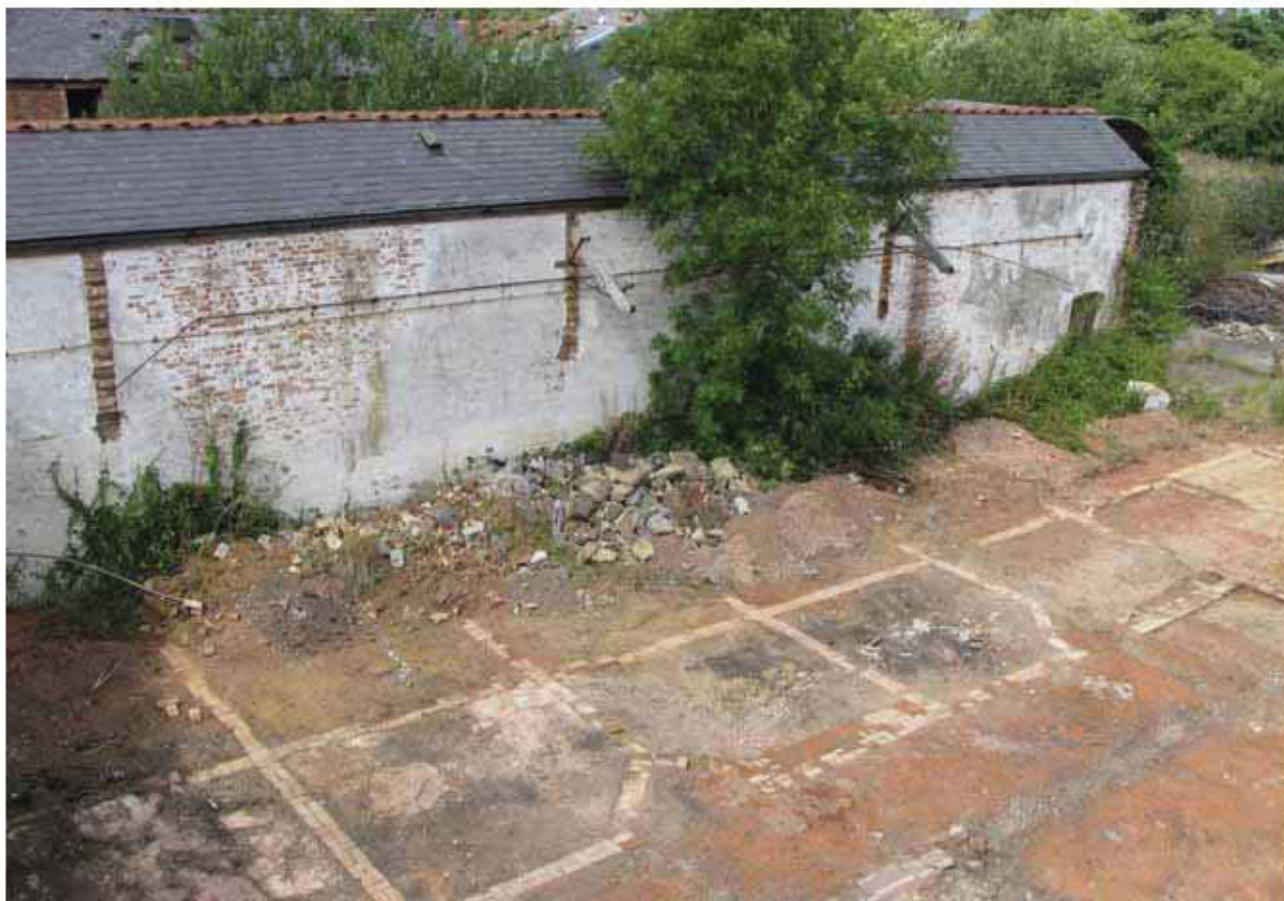
Fig 20 Standing farm building, looking north

The layout of the piggery can be deduced from the remaining standing buildings. Struts evident on the standing wall at the north-west of the site indicate a covered area would have run behind the pigsties (Fig 20). The rear bay of the piggery would also have been covered and a roof line visible on the standing building would indicate a sloping tiled roof was used (Fig 21). Scars in the wall show where the front brick wall had joined the standing building and this demonstrated that the sty wall was about 0.85m high.

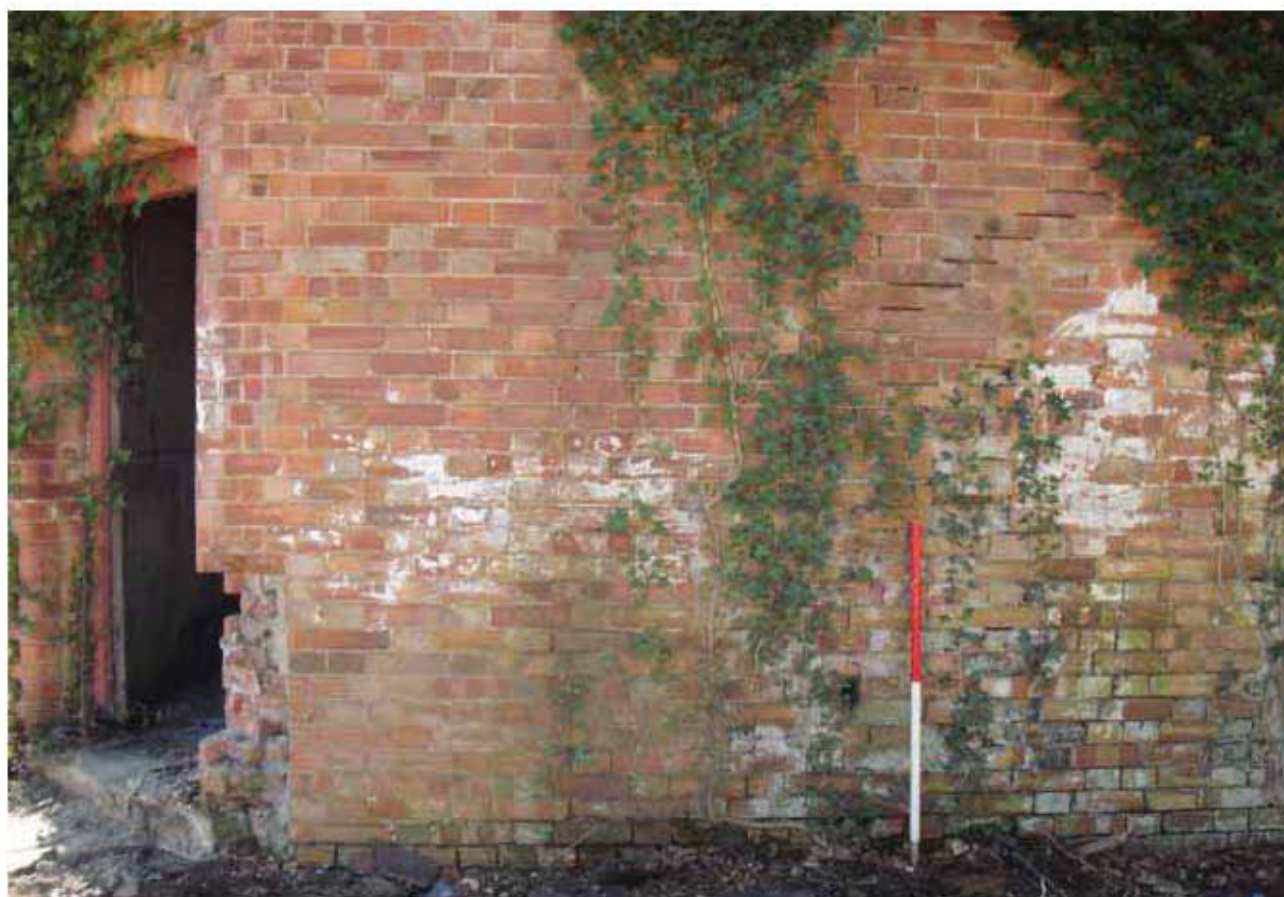
Fig 21 Standing farm buildings showing wall scars, remains of whitewash and former roof line
