# Northamptonshire Archaeology

The excavation of the Portobello Cutlery Works and  
19th-century housing on the site of the former  
Assay Office, Sheffield  
January - May 2009

Report 09/160

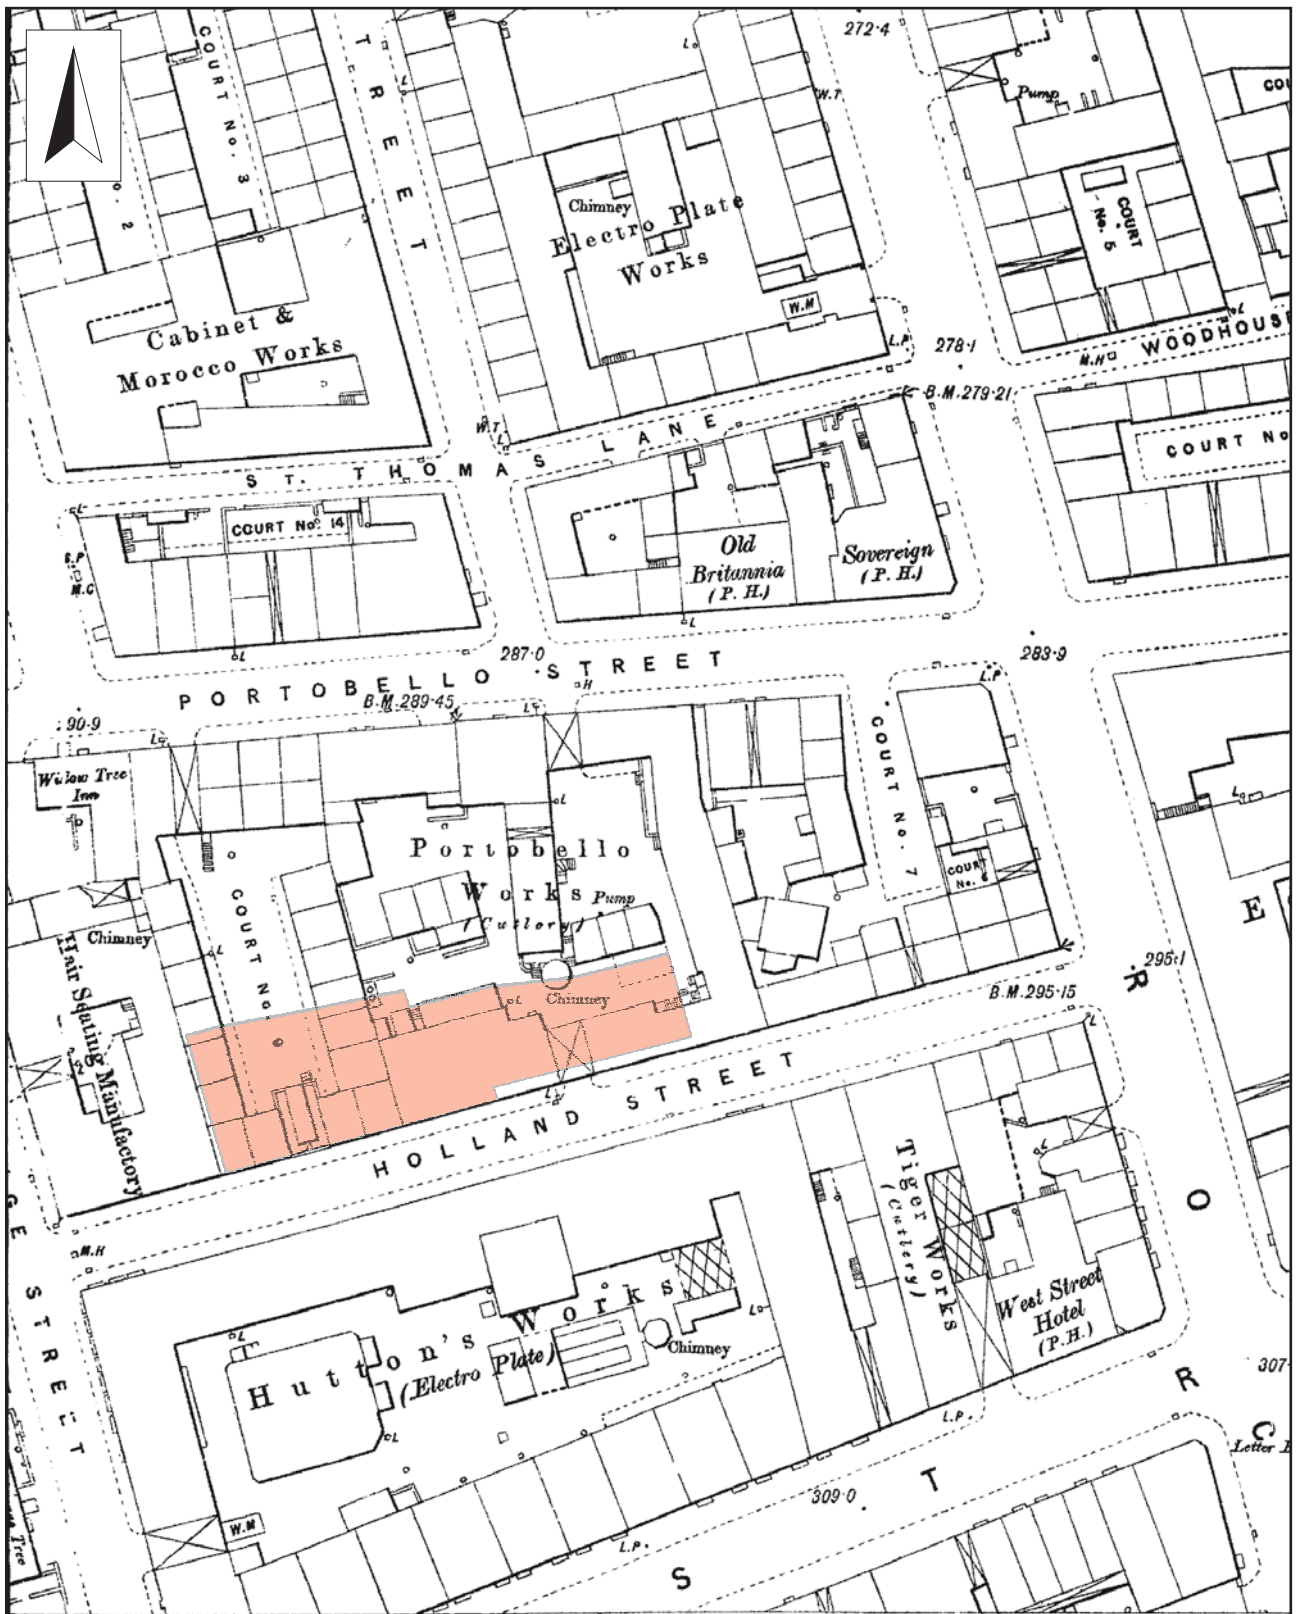
1890 Ordnance Survey Map Fig 5

Area of excavation

By 1890 a number of additions had been made to the buildings. The Ordnance Survey map of that year shows the Portobello frontage of the cutlery works had been built up, with a new building to the west completing the street frontage (Fig 5). There was a new central entrance from Holland Street, facing a large chimney. The buildings either side of this entrance appear to have been more substantial than those shown earlier. The court to the west of the works is identified as Number 9 and individual properties within it are shown.

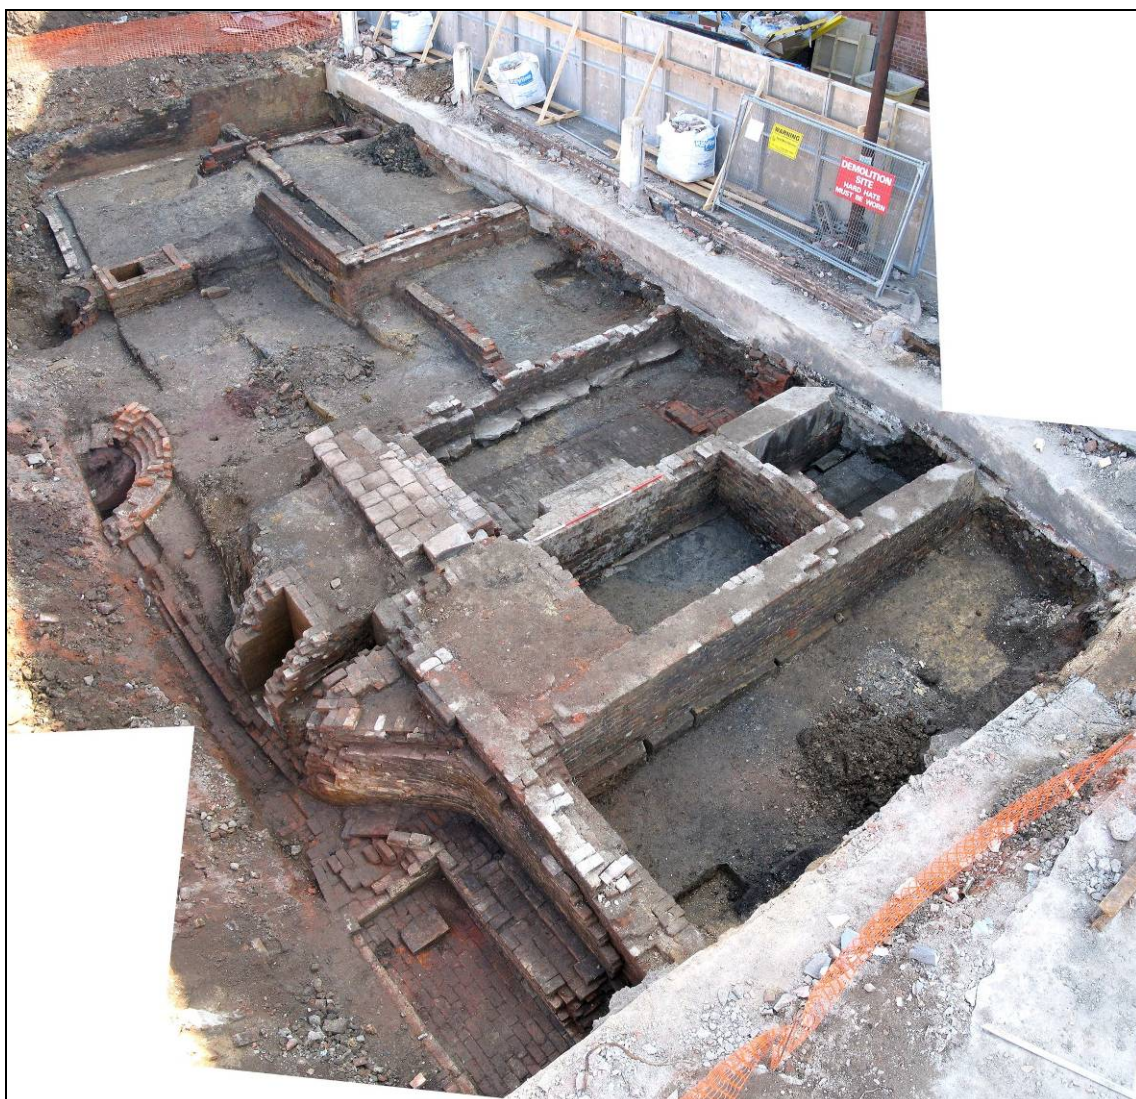
The excavated cutlery works, looking south-east Fig 12

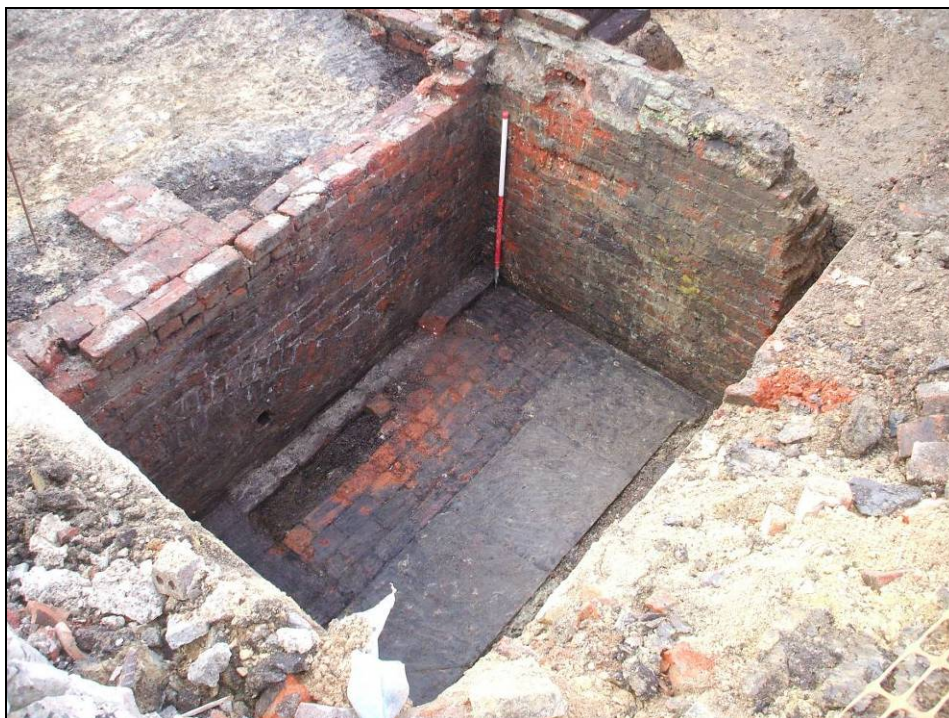
The cellar at the eastern end of handle-cutting workshop, looking north-west Fig 14

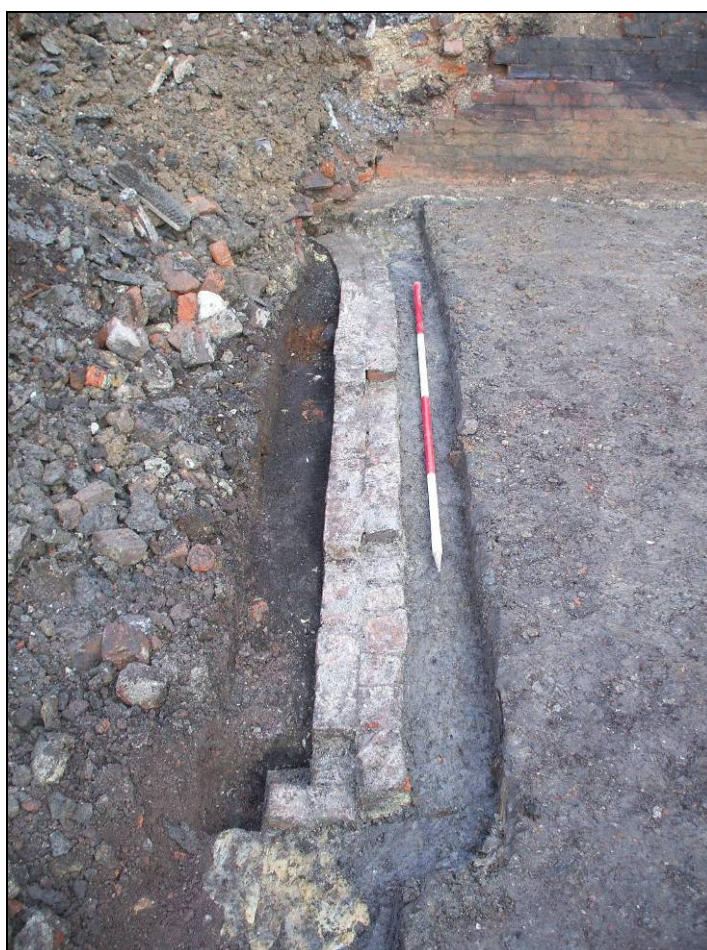
The southern extension to the forge, looking east Fig 15

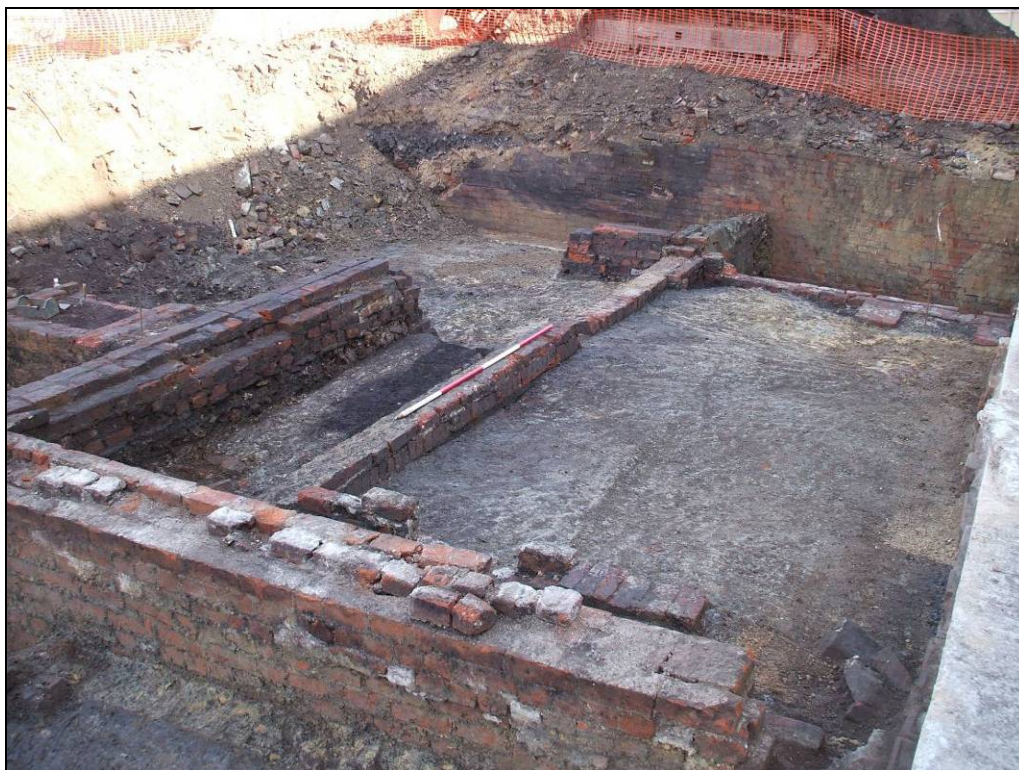
The handle-cutting room, looking north-east Fig 16

Walls in the south-eastern part of the excavated area (Figs 11 and 16) were remnants of the building annotated 'Handle Cutting' on the 1896 plan. Much of the north wall of the new southern range survived [6088], which was 1.3m wider than its predecessor. It was built over a light foundation comprising a single course of bricks [6095] which lay at a level comparable to the top of the reduced remains of the original north wall of the range [6090].

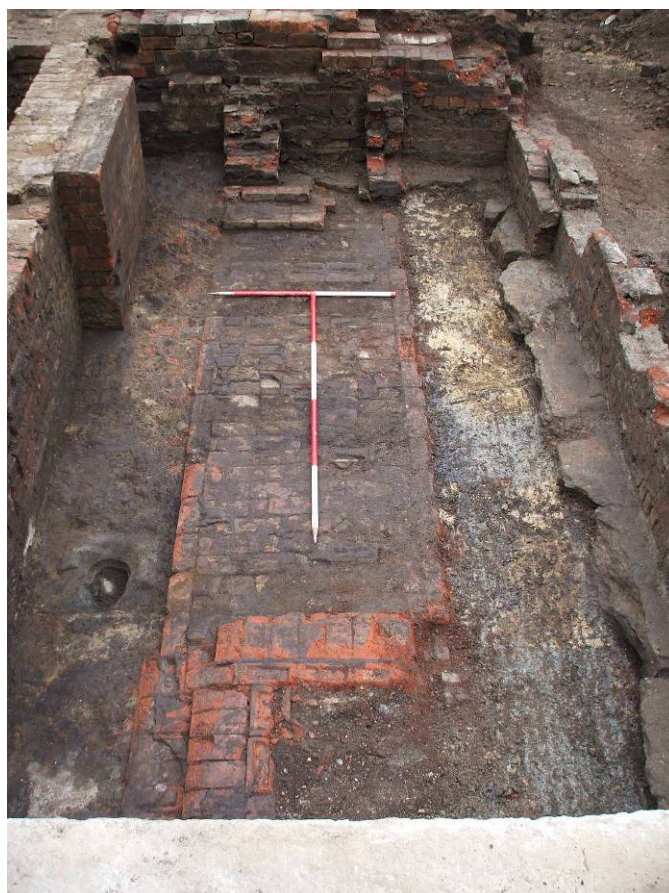
The engine house, looking north Fig 17

To the west of the passage lay a 3.0m wide room with its east and north walls [6053] and [6054], which were of brick over heavy stone foundations, abutting the eastern wall [6029] of the workshop (Fig 17). The Goad plan indicates that it housed a steam engine which would have powered the grinding wheels used to sharpen the blades, examples of which were found unstratified in the rubble overlying the factory remains to the west and in the vicinity of the court housing.

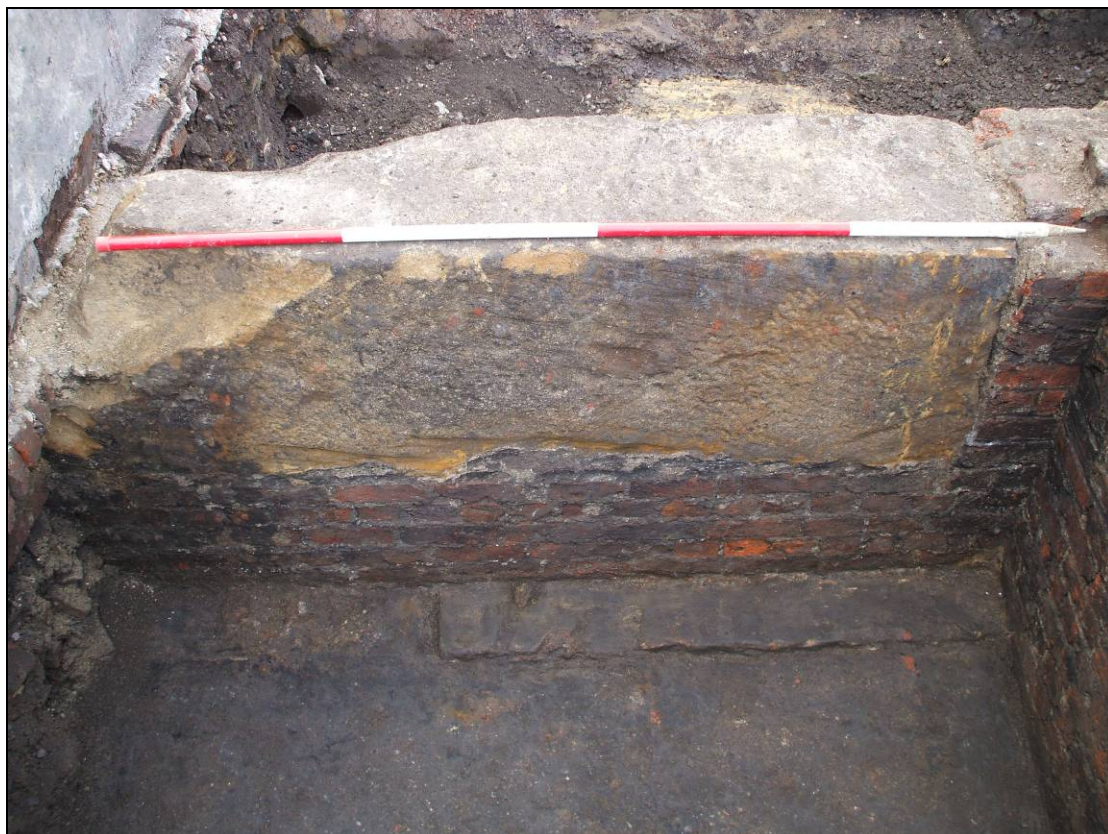
The machine base next to engine house, looking west, showing grooved sandstone block Fig 18

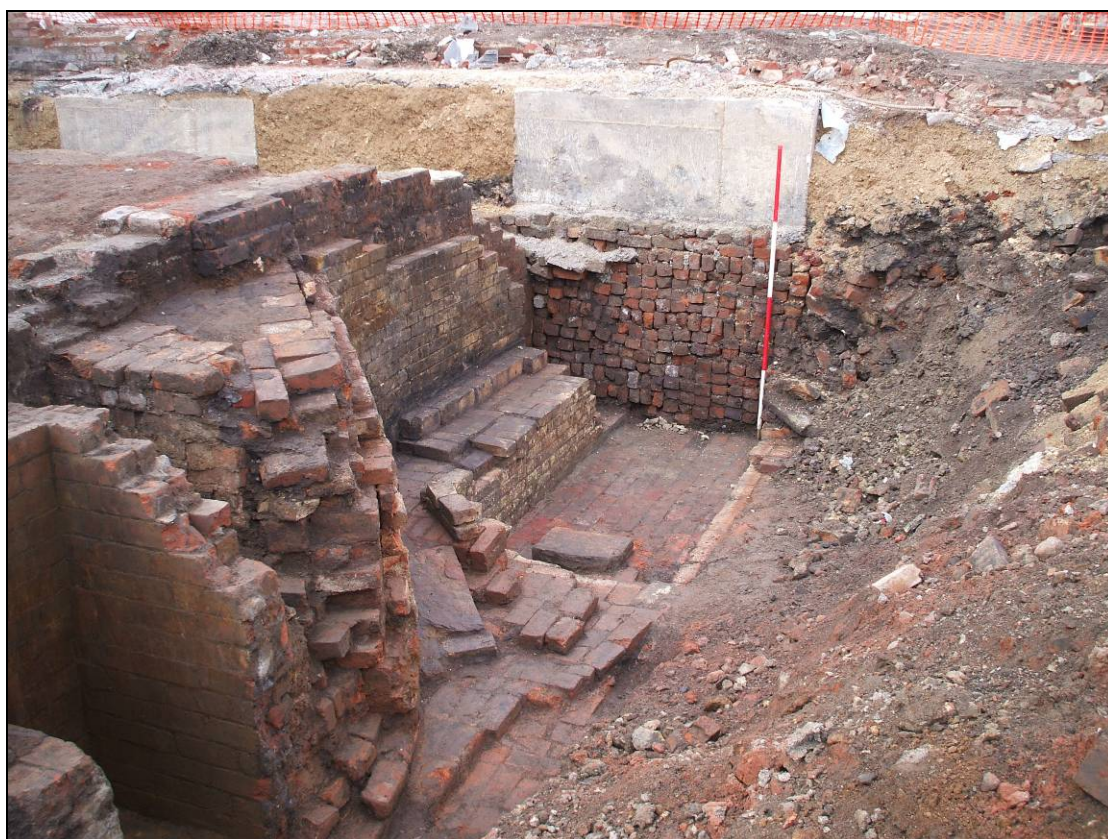
The boiler room, looking south-west, showing brick-lined housing and flue Fig 19

The sunken boiler room was fully brick lined, with a walkway surrounding the rectangular brick-lined pit [6010] that had contained the boiler (Fig 19). The pit was 1.0m wide and the sides were in cream-coloured fire bricks. A ceramic block set in the base of the pit towards its eastern end was perhaps a plinth to support the boiler. The brickwork at the eastern end of the boiler pit was damaged, and the western end of the pit had been truncated by the foundations of a later structure.

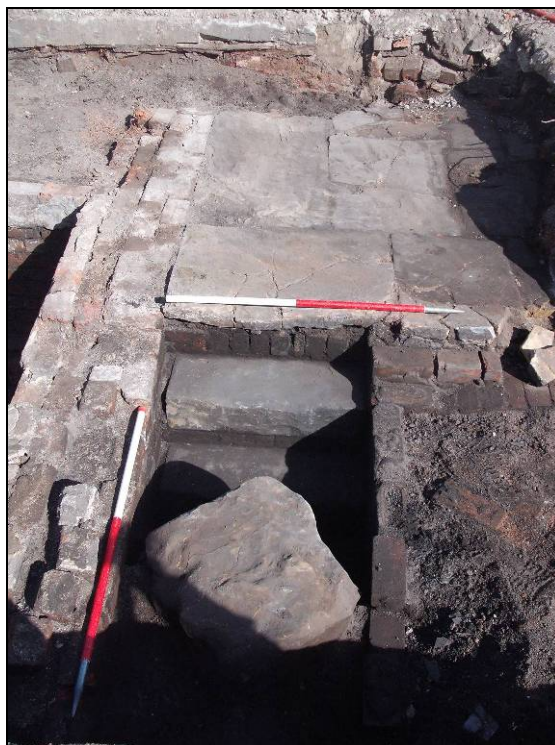
Steps leading to boiler room/furnace, looking north Fig 20

At the top of the flight of steps was a flagged yard surface (6165). It lay at 90.24m OD, a level comparable to the raised yard surface lying to the north of the engine house (6057). As groundworks were monitored during the final phase of archaeological works, it was noted that a cellared space lay below the yard surface. This may have been part of an earlier building demolished prior to the building of workshop, boiler house and engine room.

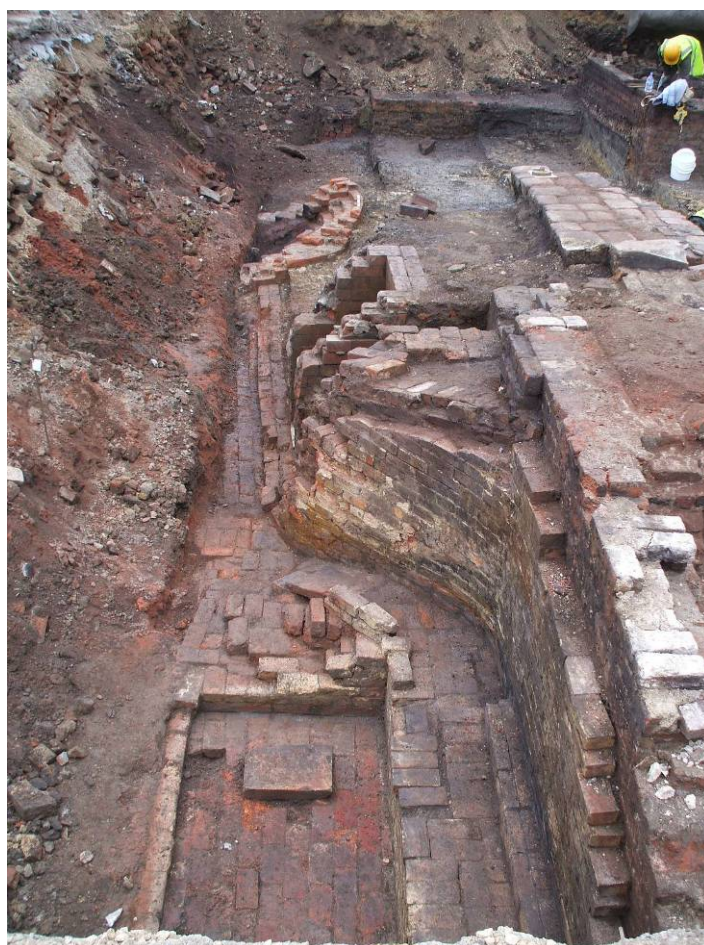
The boiler room, flue and chimney, looking east Fig 21

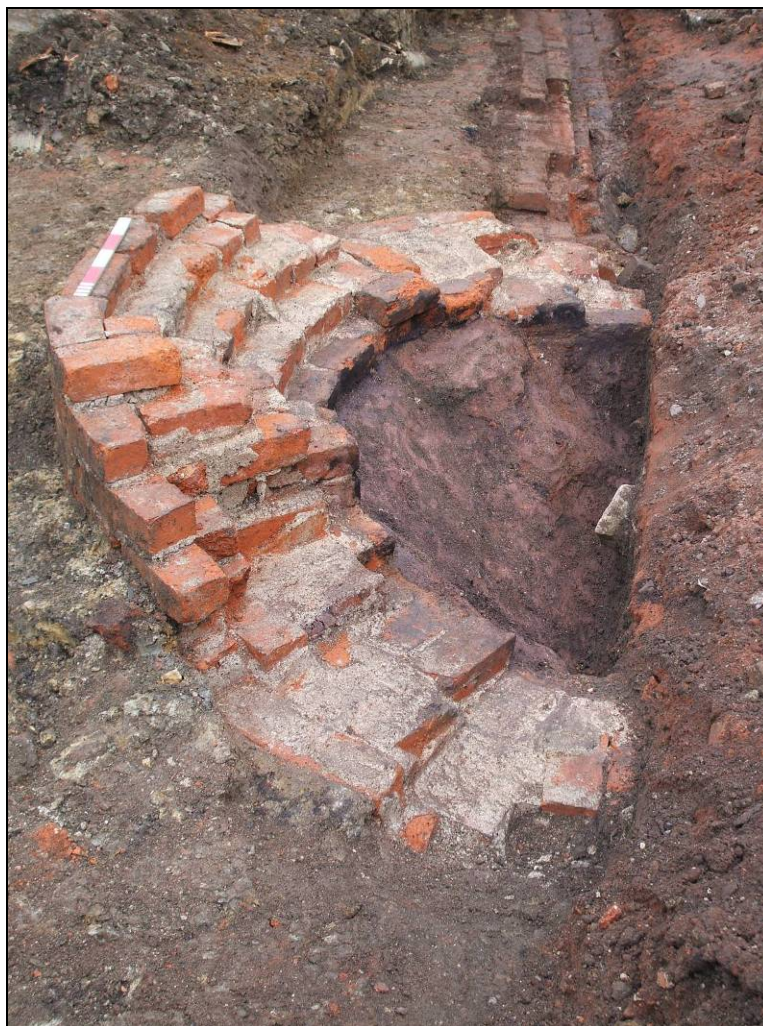
The brick foundations for the circular chimney stack, looking west Fig 22

Approximately half of the circumference of the chimney lay within the excavated area, allowing its exterior diameter to be estimated as c 3.0m and its internal diameter as c 1.8m (Fig 22). The walls of the surviving half of the chimney were five bricks thick and stood to a height of fifteen courses. Its base was formed by stone flags [6084] cut to fit the interior of the chimney and mortared into place with a white lime mortar. These were overlain with mottled yellow-grey-brown clay loam with fragmentary building material, in turn overlain by a 0.2m thick layer of dark grey sand and soot (6082). This was sealed by a 0.55m deep deposit of reddish-brown sand (6070), perhaps an accumulation of brick dust from the interior of the chimney.

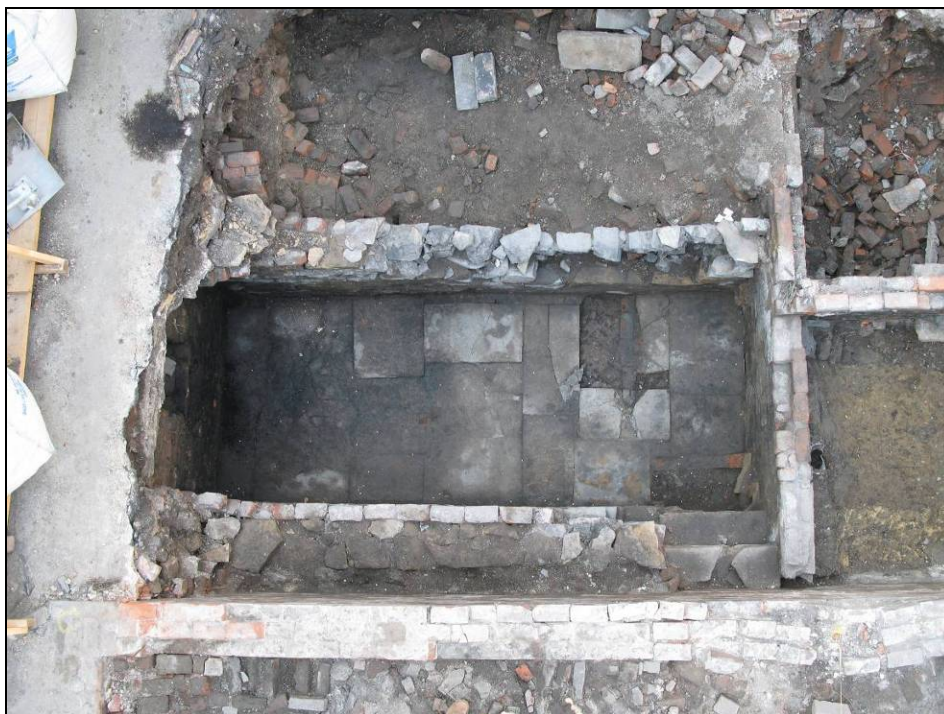
The cellar floor of 32 Holland Street, from above Fig 25

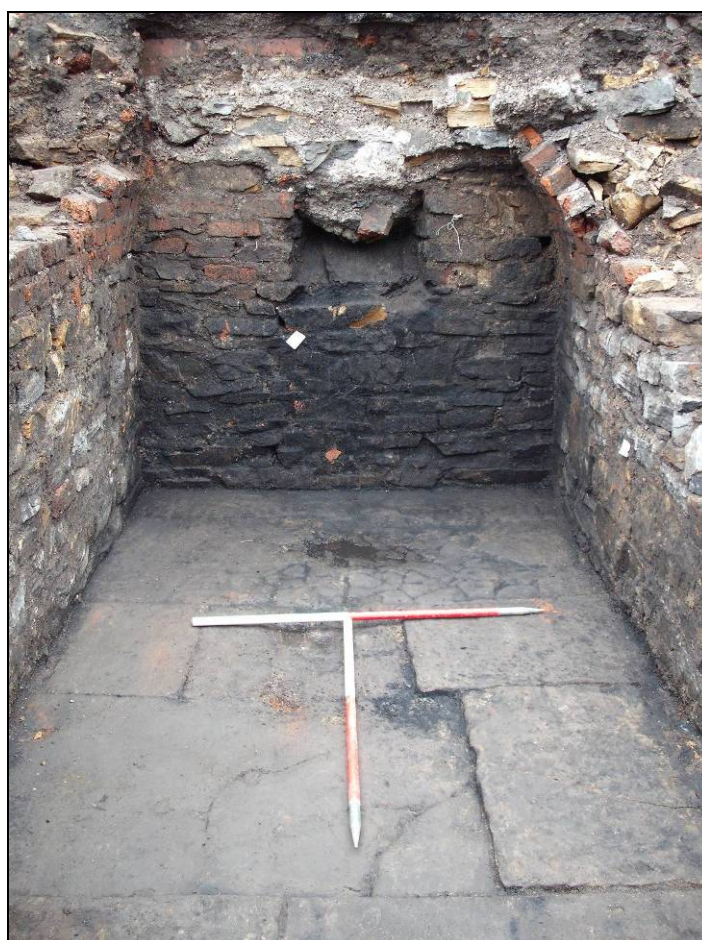
Cellar vaulting scar and coal chute on front (south) wall of 32 Holland Street, looking south Fig 26

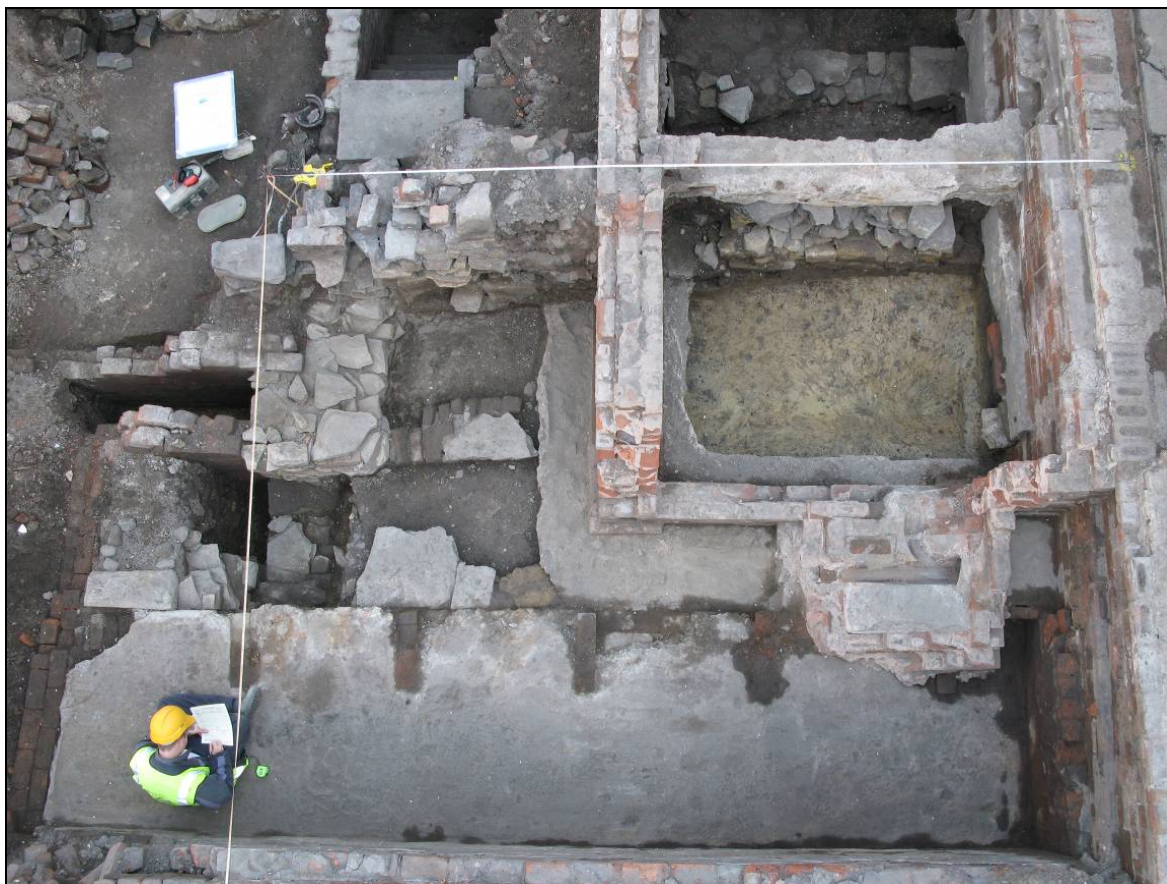
The wash house, from above, showing the concrete skimmed floor (foreground), brick partitions for basins and drainage (centre left) Fig 27

Between 30 and 32 Holland Street heavily truncated walls, drains and surfaces related to a probable wash house (Figs 24 and 27), which presumably served the whole court of houses. Parts of the brick walls survived to the west [6110], north [6151] and south [6204] and to the east there was a foundation [6158]. The floor space was 6.0m long by 2.3m wide.

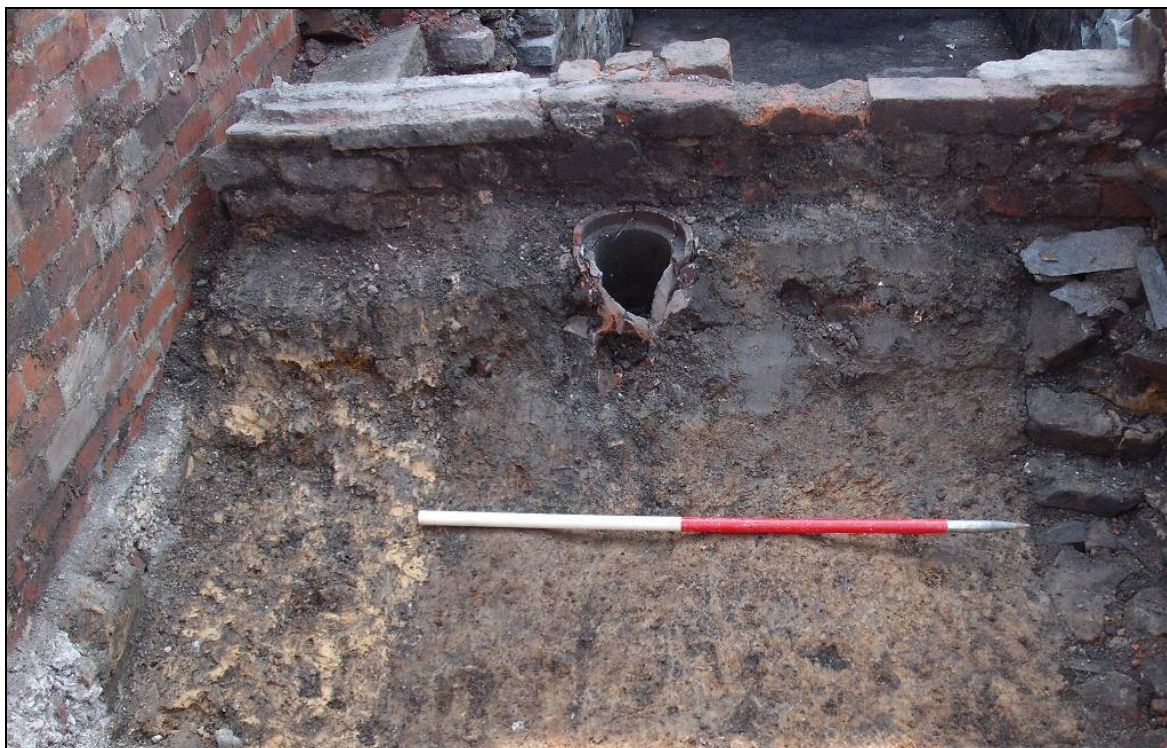
Base of ceramic toilet to rear of 30 Holland Street, looking south Fig 28

Perhaps at the same time as alterations were made to the wash house, toilets were added to either side of the wash house, set in the angle between the Holland Street frontages and the two lines of Court houses to the rear. The truncated remains of ceramic toilet bowls [6216] and [6217] were found to the rear of numbers 30 and 32 Holland Street (Fig 28); presumably they were enclosed by lightly built cubicles, of which nothing remained other than a small stub of stone wall foundation [6218] attached to the west wall of number 30. A section of salt-glazed ceramic pipe was located to the north of one of the toilets, presumably once connecting to the sewage system serving the toilets/wash house.

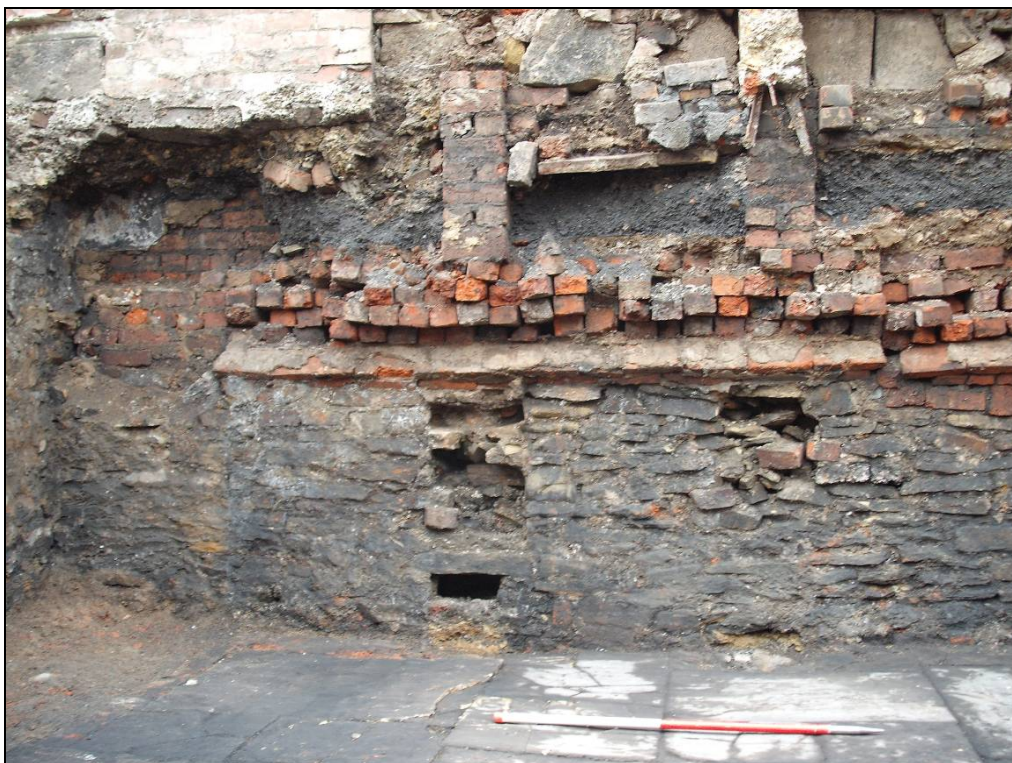
The stone cellar wall of No 8, Court 9, looking south, showing scars of the removed brick piers beneath the ground floor fireplace, and the springing of the brick vault, with the removed stairs to the left Fig 30

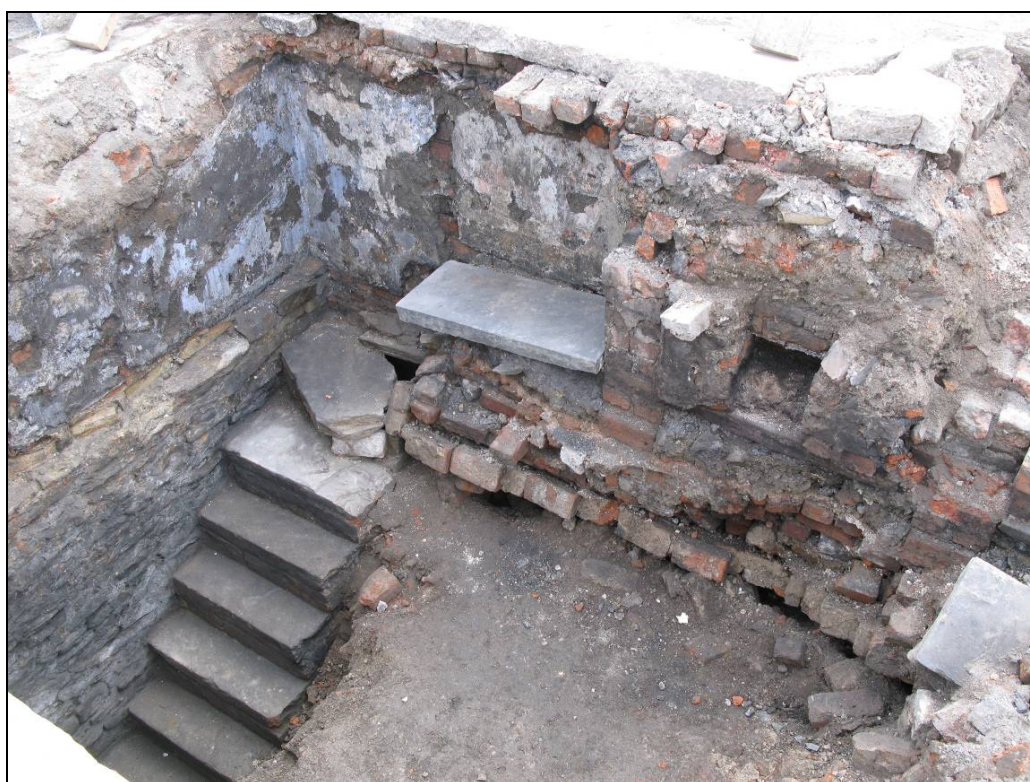
The cellar stairs of No 9, Court 9, looking south-east, showing the ground floor fireplace on the south wall Fig 31

As with numbers 7 and 8, the fireplace was in the southern wall. The original width had been reduced by a re-lining of brickwork, and there was a niche or cupboard to one side. The fireplace had a stone hearth and a lintel made of iron.

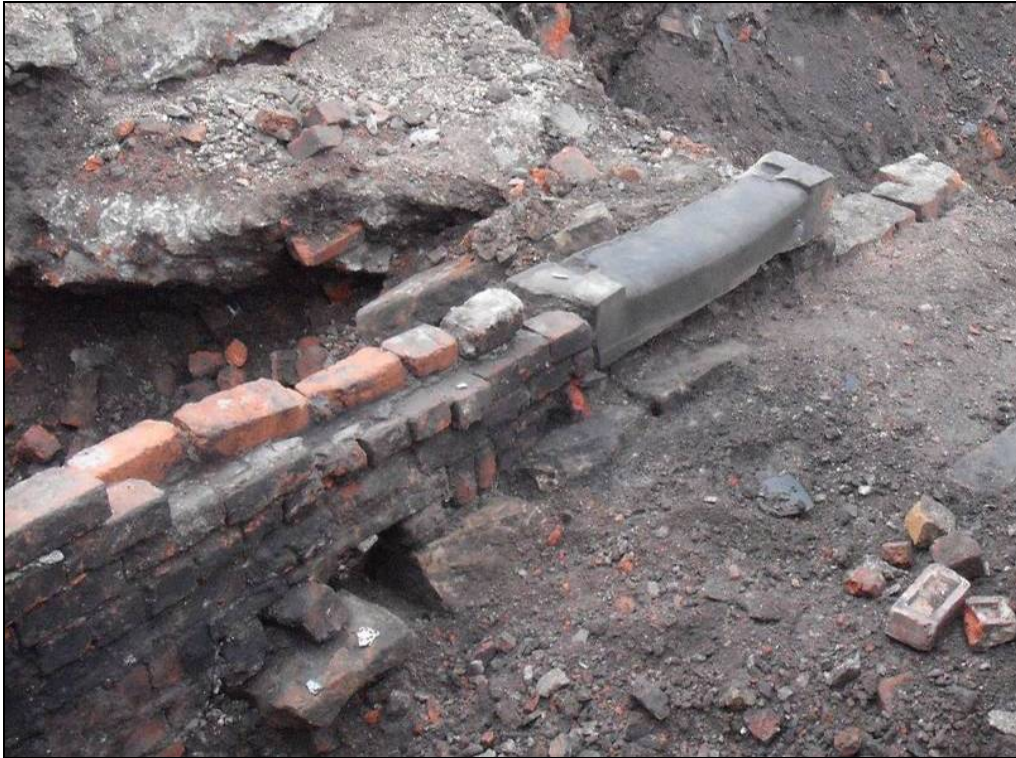
The front wall of No 10, Court 9, looking north-west, showing the threshold (right) and coal chute (left) Fig 32

The front wall contained a number of features. The position of the front door at the northern end of the wall was indicated by a c 1.10m-wide threshold stone, with a worn and rounded surface and square recesses to house the timber door jambs (Fig 32). There was also a central coal chute. A stone 'buttress' built into the southern cellar wall was similar to those observed in numbers 7, 8 and 9.

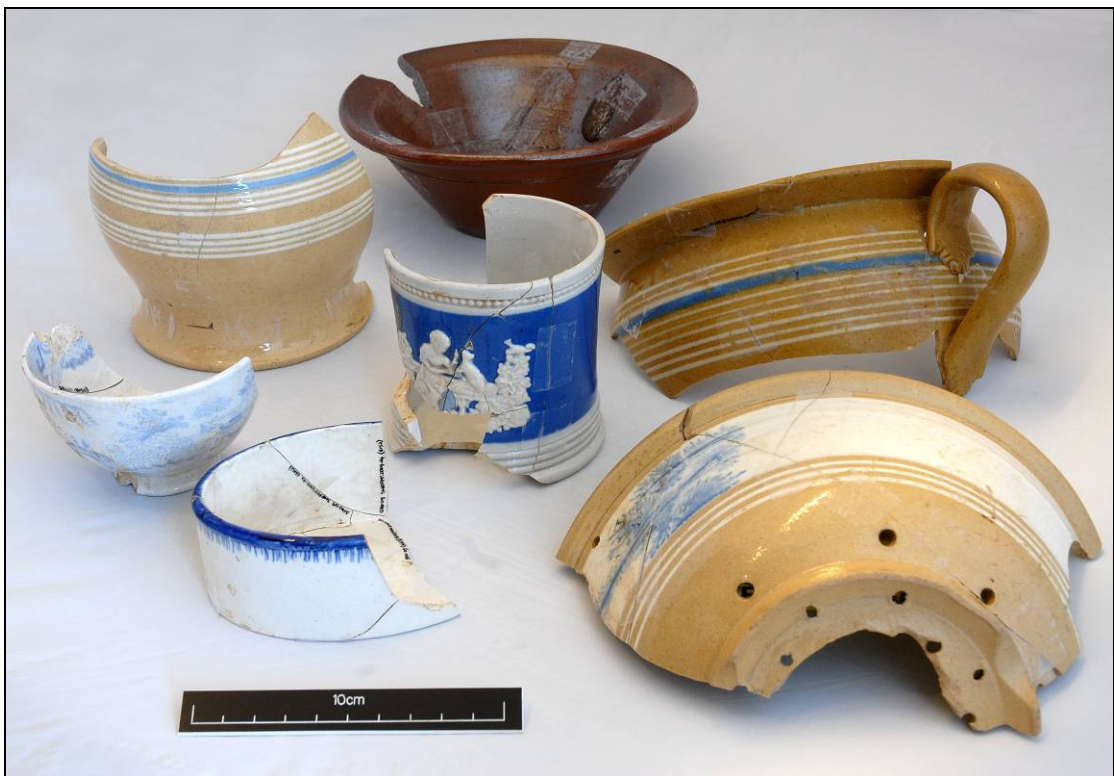
Pottery found in fill of pit [6149] and drain [6153] Fig 33

Figure 33 shows the most re-constructible vessels, clockwise from top left: Mocha Jug; Nottingham stoneware bowl; Mocha chamber pot; Mocha colander; Blue shell-edge pearlware dish; Underglaze blue transfer-printed tea cup; Sprigged earthenware tankard. In most cases no more than half the vessel was present.

Beneath the walls of the wash house lay a partially stone-lined pit. It was first seen in Evaluation Trench 3 and was emptied during later excavation of the court. The pit pre-dates the wash house wall in this area, but may have been part of its original drainage system, perhaps later replaced by piped drains. The pottery from the pits fills (6150, 6152) is therefore probably associated with the early usage of the court houses in the mid-19th century.

The assemblage comprised 257 sherds in fifteen basic types, all mass-produced from the 18th century onwards. A minimum of 34 vessels were represented, although the smashed nature of mass-produced wares means that only very distinct form-sherds have been used in this estimation. The pottery was kept separated into its distinct halves, to either side of the wash-house wall foundation. There was material in both sides which derives from the same vessels but there were few joining sherds, fractures being indistinguishable in the heavily pre-prepared clays of mass production types. No tip-lines were apparent in the pit, nor was there any indication from which side or sides the pit was filled. The wash house wall through the middle of the pit had accounted for an unknown amount while with only three pit sides extant, an unknown percentage of the pit has also been lost and with it more of the pottery assemblage.

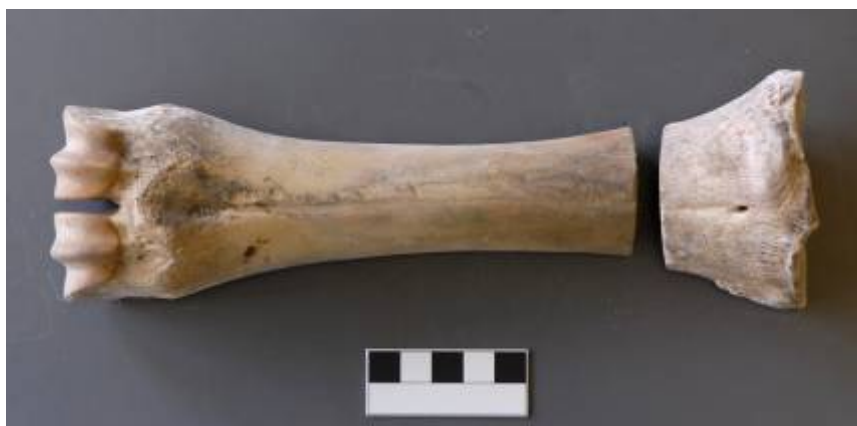
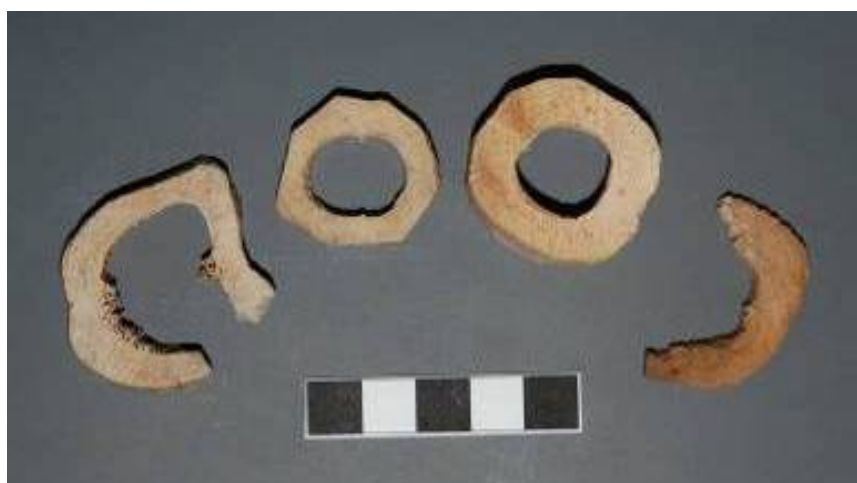
The by-products of the handle working process, found in handle cutting workshop (Scale: 50mm) Fig 34

Only a very small number of finished scales were found, though a handle was found with the scales attached to each side of the flat scale tang of a table knife [context 3007/small find 2] (Fig 35). Bone was used to make many other items, especially button making. No evidence for this has been found here, though a bone 'washer' may in fact be a button with the central depression totally cut through [6182/147].

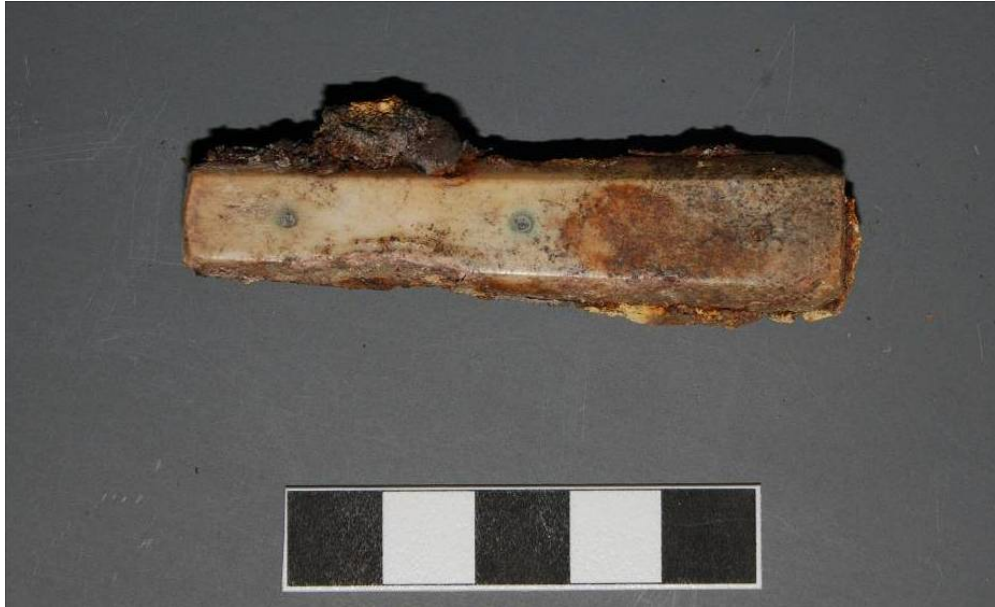
A scale tang handle with bone scales attached with three rivets (Scale: 50mm) Fig 35

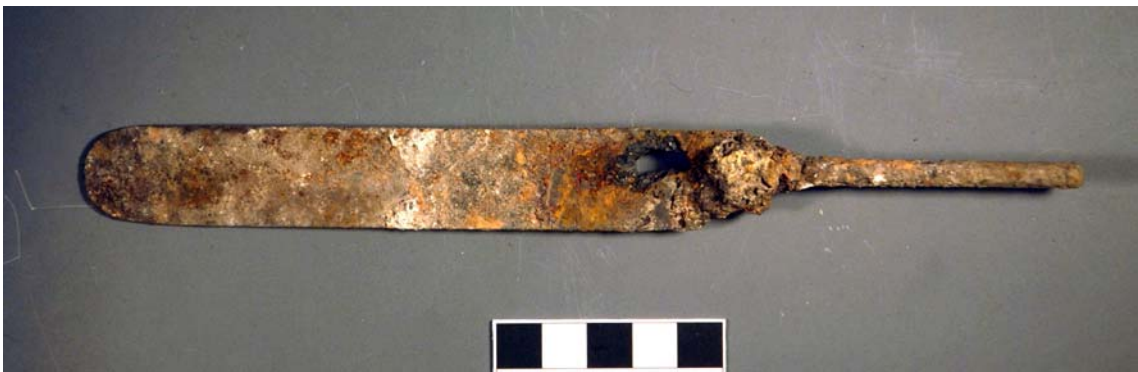
A straight table blade with round tang showing evidence of burning (Scale: 50mm) Fig 36

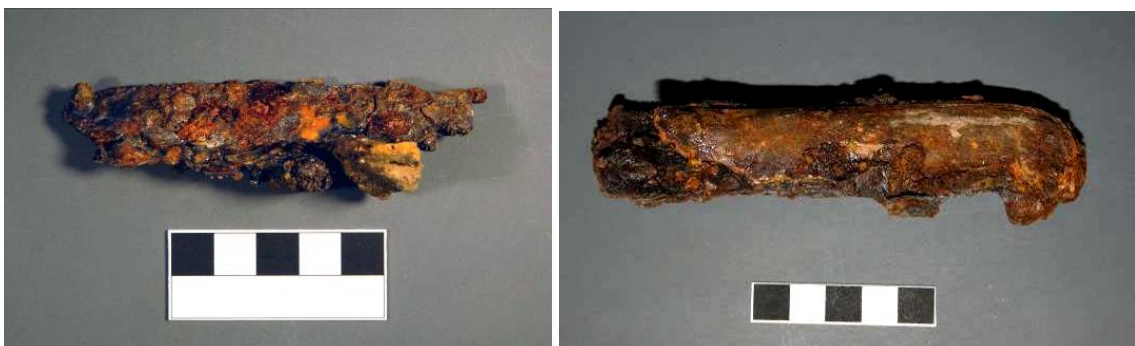
Pocket knife blade with 'neb' to hold blade while forging (l) and single blade pocket knife (r) (Scale: 50mm) Fig 37

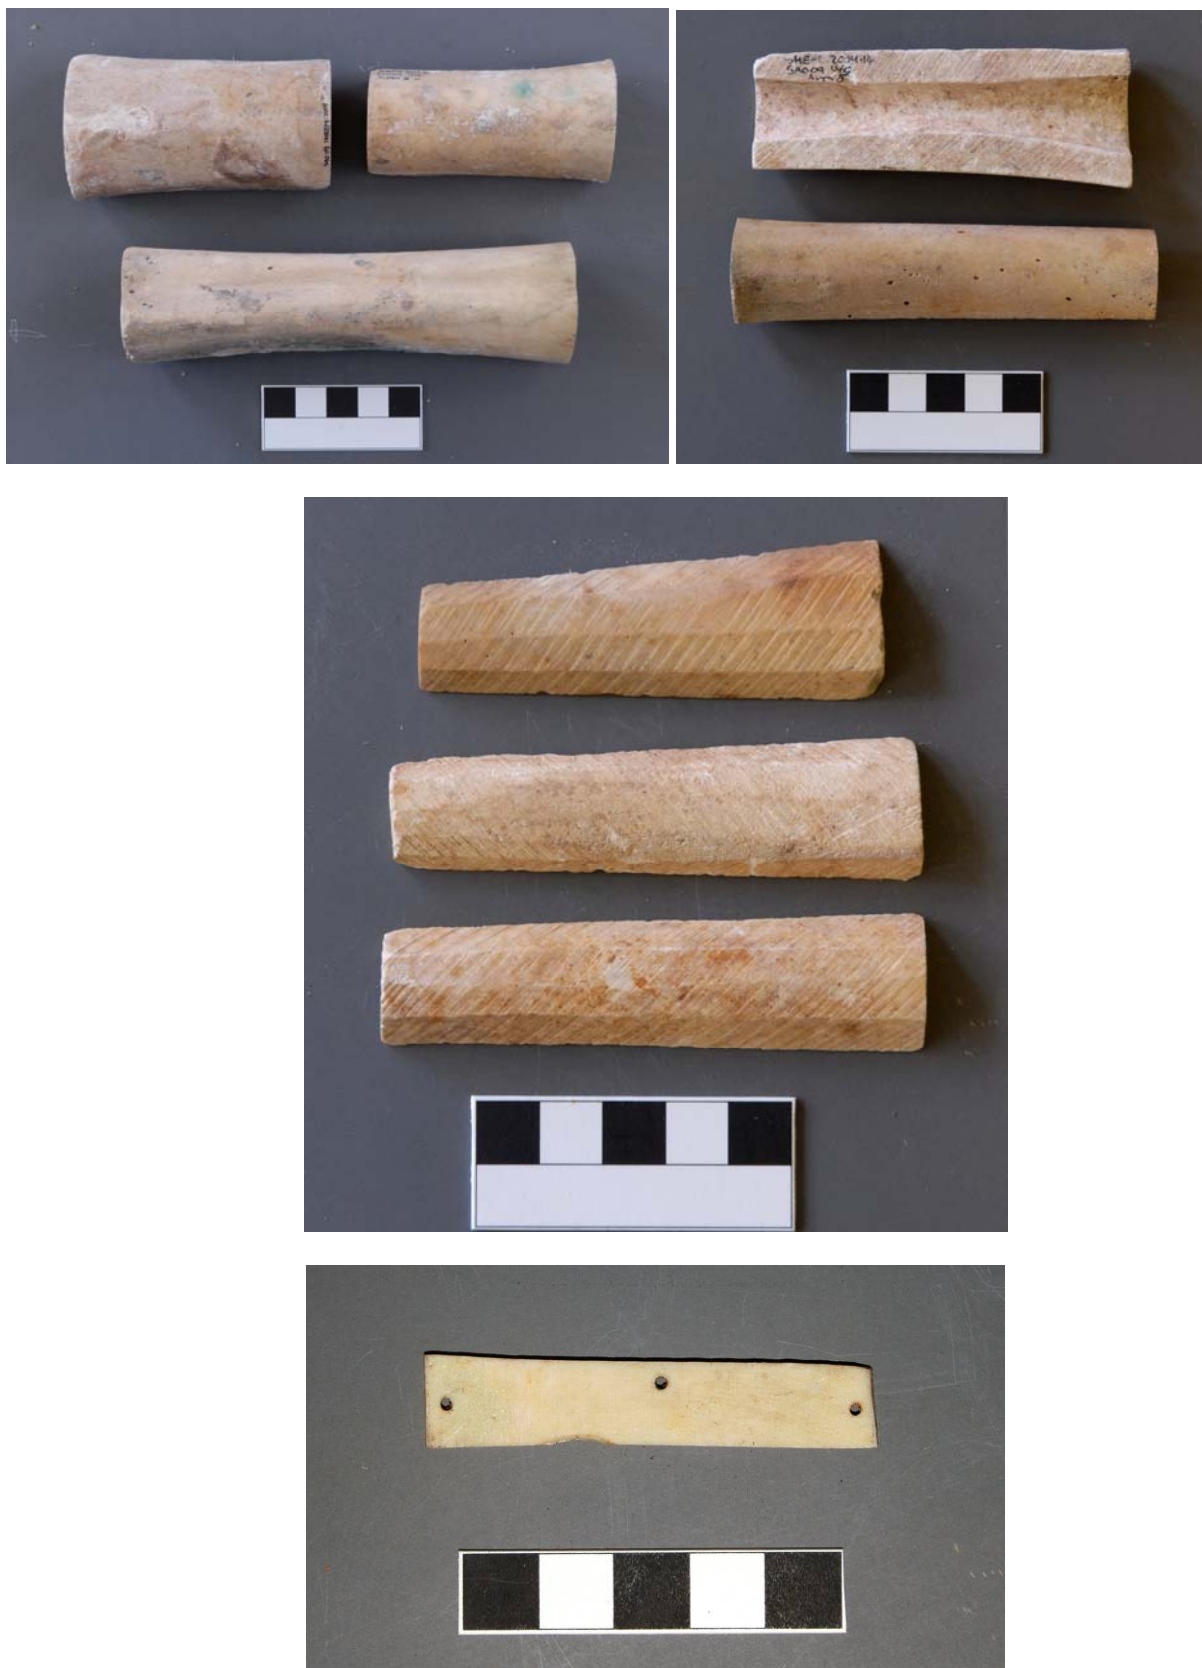
Stages in making handle scales from bone (Scale: 50mm) Fig 38
