# Northamptonshire Archaeology

The excavation of the Portobello Cutlery Works and  
19th-century housing on the site of the former  
Assay Office, Sheffield  
January - May 2009

Report 09/160

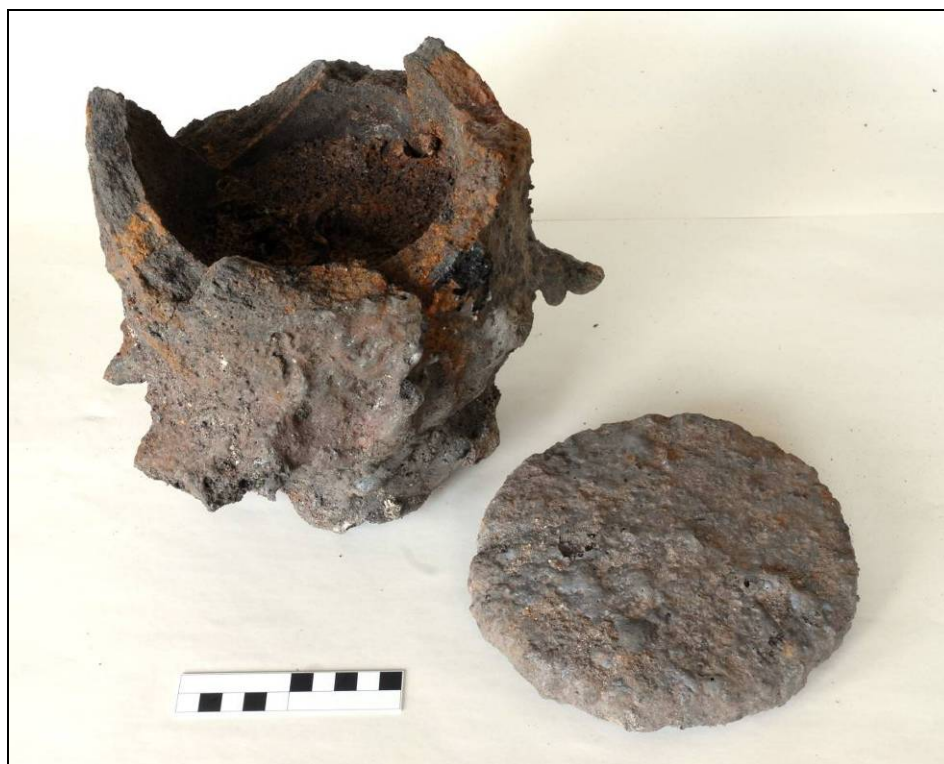
Crucible fragments found below surface of Court 9  
(Scale: 100mm) Fig 39

The assemblage contained several fragments of used steelmaking crucibles (Fig 39). Traditional Sheffield (or 'Huntsman') steelmaking crucibles had a very short service life and were typically discarded after one day's use, fragments of used crucibles are a relatively common archaeological find within Sheffield, where they were often used as free draining hardcore to make up ground. Although common finds, used crucible fragments can be of archaeometallurgical potential when recovered from specific 'dateable' contexts or those that can be related to a particular steelworks.

The fragments in this assemblage were recovered from unstratified contexts that lay beneath a 19th-century courtyard. The difference in size between some of the crucible bases suggests that the assemblage contains crucibles from more than one works.

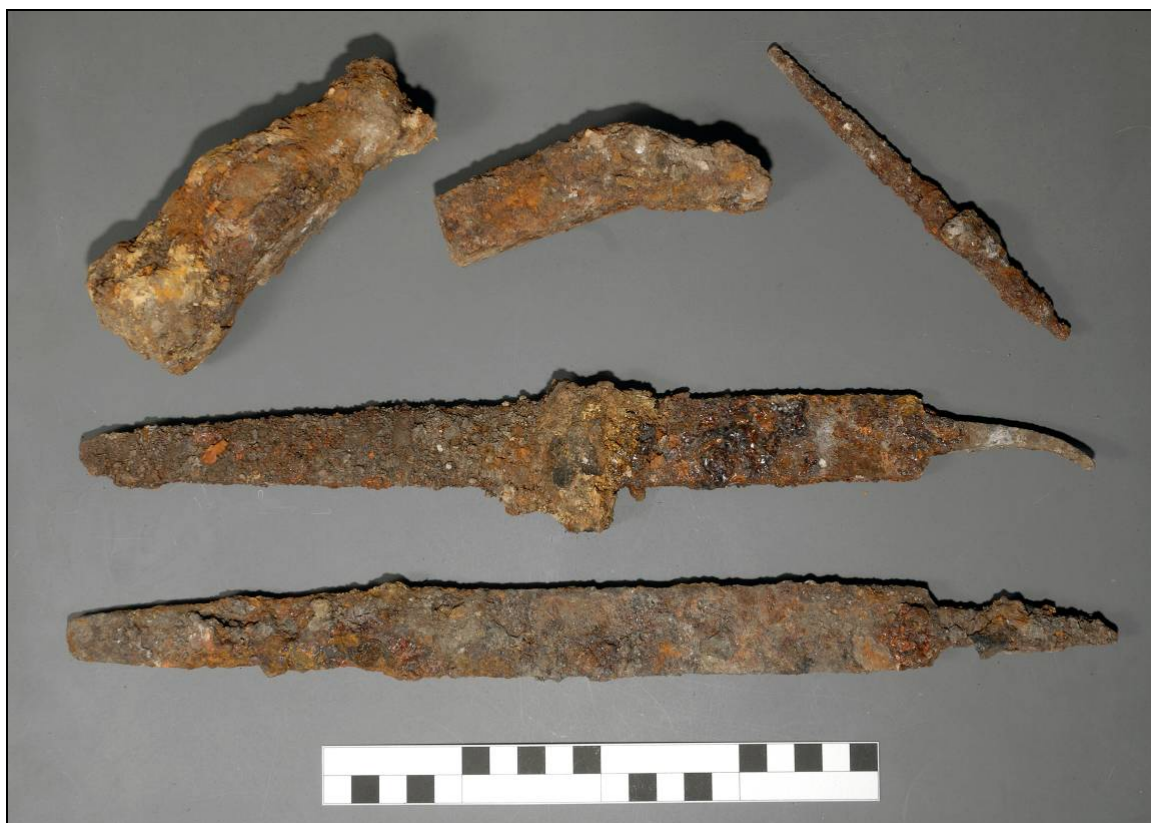
Tools found during excavation of factory and houses  
(hammer heads, a possible awl and files) (Scale: 200mm) Fig 40

Other tools recovered include, a claw hammer (weight: 419g) (Fig 40, top middle) and a "double faced" hammer (weight: 820g) (Fig 40, top left), and these may have had any number of uses including riveting (cf. Symonds 2002, 31).

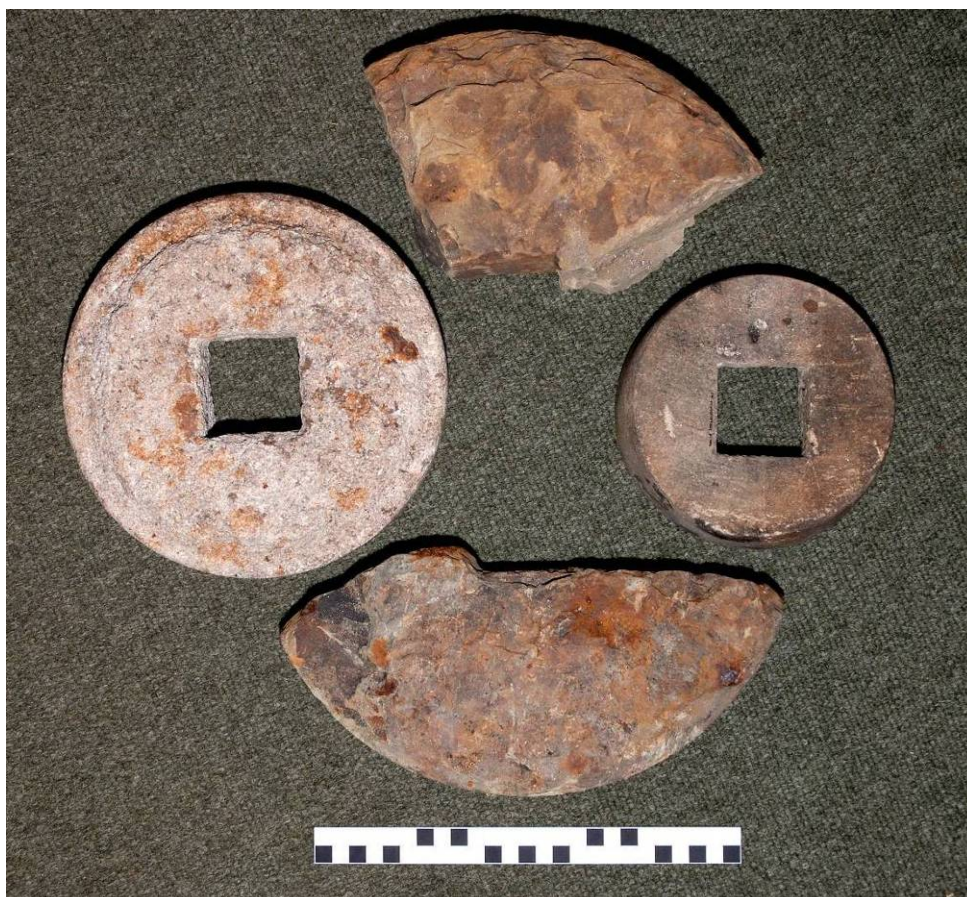
Grinding stones found during excavation of factory and houses  
(Scale: 250mm) Fig 41

It is impossible to determine if all the iron tools recovered, originated from the Portobello Cutlery Works, but the grinding stones must have. They would have been used during the final stage of knife manufacture, to execute a sharp cutting edge and clean the surface of the blade (polish). Three different grades of stone are represented, coarse-grained millstone grit, medium-grained sandstone and fine-grained sandstone, each presumably used to achieve a different finish. Three forms of

grinding stone are represented (Fig 41), two are discoid, one tapered and one although incomplete, may originally have been part of a stone for grinding razors or files. All have central square perforations, which measure 55mm or 60mm cross. The dimensions of the stones range from 220mm-320mm in diameter and the faces measure 40mm-75mm across. All grinding faces display signs of wear and three of the stones are furnished with faint, shallow or deep incised linear markings cut into their grinding surface, a form of dressing known as 'hacks'. The 'hacks' are represented by three different patters, zig zag, diamond-shaped and oblique parallel grooves, and they would have helped to produce a better finish.

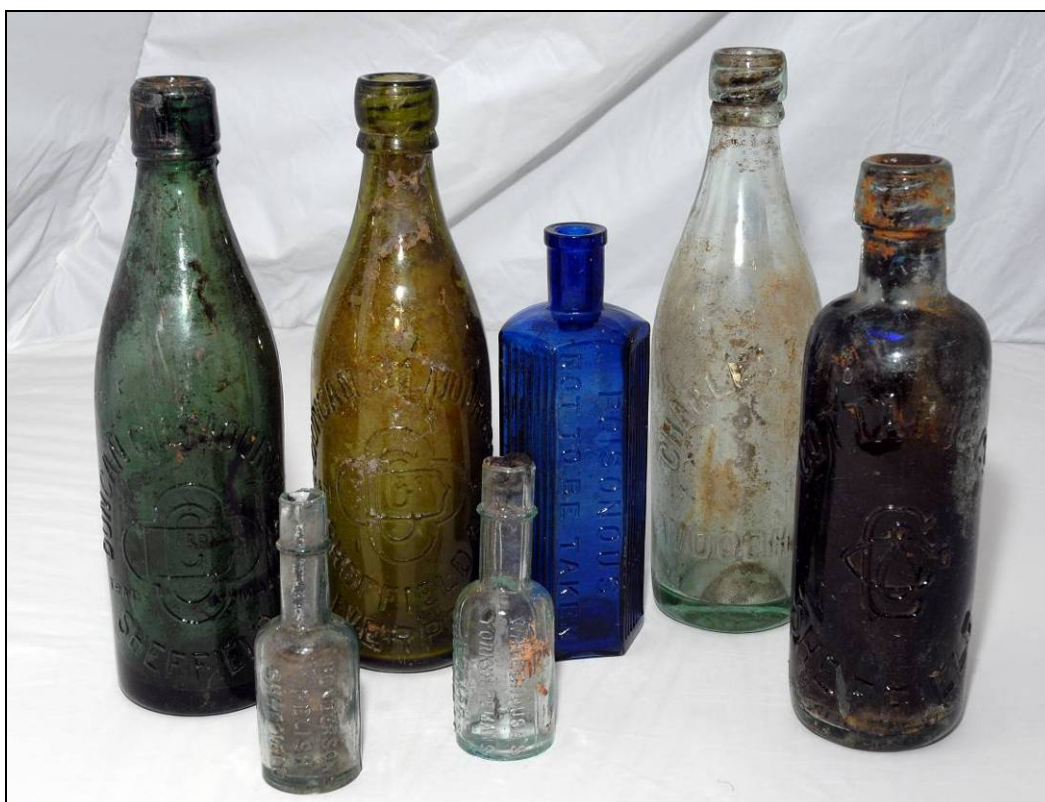
Examples of glass bottles found in the rubble fill of house cellars Fig 42

Within demolition deposits 40 complete or partially complete glass vessels were recovered. With the exception of two pieces recovered from the factory area, the entire assemblage was located within demolition deposits overlying the cellared houses; much of it deriving from the stairwell in house number 8. The range of vessels illustrate the types which would have been in use within a domestic setting in the early
