Archaeological trial trench evaluation on land
at 23-25 High Street, Stagsden

Report 09/069

**ARCHAEOLOGICAL TRIAL TRENCH EVALUATION
ON LAND AT 23-25 HIGH STREET
STAGSDEN, BEDFORDSHIRE**

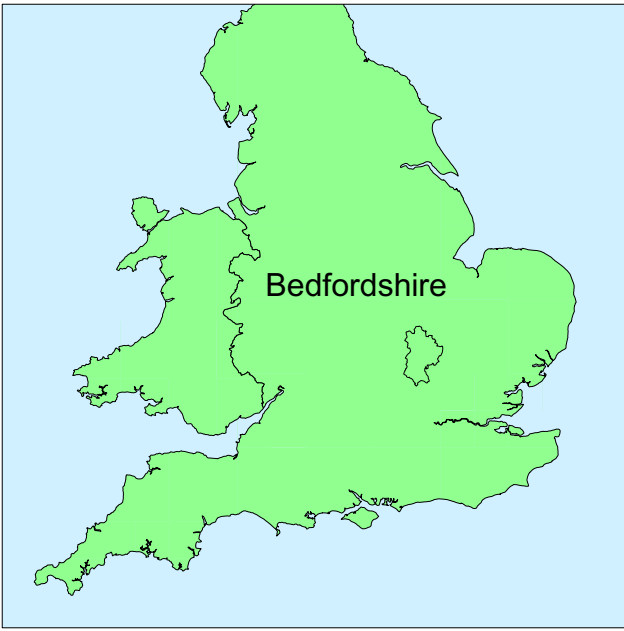
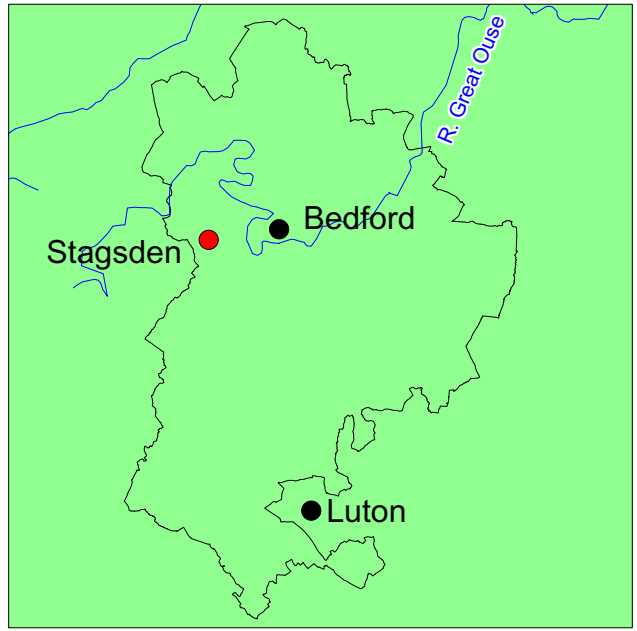
Site location Fig 1

1:5000

An archaeological evaluation comprising trial excavation was carried out by Northamptonshire Archaeology (NA) on behalf of T C Newton and Sons Ltd, on land to the rear of 23-25 High Street, Stagsden, Bedfordshire (NGR: SP 9831 4903; Fig 1).

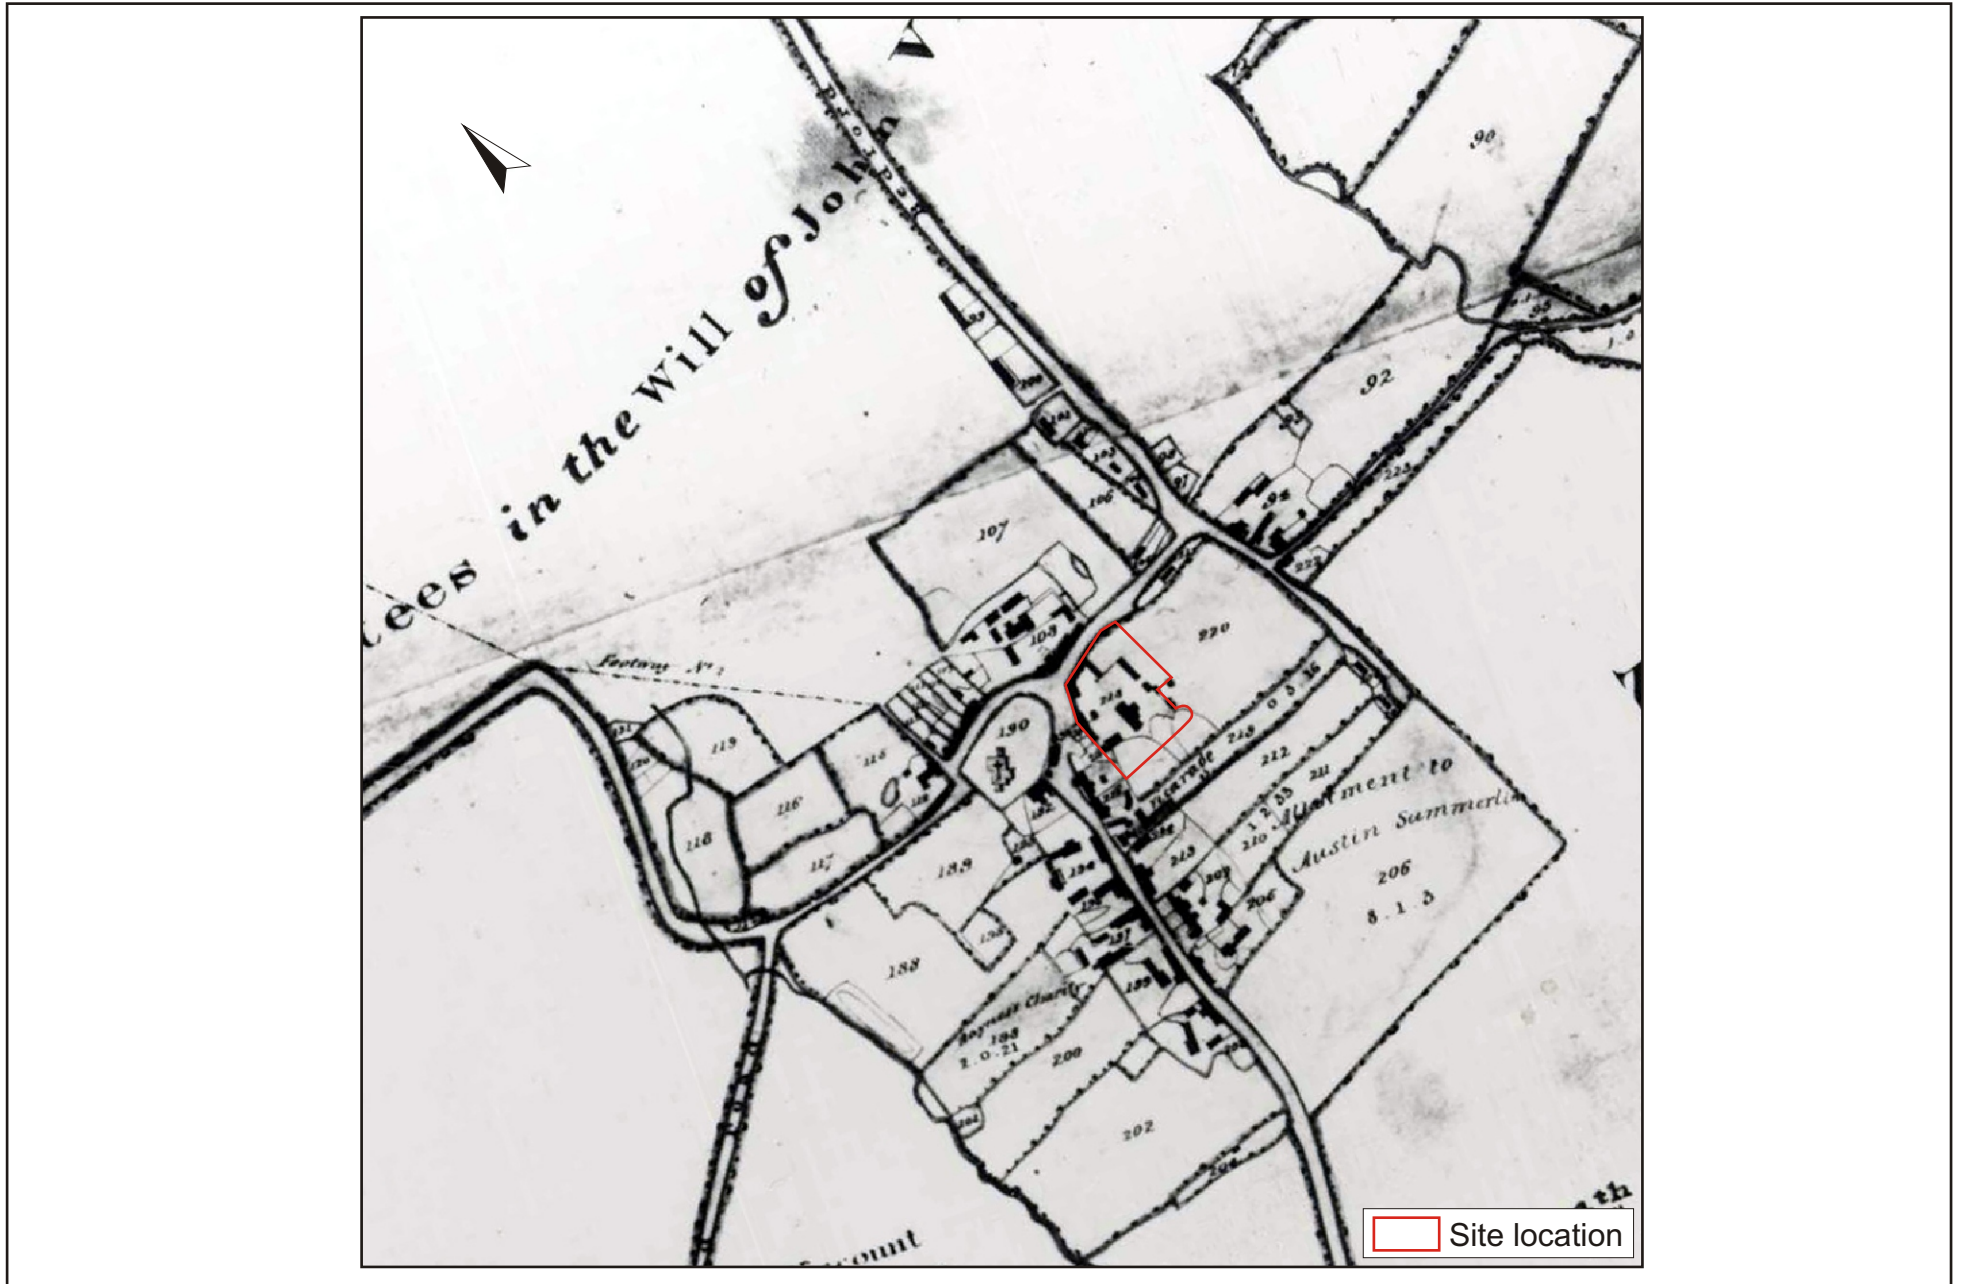
Enclosure Map of 1828 (CRO MA53) Fig 4

The parish was enclosed by act of Parliament in 1828 (CRO MA53; Dawson 2002 fig 4) and the village became much more sub-divided, with many plot boundaries extending south off the High Street. The field established to the east of the site, named as 'Home Close'.

The Tithe Barn is shown as a long, narrow structure. A much smaller out-building lies adjacent to the south.

The map also shows another, substantial square building in the area of Trench 2. It has an extension on the east side, orientated north-east to south-west. Another small building occupies the street frontage adjacent to the crossroads, in

the area of Trench 5. The building shown at 25 High Street is possibly the same house that survives today.

Trench 2, aligned north-west to south-east, was located within the footprint of proposed building plot 1 (Fig 11). No structural evidence was found for the large building depicted in this area on the 1828 Enclosure Map, although a layer of possible demolition rubble was present.

The natural boulder clay (204) was at a depth of 0.44m. Above (204) on the south-west of the trench was a spread of dark grey sandy clay loam (203), up to 0.12m thick, containing frequent limestone fragments and charcoal flecking and four sherds of 19th-20th century ceramics. This deposit was very similar to the overlying subsoil. The same material could be seen across an area of the site to the north of Trench 2 which had been previously stripped away by machine, indicating this deposit covered a sizable area. It is possible that layer (203) represents demolition debris from the building depicted in this area on the 1828 Enclosure Map.

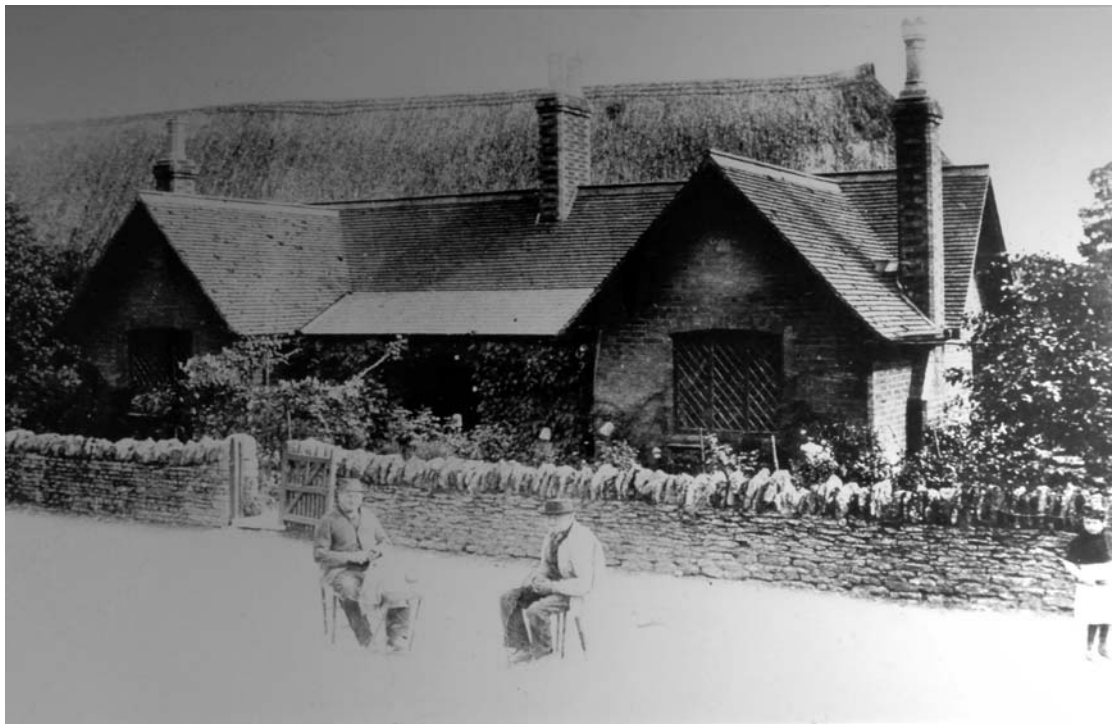
The earlier photograph (Fig 8) was taken from the Church Yard, looking south-east. It dates from between the building's construction in 1869 (the date is visible on a plaque on the front wall) and its renovation and enlargement in 1898 (see

Table 1; HER No: 6940). The Tithe Barn can clearly be seen behind the Church Rooms as a large structure with a steeply-pitched thatched roof. The south-western end (on the right) corresponds with the foundations recorded in Trench 1 (Fig 11). As the historic maps indicate, the west end of the barn was demolished sometime between 1884 and 1902, this would suggest the photograph dates to between 1869 and 1902.

Fig 8: Photograph taken between 1867 and 1898 of the Church Rooms, with the Tithe Barn roof in the background

The evidence from the historic maps shows that the smaller western end of the barn, excavated in Trench 1, was demolished at some point between 1884 and 1902. Both the photograph in Fig 8, taken after 1869 and the 1884 Map clearly show the Tithe Barn extending to the south of the Church Rooms where the foundations were present in Trench 1. Although this western part of the barn was demolished first, its foundations remain intact. Mapping from 1902 onwards show only the larger eastern section of the barn, excavated in Trench 4.

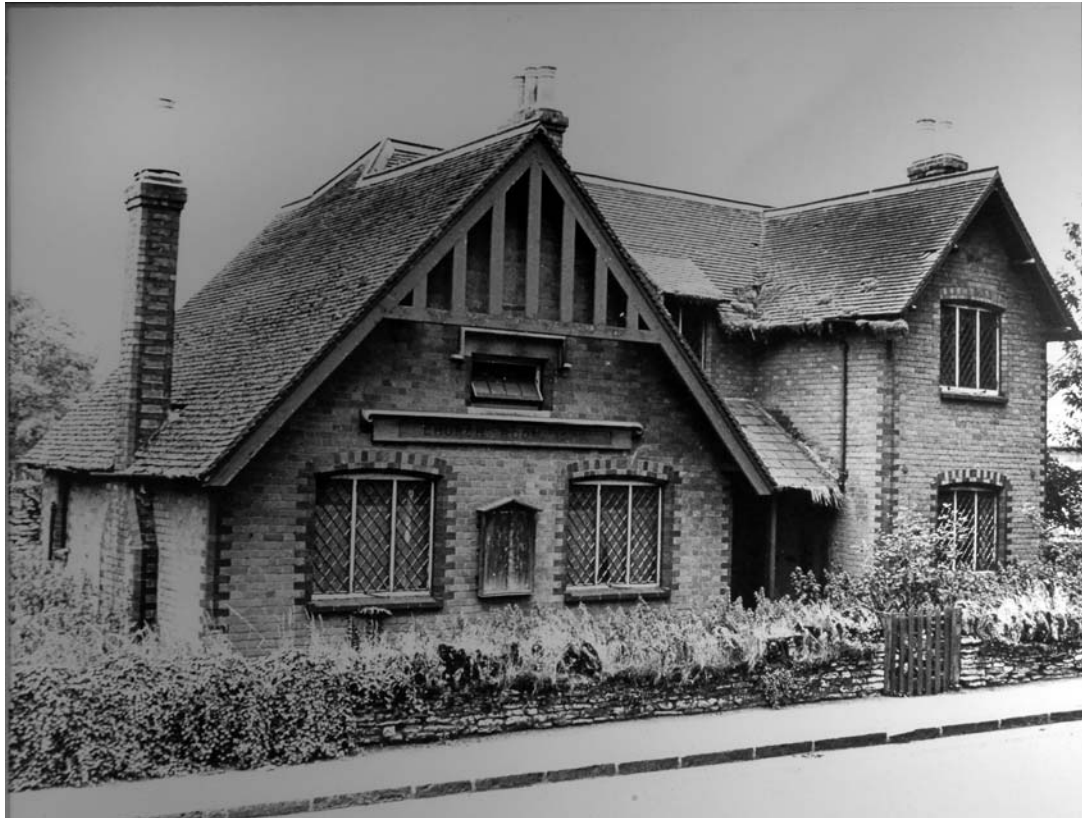
The later photograph (Fig 9) post-dates the large scale 1898 extensions to the Church Rooms. The western section of the Tithe Barn is no longer standing although the masonry wall between the two buildings can be seen. The Ordnance Survey shows that the demolition of the western end of the barn had occurred before 1902.

Fig 9: Photograph of the Church Rooms taken after the extensions in 1898, probably 1940's or later. The Tithe Barn is no longer present.

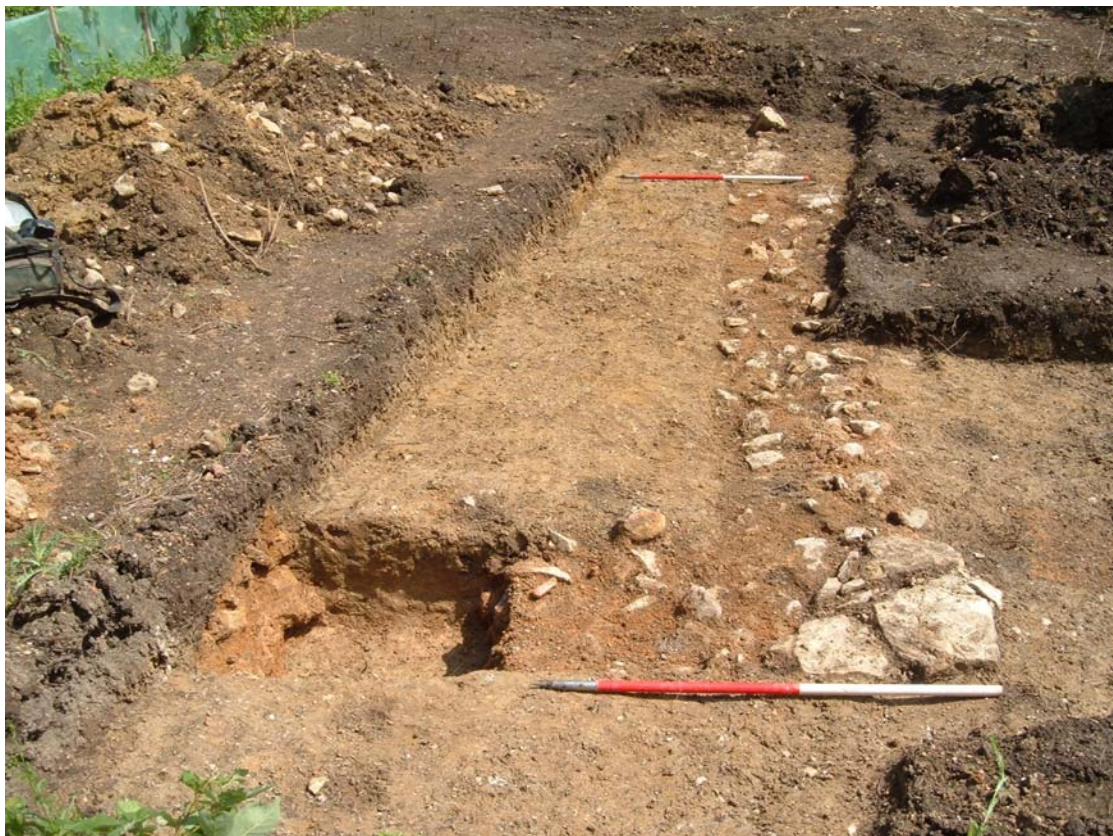
A section of the south-west corner of the structure was present in Trench 1. The foundation trench [104], which cut the natural clay, was orientated north-east to south-west. It measured 0.7m wide and 0.4m deep, with vertical sides and a flat base (Fig 12, Plan 1 and Fig 13, Section 2; Fig 8). The wall foundations (102) were constructed of roughly cut and un-hewn limestone, up to 0.4m long, within a matrix of compacted yellow lime mortar. A large rectangular slab of limestone on the corner of the foundation wall may have been a post-pad for a structural timber.

On the north-east side of the trench the material of the barn's southern wall foundation was different, comprising a darker mixed yellow/grey clay (103) with limestone pieces and yellow mortar. Alternatively, it may have been the backfill of a robber trench dug to remove the limestone following the demolition of the barn as in Trench 4. No dating evidence was recovered from the barn foundations in Trench 1.

Fig 10: The foundations of the Tithe Barn in Trench 1, looking north-east
