Archaeological strip, map and record

on land at 25 High Street,

Stagsden, Bedfordshire

Report 09/166

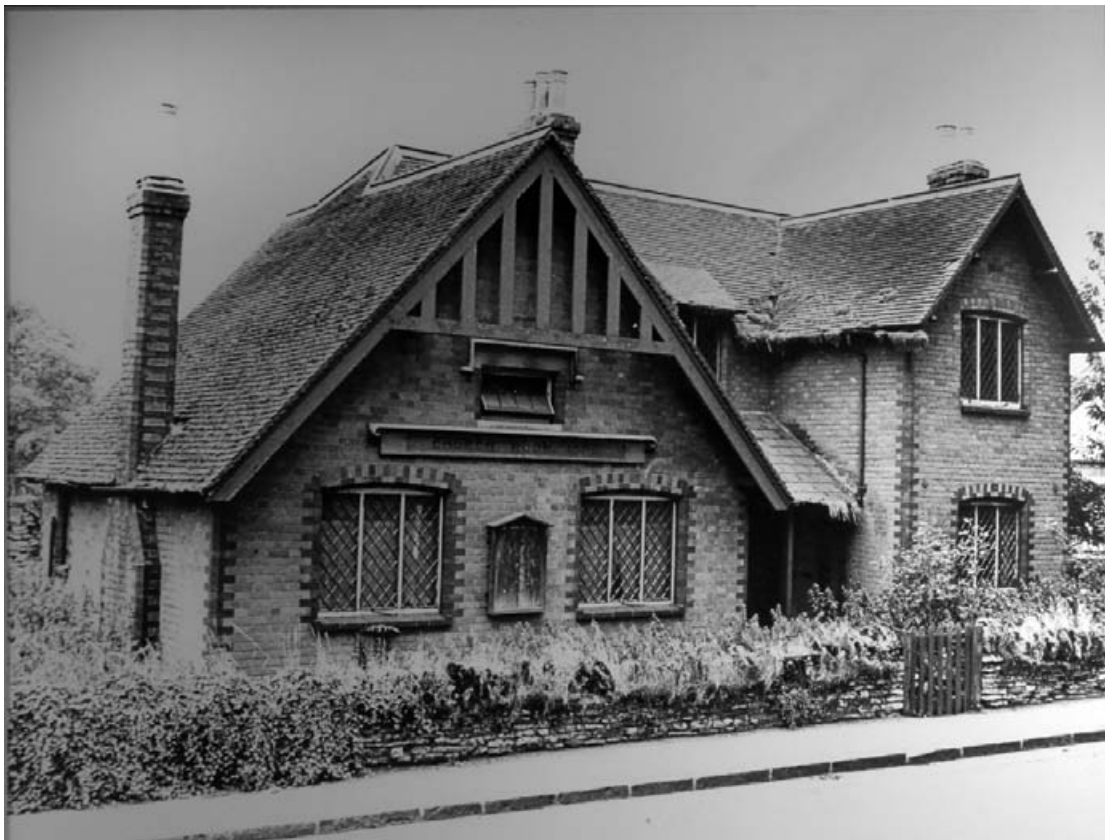
Fig 11

Photograph of the Church Rooms taken after the extensions in 1898
probably 1940s or later. The Western barn is no longer present

A later photograph (Fig 11) post-dates the large-scale extension to the Church Rooms in 1898. The western section of the barn is no longer roofed, but part of the north wall is still standing, seen to the left, behind the house. Unfortunately the photograph does not show the condition of the eastern end of the barn.

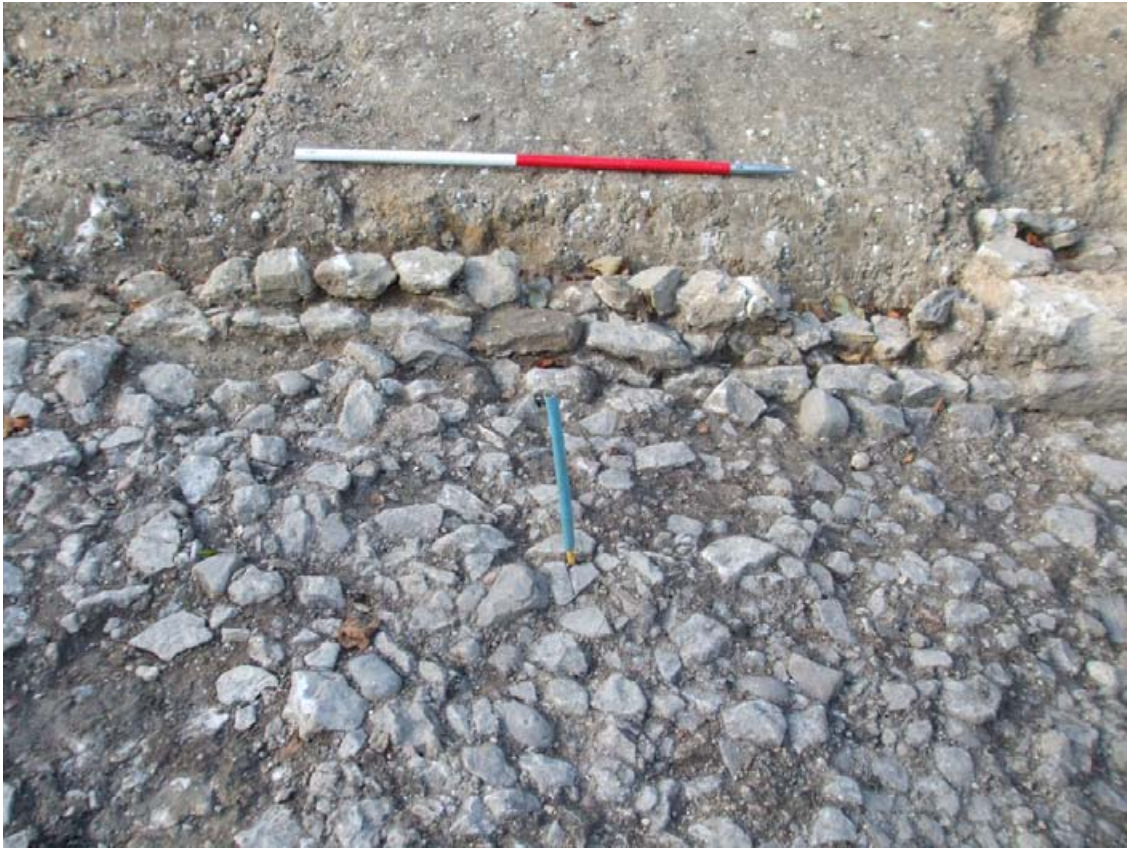
Fig 16

Dry-stone wall (631) and cobbled surface (633), looking north-west

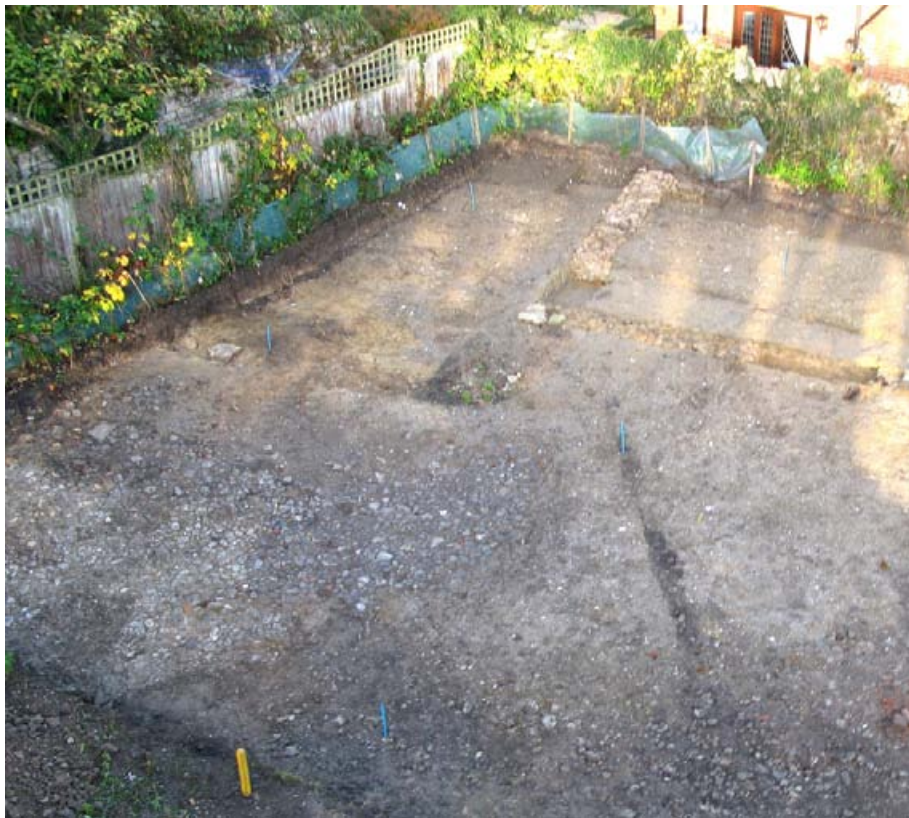
Fig 17

Cobbled surface (604), looking north-west

modern ground disturbance (Fig 13 and Fig 17). The cobbles, between 100–190mm in diameter, lay within a natural clay matrix and were tightly compacted, with smaller limestone cobbles replacing missing cobbles. A group of nails associated with a spread of charcoal were retrieved from the cobbled surface. The nails had been used, their points were hammered down at the same length (50mm), indicating the thickness of the timber through which they were fixed. Fragments of iron crooks (Fig 18) for the thatched roof were also found in this area, suggesting that this surface was still in use when the western barn was demolished, or has been disturbed with the modern ground disturbance.

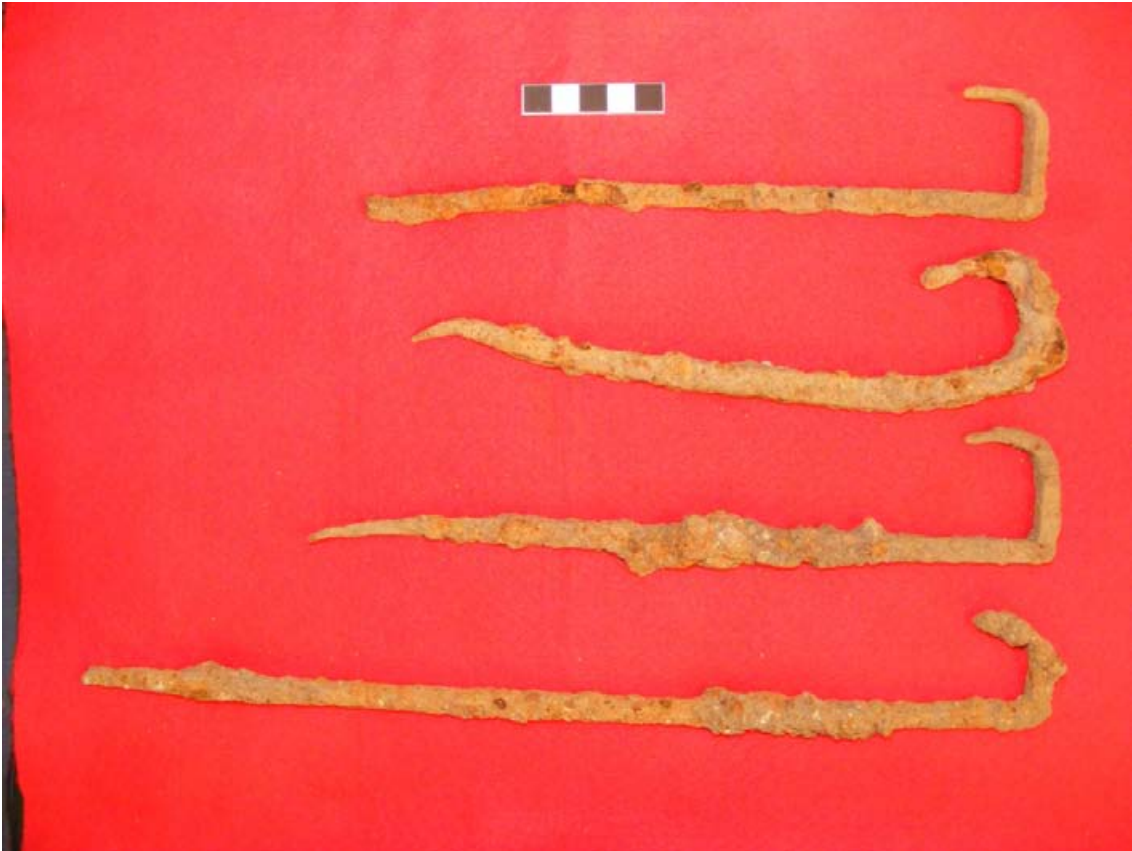
Fig 18

Thatching pins (Crooks)

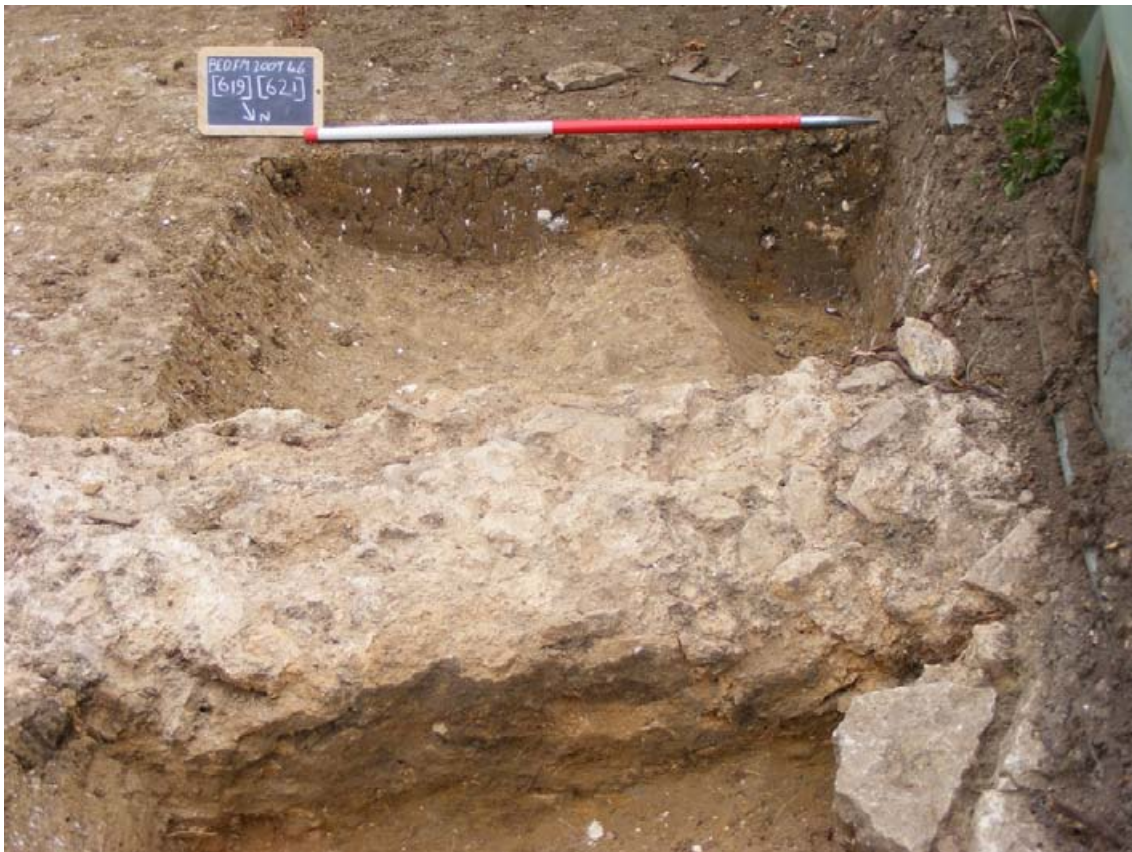
Fig 19

19th-century barn foundations, western end, and ditches [619] and [621]

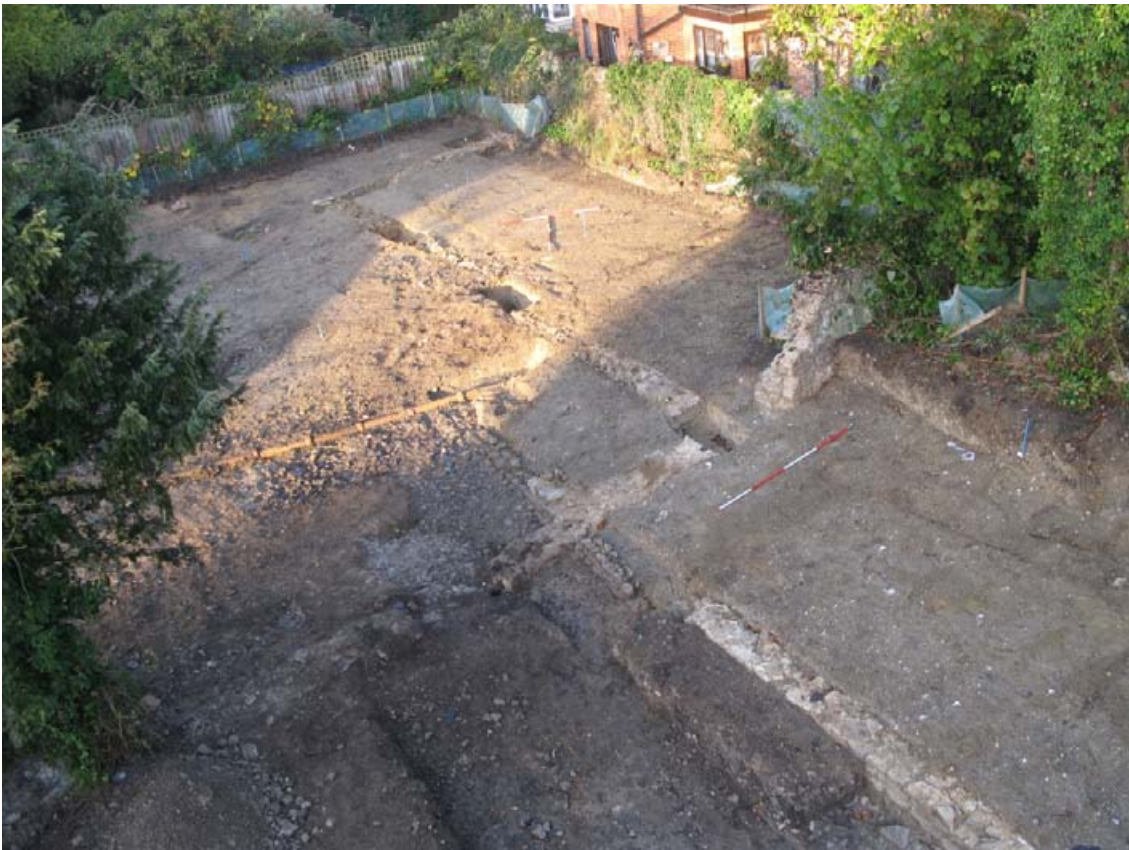
Fig 20

General view of 19th-century barn foundations looking west

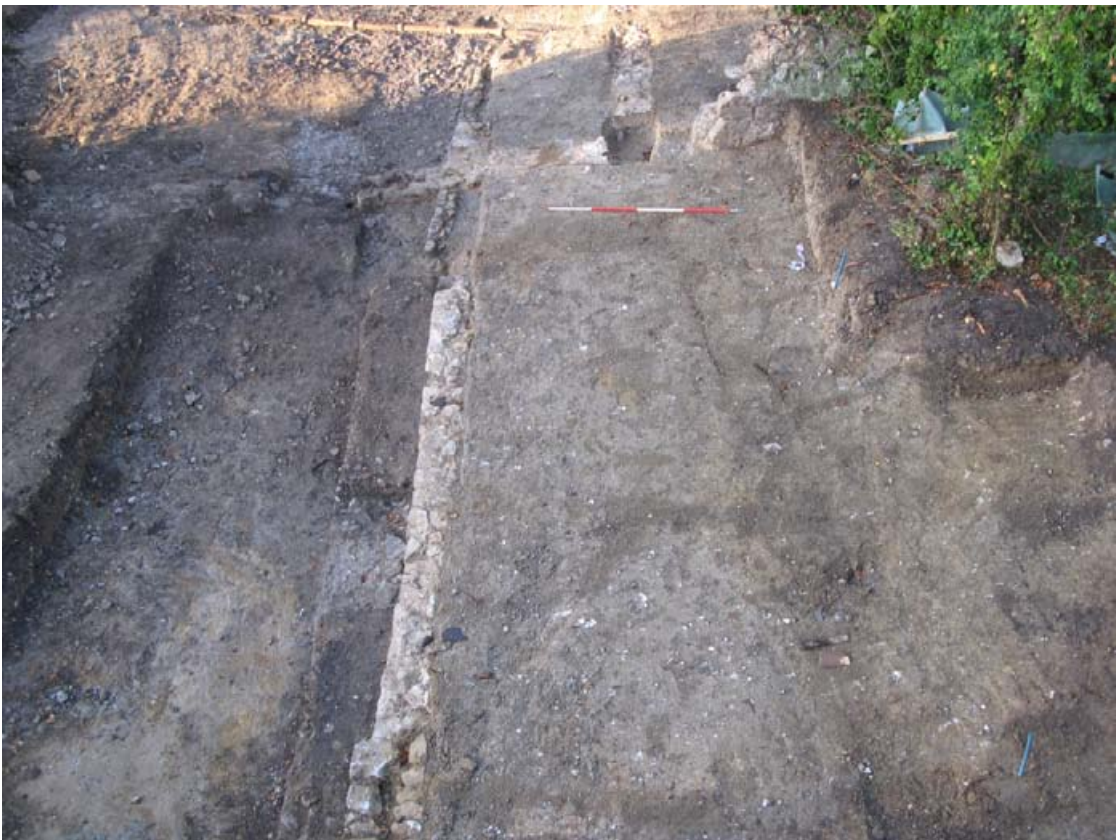
Fig 21

General view showing the alignment of the earlier wall (630,631) and the later foundations (615) looking south-west

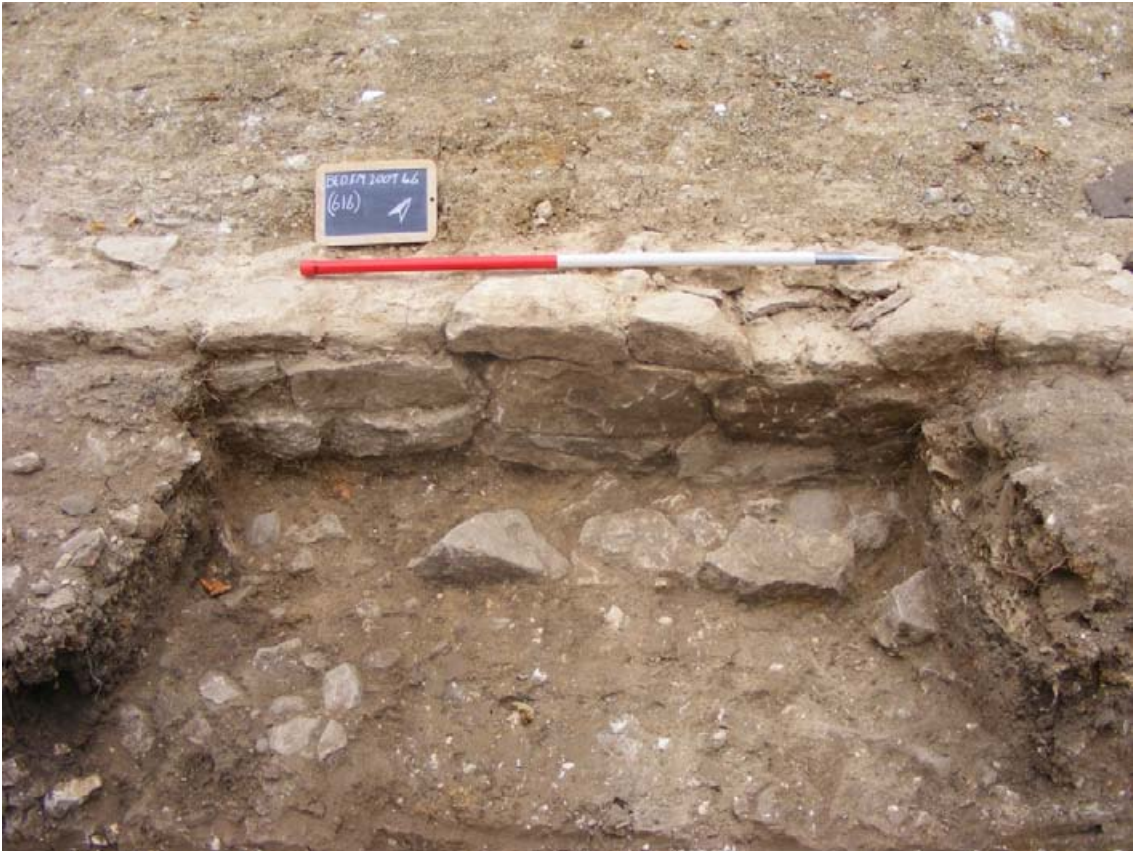
19th-century barn foundations (616), (Fig14 Section 10) looking north-west Fig 22

The eastern barn foundation wall (616) only survives as far as the present dwelling. This wall has been truncated by modern drainage near the centre of the two barns (Fig 13). The construction of this barn was more substantial with limestone blocks for foundation footings (Fig 14, Section 10 and Fig 22). The limestone blocks had been roughly faced and varied in sizes 0.3m to 0.4m in length 0.2m to 0.3m in width, a course of thinner limestone stone lay on top on the foundation blocks 0.3m to 0.4m in width and 0.05m to 0.15 in thickness.

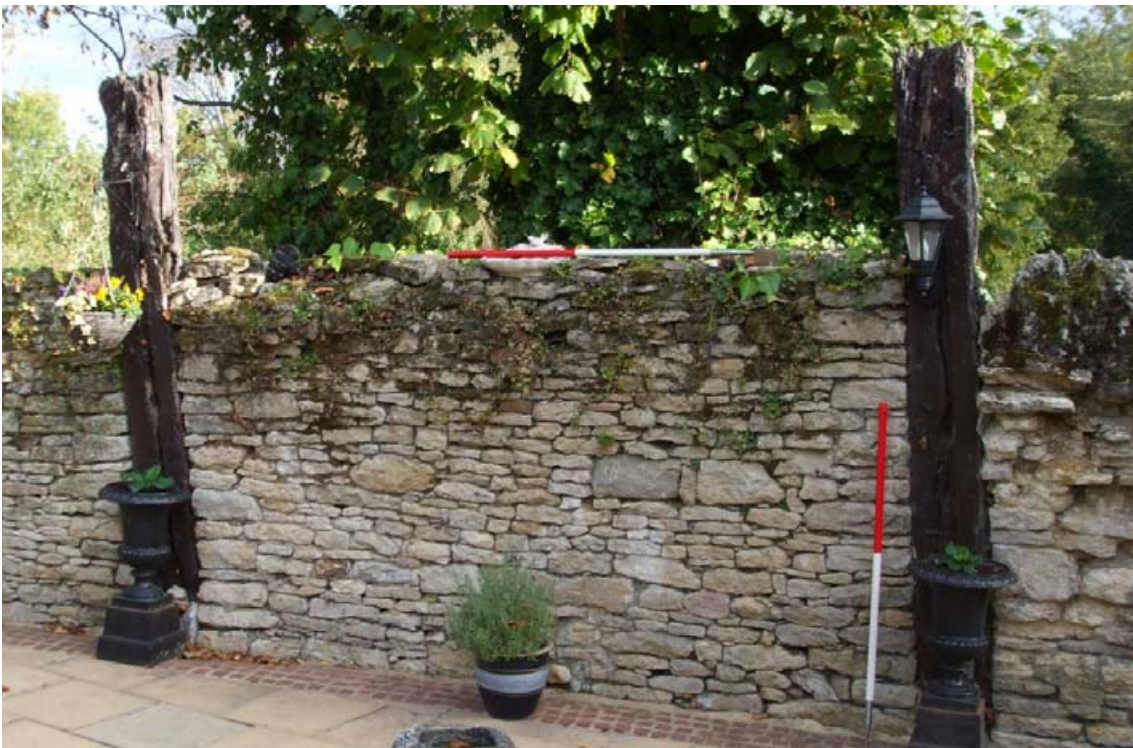
Surviving wall of the 19th-century barn, viewed from the Church Rooms, looking south-east Fig 23

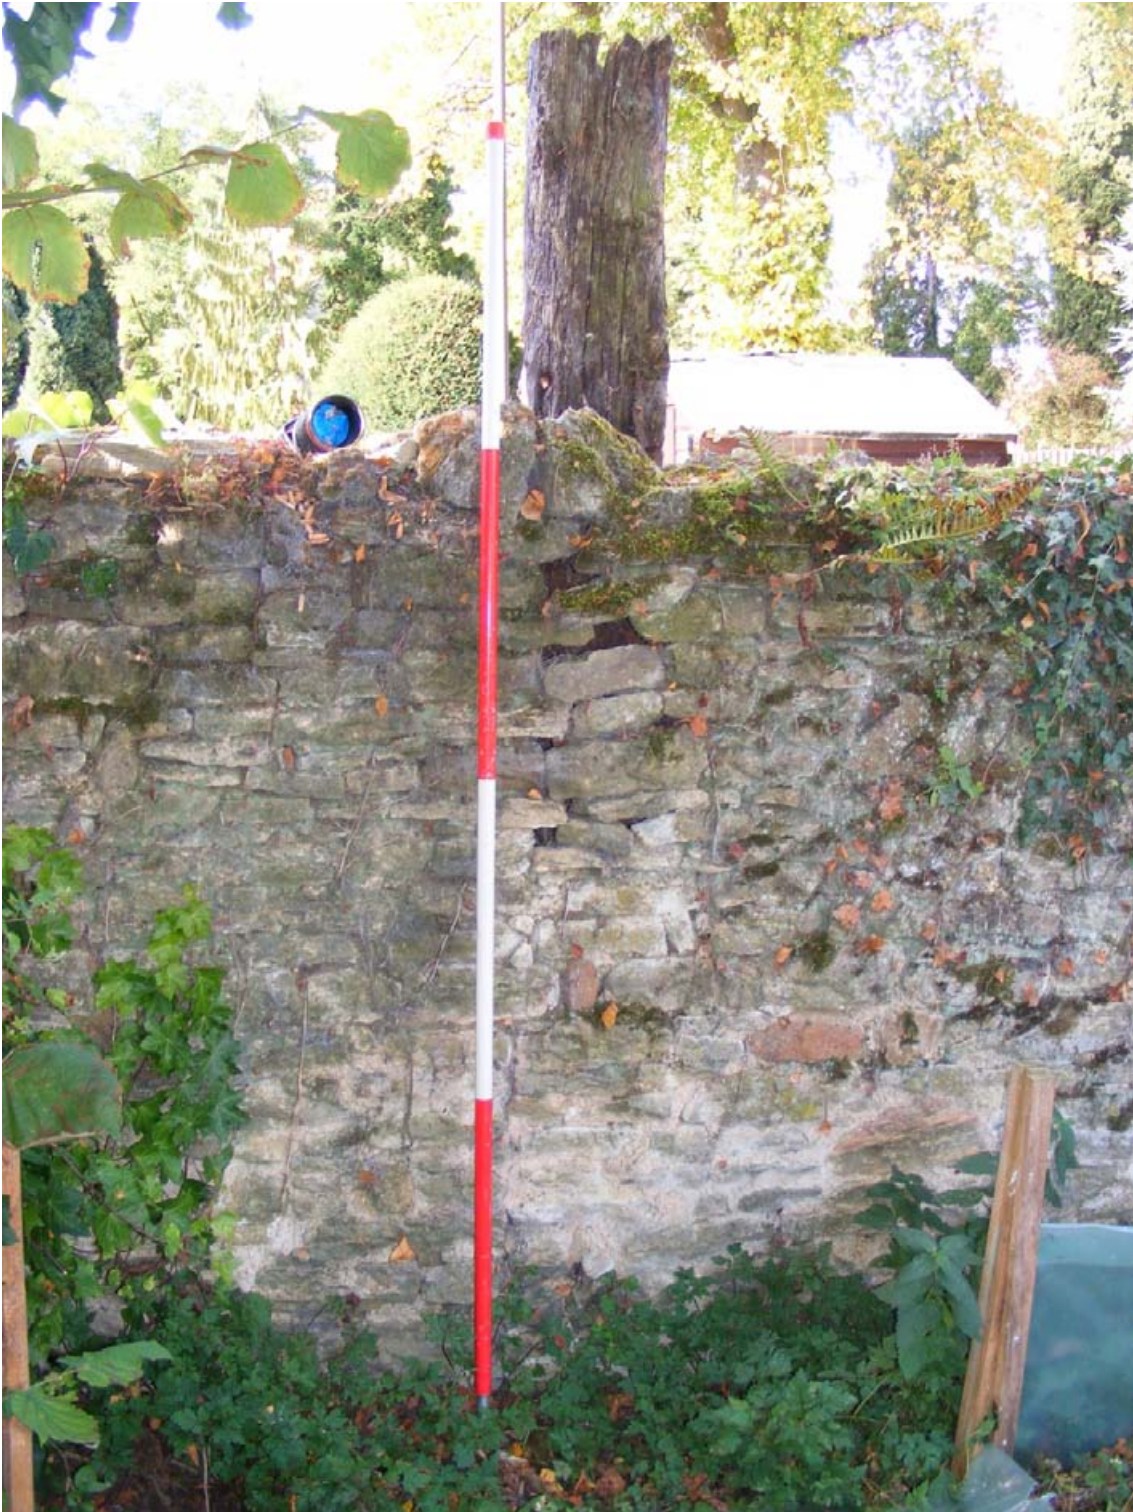
Fig 24

The eastern barn second bay from development site looking north

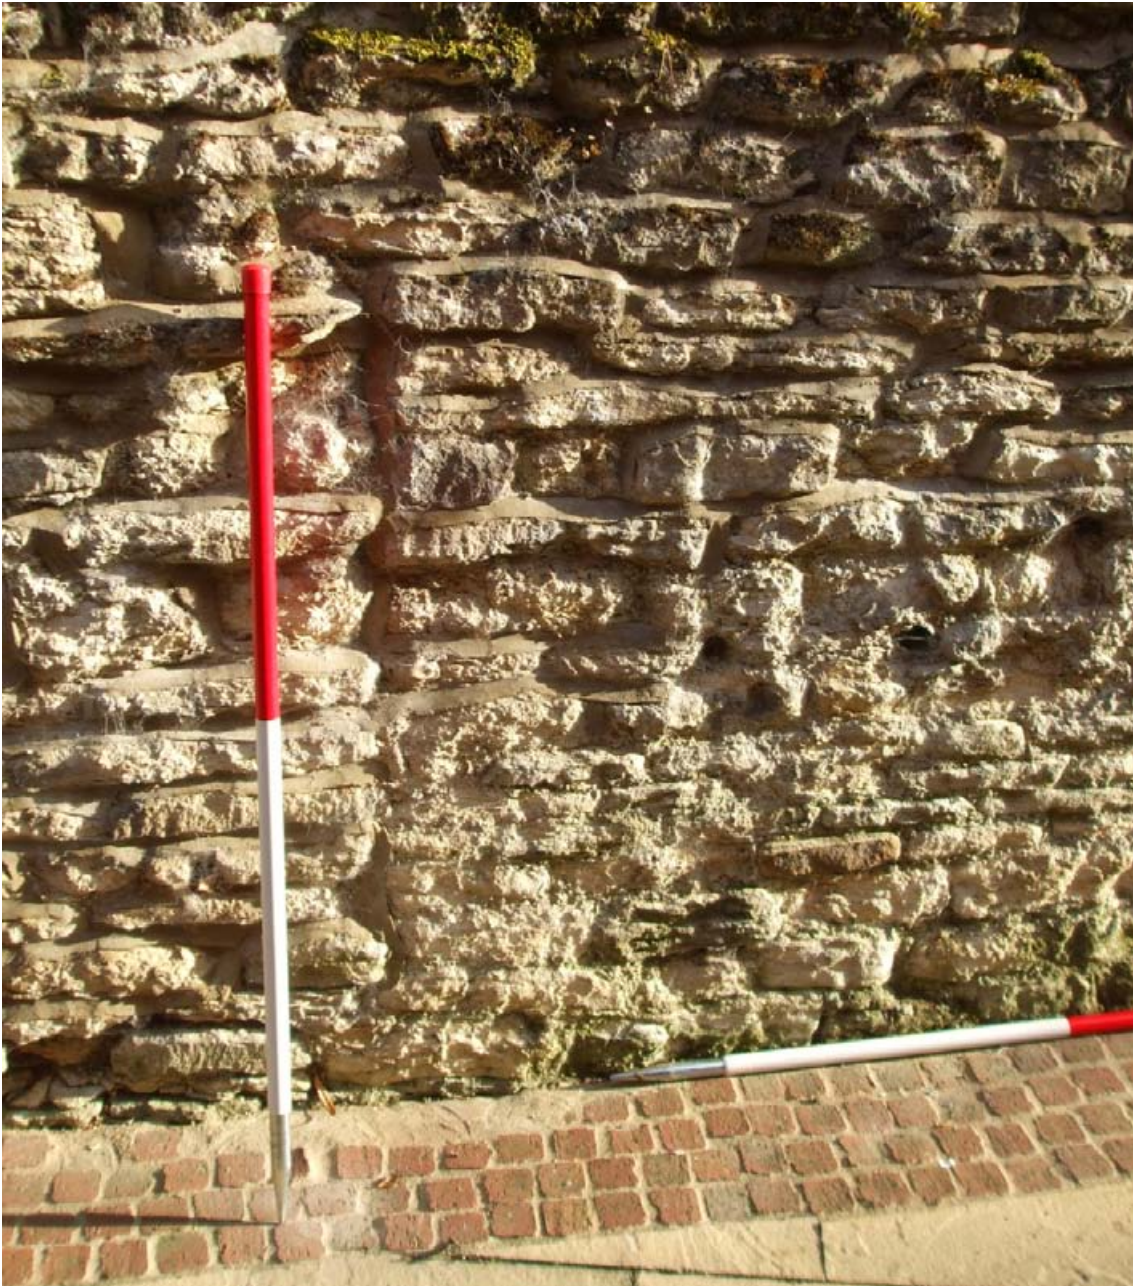
Fig 25

Surviving wall of the 19th-century barn viewed from Church Rooms looking south

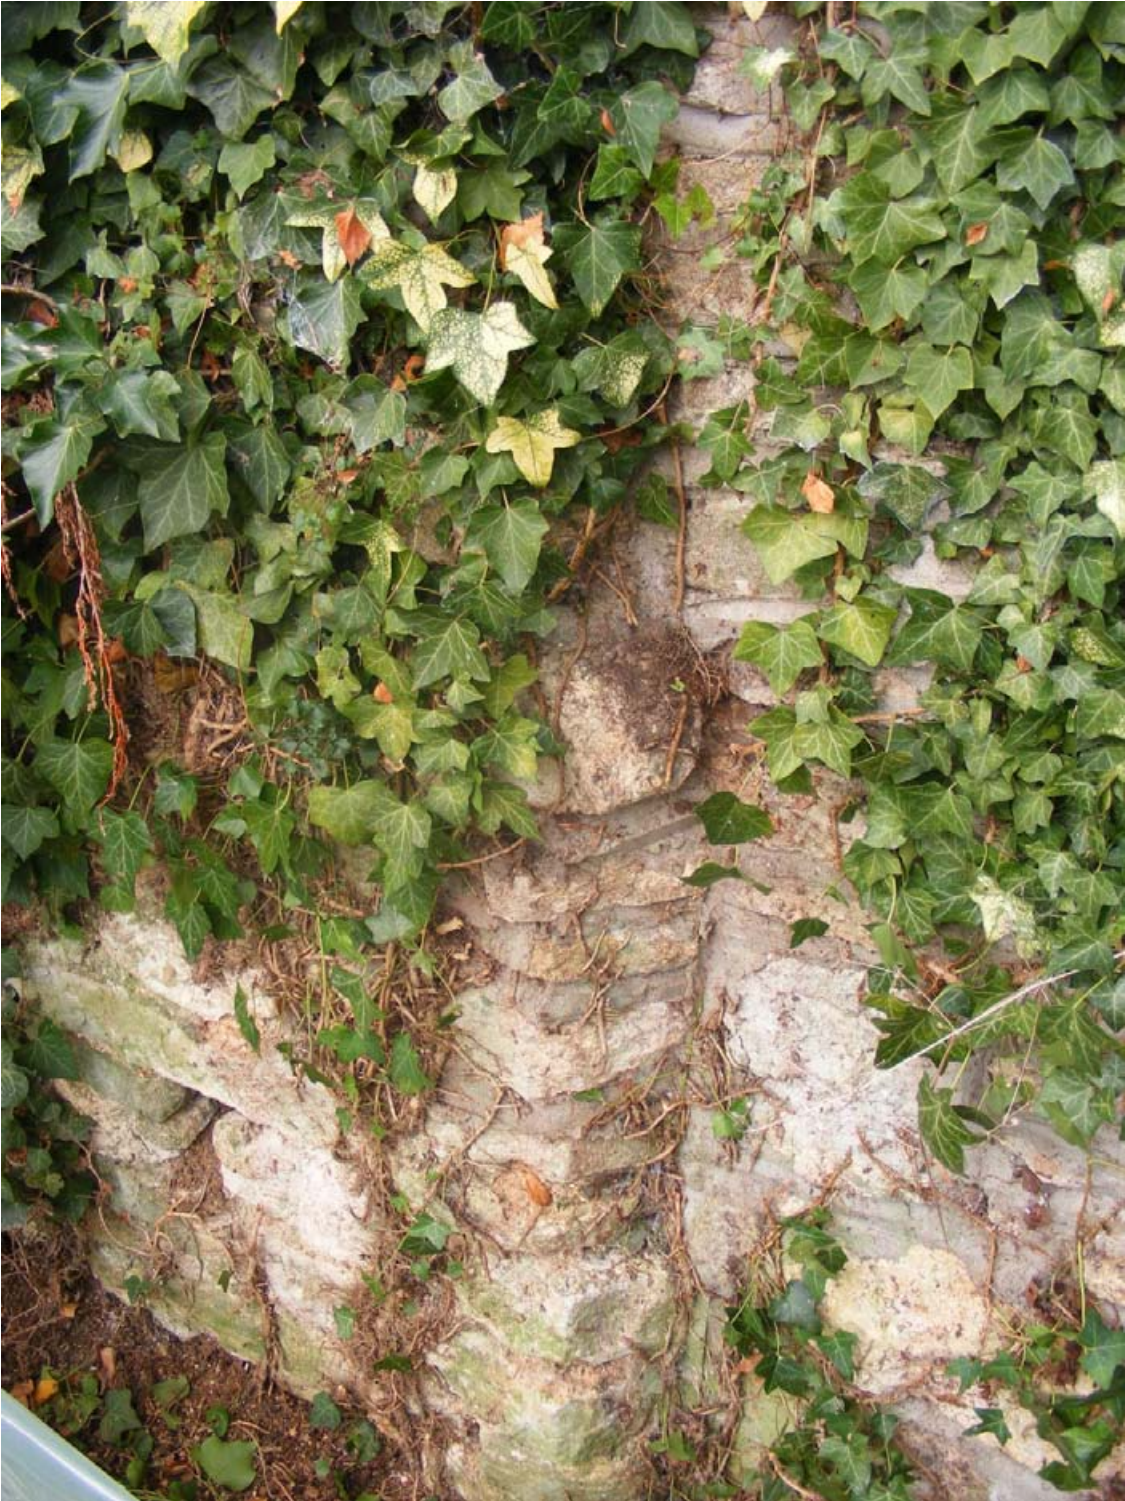
Fig 26

The eastern barn third bay and wall rebuild from the development area, looking north-west
