Archaeological Buildings Recording

Park House (Clipsham Hall stables)

Clipsham, Rutland

August 2009

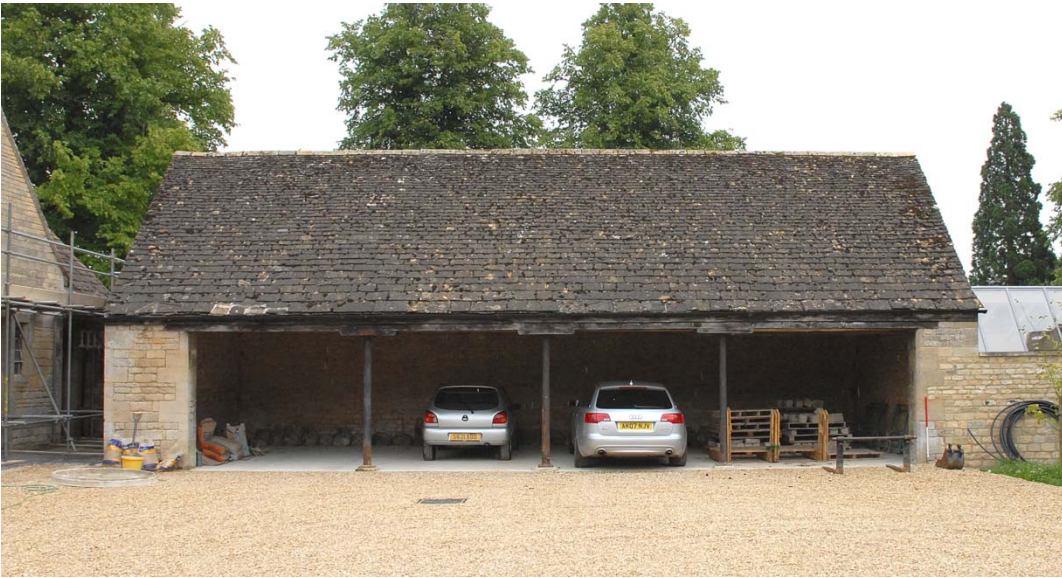
Fig 4: Open stock/cart shed

The open shed 9 formed the eastern side of the yard (Fig 4). The building was constructed in coursed limestone rubble with ashlar quoins. The open side of the building was supported by three cast iron columns, set on limestone pads. The roof trusses, however, were king post (Fig 36) as opposed to the queen strut as seen in the other buildings.

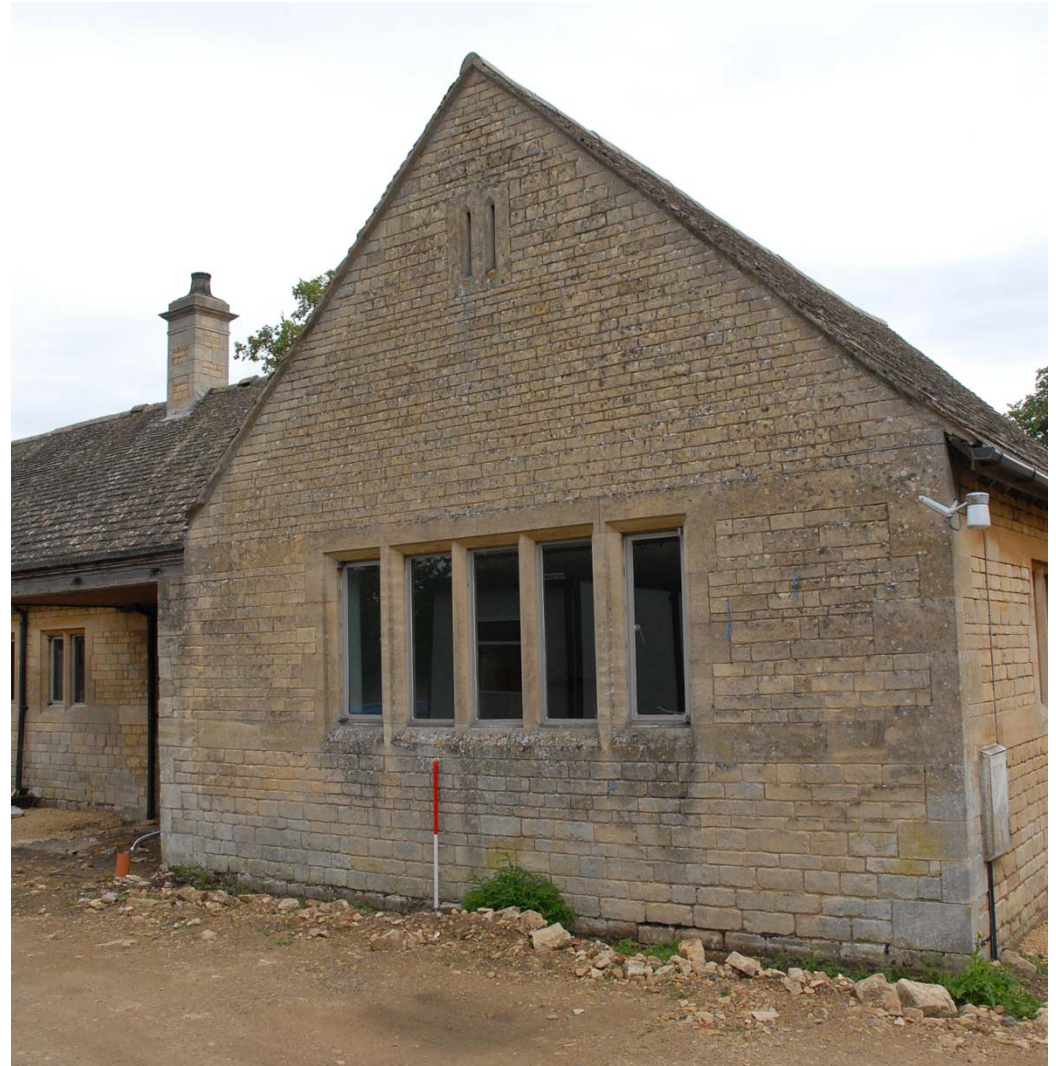
Fig 5: Gable west range

The buildings are all of one build with the exterior walls being coursed Clipsham limestone rubble, with a fine limestone lintel and sill course and fine limestone detail around the stone mullioned windows (Figs 5 and 6). The interior dividing walls of the buildings are of red brick. The floors are concrete throughout. The roofs are all Collyweston slate. The buildings have a bitumen damp course (Fig 7). There is also a lead flashing under each window frame to protect the limestone sills (Fig 8). Within the gables are pairs of vents with fine limestone surrounds (Fig 9).

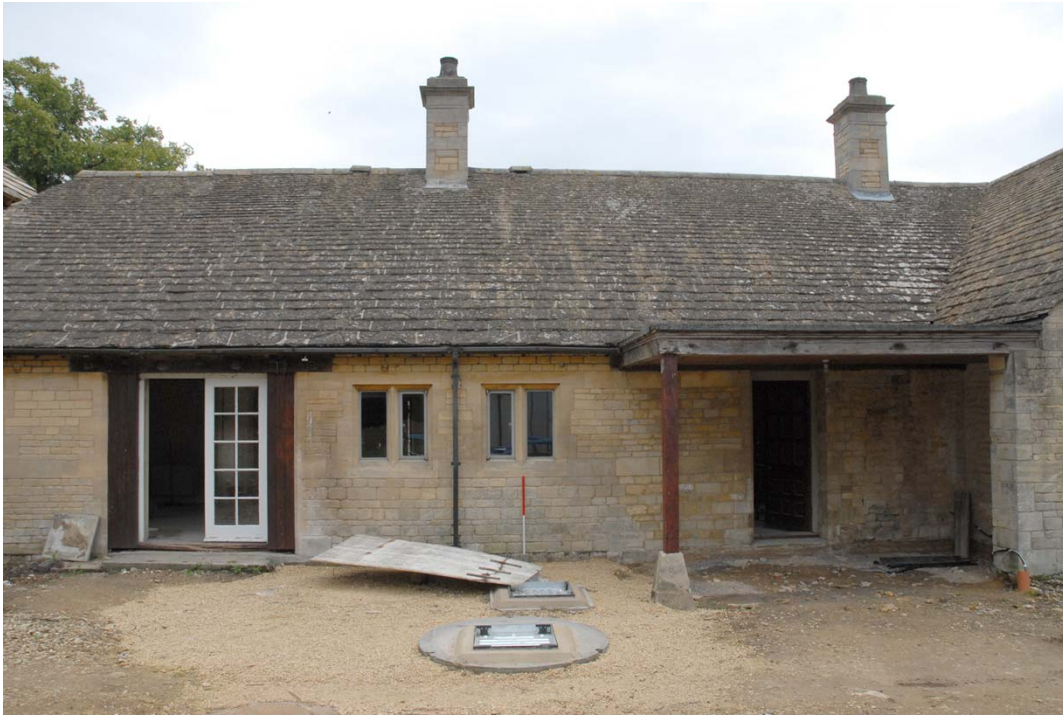
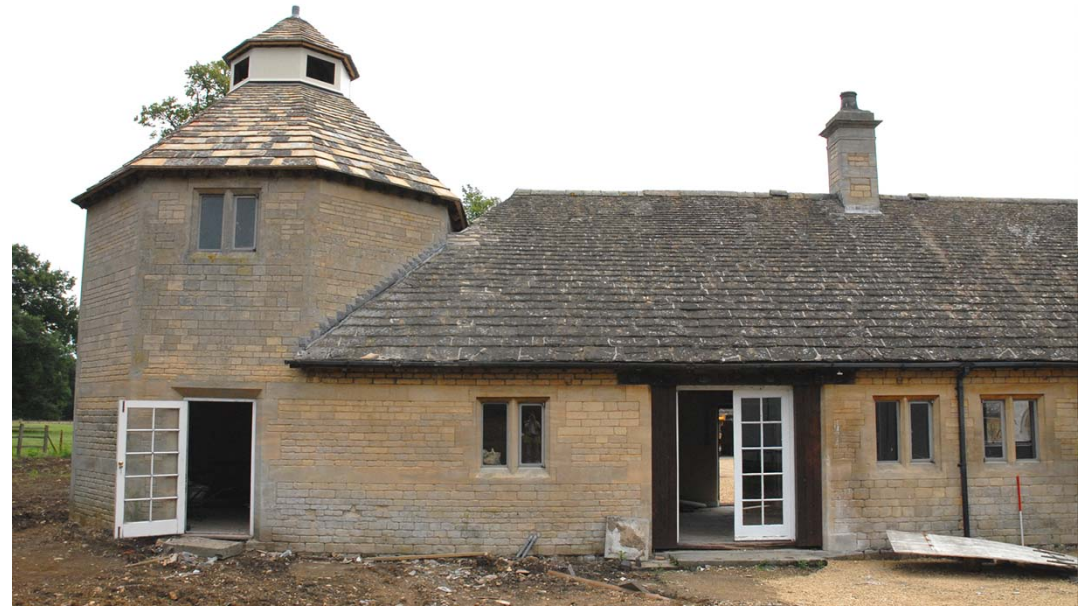
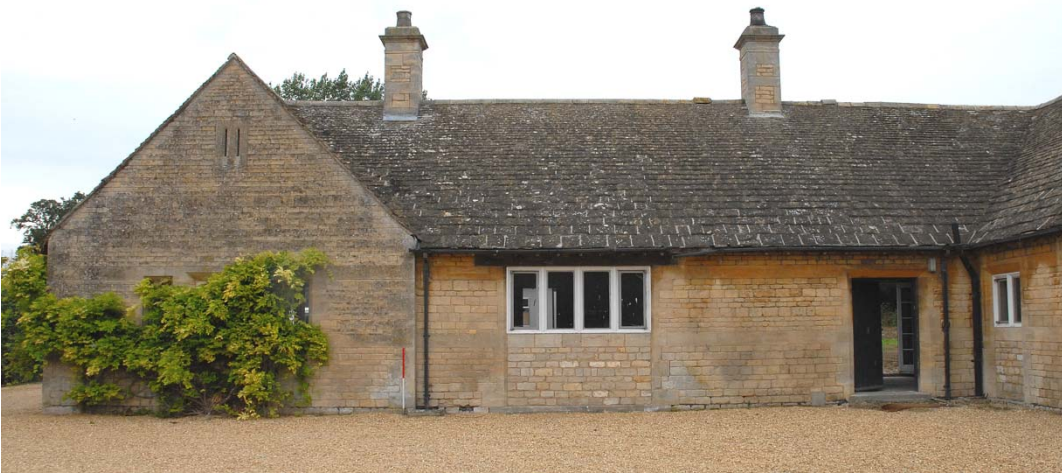
The western range (Cover, Figs 10, 11 and 12) was formerly the engine room, sawmill and carpentry shop. These three rooms had been subdivided in the 1984 conversion of the building (Fig 3). At the time of the survey these partitions had been removed and the inserted ceilings in all rooms had been removed, except in Room 1 (Fig 13) to expose the queen strut roof structure (Fig 14).

All of the doors in this part of the building had been replaced in 1984. The original four-light steel-framed windows had also been replaced in this part of the building with single-light steel-framed windows (the original windows survived in the eastern end of the north range).

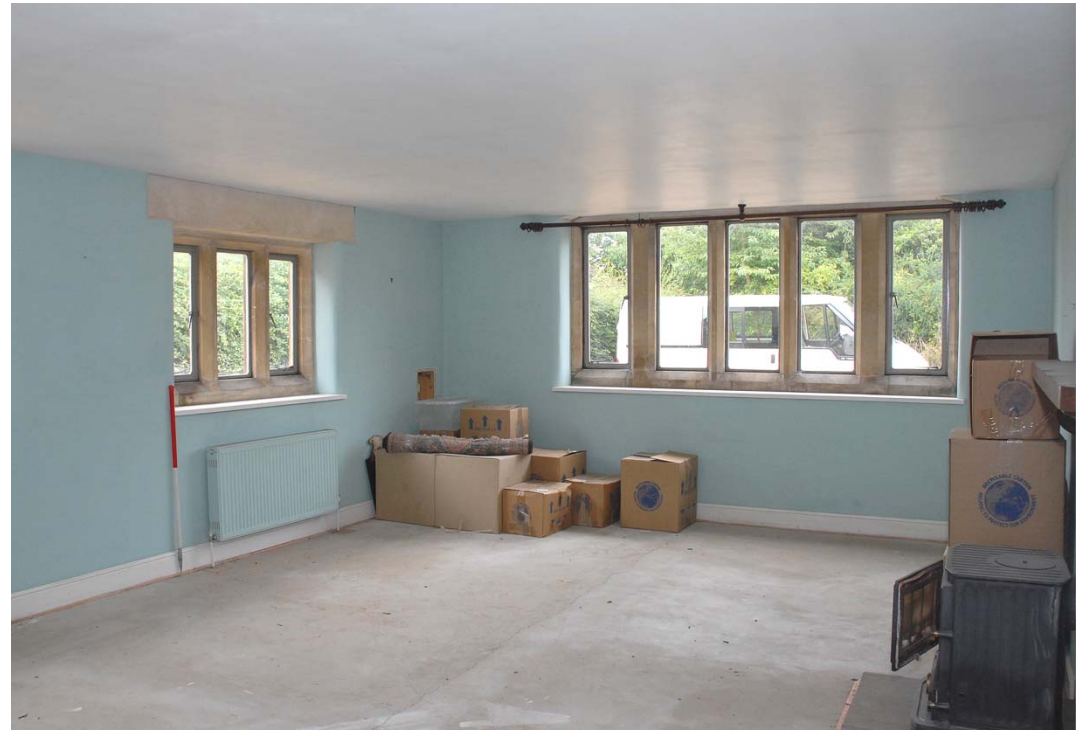
Fig 13: Room 1 general view

This room had originally been the carpentry shop, although no evidence of this former use survived. The room retains its 1984 inserted ceiling so it was not possible to see the roof structure in this room. The room has a modern concrete floor and a modern wood burning stove in the chimney breast, which was added as part of the 1984 conversion when a chimney was removed from the western end of the north range and rebuilt on the new chimney breast.

The central window on the eastern wall was formerly a door, which was blocked in 1984.

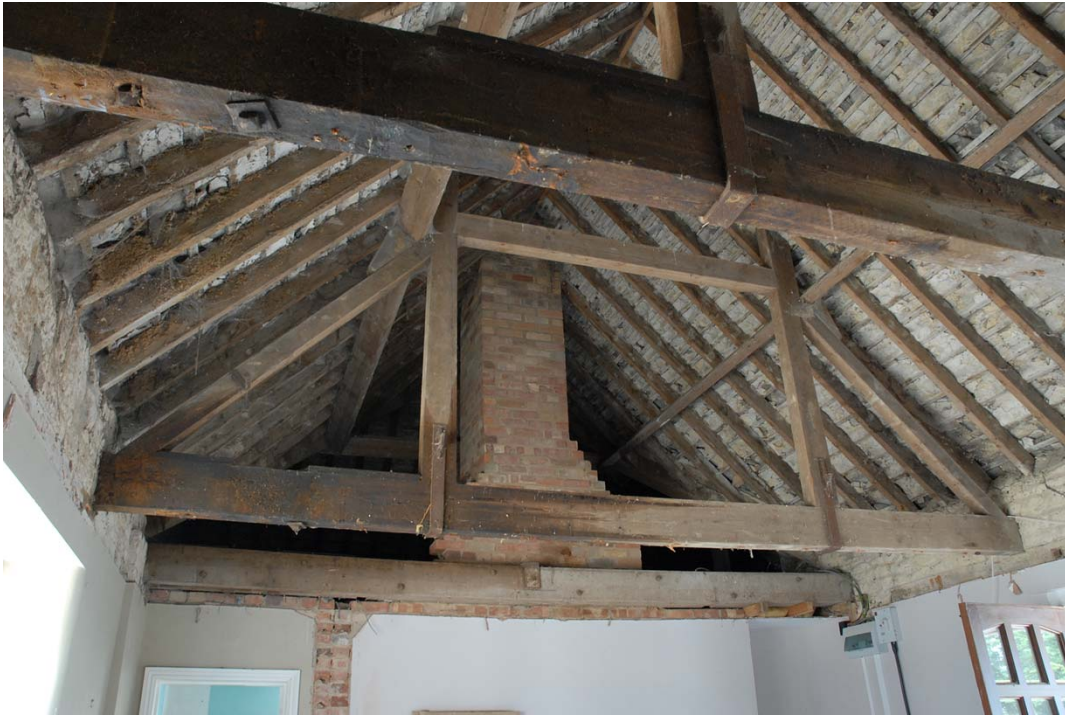
Fig 14: Room 2 queen strut truss

This room had been subdivided in 1984, however, this partition has been removed as part of the current works, and the inserted ceiling has also been removed exposing the queen strut roof (Fig 14). The current door to the room from outside in the western elevation is set into a reduced width opening, which matches in width the window opening on the eastern side, which in turn is a partially blocked door. This room was originally the sawmill, and the openings would have been required to move timber through the building. The saw was powered from a driveshaft (now removed), which ran along the tie beams, the evidence of its position is provided by the extensive oil staining on the tie beams over which it had passed (Fig 15).

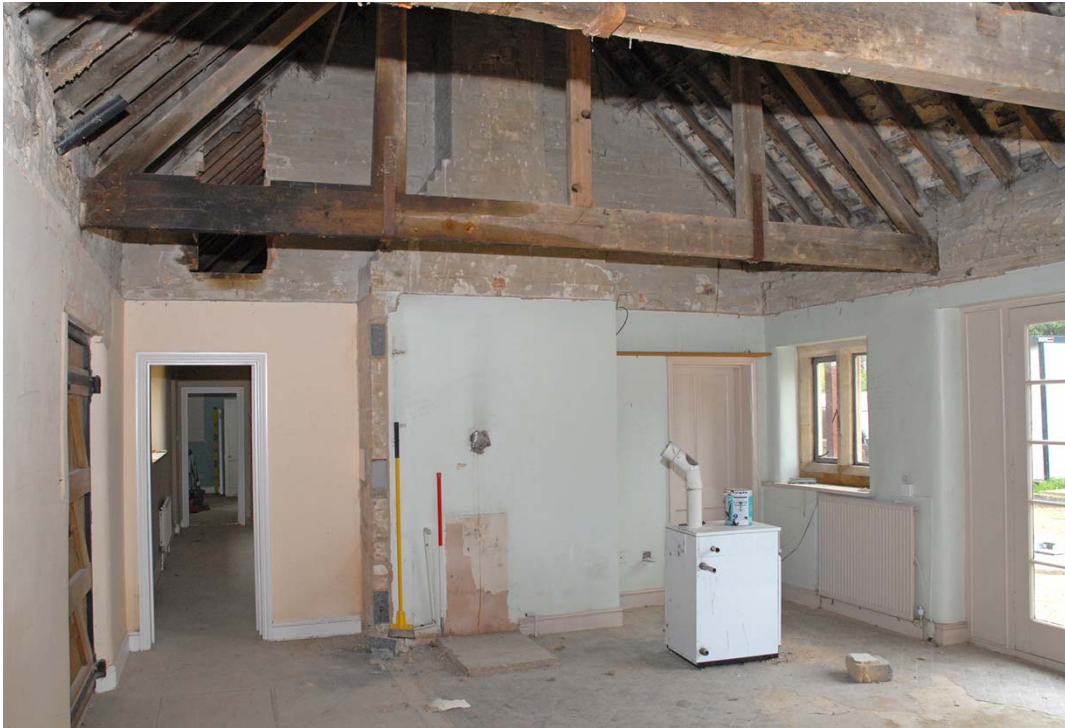
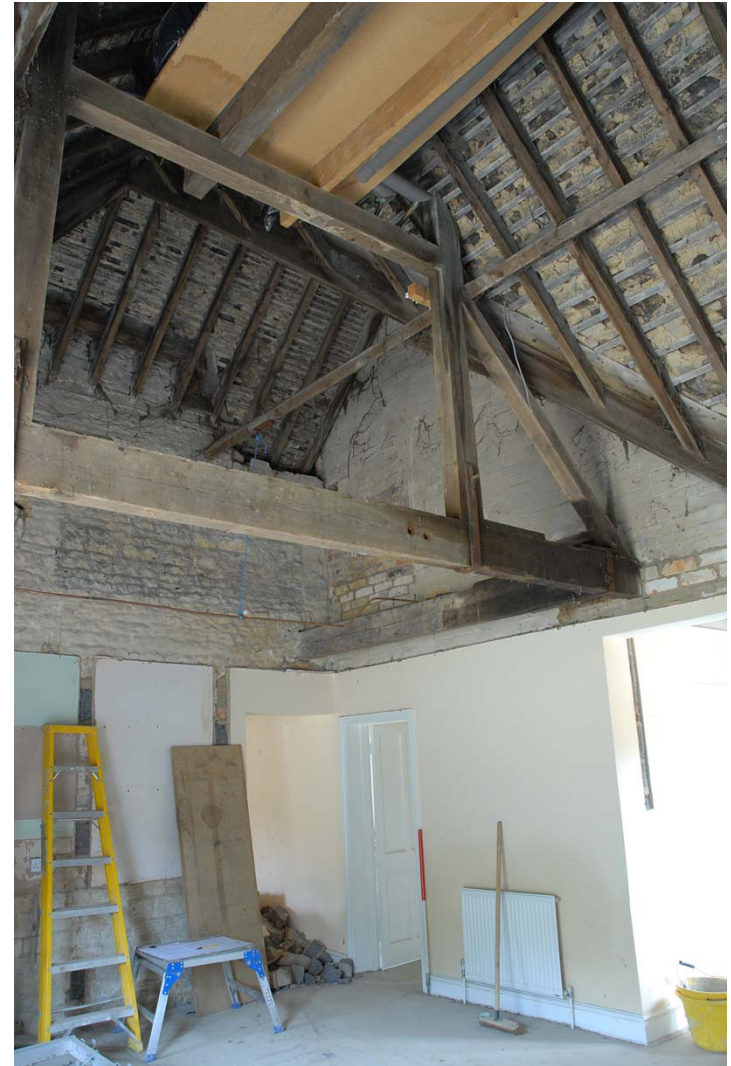
This room had been subdivided in 1984. These partitions were removed as part of the current work. This room was originally the engine room, however, apart from the oil staining on the tie beam from the driveshaft grease there was no surviving evidence of the type of engine or its position within the room (Figs 16 and 17). The lack of any chimney suggests that it was not a steam engine.

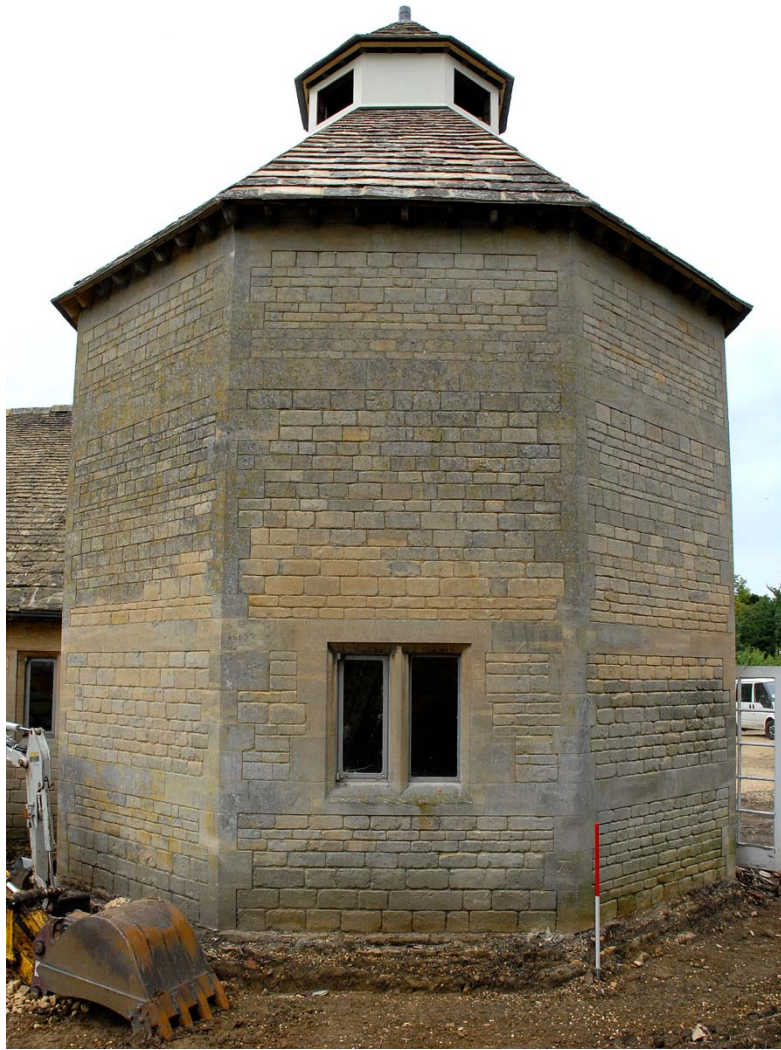
Fig 18: Dovecot exterior

The dovecote is an octagonal two storey building, with a lantern roof (Fig 18). The ground floor room, Room 4, has plastered walls and replacement doors and window. There are seven kneelers for beams for a lower ceiling; but it is unclear whether the ceiling was ever lower than it is now (Fig 19). In the ceiling there was a hatch through into the dovecote loft.

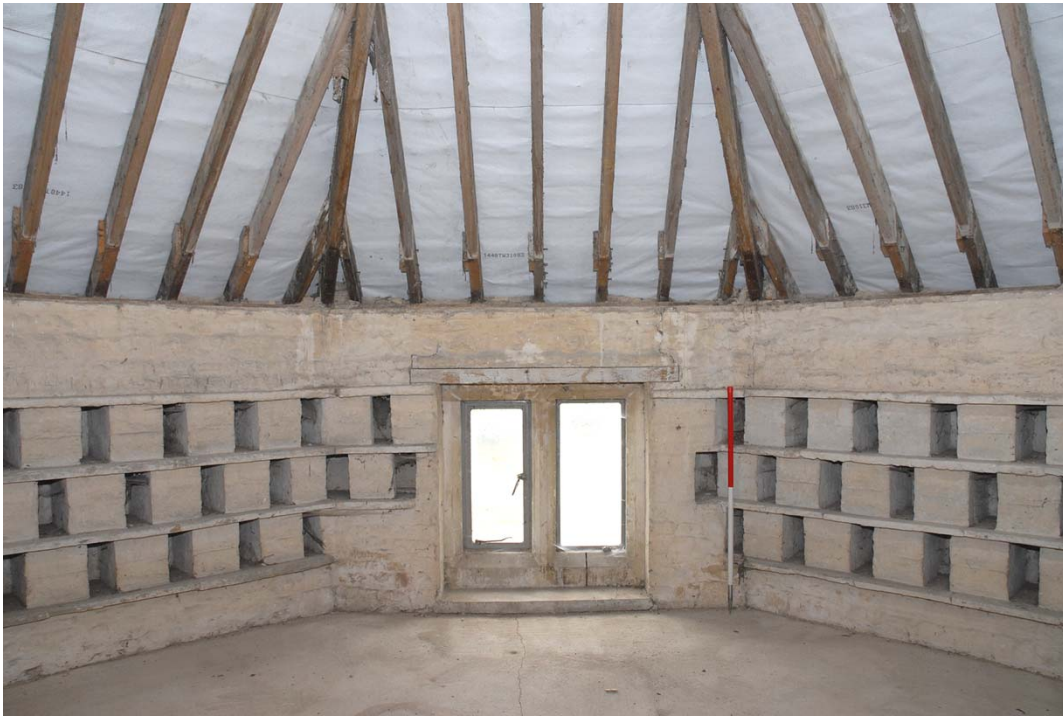
Fig 20: Room 4a dovecot interior

The dovecote (Room 4a) is octagonal in plan with three tiers of nesting boxes on all internal walls, including either side of the window (Fig 20). The floor of the dovecote is lime ash and the central area is quite pitted from droppings indicating where the birds would have perched over the lantern top (Fig 21).

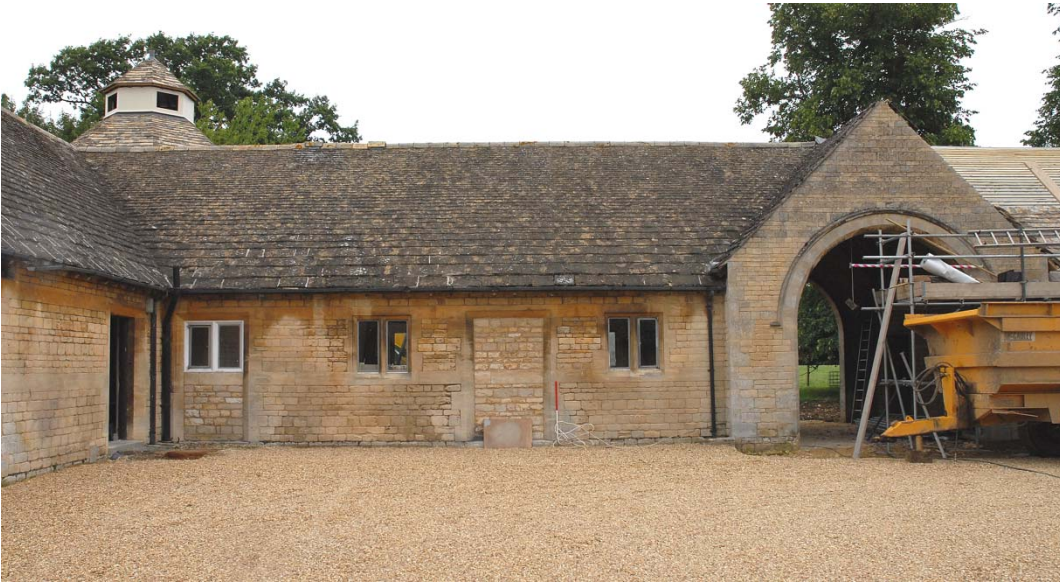
Fig 22: North range south facing elevation

Externally this part of the building followed on from the western range (Fig 22). In Room 5 the 1984 partitions have been removed, although the inserted ceiling was remaining at the time of the survey (Fig 23). This room was originally a stable, although no evidence of this former use survived other than a wider blocked doorway (Fig 22) and the door through into the covered passage is ledged and braced stable door with iron strap hinges and latch (Fig 24).

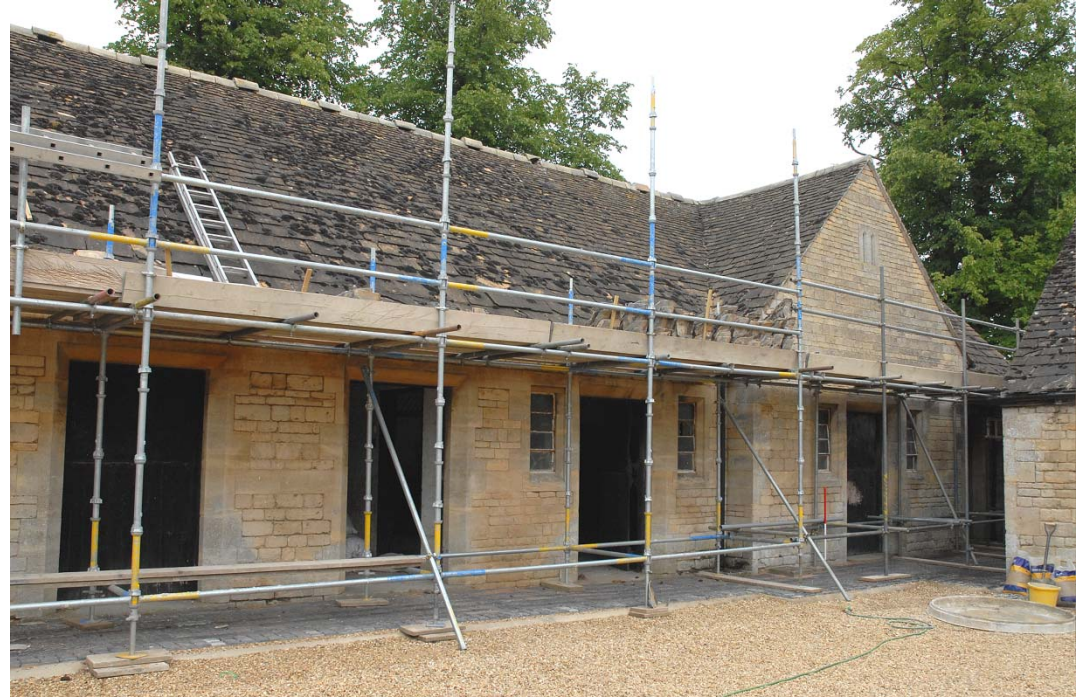
Fig 25: North range south facing elevation

The eastern end of the north range (Figs 25 and 26) was not converted in 1984 and consequently it retains more of its original features. The floors in this part of the range are all concrete, the walls are painted black to c1.1m high and the remainder of the wall is white. The roofs have queen strut trusses (Fig 27). The windows in this part of the building had four-light steel-frames, which were likely to be the original frames (Fig 28).

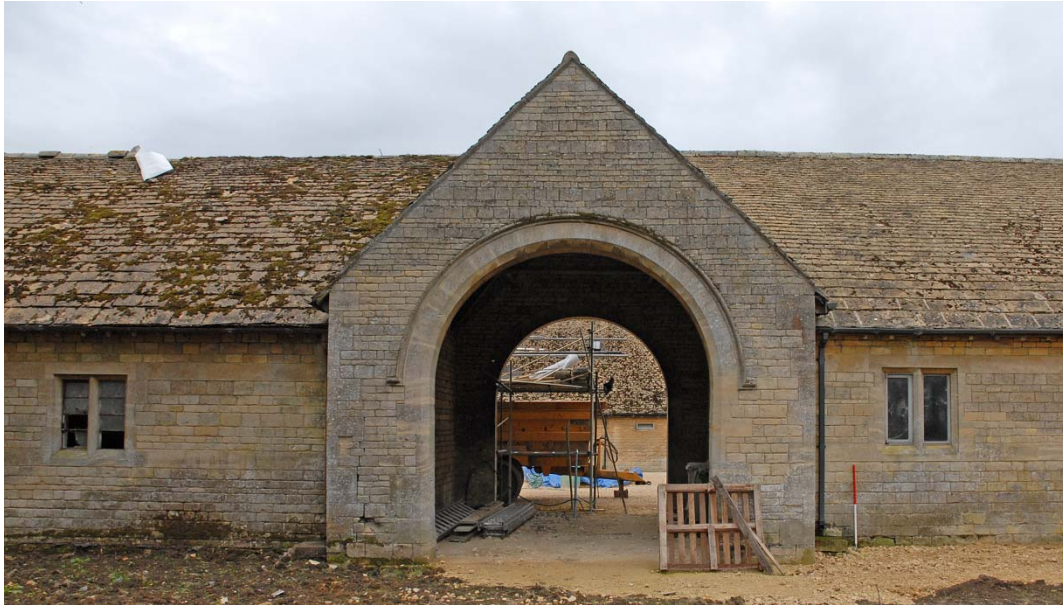
Fig 26: North range north facing elevation of arch

Between the two parts of the north range was an arched entrance/exit to the courtyard area (Figs 22 and 26). Stable doors on either side of the passage lead into Room 5 to the west and Room 6 to the east.

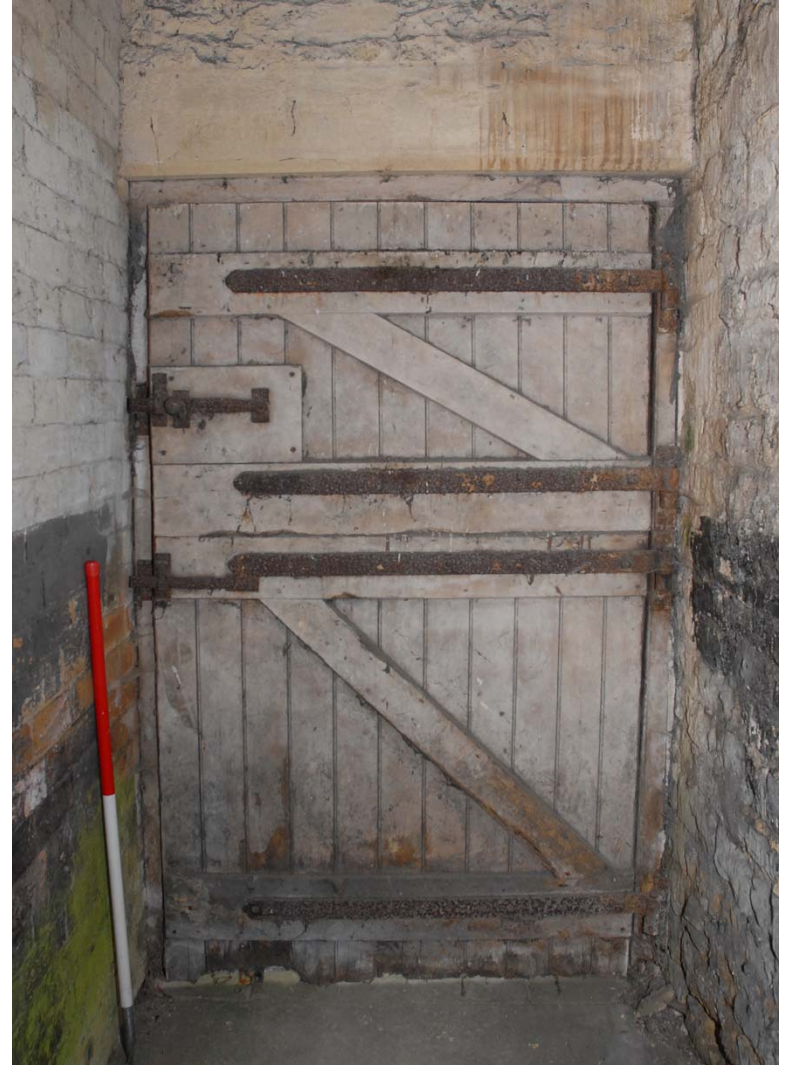
Fig 29: Ledged and braced door in Room 6

This room had originally been a stable. Prior to the 1984 conversion the room had been used for a pig sty, so the stable fittings had been removed (pers comm Mr J Featherstone), although the door from the covered archway into this room is a ledged and braced stable door (Fig 29). Access could not be gained to room 6a, however, this room may have served as a foaling stall.

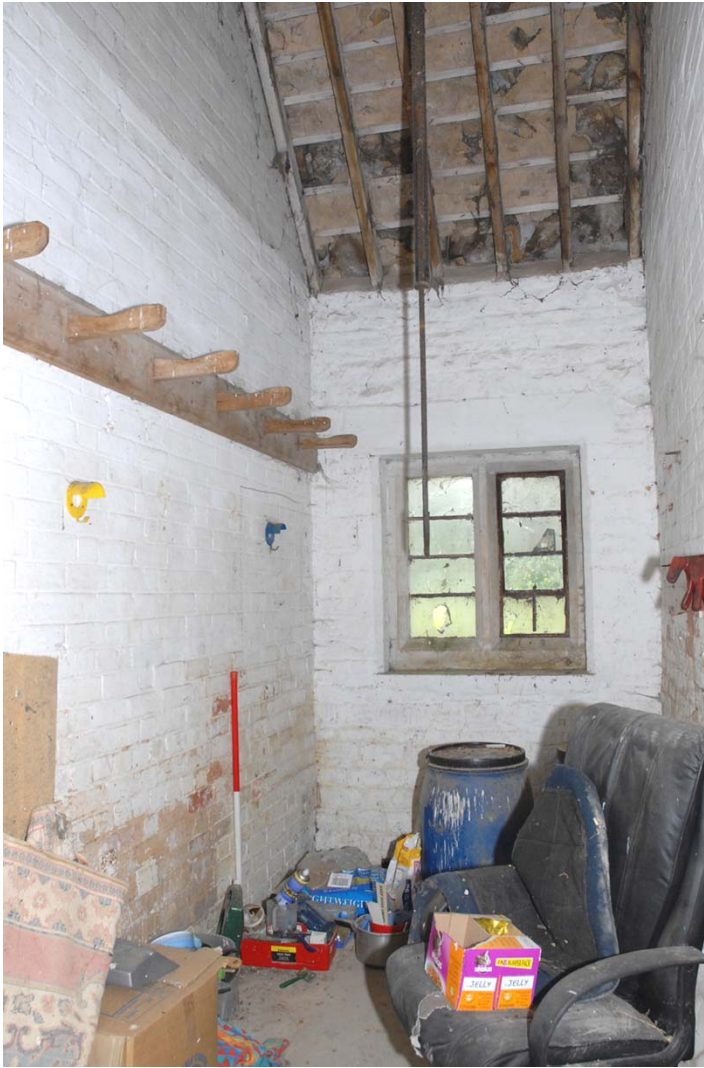
Fig 30: Room 7a general view of tack room

This room, adjacent to Room 7 had access off the yard and from Room 7 and served as the tack room. A row of wooden pegs for hanging the tack survive on its long wall (Fig 30). An iron rod hanging from the ceiling with two curved ends may have been to hang tack on whilst it was being cleaned.

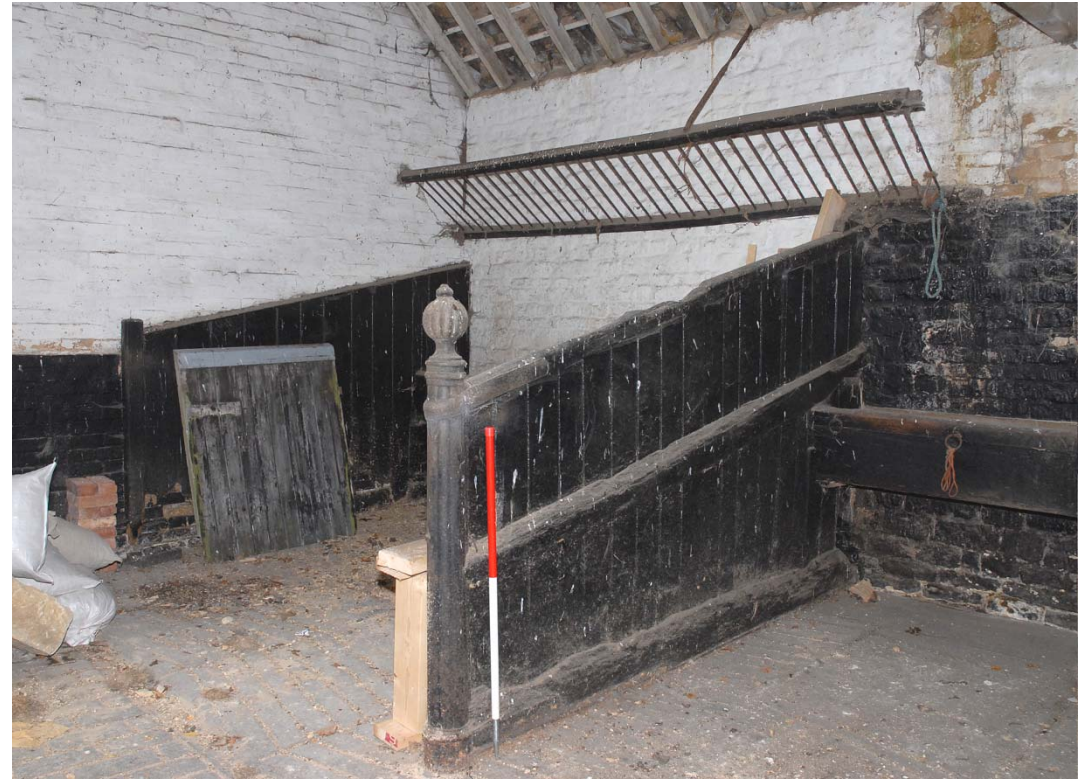
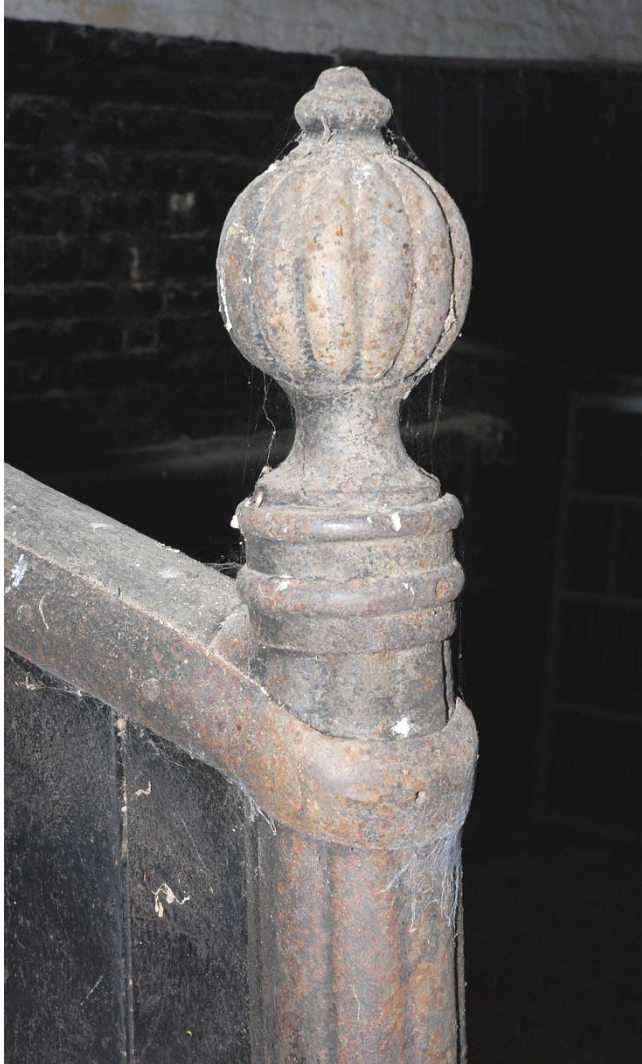
Originally a stable this room retains many of its original features. The eastern end of Room 7 is sub divided off by a low wooden stall, which has its own exit/entrance out into the yard. The main part of the room is divided into two equal parts by a wooden stall with a cast iron post (Figs 31 and 32). Each stall was provided with a manger and hay rack along its back wall (Fig 31). On each manger there are two tether rings, making space for four large horses with the divided off space at the eastern end for a fifth. On the inside of the southern wall of the room there are five further wooden pegs for hanging tack (Fig 33).

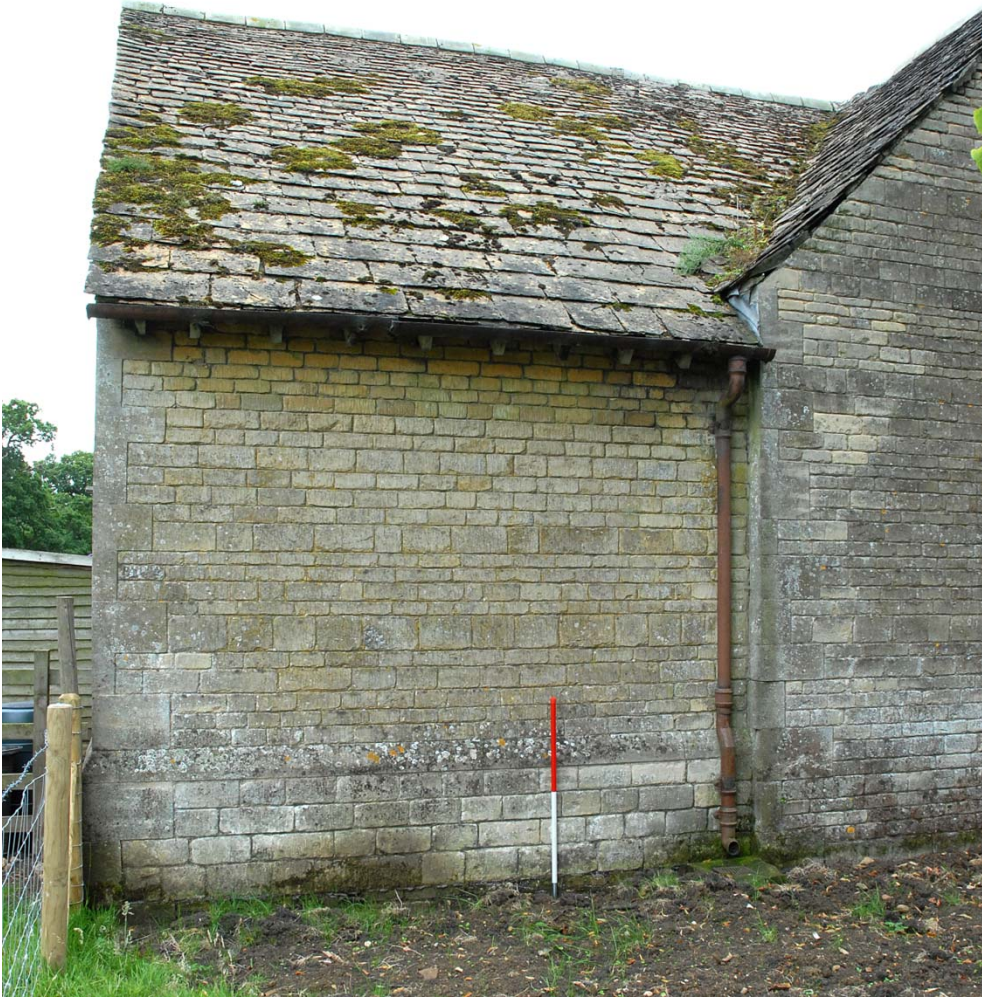
Fig 34: North facing elevation of north range showing the extension

At the eastern end of the northern range, this room was a later addition as it had a butt join to the main range and had been built slightly differently with a projecting plinth (Fig 34). Other than the plinth it followed the same style of building with the

same style of steel-framed windows as elsewhere in the building, which suggests that it was added soon after the main building was completed.
