# North Pennines Archaeology

Client Report No. 307/06

## **METRIC BUILDING SURVEY OF BLENCOW HALL, PENRITH, CUMBRIA**

**GRAHAM K NORMAN  
(ARCHITECT) LTD**

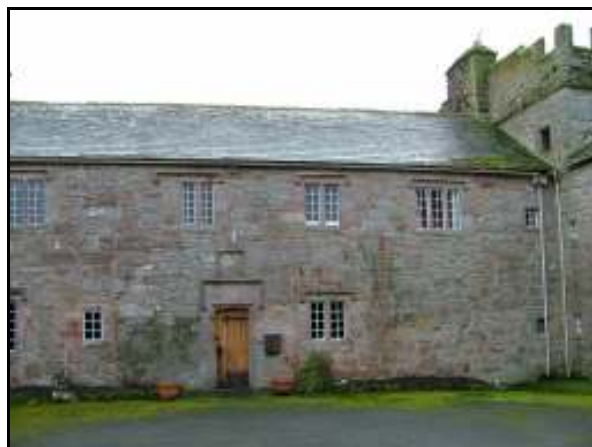
Plate 1: The Hall Block from the northwest

4.3.1 The Hall Block, flanked by the North Tower and South Tower, is illustrated in Figure 5. The entrance to the Hall is located centrally on the northwest wall, and has a moulded square frame with an inscription in Latin on the lintel, translated as “*Live still to die, that you may by death purchase eternal life*” (Curwen 1907). The inscription is dated ‘1590’ and bears the name of Henry Blencow. Above this is a panel containing three shields, which are believed to bear the arms of Crackenthorpe, Curwen and Blencow (now blank).

- 4.3.2 Both walls of the Hall Block contain mullioned windows, decorated by hoodmoulds with carved stops, which vary in design from window to window. These are attributed to Henry Blencow, and some bear the initials 'HB'. The northwest wall also contains a number of earlier features, including simple square-headed windows (one blocked) and a relieving arch, which marks the probable location of an earlier opening. There are also a number of breaks in masonry in this wall, marking episodes of rebuilding.
- 4.3.3 A section through the Hall Block and both towers is illustrated in Figure 5, Section A-A1. Section B-B1 shows a section through the Hall Block and cellar, which measures 2.75m by 2.75m and is 1.9m deep. The cellar is reached through a trap door in the Dining Room and is lit by a small window on the southeast side, which is located just below the present ground level.

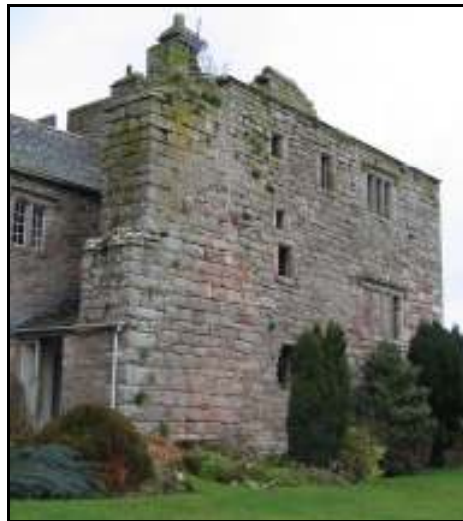
Plate 2: The North Tower and chimneystack, looking north

- 4.4.1 Four outline elevation drawings of the North Tower are shown in Figure 5. Most of the parapet has been lost from this tower except on the southwest side. The southeast wall contains the chimneystack from the earlier Hall, which acts as a buttress to the tower. An entrance to the tower is located on the southeast side next to the newel stair. A rough opening in the wall here may have originally been a window, but no window dressings survive. Two blocked mullioned windows are located on this side of the tower, both with hoodmoulds and decorative carved stops. The lower window has a relieving arch above. A number of smaller, square-headed windows are positioned in this wall, lighting the stair and the ground floor room.

- 4.4.2 The northeast wall contains two early mullioned windows, both with hoodmoulds and stops carved with human faces. A ground-floor doorway and window are later additions, and the window bears the date '1818' with the initials 'MH'. This window mimics the earlier mullioned windows, and bears a simpler hoodmould with plain

stops. A central break in the wall, and internal recess at second-floor level, may mark the location of a former window. There is a hole in this wall for a drain spout, which is associated with a modern corrugated iron roof, shown in Section A-A1.

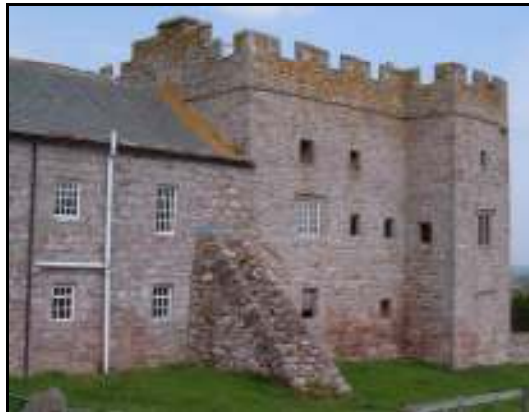
Plate 3: The South Tower and West Range, looking east

- 4.5.3 The southwest elevation of the South Tower includes is illustrated in Figure 6. Two mullioned windows with hoodmoulds and carved stops are at situated at first floor level, and the third at ground floor level is blocked up. To the east of this window is another carved sundial. Seven other square-headed windows, of various sizes, are located on the southwest side of the South Tower. Between this tower and the West Range is a sloping line of slates, which marks a former roofline. Below is a relieving arch, partly obscured by a stone buttress, which is the probable location of a former oven.

- 4.6.1 The outline elevations of the West Range are illustrated in Figure 6. The gateway passage has a segmented arch and provides access to the courtyard. Above the passage is a blocked opening below a window, which may once have formed a doorway. To the east is a mullioned window with hoodmould and carved stops bearing the initials 'H B'. Six other chamfered square windows are located in the southwest wall of this building.

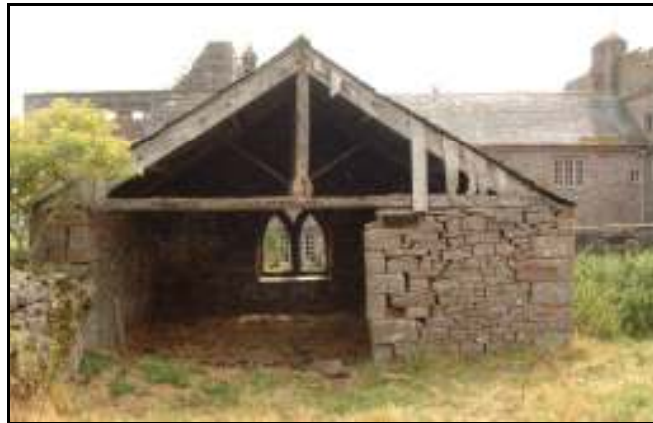
Plate 4: The Chapel from the northwest

- 4.7.1 The Chapel elevations are shown in Figure 10. The southeast wall, which faces the courtyard, contains a two-cantered window with Y-tracery. The northeast wall has been reduced in size, but footings of the former building can be traced in the adjoining stonewall. The northeast wall contains a square chamfered window, which is made from reused stone. The open entrance to this building is on the northwest side.
