NORTH PENNINES ARCHAEOLOGY LTD

Client Report No. CP/369/06

August 2006

In August 2006, North Pennines Archaeology Ltd undertook a watching brief in Ponteland, Northumberland, on behalf of Northumbrian Water. The area of the watching brief lay within an area of Ponteland demarcated as of potential medieval and post-medieval archaeological interest. There was a strong possibility that the groundworks associated with the mains refurbishment scheme would intrude on areas of the early Ponteland settlement.

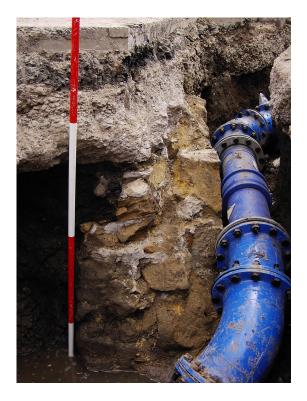
- 4.1.2 A wall was identified within the trench, and when examined the wall [103] was found to be c.0.75m thick and curving from the south east through to the north-west, aligning with the current bridge. A plan and section of the trench can be found on *Figure 2*.

Plate 2. Wall section by new water pipe, looking south-east.

- 4.1.4 Interpretation of the wall seems to indicate that the wall is part of an earlier bridge across the Pont, and as suggested by Assistant County Archaeologist Karen Derham, could quite possibly be of medieval date. However, no dateable artefactual evidence was present in the trench when it was examined.

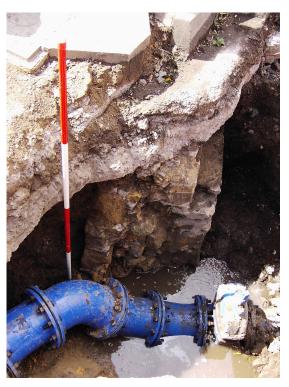
- 4.1.3 The wall has had a large section (just over a metre wide) removed during the excavation of the water pipe trench. Upon questioning the excavators, they described the wall as extremely well built and sturdy.

Plate 3. Wall section by new water pipe, looking north-west.

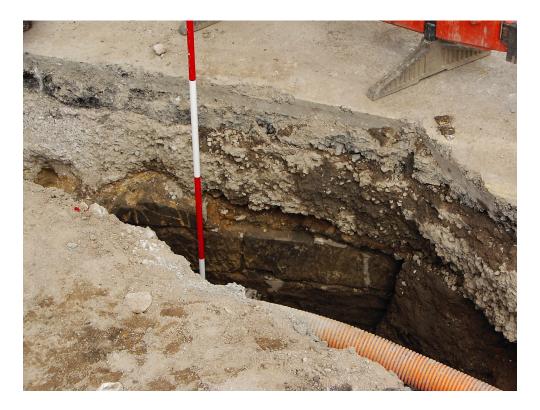
Plate 4. View of the buried wall, showing its southern face.

- 5.1.1 Area A, on the south-east corner of Ponteland Bridge revealed a structure identified by Assistant County Archaeologist Karen Derham as a medieval wall. This feature seems to indicate the well preserved presence of an early bridge footing.
- 5.1.2 The watching brief in designated areas B and C encountered no features of an archaeological nature within the confines of the trenches cut to expose the water main. However, as these trenches did not expose stratigraphy outside present service cuts, the possibility of archaeological potential in the area still remains high.

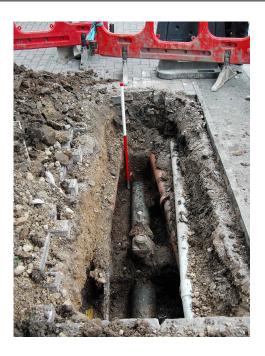
Plate 8. Area B. Trench 5, looking west.

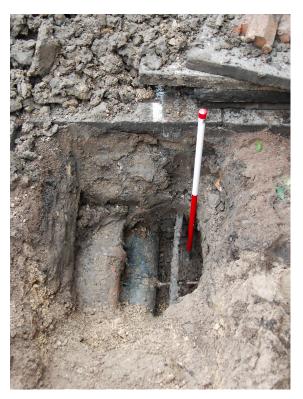
Plate 9. Area B. Trench 7, looking west.

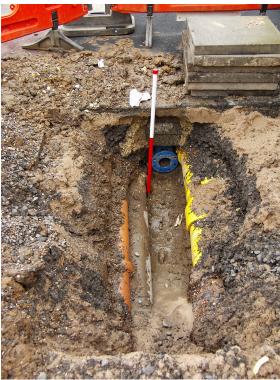
Plate 10. Area B. Trench 8, looking east.
