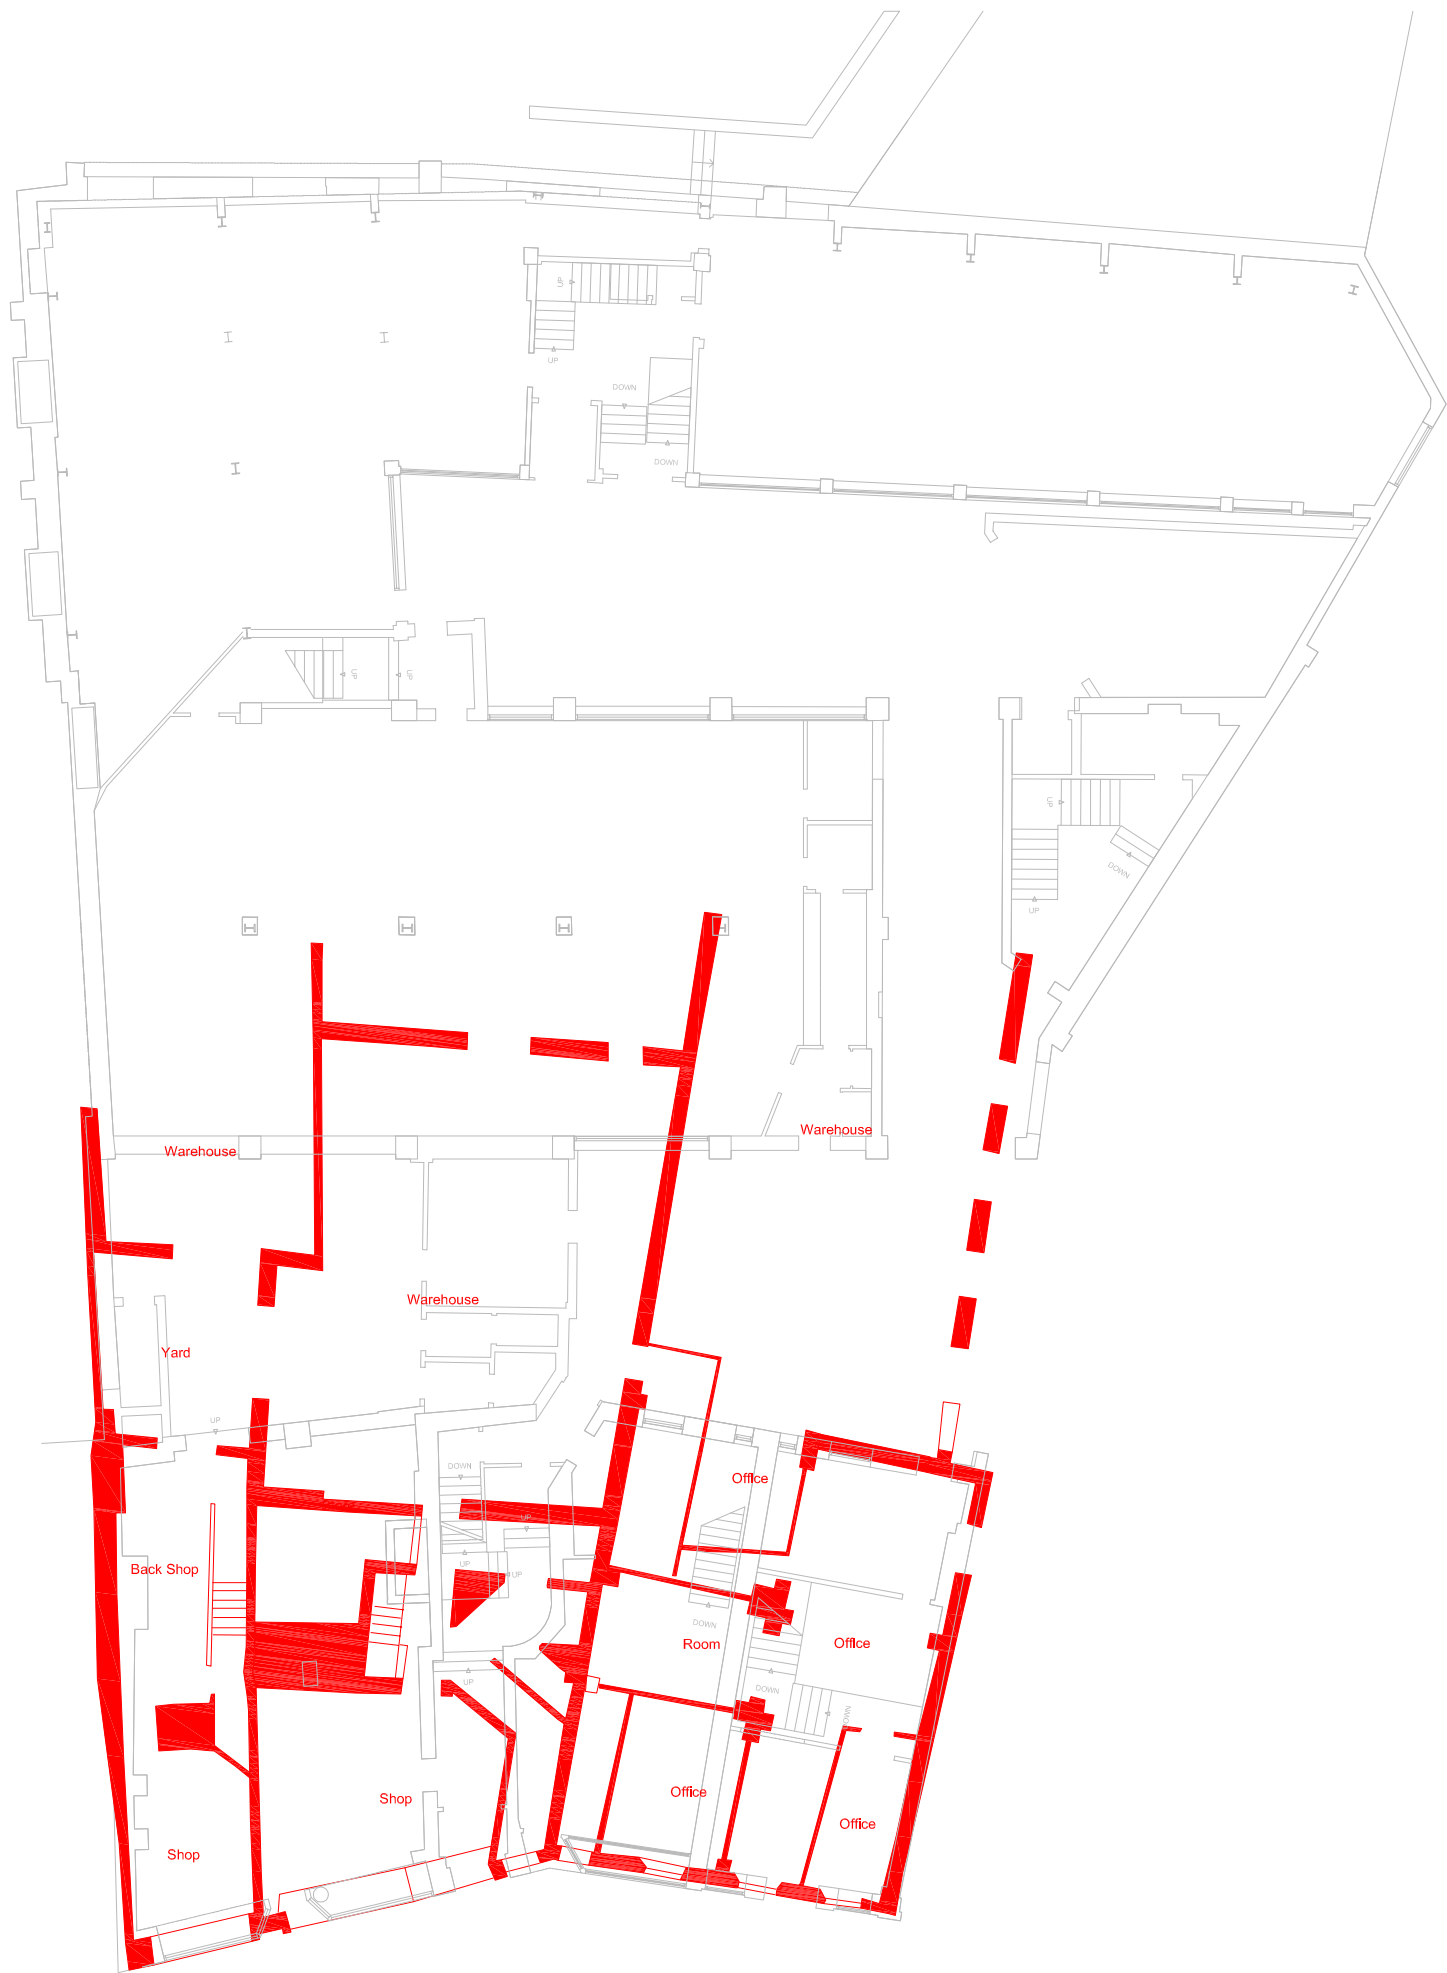
Figure 11: Phase I: Ward's nineteenth century premises (Ground Floor) prior to conversion in 1901. Ground Floor as existing overlain in grey. Distortion and misalignment of the walls is due to the poor quality original 1901 plans used to produce this figure.
