Client Report No. CP 242/06

September 2006

ARCHAEOLOGICAL WATCHING BRIEF AT HALTON EAST FARM, NORTHUMBERLAND

**ALSTON MURPHY
ASSOCIATES**

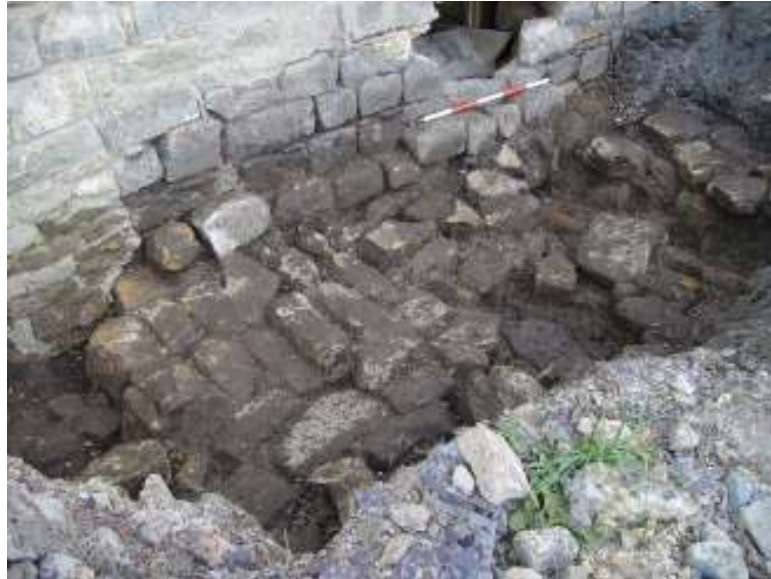
5.5.1 Excavation in Area B was for a walkway on the north side of Unit 2. An area measuring 6m by 2m was excavated to a depth of 0.6m blg. The excavation revealed a stone surface [224], which was cleaned and recorded before work continued. The excavation was subsequently extended to an area measuring 3m wide and 0.8m deep revealing a second sandstone surface in part of the trench. A section through these features is shown in Figure 5.

5.5.2 The lower of the two surfaces [233] was located on the north side of the trench and was made of rough sandstone blocks. This was located at a depth of 0.8m blg and was only partly uncovered by the excavation. Above this surface was a 0.5m-deep layer of brown clayey silt [232], in which was embedded a second sandstone surface [224], being 0.3m thick. This surface was 0.6m below ground level. These deposits were cut by a 0.5m-wide pipe trench [F226], containing a ceramic drainpipe [228] and rubble backfill [227]. On the south side of the excavated area, the sandstone surface was covered by a 0.4m-wide dumped deposit of burnt material, probably from a bonfire. This was overlain by a 0.4m-deep layer of made-ground, containing a mixture of brick and sandstone building rubble [225]. This layer contained a variety of finds including roof tile, glass, pottery, iron objects and animal bone (see Section 6 below), all of which could be dated to the post-medieval period or later. This layer also sealed the foundation trench [F229] for Unit 2, which was filled by brown clay [230] and the foundation stones of the building [F221].

Plate 1: Stone surface [224] in Area B, looking southwest

- 5.9.4 The stone surface [224] in Area B also appears to be post-medieval and is cut by a post-medieval drain. The lower surface was only partially excavated and did not provide any dating evidence, however it is also likely to be post-medieval. The stonewall in Area C is earlier than, the present buildings may be post-medieval or medieval in date.

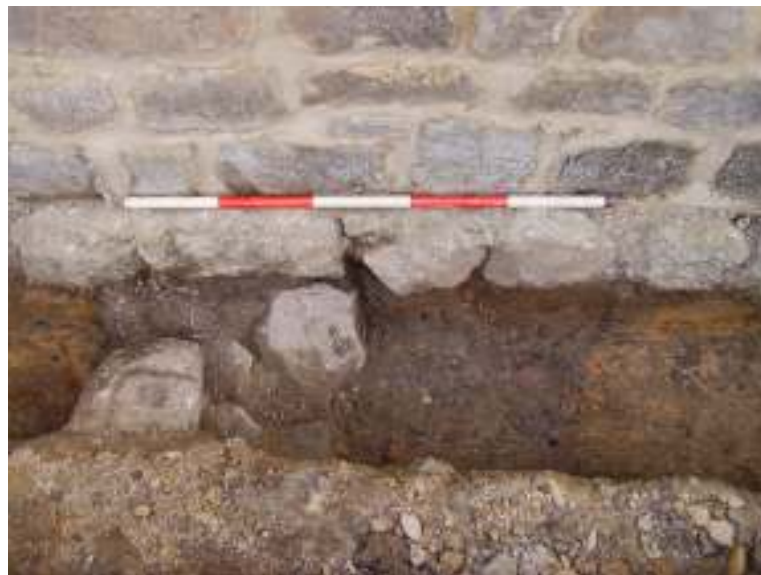
- 5.6.1 Excavation was undertaken on the west and north sides of Unit 3 to a maximum depth of 0.6m. Natural clay [217] was revealed at the centre of the trench at a depth of 0.3m. Cutting this was the foundation trench [F219] for a wall [F218], which was aligned north-south. Above the wall was a 0.3m-deep deposit of brown clay [220], on top of which were the foundation stones of the building [F221]. At the west end of the excavation was a layer of re-deposited topsoil [216], above which was modern made-ground [222]. A modern sandstone wall [F223] was located to the north of Area C.

Plate 2: Wall running beneath Unit 3 in Area C, looking south

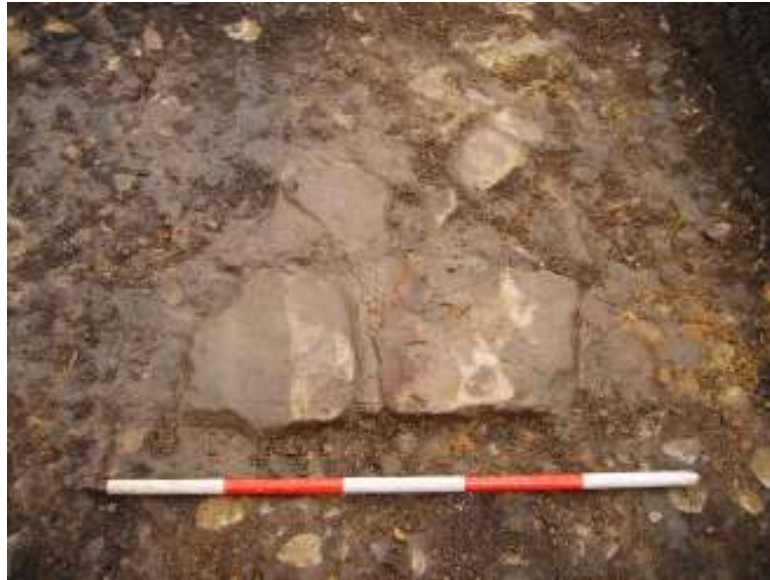
5.7.1 South of the garage was a layer of modern made ground [210], covered by road chippings [209]. This varied in depth between 0.35m and 0.05m, and was removed by machine to reveal two areas of stone wall; Area D and Area E. A 1m-long section of wall [F211] was detected in Area E, with three pieces of stone making up the north face. This was located at a depth of 195.3m OD. Area E contained a section of wall [F206] measuring 2.5m in length, consisting of undressed sandstone with a wall face on the north side. The wall was located at depths of between 195.4m and 195.5m OD. No finds were recovered from these areas.

Plate 3: Section of wall [F211] in Area D, looking south

- 5.9.1 The sections of wall revealed in Area D and Area E, are on the same alignment as the projected course of Hadrian's Wall, and the sections of wall discovered in the evaluation trenches: Trench 1 and Trench 5a. This evidence suggests that these remains may be parts of Hadrian's Wall, and that the Wall survives to a greater height in this area than the evidence from the evaluation suggested.

- 5.5 Given the apparent proximity of Hadrian's Wall to the present ground surface, it is recommended that any further ground disturbance at the site is subject to archaeological monitoring. The sections of wall revealed in Area D and Area E should be preserved *in situ*. It is recommended that the yard surface in Area F be preserved within the development, as this will help to protect the remains of Hadrian's Wall.

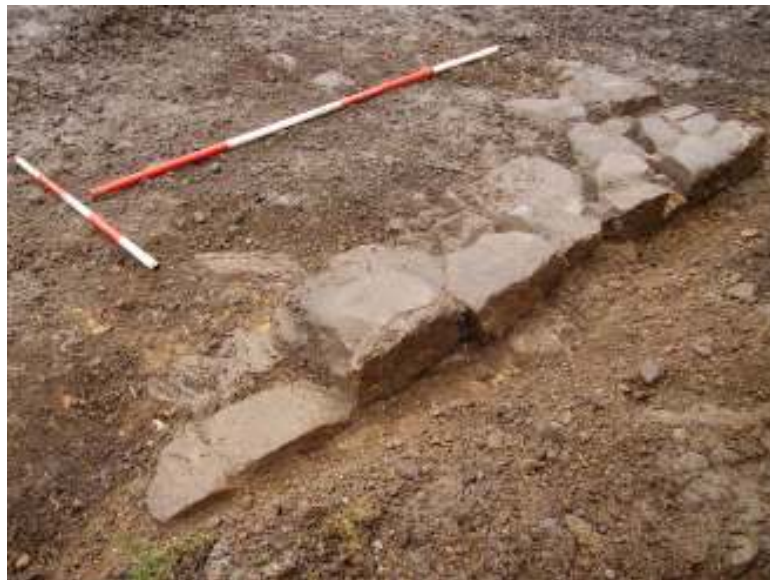
Plate 4: Wall section [F206] in Area E, looking southwest

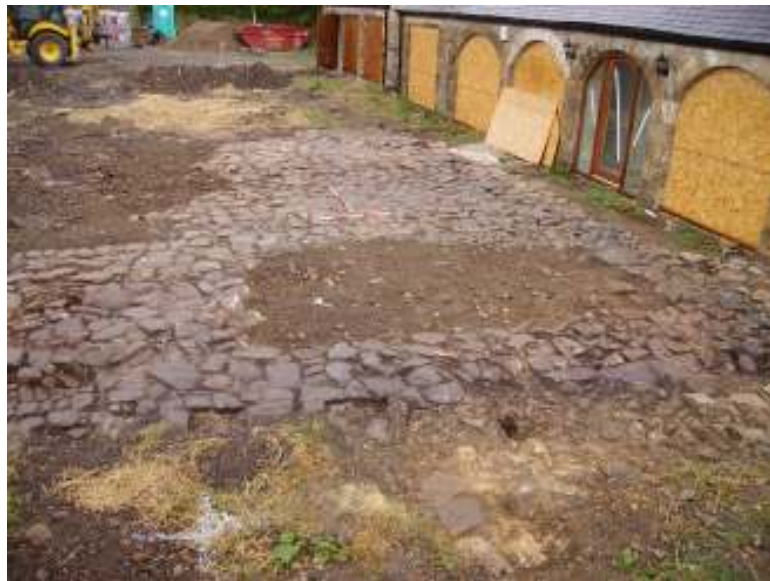
- 5.8.1 A layer of stone hardcore [200] covered the north side of the farmyard, to the south of Unit 1. Immediately beneath this, on the south side of Unit 1 was a sandstone surface [201]. Following machine excavation, this surface was cleaned and recorded by hand. The northern part of this surface was drawn and is reproduced in Figure 7. The surface continued to the south of this area, but only a representative sample of the surface was drawn. This surface was cut through by Trench 5a at the eastern end.

- 5.8.2 The surface [201] was constructed from course sandstone pieces and was bedded in orange-brown clayey silt [215]. The surface was bounded on the south side by a sandstone wall [F204] and to the east by a similar wall [F202]. A later wall [F203] overlay this and was aligned approximately north-south, being 0.65m wide.

Plate 5: Stone yard surface [201] in Area F from the east

- 5.9.3 The majority of the features detected were post-medieval in date, including the stone surface in Area F. The location of this surface corresponds to an enclosed yard shown on the 1864 1st edition Ordnance Survey map.

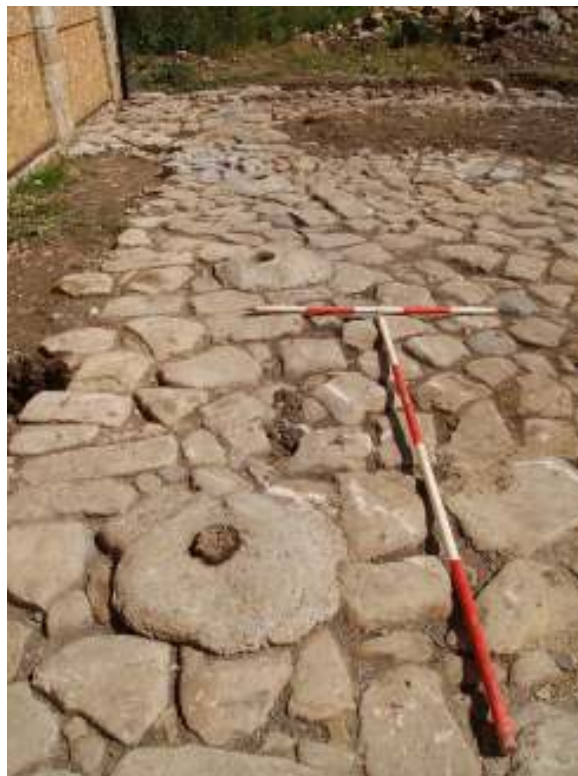
- 5.8.3 Two rows of rounded concrete bases [F213] were set into the yard surface at intervals, aligned east-west. These contained holes that would have supported uprights for a building. Two square concrete bases [F214] were located on the south side of Area F with the same alignment, and were probably part of the same structure.

Plate 6: Bases of a modern barn [F213] overlying the post-medieval yard surface, looking east

- 5.9.5 A date of 1945 was inscribed into one of the concrete bases, which were inserted into the yard surface in Area F in order to support a roof. This was presumably to convert the yard into a covered building, probably a barn. The wall to the east of this area [F203] was a later boundary wall, which had stood until recently
