NORTH PENNINES ARCHAEOLOGY LTD

Client Report No. CP/240/05

**REPORT ON AN
ARCHAEOLOGICAL
BUILDING RECORDING
PROJECT AT A BARN ON
LAND ADJACENT TO
SYCAMORE HOUSE,
BLENCARN,
PENRITH,
CUMBRIA**

04 October 2005

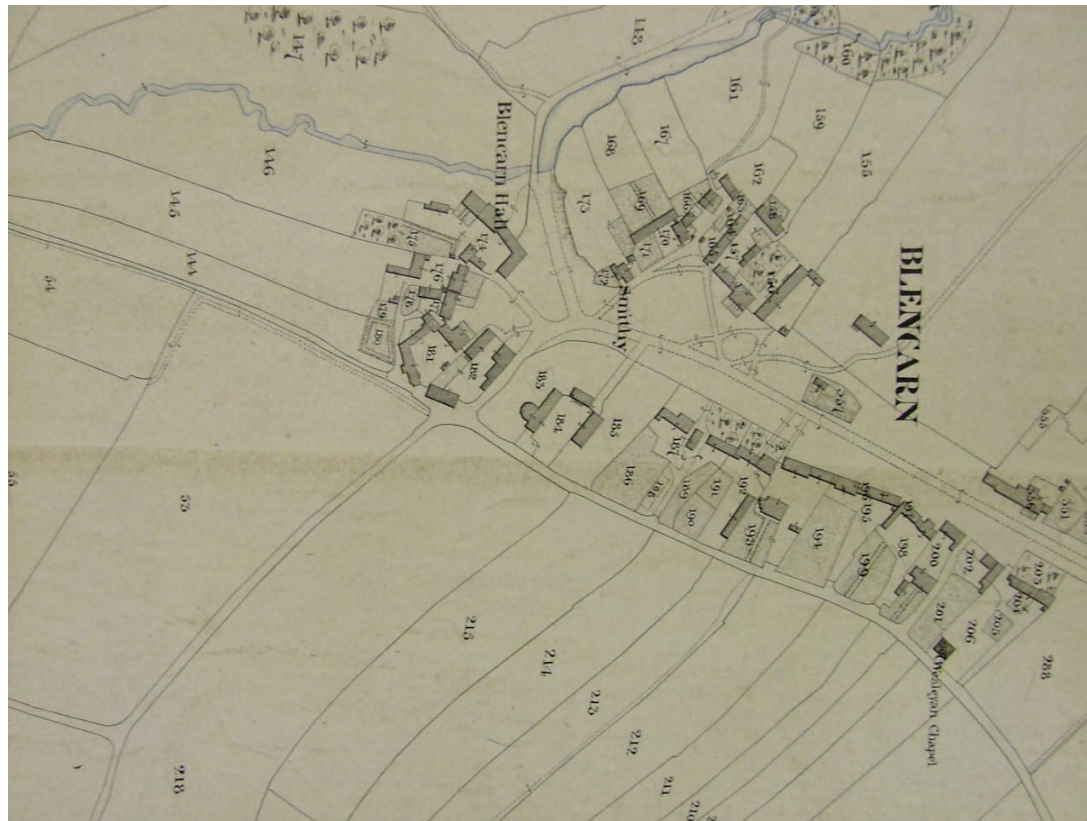
Figure 4 – Tithe Award Map of 1850

- 2.3 The barn may be shown on the Hodkinson and Donald map of 1774 (surveyed 1770) (figure3), it is however, clearly shown on the Tithe Award map for the Township of Culgaith, Skirwith and Blencarn of 1850², along with a gin-case on the north-west facing elevation. Other buildings on the site are also shown (figure 4).

- 6.6 The barn and cart shed should not be seen in isolation, but rather as part of an organised farmstead. The buildings that occupied the site of the threshing barn at the dates of the Tithe Award map (figure 4), and the First and Second Edition maps (figures 5 & 6) no longer exist, and it is difficult to know what function these buildings served. Mr Blackett of Cumbrian Homes has mentioned a 'Meeting Hall' on the site, from which some of the masonry was retained for the development work. There was, however, no meeting house observed on any of the Ordnance Survey maps, so the original function of this building may have been agricultural.

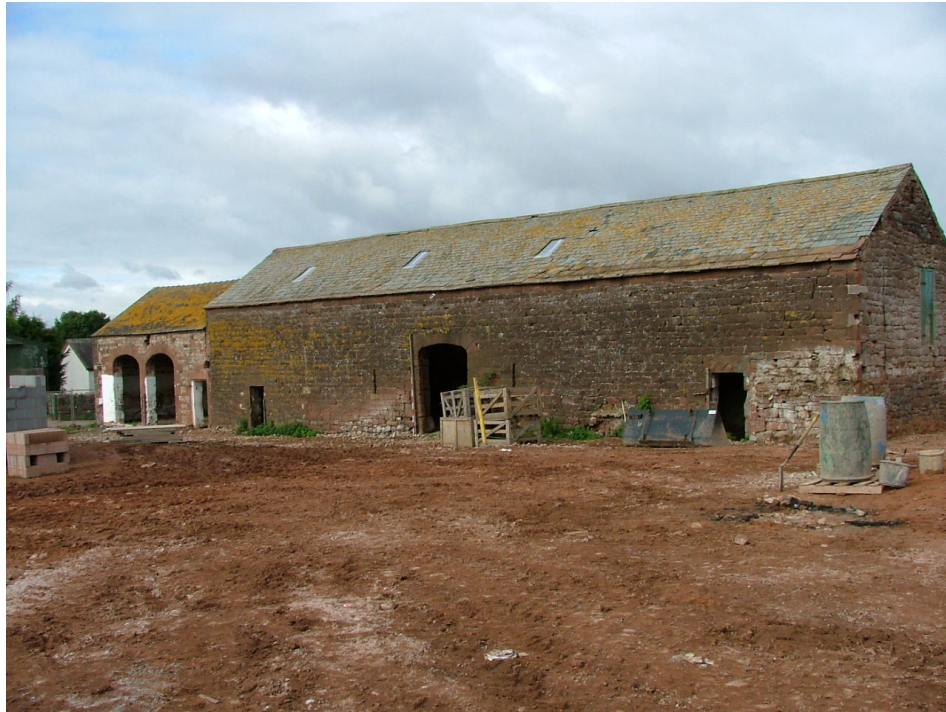
Plate 1 - South facing elevation of barn and cart shed

5.1 The building that is the subject of the present survey consists of two separate structures; a threshing barn with byres and haylofts, and a cart shed which is attached to the western end of the barn (plate 1 and figure 7).

5.2.3 On the southern elevation there are two standard doorways, two ventilation slits and a central large double doorway (plate 1); there are corresponding doorways and ventilation slits on the northern elevation (plate 2). The eastern gable end has a pitching doorway at first floor level, used for transferring hay or straw to the loft, and a ventilation slit to the left (plate 3 and figure 8). The western gable end of the barn, which is mainly obscured by the cart shed (plate 4), has two ventilation slits at first floor level. There are owl holes in the apex of both gable ends of the barn; these would have allowed access for owls to hunt vermin.

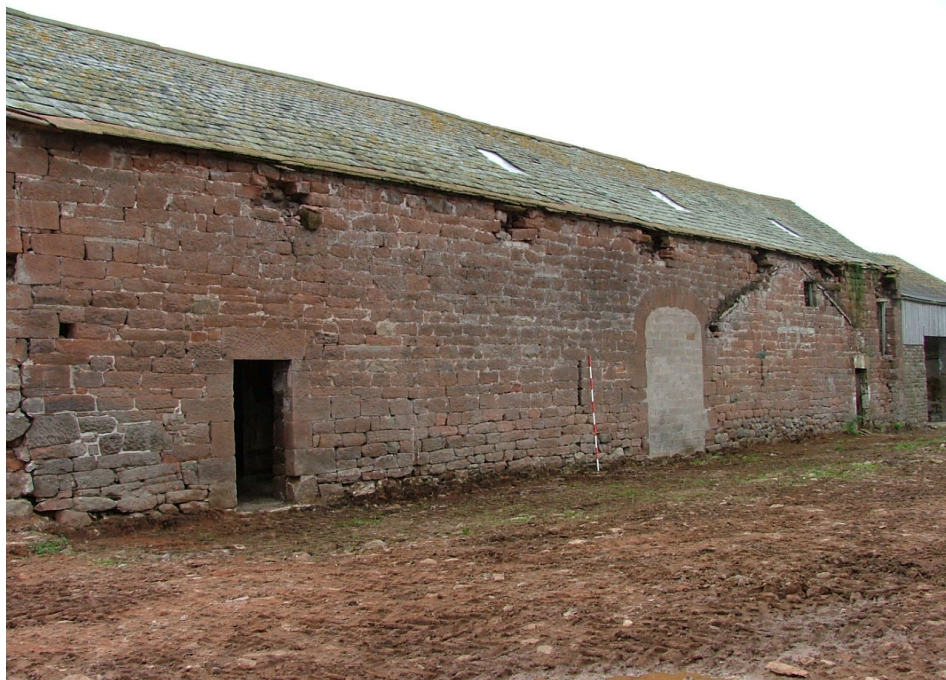
Plate 2 - North elevation of threshing barn

- 5.2.5 Just below eaves level, along the length of the northern elevation of the barn are several large holes (visible on plate 2). These presumably relate to a modern shed or 'lean-to', for which steel girders were bonded into the masonry of the barn, but which have subsequently been removed.

- 5.2.7 The large doorway on the northern elevation has been filled in with concrete blocks (plate 2). Carved into the cement above the uppermost layer of these blocks are the initials and date: -

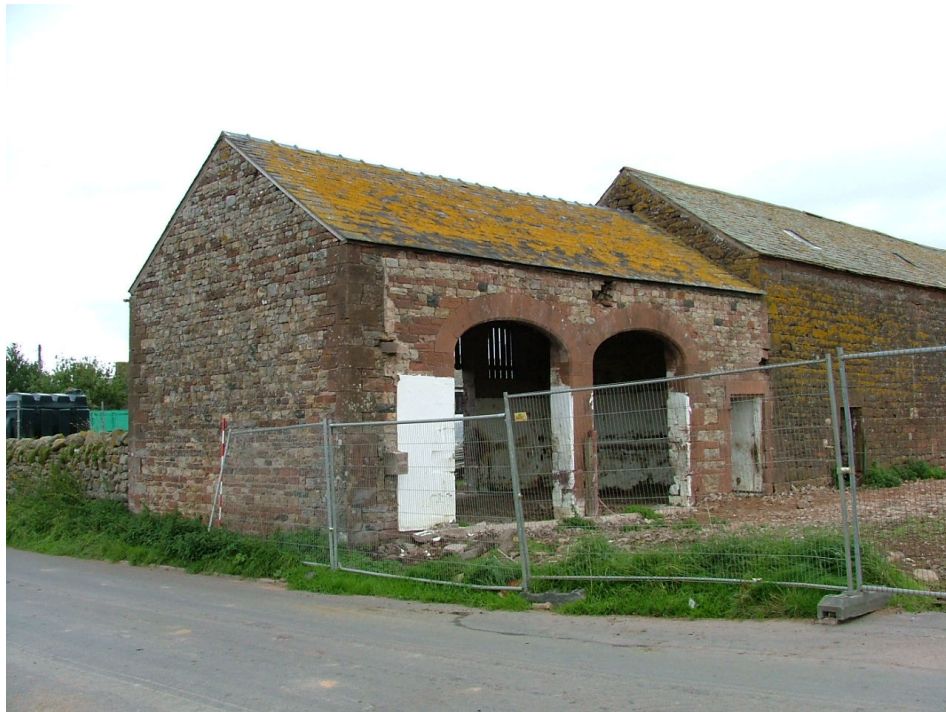
Plate 4 – Western end of barn and gable end of the cart shed

- 5.3.2 The cart shed is located at the western end of the barn (plate 4 and figure 7), and a clear construction break shows that it was built after the barn. It is constructed of coursed red and yellow sandstone masonry, with some granite. The corner quoins are of alternating blocks of red sandstone masonry. The northern elevation has at some point been rebuilt, as it now consists of a block wall with stone facing at the lower level and 'Yorkshire Boarding' of vertical timbers at the upper level (plate 8) with a large doorway inserted. In the southern elevation are two large arched doorways with nicely dressed red sandstone masonry blocks making up the door jambs and voussoirs. A further doorway to the right has alternating blocks making up the jambs and a single

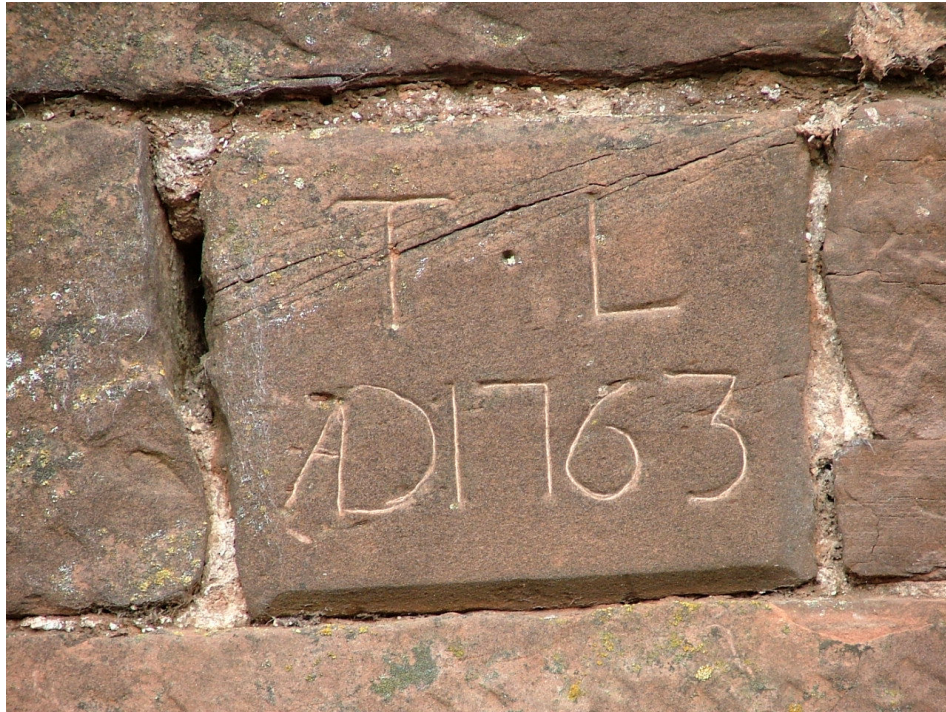
Plate 5 – Inscription above doorway, south elevation of barn

5.2.4 Above one of the doorways on the southern elevation is a simple, and slightly crude inscription, which may not necessarily be original (plate 5): -

T L

AD 1763

- 6.2 The date stone of 1763 above the eastern byre door on the southern elevation fits in with this general period of rebuilding, however the simple and unweathered appearance of the inscription does hint at it being a later insertion.

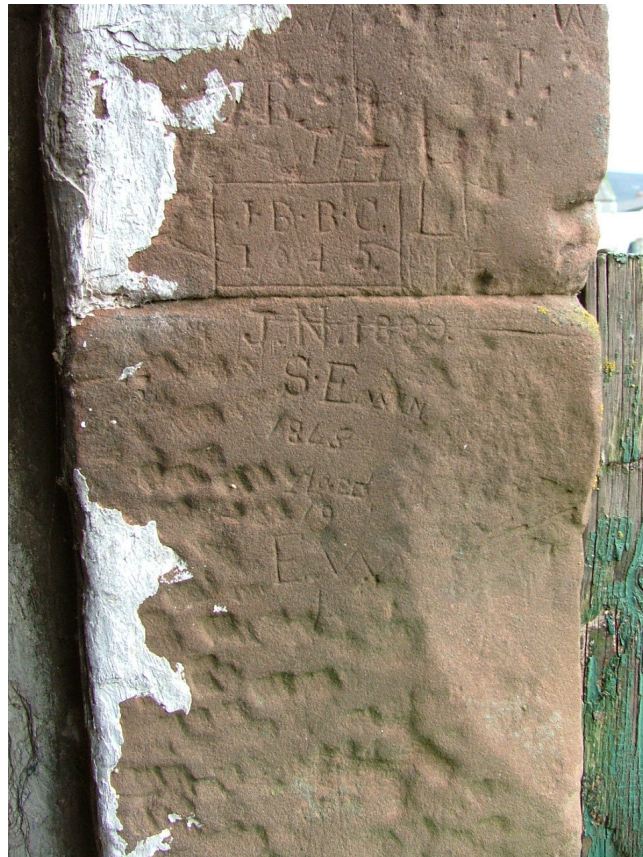
Plate 6 – Initials and dates carved into the door jamb of the western byre

Carved into the jamb of the western byre doorway are several initials and dates (plate 6), these include: -

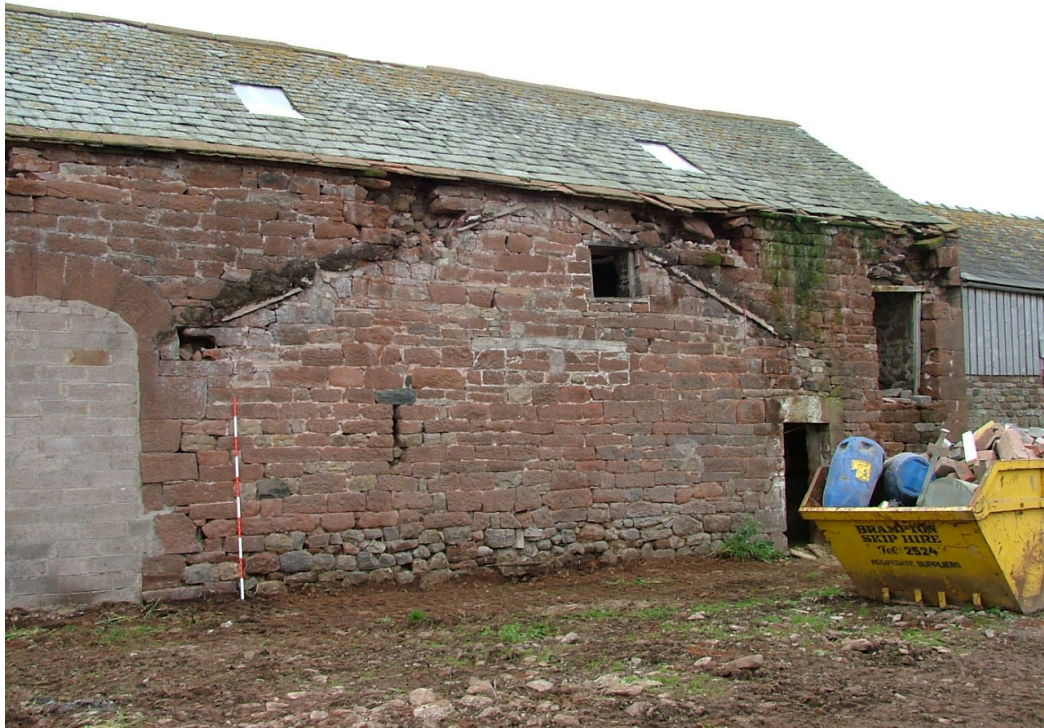
Plate 7 – Scar of the roof line of a gin-case

- 5.2.6 Also on this elevation is the scar for the roof line of the gin-case, or horse-engine house (plate 7 and figure 7), which is shown on the Tithe Award map of c.1850 (figure 4) and subsequent Ordnance Survey maps (figures 1, 5 and 6). The gin-case would have been used to house the horse-engine which powered a threshing machine located within the barn. A hole through the wall at a height of c.2.30 metres from ground level would have accommodated the drive shaft that transmitted the power from the horse wheel to the thresher (figure 7), either side of the drive shaft hole there appears to be two blocked-up holes, just below the timber lintel. These may have been the holes for the two horizontal timber beams either side of the drive shaft (figure 9). The gin-case itself would have been of masonry construction and from cartographic evidence it would appear it would have been apsidal in form (figure 9). The maximum diameter of the horse-engine inside would have been c.7.50 metres (allowing for wall thickness and based on the 1:2500 OS map), a diameter that would fit in with Brunskill's range of 24 feet to 26 feet (7.3m to 7.9m), as being the most common³. Gin-cases were prevalent in the fertile areas of Cumbria; the Eden Valley and West Cumberland, but sadly they are a structure that is disappearing from the landscape. The gin-case at Blencarn appears to have been demolished within the last thirty years. A similar gin-case existed at Sykeside Farm, Soulby, Kirkby Stephen, a farm of comparable acreage to that at Blencarn Hall Farm (i.e. around 330 acres in the mid-nineteenth century), but which was demolished c.1993 without being recorded⁴. The gin-case was constructed after the barn, as shown by the structure obstructing a first floor window and ground floor doorway.

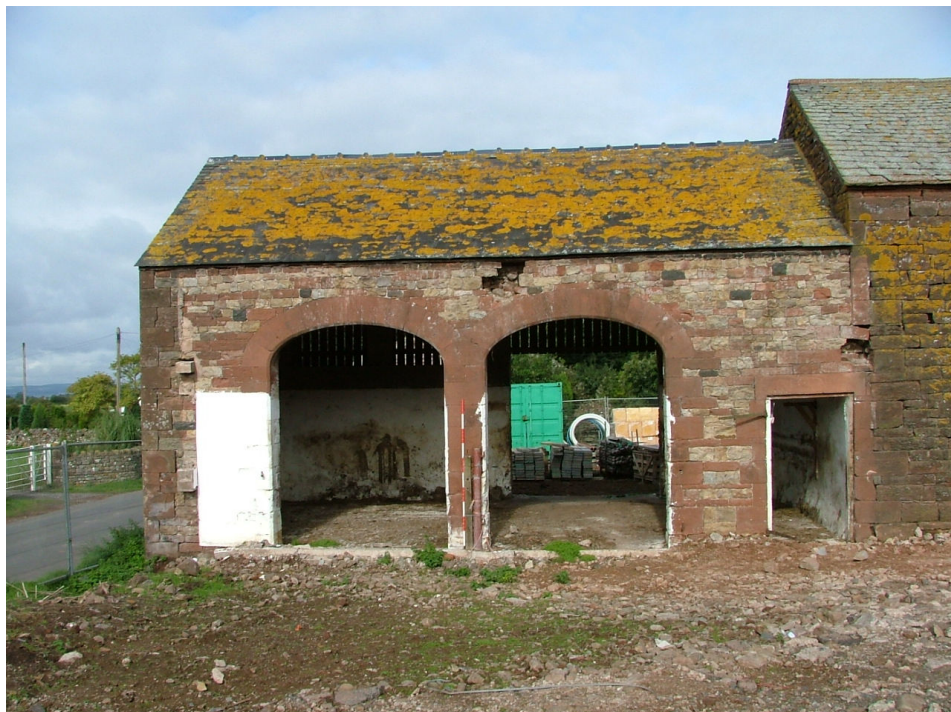
Plate 9 – Southern elevation of the cart shed

piece of sandstone for the lintel (plate 9). This doorway is the only one that has its jambs rebated externally; consequently the doors would have opened outwards. A single hinge from the door survives at the base of the doorway. It is possible that this was a stable door.

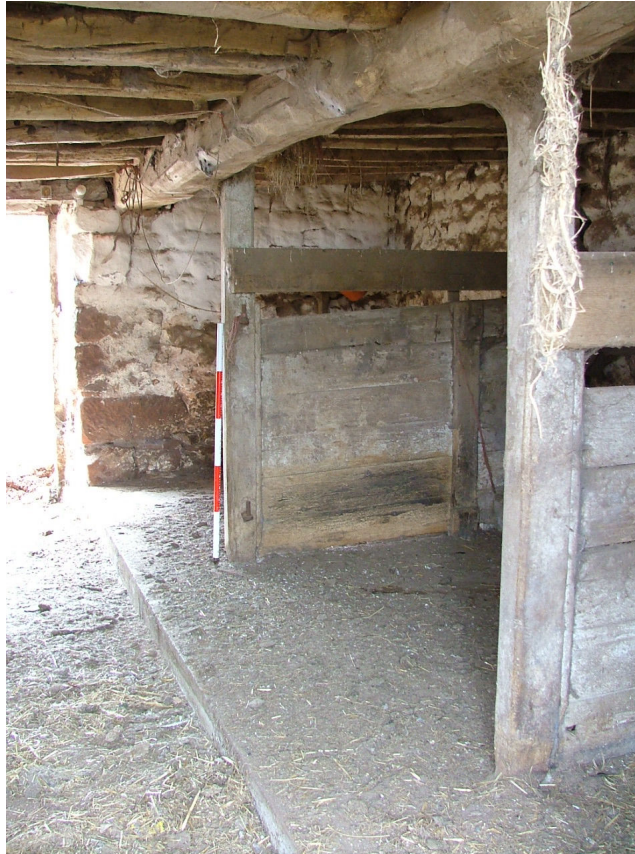
Plate 10 – Interior of western byre

5.4.2 The western byre has a concrete floor with a central manure passage. The stall divisions, or 'scale boards'⁵, are of timber (plate 10), and would originally have provided accommodation for 11 cows at one time, one of the stalls only having a single ceramic feeding trough. The walls are whitewashed, a common wall covering in Cumbria which acted as a wall coating and disinfectant. The height of the ceiling from the base of the manure channel is c.2.12 metres. The two ventilation slits shown in the western wall of this byre on the architects plan (figure 10) are actually at first floor level. There appears to have been at one time a doorway through the partition wall that separates this byre from the central barn area. A clear construction break is visible in southern end of this wall (plate 11). This opening of one metre in width has subsequently been blocked-up.

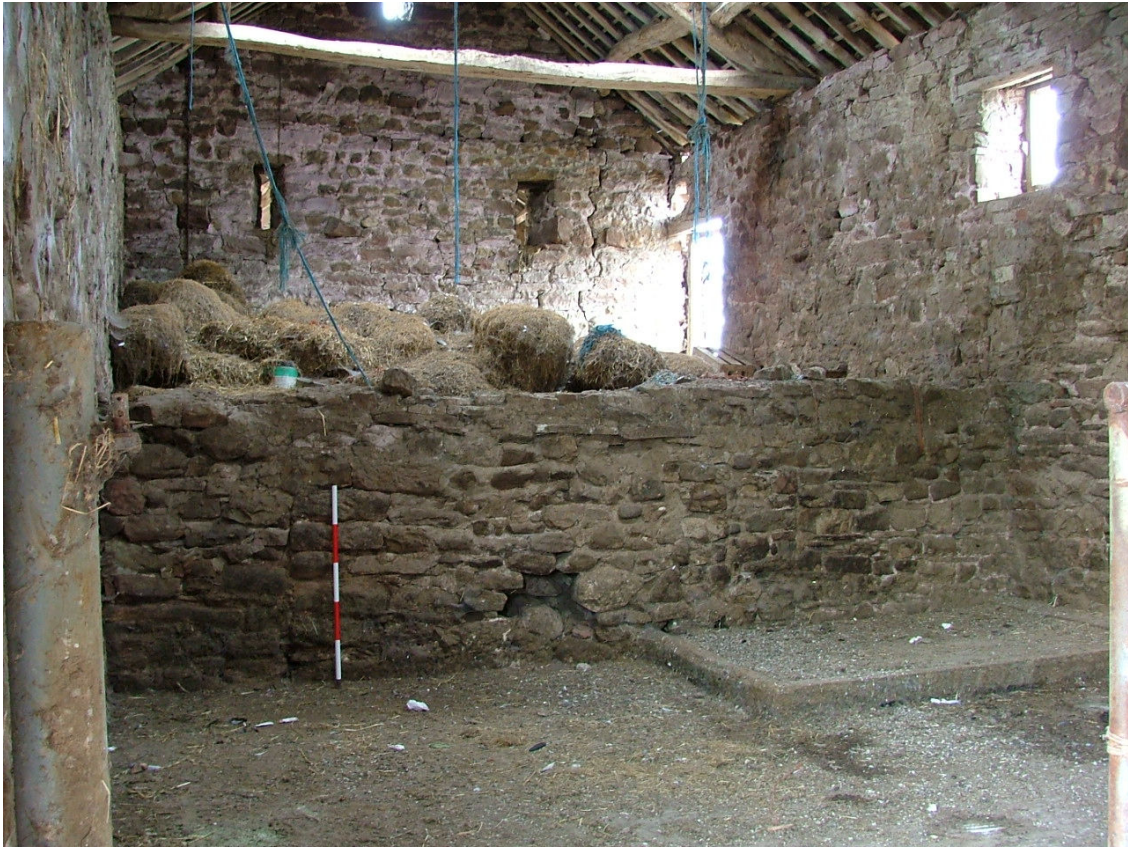
Plate 12 – View of the hayloft above the western byre as seen from the threshing area

5.4.4 The walls that separate the byres from the central part of the barn do not extend the full height; this has created haylofts above both of the byres which could be easily accessed from the central barn area or via the pitching doors at first floor level (plate 12). Haylofts above byres or cowhouses are common as they provided insulation for the cows through the winter months.

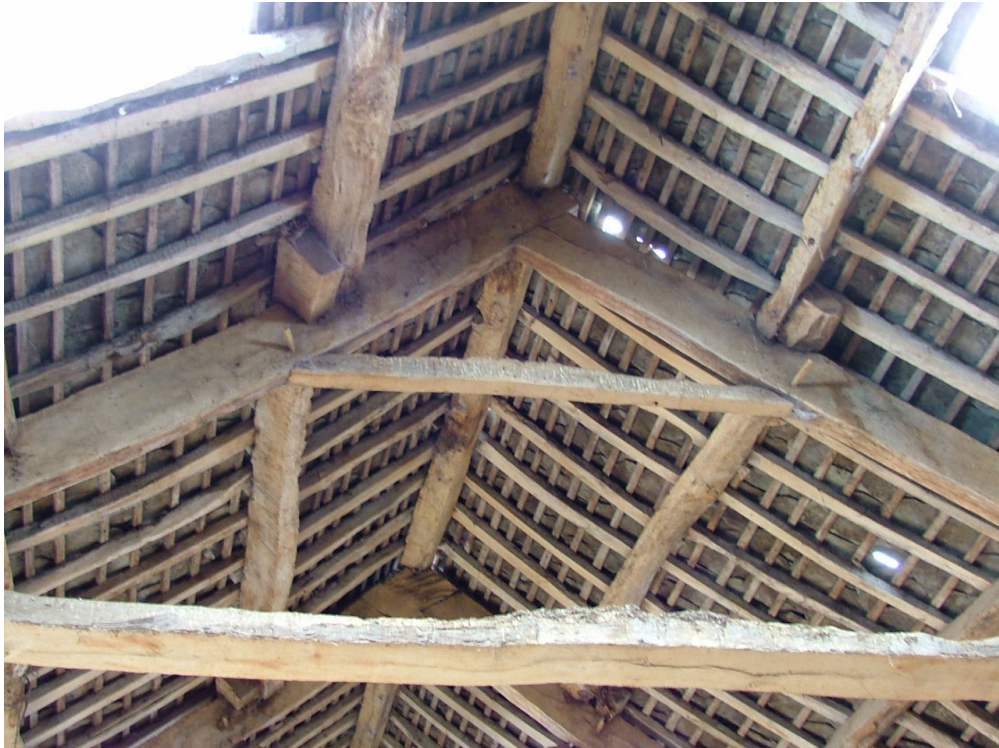
Plate 13 – Roof detail of barn

- 5.4.6 From the central area of the barn it was possible to note that the length of the barn, including that over the haylofts, was nine bays, with the roof trusses being of principal rafters and tie beams with collars, and trenched through purlins (plate 13). The collars and tie beams are fixed to the rafters with wooden pegs. Six of the roof trusses, as well as the purlins and ridge beam, appear to have been hand cut, with bark still attached to several pieces of timber. The two trusses above the eastern hayloft are machine sawn. Carpenter's or assembly marks were visible on several of the trusses, with the following numbers being observed (in numerical order): -

II, III, IIII, V

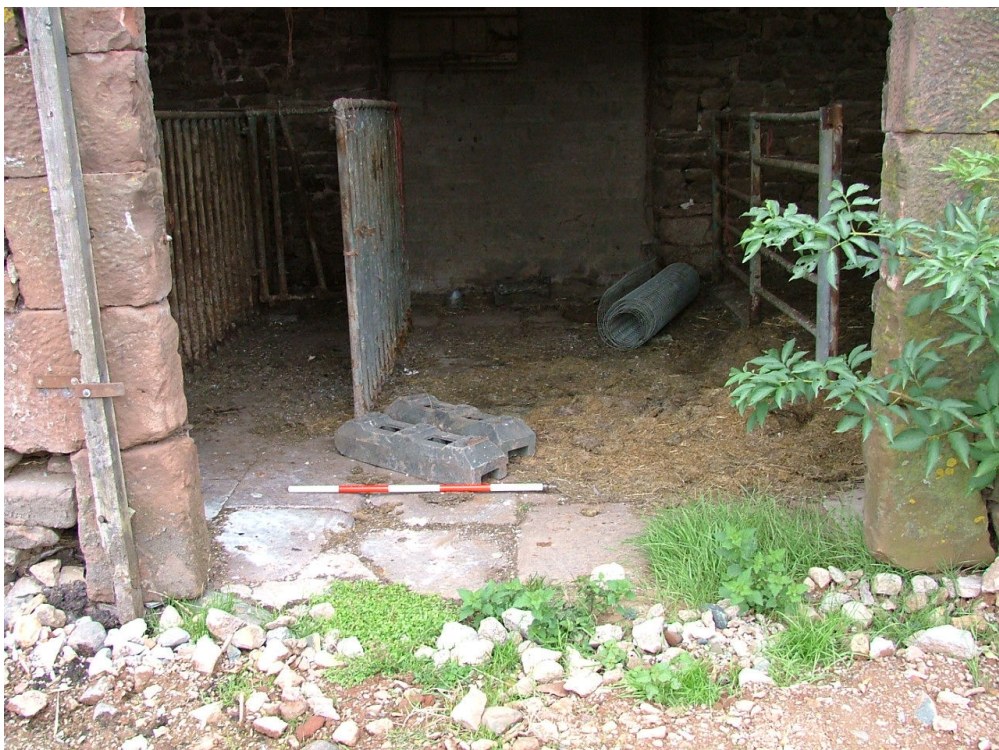
Plate 14 – Sandstone floor in central axis of barn

- 5.4.7 The interior walls of the barn were noted to be of inferior quality to the external walls, with the stonework consisting of more rubble masonry than the squared and dressed masonry of the external walls. As the interior walls were unlikely to be seen generally, there may have been no reason to use the more expensive dressed stonework, which may have been as much for aesthetic purposes as practical.
- 5.4.8 The floor of the central area of the barn is of two materials. In line with the large double doorways the floor is constructed of sandstone flags, which may be the original hand-flail threshing floor (plate 14). To either side of this central axis, the floor is of concrete.

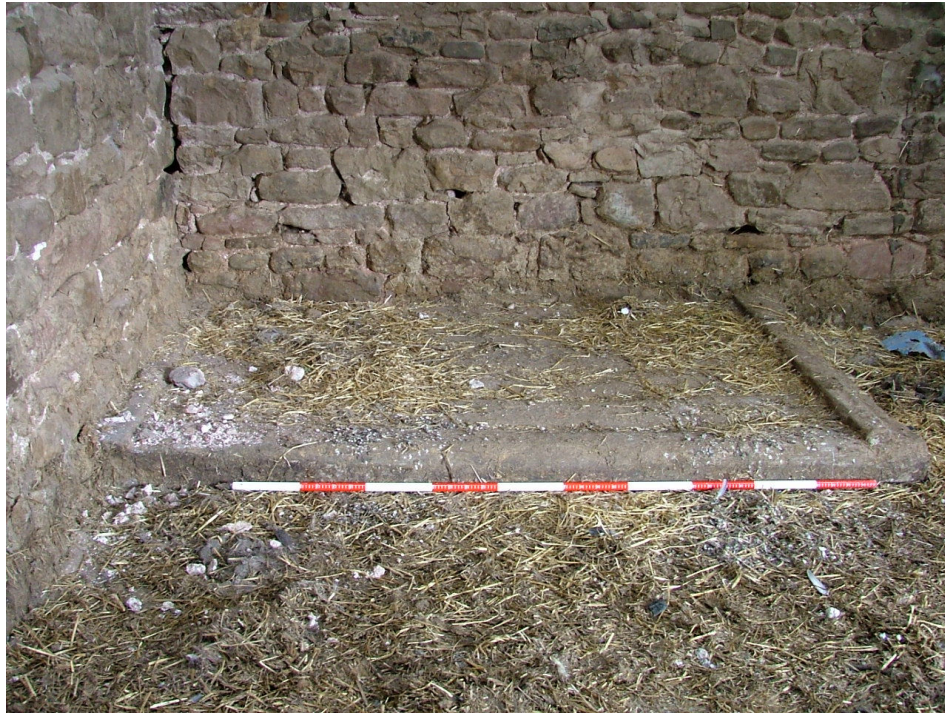
Plate 15 – One of the two timber platforms in the barn

- 5.4.9 In the north-west and south-east corners of the central section of the barn, there are timber platforms measuring *c.* 1.60 metres by *c.* 2.60 metres and 0.16 metres high (plate 15). They appear to overlay the concrete floor, so they may be a fairly recent insertion. It is possible that they could relate to threshing machinery, however, they do not correspond with the location of the drive shaft from the gin-case, and generally there would only be one threshing machine.

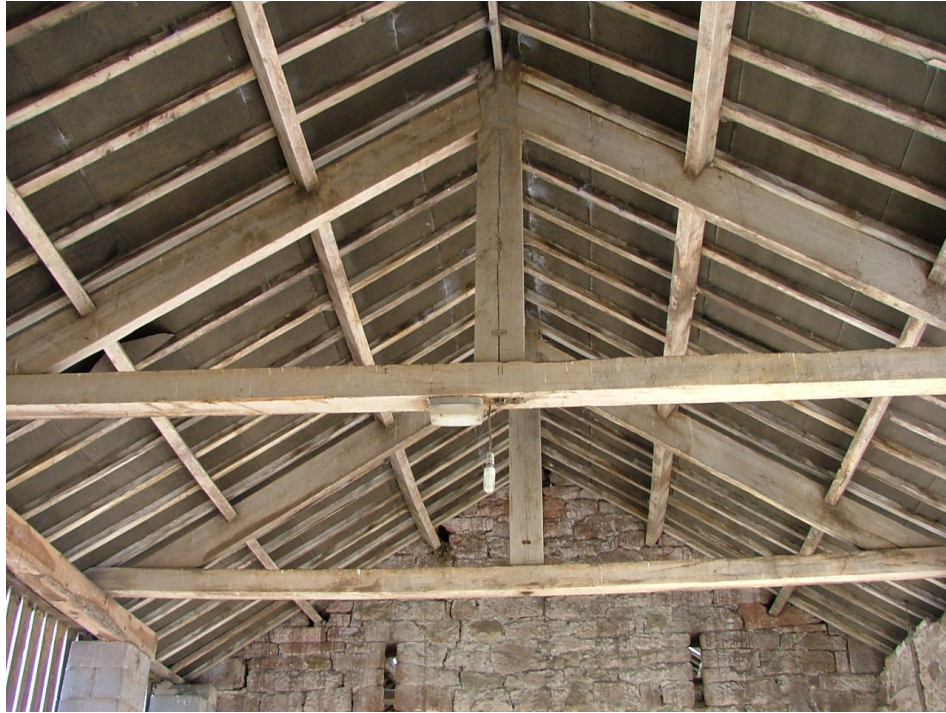
Plate 16 – King post roof trusses, cart shed

- 5.5.1 The interior of the cart shed could be accessed either via the two large double doorways or standard doorway in the southern elevation or the large modern opening in the northern elevation (figure 10).
- 5.5.2 The cart shed is of four bays with the roof trusses being of king post construction of machine-sawn timber (plate 16).

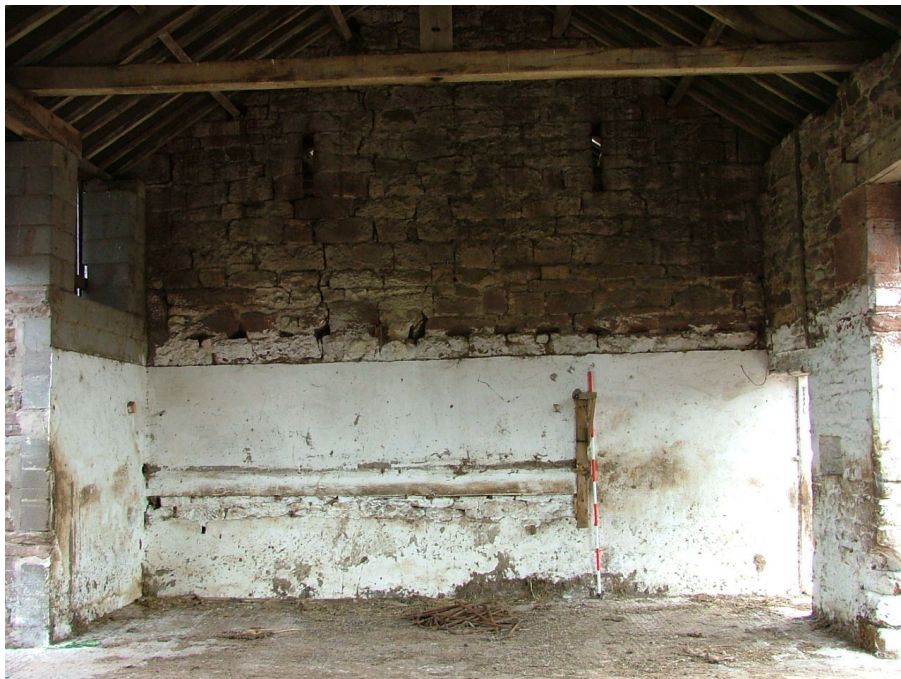
Plate 17 – Remains of manger, eastern wall of cart shed

5.5.3 The western side of the cart shed floor is cobbled, while the eastern side has been concreted over. Although there was no substantial evidence for a partition, the eastern side of the cart shed may have been more recently used as a stable or loose box, as there was the remains of a manger on the eastern wall (plate 17).

- 6.4 The cart shed appears to date between 1865 and 1900, as it is not shown on the First Edition Ordnance Survey of 1865 (figure 5), but it is present on the Second Edition map of 1900 (figure 6). There is some evidence for a small lean-to against the western wall of the threshing barn, which may be shown on the First Edition OS map. Above the manger in the cart shed several holes were observed, which may have once held timbers for a pitched roof (just visible above the line of plaster on plate 17).

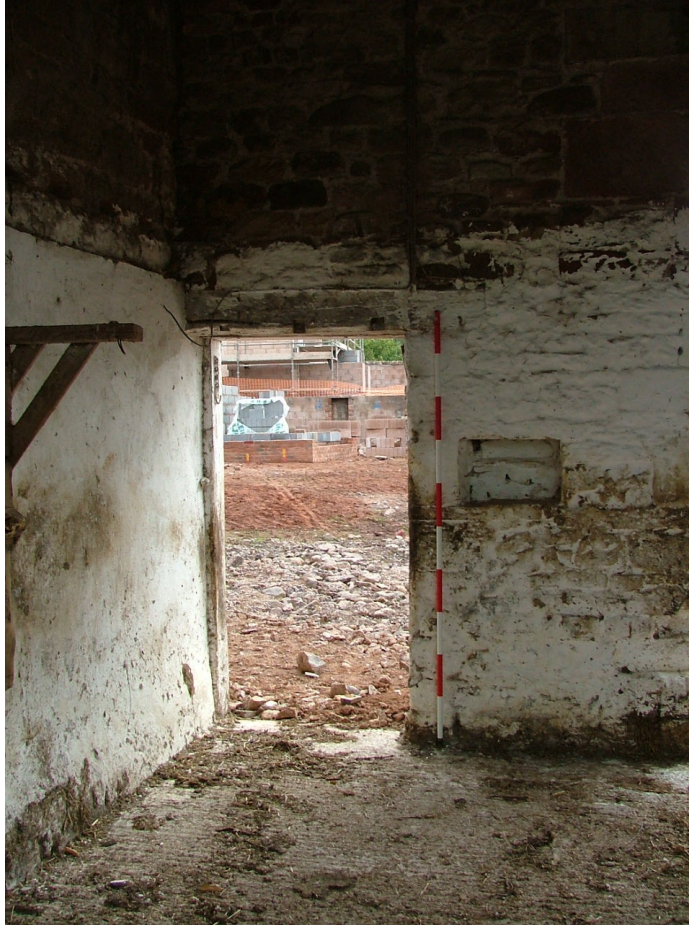
Plate 18 – Doorway and niche, southern wall of cart shed

- 5.5.4 Within the southern wall of the cart shed, and beside the smaller doorway, is a niche that measures *c.*4.7m wide, 0.3 m high and 0.22m deep (plate 18). This may have either been used to house a candle or oil light, or may have contained grooming equipment or medicines for the horses.
