Client Report No. CP/383/06

**REPORT ON AN
ARCHAEOLOGICAL
BUILDING RECORDING
PROJECT AT
MIDTOWN FARM
BLENCARN
CUMBRIA**

**FOR
GRAHAM K NORMAN
(ARCHITECT) LTD**

**NY 63785 31235
Planning Application Ref:
3/06/0476**

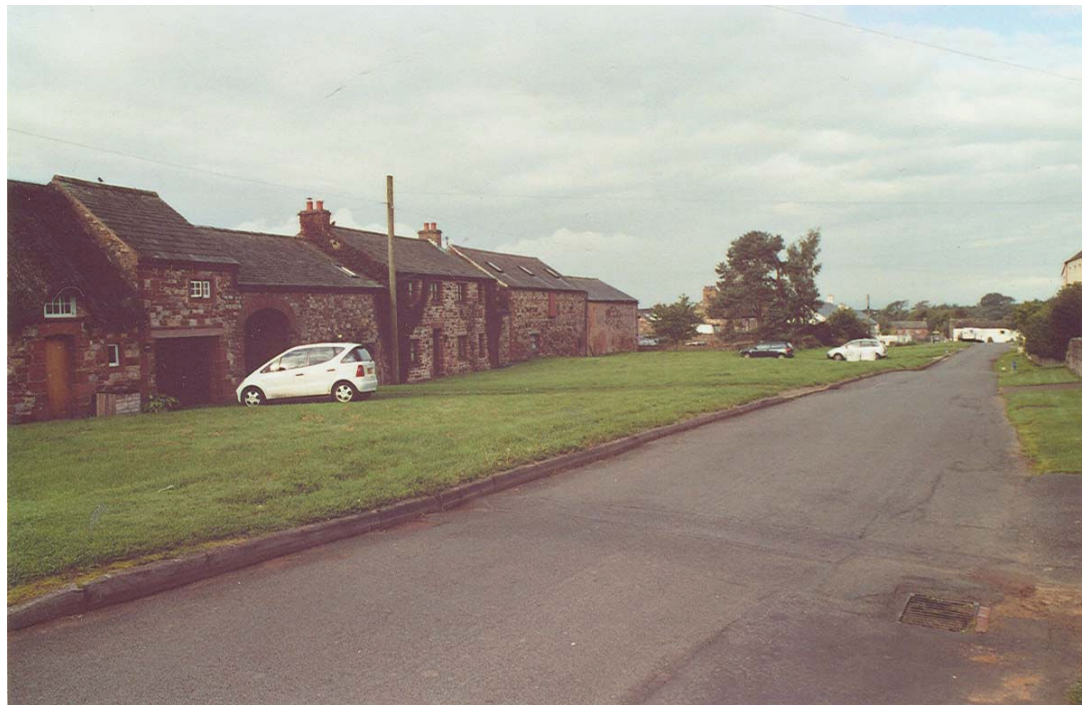
Plate 1 – Blencarn village looking north-west. The buildings that are the subject of the present survey are located in the centre of the photograph at the end of the row of buildings

- 1.2.2 Midtown Farm is located, as its name suggests, in the middle of Blencarn, on the southern side of the village green (Figure 2 and Plate 1). The farm buildings that are the subject of the present survey have their backs to the village green, whilst the house faces towards the Eden Valley. Access to the property is either via the track over the village green to the north, or from the back lane to the south (Figure 2).

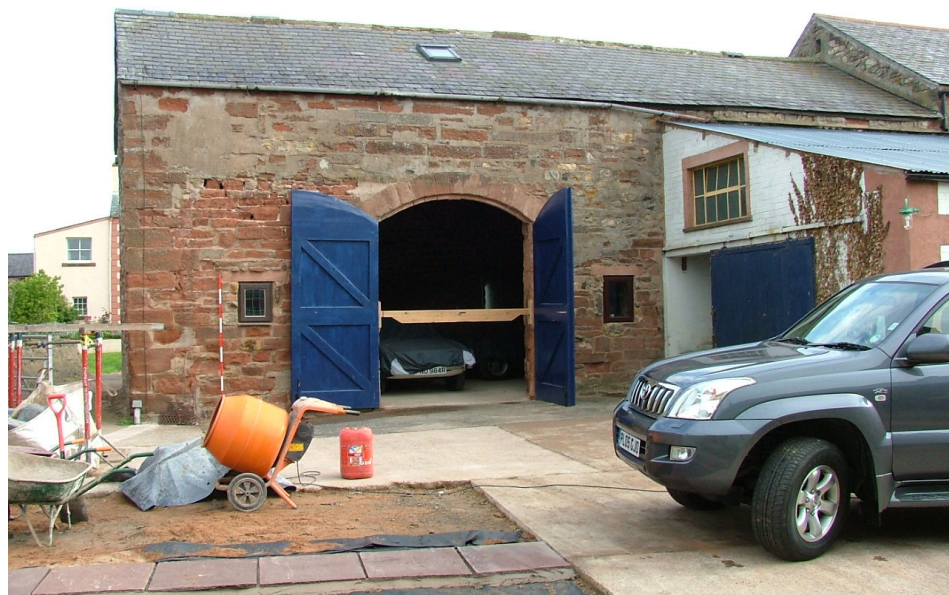
Plate 3 – Southern elevation of Building A

- 5.2.7 The southern elevation of Building A faces the house and farmyard. There is a large double doorway set off-centre, and two modern windows (Plate 3). The large doorway has well-dressed red sandstone voussoirs (13) making up the arched head, and the jambs are constructed of alternating blocks of dressed sandstone. The doorway is rebated externally, therefore the original doors would have opened outwards. This is slightly unusual as at most recently recorded farmsteads the rebates for the large doors have been internal, indicating that the doors opened inwards. Having the large doors opening outwards would have allowed for more space to hand-thresh the corn, or for storage.
- 5.2.8 Most of the southern elevation has been obscured by the addition of Building E (Figure 10); however there is a further standard doorway to the right of the large entrance (Figure 11).

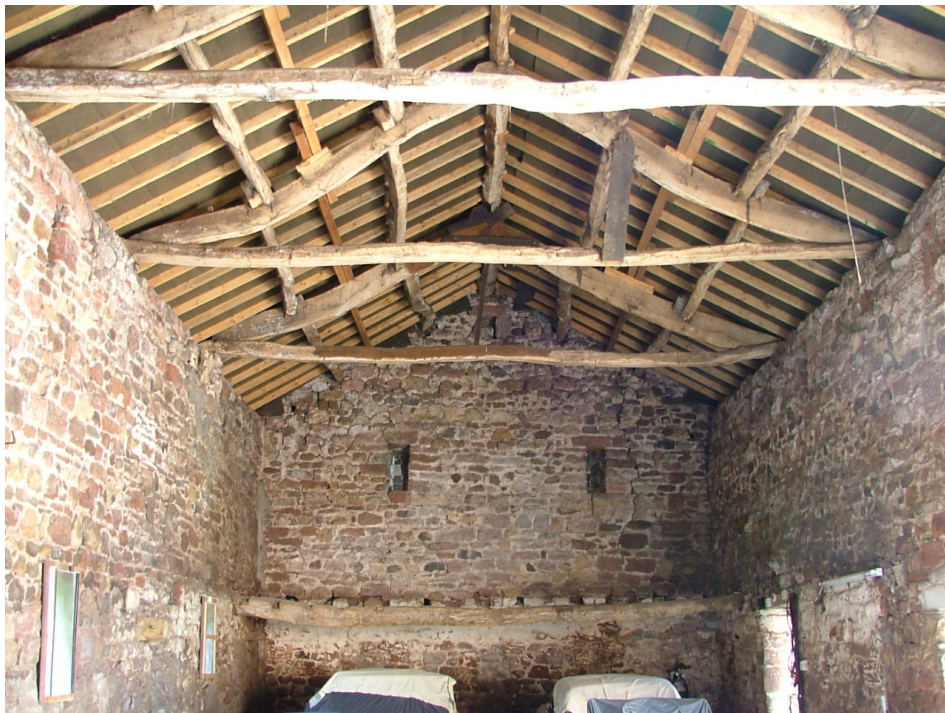
- 5.3.2 The eastern gable end has an owl hole close to the apex as well as two ventilation slits (Plate 4). This possibly suggests that Building A was constructed before Building B, although owl holes within internal gables are not unusual, as they would have allowed owls to access all of the buildings.

- 5.3.3 The roof structure consists of four roof trusses of hand-cut timber making up five bays (Plate 4). The trusses are tie beams with trenched purlins. One of the trusses has a collar which was held to the rafters with wooden pegs (Plate 5). There were no assembly (or carpenters) marks observed due to the height of the roof.

Plate 4 – Eastern gable end of Building A. Remains of limewash and rafter holes can be seen providing evidence for a former first floor

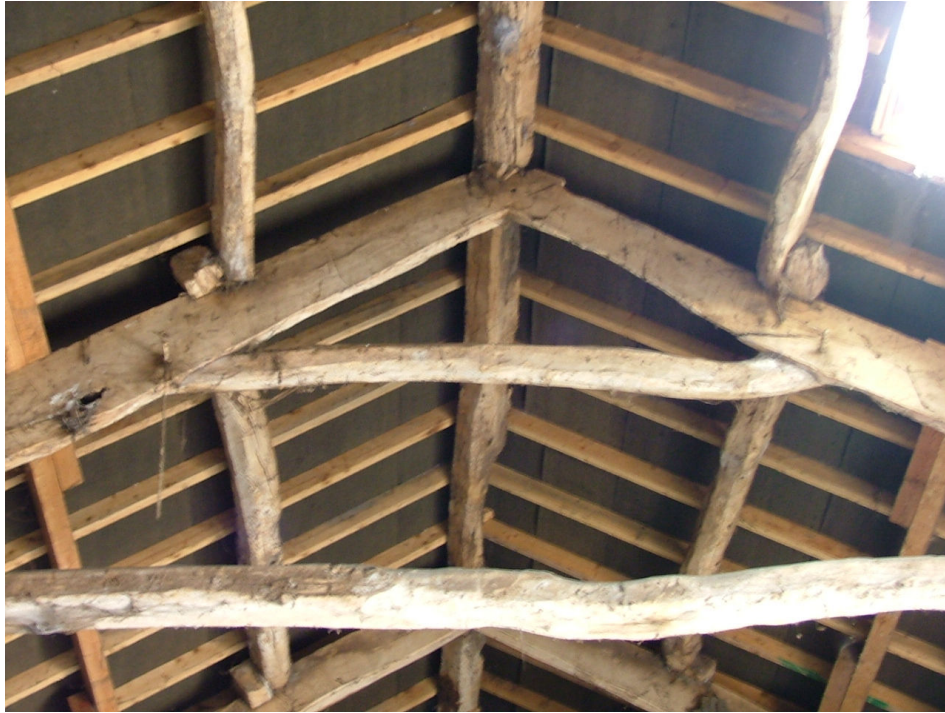
Plate 5 – Detail of roof truss with collar showing wooden pegs

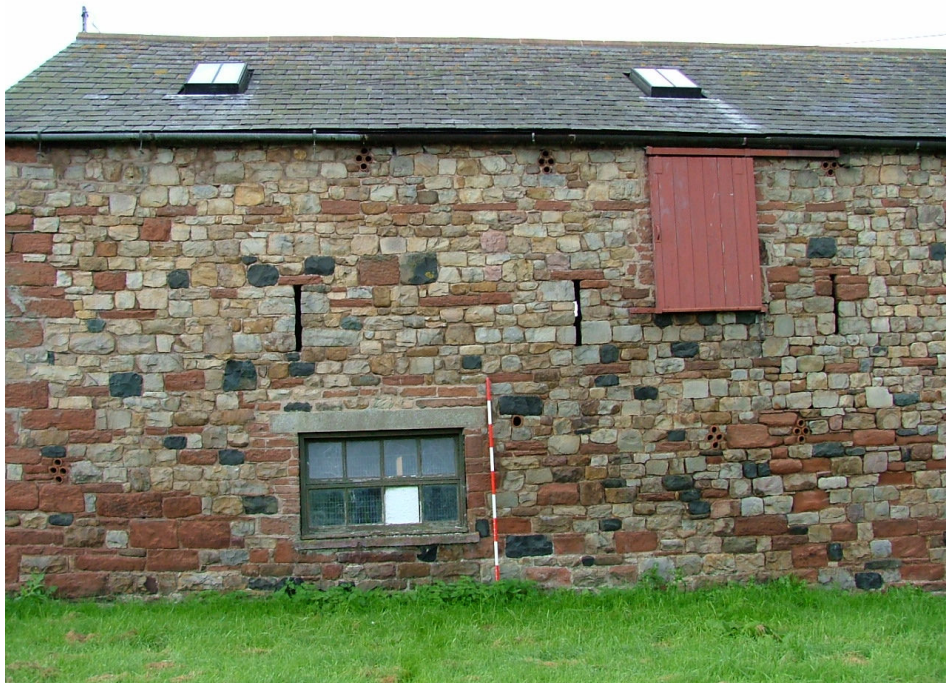
Plate 6 – Northern elevation of Building B

- 5.4.3 Along the northern elevation there is window at ground floor level, which is probably a later insertion as shown by the brickwork and concrete lintel. There are four ventilation slits, which, unusually, are located at mid-height, rather than at ground floor or first floor level. Sections of ceramic pipe have also been used to create ventilation; four pieces of pipe have been set in a diamond shape and there are four sets along the elevation at ground floor level and six sets just below the eaves (Plate 6). There is a pitching door at first floor level which would have been used to transfer hay and/or straw from a cart to the first floor of the building. A smaller window is located to the western end of this elevation.

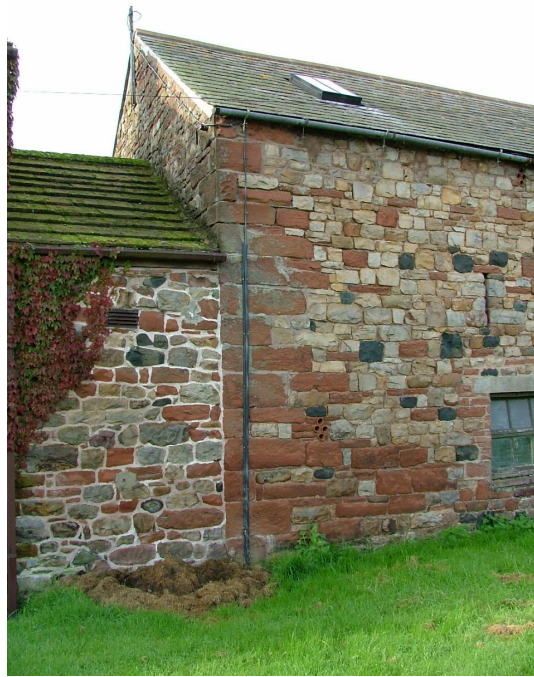
Plate 7 – Eastern end of the north elevation of Building B

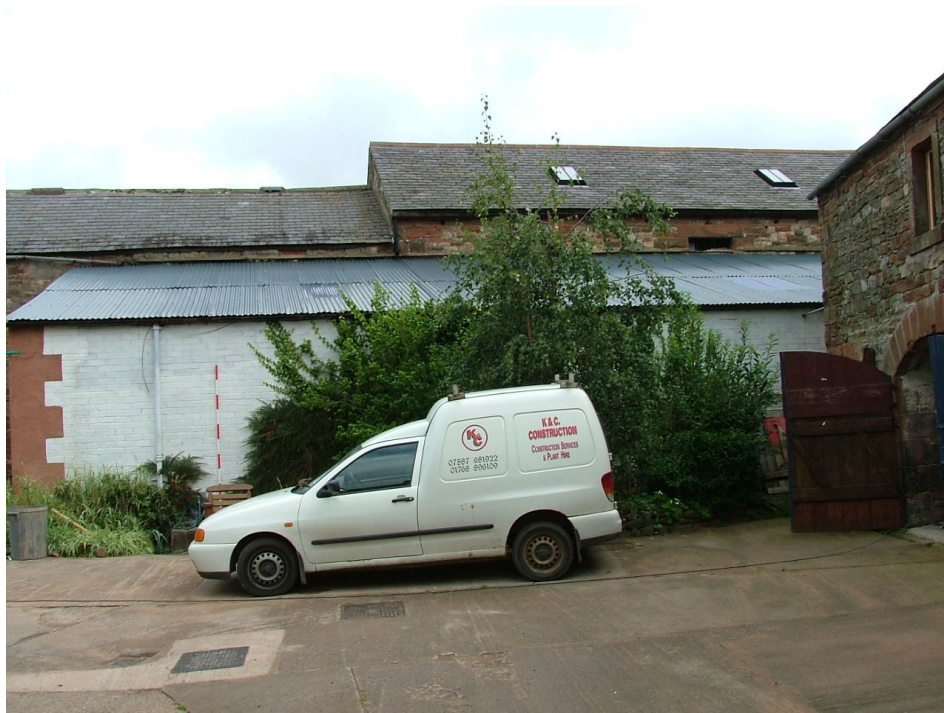
- 5.4.5 The southern elevation is largely obscured by Building E, a later addition. It was possible to note the top of a pitching door at first floor level, which has a sandstone lintel and alternating blocks making up the jambs.

Plate 8 – Southern elevations of Building A, B and E with Building C to right of photograph

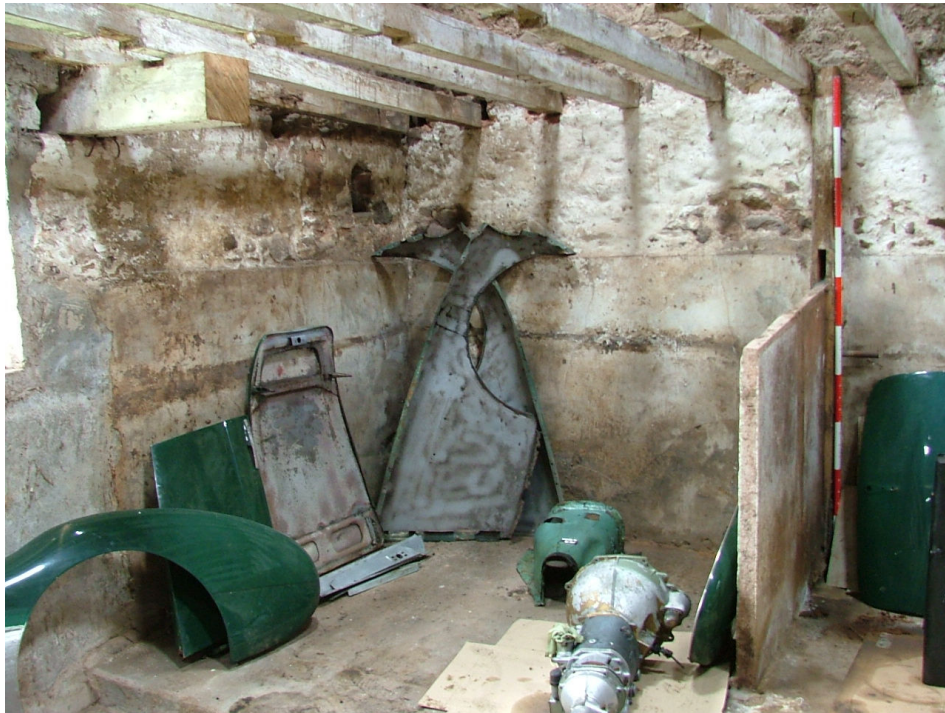
Plate 11 – Byre, Building B

- 5.5.2 The next room at ground level in Building B, which is divided from the store by a ground floor masonry cross wall, was also originally used as either a byre or stable. A single sandstone stall division remains, although the floor is of concrete so it was presumably reused when the new floor was laid, as often concrete stall divisions replace earlier sandstone or timber versions. As with the previous room, the joists and beams for a former first floor remain. The walls in this room have been plastered to a height of approximately 1.30 metres from the floor of the stalls. This is a common feature of byres which have been concreted; therefore plaster must have been regarded as more hygienic than the traditional limewash, although whitewash remains on the walls (Plate 11). Concrete floors, proper manure channels and easily-cleaned surfaces were required following regulations such as the *Dairies, Cowsheds and Milkshops Order of 1885* intended to secure *'the health and good condition of the cattle therein, the cleanliness of milk vessels therein and the protection of the milk therein against*

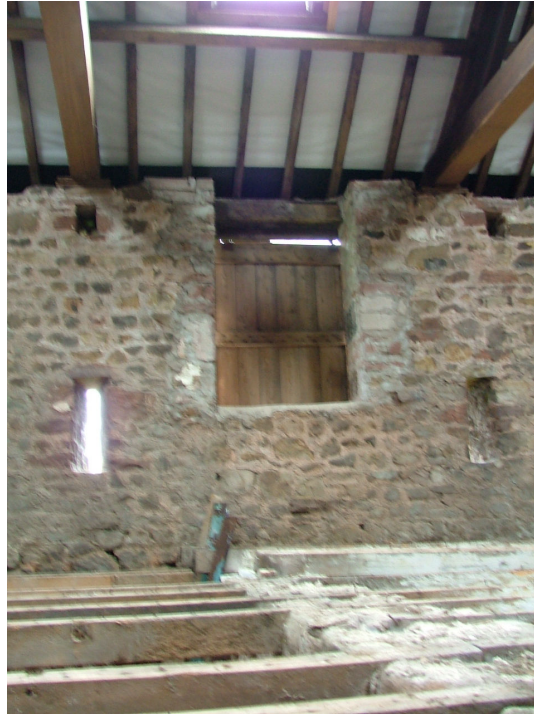
- 5.5.4 The roof structure of this building consists of four roof trusses of machine-sawn timber, creating five bays. Just below the eaves, holes were noted which presumably once held beams from an earlier roof structure (Plate 12). The location of the joists for the first floor was below the position of the ventilation slits observed on the northern elevation (See 5.4.3).

Plate 12 – Northern elevation of Building B, ventilation slits and pitching door

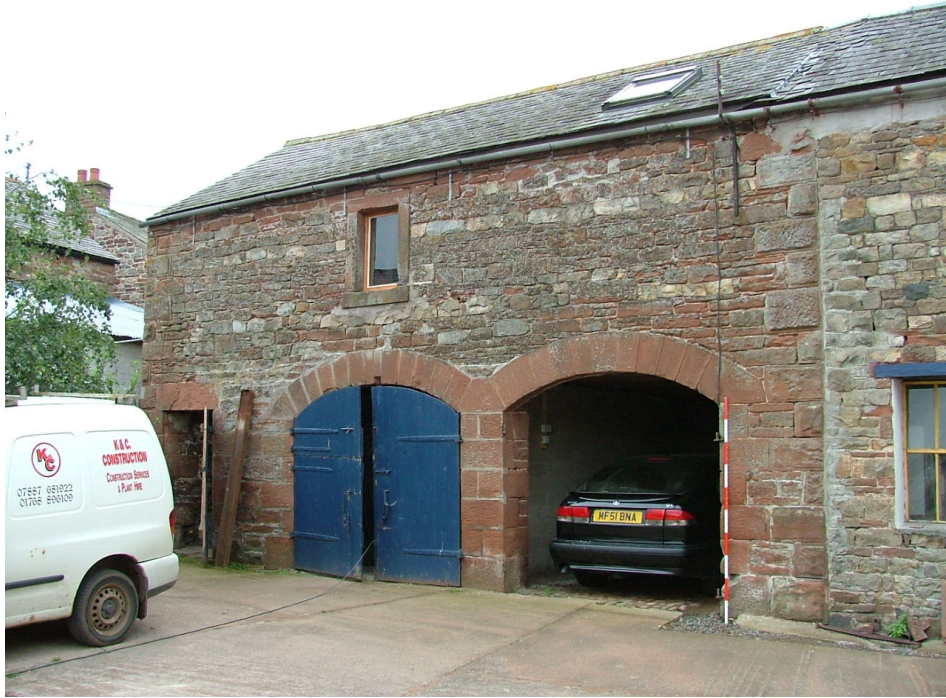
Plate 13 – West facing elevation of Building C

- 5.6.2 Building C is two storeys high, measures approximately 9.0 metres in length by 5.0 metres wide and is constructed of roughly coursed and squared red sandstone masonry (Plate 13). The quoins consist of dressed alternating sandstone blocks. The roof is laid in Welsh slate and a modern skylight has been inserted in the west facing side. Along the western elevation there are two large cart shed doors with arched heads of well-dressed sandstone, and a further standard-sized doorway at the northern end. Against the northern gable end are a set of sandstone stairs leading to a door at first floor level (Plate 14). There is a window at first floor level with rectangular blocks of sandstone making up the surround. It was not possible to note any features along the eastern elevation as this faces into the garden of the property next door, however there was no evidence internally for any windows or doors.

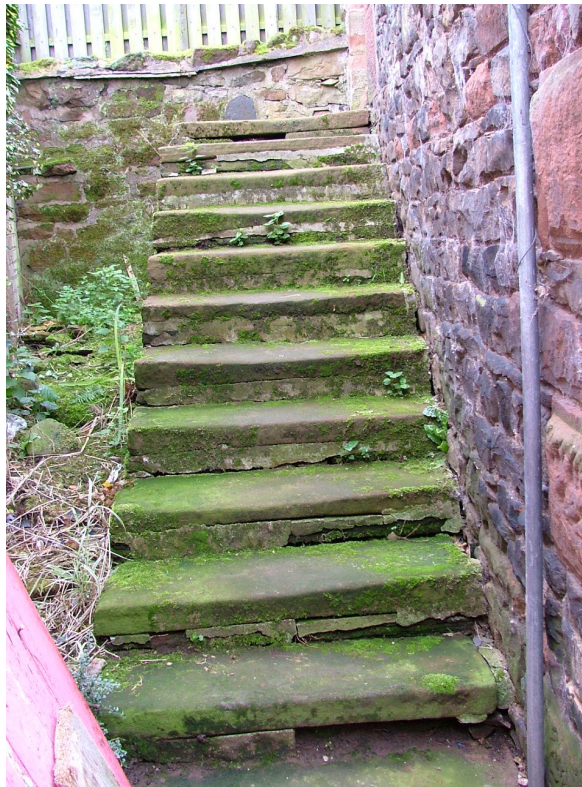
Plate 14 –Stairs, northern gable end of Building C

- 5.7.3 The first floor of Building C was accessed via the stone stairs on the northern elevation (Plate 14). The first floor consists of a single room over the two car sheds and small room below. There are two roof trusses of hand-cut timbers with trenched purlins (one row either side) (Plate 16). At the end of each timber making up the trusses are assembly (or carpenters) marks, one truss has the mark 'I' and the other 'II' (Plate 17). The roof trusses rest on the top of the wall. Apart from the trusses and the purlins the rest of the roof is modern.
- 5.7.4 It is likely that this first floor room was originally used as a granary for storing grain. Brunskill notes how granaries on farmsteads in Cumbria were always on the first floor, often had external staircases and domestic sized windows¹¹.

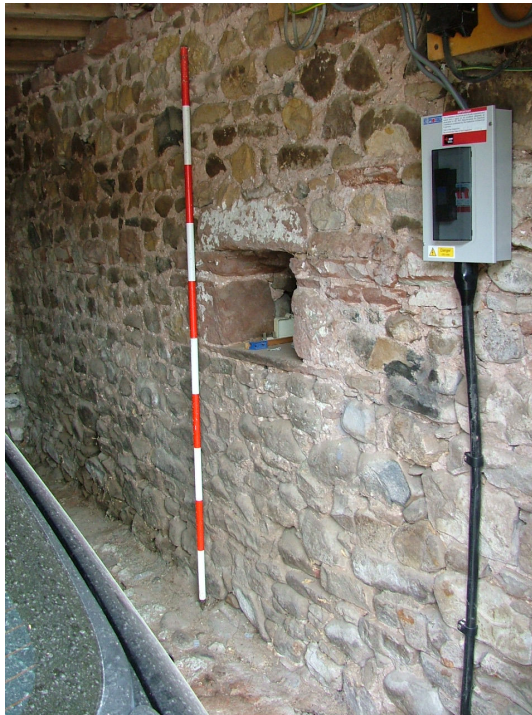
Plate 15 - Niche, interior of cart shed, Building C

- 5.7.1 Internally, Building C is divided into three rooms at ground level, although a division between the two cart sheds is modern (block wall). At the northern end is a small room with a cobbled floor. There were no windows observed in this room therefore it is possible it was used for the storage of tack or even as a root store.
- 5.7.2 The floors of the cart sheds were also cobbled and a niche was observed in the southern of the two cart sheds, which may have been used to hold a candle or oil light (Plate 15). Fixed into the floor below this niche were some iron bolts which may have related to some equipment for the dairy (room next door).

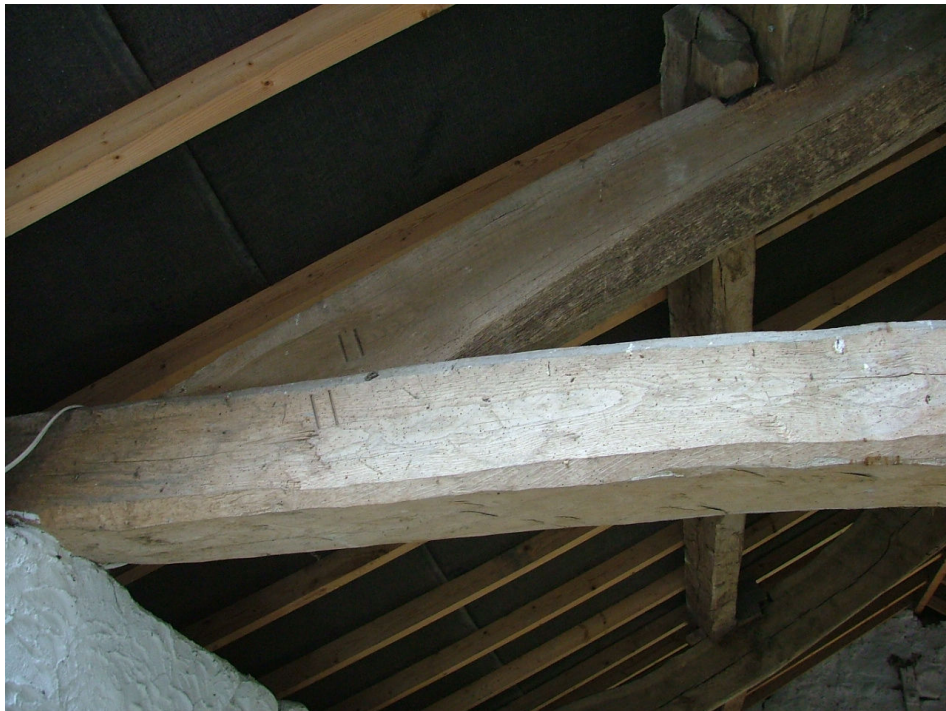
Plate 17 – Assembly mark 'II', roof truss first floor of Building C

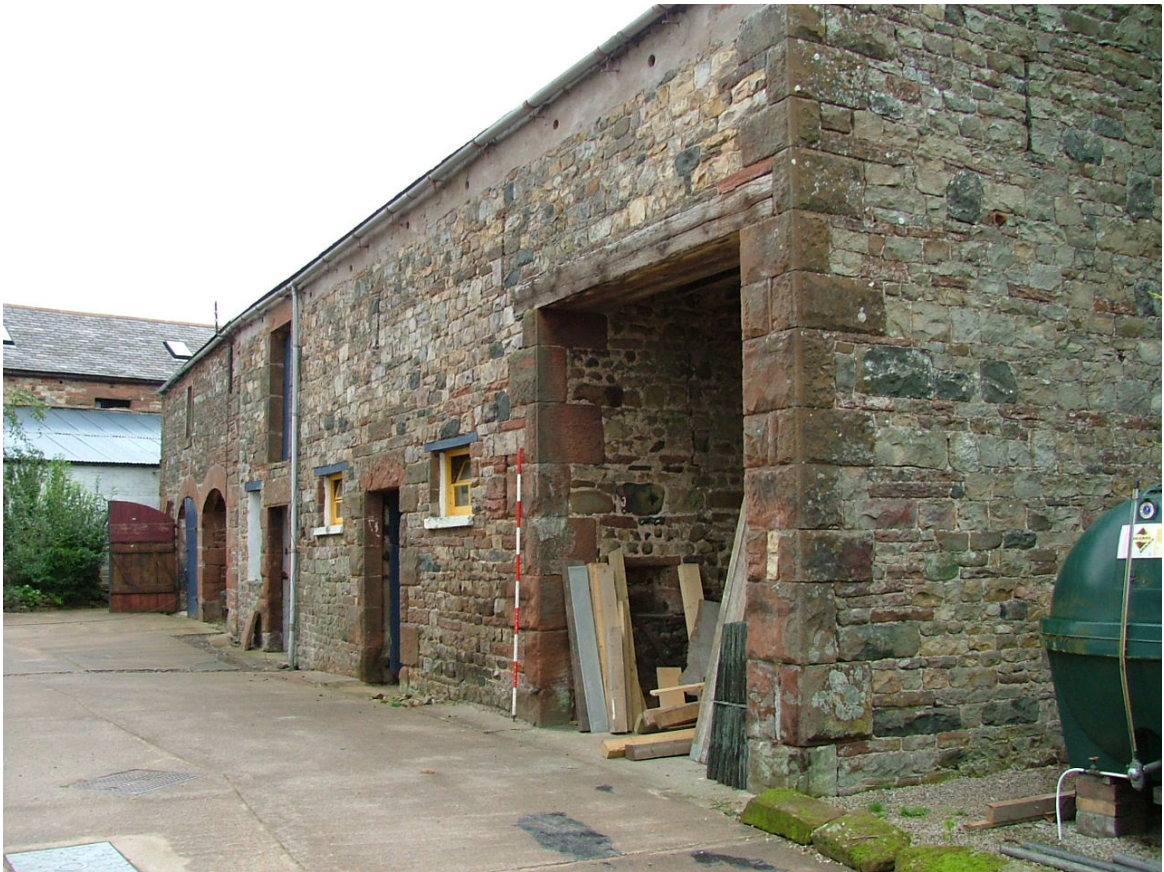
Plate 18 – Building D, western elevation

5.8.1 Building D is attached to the southern end of Building C to create a long range at the south-eastern side of the site (Figure 7). It measures approximately 12.50 metres in length by 5.0 metres wide externally and the walls are c.0.50 metres thick. It is constructed of a roughly coursed mixture of red and sandstone and possible granite masonry. The quoins, door jambs and lintels are all of dressed blocks of red sandstone. Along the western elevation there are two standard sized doorways, a large doorway and three windows at ground floor level. At first floor level there is a pitching door (Plate 18). Ventilation slits are located at both ground floor and first floor level on the western and southern elevations, and observations in the interior of the building confirm that some exist on the eastern elevation facing the garden of the property next door. Located just below the eaves along the western elevation are seven circular holes, presumably sections of pipe, which have also been inserted for ventilation.

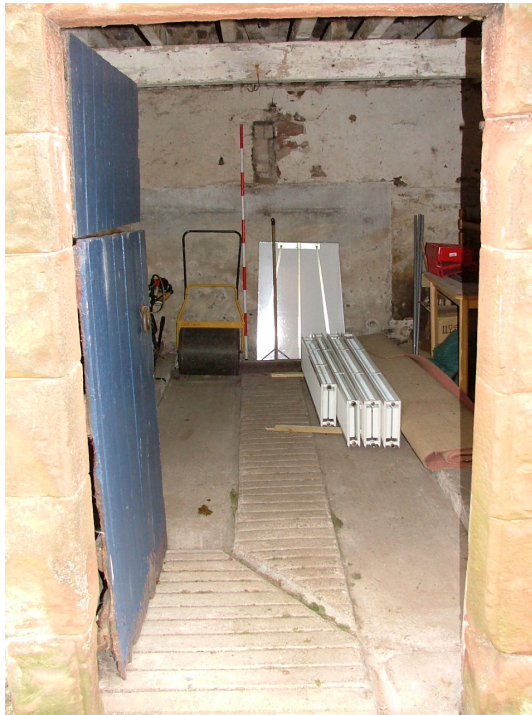
Plate 19 – Interior of byre, Building D

- 5.9.1 Internally, Building D is divided into three. At the northern end of the range is a room which may have been the dairy where milk from the milking parlour (Building E) was collected, although no pipe work remains. The presence of a large window suggests that this was a room designed for humans to work in rather than for housing animals.
- 5.9.2 Beside the dairy is a room that appears to have been originally used as either a stable or byre. The floor is of concrete and the walls have been plastered to a height of c.1.50 metres, although the limewashed walls are visible behind (Plate 19). Joists and beams for the former first floor remain. In the right-hand corner as you enter this room there is an iron fitting which Mr Hammond believes may have been where a bull was tethered.

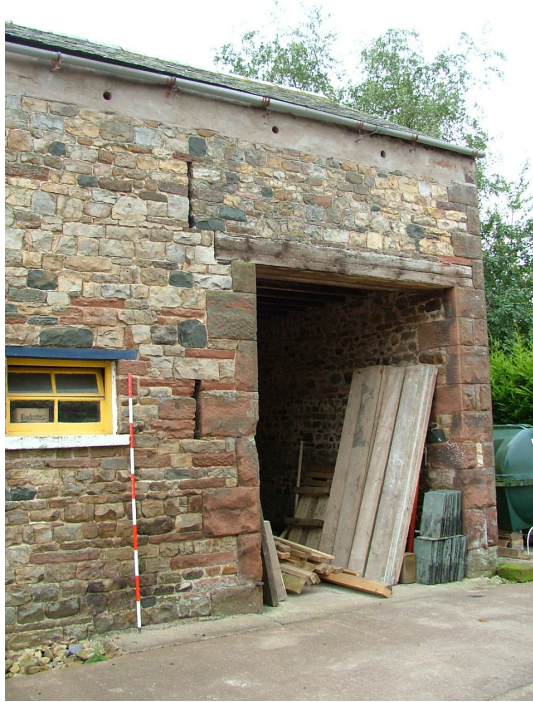
Plate 20 – Large doorway, southern end of Building D

- 5.9.3 At the southern end of Building D is a room which has a large entrance with a wooden lintel and is open to the roof (Plate 20). This large aperture had no evidence of having had a door. In one of the walls there is a niche, set quite low down, with some ironwork attached to the wall beneath. This ironwork appears to correspond to that noted in the byre next door.
- 5.9.4 The purpose of this room is not shown for certain. It does not appear to have been used to house animals, so its purpose may have been to house tools or machinery such as a threshing machine.

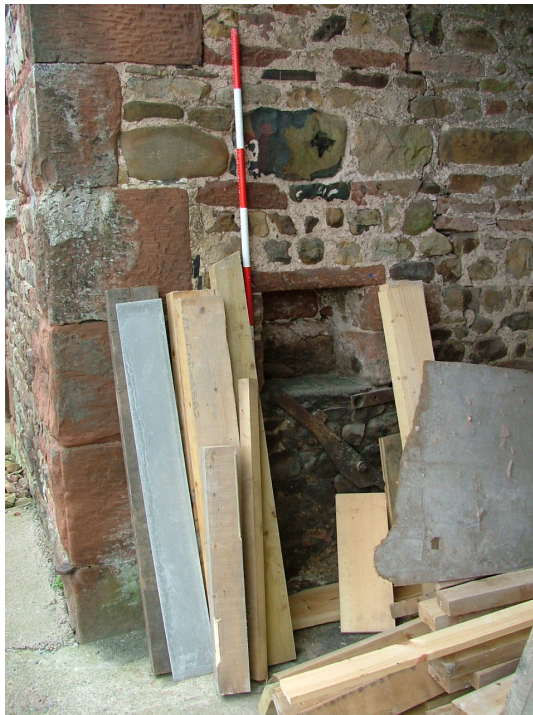
Plate 21 – Niche and ironwork, Southern room of Building D

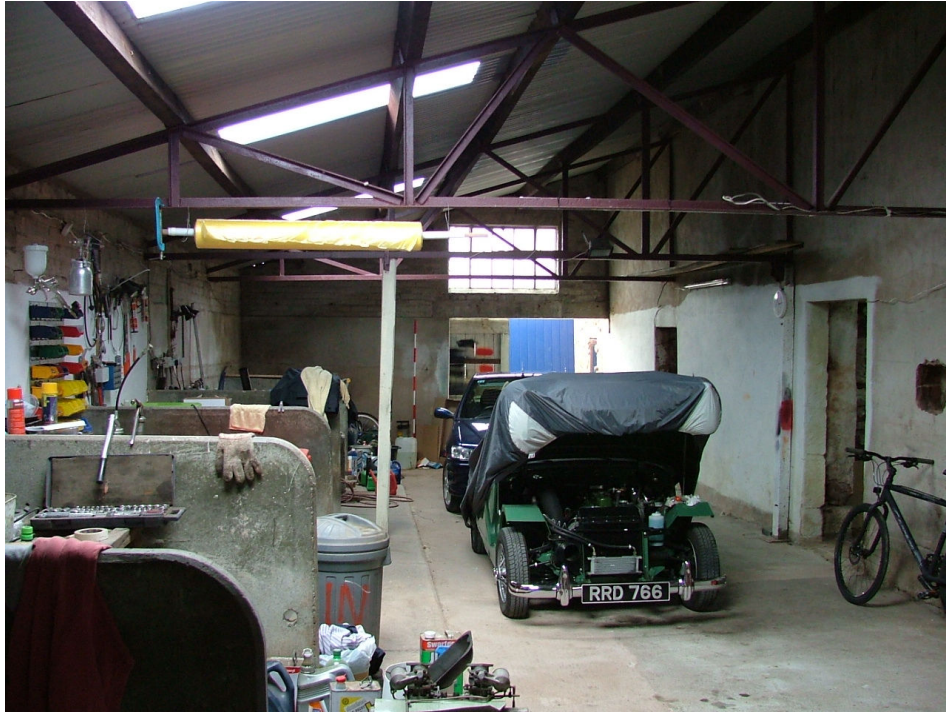
Plate 23 – Interior of Building E looking west

- 5.11.1 The interior of Building E could be accessed via the large doorway in the western elevation (Plate 22). The floor of the building is of concrete and the walls (originally the external walls for Buildings A and B) have been plastered and painted white. Along the length of the southern elevation there are six remaining concrete stall divisions.
- 5.11.2 This building was presumably constructed to house animals; it may have been a specially-built milking parlour. Portable electric milking machines were available from the around the 1950s, fixed electrical equipment from around the 1960s, so gradually milking parlours replaced bucket milking in the byre¹².

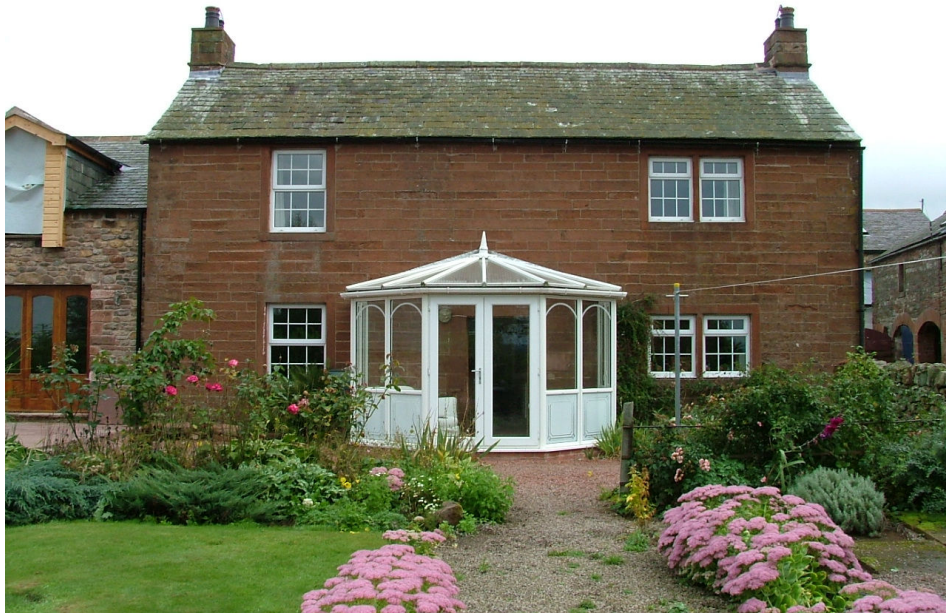
Plate 24 – South facing elevation of house

- 5.12.2 The house is located on the western side of the site, with its garden extending southwards to the back lane (Figure 7) (Plate 24). It is good example of a ‘Continuous-outshut’ house, the outshut being the rear of the house (northern side) which has a continuation of the main roof often referred to as a ‘catslide’, or in Cumbria as a ‘toofall’¹³ (Plate 25). The elevation facing the back lane is of coursed, well-dressed red sandstone masonry, with alternating blocks making up the quoins. Rectangular blocks of sandstone make up the window surrounds and lintels. The windows of the right-hand side of the main central doorway are larger than those on the left and are split into two by a vertical stone mullion (Plate 24). This means that this important elevation is not entirely symmetrical.

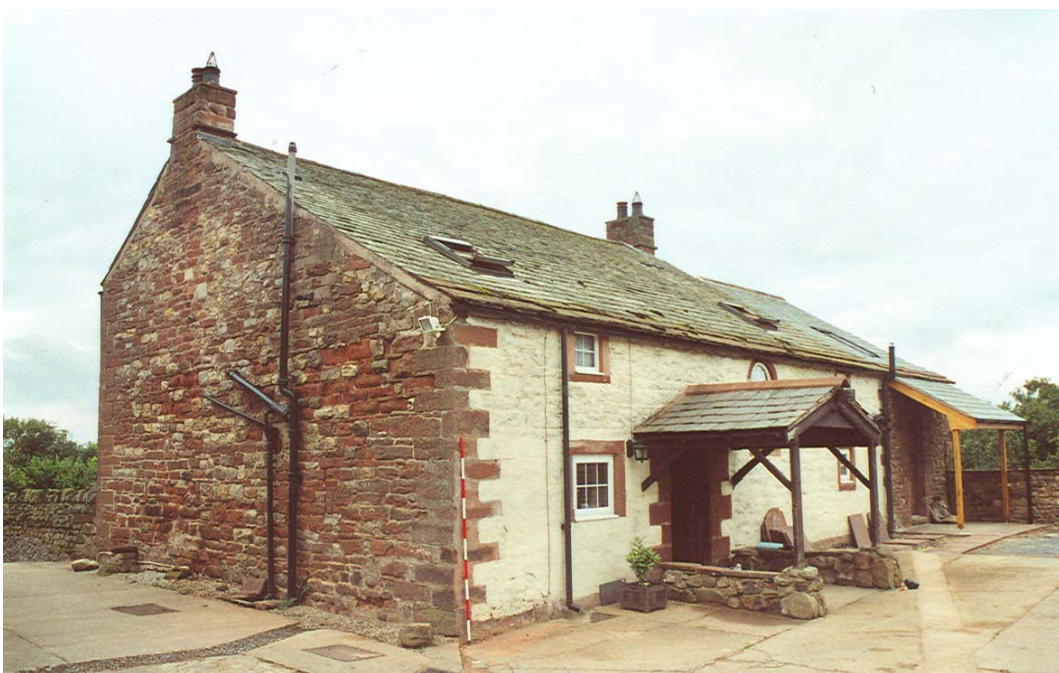
Plate 26 – North and eastern elevations of house

- 5.12.6 The eastern elevation, upon first observation, has what appears to be a vertical construction break indicating that there are least two phases of building. This, however, does not necessarily make sense when the pitch of the roof for, what may have been the earlier house to the rear (northern elevation – Plate 25), is duplicated to the other side of the ridge line; this would have created a wide house with a shallow pitched roof (creating a very large area of roof space). Upon further examination it appears that what originally appears to be a vertical joint is in fact misleading. The chimney is obviously not original as shown by the difference in stonework and sections of the wall are heavily mortared, creating a ‘false’ vertical joint. When the stonework for both sides of this ‘joint’ is examined, it can be observed that it is the same mix of red and yellow roughly square masonry, and in some places the horizontal courses carry on into both sides. The western gable end has a building against so it was not possible to note if a similar construction break existed there.

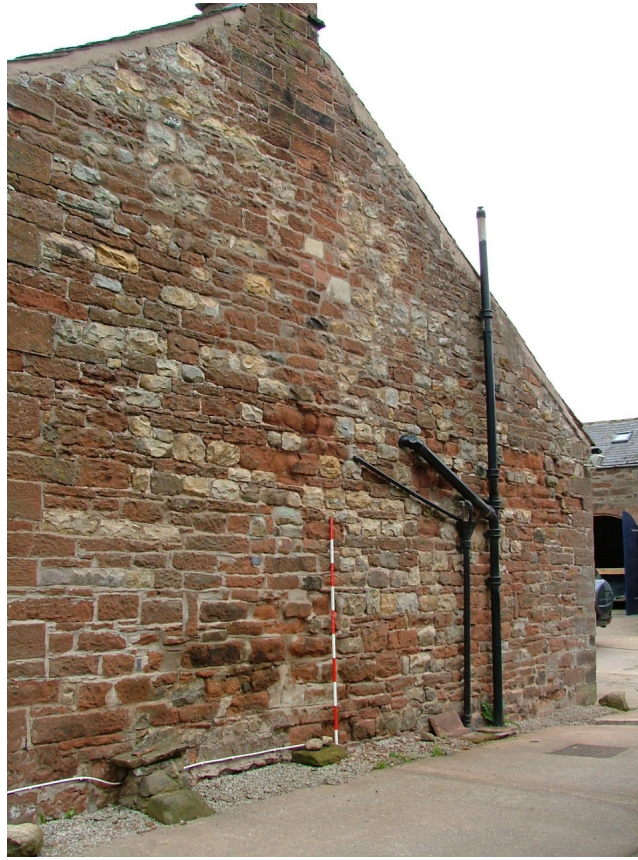
Plate 27 – Eastern elevation of house

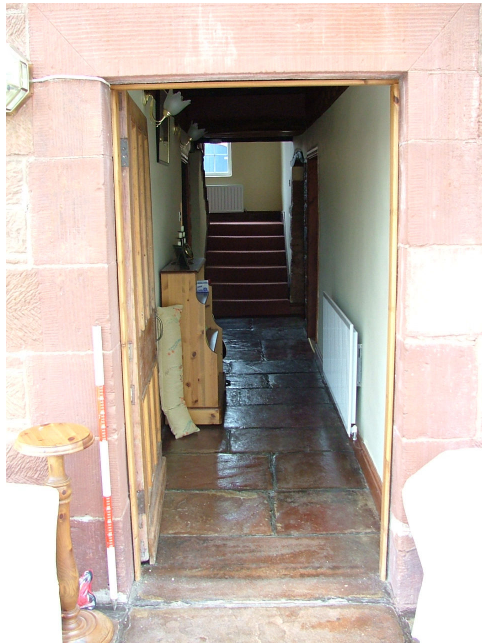
Plate 28 – Hallway of house looking north

5.13.1 Internally the current ground plan consists of a hallway accessed from the outside by the central doorway on the southern elevation (Plate 28). Either side of this hallway is a room (one currently the kitchen and the other a living room). At the back of the house, located within the outshut, is a central dog-leg staircase, with a former pantry on the left and former kitchen or scullery on the right (Figure 12). The pantry (or buttery), which is now used for storage, still retains its sandstone shelving which is a nice survival, although they have been moved around (Plate 29). The pantry was where food and eating utensils would have been stored. The sandstone shelves would have been used to salt meats and for storing milk, butter and cheese, presumably because they retained moisture and remained chilled throughout the year. In some instances, a shelf with a shallow recess exists which would have prevented the spillage of salt, as was the case at Tottergill Farm near Castle Carrock¹⁶. The small window in the north facing wall would have prevented too much sunlight warming up the room.

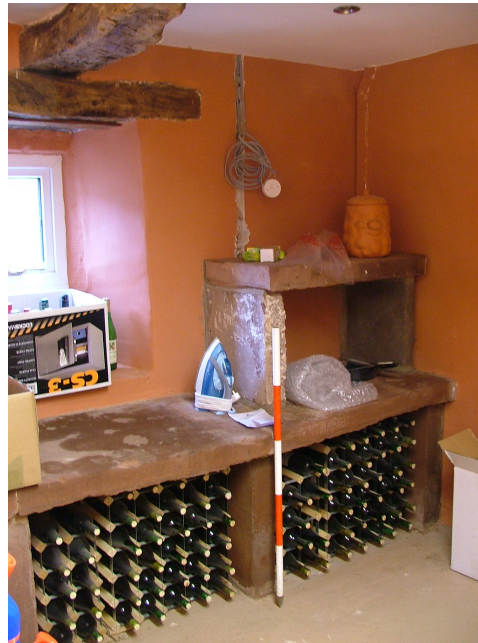
Plate 29 – Sandstone shelving in pantry

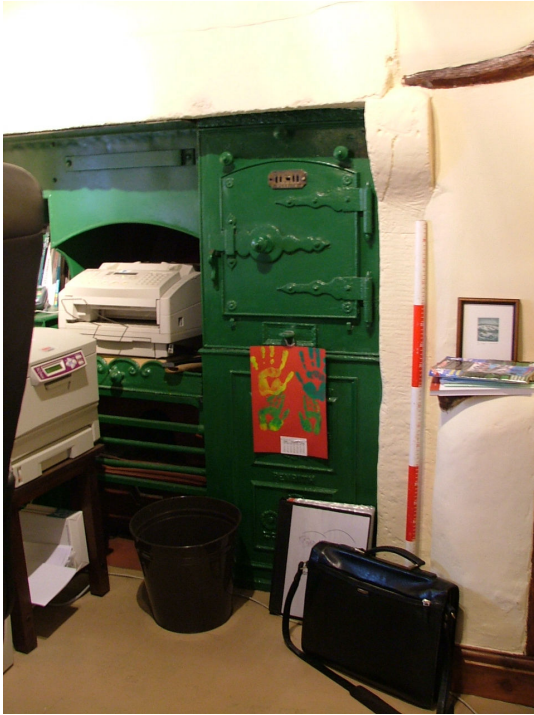
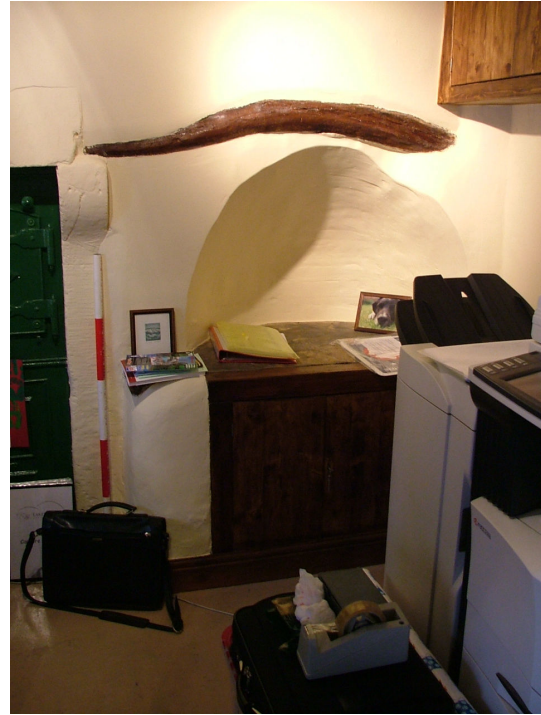
5.13.2 In what would have formerly been the scullery (now used as an office) there remains a range and a probable set-pot (or washtub) in the eastern wall (Plates 30 and 31). The range is set into an alcove with a stone lintel and a right-hand vertical stone support which has a carved circular top. This vertical support has probably survived from a period before the range was inserted, and may have held up a mantle over an open fire. To the right of the range is a semi-circular recess with a wooden lintel and cupboard below. This was a possible set-pot which was used for washing clothes and bedding. A fire at the base would have heated up water in a cauldron and the washing would be boiled, scrubbed, blued and starched; oral history records that a certain day of the week would be set aside for this task¹⁷.

**Plate 30** – Victorian range, outshut

**Plate 31** – Set-pot (or wash tub), outshut

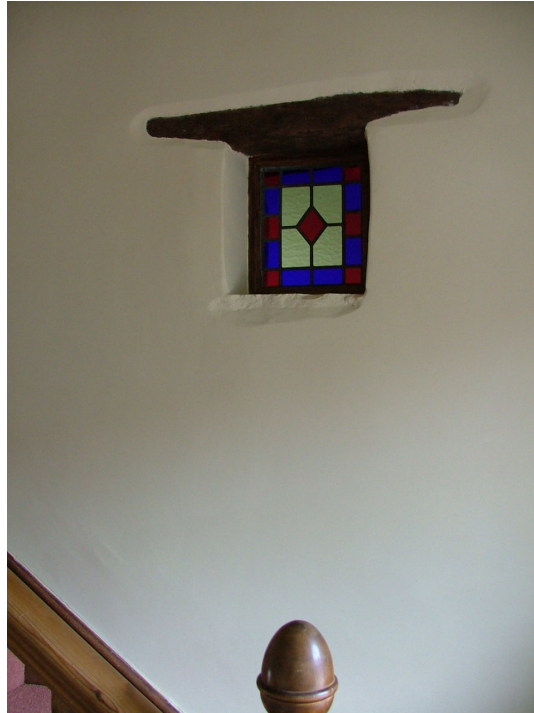
Plate 32 – Small window as seen from staircase

- 5.13.4 The first floor is accessed via the central dog-leg staircase located at the back of the house within the outshut. At the top of the first flight of stairs, the staircase turns back on itself to head towards the small landing at first floor level. A window with arched head is located at the first landed and this provides plenty of light for the staircase. Halfway up the second flight of stairs is a small window (Plate 32). The presence of this window at first suggests that this was originally an external wall, and that at some point the outshut was extended either eastward or westward. There was, however, no evidence for this on the exterior wall of the northern elevation (Plate 25), and it may therefore have been inserted in this internal wall deliberately when the outshut was lofted and the roof space used for storage or extra bedrooms (See 5.13.5 below).

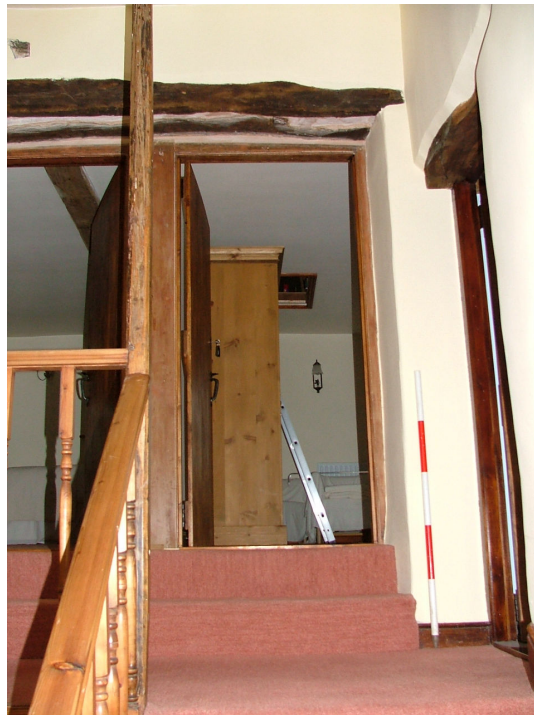
Plate 33 – First floor landing showing steps up to two front bedrooms

5.13.7 At the front at first floor level there are two double bedrooms accessed up two steps from the main landing. According to Brunskill a common feature of the outshut being lofted was a difference in floor level between the rear rooms (in outshut) and the front rooms²² (Plate 33). Both rooms have period fireplaces (Plates 35 and 37). Plates 35 and 36 show a cast-iron fireplace and grate set within a simple stone surround with a wooden mantel. Plate 37 shows the fireplace in the other bedroom. This also has a simple stone surround with wooden mantel. The fireplace itself is different in that it has decorative tiles lining the cast-iron gate. Because the house has been renovated only ten years ago, it is necessary to consider the possibility that these two fireplaces have been brought in from elsewhere; however the stone surrounds and mantels are similar. Dating these types of fireplaces in vernacular buildings can be difficult because fashions took some time to disseminate into rural areas therefore further research may be necessary, however Quiney includes similar examples in his section on ‘Victorian and Edwardian Houses’²³.

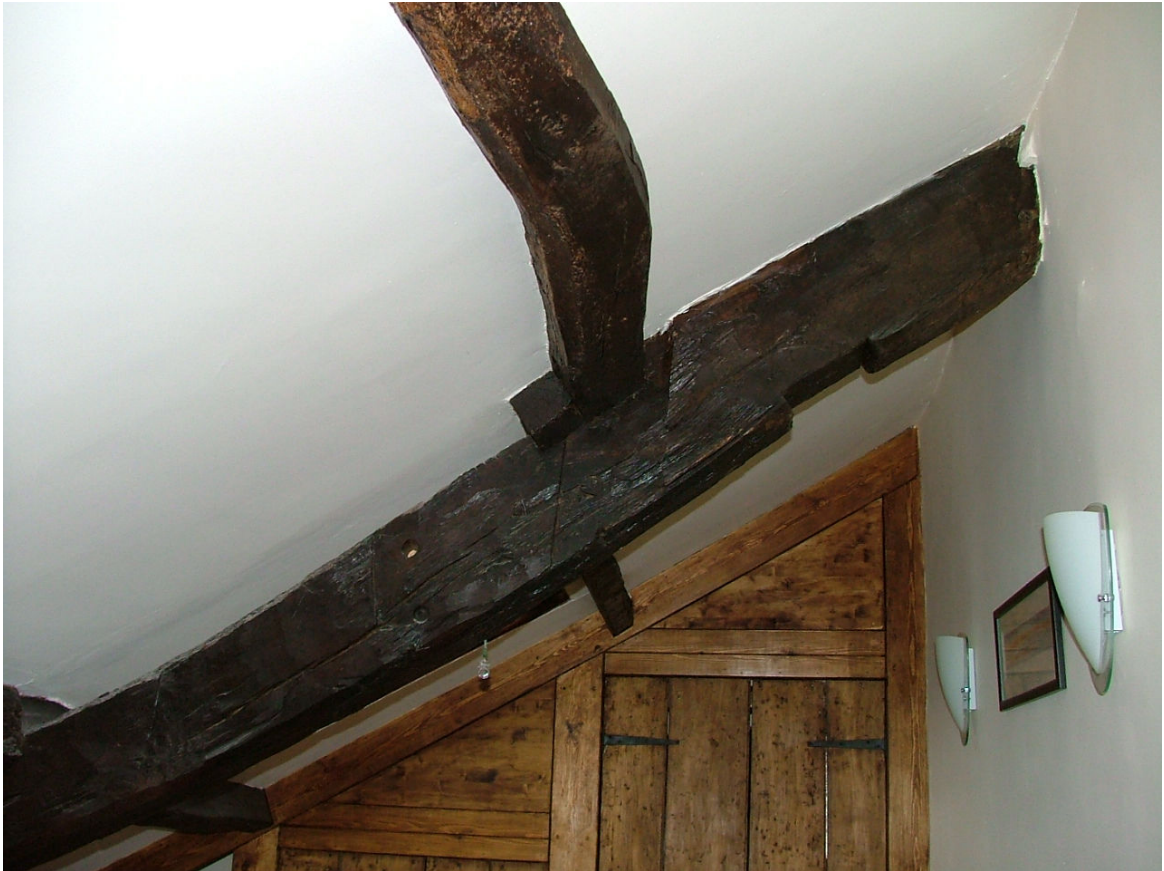
- 5.13.6 Opposite the door to the present bathroom is a room now used as a bedroom, which is located over the former scullery (where the range and set-pot are situated). The timbers for the roof structure are exposed in this room, and at least one of the oak rafters shows that some of the timbers have been re-used (Plate 34). There are two rows of trenched purlins. The rafter is bonded into one of the main load-bearing walls.

Plate 34 – Roof timbers, back bedroom over former scullery

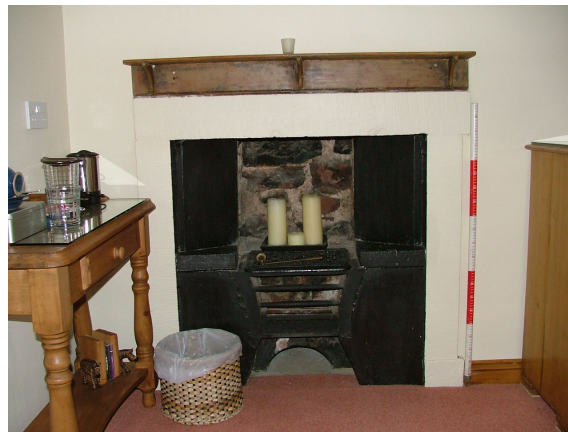
Plate 35 – Fireplace, first floor bedroom

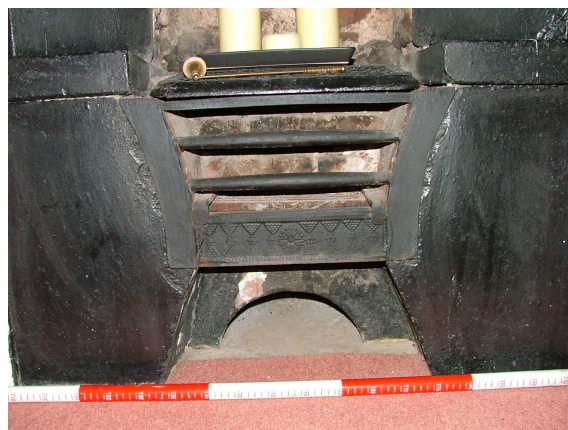
Plate 36 – Detail of grate, first floor bedroom

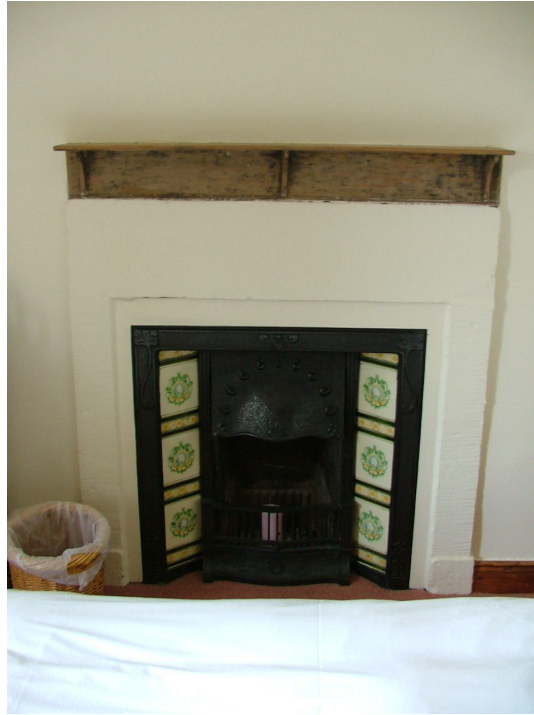
Plate 37 – Fireplace with decorative tiles, first floor bedroom

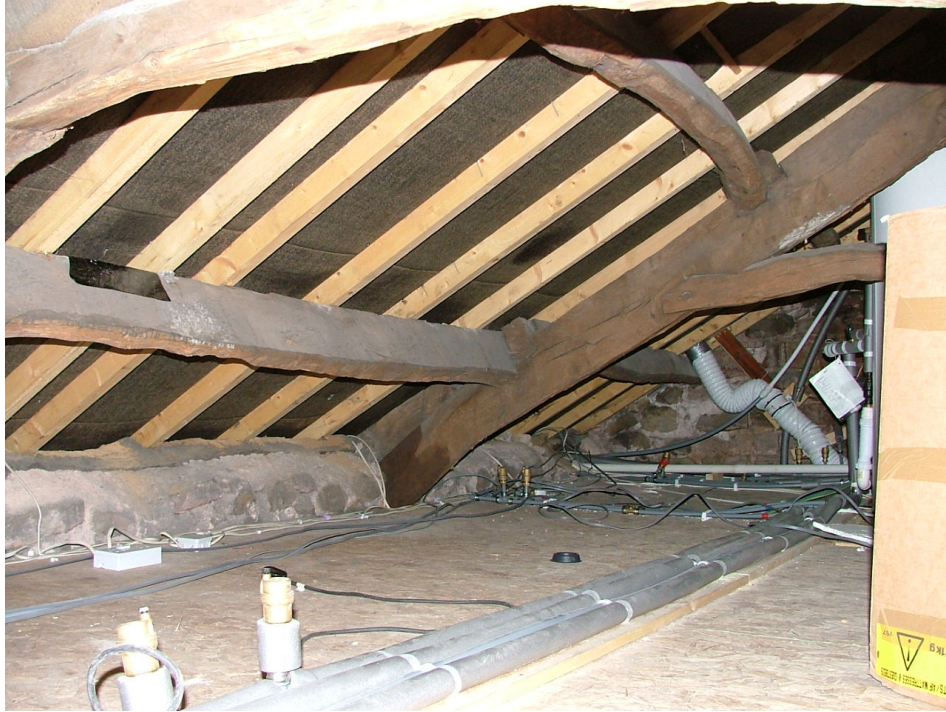
- 5.13.8 During the survey it was possible to access the loft to note the roof structure of the house. The roof is made up of two hand-cut roof trusses which create three bays. The trusses consist of principal rafters with collars, which are fixed to the rafters with wooden pegs. The ends of the rafters are bonded into the top of the walls, rather than resting on them (Plate 38). On either side of the roof are two rows of trenced purlins. Assembly marks were observed on one of the trusses as 'II' (Plate 39). The underside of the roof itself shows that it has been replaced fairly recently in local slate.

Plate 38 – Roof structure, main section of house
