Client Report No. CP/383/06

**REPORT ON AN
ARCHAEOLOGICAL
BUILDING RECORDING
PROJECT AT
MIDTOWN FARM
BLENCARN
CUMBRIA**

**FOR
GRAHAM K NORMAN
(ARCHITECT) LTD**

**NY 63785 31235
Planning Application Ref:
3/06/0476**

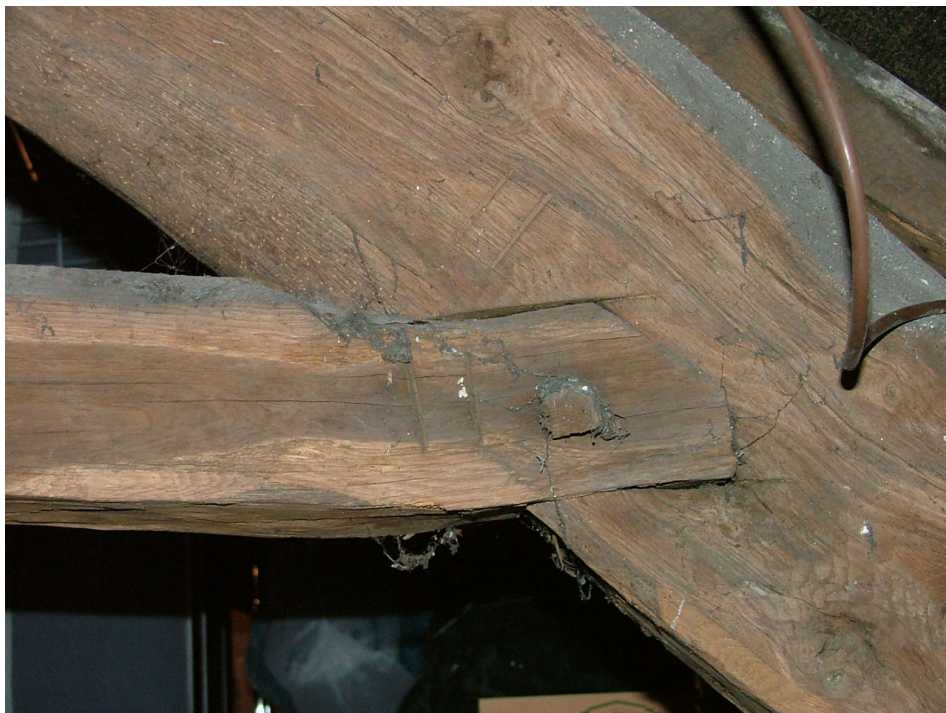
- 5.13.8 During the survey it was possible to access the loft to note the roof structure of the house. The roof is made up of two hand-cut roof trusses which create three bays. The trusses consist of principal rafters with collars, which are fixed to the rafters with wooden pegs. The ends of the rafters are bonded into the top of the walls, rather than resting on them (Plate 38). On either side of the roof are two rows of trenced purlins. Assembly marks were observed on one of the trusses as 'II' (Plate 39). The underside of the roof itself shows that it has been replaced fairly recently in local slate.

Plate 39 – Detail of joint, peg and assembly mark on roof truss
