**Project Designs and Client Reports No. CP/363/06**

**REPORT ON AN ARCHAEOLOGICAL  
BUILDING RECORDING PROJECT AT  
PARTON METHODIST CHAPEL  
BANK YARD ROAD**

**PARTON  
WHITEHAVEN  
CUMBRIA**

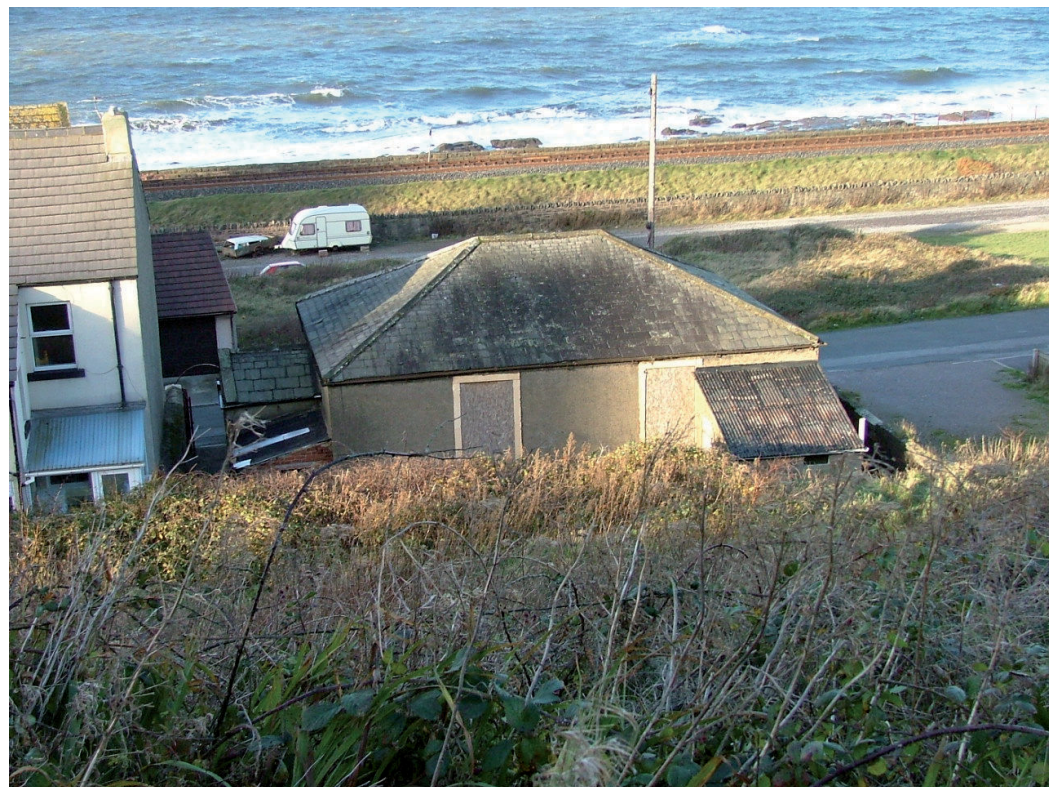
**Plate 1** – Parton Methodist Chapel as seen from the east

- 1.2.4 Parton Methodist Chapel is located at the south end of the village on the eastern side of Bank Yard Road. The chapel is situated at the foot of a steep slope, with the railway line and sea just to the east (Plate 1 and Figure 2).

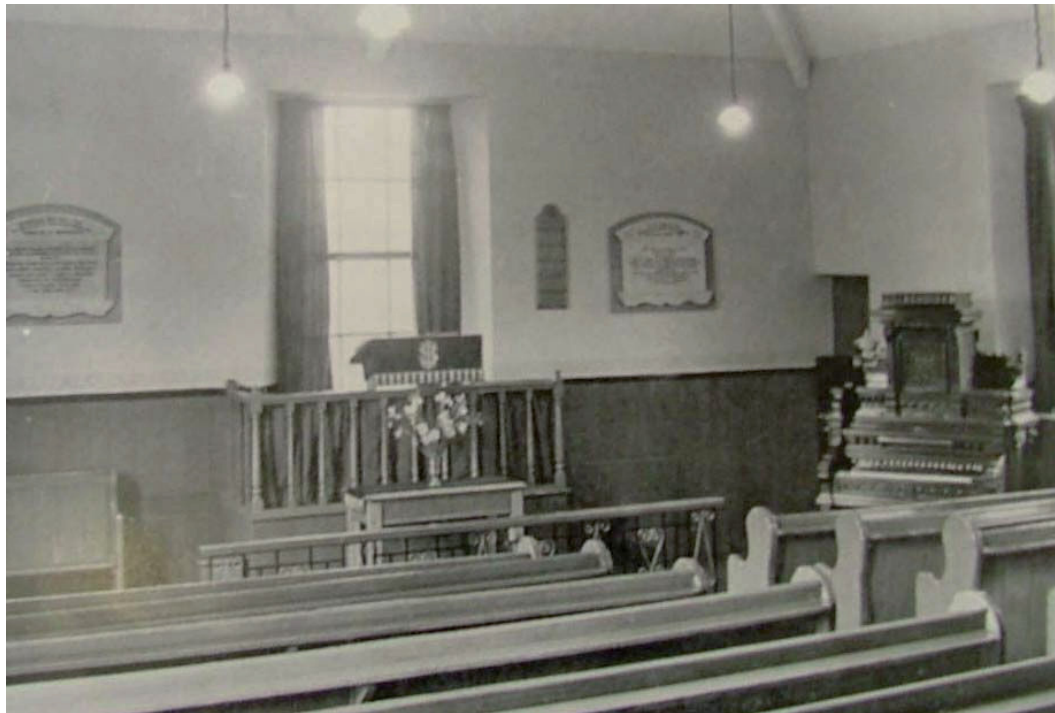
**Plate 2** – Interior of chapel c.1962

- 5.2.5 At the northern end of the chapel interior, located underneath the window, is a small timber platform complete with steps (Plate 12). This was presumably the pulpit which in 1962 also had slender decorative balusters and a hand-rail (Plate 2), although these were not extant at the time of survey.

- 5.2.10 On the photograph of c.1962 (Plate 2) a piece of decorative ironwork, complete with wooden hand-rail, can be observed separating the pews from the pulpit. There was no evidence for this feature at the time of survey.

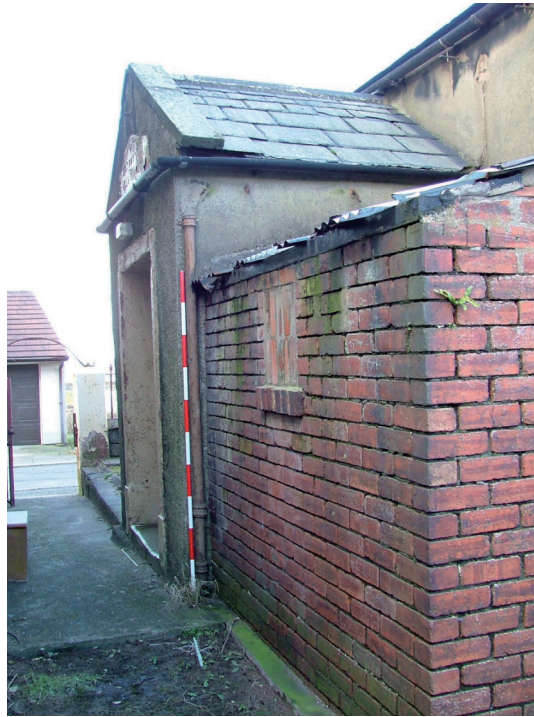
**Plate 5** – Brick-built lean-to against eastern side of chapel porch

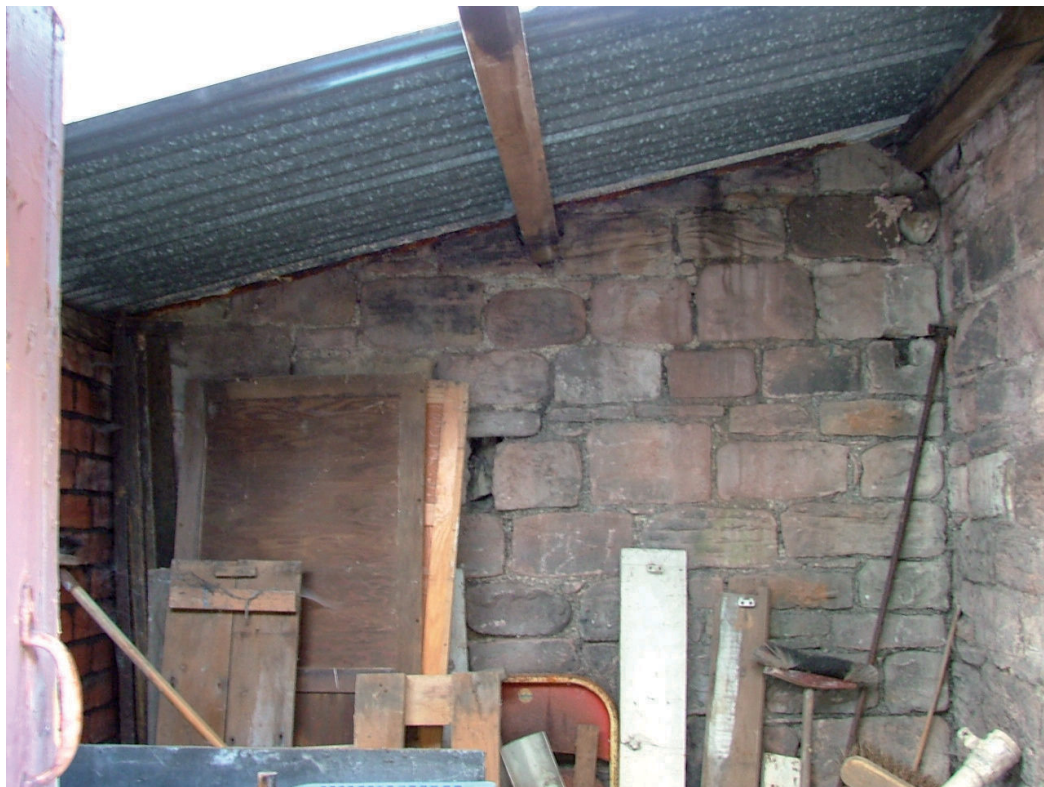
**Plate 6** – Interior of brick-built lean-to showing construction material of chapel

- 5.1.2 The main body of the chapel measures approximately 11.40 metres in length by 8.30 metres in width. At the southern end is a small gabled porch which projects approximately 2.30 metres from the main body of the chapel, and measures *c.*2.20 metres wide. Against the eastern side of the porch is a modern brick-built lean-to which has a plastic corrugated roof (Plate 5). Although all of the exterior walls of the chapel are covered in cement render, it was possible to observe in the interior of this lean-to that the chapel is constructed of roughly coursed, squared sandstone masonry (Plate 6).

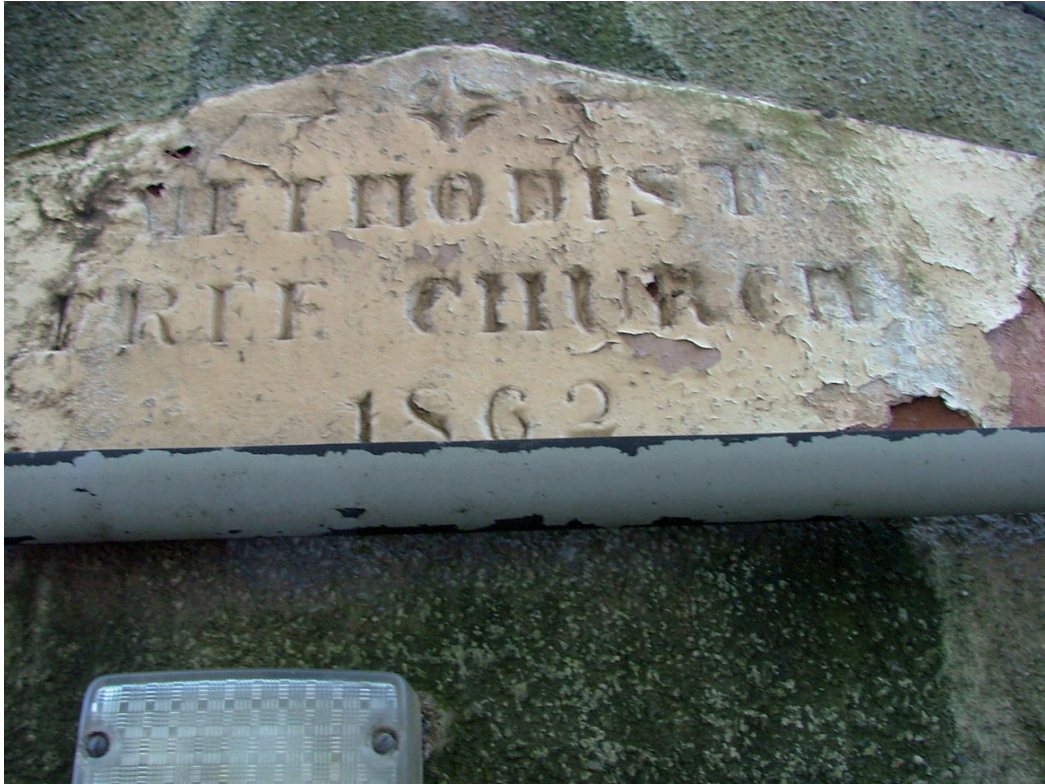
**Plate 7** – Inscription over main entrance to chapel

- 5.2.3 The chapel had a hipped roof laid in slate with ridge tiles. The gable of the porch has coping stones. Above the main doorway into the chapel is a sandstone inscription which reads: 'Methodist Free Church 1862' (Plate 7). As the chapel is not shown on the First Edition Ordnance Survey map, then it is possible that this inscription came from an earlier chapel on another site. The porch way has a single window on its western elevation (Plate 4).

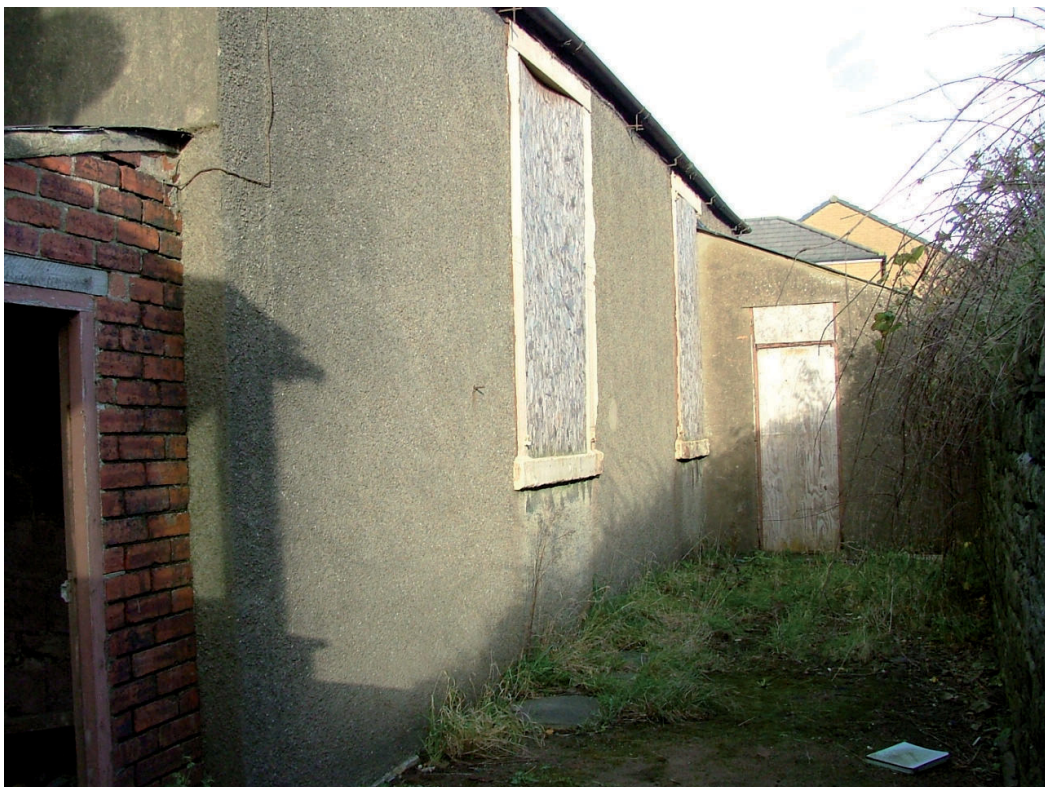
**Plate 8** – Eastern elevation of the chapel, with later extension shown to the right

- 5.2.6 Against the east elevation at the north end of the chapel is a further brick-built extension (Plate 8). It would appear that this extension is not contemporary with the main body of the chapel as shown by one of its walls concealing part of a window jamb (Plate 10). There is a doorway in the south elevation of the extension, a small window in the east elevation located just below the eaves and a further window in the north elevation of the extension. The pitched roof is of corrugated sheeting.

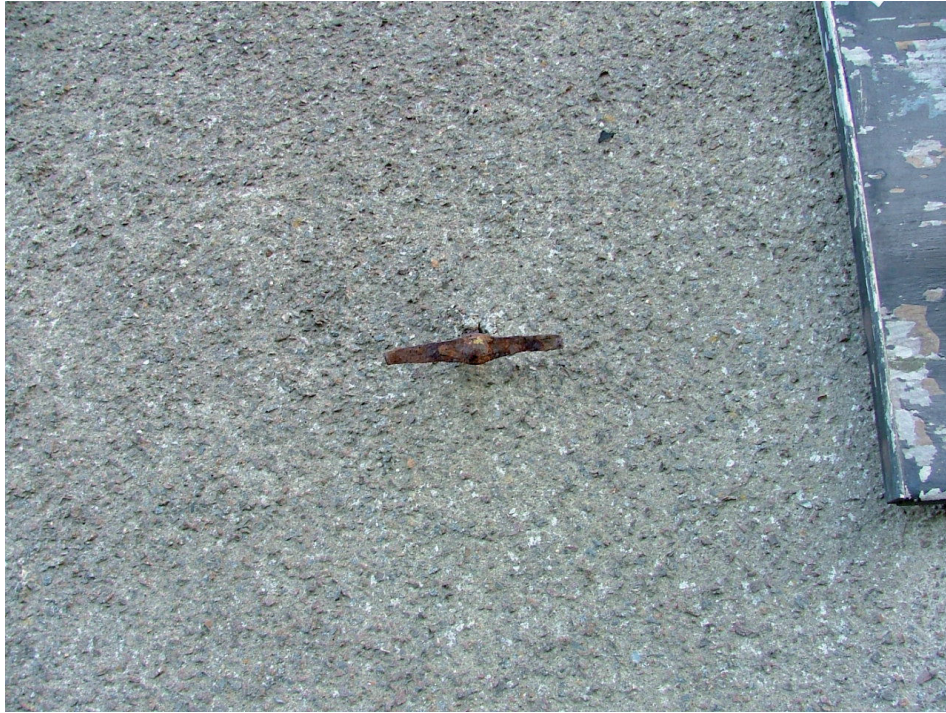
**Plate 9** – Western elevation, one of four iron fittings set into the wall

- 5.2.5 Set into the wall of the west elevation, located approximately half way up the elevation, are the remains of four iron fittings set in a row (Plate 9). One of these fittings remains *in-situ* on the east elevation. Given the proximity of these fittings to the windows it seems likely that they were used for securing the external shutters when open.

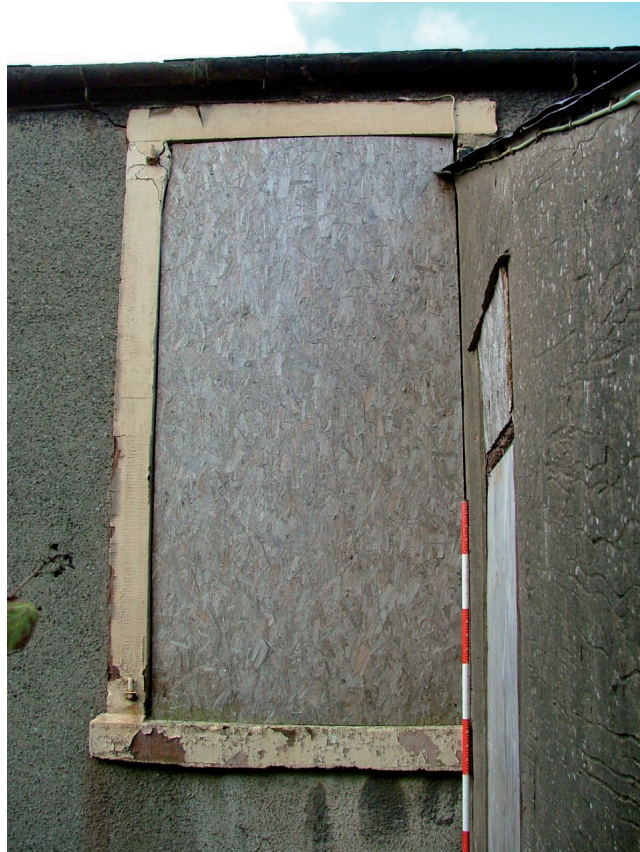
**Plate 10** – Eastern elevation, showing wall of extension concealing part of the window jamb

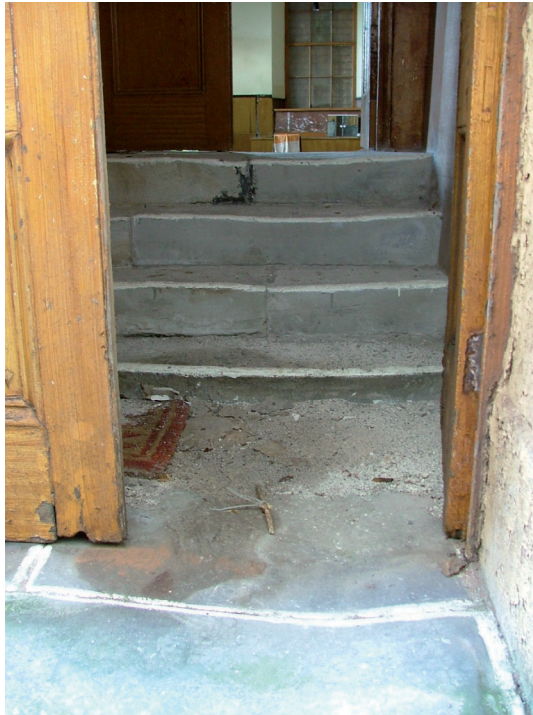
**Plate 11** – Entrance into the chapel showing the stone steps

- 5.2.1 The interior of the chapel was accessed through the doorway in the porch. Upon entering the porch, four stone steps provide access to the main of the chapel. The right-hand side of these steps showed signs of wear from the feet of the congregation over decades of use (Plate 11).

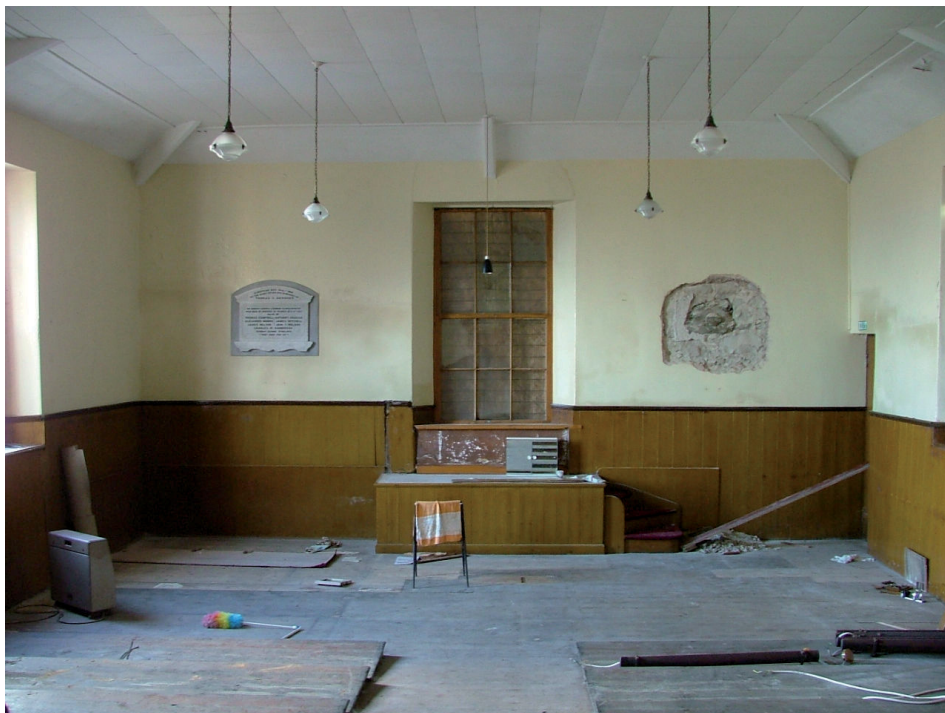
**Plate 12** – Interior of chapel showing timber flooring and pulpit at northern end

- 5.2.2 The floor of the chapel is constructed of timber floorboards, and the level of the floor gradually decreases towards the northern end, where the pulpit is situated (Plate 12). Although the pews were no longer *in-situ*, scarring on the walls and the platforms for the pews provide evidence for eight rows on either side of the church (Plate 13).

- 5.2.6 Parts of the rafters which form the hipped roof were visible in each corner of the chapel interior, as well in the middle of each elevation (See Plate 12). The edges of these timbers were chamfered which provides a hint of architectural detail. The ceiling was constructed of modern tiles, and where these tiles had fallen away, it was possible to observe that some modern insulation had been installed to the underneath of the roof slates.

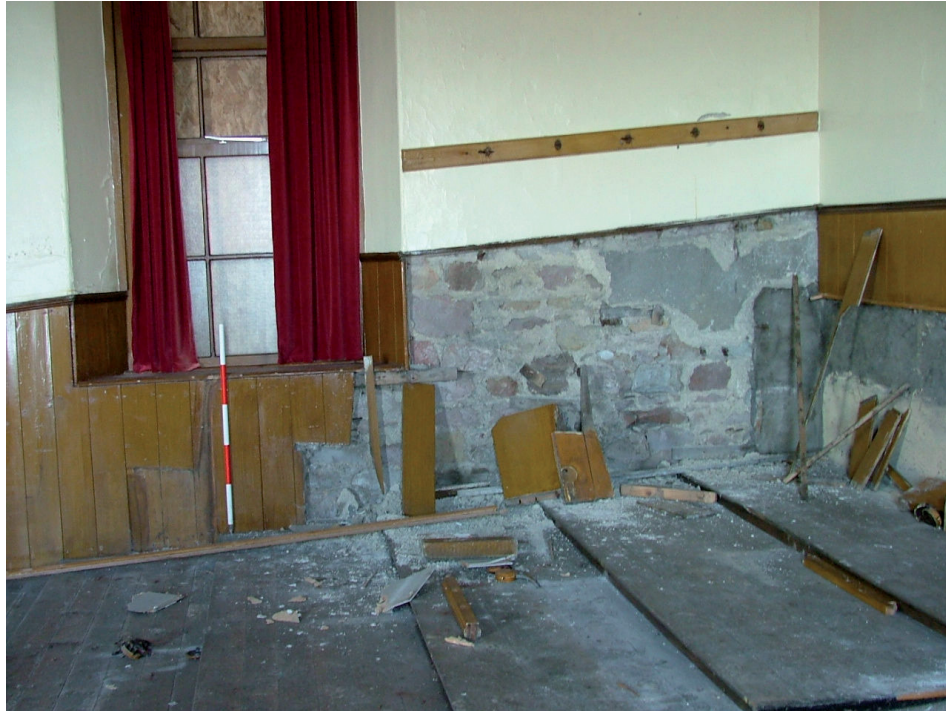
**Plate 13** – Interior of chapel showing platforms and scarring from former pews

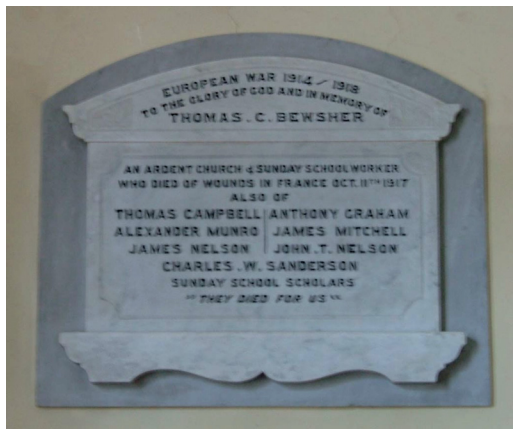
**Plate 14** – Thomas Bewsher memorial

- 5.2.4 On the northern interior wall is a marble memorial dedicated to Thomas C Bewsher, who died during the First World War in 1917 (Plate 14). This plaque also remembers Thomas Campbell, Alexander Munroe, James Nelson, Anthony Graham, James Mitchell, John T Nelson and Charles W Sanderson. A second plaque, located to the right of the pulpit (and shown on Plate 2), had been removed by the time of survey. There is a further memorial on the western interior wall which is dedicated to John Corlett, who died in 1937 (Plate 15).
