NORTH PENNINES ARCHAEOLOGY LTD

Client Reports No. CP/337/06

**AN ARCHAEOLOGICAL
WATCHING BRIEF
AT
CRANTOCK HOUSE,
GILSLAND,
NORTHUMBERLAND**

NGR: NY 6360 6621

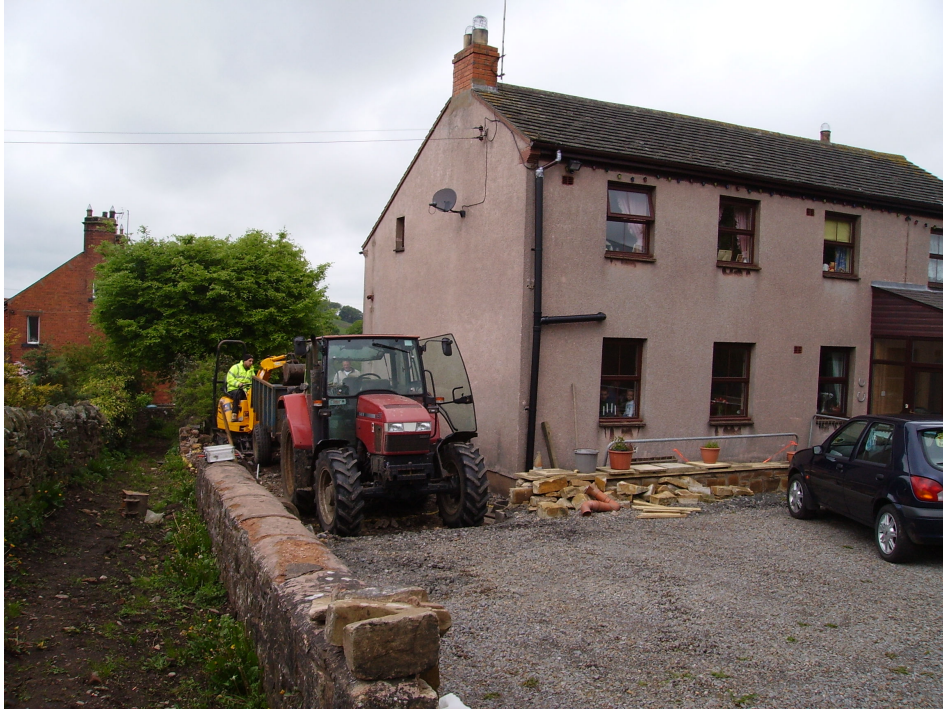
Plate 1: Location of trench to the south of Crantock House, facing west

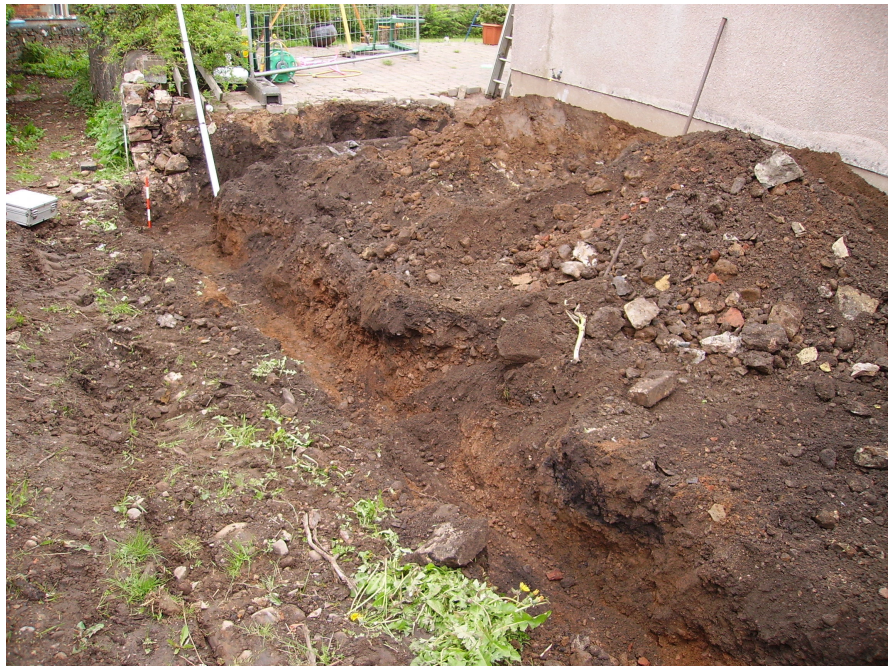
- 4.1.2 The excavation was undertaken on 27th May 2006. It began with the western side of the foundation trench where machining removed 0.4m of dark blackish grey clayey silt, interpreted as old garden soil. This overlay a mid-orange sandy gravel with sub-rounded large stones, containing brick. This was a redeposited natural. Remnants of a sandstone wall were observed along the southern edge of the trench, beside the path, which had been mortared. This was modern.

- 4.1.3 The excavation of the south side of the trench followed the same profile as the western side. Here the redeposited natural layer became increasingly more clayey and silty, and the topsoil decreased to a depth of 0.25m. A brick manhole was observed at the eastern end of the trench.

Plate 2: View of south and west part of the trench, facing north-west

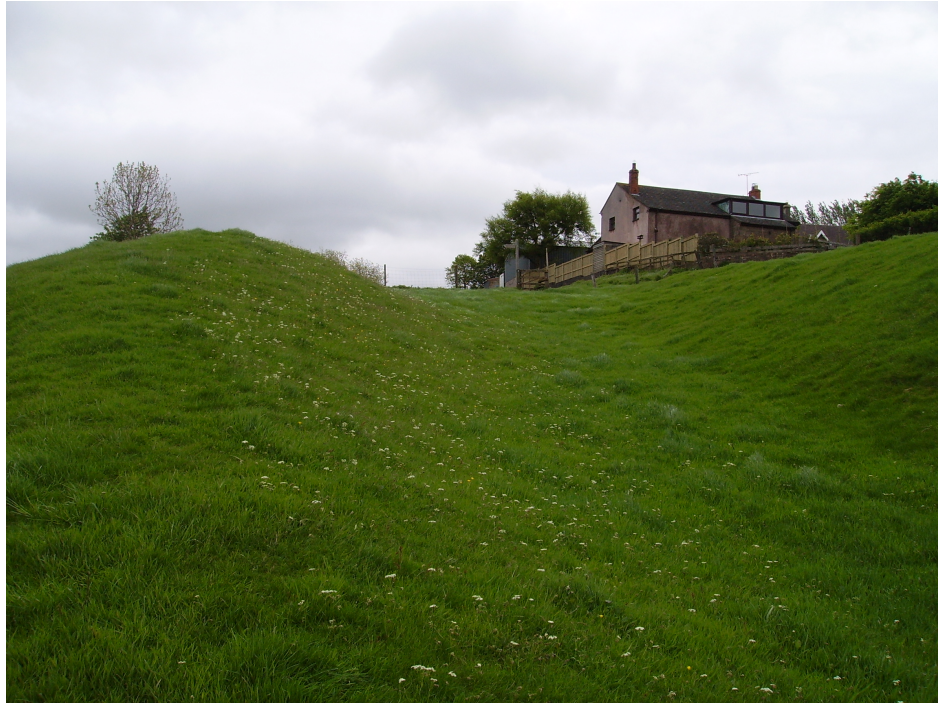
Plate 3: View of visible earthwork remains of Hadrian's Wall World Heritage Site to the north of Crantock House, facing east

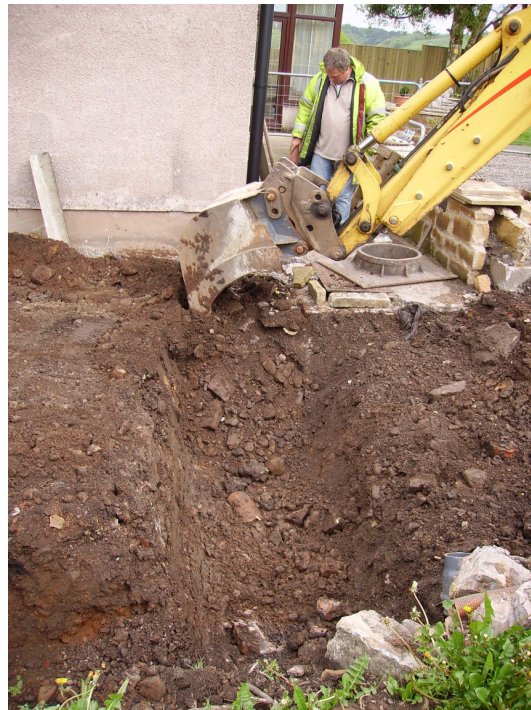
- 4.1.4 The excavation of the eastern side of the trench revealed topsoil of a more rubble-like nature surviving to a depth of 0.6m, which was the total depth of the trench in this area. This was due to the area having been excavated previously for services, including water and sewage pipes. Gravel and clay-like silt was observed at the base of the trench, similar to that encountered in the south side. High quantities of brick rubble and concrete was observed in the topsoil.

Plate 4: View of eastern section of trench under excavation, facing north
