NORTH PENNINES ARCHAEOLOGY LTD

Client Report No. 335/06

In June 2006, North Pennines Archaeology Ltd undertook an archaeological field evaluation on land at Church Lane, Melmerby, Cumbria, in advance of a proposed affordable housing development by Eden Housing Association. This work was requested by Cumbria County Council Historic Environment Service in advance of the planning application which would affect an area considered to have archaeological potential, as identified by a previous Rapid Archaeological Desk-Based Assessment (Hewitt, R and Beatty J, 2005, *Rapid Archaeological Desk Based Assessment for Land at Church Lane, Melmerby, Cumbria, NPA report CP/234/05*).

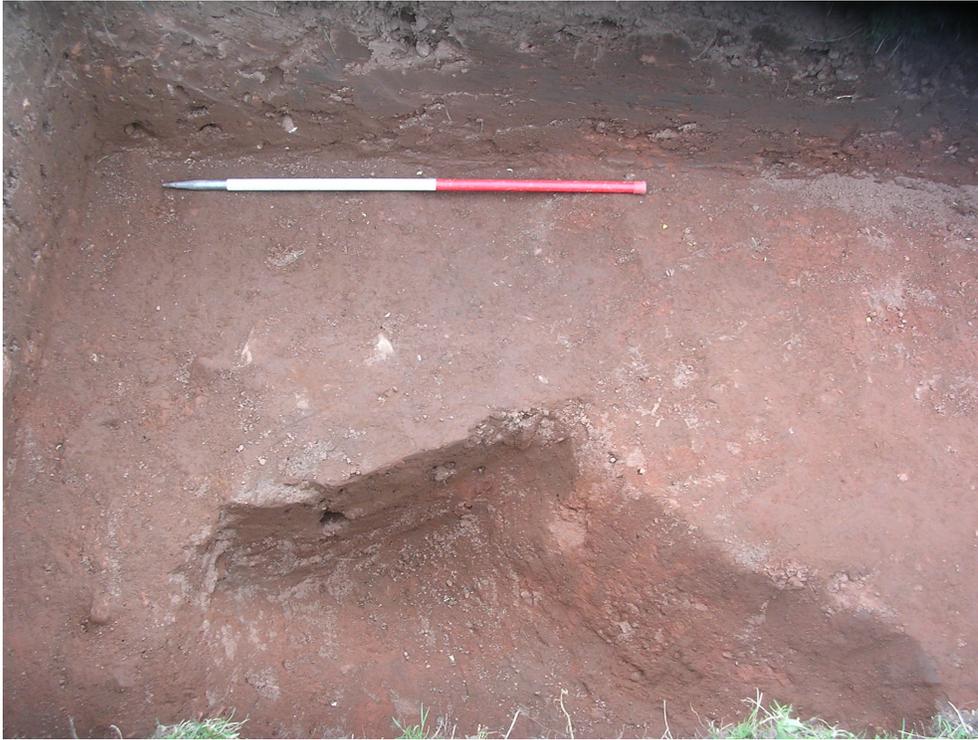
Plate 1: Ditch [104] under excavation. Looking west.

- 5.3.4 The feature, cut [104], was identified as a ditch running on a north-south alignment containing fill [105], a fairly compact dark brown silty sand with frequent small stone inclusions.

- 5.3.5 There is no dating evidence for this feature, and the environmental sample taken from fill [105] revealed nothing of interest.
- 5.3.6 Trench 3 produced one sherd of medieval pottery, found within subsoil [103].

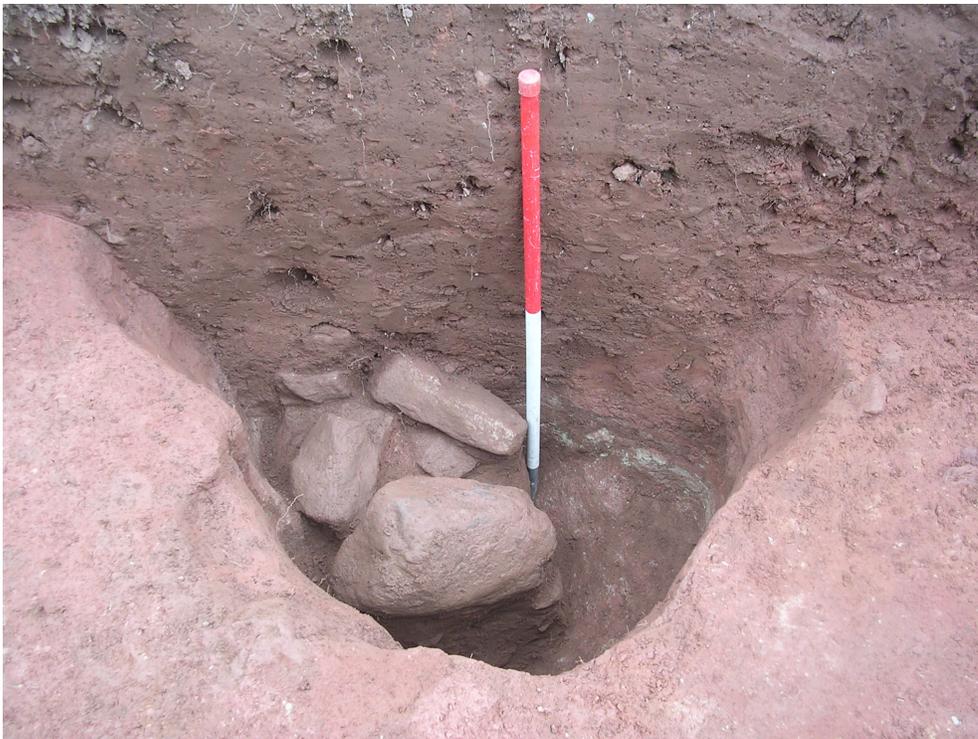
Plate 2: Possible wall butt-end. Looking southwest.

- 5.2.4 The feature was recorded as being cut from the surface of natural [102], the maximum depth being 1.46m below turf height. The cut, [106], was observed to still bear the marks of the original spades that cut it, with nearly vertical sides angling sharply east within the small area observed. The cut contained a mixed orange and yellow clay matrix [110] within which large stones [111] were set. A compact dark red-brown silty

sand deposit [107] had built up against [110]/[111] in antiquity, indicating that the feature had been open to allow for natural silting to take place.

- 5.2.5 There is no dating evidence for this feature and the samples taken produced nothing of interest. Without observing more of the feature it is difficult to ascertain the precise nature of this feature, though it can be tentatively suggested that it may be a wall foundation from the feature's structure.
- 5.2.6 Trench 2 produced no finds barring a sherd of modern/post medieval pottery and a sherd of modern glass.
- 5.2.7 *Stratigraphic Summary:* Overlying both feature [106]/[107]/[110]/[111], and the subsoil, [103], was the topsoil/turf [100]. The topsoil [100] averaged a depth of 0.28m with the subsoil layer [103] below measuring a minimum of 0.12m in the north-eastern end of the trench, deepening to 0.62m in the south-western end. Below this lay natural [102].
