NORTH PENNINES ARCHAEOLOGY LTD

Project Designs and Client Reports No. CP/250/05

North Pennines Archaeology Ltd. were approached by Northumbrian Water PLC to design a programme of archaeological recording following the clause placed on the planning consent for a programme of recording, by the Northumberland County Conservation Team, on areas in Hexham disturbed by a Water Mains Refurbishment Scheme. This archaeological recording took the form of a watching brief, as required, adhering to the brief and Written Scheme of Investigation. This report outlines the results of this programme of archaeological monitoring.

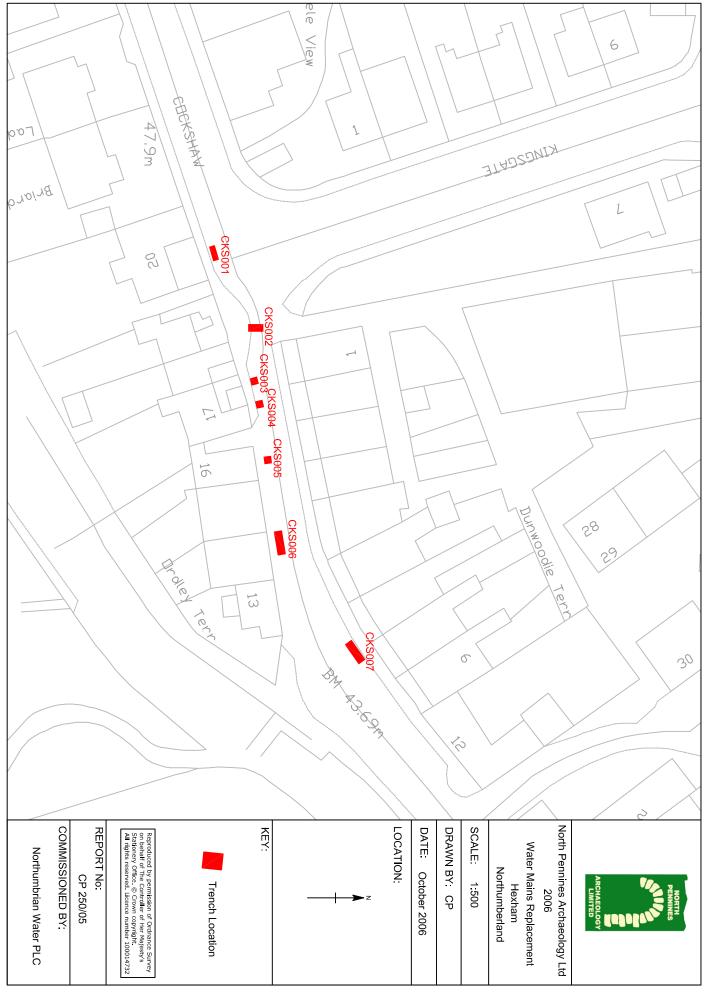
Figure 12 : Location of Test Pits on Cockshaw

- 4.1.23 A total of 7 test pits were observed in this area. None measured more than 3.2m in length, 2.1m in width or 1.0m in depth. All test pits showed evidence of heavy previous disturbance, containing services and mixed backfill. No natural was visible and no archaeological features were observed in any of the test pits in this area of Hexham.

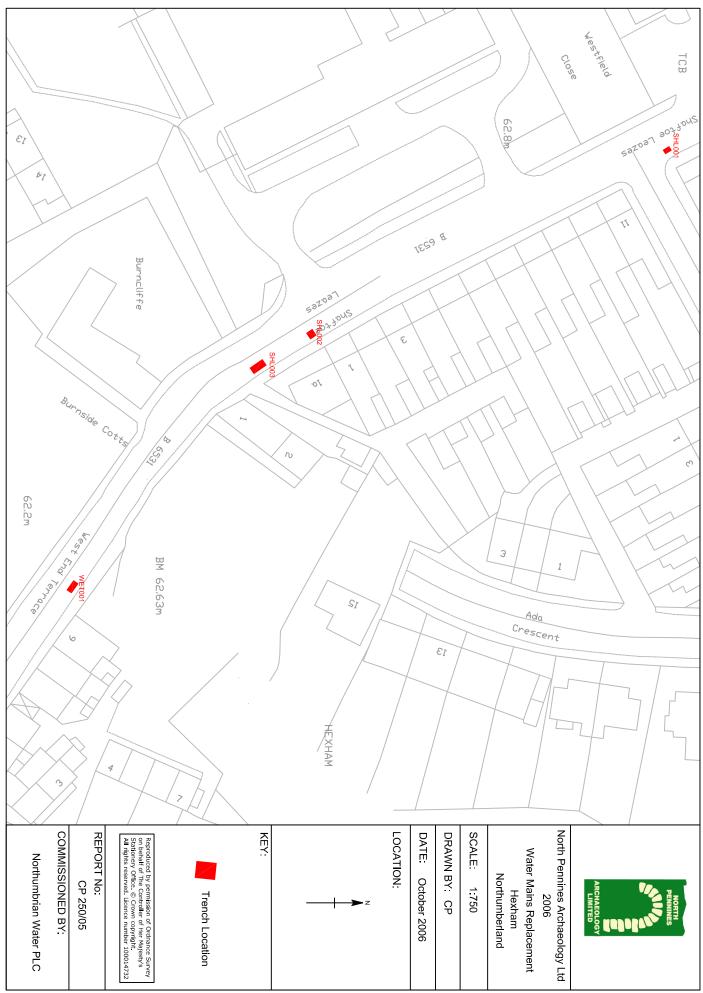
4.1.27 *Shaftoe Leazes (SHL: Fig 14):* Shaftoe Leazes is located on the B6531, to the west of Temperley Place. It forms the westernmost area observed during the programme of archaeological mitigation. It was once held by Wentworth Beachmont Esq. and formed a part of the rural hinterland surrounding the settlement in the 1800s (Fig 44). The image below shows what the area looked like as it underwent groundworks.

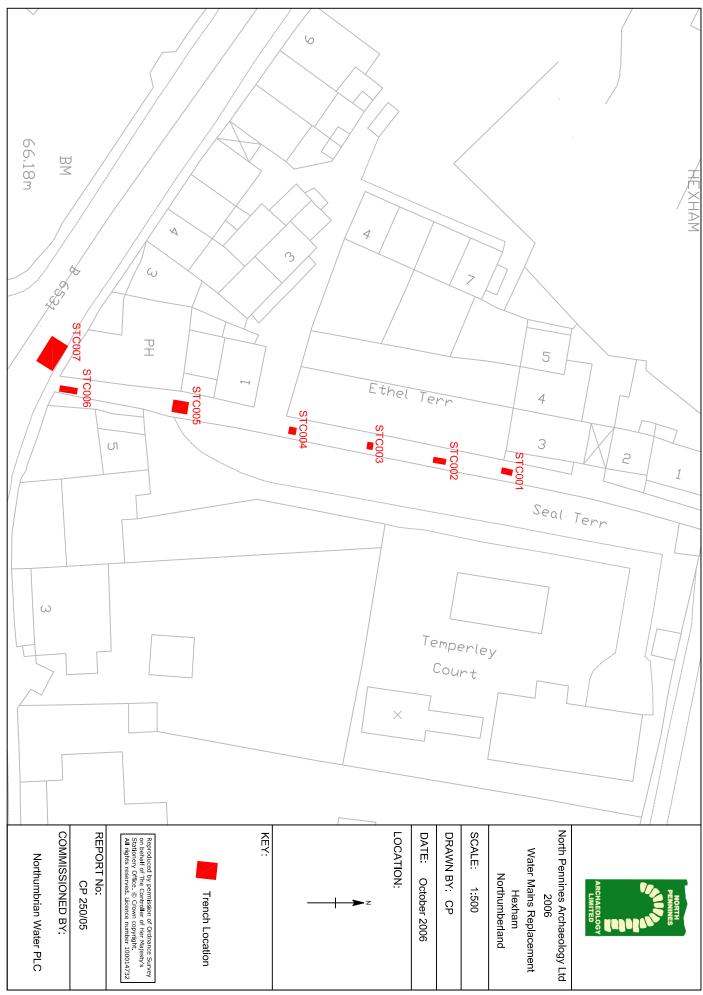
Figure 15 : Location of Test Pits on Seal Terrace

- 4.1.32 7 test pits were observed in this area, the largest being STC007 measuring 3.92m by 2.55m by 1.03m. All test pits contained a mixed mid-brown backfill overlain by a modern tarmac surface. STC001 produced some fragmentary pieces of clay pipe, and SCT002 included ceramic drain fragments. No other archaeological features were encountered during these works. The image below shows Seal Terrace during excavations.

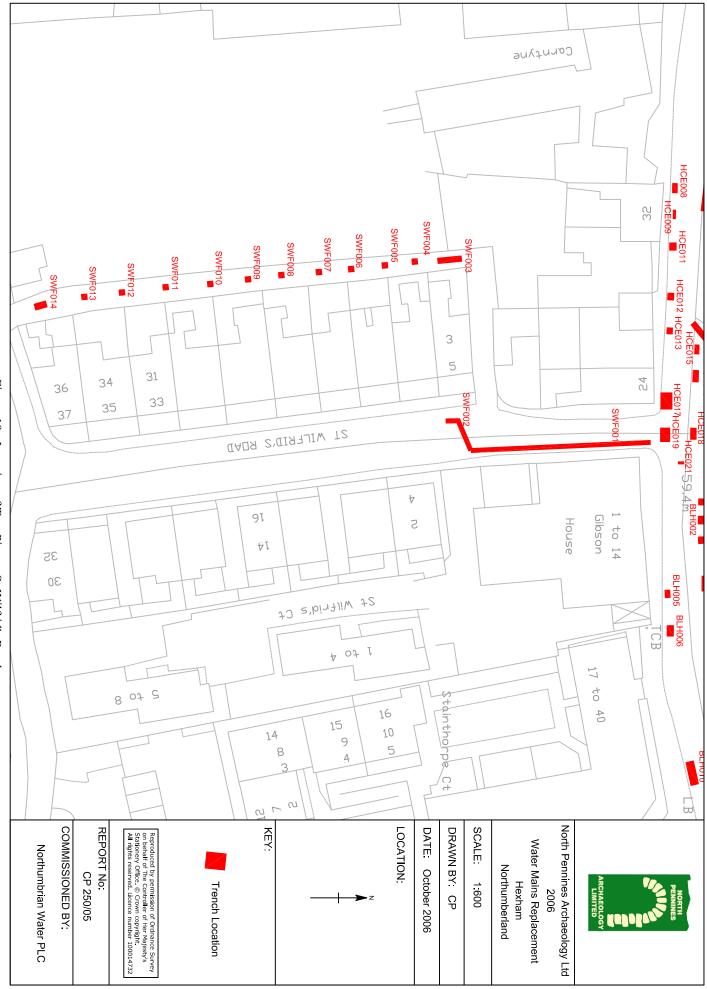
Figure 19 : Location of Test Pits on St Wilfrid's Road

- 4.1.40 14 test pits were observed in this area, none exceeding 3.9m in length, 1.0m in width and 1.75m in depth, although SWF001 was later extended to meet SWF002, creating a total excavation length of 28.5m. The test pits excavated at the north end of St. Wilfrid's Road (i.e. SWF001 and SWF002) were made up of orange-yellow sand with occasional concrete fragment and limestone hardcore inclusions. Test pits SWF003-SWF014 however, consisted of a mixed brown silty backfill overlain by a thin layer of orange clay, which was in turn overlain by irregular sandstone pieces, which was superseded by a tarmac road surface. Small fragments of pottery were recovered from SWF003, SWF004, SWF005, SWF007, SWF008, SWF009, SWF010, SWF011, SWF012 and SWF014.

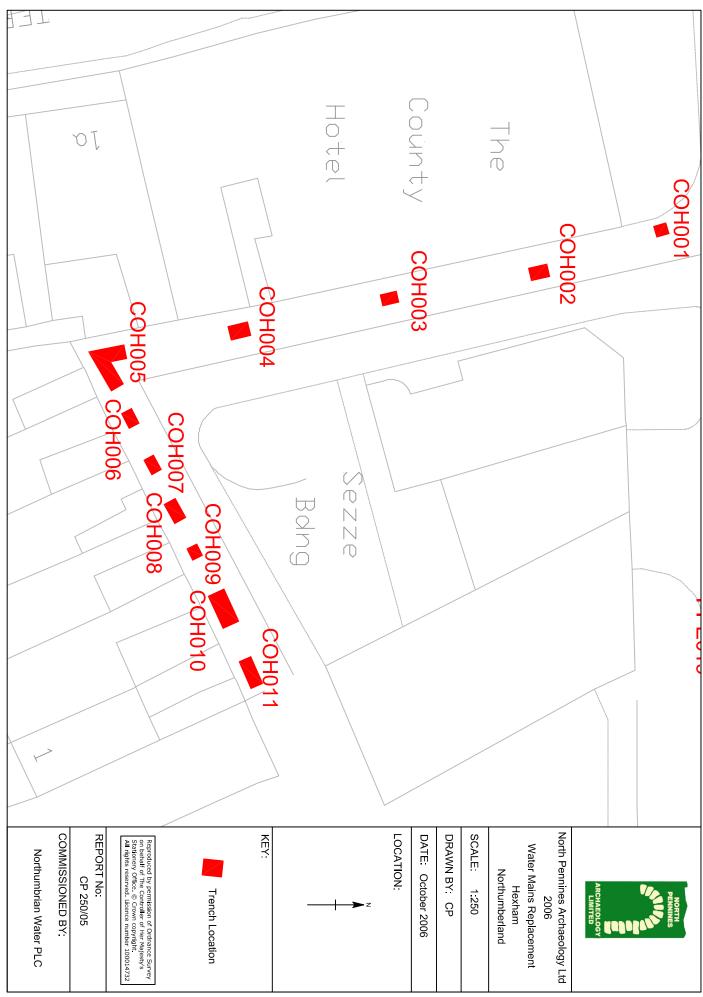
Figure 20 : Location of Test Pits on Argyle Terrace

- 4.1.41 *Argyle Terrace (AGT: Fig 20):* Argyle Terrace runs to the south, from Priestpopple West to the west of the County Hotel. Argyle Terrace is a relatively modern name for

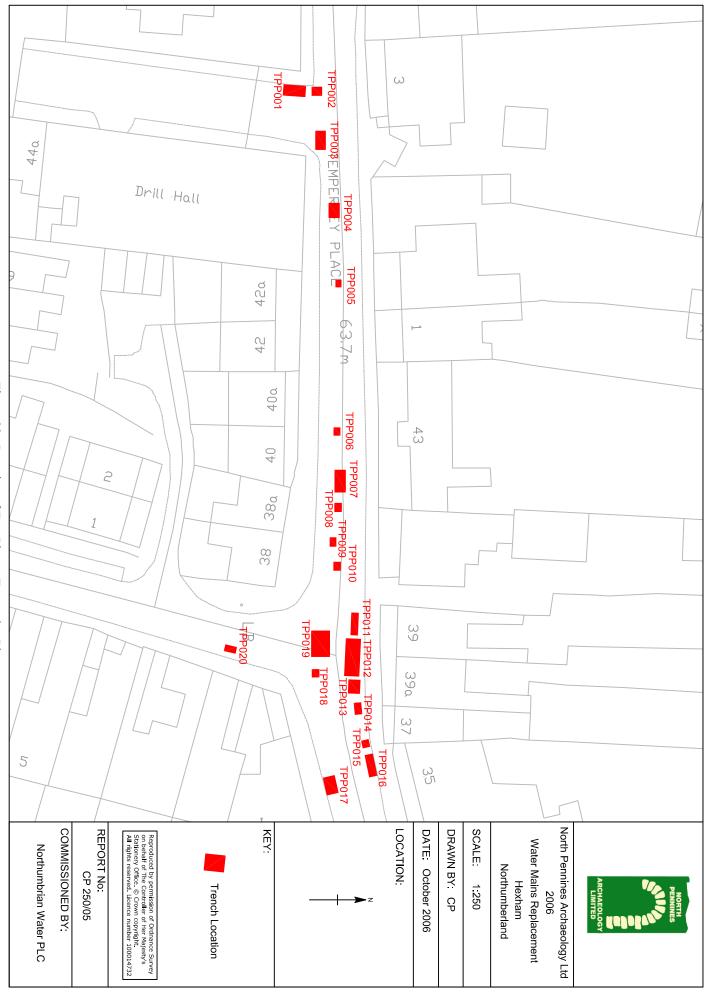
Figure 21 : Location of Test Pits beside the County Hotel

- 4.1.43 Area beside the County Hotel (COH: Fig 21): this area consists of a dog-legged side street leading south, and then east, from Priestpopple (west), providing access to the rears of properties fronting Argyle Terrace and Maiden's Walk. In 1827 the area remained under predominantly agricultural use for buildings on 'Priestpople' (Fig 31). At some time between 1860 and 1897, with major building developments in this part of Hexham, this area formed a back alley for surrounding buildings (Fig 34).

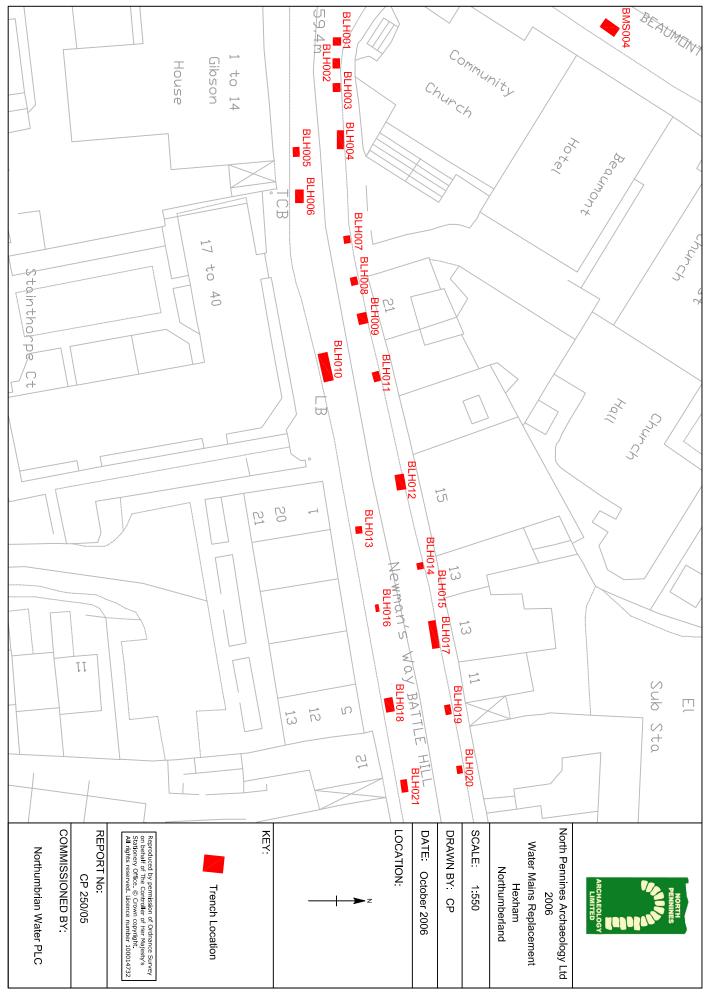
Figure 24 : Location of Test Pits on Hencotes (east)

- 4.1.49 *Hencotes (east) (HCE: Fig 24):* Hencotes (east) forms a part of the B6305, which is the main thoroughfare through the south part of the centre of Hexham, adjoining to the west, Hencotes (west), and to the east, Battle Hill, and is centred around the junction of the B6305 with Beaumont Street which runs northwards. The north side of Hencotes (east) was the Abbey Grounds in 1827 (Fig 31), which remains the case today. A square building existed on the same plot as the present church at this date. This part of Hexham had the potential to yield archaeological evidence for pre-existing street surfaces, or buildings fronting the street, particularly on the south side.
