NORTH PENNINES ARCHAEOLOGY LTD

Client Reports No. CP/424/06

REPORT ON AN
ARCHAEOLOGICAL
BUILDING RECORDING
PROJECT AT
GATEHEAD CHAPEL
GARRIGILL
ALSTON
CUMBRIA

04 January 2007

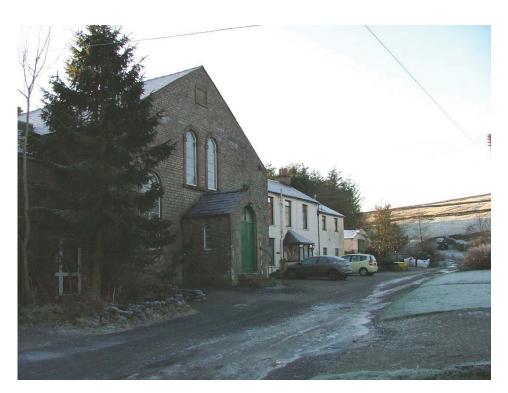
Plate 1 – Gatehead Chapel as seen from the north

- 1.2.2 Gatehead Chapel is situated at the southern end of the village of Garrigill to the west of the road which continues southwards to Tynehead. The rough track immediately in front of the chapel forms part of the Pennine Way which continues south-westwards over Skirwith Fell and towards the Eden Valley. The chapel forms part of a row of houses fronting the track (Plate 1).

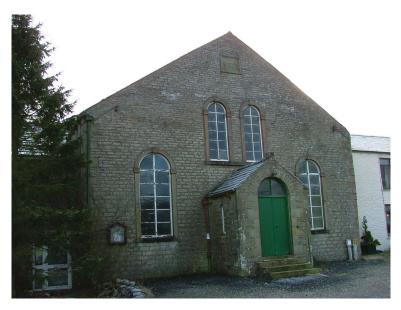
Plate 2 – North-west elevation of Gatehead Chapel

- 5.1.3 On each side of the porch, in the main frontage, is a large window with a further pair above the porch itself (Plate 2 and Figure 5). These arched windows have dressed rectangular pieces of what appears to be sandstone masonry which make up the surround, with a 'keystone' and 'imposts' where the arches terminate which provides architectural detail to the main façade. The window frames are wooden.

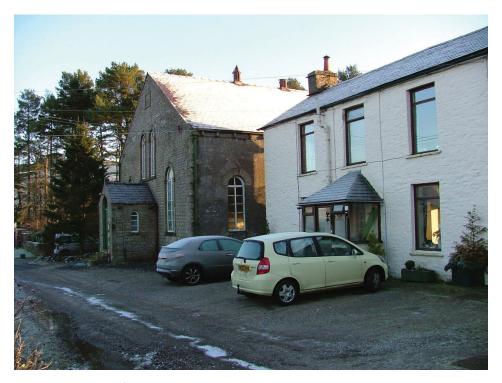
Plate 3 – Gatehead Chapel as seen from the south-west

- 5.1.1 The main body of Gatehead Chapel is rectangular in shape and measures approximately 14 metres in length by 12 metres in width externally and is constructed of coursed and squared limestone, bonded with cement mortar. The quoins consist of alternating long and short blocks of squared and dressed masonry (Plate 2). The roof is laid in Welsh slate with ceramic ridge tiles. There is a chimney on the southern end of the roof and two iron ventilation flues along the ridge (Plate 3).

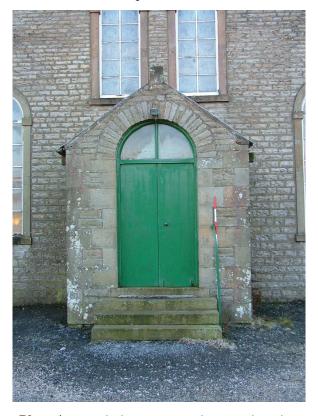
Plate 4 – Porch doorway, north-west elevation

- 5.1.2 On the north-west facing elevation is a gabled porch with a central doorway with arched head (Plate 4). Like the quoins, the jambs of the doorway consist of alternating long and short blocks of dressed masonry. Four steps up provide access to the doorway. On either side of the porch are windows with similar arched heads to that of the main doorway (Plate 5). Stone supports for the guttering remain *in-situ*, although not all of the guttering itself is present; the down pipes do, however, still survive either side of the porch (Plate 5).

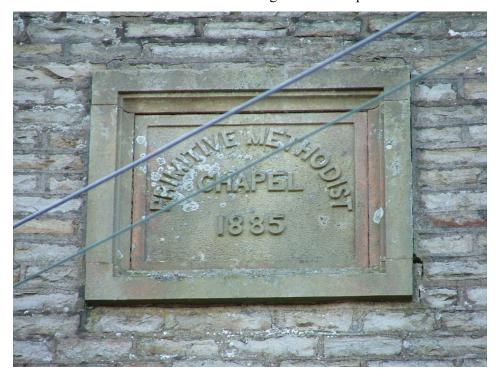
Plate 6 – Inscription, north-west elevation

- 5.1.4 Above the central pair of windows on the north-western elevation, close to the apex of the gable, is a stone inscription 'PRIMITIVE METHODIST CHAPEL 1885' (Plate 6).

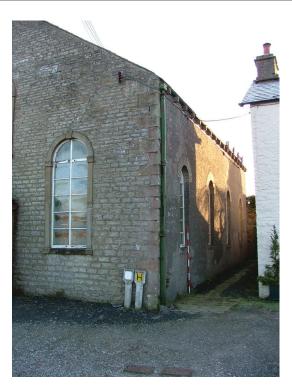
Plate 7 – South-west elevation

- 5.1.5 The south-west elevation (Figure 5) of the chapel was largely obscured by the cottage next door, although there is an alleyway which divides the two (Plate 7). This elevation (which unlike the main façade has been rendered) has four large arched-head windows, although the arches are the same as those over the doorway and the windows in the porch, and not like those of the windows in the main façade facing the track, suggesting that there was no need for architectural detail on an elevation which was not going to be seen from the road or village. Stone supports for the guttering remain *in-situ* all along this elevation at eaves level. The alleyway between this elevation and the property next door provides access to the school room at the rear of the chapel and to the two outbuildings (Figure 7).

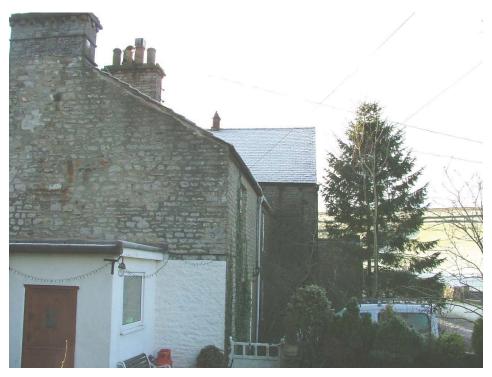
Plate 8 – North-east elevation, largely obscured by the adjoining cottage

- 5.1.6 The north-east elevation of the chapel is also largely obscured, this time by an adjoining cottage (Plate 8 and Figure 6). There would only appear to have been one window in this elevation, at the southern end, which is the same as those observed on the south-west elevation. As with the south-west elevation, the north-eastern wall has been cement rendered.

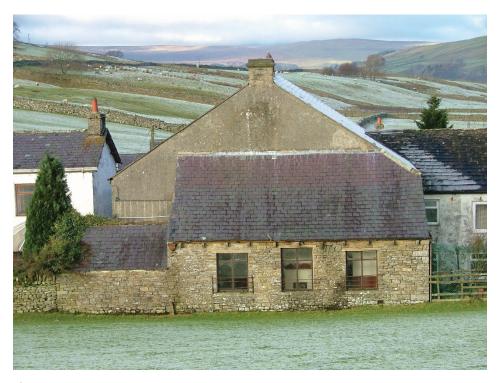
Plate 9 – South-east elevation showing the school room and outbuilding to the rear of the chapel

- 5.1.7 The south-east elevation faces into a field behind the chapel (Plate 9). Against this elevation is the school room and outbuildings, both of which have pitched roofs of Welsh slate. The pitch of the roof for the school room appears to be quite high, and to prevent the line of this roof projecting from the main body of the chapel, the easterly section has been 'cut off' to fit in with the roof of the chapel (Plate 10). Plate 10 also shows the relationship between the main chapel and the adjoining cottage, with the roof of the cottage built into that of the chapel. Although on first appearance this would suggest that the cottage was constructed after the chapel, this may not necessarily be the case, as the cottage could have been re-roofed at the time of the chapel's construction. What is exposed of the main elevation of the chapel has been rendered, although the south-west elevations of the school room and outbuildings have remained untouched (Plate 9). There are three square windows in the south-east elevation of the school room and the stone supports for the guttering remain. The smaller outbuildings to the south-west of the school room have no features in the south-east elevation.

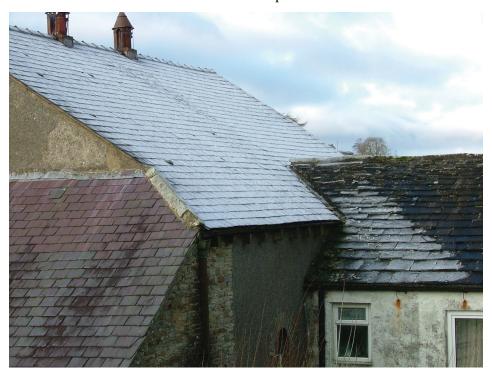
Plate 10 – Join of the roofs of the main chapel, the school room (left) and the adjoining cottage (right)

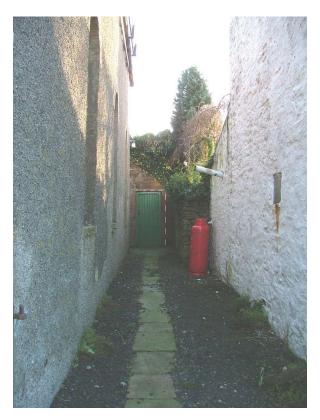
Plate 11 – Alleyway down side of chapel provides access to outbuildings and school room

- 5.1.8 Access to the outbuildings and the school room at the rear of the chapel is down the alleyway to the side (Plate 11 and Figure 7). The outbuildings consist of two separate rooms, one presumably a store and the other a toilet. Above the doorway into the school room is a small doorway which provides access into the roof space above (Plate 12). This was presumably used for storage and may indicate why the pitch of the roof appears steep, to allow more space.

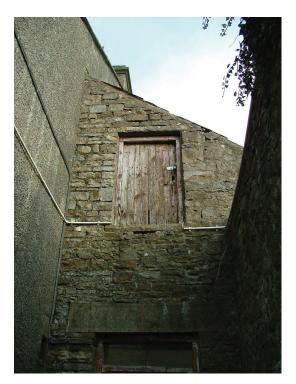
Plate 12 – Doorway to attic space above school room

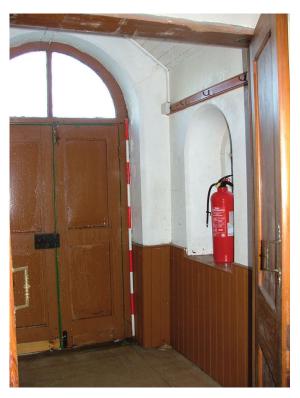
Plate 15 – Interior of porch showing inside of main doors

- 5.2.1 The main interior of the chapel could be accessed via the main entrance in the porch, or through the school room to the rear (Figure 7). Upon entering from the main doors (Plate 15) in the porch, entrance was through a further set of doors, at which point a lobby provides access into the main body of the chapel either to the left of the right, each side having its own set of doors (Plate 16). The wooden partition which makes up the lobby has a square window to provide light. This partition itself presumably acted as a protection against the wind and prevented draughts blowing into the chapel.

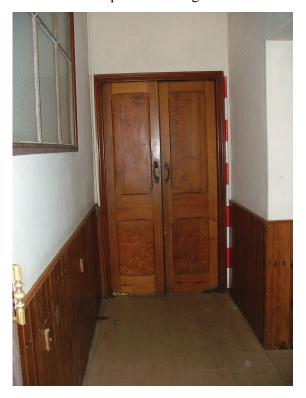
Plate 16 – Doors into main body of chapel from lobby (RH side)

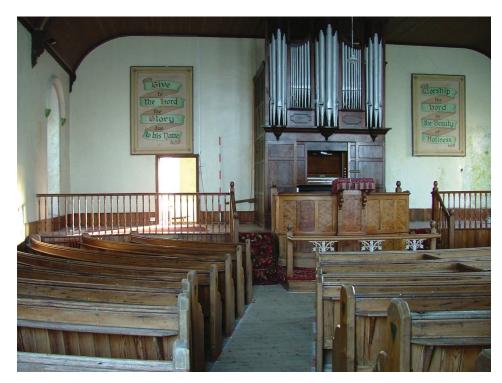
Plate 17 – Interior of chapel showing curved pews, preacher's reading desk and organ

- 5.2.2 The interior of the chapel still retains its wooden pews which are laid out in curves facing the preacher's reading desk and organ which are set on a platform at the southern end of the chapel (Plates 17 and 18). The floor level decreases from the back of the chapel towards the front where the reading desk and organ are situated, this is reminiscent of the floor at the recently recorded Parton Methodist Chapel near Whitehaven, where the congregation would have sat on pews which decreased in height from the back towards the front where the preacher would stand¹⁵, emphasising the importance of the readings compared to the altar of the established church.

- 5.2.6 Located on the southern interior wall of the chapel, either side of the organ, are two painted boards in wooden frames which read 'Give to the Lord the Glory due to his Name' (LH side) and 'Worship the Lord in the Beauty of Holiness' (RH side) (Plate 17).

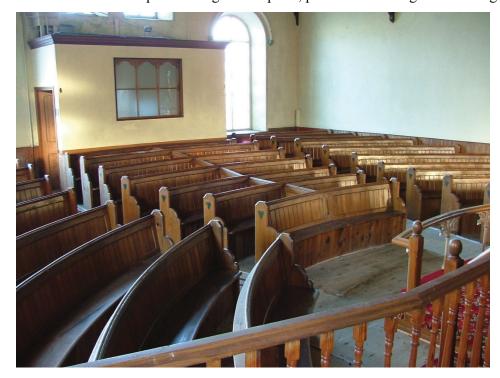
Plate 18 – Pews as seen from platform at southern end of chapel, showing entrance lobby with window in background

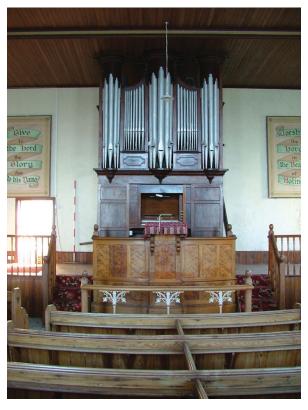
Plate 19 – The organ, centre of the platform at south end of chapel

- 5.2.4 The organ is situated at the centre of the platform at the southern end of the chapel, behind the preacher's desk (Plate 19 and Figure 7). The organ itself is contained within wooden panels, with the silver pipes arranged decoratively at the top. The keyboards remain *in-situ* and there is a small brass plaque fixed just above the upper keyboard which reads 'Rebuilt Nelson and Co, Durham' (Plate 20).

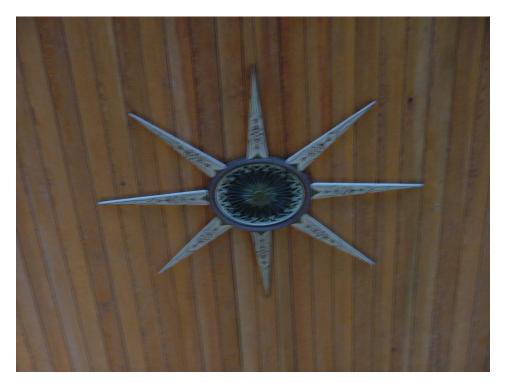
Plate 21 – Star shaped ventilator, ceiling of chapel

- 5.2.7 The ceiling of the chapel is of timber cladding which curves to meet the longer walls. At the centre of the ceiling are two metal star shaped ventilators (Plate 21) which presumably correspond to the iron ventilation flues observed on the ridge line of the roof (Plate 3). The timber cladding is supported by thin 'ribs' which terminate on each long wall in decorative timber 'corbels' (Plate 22).

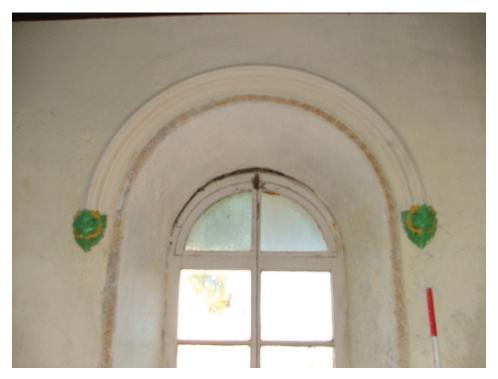
Plate 23 – Detail of decorative window surrounds

- 5.2.8 Internally, the windows have ornamental surrounds, parts of which have at some point been painted in bright greens and yellows (Plate 23).
- 5.2.9 To the left of the organ is a doorway which provides access, down some steps, into the school room. There were few features of note within the school room except for a stone fire surround in the north-western wall. The south-eastern internal wall was observed to be very damp at the time of survey. Set in the floor close to the doorway which provides access to the exterior of the chapel, was a hatch with an iron ring and iron hinges (Plate 24). This hatch gives access to a small cellar, although it was not possible to access the cellar due to the amount of debris deposited there. It was just possible, however using the digital camera to take some photographs of what the purpose of the cellar may have been. From the photographs it was possible to observe that some of the cellar walls were constructed of brick, that there were some piles of coal still *in-situ* and, what appeared to be, a boiler remained(Plates 25 and 26).. The boiler had a suppliers label on its top which read: Santon Ltd, possibly of Newport

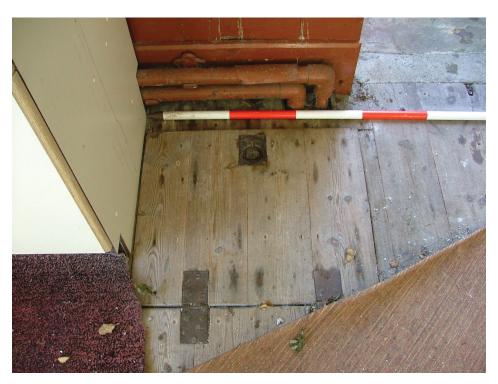
Plate 24 – Hatch in floor of school room provides access to boiler

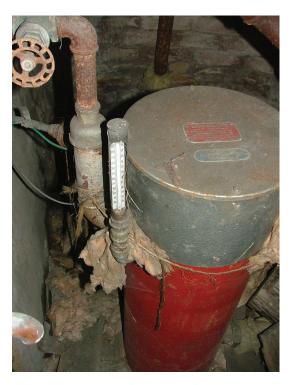
Plate 25 – Boiler Cellar beneath school room

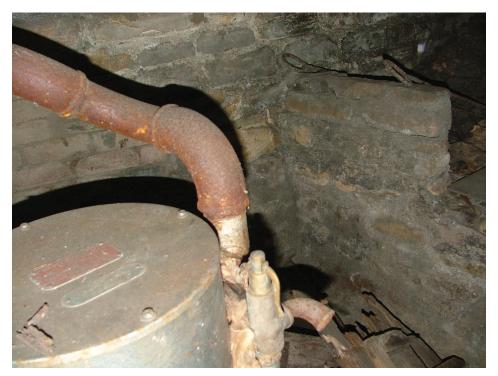
Plate 26 – Brick walls in the cellar and top of boiler
