NORTH PENNINES ARCHAEOLOGY LTD

Client Report No. CP404/06

In December 2006, North Pennines Archaeology Ltd undertook an archaeological field evaluation on land at Willowford Farm, Gilsland, Cumbria (centred on NGR NY 362484 566526). This work was requested by Mike Collins, English Heritage Hadrian's Wall Archaeologist (EHHWA) in response to a planning application by Michael Birnie of Smiths Gore. The main aim of the evaluation was to provide a predictive model of surviving archaeological remains pertaining to detailing their character, condition, and significance, which would enable the client to proceed in a highly informed way.

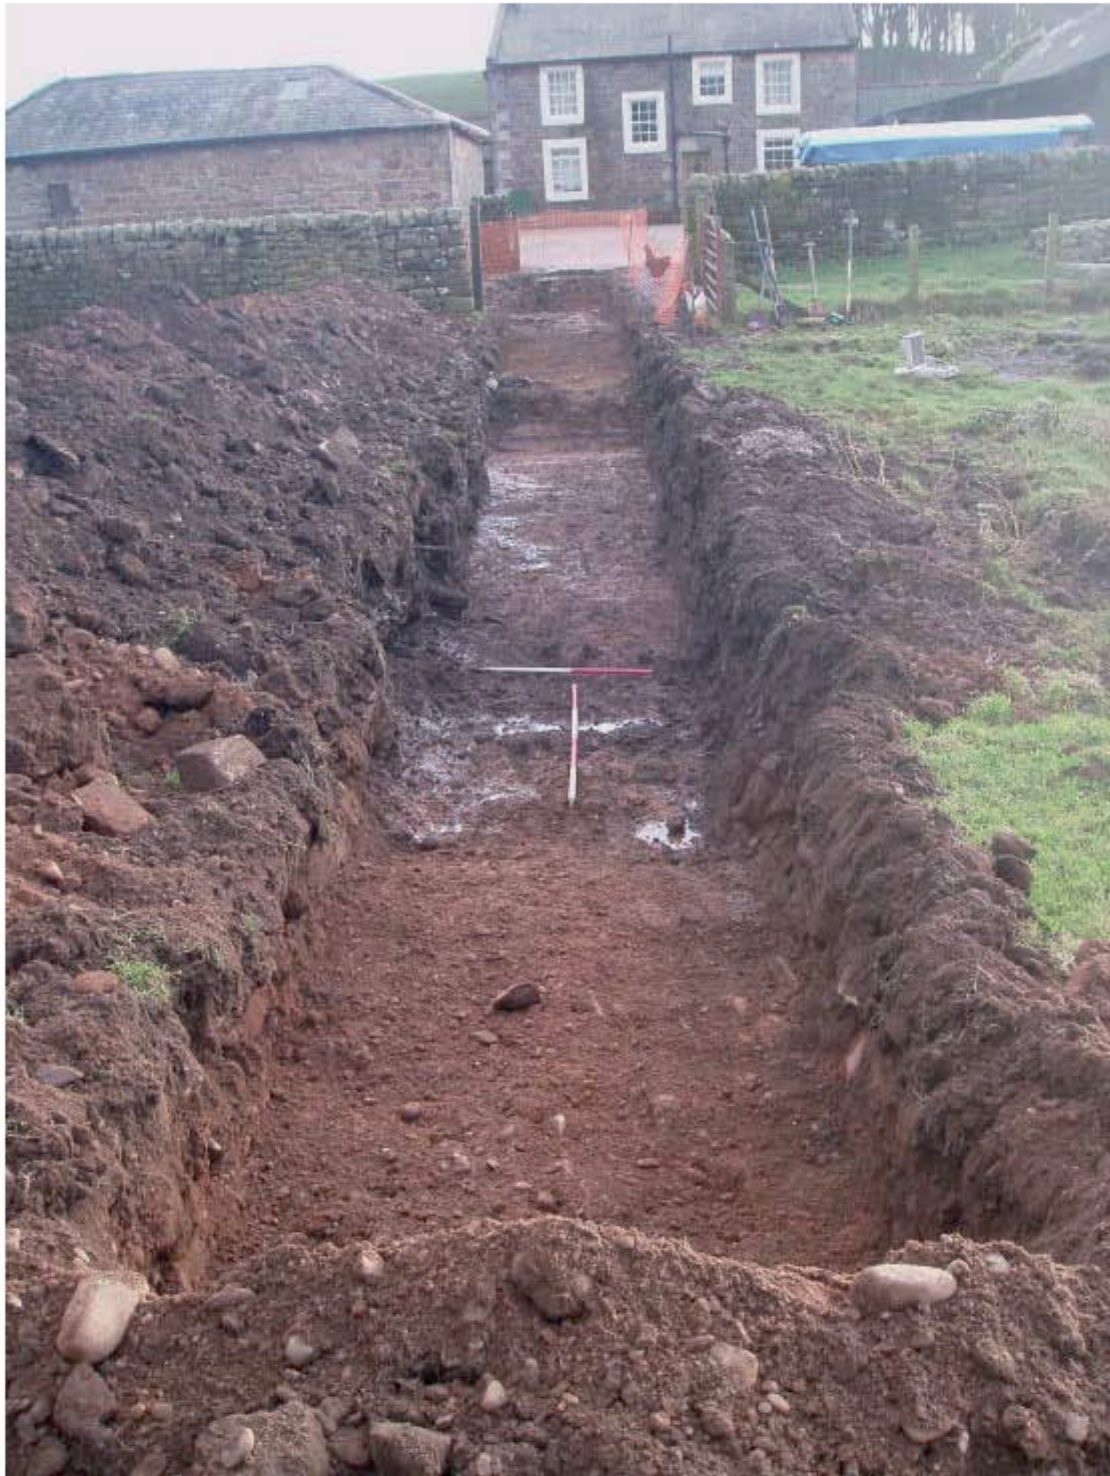
Plate 1: Trench Location, Hadrian's' Wall in the background and the Wall Ditch in the foreground, facing south

4.2.1 The evaluation trench was located immediately to the north of Willowford Farm and measured 1.6m wide by 28m long, and was orientated north-south (Fig 3, Plate 1). The trench was positioned over the projected line of Hadrian's Wall and associated ditch. The natural subsoil (**100**), which consisted of a moderately compacted brownish orange silty sand, was encountered at a maximum depth of 0.65m and sloped down from south to north from a level of 130.29m to 128.97m AOD.

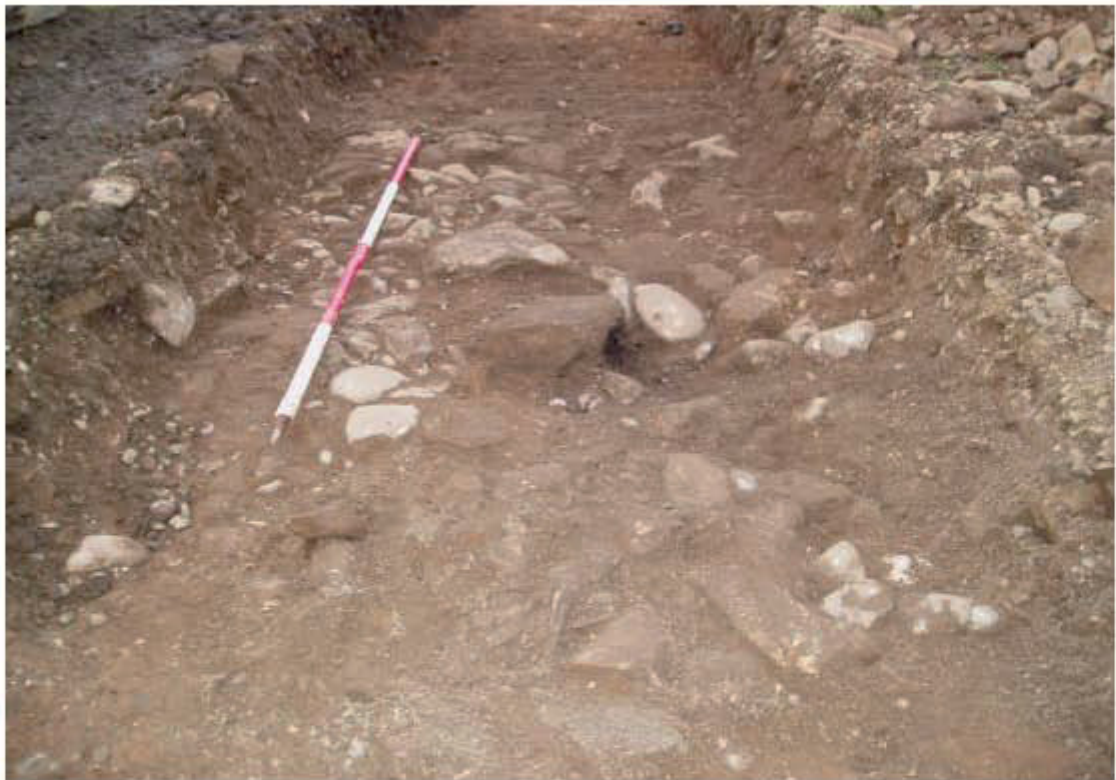
Plate 3: Cobbled surface (106), facing north

4.2.4 Sealing the Wall foundation was a deliberately laid layer of compacted small to medium sized stones, (**106**) which appeared to form part of an earlier surface again of post medieval date. It is likely that when masonry from the Wall was removed down to its foundation course for re-use elsewhere, it formed a void which had to be filled in order to provide access to the fields surrounding the farm (Fig 4, Plate 3).

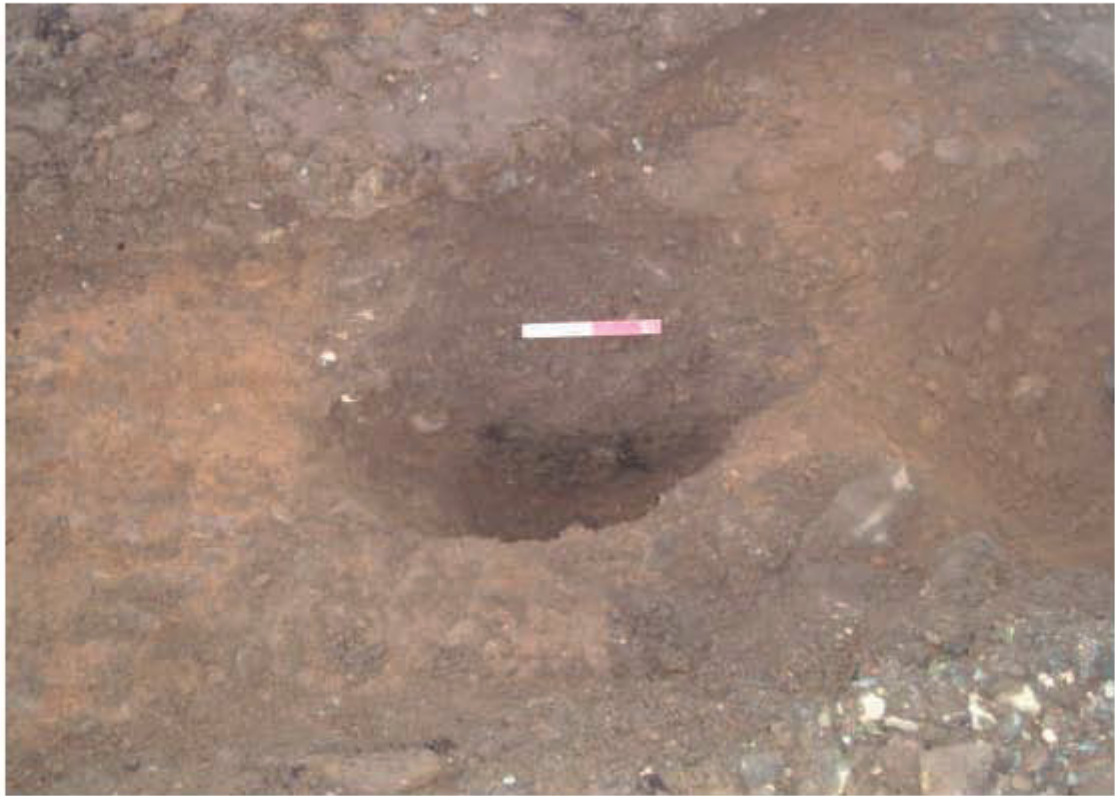
Plate 4: Posthole [105], facing east

4.2.3 Contained entirely within the Wall foundation, was a large sub-rounded posthole [**105**], measuring 0.70m wide by 0.66m deep. It contained a single fill (**104**), which consisted of dark almost black organic material, which was formed by a large timber post that was left to degrade in-situ. It is likely that this feature formed part of a fence post/gate post of post-medieval date (Fig 5, Plate 4).

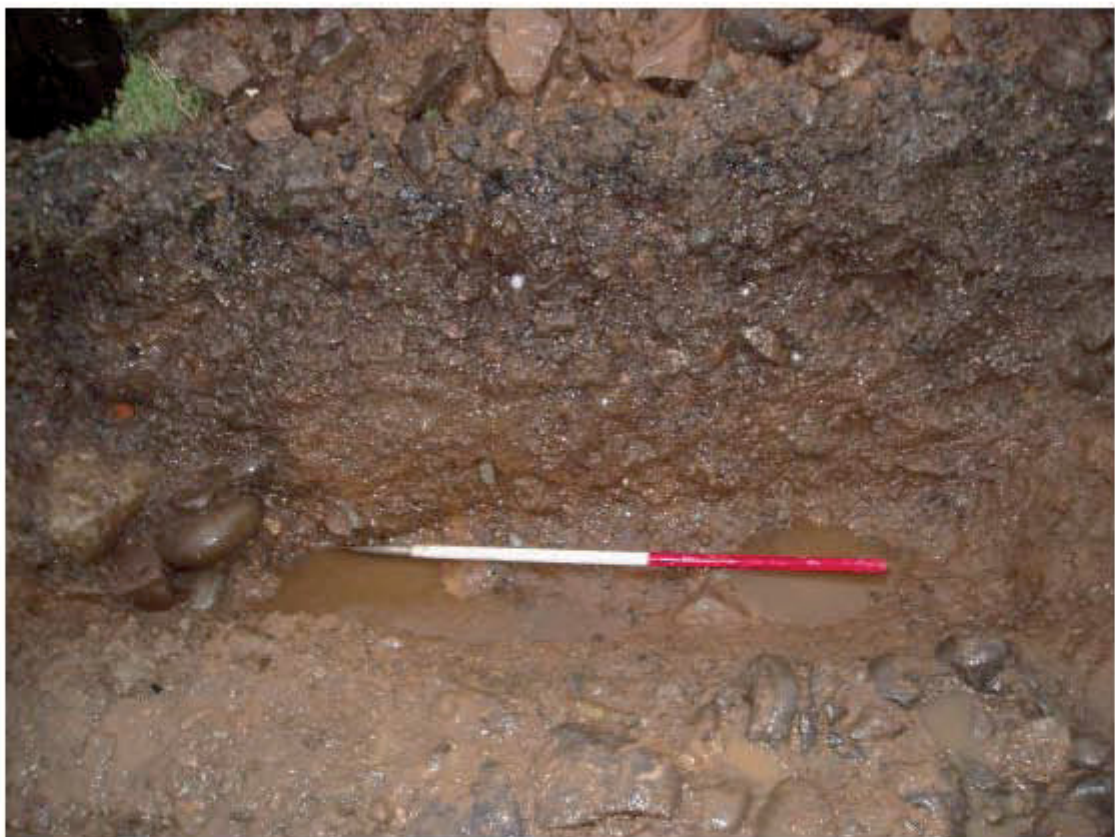
Plate 5: Cut [103], showing Wall core (102), left side of picture, facing east

4.2.2 Towards the southern end of the trench the foundation cut for Hadrian's Wall [103] was recorded cutting the natural subsoil, (**100**). It measured approximately 3.2m wide and 0.35m deep with almost vertical sides and a flat base. No evidence of facing stones from the Wall, were revealed due stone robbing, however fragments of the core of the Wall (**102**), was visible. It consisted of large river washed stones varying in size up to 0.30m in diameter. The fill of the foundation cut (**101**), appears to have been disturbed in the post-medieval period, a single sherd of 19th century domestic ware was recovered as well as several fragments of unidentifiable iron. It is likely that the majority of Wall stones were removed during the construction of Willowford Farm (Fig 4, 5 and 6, Plate 5).

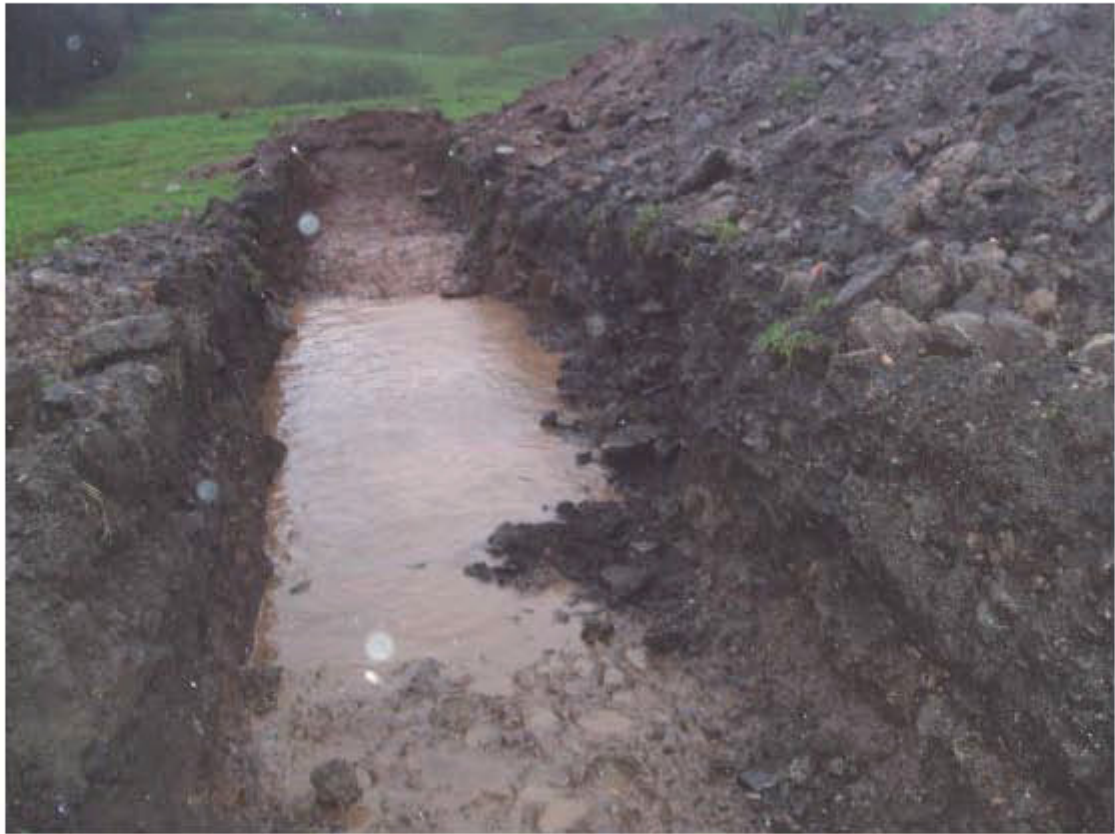
Plate 6: Wall Ditch **[113]**, facing north

4.2.5 At the southern end of the trench, the associated ditch [**113**], was located approximately 10.30m from the Wall. Due to this area of the trench being largely unworkable because of water, it was impossible to expose the ditch and define its full extent. The upper fill of the ditch, (**112**), contained a large amount of stonework from the wall. It is impossible to say if this was a deliberate infilling of the ditch with stone removed from the Wall or

the gradual accumulation of material of a period of time. A single sherd of medieval pottery was recovered from this layer implying that the farm has medieval origins (Fig 4, Plate 6 and 7).

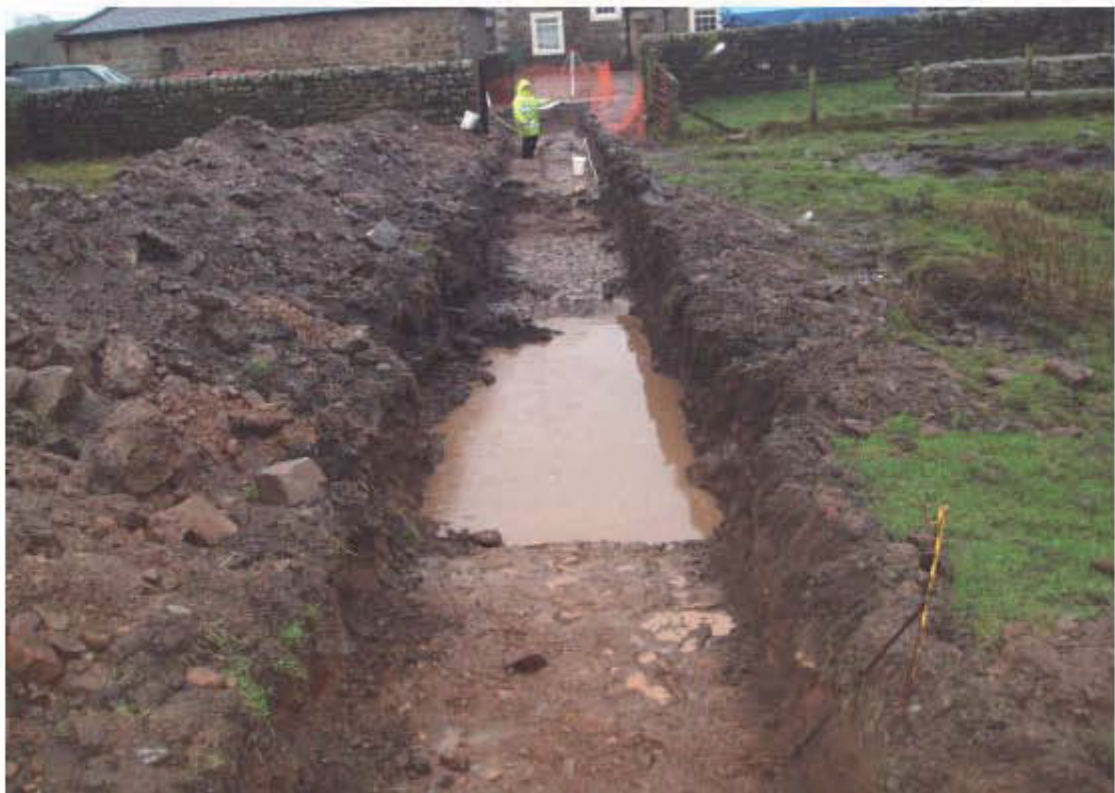
Plate 7: Wall Ditch **[113]**, facing south
