**Client Report No. 426/06**

**REPORT ON  
AN ARCHAEOLOGICAL  
WATCHING BRIEF  
AT CHURCH ROAD, MELMERBY,  
CUMBRIA**

**EDEN HOUSING  
ASSOCIATION LTD**

January 2007

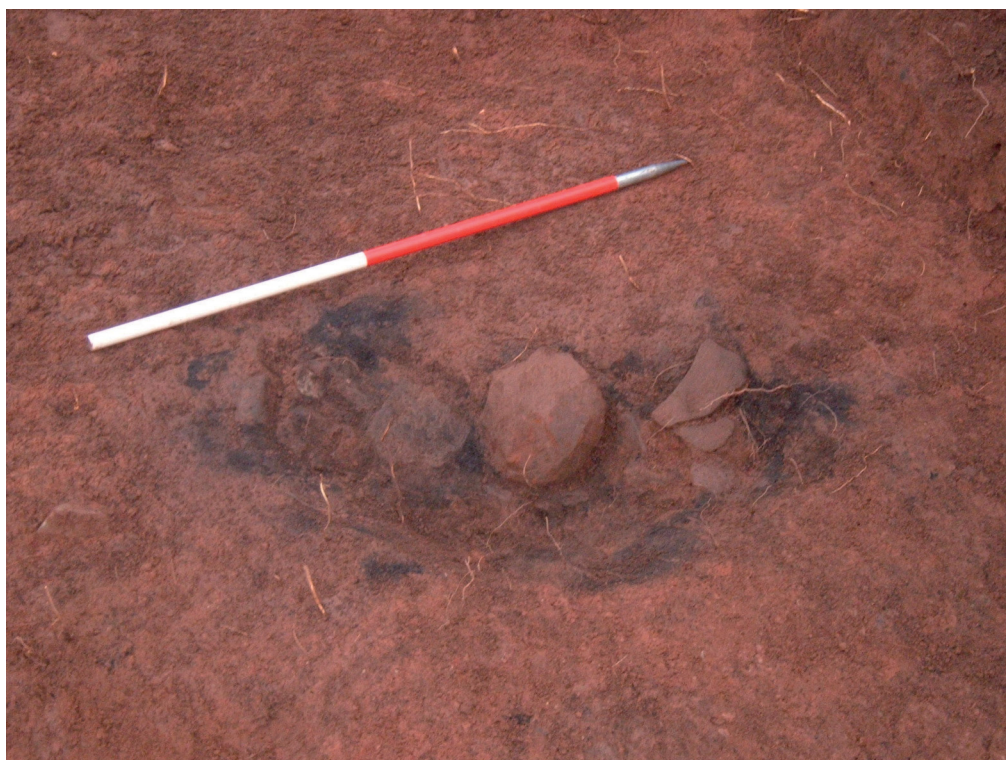
**Plate 1** Fire pit [103], [104] looking west

4.2.3 During the levelling of the site an archaeological feature was observed at the northern edge on the subsoil / natural soil interface. The feature was half sectioned as part of the archaeological investigative process (Plates 1 and 2). It consisted of a sub-oval pit [103] measuring 1.20m by 0.80m and having a depth of 0.18m. Within the pit were several stones < 0.20m. The sloping edges of the pit contained irregular patches of black burnt material [104] containing charcoal (Figure 4). This material was collected as environmental sample <1>. Around the wider periphery of the pit pieces of charcoal were observed embedded in the natural. No datable finds were recovered from the feature and it has been interpreted as a small fire pit.

- 6.3.1 The fire cracked stones and charcoal are indicative of the feature being a fire pit.

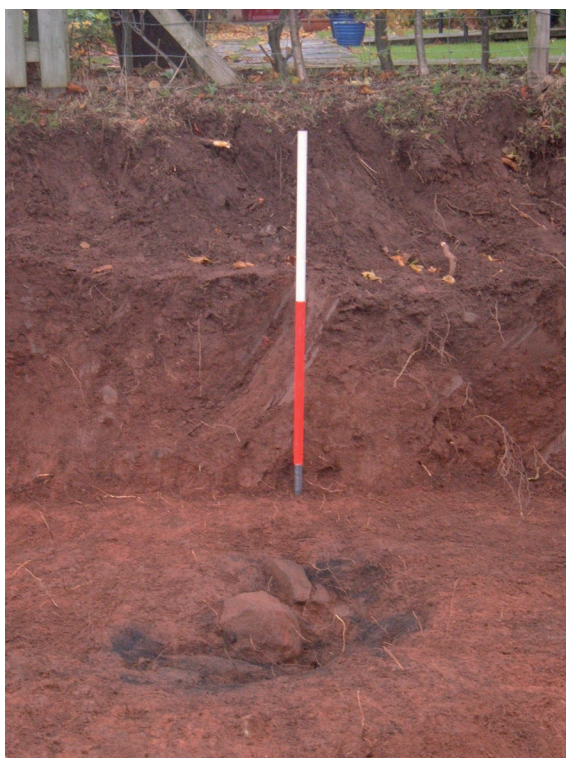
**Plate 2** Fire pit [103], [104] looking north west

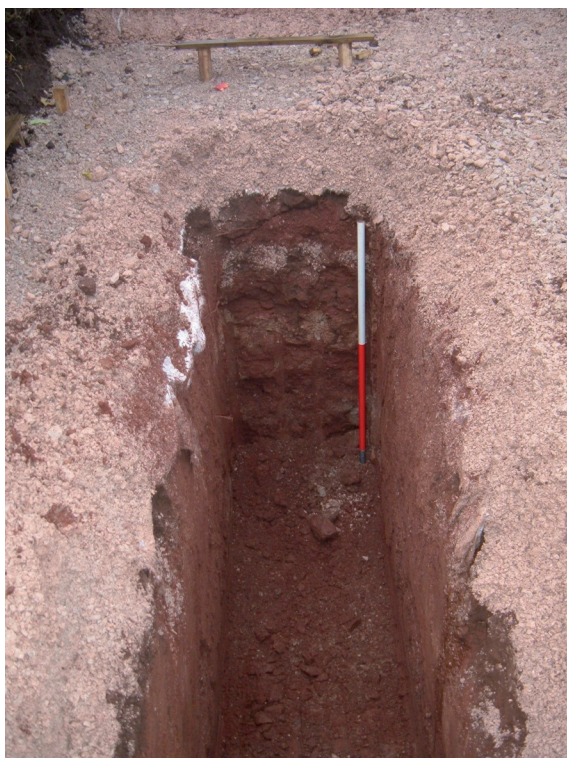
**Plate 3** Unit 1 foundation trench looking south west

3.1.1 The watching brief comprised of nine non-consecutive days of observation on the area of development. Excavation was concentrated in the northern eastern sectors of site with machine excavated trenches reaching depths between 1.20m and 2.10m in depth (Plates 3 and 4).

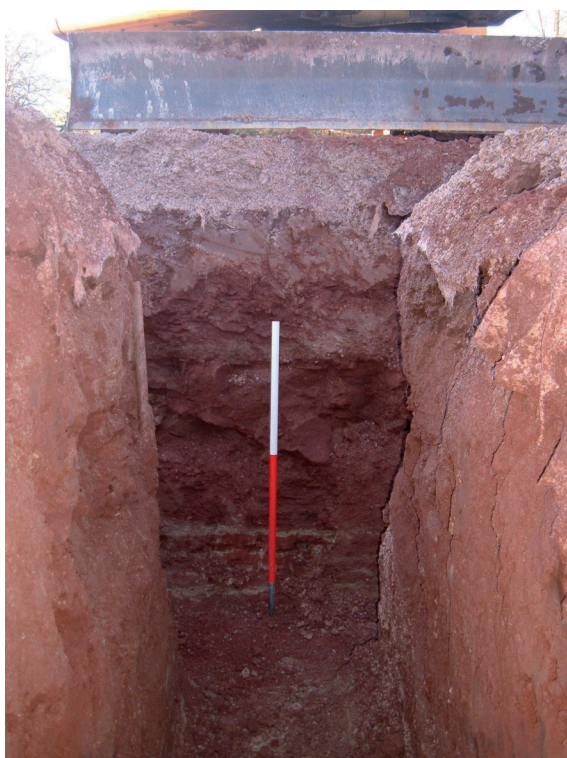
**Plate 4** Unit 4 foundation trench looking south west

- 4.4.1 Phase 3 consisted of the excavation of a series of foundation trenches for Units 3 and 4. These were excavated in the northern corner of the site by a 360 mechanical excavator with 0.60m wide toothed bucket. The trenches penetrated the hardcore, geotextile membrane, any remaining subsoil and into the natural ground. Due to the sandy nature of the natural ground the foundation trenches were dug down until the sand became sandstone in order to provide a firm footing. This happened at various depths between 1.50m and 2.10m. No archaeological features were observed.

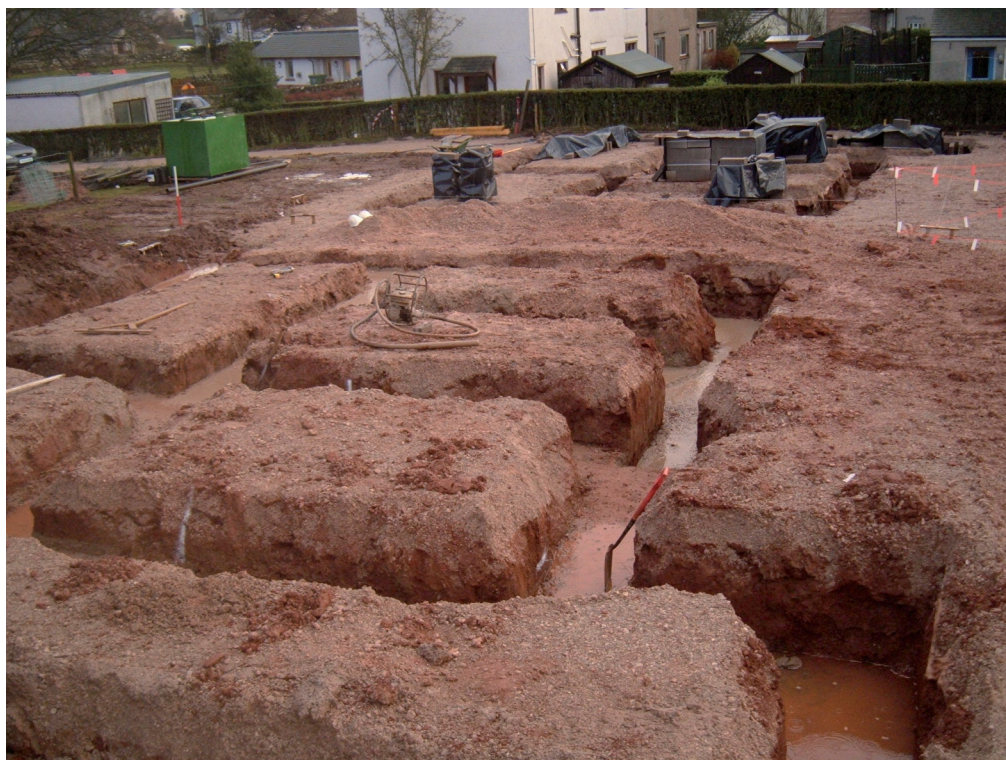
**Plate 5** Development site foundation trenches looking south east

- 4.3.1 Phase 2 consisted of the excavation of a series of foundation trenches for Units 1 and 2. These were excavated in the eastern corner of the site by a 360 mechanical excavator with 0.60m wide toothed bucket. The trenches penetrated the hardcore, geotextile membrane, any remaining subsoil and into the natural ground. Due to the sandy nature of the natural ground the foundation trenches were dug down until the sand became sandstone in order to provide a firm footing. This happened at various depths between 1.20m and 1.85m (Plate 5) No archaeological features were observed.

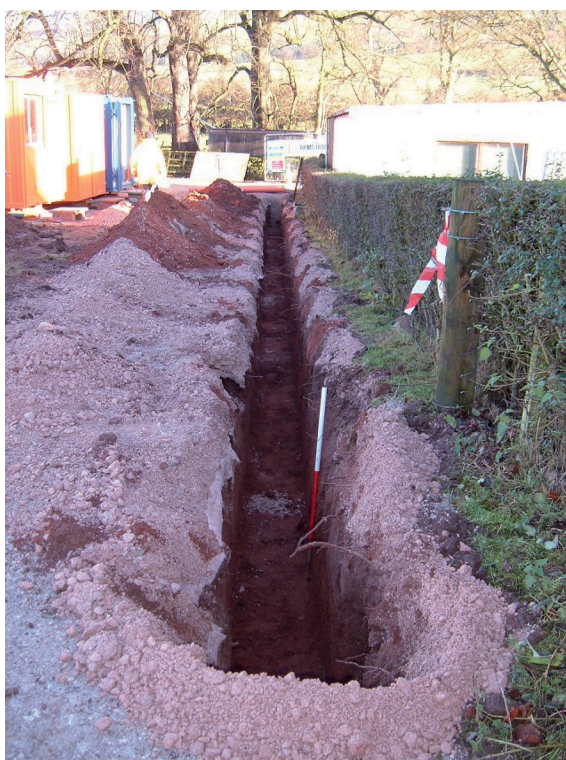
**Plate 6** Trench for foul drain looking north east

- 4.5.1 Phase 4 consisted of the excavation of a service trench for the foul drain serving the four units. The trench extended from the eastern corner of the development area and ran parallel and adjacent to the southern boundary hedge of the adjacent field (Plate 6). The excavation was 0.50m wide with an average depth of 1.0m. Stratigraphy consisted of 0.20m of hardcore [105] over a Bontec membrane [106] over 0.20m of topsoil [100] over 0.60m of subsoil [102]. The natural soil [101] was just beginning to appear at a depth of 1.0m. A cast iron water supply pipe crossed the trench in a north-south direction, 18.3m from the south west end. No archaeological features were observed.

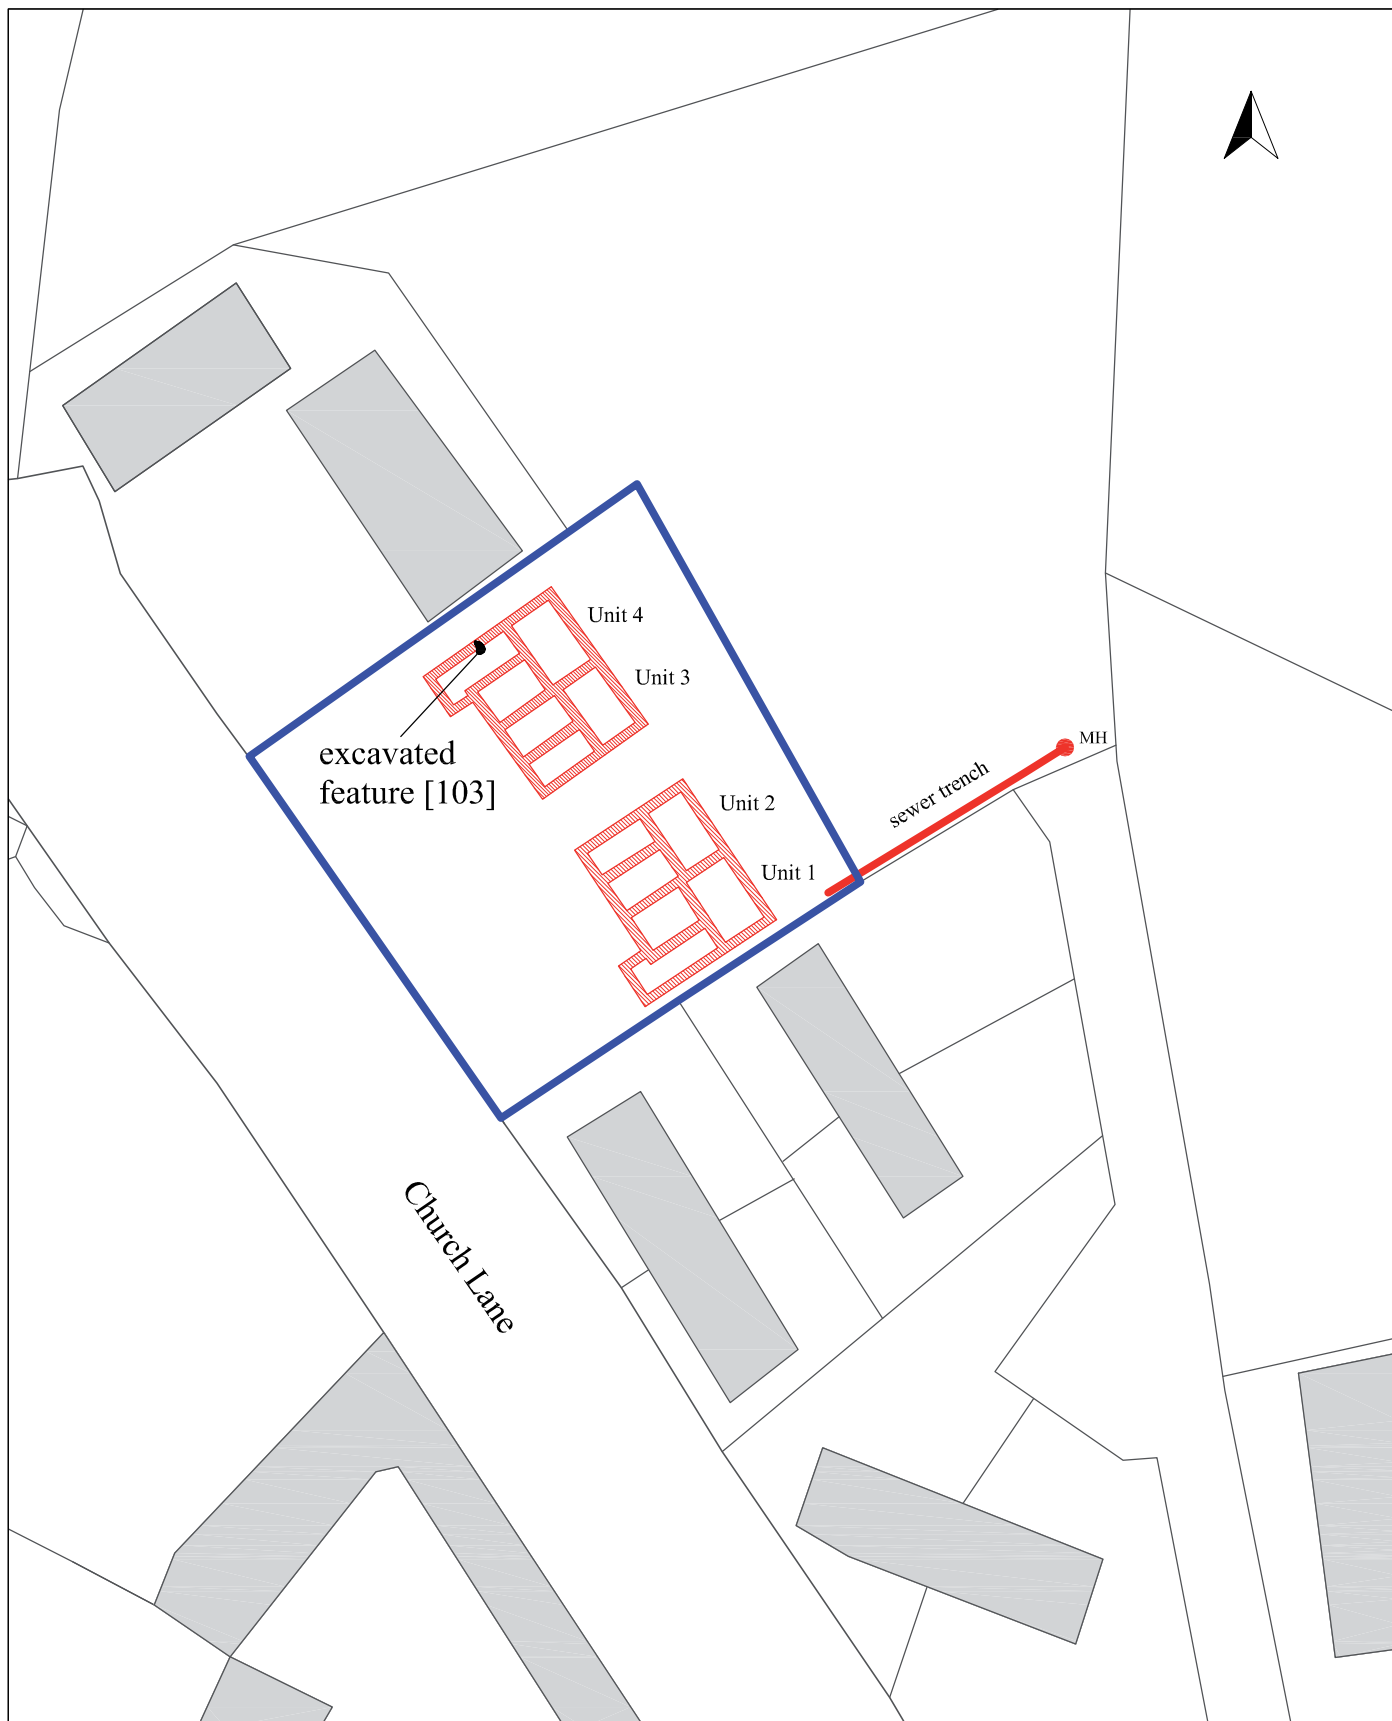
PROJECT: Watching brief at Church Lane, Melmerby  
DRAWING No: Fig 3  
SCALE: 1:500  
TITLE: Areas of archaeological monitoring  
CLIENT: Eden Housing Association Ltd  
DRAWN BY: KM & MDR  
DATE: January 2007

4.1.2 Groundworks on the site were essentially carried out in four main phases by mechanical excavator. The site was initially levelled. Two sets of foundation trenches were then excavated for four units (Units 1-4). Finally a service trench was excavated to accommodate the main foul drain (Figure 3).
