Client Report No. CP 351/06

**REPORT ON AN ARCHAEOLOGICAL WATCHING BRIEF AT
*CHURCH ROAD, SOUTH GOSFORTH, NEWCASTLE UPON TYNE.***

**COMMISSIONED BY
NEW FOREST CONSTRUCTION LTD**

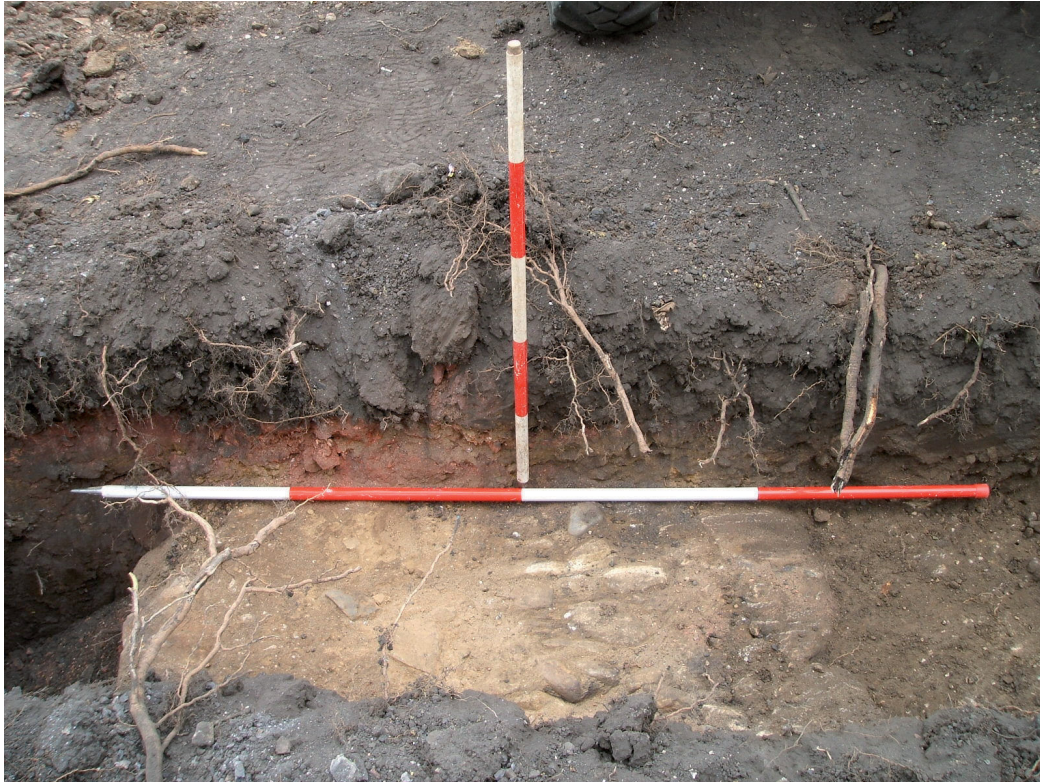
- 4.1.3 **Trench 1** (see Figure 1) revealed a cobbled/rubble surface faced by larger sandstone kerbstones [102] (400mm x 500mm max) aligned northwest southeast and lying at a depth of 350mm below ground level (see Plate 1). The precise alignment of this masonry could be further projected, when landscaping between trenches 1 and 5 exposed a layer of burnt red shale [103] at a depth of 220mm, which lay just above masonry [102] and was associated within the same archaeological context (see Plate 2).

Plate 1: Wall Feature [102] in Trench 1, Facing South.

- 6.1.1 The masonry discovered in Trench 1 [102], has been interpreted as identical to that seen in 2004 by Tyne & Wear Museums (Telford 2004). Due to a lack of datable remains, the same conclusions must be held as for the earlier record: that the masonry represents a post-medieval street surface.

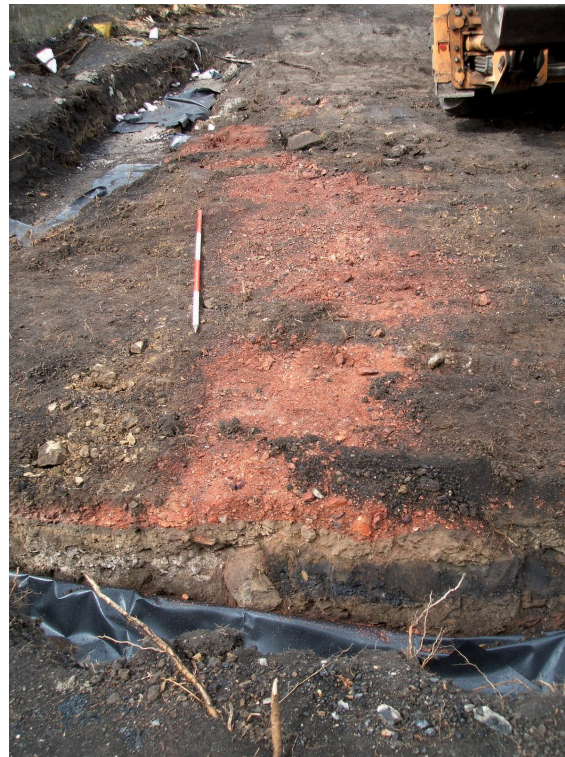
Plate 2: Red Shale Deposit (103) between Trenches 1 and 5, Facing Southeast.

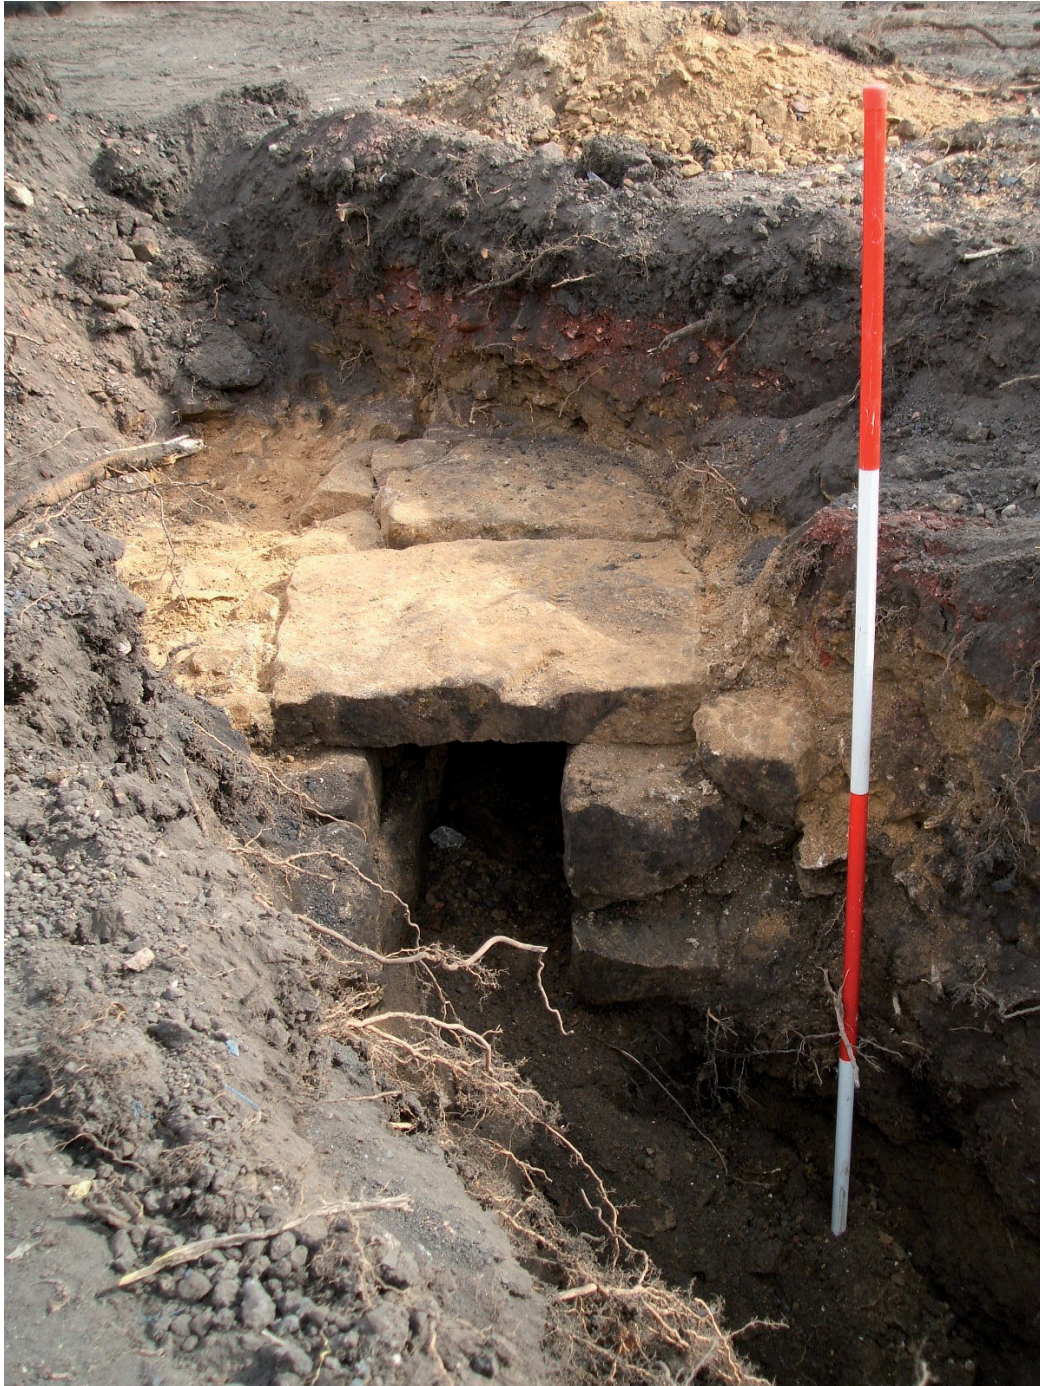
- 4.1.4 **Trench 2, 3 and 4** contained no archaeological remains.
- 4.1.5 **Trench 5** (see Figure 1) contained the remains of a coarsely grained yellow sandstone culvert feature [105] observed at a depth of 600mm below ground level (see Plate 3 and Figure 2). It comprised of large sandstone facing blocks at either side of a drainage channel, capped by very large flat paving slabs of the same sandstone (760mm length, x 560mm width, x 120mm depth, max) (see Plate 4). The culvert was aligned roughly north south and was observed in an excellent state of preservation throughout this foundation trench. Although no datable remains were associated with the culvert feature, an environmental sample was taken from inside the channel of the culvert, deposit (106).

Plate 3: Sandstone Culvert Feature [105] in Trench 5, Facing Southwest, (Section View).

- 6.1.2 The sandstone culvert [105] was observed for a stretch of 25 metres across the entire length of the site (see Figure 1) and most likely continues underground in a southern direction towards (and probably ending at) the present property boundary. The culvert is also likely to continue northwards beyond Trench 8 for an unknown distance, although it seems to be heavily truncated beyond this point. The lack of dateable material associated with culvert [105] makes it difficult to assess a time period for its construction, though it is most likely associated with the South Gosforth Farm and therefore of a post-medieval origin and of 18th-19th century date. An environmental sample taken from within the channel deposit of the culvert [106] is housed at the North Pennines Archaeology head office at Nenthead, Cumbria and could be examined in the future upon request.

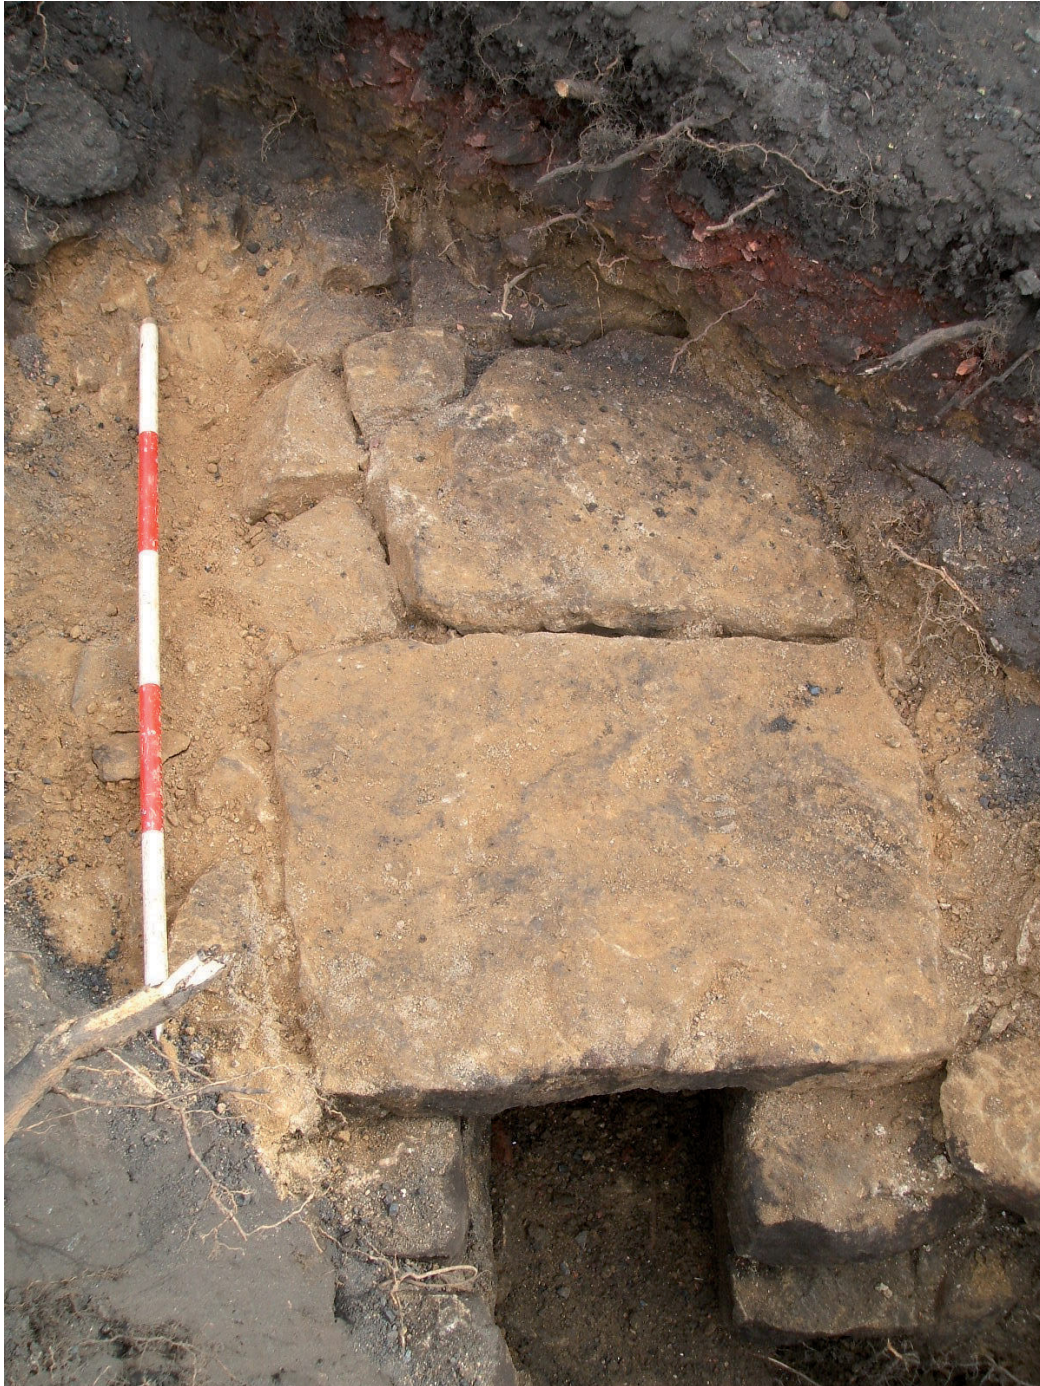
Plate 4: Sandstone Culvert Feature [105] in Trench 5, Facing Southwest, (Plan View).

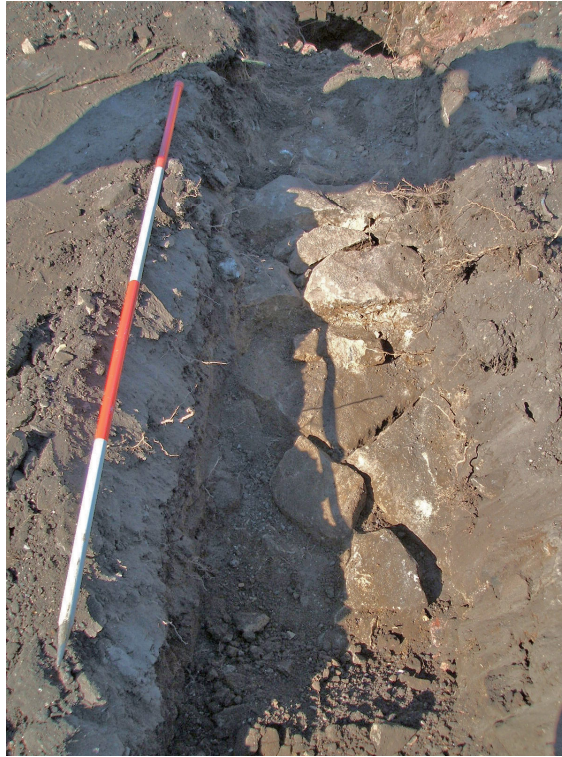
- 4.1.6 **Trench 6** (see Figure 1) contained the same culvert feature [105] as in Trench 5, which was aligned north south and was generally in a good state of repair (see Plate 5). The trench reached a depth of roughly 2m.

Plate 5: Broken Sandstone Capstones of Culvert Feature [105] in Trench 6, Facing East.

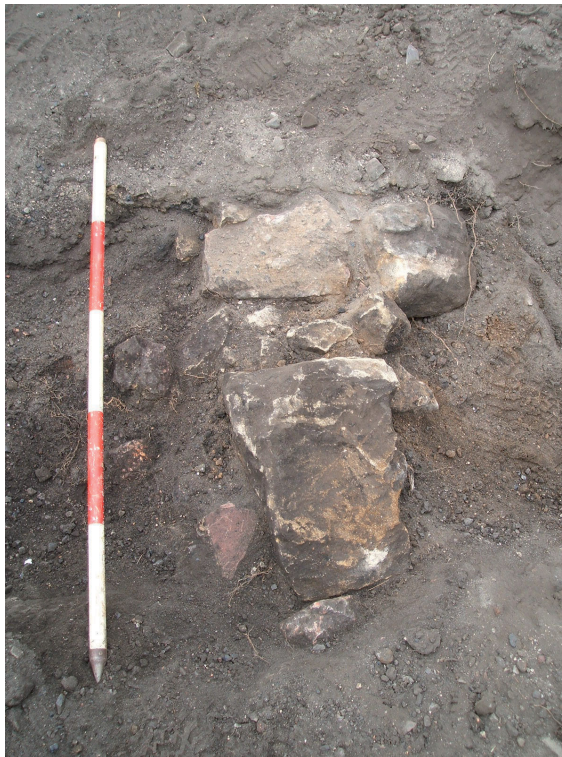
- 4.1.7 **Trench 7** (see Figure 1) contained a cluster of roughly hewn sandstone blocks (400mm x 300mm max) forming part of a suspected demolished wall [107], aligned roughly northwest southeast and observed at a depth of 100mm below ground level (see Plate 6). The wall was bonded with a degraded light brownish yellow sandy mortar and sat

directly above culvert feature [105]. Very similar portions of wall were also discovered in Trench 11 on the same alignment as wall [107] and probably belong to the same archaeological context.

Plate 6: Wall Feature [107] in Trench 7, Facing East.

- 6.1.3 Walls [107] and [108] observed in Trenches 7 and 11, represent the eastern wall of a post-medieval barn building first discovered by Tyne & Wear Museums in 2004. Tyne and Wear Museums found remains of the western wall of this post-medieval outbuilding associated with South Gosforth Farm. The building was depicted on the First Edition Ordnance Survey map of the area and subsequent revisions. This two-storey barn was demolished within living memory prior to the building of a brick scout hut, which occupied the site from around 1952 until recent times. The construction of this building can only be broadly dated to the post-medieval period, most likely to the late 18th/early 19th century.

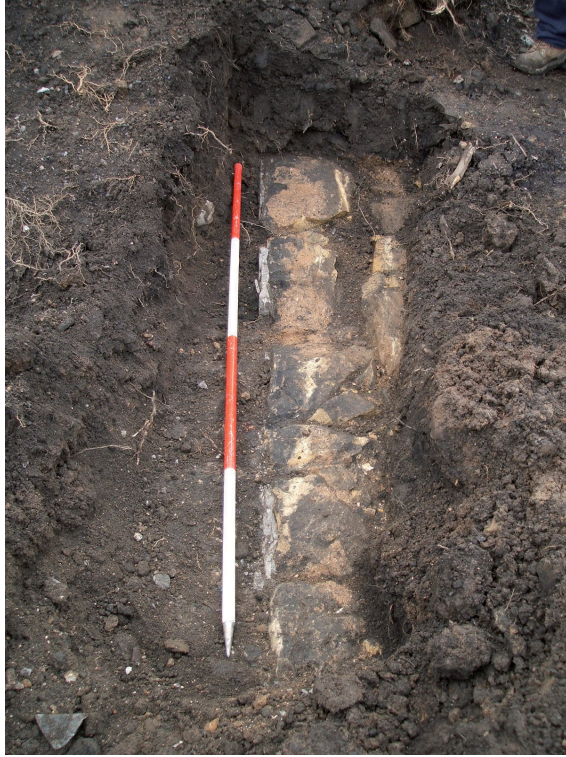
- 4.1.11 **Trench 11** (see Figure 1) revealed well preserved stonework [108] of the same type and on the same alignment as [107] within Trench 7, and probably belongs to the same archaeological context. This masonry was observed to be a linear sequence of sandstone foundation stones, 300mm below ground level and immediately north of the cemetery wall corner (see Plate 7). The facing stones had a hard, light grey cement based render on their eastern (external) edge. Finds recovered from the topsoil directly above wall [108] included ceramic material (including a broken stone-ware stout bottle), broken glass and a small amount of animal bone.

Plate 7: Wall Feature [108] in Trench 11, Facing Northwest.
