# **NORTH PENNINES ARCHAEOLOGY LTD**

**Client Report No. CP/195/05**

**REPORT ON AN  
ARCHAEOLOGICAL  
WATCHING BRIEF  
ON LAND AT  
19 HILL STREET  
CORBRIDGE  
NORTHUMBERLAND**

**FOR  
CRAWFORD HIGGINS ASSOCIATES**

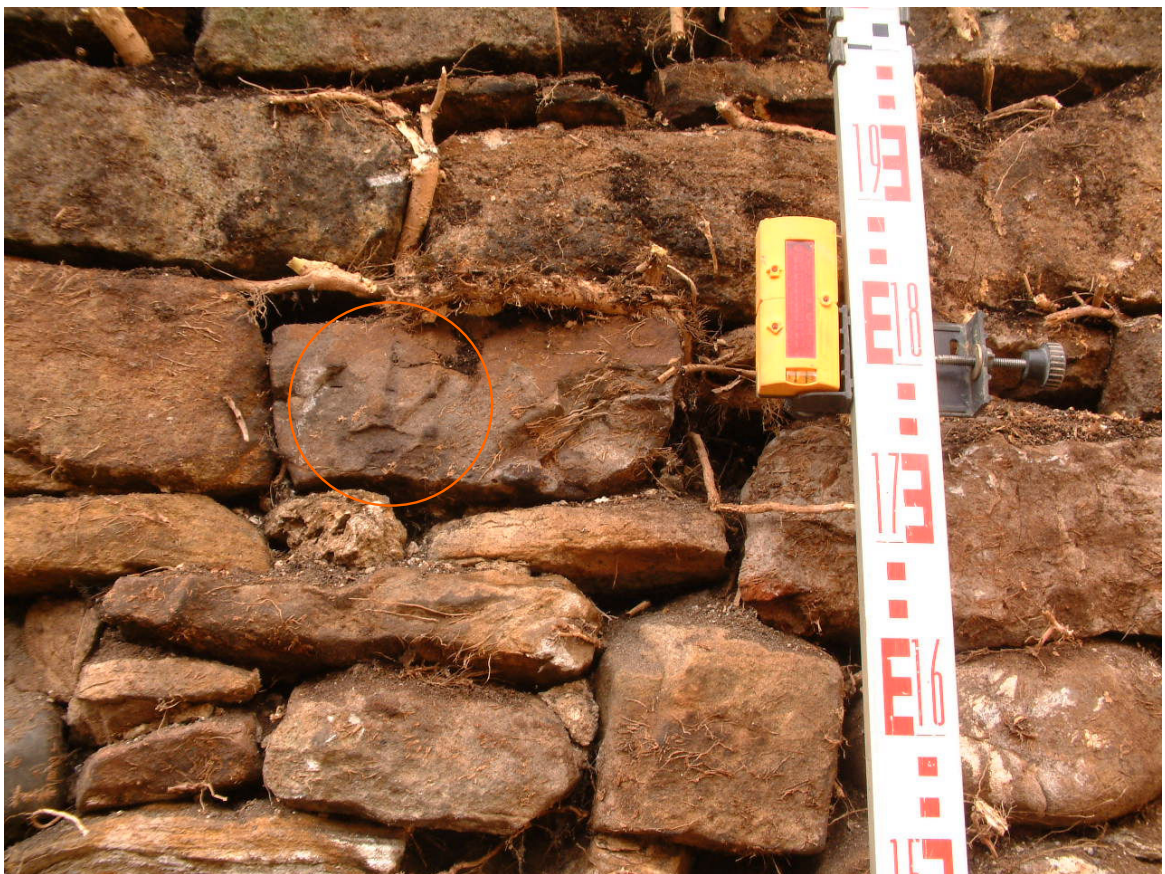
- 5.2 On the western edge of the area examined an existing boundary wall was being re-used in the construction of the extension. This wall (context 100) was 2.2 metres in height topped with flat capstones. The main structure of the wall was irregular coursed stones of various sizes. One of the stones used in the construction appears to have the remains of a bench mark carved into it (plate 1), with the stone itself inverted.

**Plate 1:** View of wall 100 showing possible inverted benchmark

- 6.1 The watching brief revealed no significant archaeological features or deposits within the footprint of the area being developed. The concrete yard surface is of relatively modern date. The dark soil that underlay this concrete would appear to be a former topsoil or garden soil within the plot of land behind the existing building.
- 6.2 The date of this deposit is not known, however it has built up over time and abuts the existing boundary wall, therefore it must be of later date than this. The wall itself appears to have been built in one phase in the late 19<sup>th</sup> century from at least some re-used material including a bench mark.

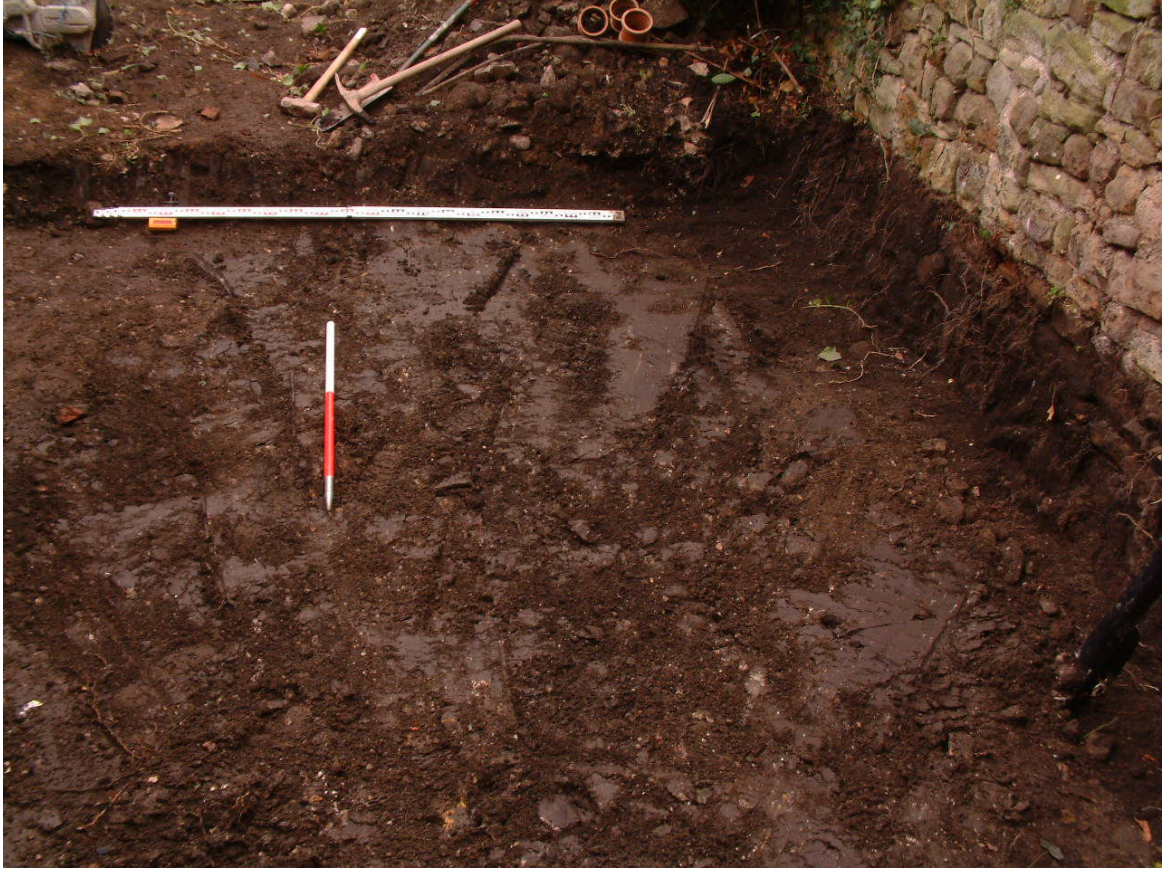
- 5.3 Abutting the wall was a very dark brown-black silty loam deposit containing occasional medium sized stone inclusions (plate 2). This deposit covered the entire area examined, and measured in excess of 0.50m in depth; its full depth remaining unknown due to depth of the development footprint. No other earlier deposits were observed, as the area was not excavated further in any areas as a concrete raft was being constructed at this defined level to support the new building.

**Plate 2:** View of deposit 102 after removal of concrete hardstanding
