NORTH PENNINES ARCHAEOLOGY LTD

Project Designs and Client Reports No. CP/333/06

In May 2006, North Pennines Archaeology Limited were commissioned by Green Design Group to undertake an archaeological building recording project of two barns at The Heugh, Walton, Brampton, Cumbria (NY 5361 6511) in advance of a proposed redevelopment, which would involve the demolition of one barn and the conversion of the other to residential and holiday use.

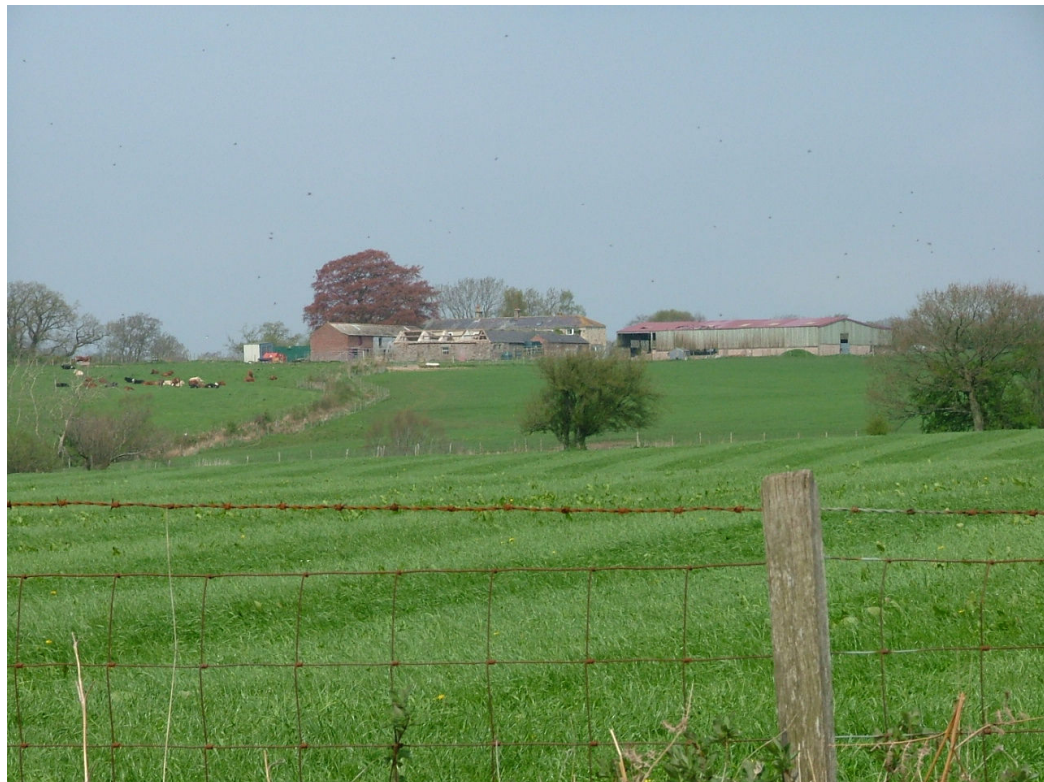
Plate 1 – The Heugh, as seen from the road between Walton and Garthside looking north

- 1.2.1 The Heugh (Plate 1) is a former farmstead located approximately four kilometres north of the market town of Brampton and approximately one and a half kilometres north-east of the village of Walton (Figure 1). The stream known as King Water flows just to the west of the farm and continues southwards to join the River Irthing below Walton. The course of Hadrian's Wall runs just under half a kilometre to the south of the farm, and gives its name to farms such as 'Low Wall' as well as the village of 'Walton' or 'Walltown' itself. The Heugh is situated at a height of *c.*90 metres above mean sea level.

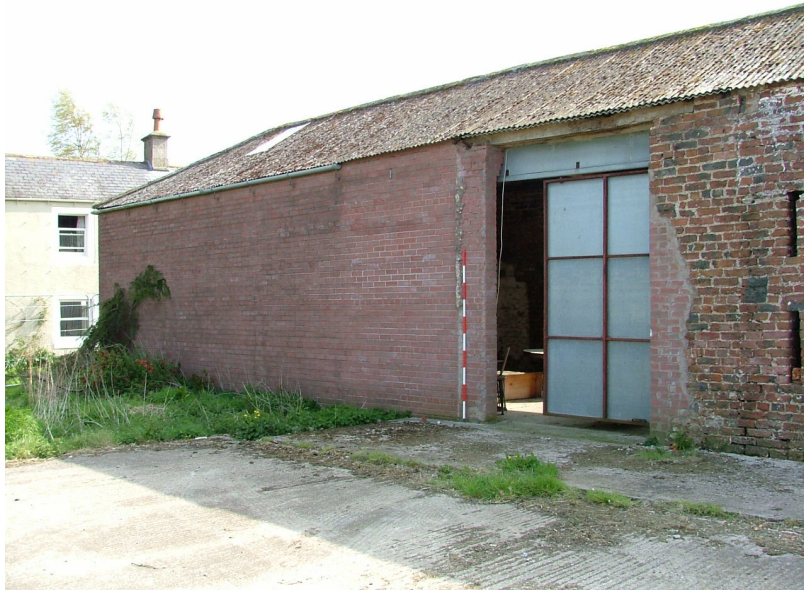
Plate 2 – Northern end of the west elevation of Building A

- 5.2.3 To the south of this stretch of brickwork is a section of the elevation constructed in coursed and squared masonry. This section measures c.2.50 metres and the construction breaks between this section and the brickwork described above could easily be observed (Plate 5). Set within this stonework is a window at first floor level, the surround of which is made from dressed masonry. The window head has been lightly tooled at the top. The southern side of this section contains dressed blocks of squared masonry; these are the remains of quoins from the corner of a building, and

the alternating nature of the remaining blocks are due to the shorter blocks having been removed to allow for the next section of the wall to be bonded in. This stonework has also been laid upon the slight plinth mentioned in 5.2.2, which suggests that the masonry section of the elevation was earlier, and the brickwork replaced a stone wall.

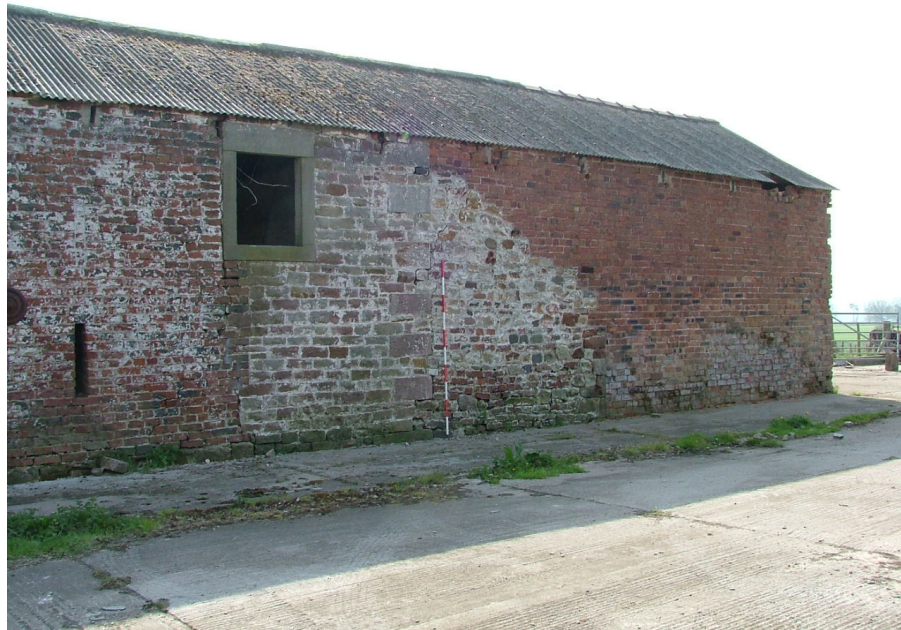
Plate 7 – Southern end of the west elevation of Building A

- 5.2.5 The remainder of the west elevation of Building A is constructed of regular red brick also laid in English garden wall bond, however in this case there are four rows of stretchers between each row of headers. The smoothness and regular nature of this brickwork suggests a date of construction which ties in with the mass production of bricks to meet the demands of railway structures and housing from the mid-nineteenth century. A comparison between the First and Second Editions of the Ordnance Survey maps of *c.*1865 and 1901 (Figures 5 and 6) shows that Building A was extended between the dates of these two maps, which gives a construction date for this end of the building to sometime 1865 and 1900. Set within part of this brickwork is a decorative iron ventilation plate (Plate 8).

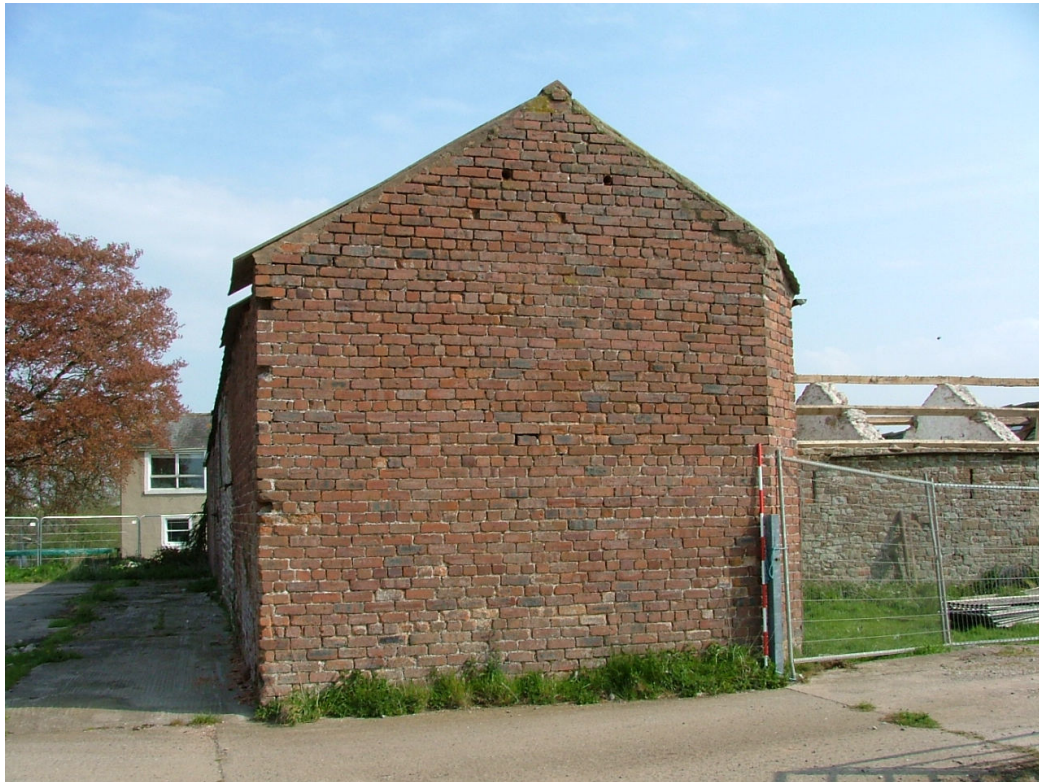
Plate 9 – Southern gable end of Building A

- 5.2.7 The southern gable end of Building A is featureless apart from the fact that the eastern side has a chamfer, almost as if the corner of the gable end has been ‘cut-off’ (Plate 9). The reason for this appears to be due to the interior of this end of the building, and will be noted in 5.3.5 below.

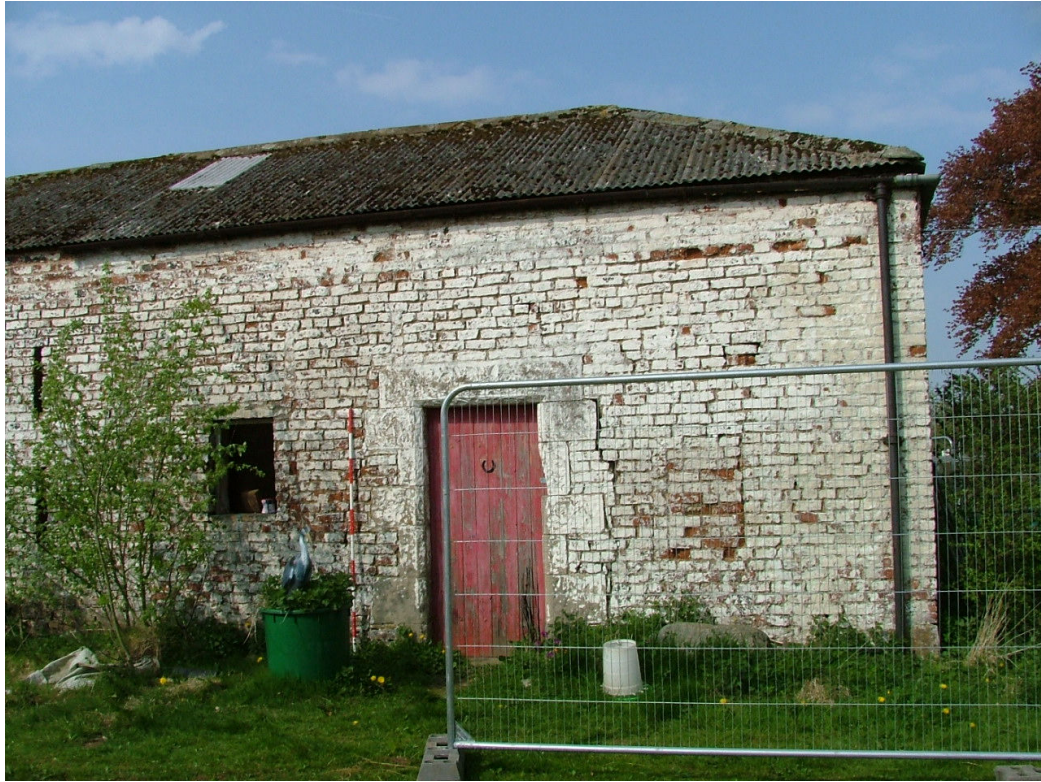
Plate 10 – Northern end of east elevation of Building A

- 5.2.8 The eastern elevation of Building A (Figure 10) displays the similar differences in construction as the western elevation. Over half of this elevation is of the rougher and less regular brick noted on the opposing wall; this white-washed brickwork section extends for c.17 metres. Contained within this section of wall, starting from the north end and working south, is a blocked window, a doorway with rusticated masonry blocks making up the jambs and lintel, and a further window. The door has a horse shoe attached to it and this may hint at the original function of this room as a stable. There remains two sets of ventilation slits to the northern side of the large doorway, however there were originally a further seven, three of which were smaller and located above the ‘stable’ door lintel, all of which have been blocked-up. The large doorway has the same rusticated masonry blocks as the stable door making up the jambs, which are rebated internally; therefore the large doors would have opened inwards. This large doorway is in line with the large doorway observed in the western elevation, and these two opposing doorways may originally have defined a threshing area in the barn, where the cereal crops were beaten with a hand-flail to separate the grain from the stalk, while the two large doorways also allowed for a through-draught for the process of winnowing, where the wind blows the chaff from the valuable grain.

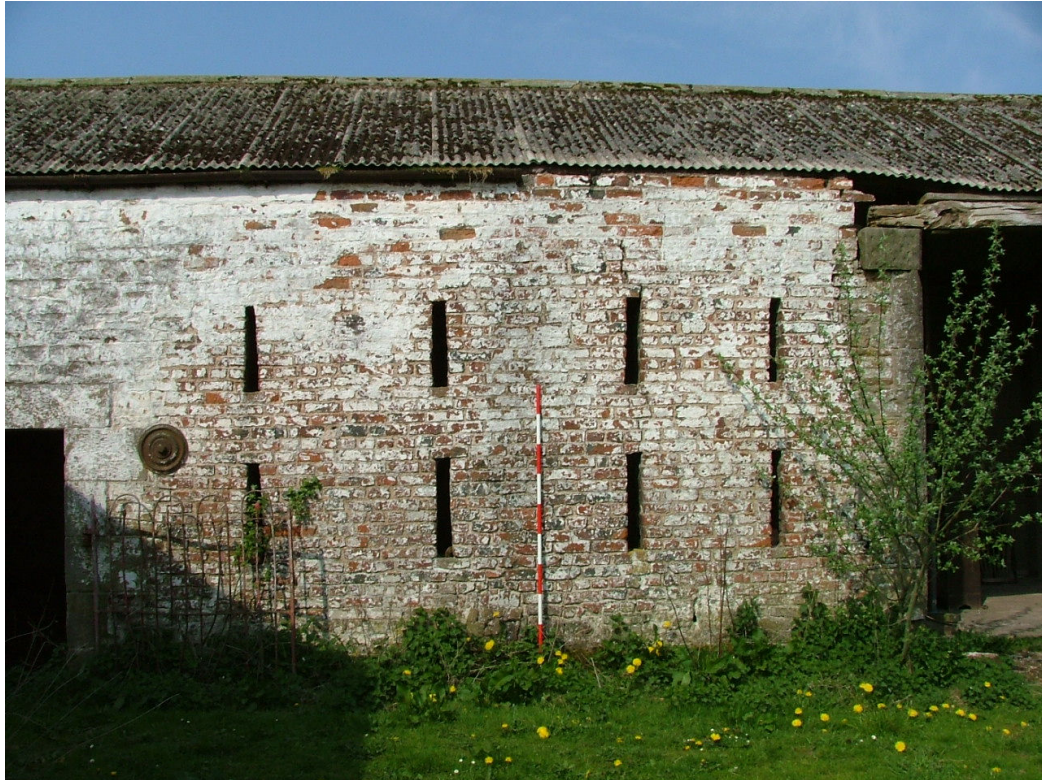
Plate 11 – Ventilation slits and tie-plate, eastern elevation of Building A

- 5.2.9 Within the brickwork to the southern side of this large doorway, there are eight ventilation slits, four to ground floor and four to first floor level (Plate 11 and Figure 10). A further circular iron tie-plate, the same as that observed on the western elevation, is located just to the left of these ventilation slits. At this point the construction material changes to squared and coursed masonry for a length of *c.*4.70 metres; this section corresponds (although it is a longer section) with the masonry on the western elevation. There is a doorway with dressed blocks of masonry making up the jambs and lintel; however these blocks do not have the same rusticated dressing as those that make up the large door surround and the stable door. There is a window at first floor level, the surround of which is made of four rectangular blocks of dressed masonry (Plate 12).

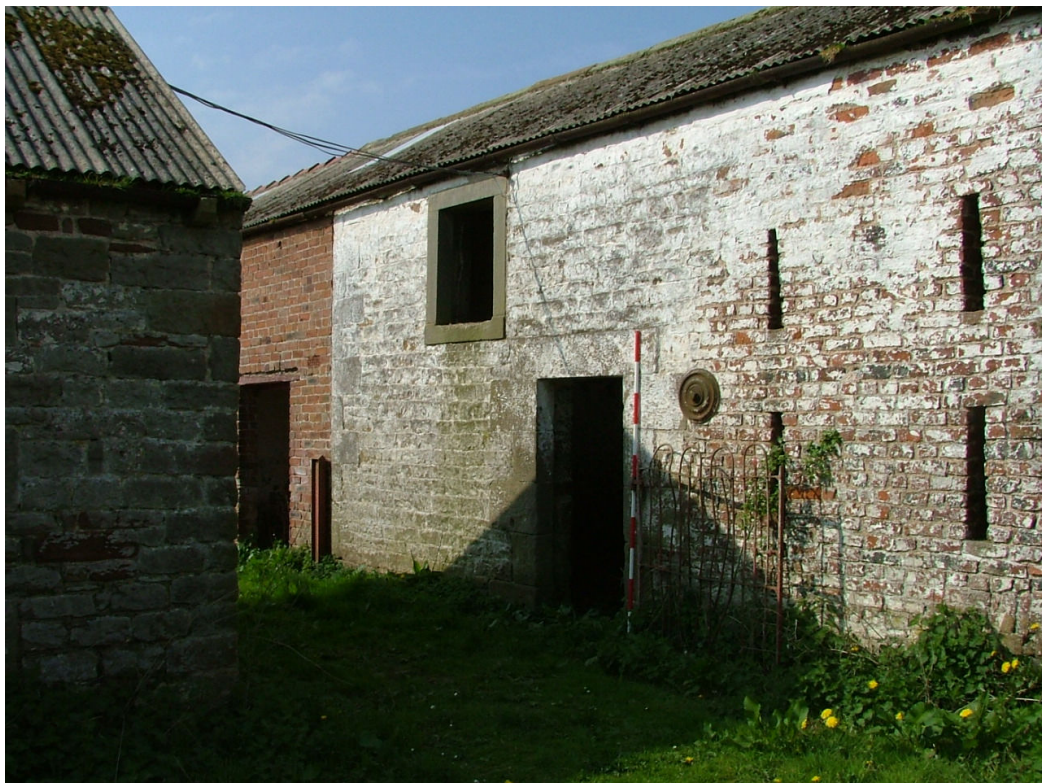
Plate 12 – Masonry section of east elevation of Building A

- 5.3.3 The next ground floor room is accessed via the doorway in the only masonry section of the building (Plate 12). This room had the remains of a cobbled floor and joist holes were observed in the walls, providing evidence for a former first floor hayloft, as mentioned in 5.3.2.

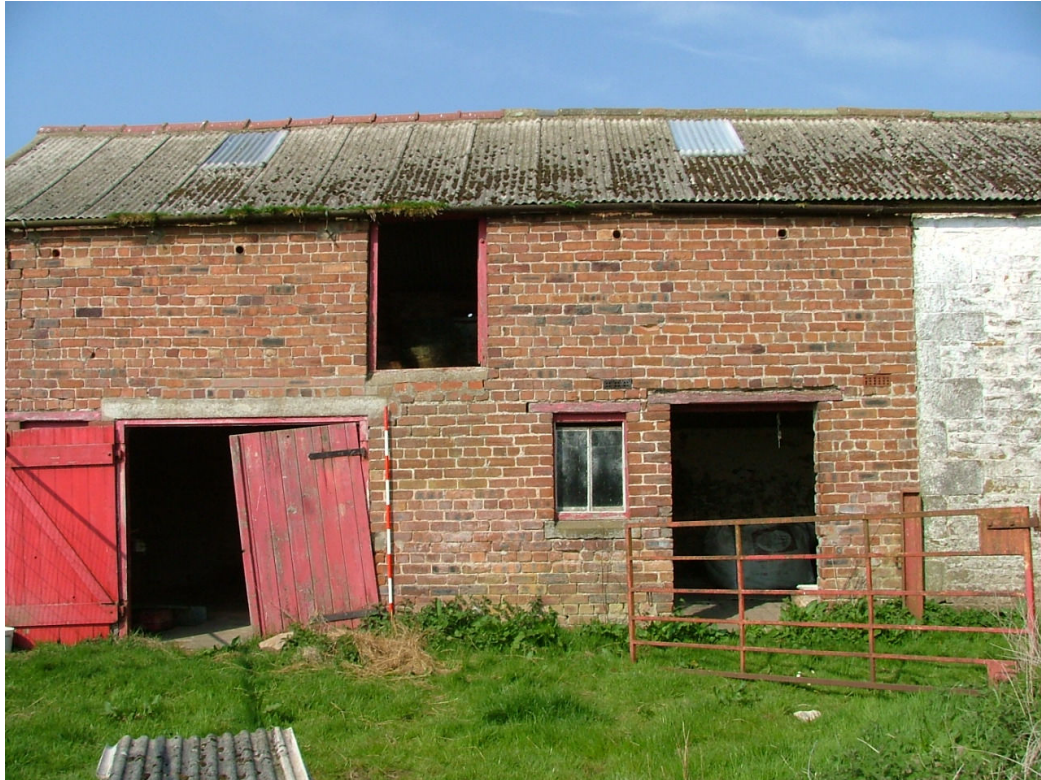
Plate 13 – South end of eastern elevation, Building A

- 5.2.10 The construction material of this wall changes again to brickwork for the remainder of the elevation, and the quoins of the earlier masonry wall are clearly visible on Plate 13. The remains of the lean-to with pitched roof was not observed along this elevation, therefore it must have been removed prior to this brick addition. Within this part of the elevation there are two doorways, two ground floor windows and an upper ‘pitching’ door, used for pitching hay into the first floor loft.

- 5.3.4 The remaining two rooms of Building A make up the brick extension to the southern end. The first is accessed through the smaller of the two doorways (Plate 13). Internally, this room has a concrete floor but little else in the way of features. The original southern wall of the masonry-built building was clearly observed however, and it was noted from the hayloft above that this masonry wall has been built up in brick to create a gable (Plate 17).

- 5.3.5 The final room in the range was accessed via the double doors on the eastern elevation (Plate 13). Against the southern wall there is a brick-built fireplace with a sandstone lintel (Plate 18), and in the south-eastern corner there is a wooden work bench, which is located where the corner of the building has a 'chamfer' as mentioned in 5.2.7. A wooden staircase in the north-east corner of this room allows access to the hayloft at first floor level.

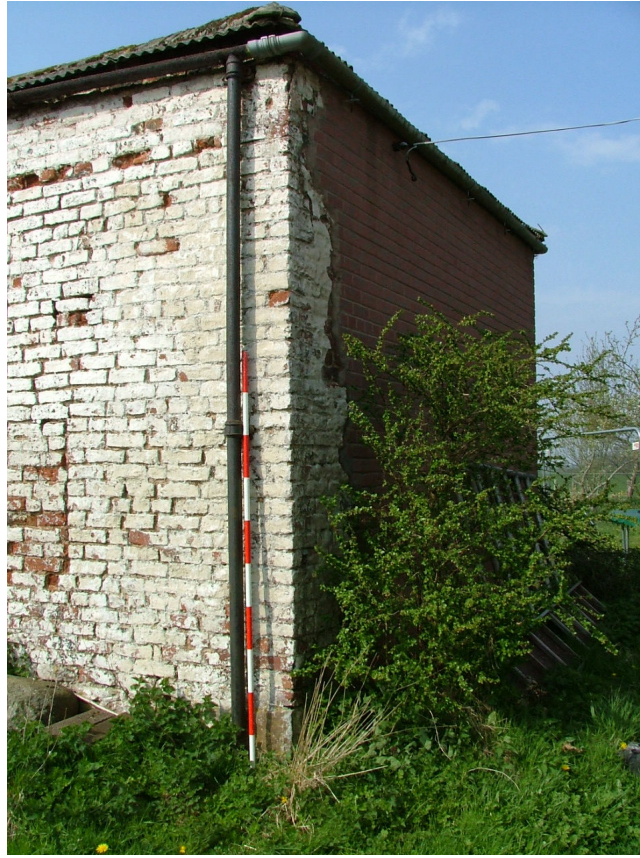
Plate 14 – Northern gable end of Building A

- 5.2.11 The northern gable end of Building A is constructed of modern brick and is a continuation of the brick noted at the northern end of the west elevation (Plates 2 and 14); apart from the remains of earlier brickwork on the north-eastern corner (Plate 14).

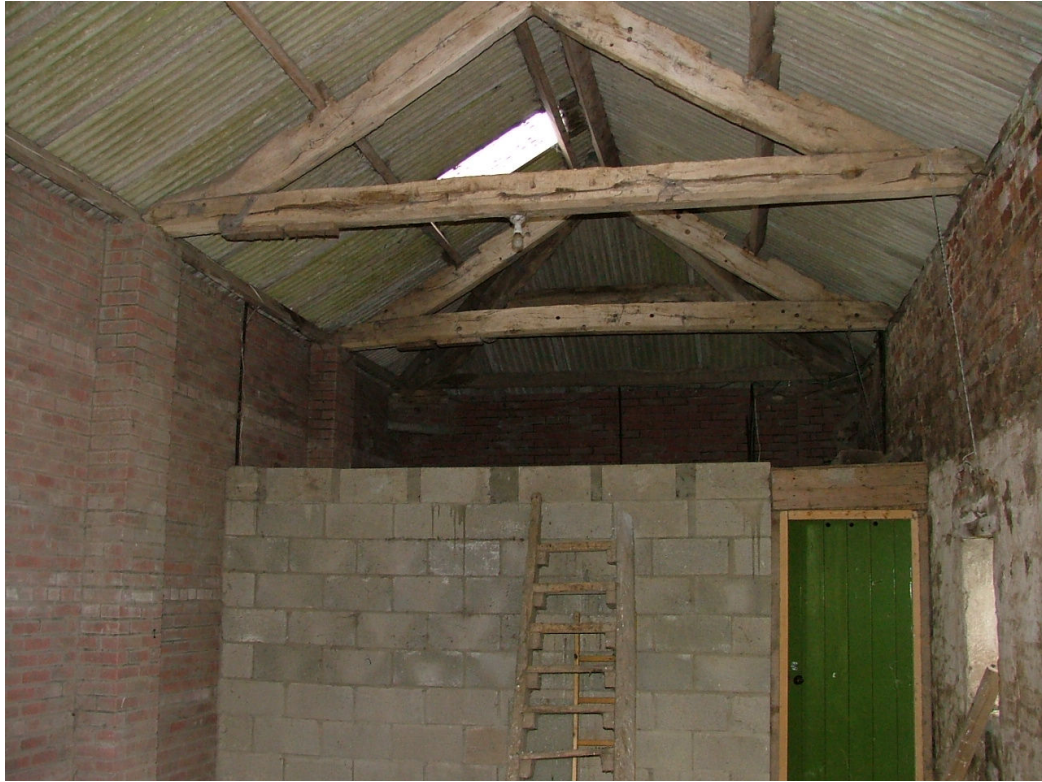
Plate 15 – Modern block wall, northern end of Building A

- 5.3.1 The interior of Building A is divided into five rooms at ground level. At the northern end, a ground floor modern block wall with a doorway presumably replaced an earlier wall on a similar alignment to separate the stable from the main body of the barn, providing a hayloft above (Plate 15).

- 5.3.6 The roof structure of Building A consists of principal rafters and tie beams, the two northernmost of which are of reused timbers (Plate 15); the remainder are of modern machine-sawn timber.

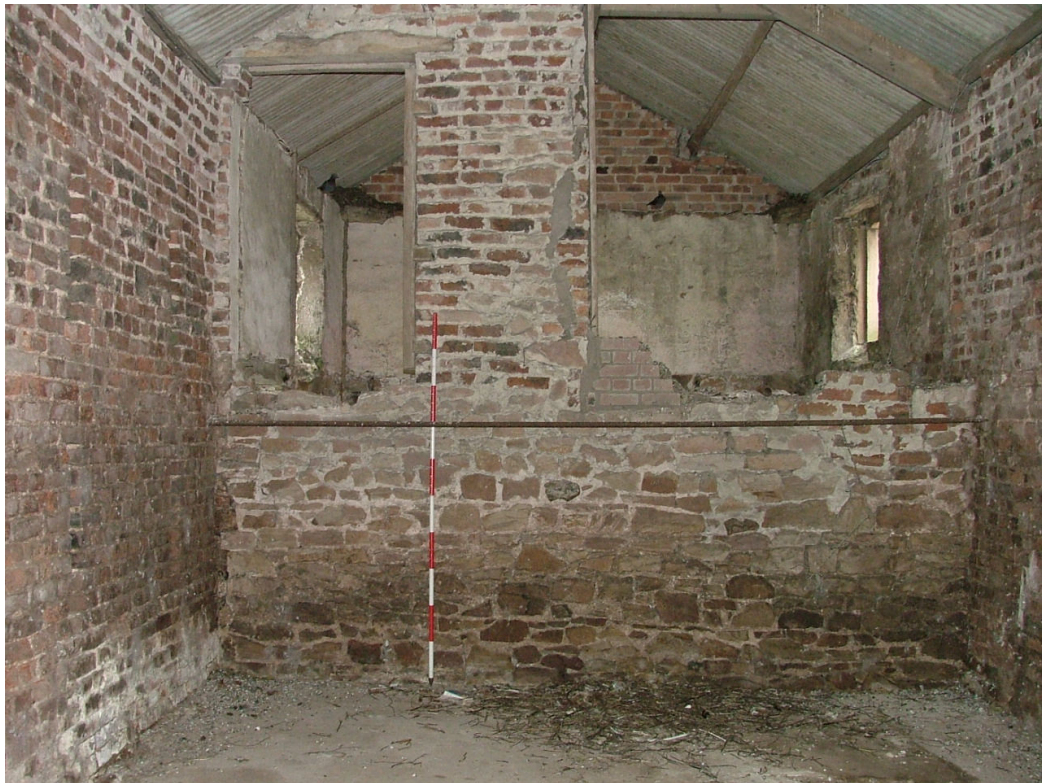
Plate 16 – Internal division, Building A

- 5.3.2 The central section of the barn, which may have been the original threshing area, is open to the roof as would be expected to allow for the swing of the hand-flail. This part of the barn measures approximately 13.5 metres in length from the block wall described above to the next internal division (Plate 16). This internal wall has undergone some alteration, the lower half being of roughly coursed masonry, whilst the upper half is of brick, with a doorway to one side and a larger opening to the western side. This doorway would have originally provided internal access to the hayloft above the next room as there was no evidence of there having been an upper floor in the main section of the barn.

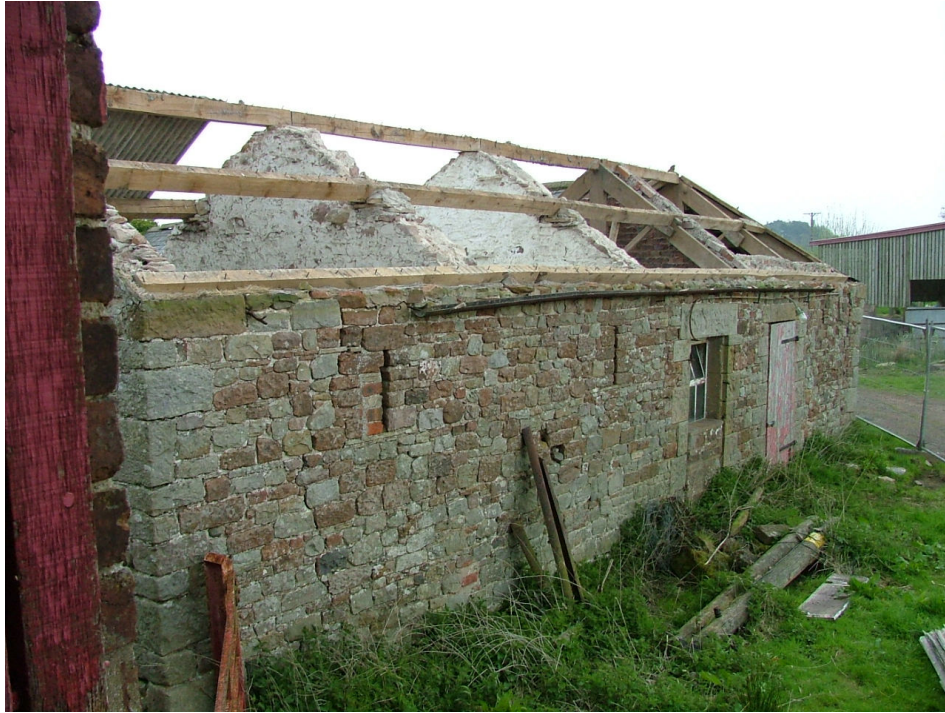
Plate 19 – South facing elevation of Building B as seen from the first floor of Building A

- 5.4.2 The south-facing elevation of Building B has two doorways, one of which has been blocked in at the base to create a window (Plate 19 and Figure 11), and three ventilation slits.

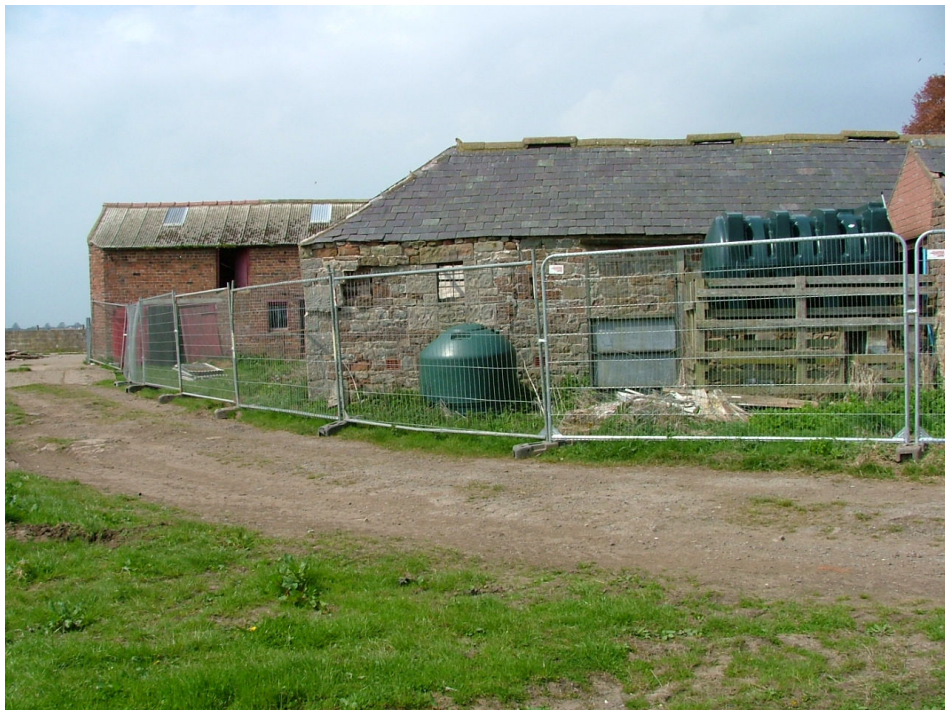
Plate 20 – East elevation of Building B with the south end of Building A in background

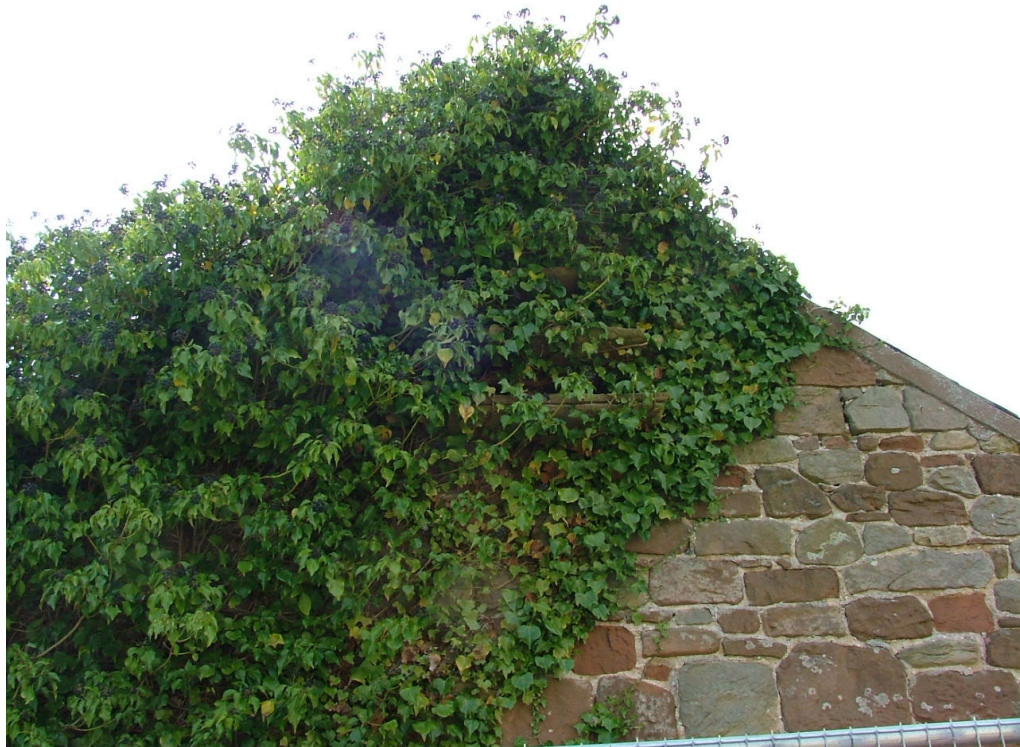
Plate 21 – North gable end of Building B showing ledges of nesting boxes under ivy

Brunskill, were often set into the walls of ordinary farm buildings in the late 18th and 19th century⁶ (Plate 21).

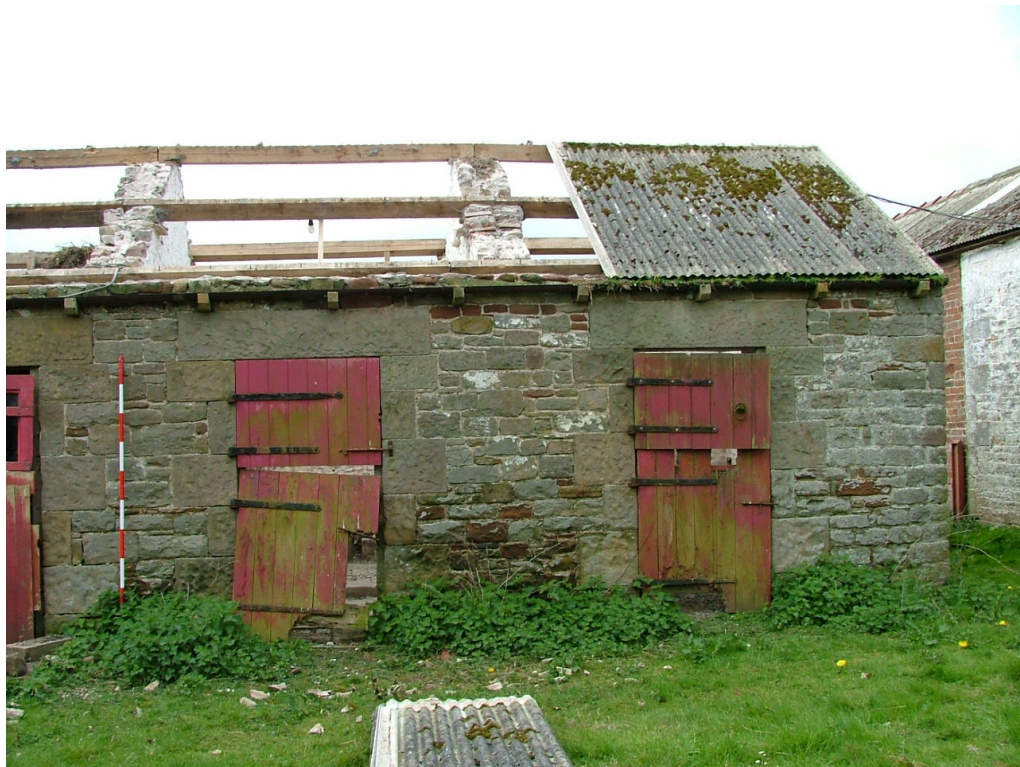
Plate 22 – North facing elevation of Building B

- 5.4.5 The north-facing elevation of the southern range of Building B has three doorways (providing access to three different rooms) all with split doors, the top half of which would have been opened to provide light and ventilation for the animals inside (Plate 22 and Figure 13).
- 5.4.6 The west facing elevation has two large doorways with arched heads made up of dressed voussoirs, a window and a smaller doorway at the northern end (Plate 23 and Figure 14). The guttering for this elevation and the north-facing elevation is held up by stone supports, rather than the more common iron brackets.

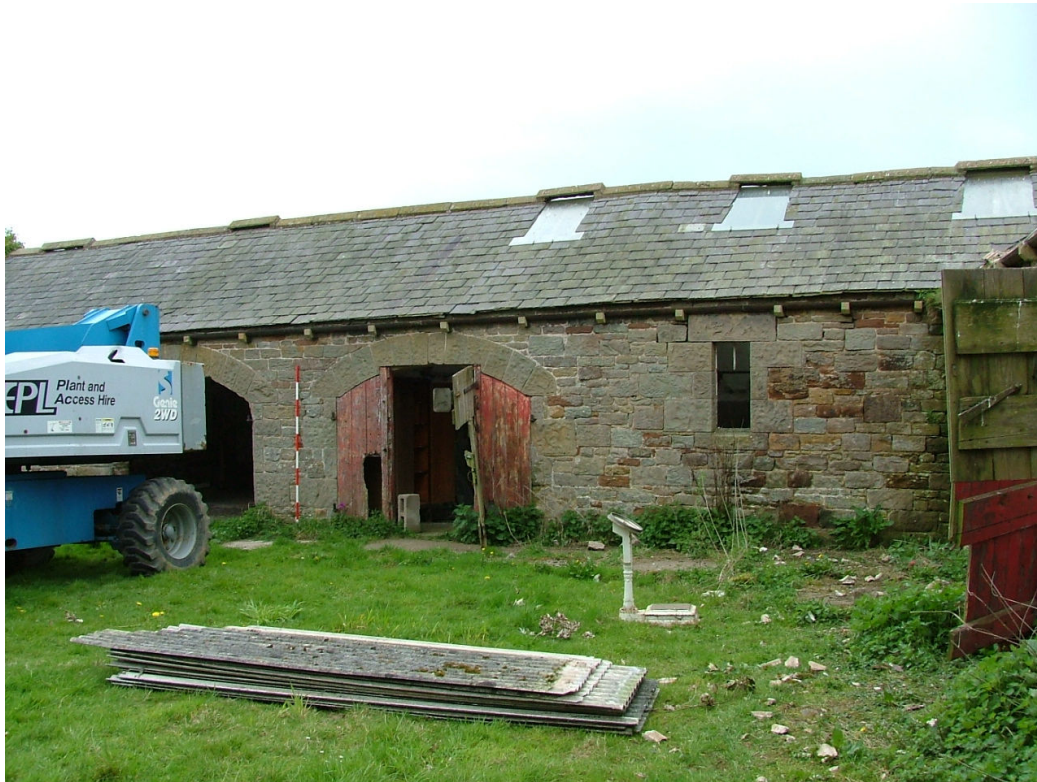
Plate 23 – West facing elevation of Building B

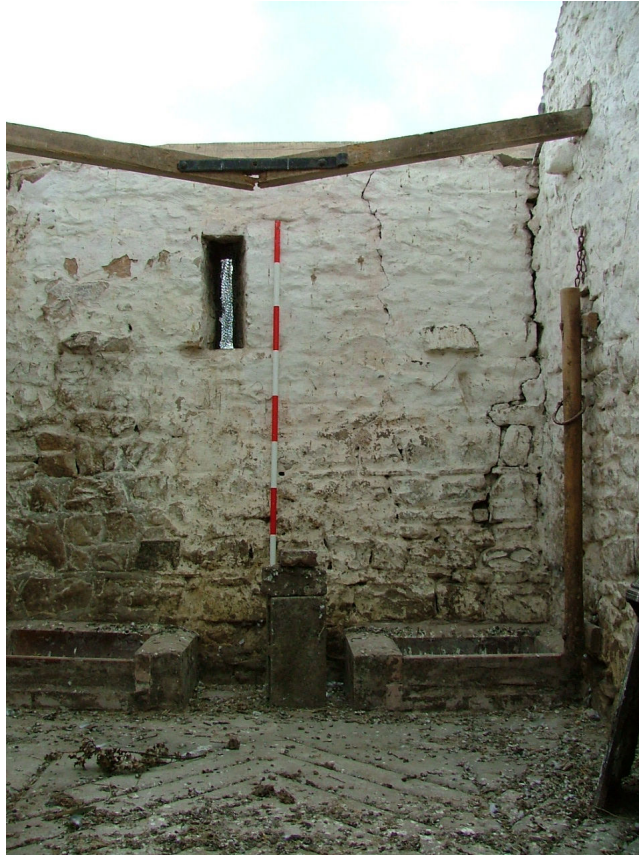
Plate 24 – Interior of byre, southern range of Building B

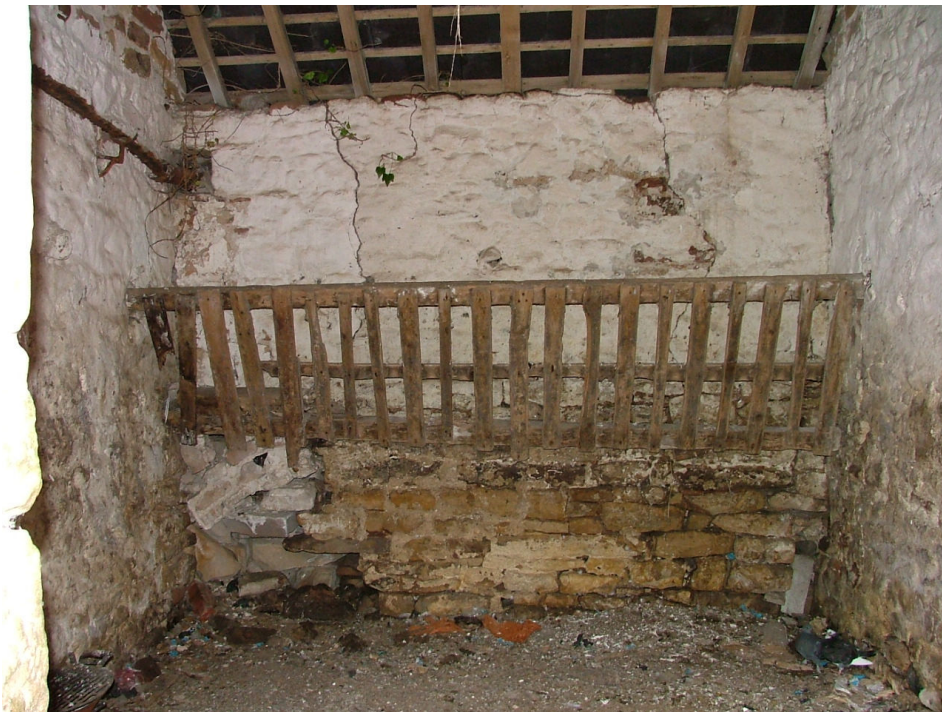
Plate 25 – Interior of loose box, Building B

- 5.5.2 The eastern range of Building B, which is aligned north-south, is divided into three rooms. The northernmost appears to have more latterly been used as a loose box, as no tethering poles or stall divisions were visible. A wooden hay rack remains *in-situ* (Plate 25). Loose boxes were used for housing sick cattle or horses or foaling mares/calving cows.

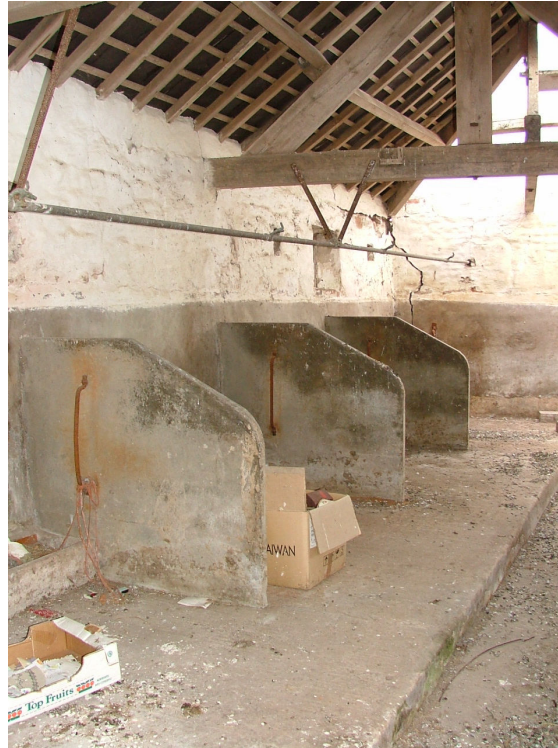
Plate 26 – Interior of Building B

- 5.5.4 The largest room in this range of Building B has also more recently been used as a byre or milking parlour (Plate 26). The floor is of concrete with a central manure passage. There are four concrete stall dividers, which would have provided accommodation for a maximum of 10 cows (five double stalls). Ceramic troughs and iron tethering bars remain *in-situ*. The walls have been plastered to a height of *c.*1.30 metres presumably for hygienic reasons, the remainder of the walls having been lime-washed, a traditional form of disinfectant that also absorbs moisture. The roof trusses in this part of the building are of king-post construction in machine-sawn timber. Assembly marks were visible on the three trusses in this part of the building and on the single truss observed in the room to the north. Heading from north to south these trusses were marked IIII, III, I and II; these marks would presumably have aided in the construction of the roof by indicating the order in which the trusses should be erected, although the trusses marked I and II have obviously been mixed up. The presence of a large arched doorway into this room also suggests that the original function of this part of Building B was as a cart shed or trap house. It is possible that this was originally a stable, as horses were generally provided with lighter and better ventilated accommodation compared to cattle⁷. Horses were held with higher regard than cattle; they were expensive to buy and feed, they were fragile and temperamental, yet by the end of the eighteenth century horses were replacing the ox as the main power source on the farm⁸. It is possible that the concrete stalls that remain in this building replaced earlier timber stall divisions for horses, which would have become obsolete as tractors replaced the horse on the farm.

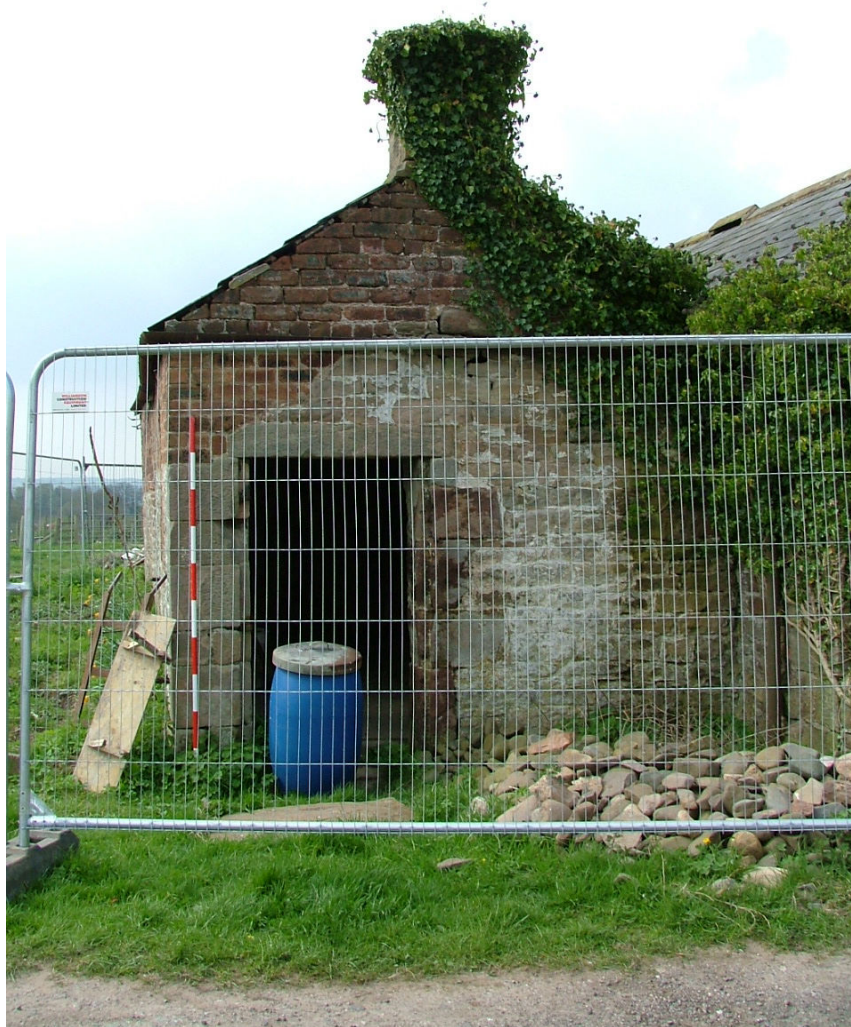
Plate 28 – Northern elevation of Building C showing earlier gable end, doorway and chimney

- 5.6.2 On the northern elevation it was possible to note the gable end of the earlier stone-built building (Plate 28). A doorway in this elevation has jambs and lintel of blocks of

dressed masonry. At the apex of the roof there is a chimney which has been constructed of nicely dressed blocks of red sandstone, and an air vent set into the ridge (Plate 29). The roof is laid in Welsh slate with sandstone ridge tiles.

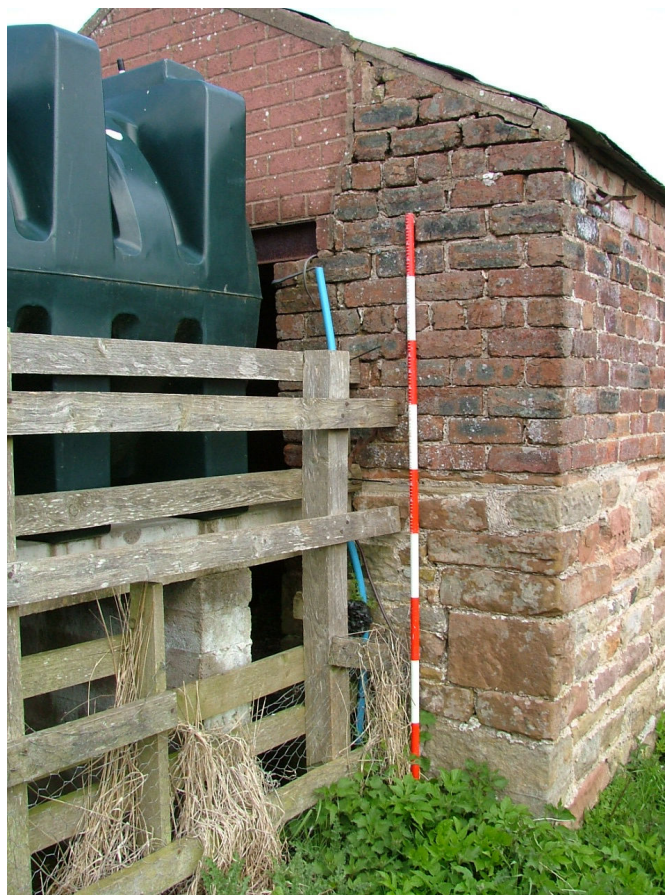
Plate 30 – Southern gable end of Building C

- 5.6.3 The southern elevation of Building C displays the different construction materials already mentioned, as well as part of the gable end having been rebuilt in modern brick (Plate 30). This elevation has a large doorway with a steel girder for a lintel.

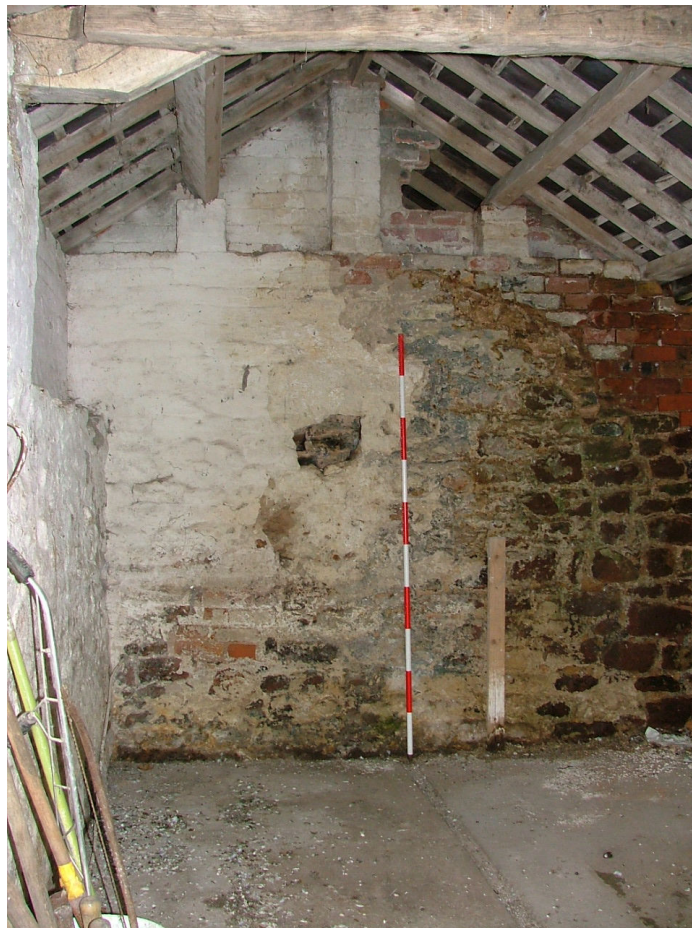
Plate 31 – Interior of Building C showing masonry and brick dividing wall

- 5.7.1 Building C is divided into two internally by a transverse masonry and brick wall (Figure 8). The gable end of the earlier stone-built structure could easily be observed onto which brick has been added to heighten the wall. Columns of brick were used to support the ridge beam and the purlins (Plate 31). The floor of this room is of concrete, which is slightly sloped upwards either side of a central channel, presumably allowing some form of drainage. In the northern internal wall there is a niche which measures 44cm wide by 22cm deep and 46cm high and a further 'niche' to the left which appears to have an internal flue rising at an angle to join the chimney (Plate 32). This 'niche' may be a ventilation flue for an oil or gas heater, which would tie in with the chimney and air vent mentioned in 5.6.2. The roof structure in the northern room of Building C consists of a single collar beam truss, which has been made from reused timbers as shown by the slots for purlins and mortice holes for struts from an earlier roof.

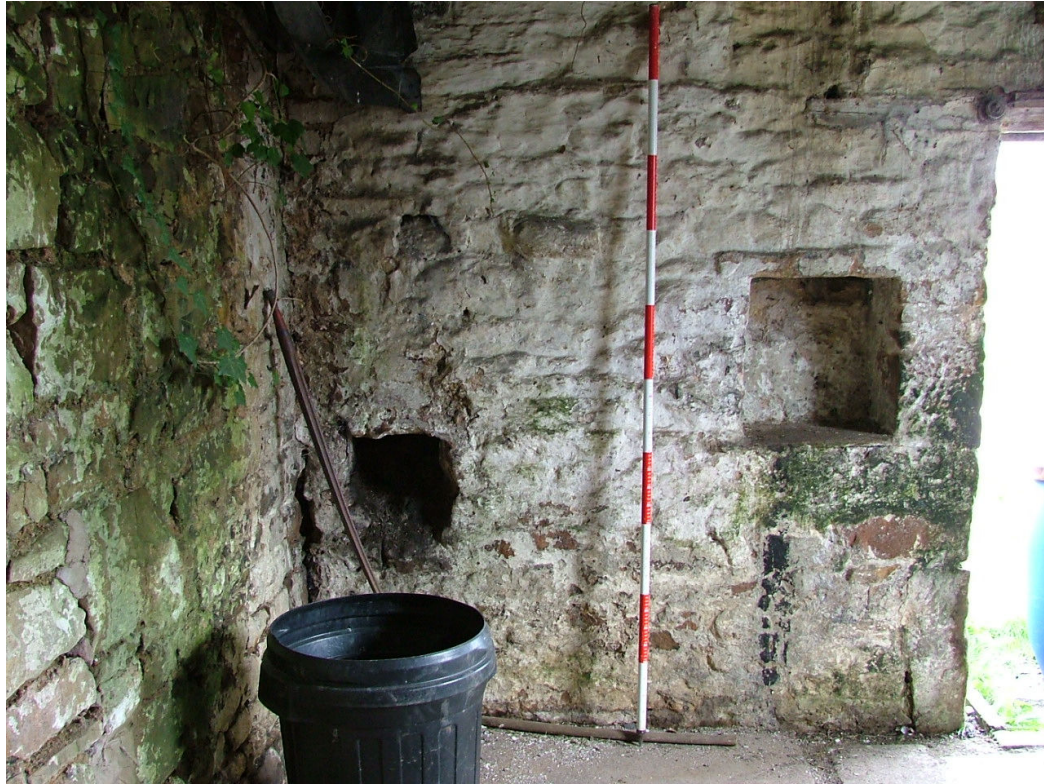
Plate 32 – Niche (beside doorway) and flue for heater? (left)

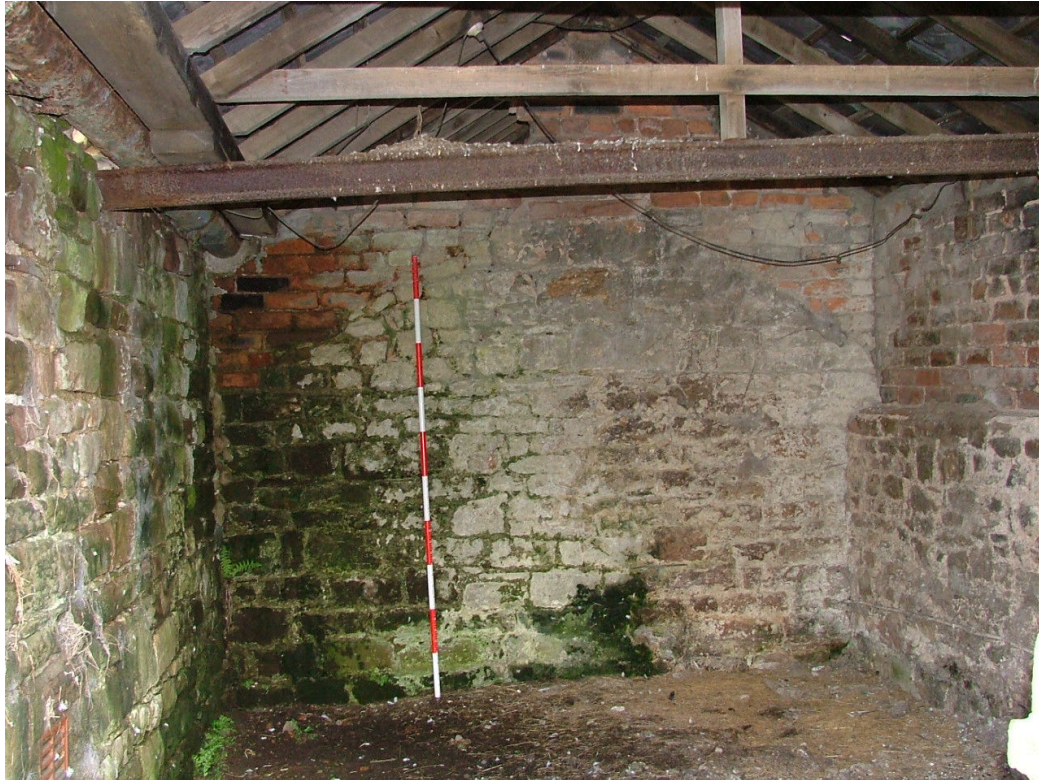
Plate 34 – Interior of southern room of Building C, guttering visible to left

- 5.7.2 The southern room of Building C was relatively featureless apart from the change in wall construction already noted. The guttering of Building B was observed within Building C (Plate 34), therefore Building B obviously was constructed prior to Building C, this is confirmed when the First and Second Edition OS maps are compared (Figures 5 and 6). Building C is not shown on the First Edition map of c.1865, but it is visible on the Second Edition map of 1901.

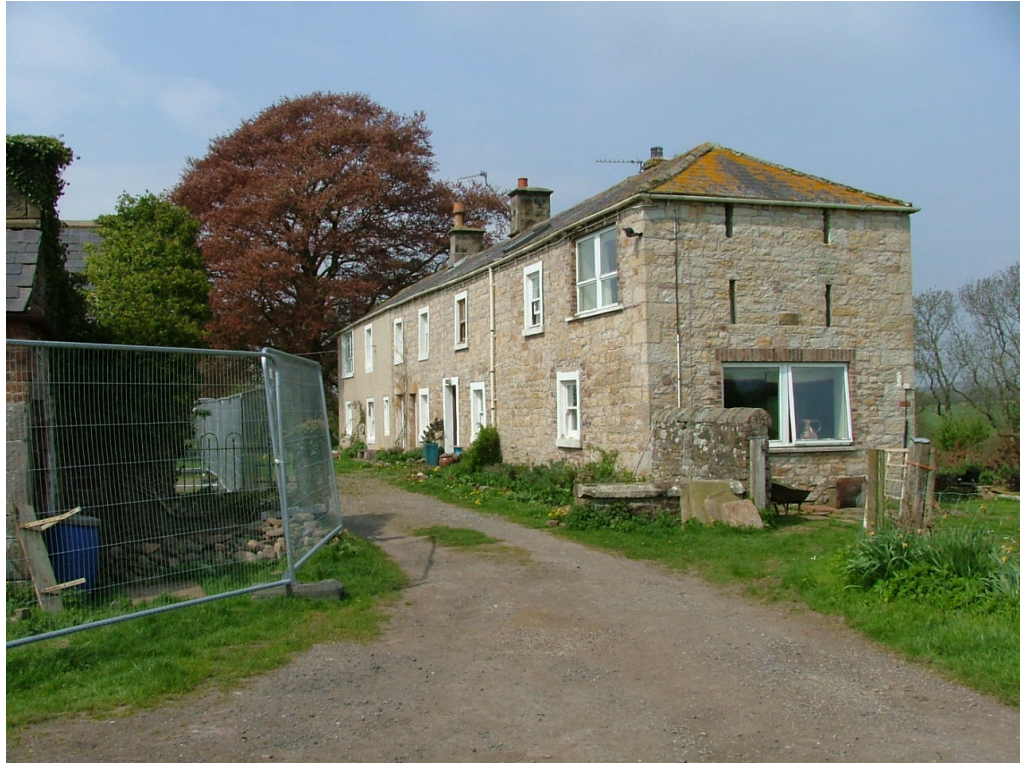
Plate 35 – South facing elevation of the farmhouse, showing former farm building now converted

- 5.8.1 The farmhouse is an integral part of any farmstead and, in Cumbrian farms at least, more often than not forms part of the enclosed farmyard (Figure 7 and Plates 35 and 36). This is quite interesting generally as it suggests, as Brunskill describes, that *'the degree of relationship and the status of the attached farm buildings seem to reflect a social bond between the farmer and his farmstead'*⁹. Although the farmhouse does not form part of this survey it is worth noting that the eastern end was originally a farm building as shown by the ventilation slits in the eastern elevation (Plate 35). Therefore it is necessary not to assume that the farm buildings which form the present survey, were the only structures used by the farmer, and that the eastern end of the farmhouse may have originally been a stable block or byre.
