NORTH PENNINES ARCHAEOLOGY LTD

Project Designs and Client Reports No. CP/333/06

In May 2006, North Pennines Archaeology Limited were commissioned by Green Design Group to undertake an archaeological building recording project of two barns at The Heugh, Walton, Brampton, Cumbria (NY 5361 6511) in advance of a proposed redevelopment, which would involve the demolition of one barn and the conversion of the other to residential and holiday use.

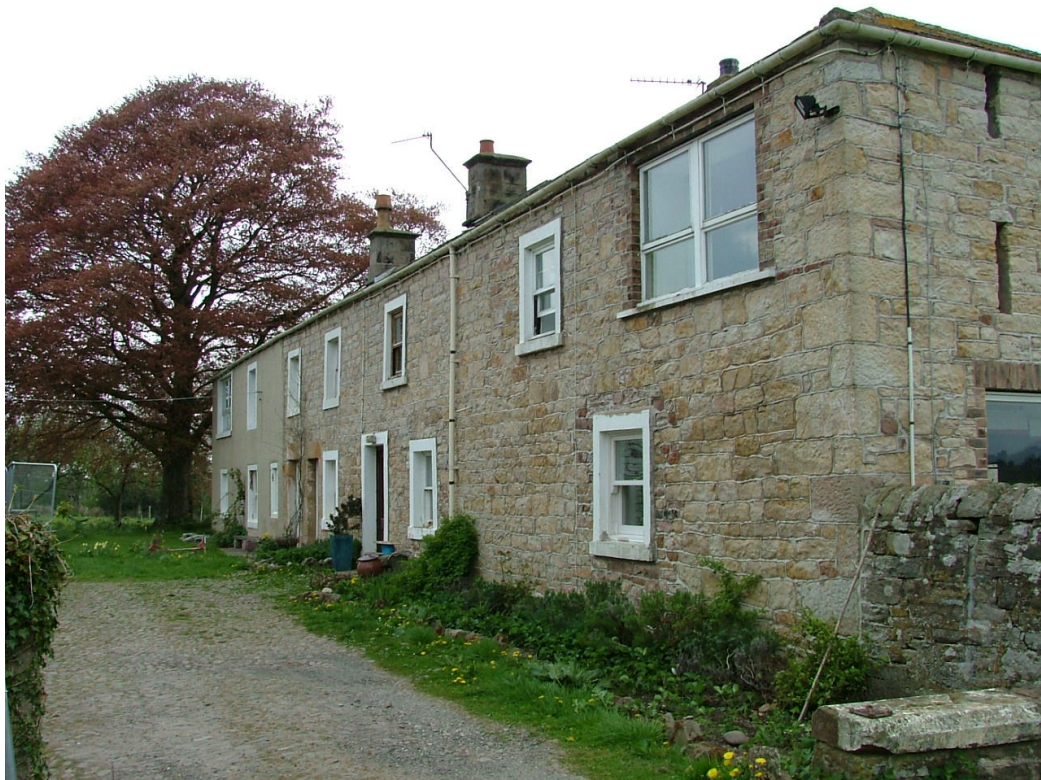
Plate 36 – South elevation of farmhouse
