1. INTRODUCTION

- 1.1 In November 2005 North Pennines Archaeology Limited were commissioned by Mr. M. Wilkinson, to undertake an archaeological building recording project of an agricultural building at Linney Brow Farlam, Brampton, Cumbria prior to its conversion to residential use (Planning application reference no. 03/0903).

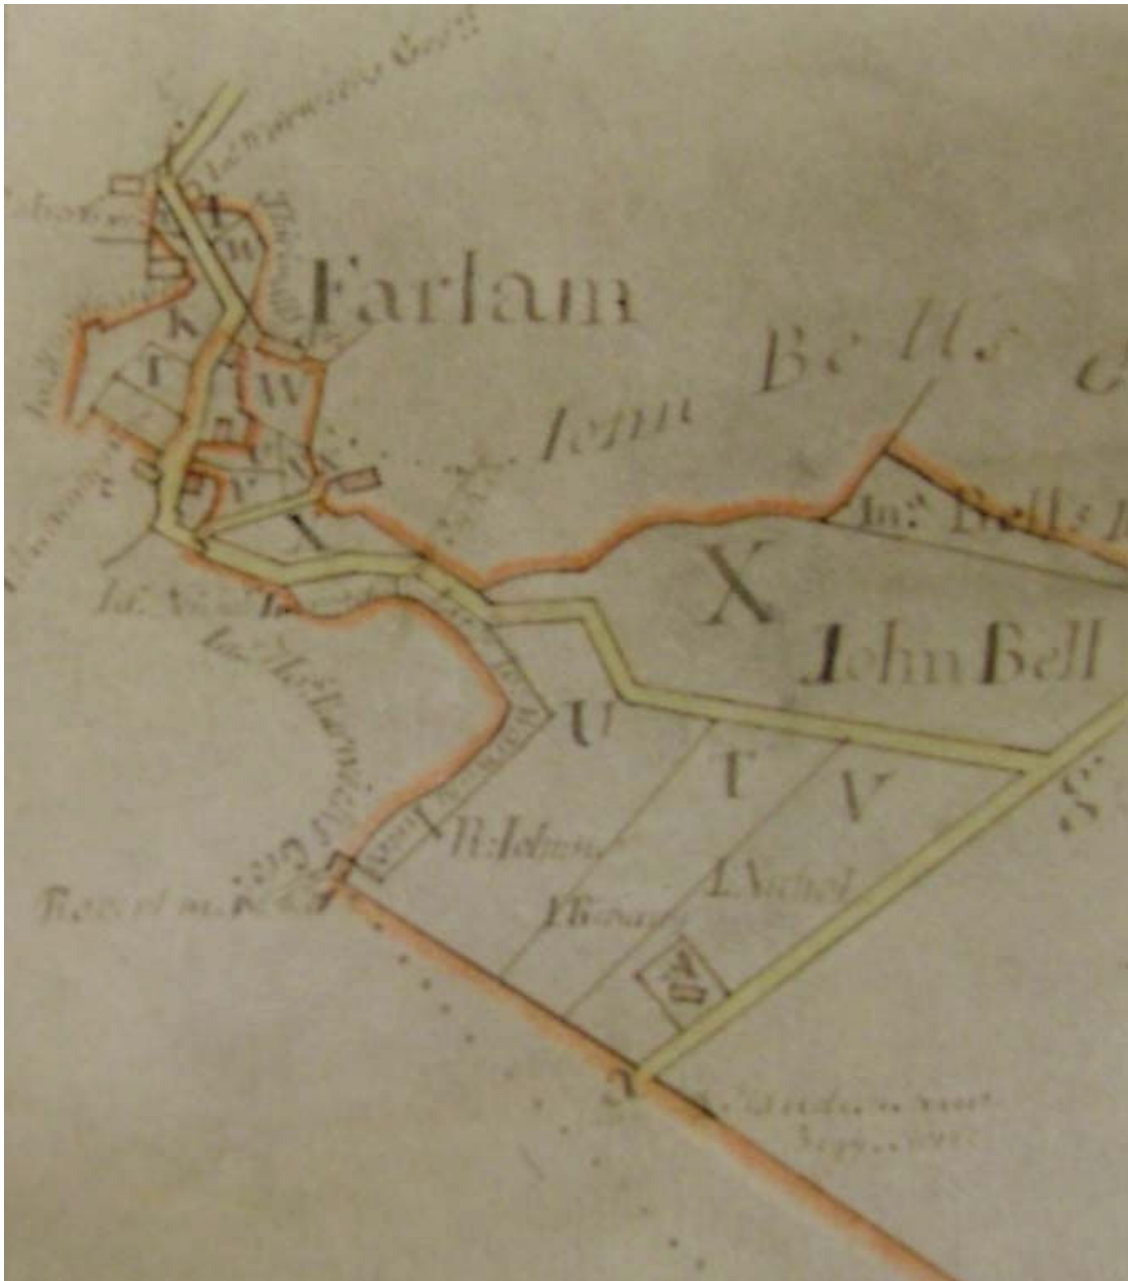
Figure 5 – Enclosure map of 1780 (CRO Ref. QRE/1/79)

- 5.2 By the date of the Enclosure map of 1780, there certainly appears to be a property shown on the site of Farlam Farm (figure 5). Enclosure maps with accompanying awards were produced from c.1770 as land that had previously been waste or common land was taken into cultivation. The maps themselves show the land which was to be enclosed while the awards recorded how much land was to be enclosed and by whom. The Farlam Enclosure map shows 'Calvert's Grounds, Lord Warwick's Grounds and Thirwall's Ground' around the village at Farlam. The land just to the west of Farlam Farm was included within 'Calvert's Grounds'.

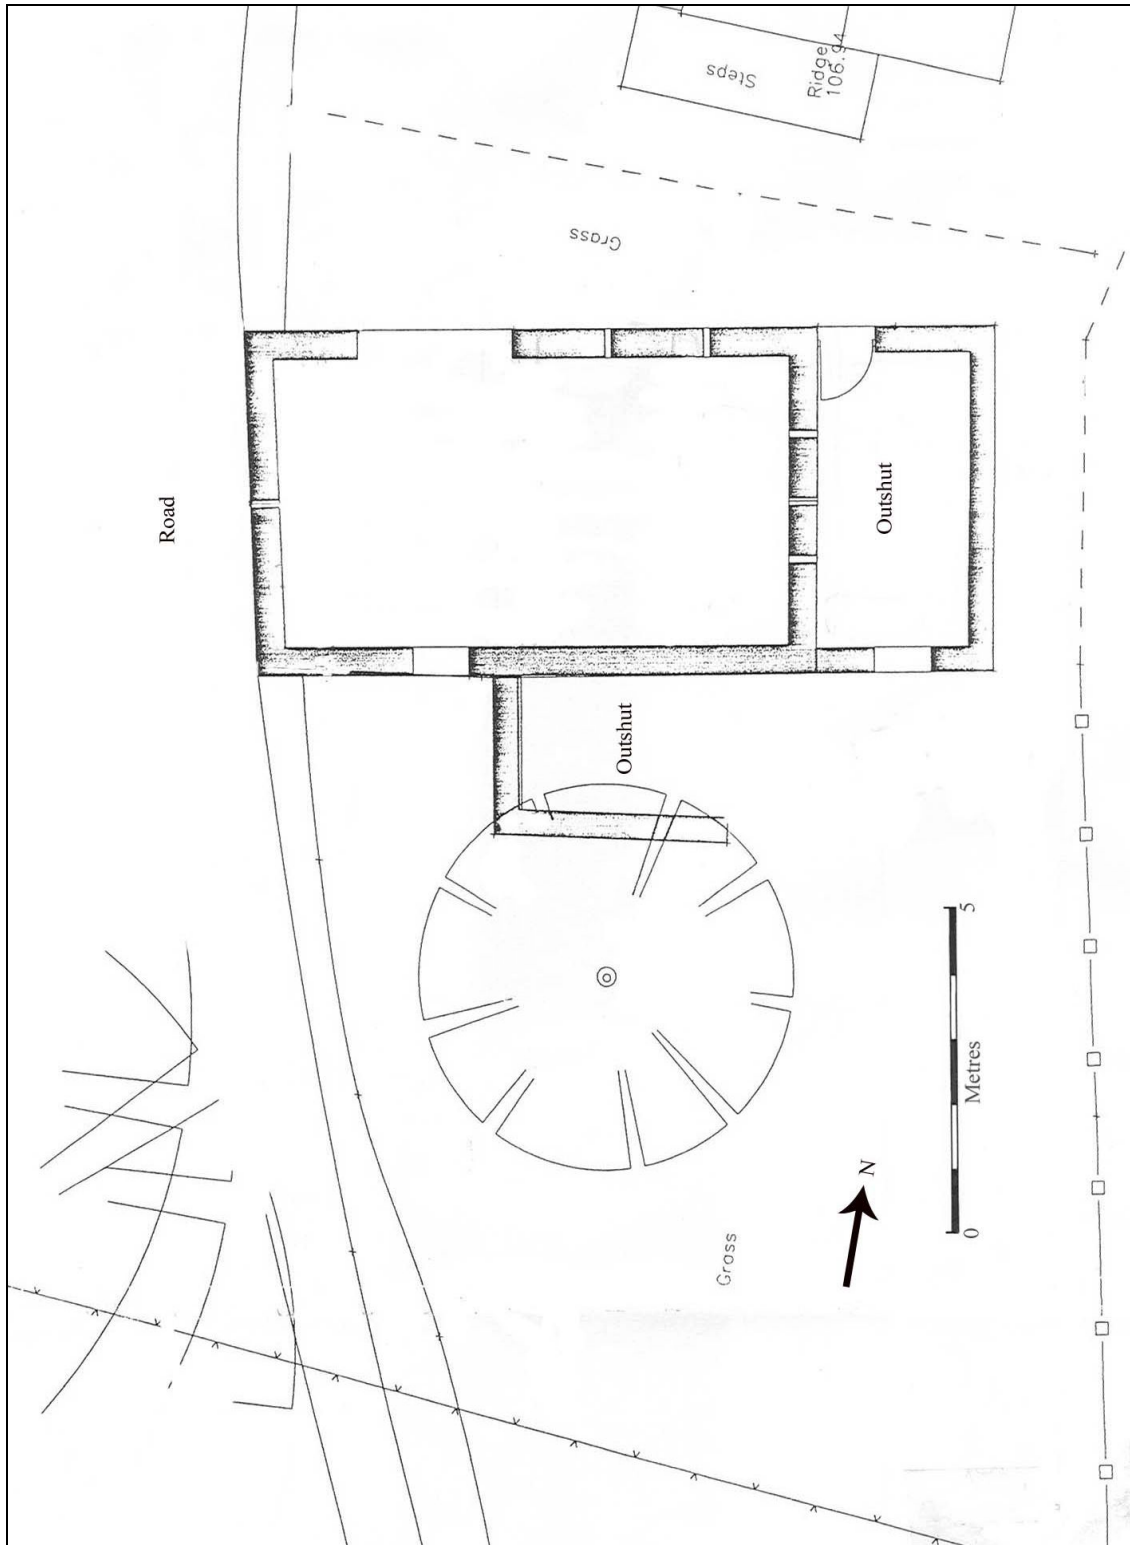
Figure 8 – Ground plan
(Data captured at 1:100)

- 6.2 The barn (figure 8) measures *c.*11 metres in length by *c.*five metres in width and is constructed of roughly coursed rubble masonry. The roof is of Welsh slate with sandstone ridge tiles. On the northern elevation there is a large doorway close to the western gable end (plate 2 and figure 9) with a timber lintel. There are two rows of ventilation slits (two to each row) to the left of this large doorway. At the eastern end of this elevation there is a single-storey outshut which is a later addition as shown by the vertical construction break. This outshut has a doorway on the northern elevation. It was noticeable along this elevation that the wall has been heightened by *c.*60cm and that the western gable end has also been rebuilt, as there was a change in masonry at the western end of the northern elevation (plate 3). There is a wall plate consisting of thin rectangular pieces of sandstone.

- 6.8 In the eastern gable end there are five ventilation slits, three at ground and two at the upper level (plate 6). The presence of ventilation slits at ground level in this wall suggests that the outshut located on the other side of the wall was constructed later. At ground level, there is a partly blocked aperture close to the southern wall (plate 9). The floor in the western side of the barn has been removed; however at the eastern side, beneath the timber platform, the floor is of concrete.
- 6.9 The interior of the outshut against the eastern wall of the barn was accessed via a doorway in the northern wall (figure 8). The roof timbers are machine-sawn and modern, and the floor is of concrete.

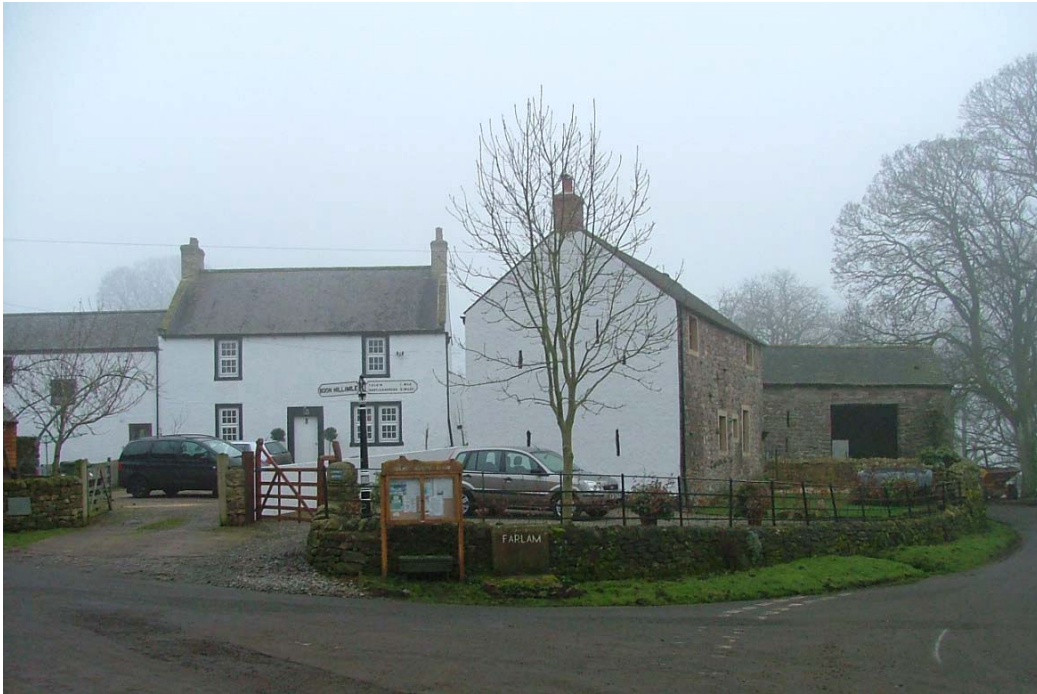
Plate 1 – Linney Browe (formerly Farlam farm) looking south, the barn is to the right of photograph

- 6.1 The barn that is the subject of the present survey is located on the western side of the area of land that was originally the site of Farlam Farm (figure 2 and plate 1). It is orientated roughly west-east, with its western gable end facing the road from Talkin.

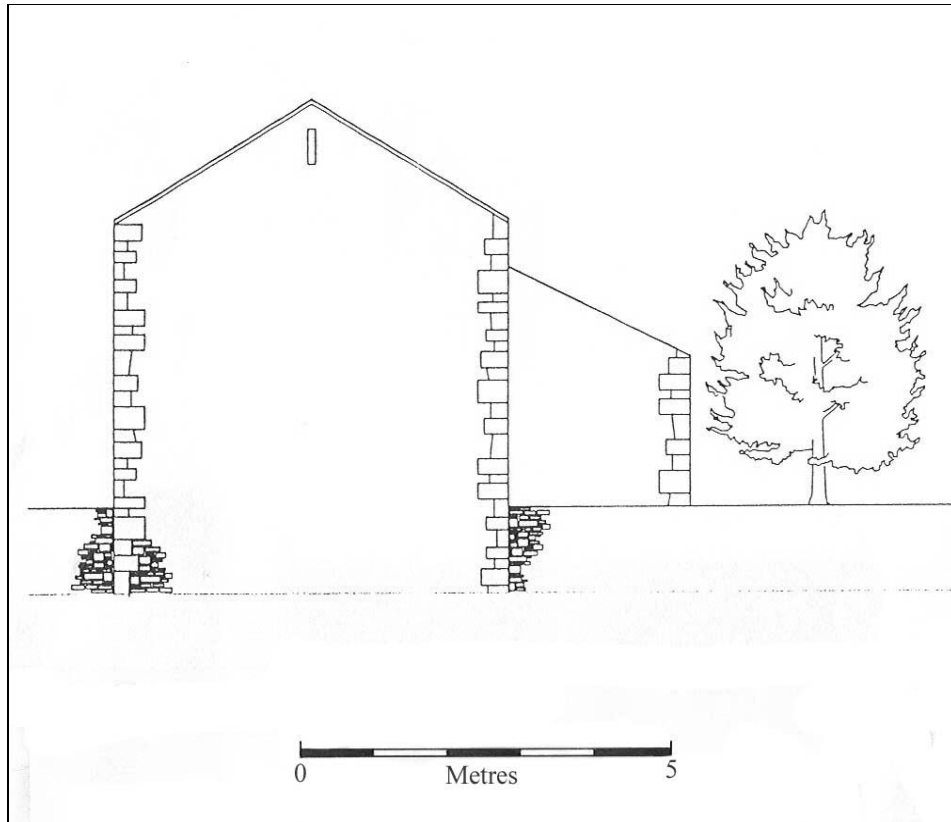
Figure 10 – Western elevation

- 6.3 The western gable end of the barn faces the road and has a single ventilation slit close to the apex (figure 10 and plate 4). The masonry of this elevation is quite heavily mortared and appears to be contemporary with the heightened sections of wall on the north and south elevations. Stone walls run north and south from this elevation.

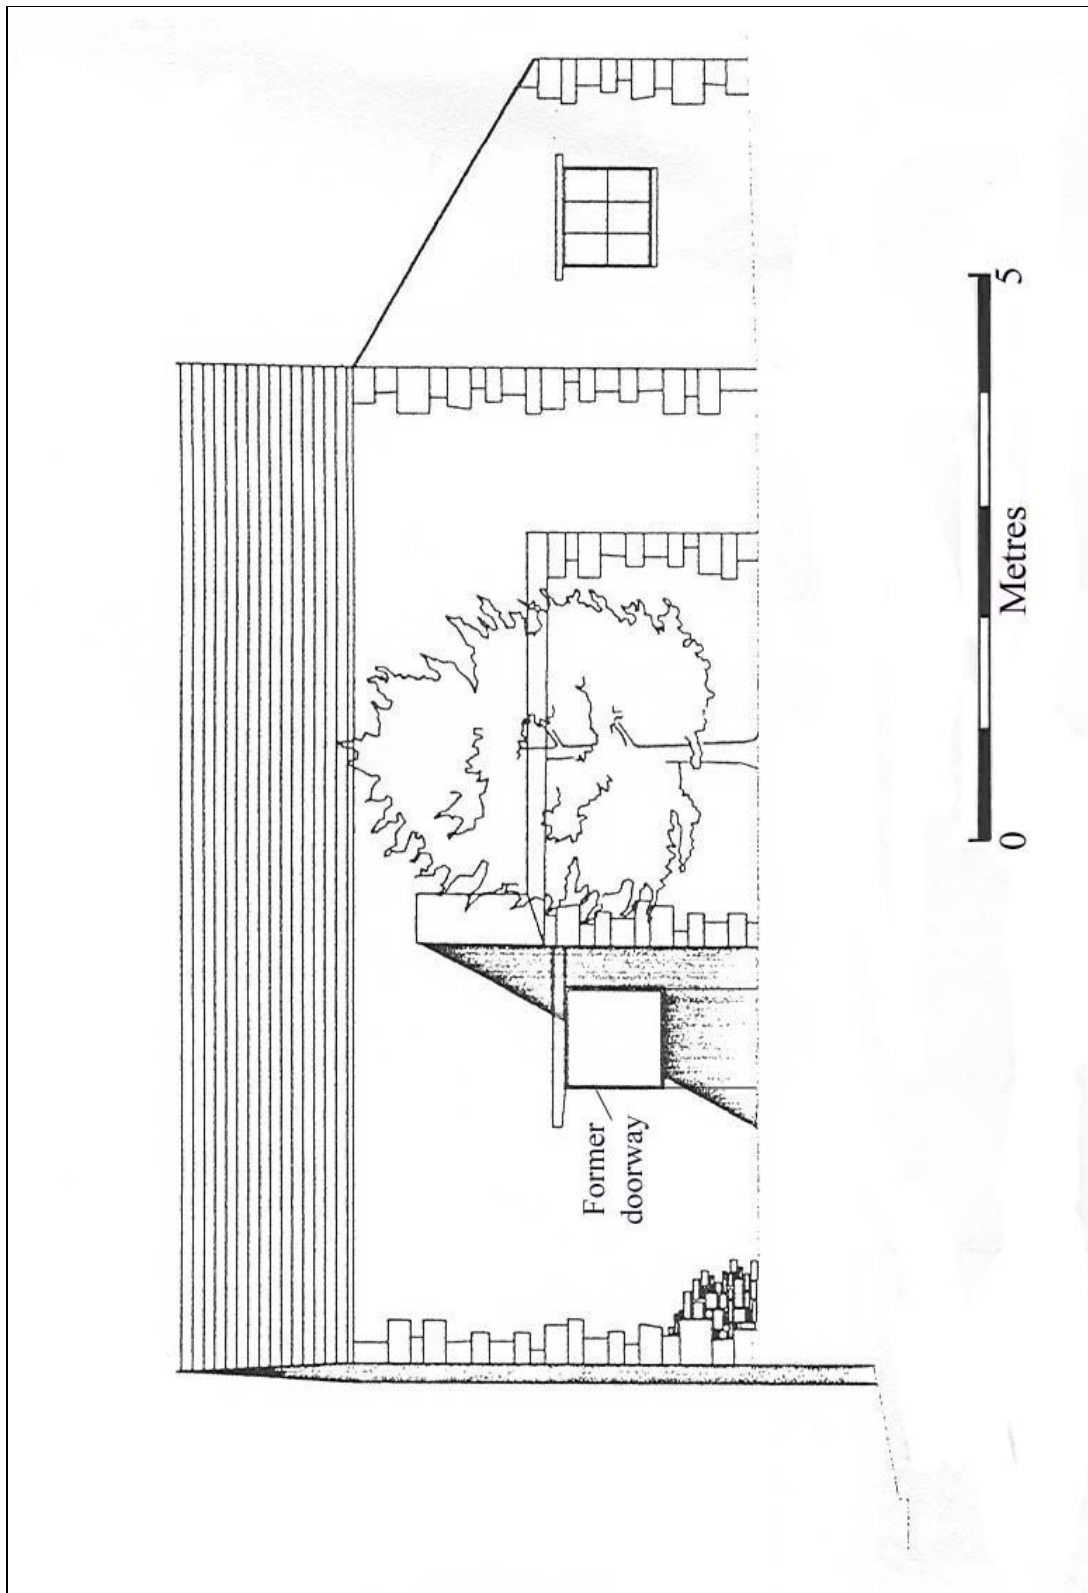
Figure 11 – Southern elevation

- 6.4 The southern elevation (figure 11) has a former doorway, now converted to a window, and is one blocked and two open ventilation slits. There is a small roofless outshut against the southern elevation, which extends outwards for approximately two metres. The doorway for this single storey outshut is in the eastern elevation (figure 8). During recent ground works within the interior of this outshut, a substantial layer of compacted coal dust was excavated, suggesting that this building has been used as a coal shed (pers.comm. Mr Wilkinson). The change in masonry observed on the northern elevation was also noted on this elevation. There is a window in this elevation that belongs to the outshut at the eastern end of the barn. The roof of this outshut is of modern profile sheeting.

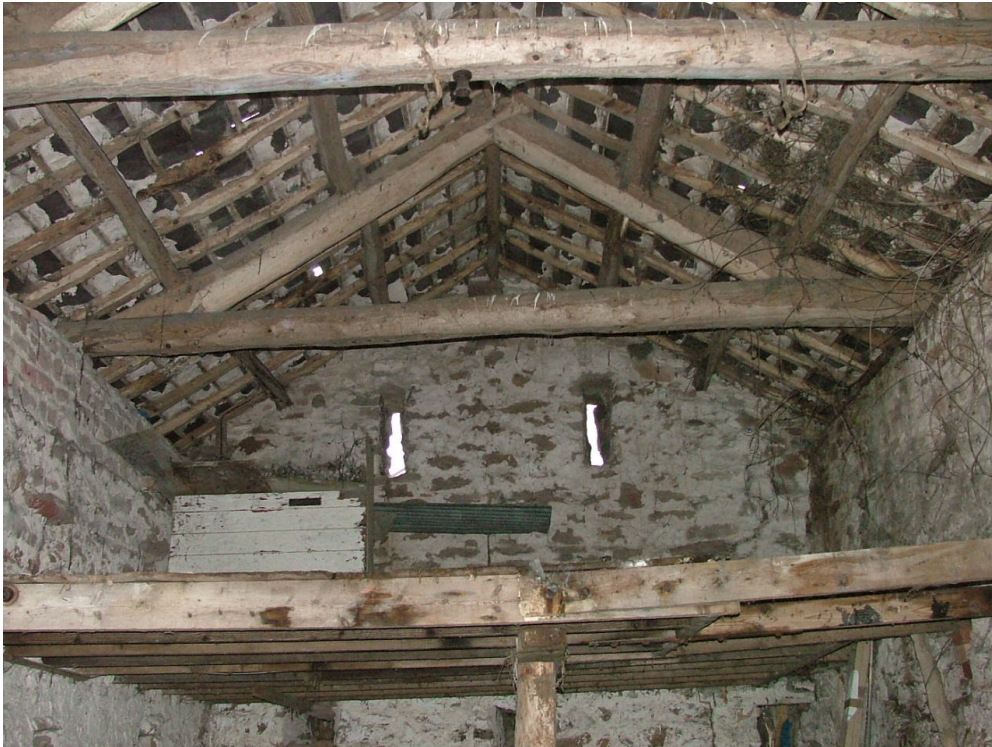
- 6.5 The interior of the barn could be accessed through the large doorway on the northern elevation (figure 9). Internally, the barn is divided into four bays by three principal rafter and tie-beam roof trusses. These roof trusses are constructed of round wood, quite different from the machine-sawn timber of most traditional farm buildings (plate 6). There are two rows of purlins on either side of the roof.

Plate 6 – Interior of the barn looking east

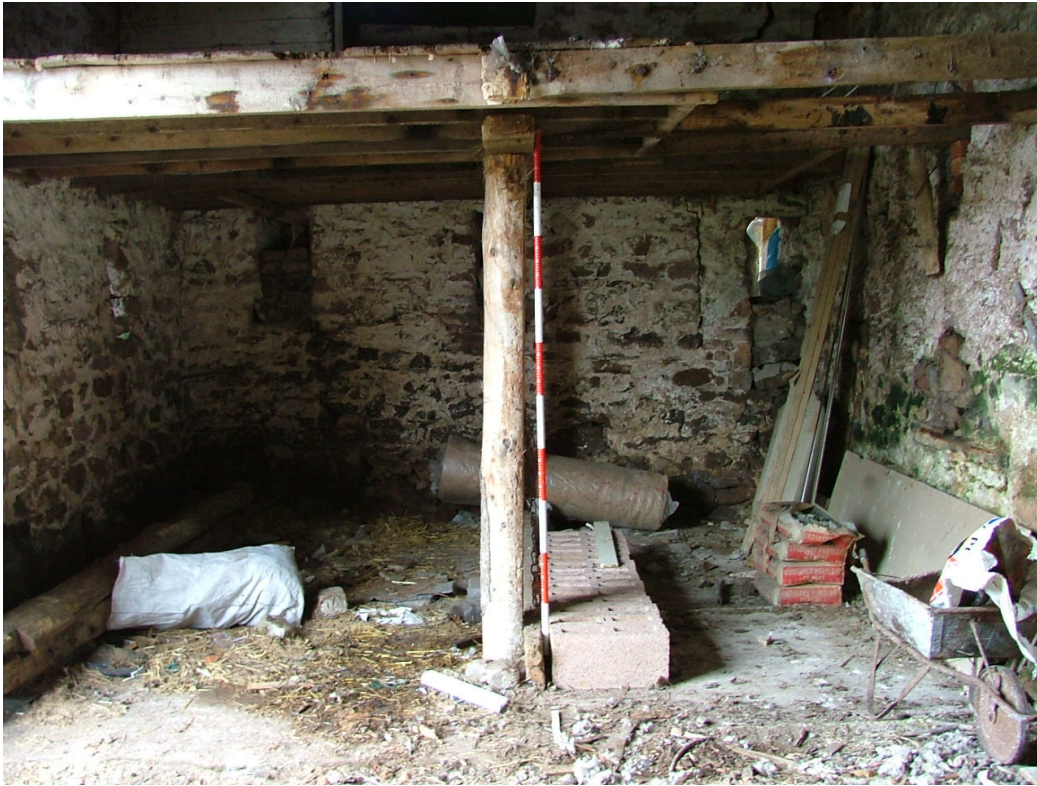
- 6.6 To the left of the large doorway into the barn there is a timber platform raised approximately two metres above ground level; it is supported by two vertical pieces of round wood, with the joists bonded into the wall (plate 7).

Plate 7 – Timber platform, eastern side of barn

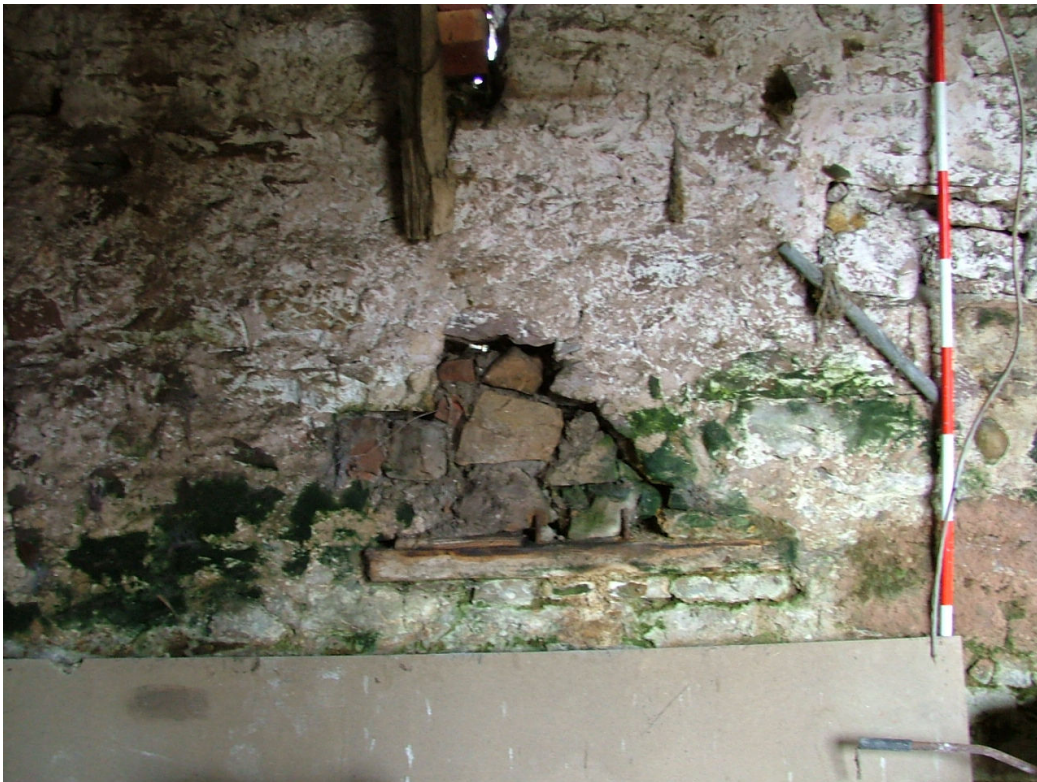
- 6.7 In the southern wall, located opposite the large doorway, there is a window which was originally a domestic-sized door. This may have been a ‘winnowing door’, used after the threshing process to utilise a through-draught to blow the lighter chaff from the valuable cereal grains. Just to the left of this window, set within the wall, there is a horizontal piece of timber with an iron housing; above which the wall has been refilled (plate 8). This may have held a drive-shaft between a diesel engine housed in the outshut on the southern wall, and a threshing machine located in the barn, although externally this iron housing could not be observed due to a raised ground level. Diesel engines were introduced onto the farmstead from the early twentieth century and they gradually replaced steam as the main source of

power⁴. A similar feature (iron housing) was recently observed at Islekirk Hall, Westward, Wigton, where a small building was located on the southern side of the main barn wall and was interpreted by the surveyor as having once housed a diesel or electric engine to drive the threshing machine⁵.

Plate 8 – Housing for drive shaft for thresher?

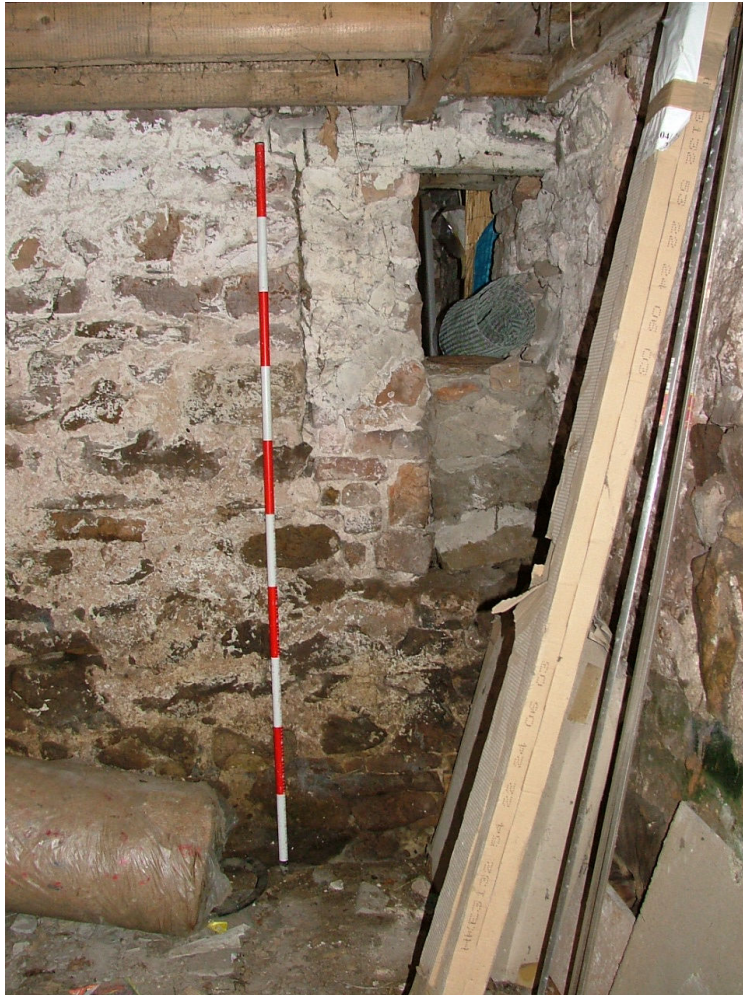
Plate 9 – Partly blocked aperture, eastern gable end
