## 1. INTRODUCTION

- 1.1 In December 2005 North Pennines Archaeology Limited were commissioned by Graham K Norman, to undertake an archaeological building recording project of a range of agricultural buildings at Langton Farm, Langton, Appleby-in-Westmorland, Cumbria prior to their conversion into two holiday lets (Planning application reference no. 3/05/0357).

- 1.2 Cumbria County Council Historic Environment Service produced a brief for a building recording project, which was to be undertaken prior to the commencement of building work. A 'Level 2' Building Survey was carried out as specified in *Recording Historic Buildings: A Descriptive Specification*<sup>1</sup>.

- 1.4 The building survey is concerned with a range that consists of four different structures, therefore for ease of reference they will be referred to as A, B, C and D throughout the report.

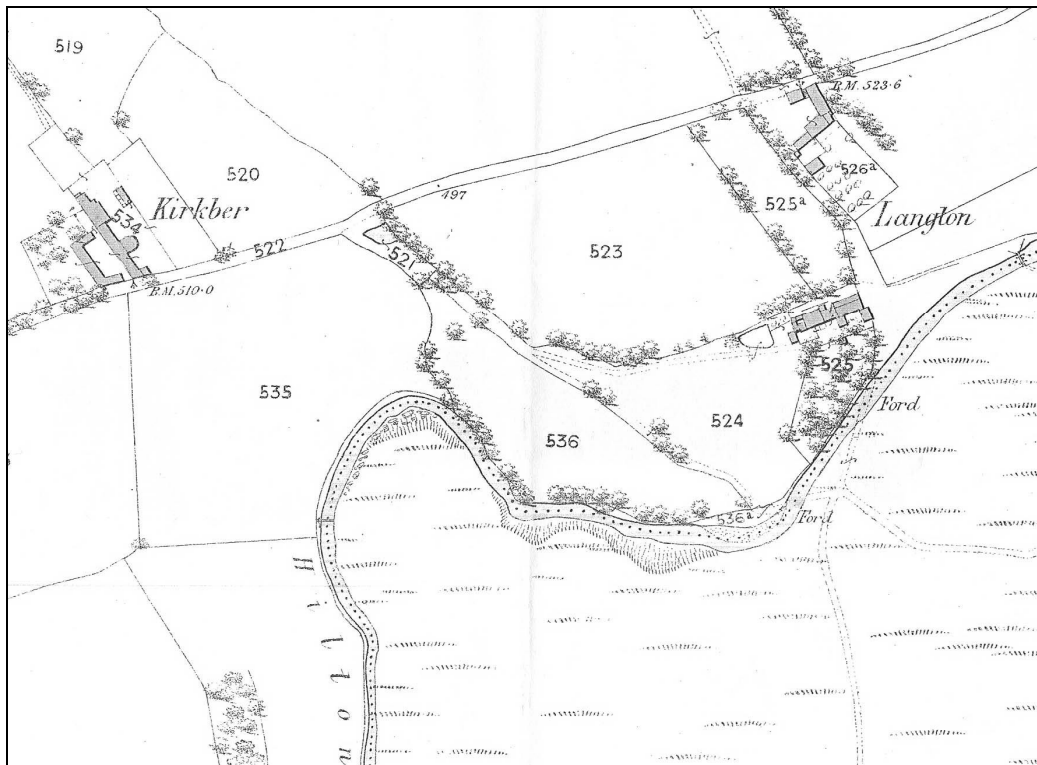
**Figure 4** – Map of c. 1840 (Unknown reference)

- 5.8 Mrs Armitage has in her possession a copy of a map of c.1840 which shows the farm buildings and farmhouse at that date (figure 4).
- 5.9 The farm buildings that are the subject of this survey appear to have been in existence in their present form by 1898, the date of the Second Edition Ordnance Survey map (See figures 5 and 6).

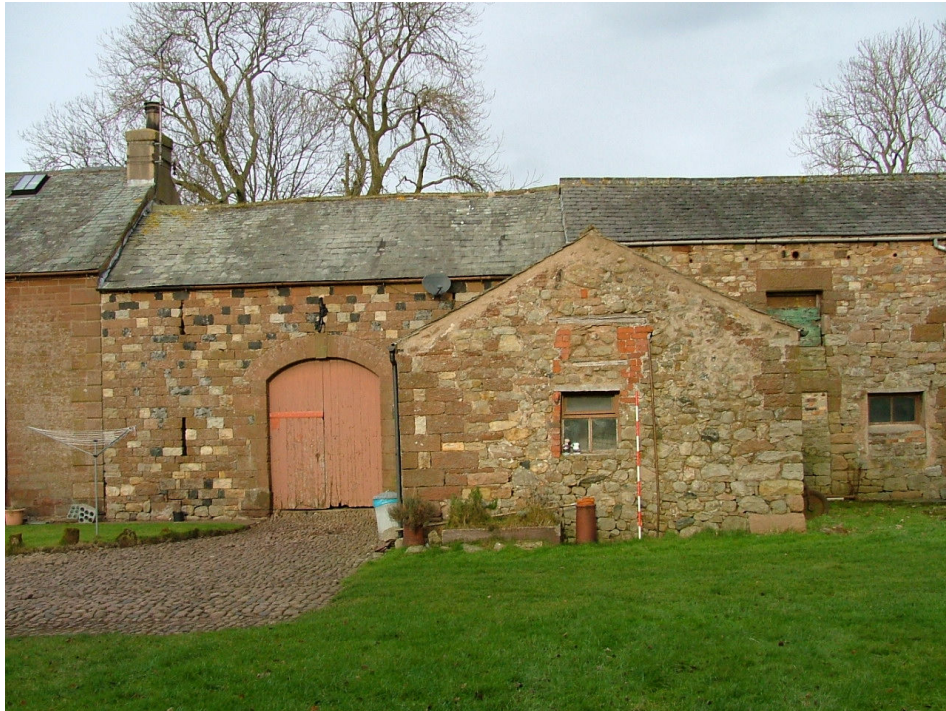
- 6.2.1 Building A forms the eastern end of the linear arrangement that includes the farmhouse and barn (figure 7), although a straight construction break between Building A and the Barn shows that the two buildings were not constructed at the same time. Building A measures *c.*16.10 metres in length by *c.*5.40 metres wide, is two storeys in height and is constructed of uncoursed and roughly dressed sandstone masonry, very different from the adjoining barn which is constructed of coursed and squared sandstone and granite masonry (plate 1).

**Plate 1** – South elevation of barn (left), Building C (middle) and part of Building A (right)

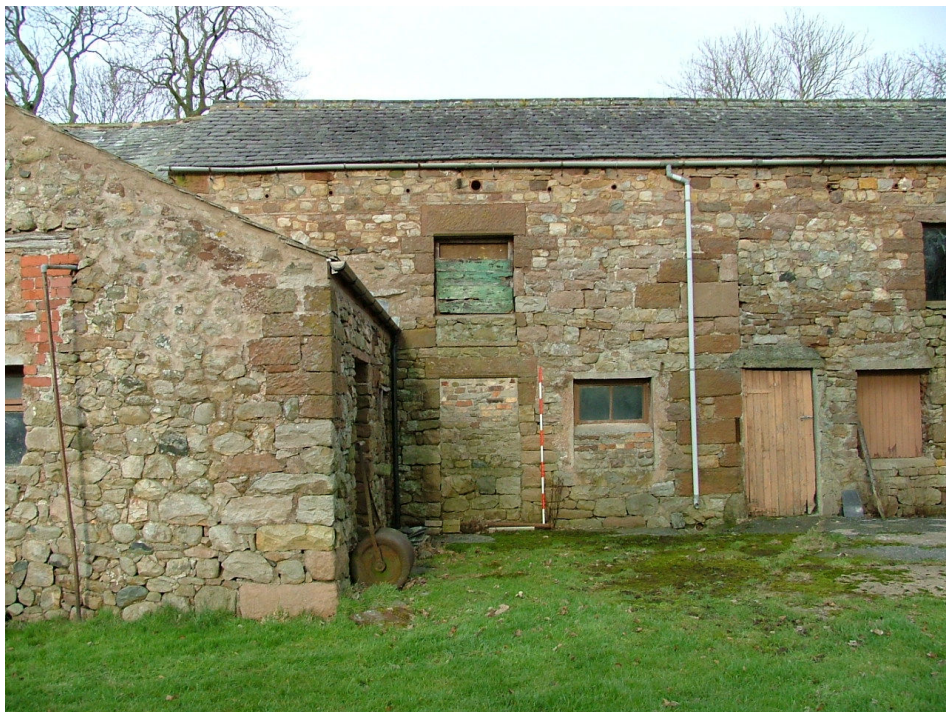
**Plate 2** – Southern elevation of Building A showing quoins of an earlier building (just to the right of the drainpipe)

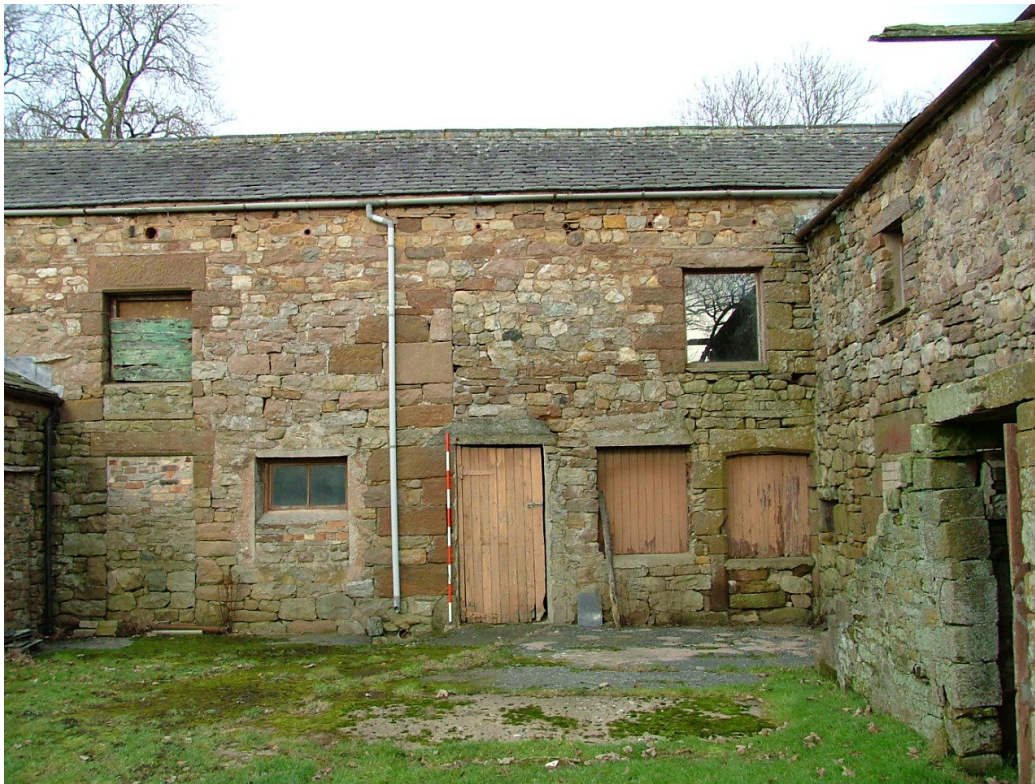
**Plate 3** – The eastern end of south elevation of Building A, construction break is in line with the ranging pole

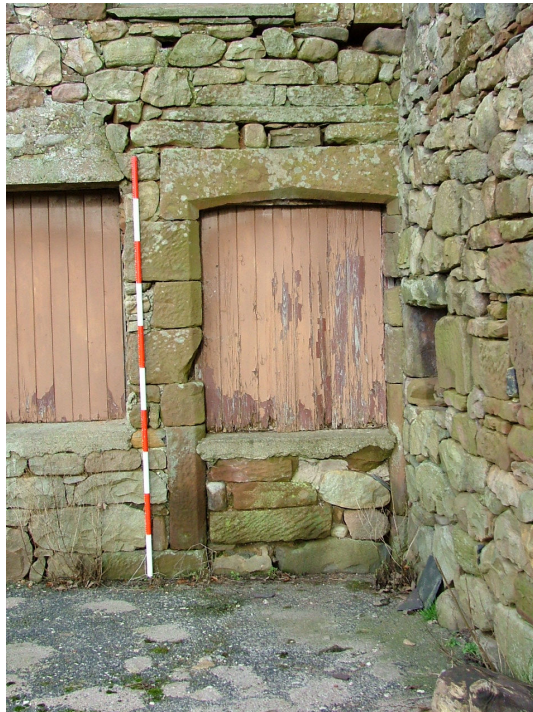
- 6.2.3 The western end of Building A (to the left of the construction break) has a blocked doorway with dressed sandstone lintel, a window at ground level which may have been a later insertion (and which has subsequently been partly blocked up), and a window at first floor level with a dressed sandstone lintel (figure 9 and plate 2). To the right of the construction break on the southern elevation, there is, at ground level, a doorway, which may be a later insertion, a window and a further doorway which has been partly blocked-up; this doorway has a

false four-centered arched head<sup>7</sup>. There is a further window at first floor level (figure 9).

**Plate 4** – False four-centered arched head, southern elevation of Building A

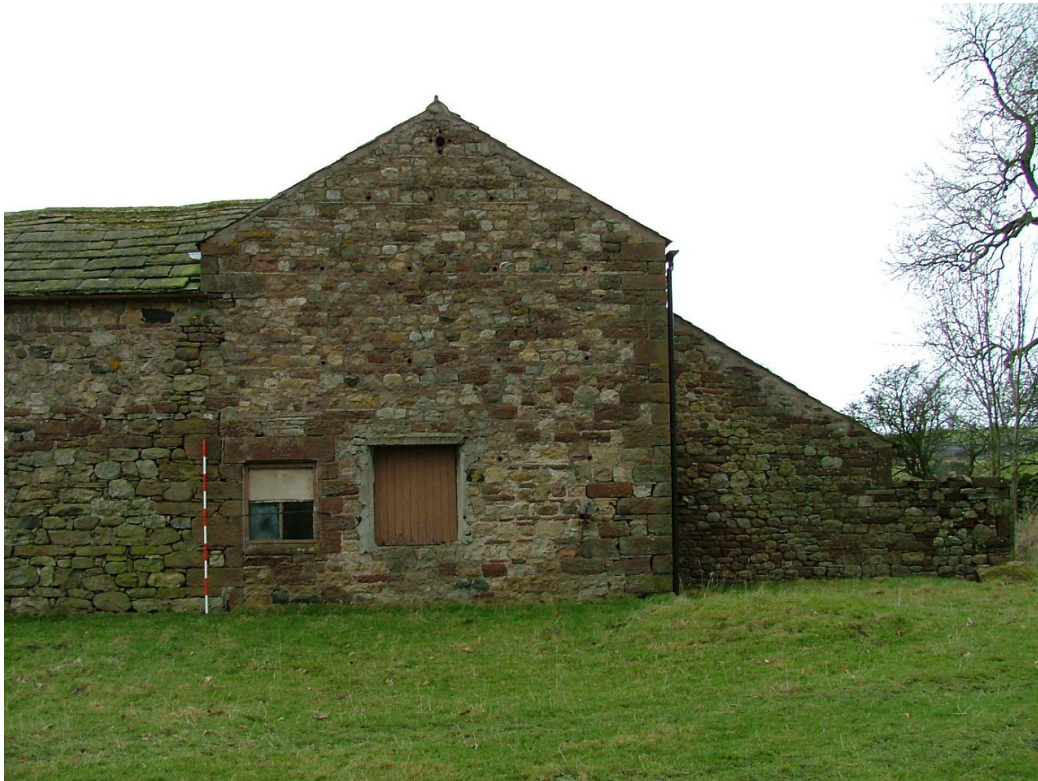
- 6.2.5 The eastern elevation of Building A has two windows at ground floor level, one of which was originally a doorway with sandstone lintel and alternating sandstone squared blocks making up the door jambs (plate 5).

**Plate 5** – Eastern elevation of Building A

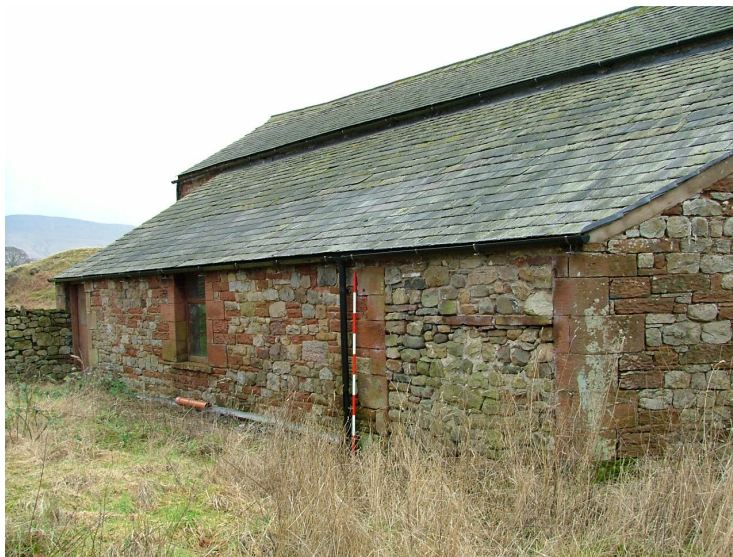
- 6.3.1 Building B butts up against the northern elevation of Building A (figure 8) and therefore must have been constructed later. This single storey building is constructed of roughly coursed rubble masonry with squared red sandstone blocks making up the door and window jambs and quoins. It has a pitched roof, which consists of regular-sized blue Welsh slate for the lower half and diminishing courses of the greener and less regular sized Westmorland slate for the top half (plate 6). There is a domestic sized doorway at the eastern end, a window and a larger 'cart' door at the western end which is now blocked-up (plate 6).

**Plate 6** – Northern elevation of Building B

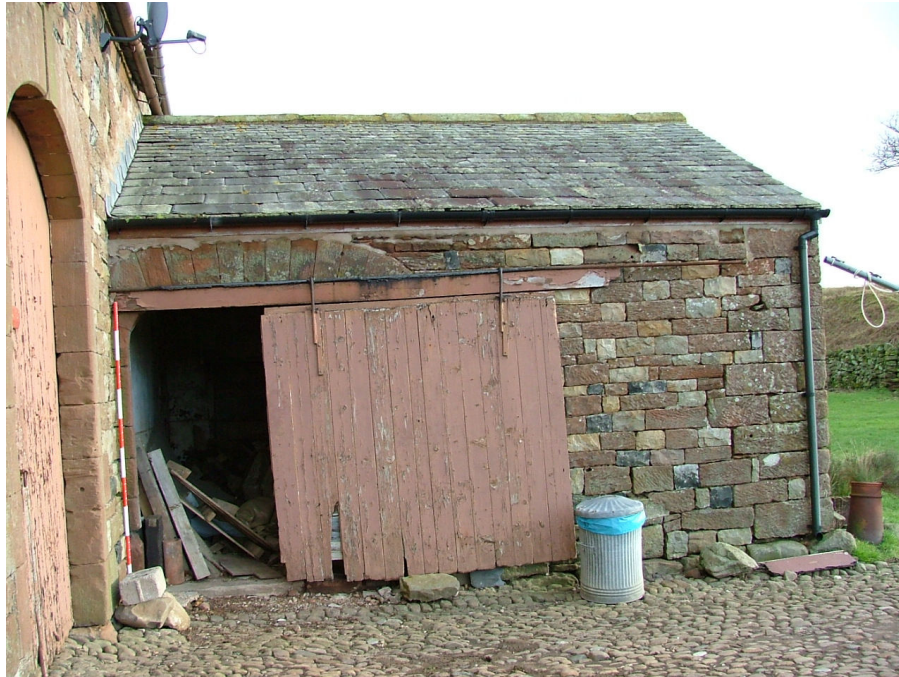
- 6.4.2 The roof is laid to diminishing courses of Westmorland slate with sandstone ridge tiles. On the western elevation there is a large doorway with an arched head consisting of 13 voussoirs. Internal hinges indicate that the original doors opened inwards. What is slightly curious about this door surround is the way the northern jamb is bonded into the wall of the barn, rather than the stonework simply butting up against it. It is possible that the barn and the western wall of Building C are contemporary. The western wall was constructed on a boulder plinth.

**Plate 7** – Western elevation of Building C

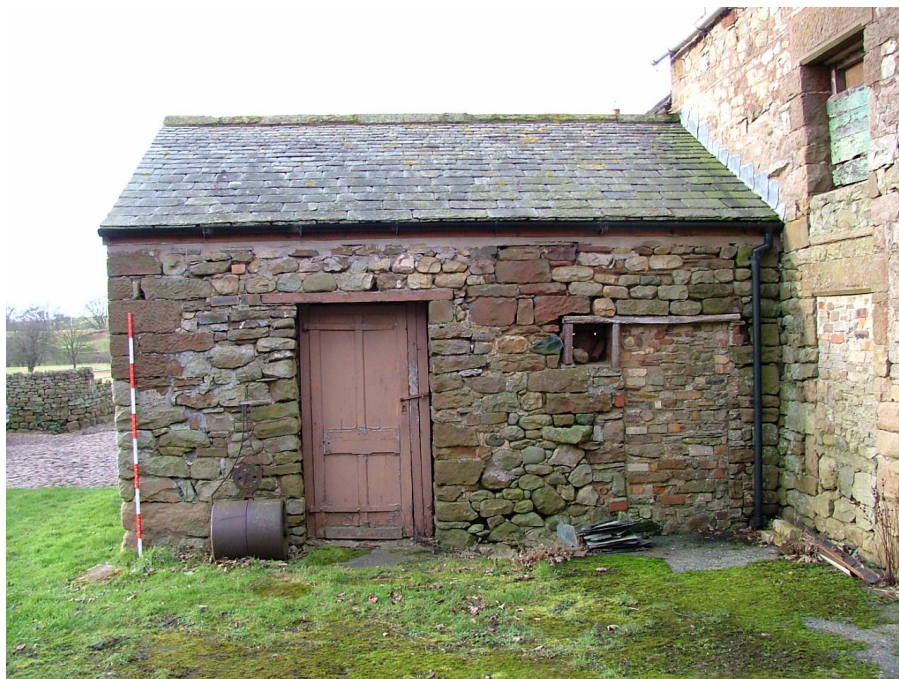
**Plate 8** – Eastern elevation of Building C

6.4.4 The eastern elevation of Building C (plate 8) has a doorway providing access to a log store. A further doorway has been blocked up; this doorway has a horizontal length of timber at its head which forms part of a niche to the left-hand side.

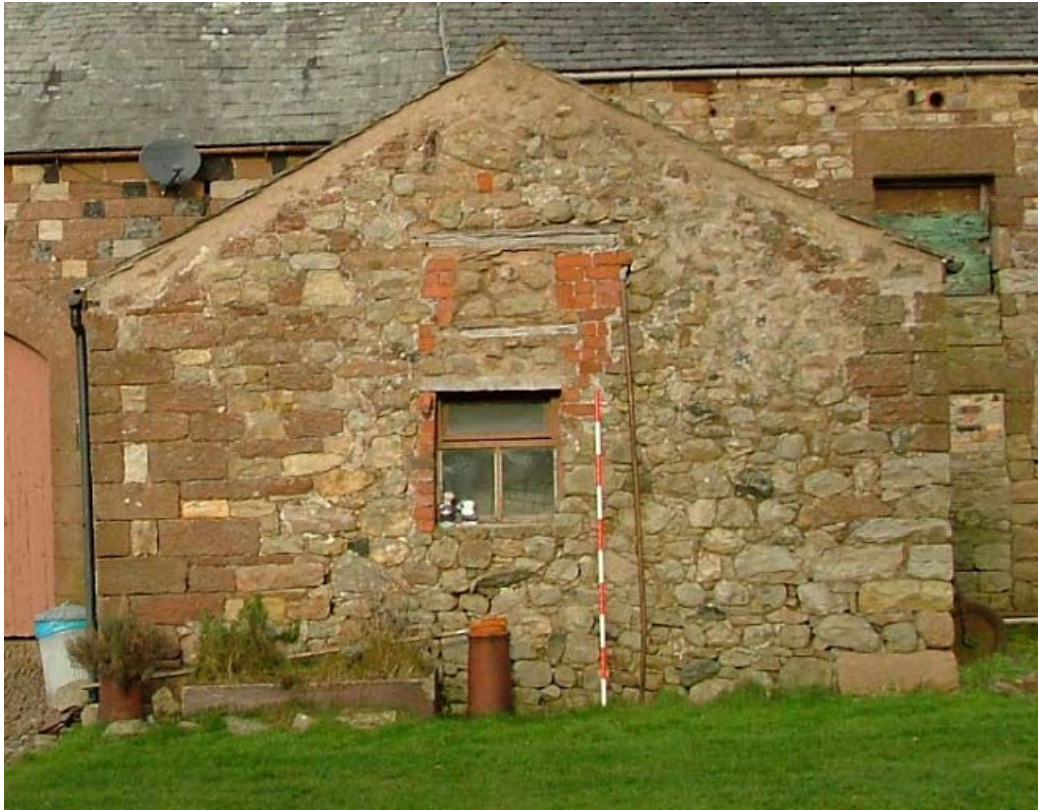
6.4.2 The southern elevation of Building C displays a mixture of construction materials. The western side is of coursed and squared masonry, with some squared stonework in the eastern side, however a

majority of this elevation is of uncoursed rubble masonry. In the centre of the elevation is a window, although some brickwork and horizontal lengths of timber indicates that there was either a large window, or that the position of the window has been moved (plate 9).

**Plate 9** – Southern elevation of Building C

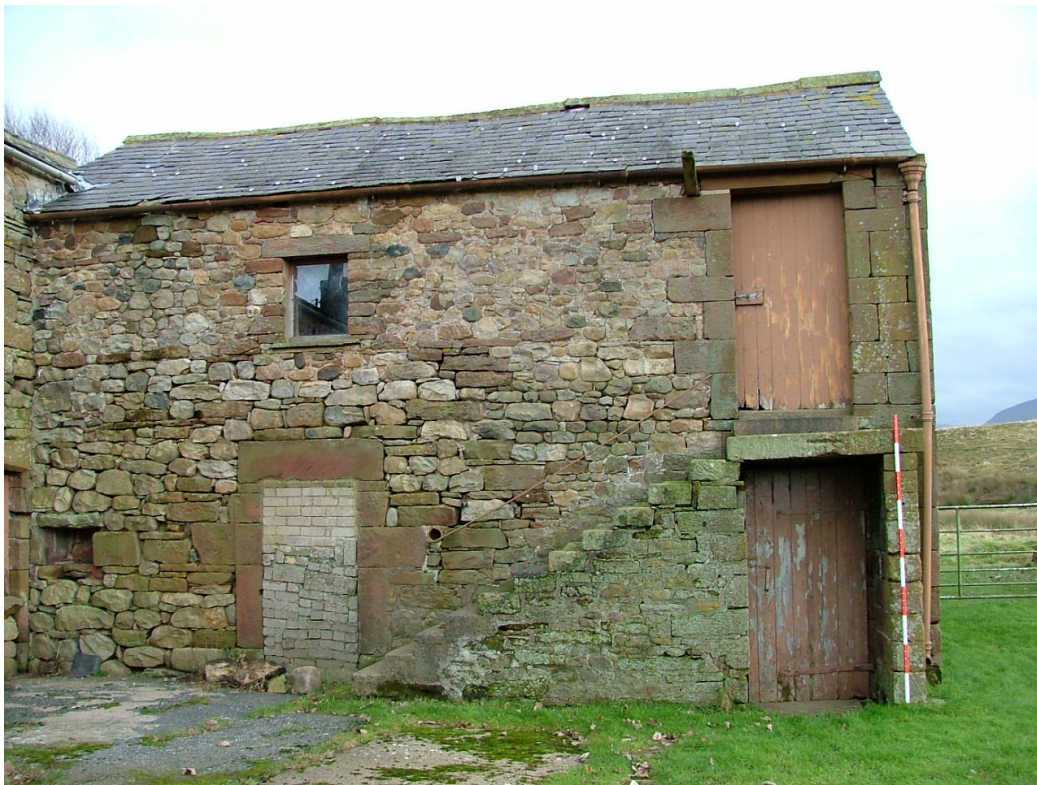
6.5.1 This two-storey building is located at the eastern end of Building A and is orientated north-south. Clearly this building was constructed after Building A as shown by the way the western elevation obscures part of a door jamb and the way that part of the roof overlaps part of the roof of Building A, yet like Building C, it is possible that Building D has undergone some rebuilding. The western elevation is constructed of uncoursed rubble masonry, the blocks of which reduce in size towards the top of the wall (plate 10).

- 6.5.2 There is a doorway with dressed sandstone lintel and jambs at ground level which has been bricked-up, to the left of which is a niche, possibly used to hold a candle or gas light. There is a flight of stairs, constructed of a mixture of concrete and sandstone, which gives access to the first floor. A doorway at ground level, to the right side of the stairs, provides access to the ground floor interior. There is a small window at first floor level. The roof on the western side is of Welsh slate. There is a projecting piece of timber beside the first floor doorway which may have been used as a hoist for lifting sacks of grain.

**Plate 10** – Western elevation of Building D

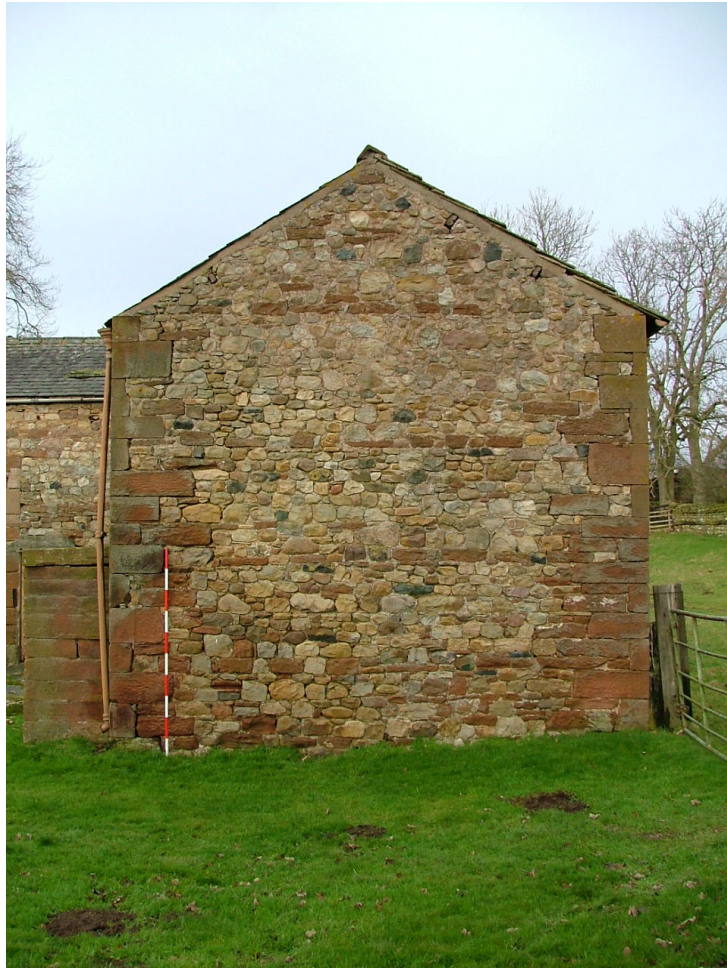
- 6.5.3 In contrast to the western and eastern elevations, the southern gable end of Building D appears to be of one construction phase, being of roughly coursed rubble masonry. Four horizontal rows of rectangular pieces of sandstone may have been used by the builders at certain heights up the wall to act as string courses; these level the wall up during construction. The quoins are of alternating blocks of red sandstone.

**Plate 11** – Southern gable end of Building D

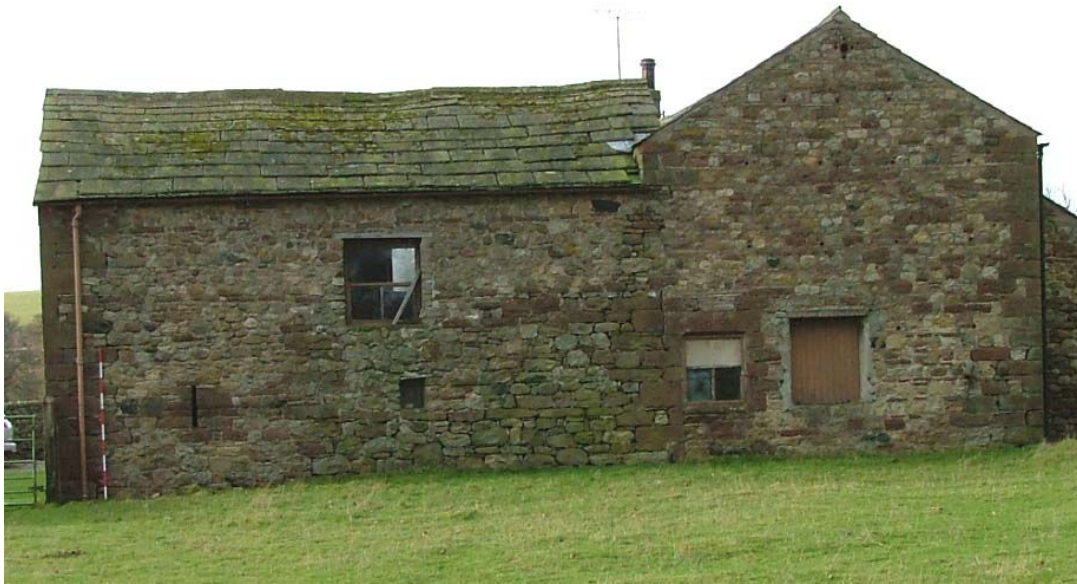
The eastern elevation also displays signs of a rebuilding. The lower half of the elevation, between the first floor window and the gable end of Building A (plate 12) is of larger uncoursed rubble masonry compared to the southern end and upper half of the wall, which is very similar to the southern gable end. There is a small window and vertical ventilation slit at ground level and a window at first floor level, which retains some of its four-pane casement. The roof on this side of the building is all of sandstone tiles.

**Plate 12** – Eastern elevation of Buildings D and A

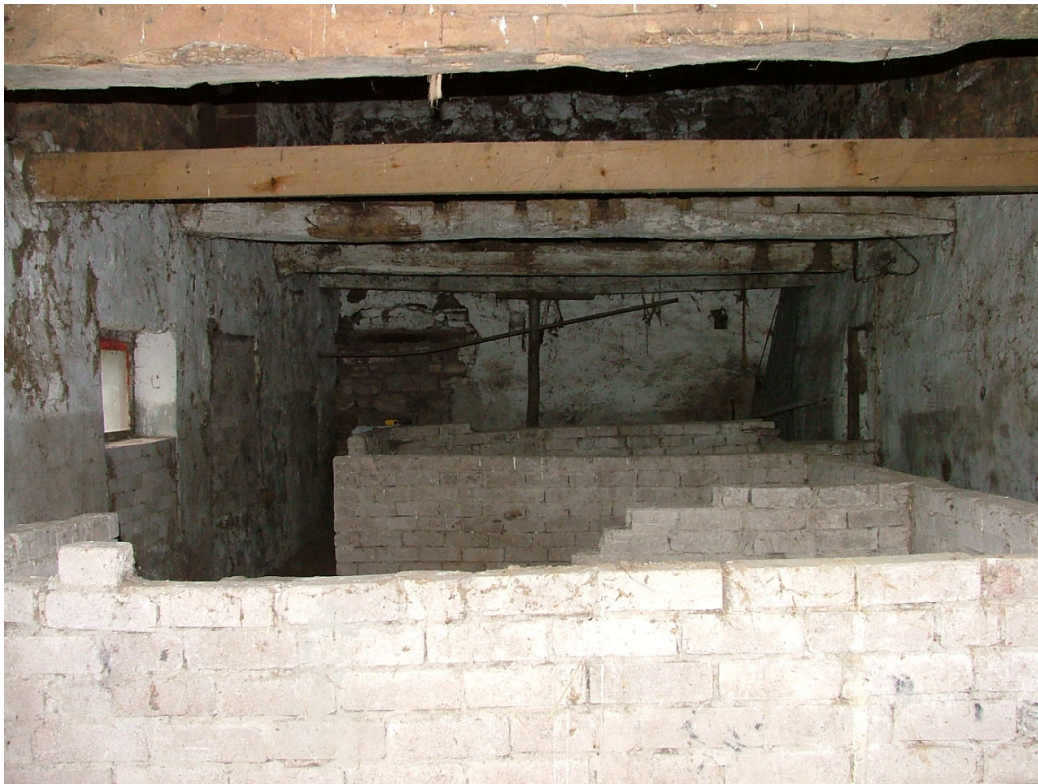
- 6.6.1 Building A has been more latterly used for housing pigs and six brick-built pig sties remain (plate 13). The first floor has been removed with only the floor joists still *in-situ*. At the western end there is a blocked doorway which would have given access to the barn (figure 8). In the northern wall there is a doorway that provides access to Building B, and at first floor level in this wall there is a pitching door, used for transferring hay or straw into the loft and vice-versa. This may have been inserted when Building B was added to the northern elevation, to allow for the easier transference of hay or straw to the byre (Building B).

**Plate 13** – Interior of Building A looking west

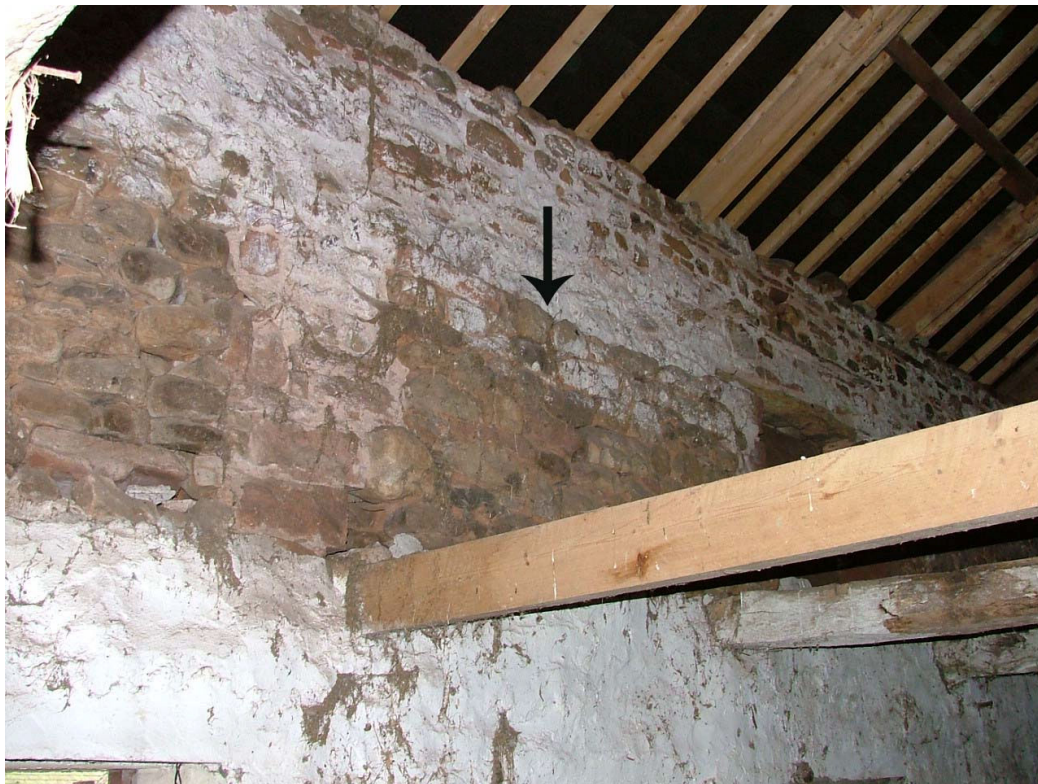
- 6.6.2 The construction breaks for the two ‘cottages’ were not as obvious internally due to lime-washed walls and lack of light and, however it was possible to note a change in wall thickness where the walls of the building had been heightened by approximately one metre (plate 14). At the eastern end of the building are two windows, one of which was originally a doorway (See 6.2.4). Carved into the cement of this window surround is the date ‘1897’. The roof is modern with six trusses creating seven bays. In the southern wall there is a doorway at first floor level, which would have provided access to the first floor of Building D. The northern wall, which externally is now obscured by Building B, has several vertical ventilation slits which would have been level with the first floor when it was still *in-situ* (plate 16).

**Plate 14** – Change in wall thickness, southern wall of Building A

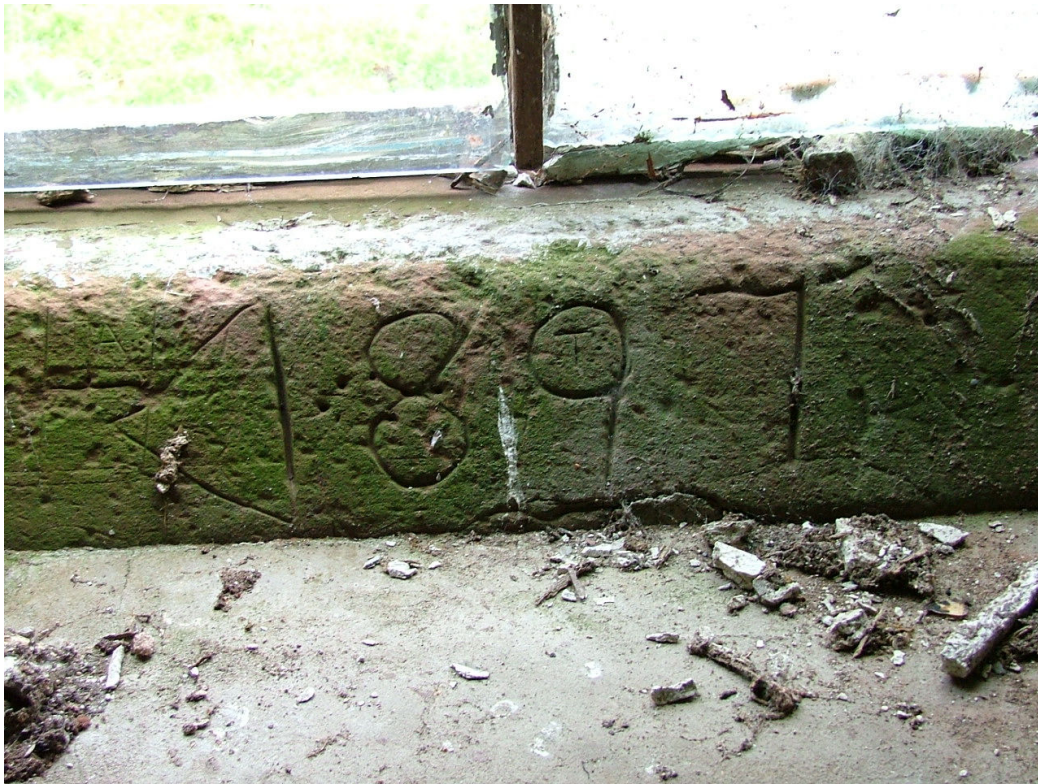
**Plate 15** – Date '1897', window (originally a door), eastern end of Building A

- 7.6 The mixture of stonework in this building would certainly suggest that this was the case, and the similarity of the masonry between sections of Building D and the southern byre, hints at the building work being undertaken at the same time. Perhaps the date of 1897 carved into the cement beneath the window in Building A provides a date for this construction period (plate 15).

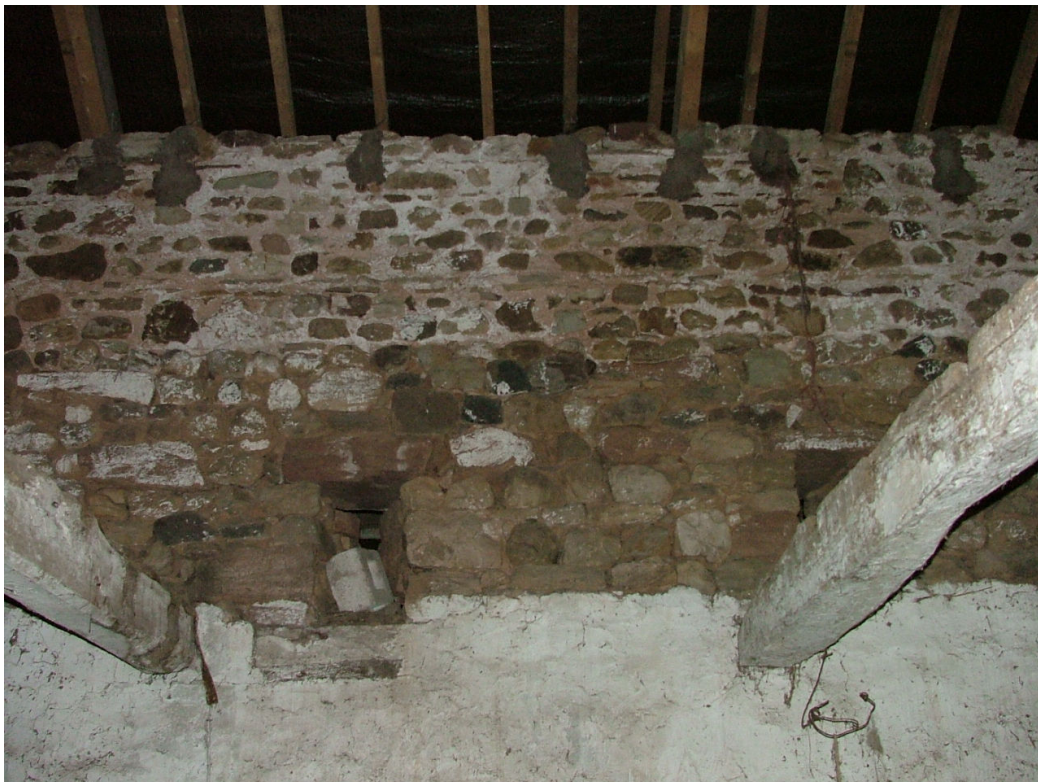
**Plate 16** – Ventilation slits, northern wall of Building A

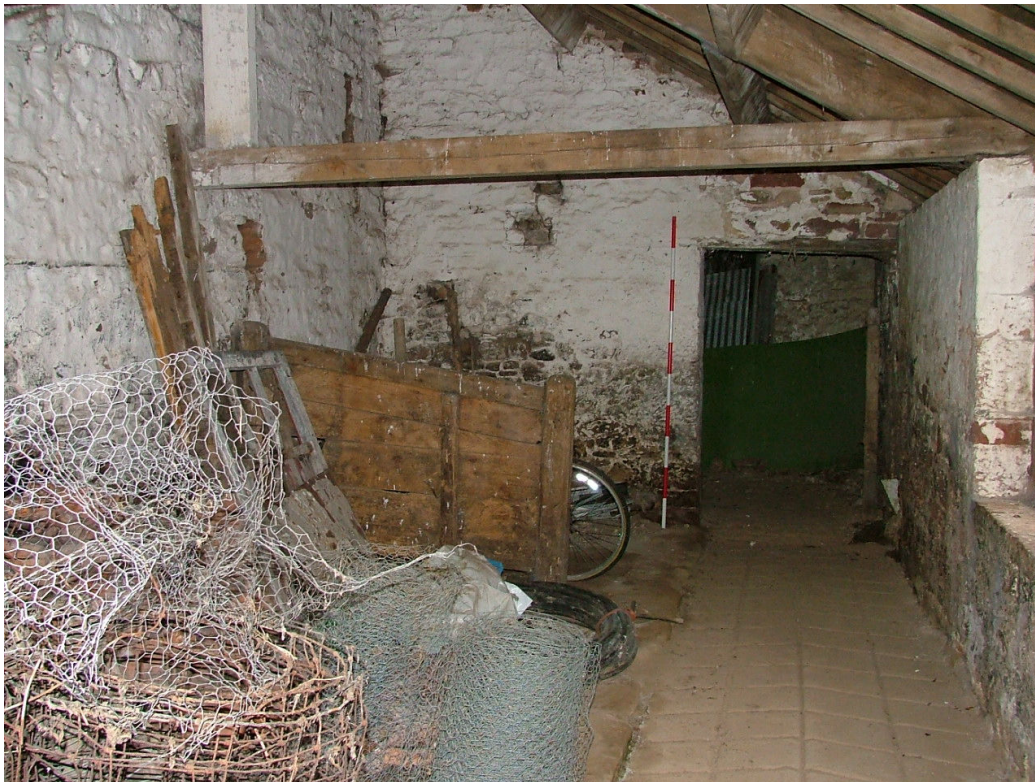
6.7.1 Building B has more latterly been used as a byre. The walls are lime-washed and the floor is of concrete, although the kerbs of the stall floors are of sandstone. The southern length of the building originally had three timber stall divisions, however only two remain (plate 17). There is a wall at the western end with a doorway (figure 8). This end of the building may have been used as a trap-house, due to the now blocked large doorway on the northern elevation (plate 6).

**Plate 17** – Interior of Building B (byre) looking west

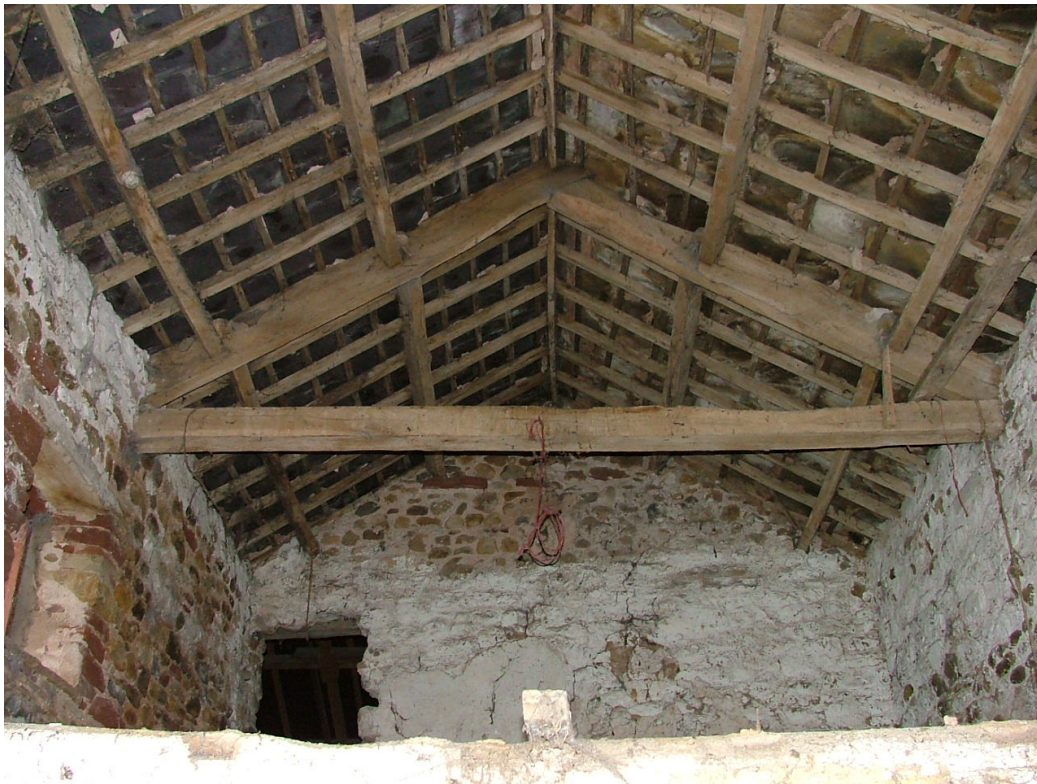
6.9.1 The interior of Building D is divided into three bays by two principal rafters and tie beams, with two rows of purlins either side (plate 18). The first floor has been removed although some of the joists remain. The floor is of concrete. The doorway that gives access into the interior of Building D is rebated externally, therefore the door opens outwards. Within the western interior wall, just beside this doorway, is a niche which measures c.43cm wide by 30cm high by 25cm deep. This may have been used for lighting or for housing grooming equipment or medicines for the animals.

**Plate 18** – Roof detail of Building D

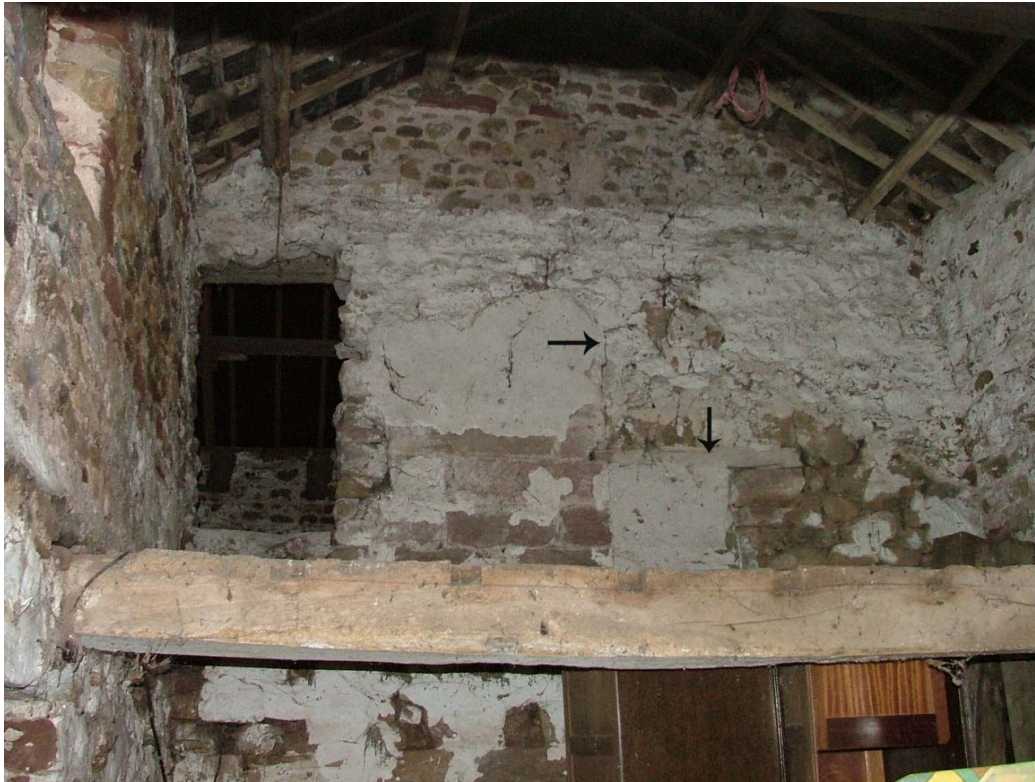
6.9.2 It was possible to note, from the interior of Building D, the vertical construction break mentioned in 6.2.3 (plate 19). There also appears to be a blocked window mid-way up the elevation just to the right of the construction break, as well as the scarring for a possible pitched roof (plate 19). The projecting piece of timber noted on the western external wall of this building, continues internally; this may have aided in the lifting of bags of grain suggesting that the first floor of Building D may have been used as a granary at some point, with a stable loose box below.

**Plate 19** – Southern elevation of Building A as seen from interior of Building D  
(Arrows mark the location of vertical construction break and blocked window)

- 7.5 The buildings that are the subject of the present survey appear to have been in existence by the date of the First Edition Ordnance Survey map of c.1865 (figure 5), although there is a slight anomaly with Building D. The First Edition OS map shows this building as projecting slightly beyond the eastern end of Building A, yet by 1898 the eastern elevations of both of these buildings are in line with each other (compare figures 5 and 6). It is possible that Building A was extended and that Building D was re-built at some point between these dates, and that the wall containing the blocked window and scarring of a pitched roof visible on Plate 19 belongs to an earlier structure.

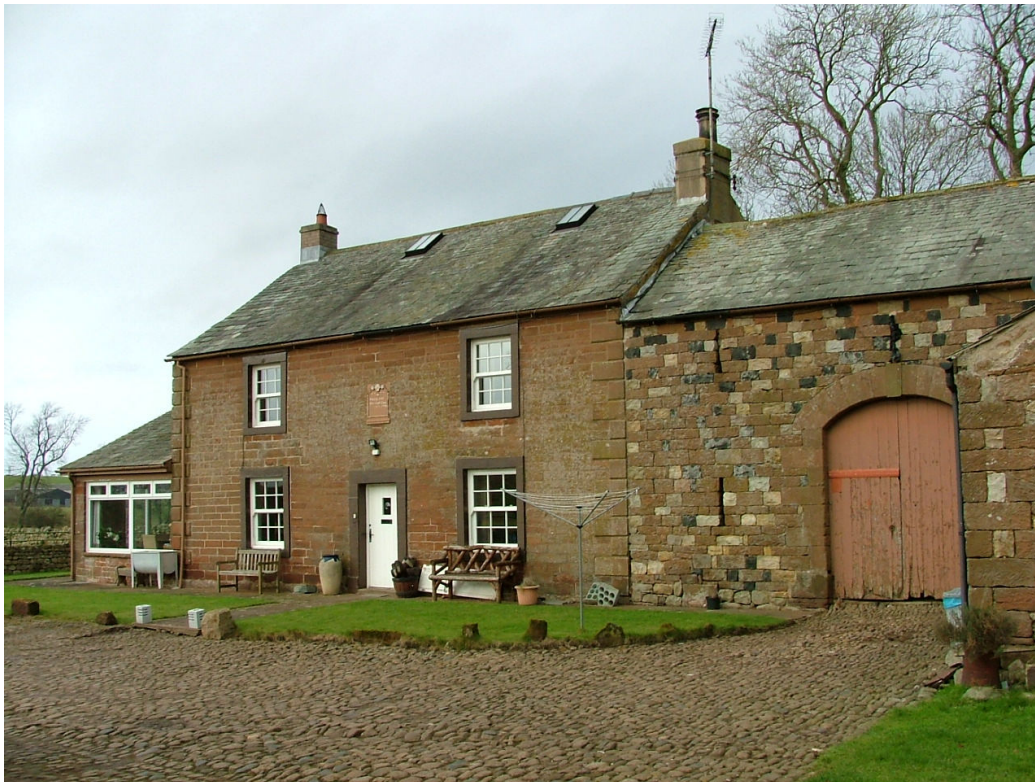
- 6.10.1 The farmhouse is an integral part of any farmstead, and despite the fact that it does not form part of the present survey it is worthy of note. The house is constructed of coursed and squared red sandstone masonry with rusticated quoins. The house is double-pile in plan; that it is consists of four rooms on each floor, two to the front and two to the back, and is symmetrical in appearance, with two windows to each floor either side of a central doorway (plate 20). According to Brunskill, the front two ground floor rooms would have been the living room and the parlour, with the front door opening into the living room.

**Plate 20** – Southern elevation of farmhouse and adjoining barn

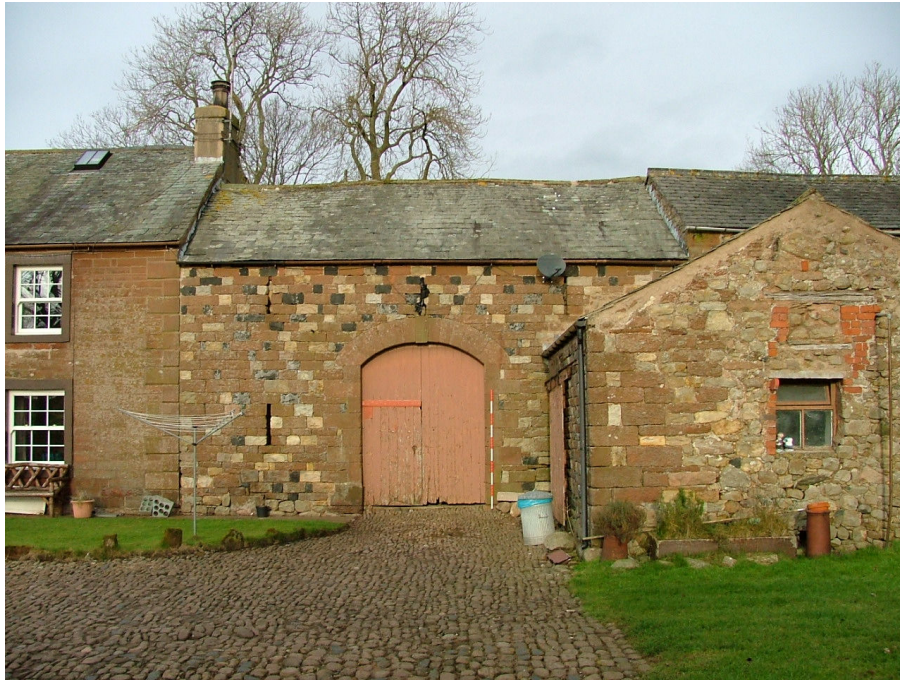
- 6.11.1 The barn is situated between the farmhouse and the range of farm buildings that are the subject of the present survey, but like the farmhouse, it does not form part of the proposed development. The barn is constructed of coursed and squared sandstone and granite with a central large double doorway with arched head. The door jambs are rebated internally, therefore the doors open inwards. There are vertical ventilation slits on both southern and northern elevations. The ridge line of the barn is slightly lower than both the farmhouse and Building A, suggesting that it was not constructed at the same time as either, this

**Plate 21 – The barn**

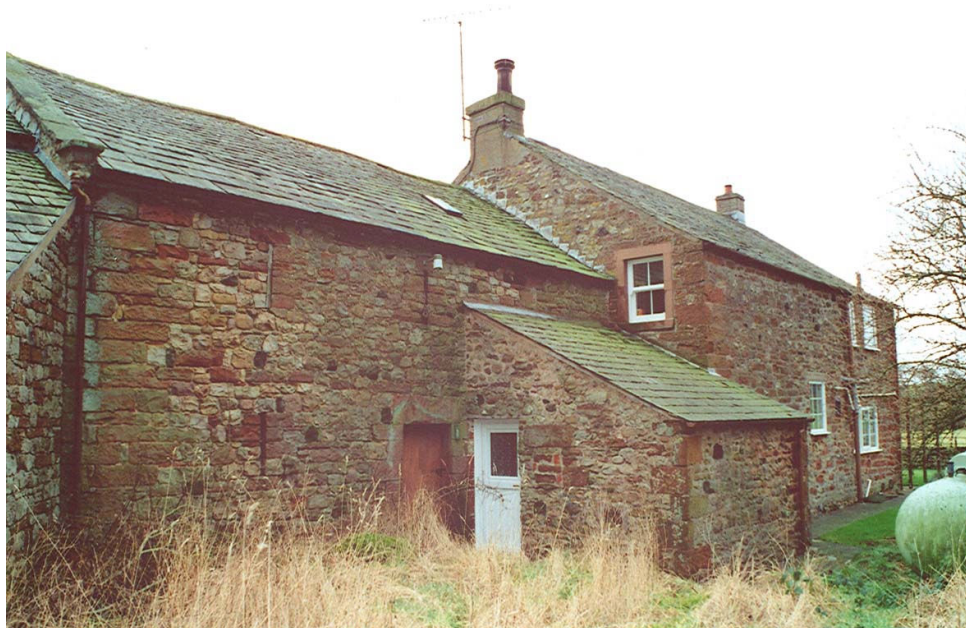
is also confirmed by vertical construction breaks. On the northern elevation there is a central smaller doorway, which may originally have been a winnowing door (plate 22): these allowed the wind to blow through the building to remove the lighter chaff from the threshed cereals. On the eastern gable end of the barn there are coping stones which terminate at a single kneeler on the northern side (plate 22).

**Plate 22 – Northern elevation of barn and house**

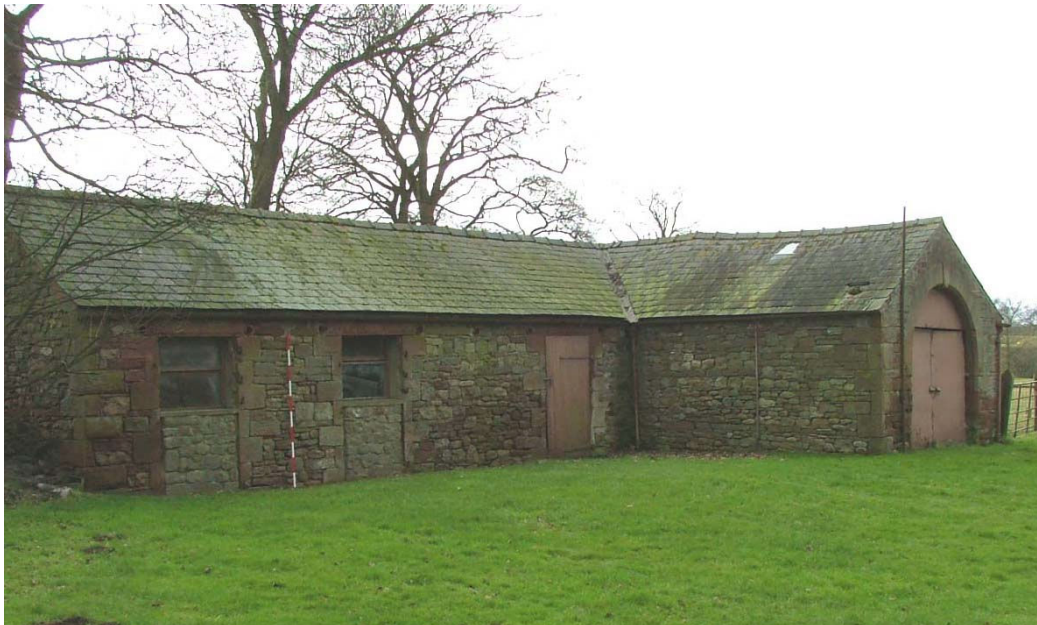
- 6.12.1 To the south of the main farmhouse and adjoining buildings there is an L-shaped single storey range, constructed of roughly coursed rubble masonry which has courses of red sandstone similar to those observed in the southern elevation of Building D (plate 11). Along the northern elevation there are three doorways, two of which have been converted to windows, and there is a cart door in the northern gable end (plate 23). Cartographic evidence shows that this building was constructed between 1865 and 1898 (figures 5 and 6). Two Dutch barns stood to the west of this building, close to Hilton Beck (one is shown on figure 6). These have both now gone.

**Plate 23** – Southern byre

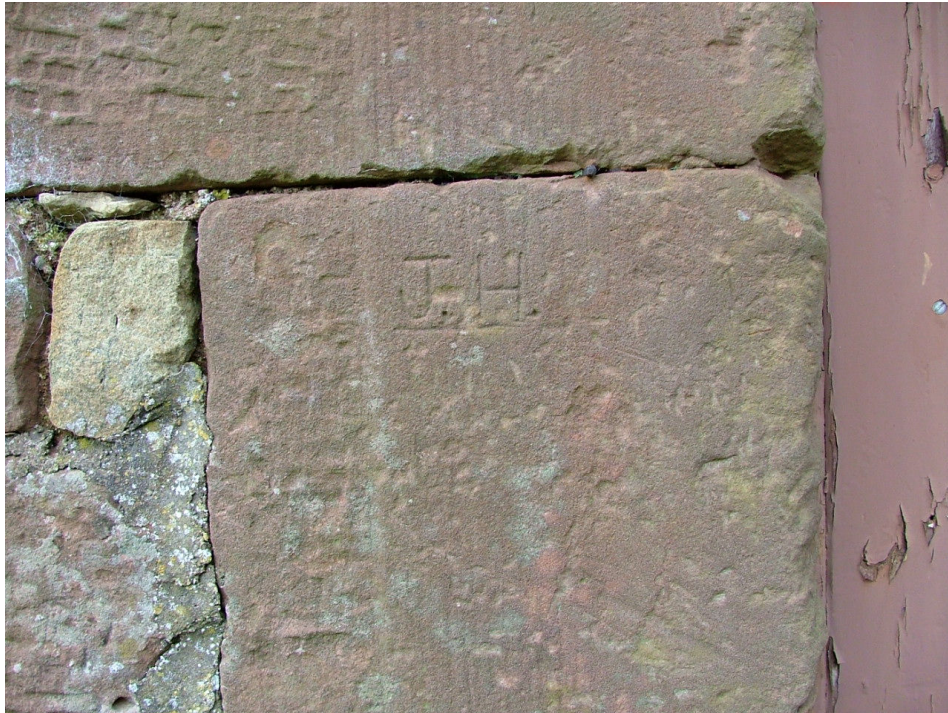
**Plate 24** – Initials ‘J.H.’, door jamb of barn

- 6.13.1 Many farmsteads have graffiti carved into the soft sandstone that make up door and window jambs and lintels. This graffiti is often in the form of initials, presumably of those who lived and worked on the farm. There are three instances of carved initials at Langton Farm, firstly in the left-hand door jamb of the barn are the initials 'J.H.' (plate 24), possibly those of John or Joseph Hebson (See Appendix). Carved into the doorjamb of the eastern doorway on the southern elevation of Building A are the initials 'LTLH', these presumably belong to 'Luke Thomas Leslie Hebson', who is listed as being at Langton Farm in the Commons Register (See Appendix). And carved into the rebate of the door jamb into the ground floor of Building D (doorway beneath stairs), are the initials 'J C? W' (plate 26), possibly those of James
