## 1. INTRODUCTION

- 1.1 In December 2005 North Pennines Archaeology Limited were commissioned by Graham K Norman, to undertake an archaeological building recording project of a range of agricultural buildings at Langton Farm, Langton, Appleby-in-Westmorland, Cumbria prior to their conversion into two holiday lets (Planning application reference no. 3/05/0357).

- 1.2 Cumbria County Council Historic Environment Service produced a brief for a building recording project, which was to be undertaken prior to the commencement of building work. A 'Level 2' Building Survey was carried out as specified in *Recording Historic Buildings: A Descriptive Specification*<sup>1</sup>.

- 1.4 The building survey is concerned with a range that consists of four different structures, therefore for ease of reference they will be referred to as A, B, C and D throughout the report.

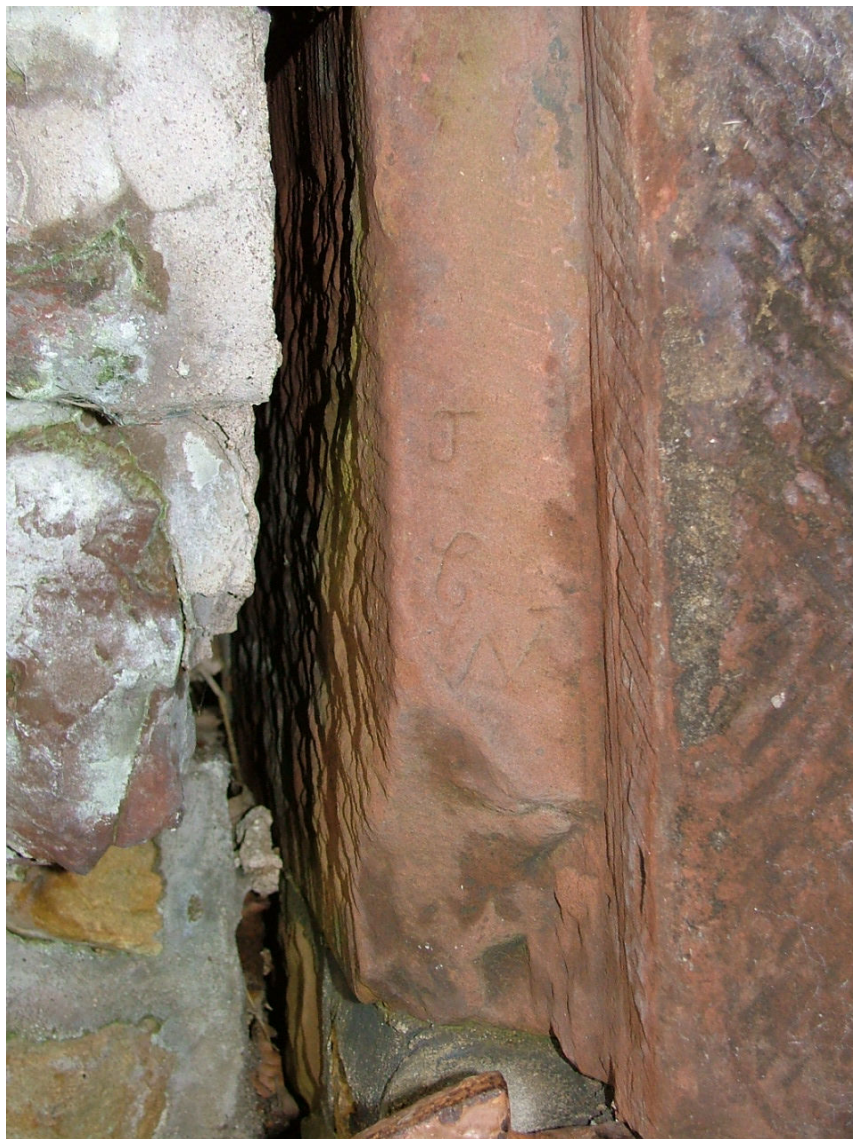
**Plate 26** – Initials 'J C? W', door jamb of Building D

- 6.13.1 Many farmsteads have graffiti carved into the soft sandstone that make up door and window jambs and lintels. This graffiti is often in the form of initials, presumably of those who lived and worked on the farm. There are three instances of carved initials at Langton Farm, firstly in the left-hand door jamb of the barn are the initials 'J.H.' (plate 24), possibly those of John or Joseph Hebson (See Appendix). Carved into the doorjamb of the eastern doorway on the southern elevation of Building A are the initials 'LTLH', these presumably belong to 'Luke Thomas Leslie Hebson', who is listed as being at Langton Farm in the Commons Register (See Appendix). And carved into the rebate of the door jamb into the ground floor of Building D (doorway beneath stairs), are the initials 'J C? W' (plate 26), possibly those of James

Wills who is listed as being a farmer at Langton in 1858<sup>11</sup>, although they could just as easily be those of an unknown farm worker.
