NORTH PENNINES ARCHAEOLOGY LTD

Client Report No. CP/446/07

Planning Reference: 2060799
NCCCT Reference: T13/23; 5982
OASIS Reference: northpen3-25609

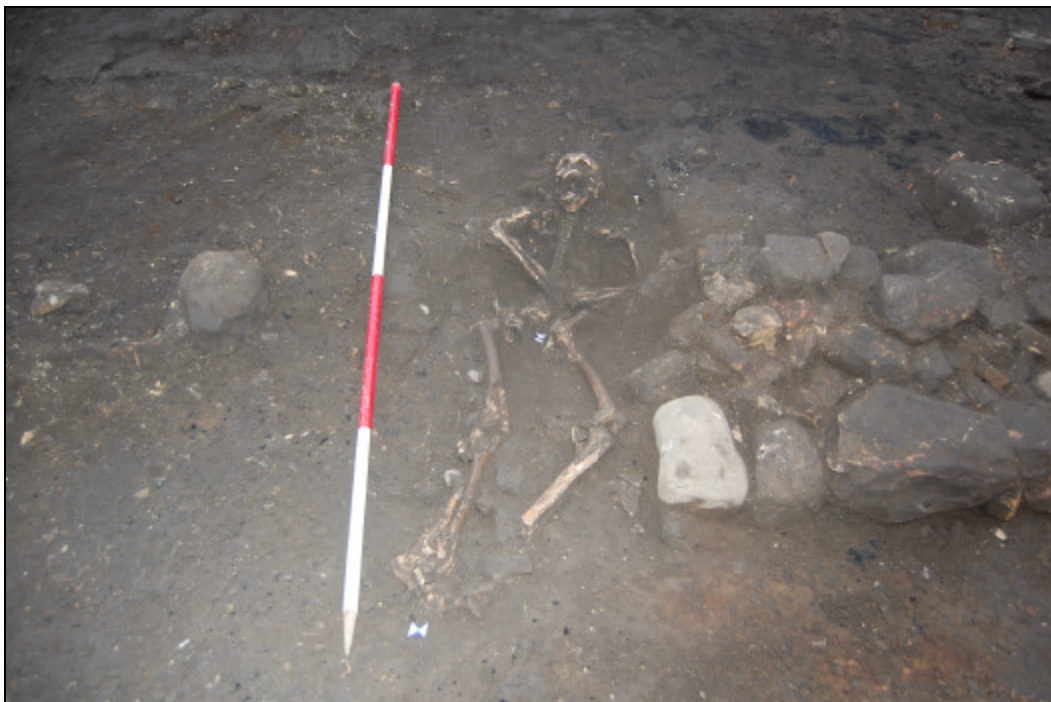
Plate 1. Skeleton #2, looking west. The skeleton had been cut through the wall.

- 5.3.5.9 3.7m from the north end of wall (117), cut [130] for Skeleton #2 (108) (see *Section 6.3.3.6* for more details) was found to be cutting through the wall. The cut, some 1.9m long and 0.5m wide was aligned east-west over the wall, and excavations revealed that the wall stones had been removed during the cutting of the grave. This indicates that

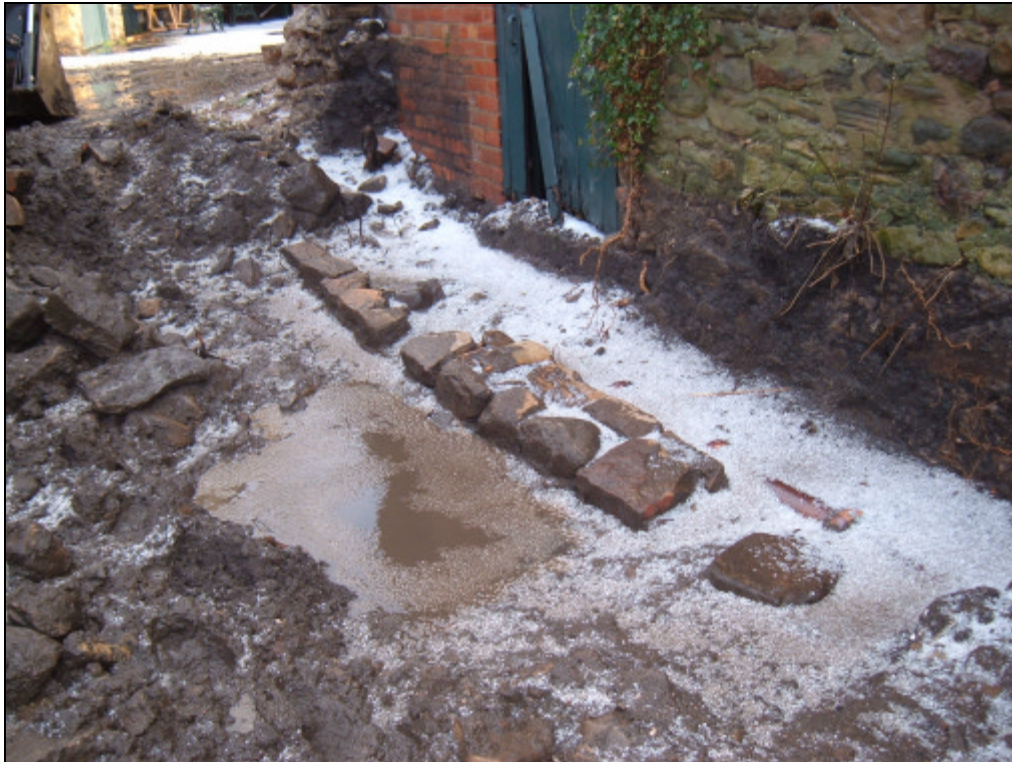
Plate 3. Building #1 (103/104) looking north-east during the watching brief.

- 5.2.3 The watching brief uncovered the remains of a medieval wall (**104**) running on a north-south alignment in the north east corner of the site. The wall section measured 3.9m in length, 0.42m wide and was constructed of sandstone. In the matrix of the wall (**103**), a number of medieval green glazed sherds were observed. To the east of the wall, post-medieval disturbance was seen in the form of a ceramic drain. A discussion of this wall can be seen in *Section 5.4.4*.
- 5.2.4 The watching brief uncovered human remains in the southern section of the site (Skeleton 1) and Assistant County Archaeologist Nick Best was informed. At this stage after consultation with the client, the watching brief was suspended and replaced with an excavation (see *Section 5.4*).

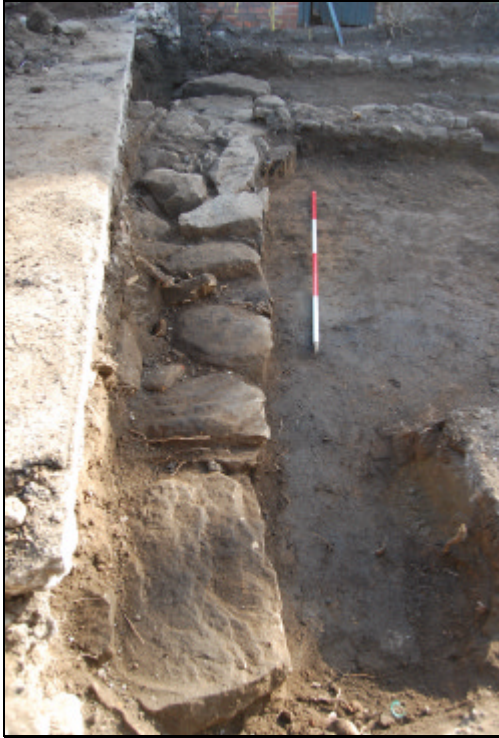
Plate 4. The remains of Building #1 (121/123) looking east. The rest of the building is presumably still under the tarmac to the west.

- 5.3.2.2 The wall, (121) and (123), measured approximately 7.8m in length by 1.17m wide and the largest single stone excavated within the wall was 0.90m long by 0.46m wide, indicating a very substantial stone building. No artefactual dating evidence was found in direct relation to the wall remains, though it can be noted that Building #3 (Section 5.4.5) either butted up against, or keyed into the wall on its southern edge.

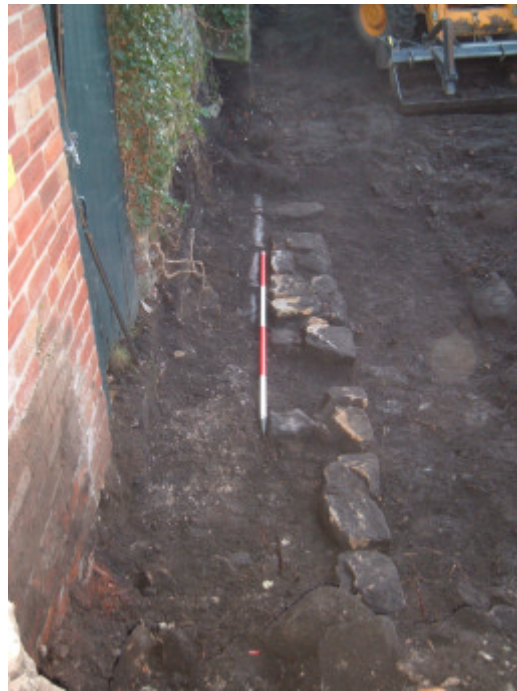
Plate 5. Building #2, looking south.

- 5.3.3 *Building #2*
- 5.3.3.1 Building #2 is located in the north east section of the site (see Figures 7 and 8). The standing remains of the building consists of a north-south aligned wall (104), found initially in the watching brief. The wall section measured 3.9m in length, 0.42m wide and was constructed of sandstone. In the matrix of the wall (103), a number of medieval green glazed sherds were observed. To the east of the wall, post-medieval disturbance was seen in the form of a ceramic drain, obviously linked with the currently standing Angel Inn.

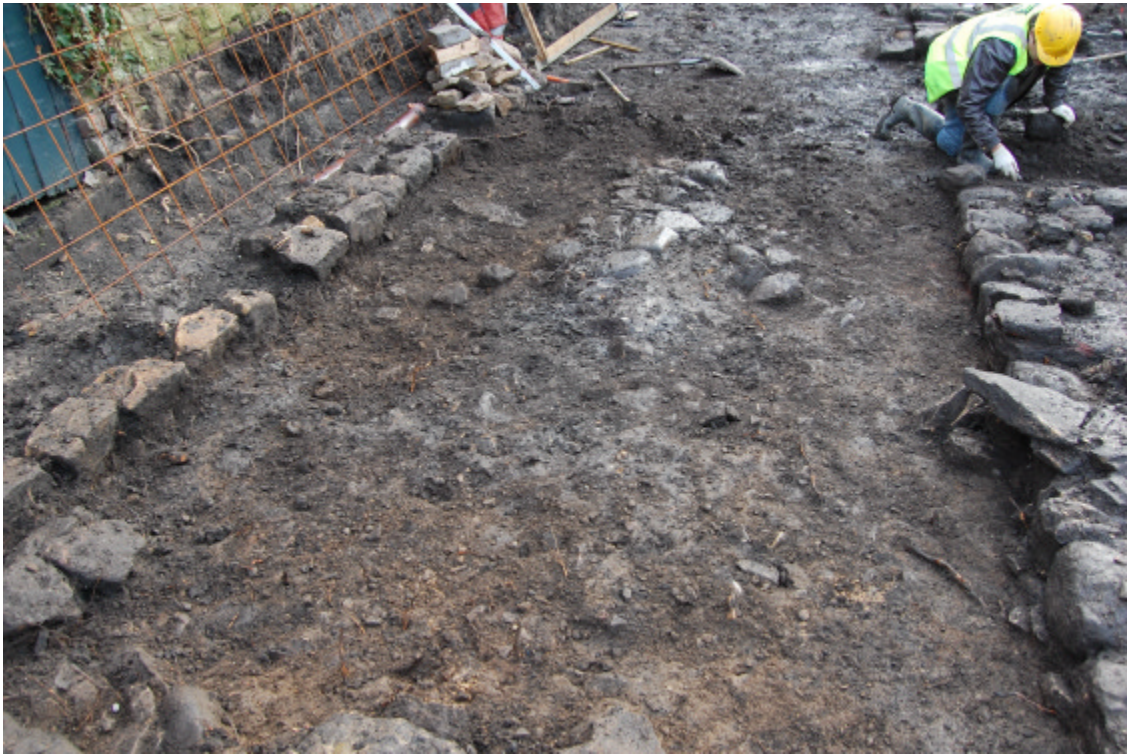
Plate 6. Road surface (148) showing stones (135) and bounded on the east by Building #1 and on the west by Building #2. The photograph was taken looking south.

- 5.3.4 *Road*
- 5.3.4.1 To the west of Building #2 detailed above lay an open area of ground that appeared to form a road or alley. The soil type (148) was a compact reddish-brown sandy clay in north-eastern section of site, and was identified as potentially the remains of a yard/road. The matrix was set with a number of flattened stones (135) which seemed to be a robbed out road surface.

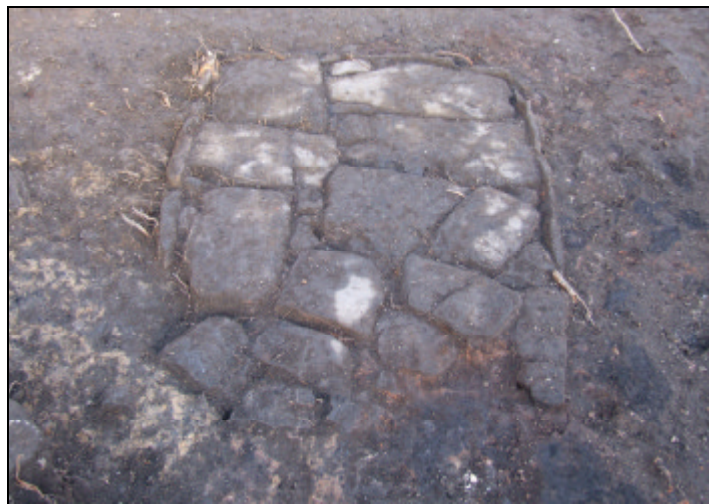
Plate 7. Hearth (128) after excavation, looking north.

- 5.3.5.5 The hearth (**128**) was situated in the northern end of the building area and measured 1.37m x 1.0m. It was constructed from a stone base with edging stones along the north, east and west edges (averaging a thickness of 0.02m). To the south of the hearth the stonework was less sound, and the remains of a 'sweeping area' where the hearth waste was swept out lay to the south west. This was a dense, compact deposit (**129**), primarily composed of black ash and traces of charcoal. The hearth structure was set on a deposit of (**141**), black and red material that seemed to be surface (**138**) subject to the intense heat of the hearth. To the west of the hearth structure was a patch of yellow beaten clay (**136**), which could be interpreted as a patch for the floor next to the hearth, or as a support repair for that edge of the hearth itself.

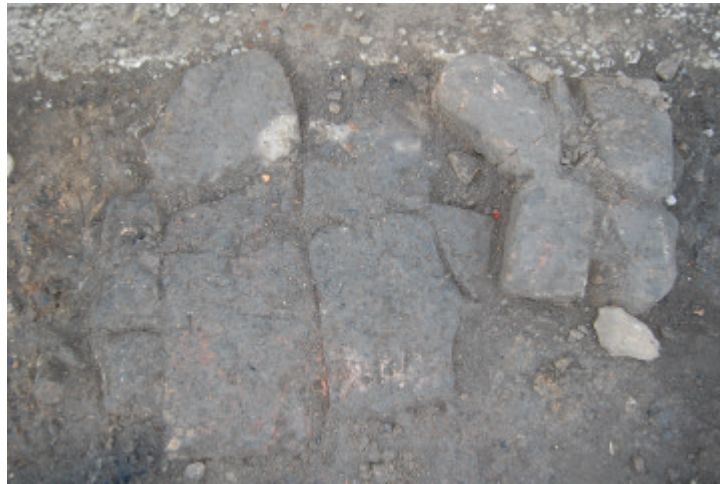
Plate 8. Floor (124) and wall section (125), looking west.

- 5.3.5.6 To the west of the hearth lay the remains of a floor level (**124**), flat sandstone slabs that bore the evidence of industrial burning and iron staining, indicating industrial usage of the building. The remaining area measured 0.85m x 0.65m. A possible interpretation for this floor surface may be as a western entrance to the building off the main medieval throughfare: this interpretation was made due to the presence of a small section of surviving wall (**125**) directly to the north of the floor level (0.52m x 0.39m), which may have marked the western boundary of the building. Rubble from this wall (**126**) was also present, scattered northerly from the wall section. To the south of the hearth also lay the remains of a section of stone slabbed floor (**137**), again showing burning and industrial staining. This has been interpreted as the remains of the same floor as (**124**) due to its construction and depth. This area of flooring measured 1.45m x 0.74m.

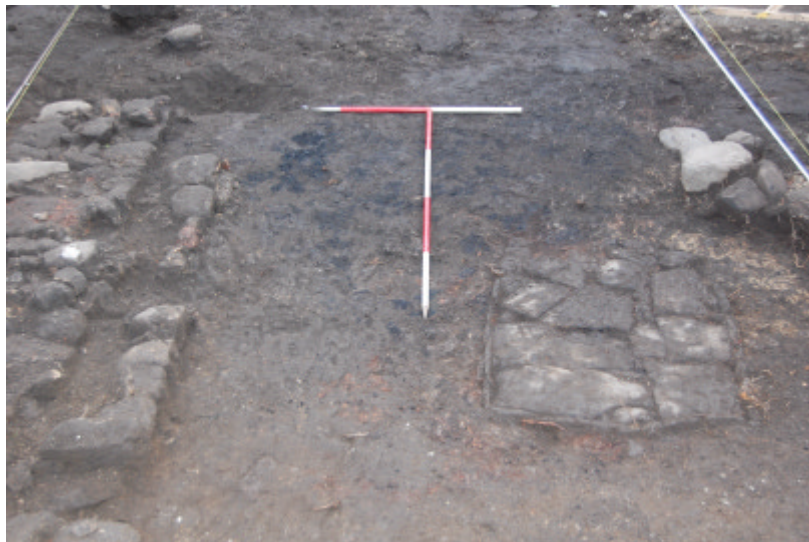
Plate 9. Building #3 looking south, showing bench (120), hearth (128) and related contexts.

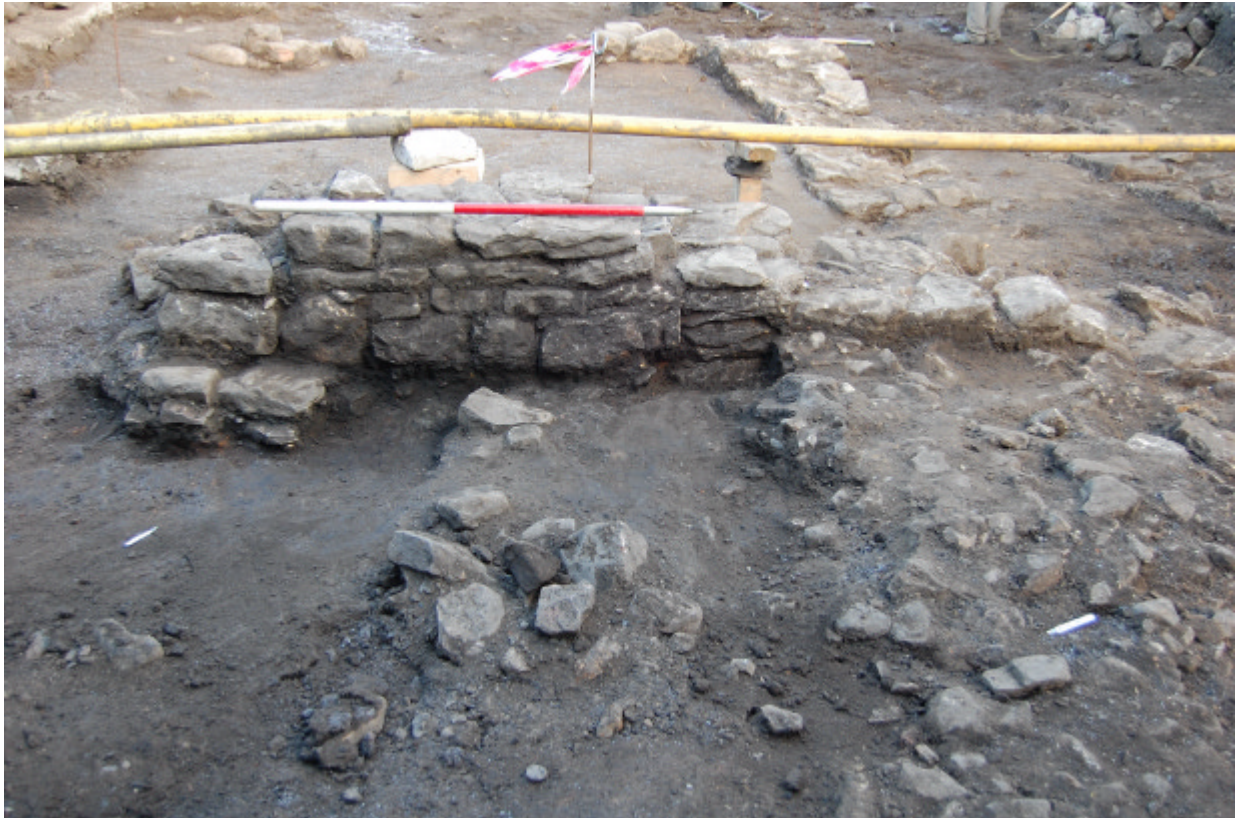
Plate 11. View of the area in the foreground with wall (116) central indicating the edge of Buildings #4/#5.

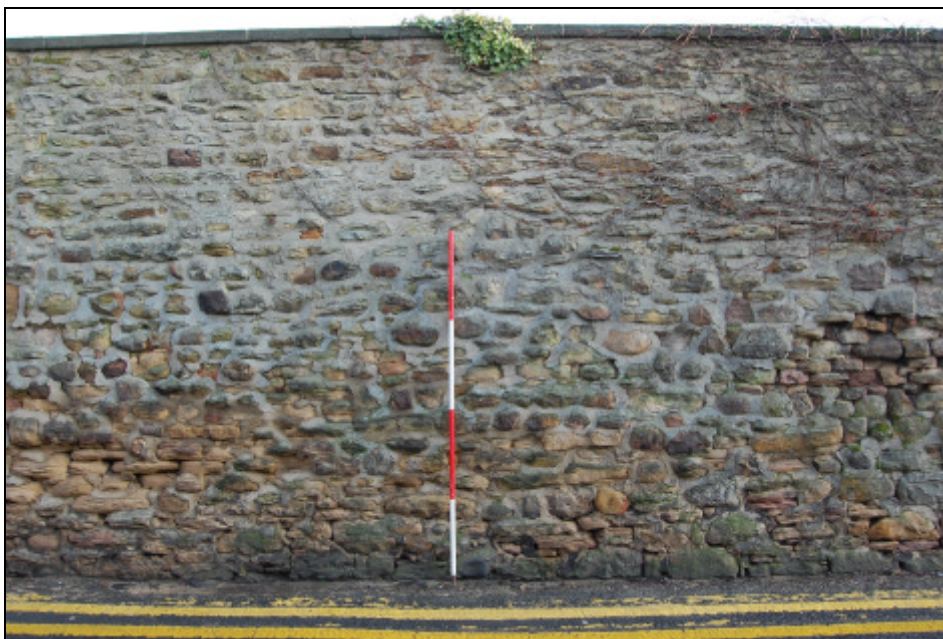
Plate 12. External face of bounding wall before demolition.

- 5.4.1 Phase II of the watching brief took place on the 24th and 25th January with Assistant Supervisor Cat Peters monitoring the demolition of the western boundary wall, after the wall was deemed unsafe by structural engineers in consultation with SBD LLP. The purpose of this watching brief was to record the removal of the wall, and the cutting of new foundations for the bistro in line with the existing wall foundations. An east-facing section of the foundation trench can be found in Figure 10.

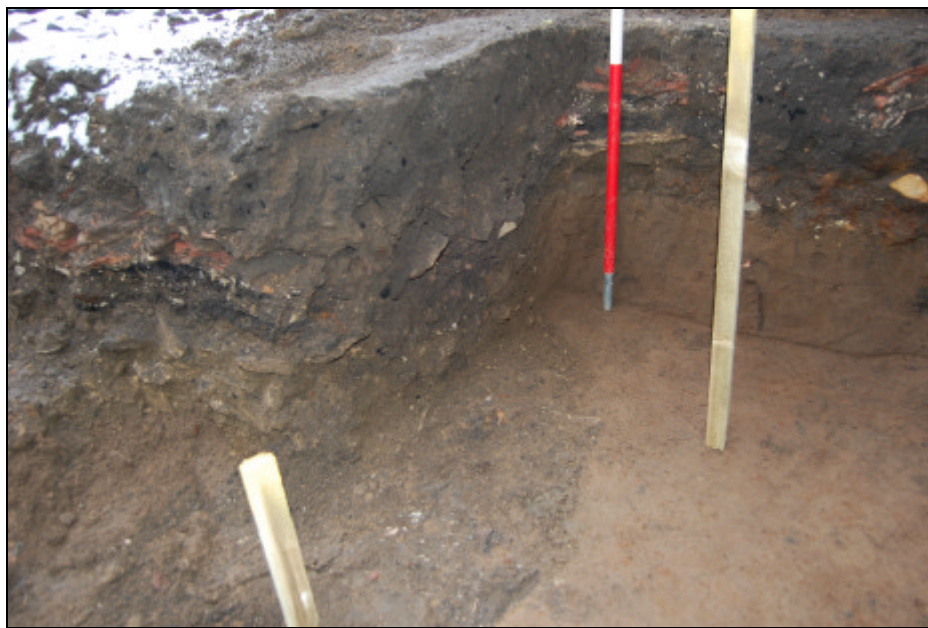
Plate 13. Pad #1 looking north west.

- 5.5.2 Pad #1 (see Figure 9 and 13) was located on line with the edge of the existing outbuilding which marked the southernmost extent of the actual bistro building. The pad was 0.78m on a north-south axis, and 1.06m on the east-west axis. The overall depth of the pad down to natural subsoil, a pale yellow/brown sand was 0.36m (from the top of (153)) and was excavated a further 0.53m into the natural. Deposit (153), a compact clay-soil with frequent stone inclusions existed to a depth of 0.22m at the western extent of the trench, mixed with degraded red sandstone moving east. Beneath this was a shallow deposit of (161), a compact black charcoal layer averaging 0.10m

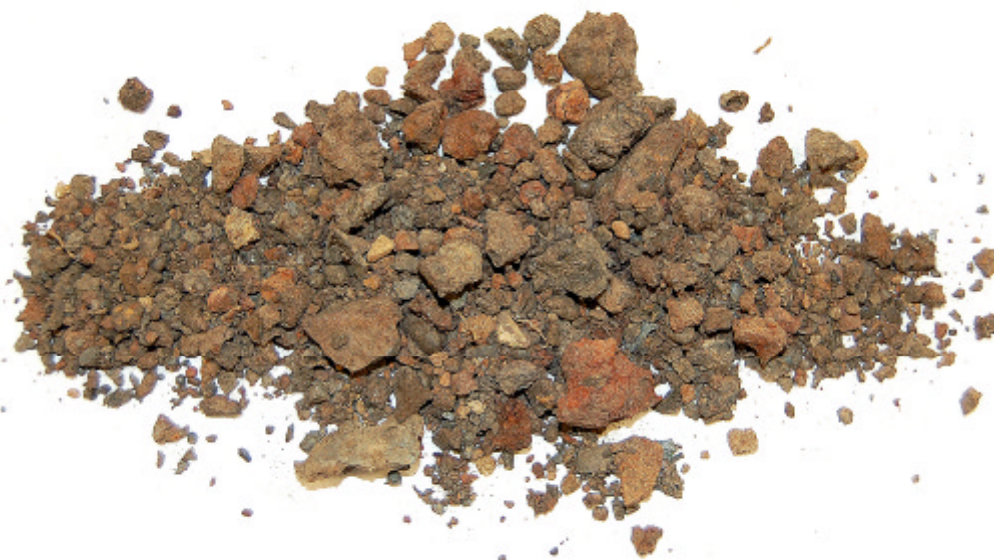
Plate 14. Sample of magnetic material recovered from (141) <19>

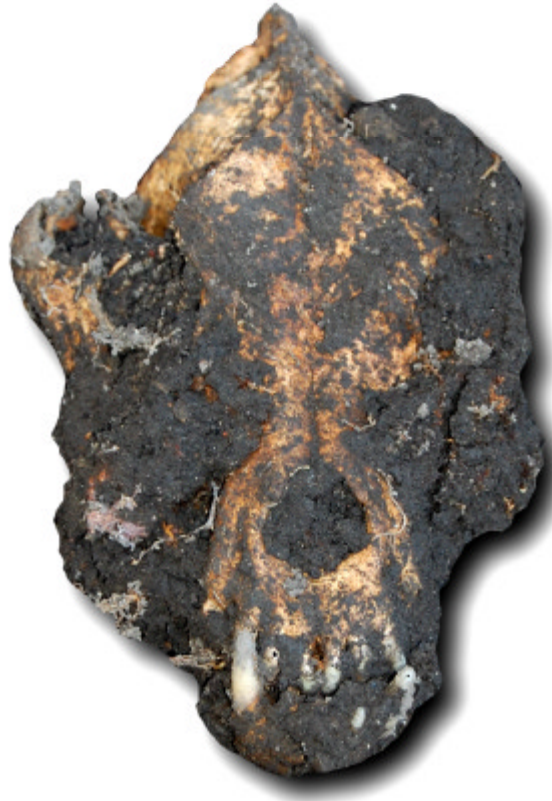
Plate 15. The dog skull immediately after excavation.

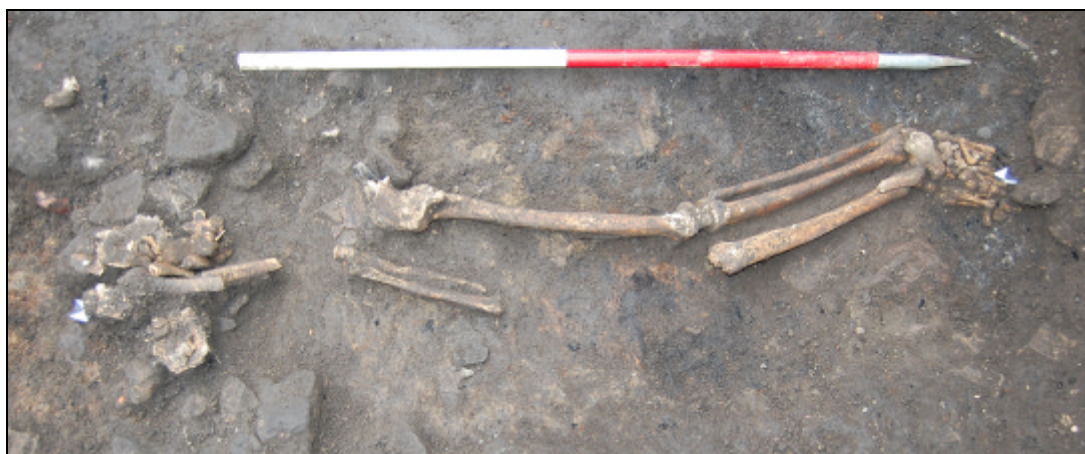
Plate 18. Skeleton #1 looking east.

Bones present: fragmentary skull missing all facial bones including maxilla, mandible and teeth; second cervical vertebra, 6 left ribs and one right 1st rib plus 9 unsided rib fragments, small parts of both scapulae, an almost complete right clavicle, fragmented right humerus, radius and ulna; 3 unsided proximal and 2 unsided intermediate hand phalanges; a small part of the right innominate bone with the acetabulum; fragmented left and right femur, tibiae and fibulae; an almost complete right patella; both feet lacking the left lateral cuneiform and several phalanges.

Summary of Pathological Conditions: DJD right hip, right knee, both feet. Enthesopathies on both calcaneal heels.

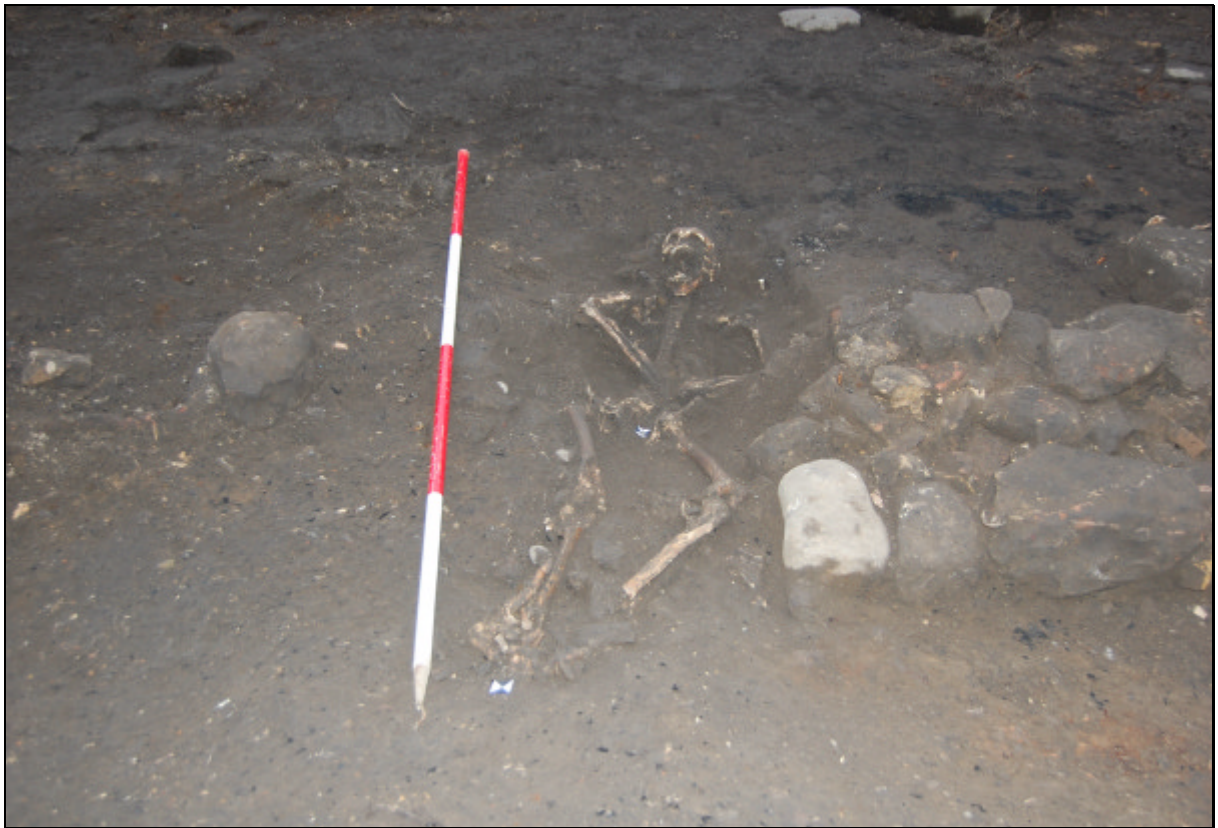
Plate 19. Skeleton #2 looking west.

Bones present: fragmentary skull missing most facial bones, but maxilla, mandible and teeth present; second cervical vertebra, 3 lumbar vertebrae (neural arches) and parts of the sacrum; left distal humerus, right fragmented humerus, fragments of both radii and proximal ulnae; both innominate bones with the acetabulum; fragmented left and right femur, tibia and fibula; an almost complete left patella; both feet lacking the left cuneiforms and right navicular as well as the right 3rd metatarsal and most phalanges.

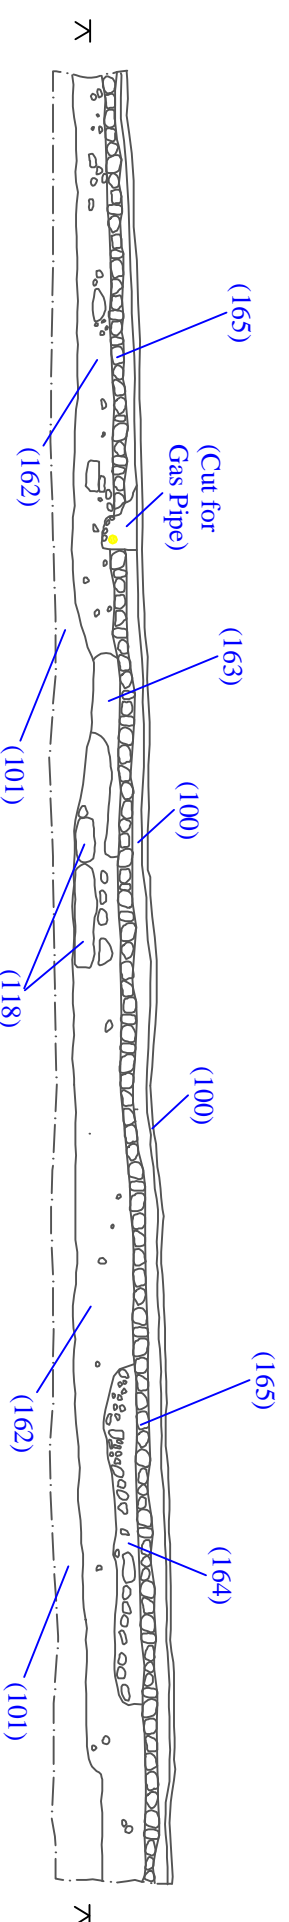
Figure 10: East facing section of site excavated and recorded during demolition of western boundary wall

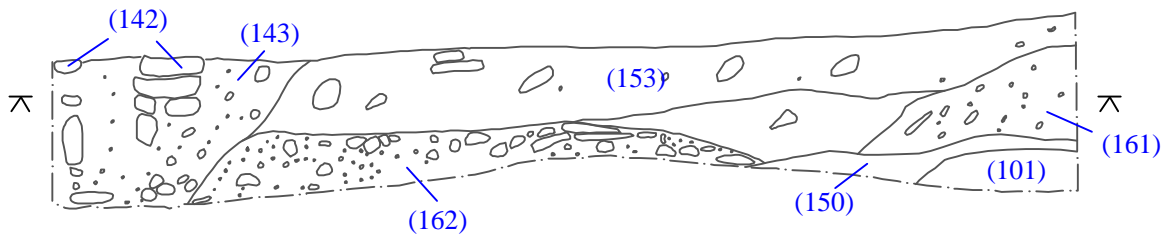
b South facing section across site.

- 5.3.9.4 The south-facing section (Figure 12b) showed that the eastern side of the site is primarily covered in medieval silty sands (153) to a further depth of 0.24m below the level needed for the foundations of the bistro, with a number of medieval industrial strata (150, 161, 162) lying below that for a further 0.13m.

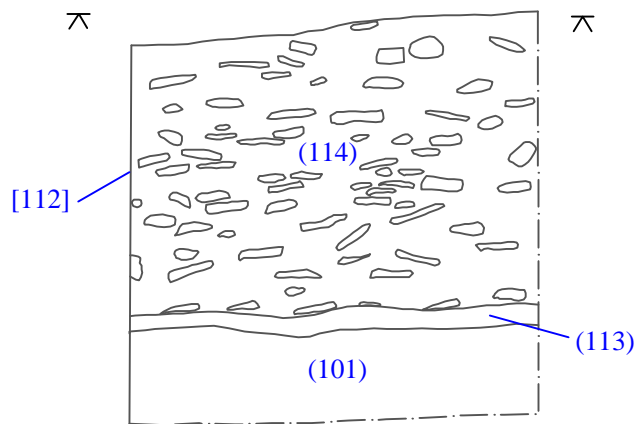
c South facing section through pit [112]

- 5.3.9.2 The excavation revealed a pit [112], 1.30m diameter at base and 1.03m deep onto natural sands (101). The pit contained two fills. The primary fill, (113), was a thin deposit of pinkish clay (0.07m thick) and the secondary fill (114) was a loosely compacted mid-brown/grey silty sand with sandstone inclusions some 0.94m thick. The pit contained no finds, but the environmental sampling did produce a metal droplets associated with industrial activity. The pit was stratigraphically situated below known medieval deposits, so the pit can be dated as being medieval or earlier.

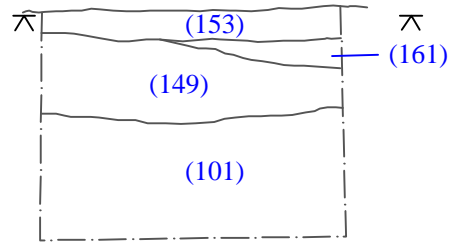
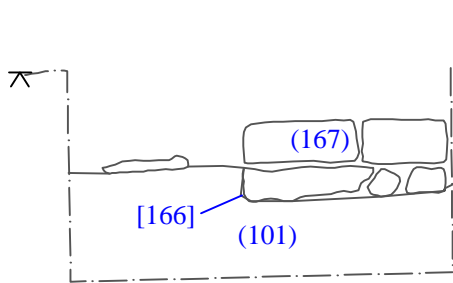
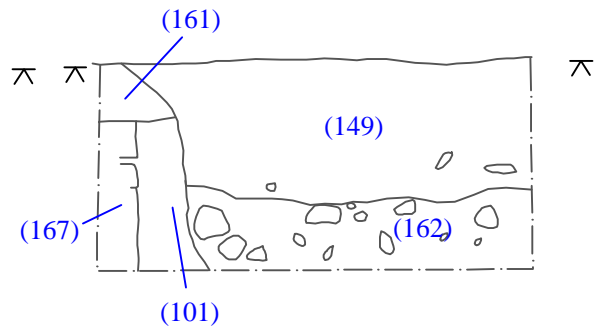
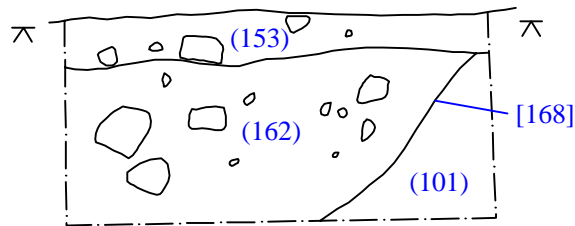
Figure 13: Sections of Pads #1-4

a. South-facing section of Pad #1

b. South-facing section of Pad #2

c. West-facing elevation of Pad #3

d. North-facing section of Pad #3

e. East-facing section of Pad #4

- 5.5.3 Pad #2 (see Figure 9 and 13) was 1.45m long in the north-south axis and 1.19m in the east-west axis. It was cut to 0.90m depth, and showed a 0.11m deep deposit of medieval sandy-silt **(153)**, below which was a further 0.32m of **(149)**, a heavy concentration of degraded iron mixed with stone and **(161)** a heavy dense charcoal dust deposit. Below this was natural subsoil.
