# **NORTH PENNINES ARCHAEOLOGY LTD**

**Project Designs and Client Reports No. CP/382/07**

In March 2007, North Pennines Archaeology Ltd was commissioned by Property Design Matters Ltd to undertake a programme of archaeological works to assess the archaeological potential of the site of the Anchor Garage, John Martin Street, Haydon Bridge (NGR NY 8442 6412), following the submission of a planning application for the demolition of the garage and the construction of four flats and three houses. The strong possibility of surviving archaeological remains relating to the medieval street frontage and associated burgage plot prompted the Northumberland County Council Conservation Team to advise that an archaeological field evaluation of the site would be undertaken prior to the development, covering 4% of the development area. Following discussions between the client and NCCCT, it was agreed that an initial small sampling exercise could be undertaken, prior to a full evaluation, which could not occur until the garage was demolished. Therefore it was agreed that two 2x2m testpits be excavated, in order to advise as to the potential for further work.

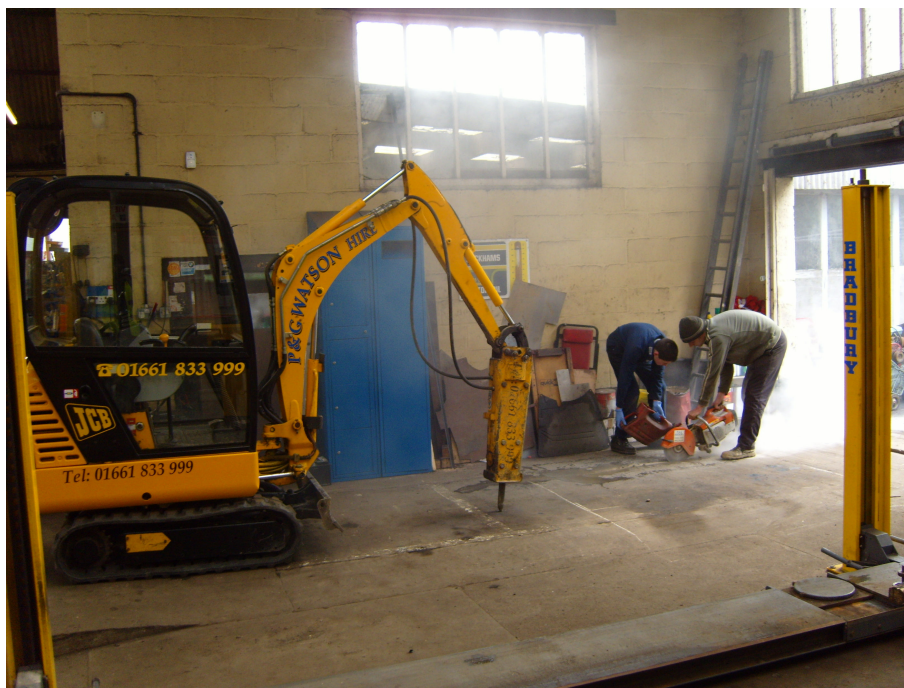
Plate 1: Cutting Trench 1

- 4.2.1 Trench 1 was 2m long by 2m wide, and was positioned in the south-eastern corner of the garage building (Figure 2). The maximum depth of the trench was over 1m.
- 4.2.2 Initial machining removed a approximately 0.05m concrete, which was set on a bedding layer of 0.20m mid brown silty clay. Beneath the bedding layer, approximately 0.40m of dark greyish brown clay, heavily contaminated with diesel and oil, was uncovered. The clay appeared to seal a deposit of demolition rubble 0.30m thick, which contained a large number of roof tiles, indicating the presence of an earlier building on the site, as well as sherds of 19<sup>th</sup> century pottery. The combined overburden deposits were numbered as **(207)**. The building is presumably that shown on the Ordnance survey maps (Figs 9-11), which occupied the site prior

to the construction of the garage. Underneath the building rubble was the natural drift geology, a compacted pale grey mottled clay. No evidence of archaeological features or significant archaeological deposits was uncovered.

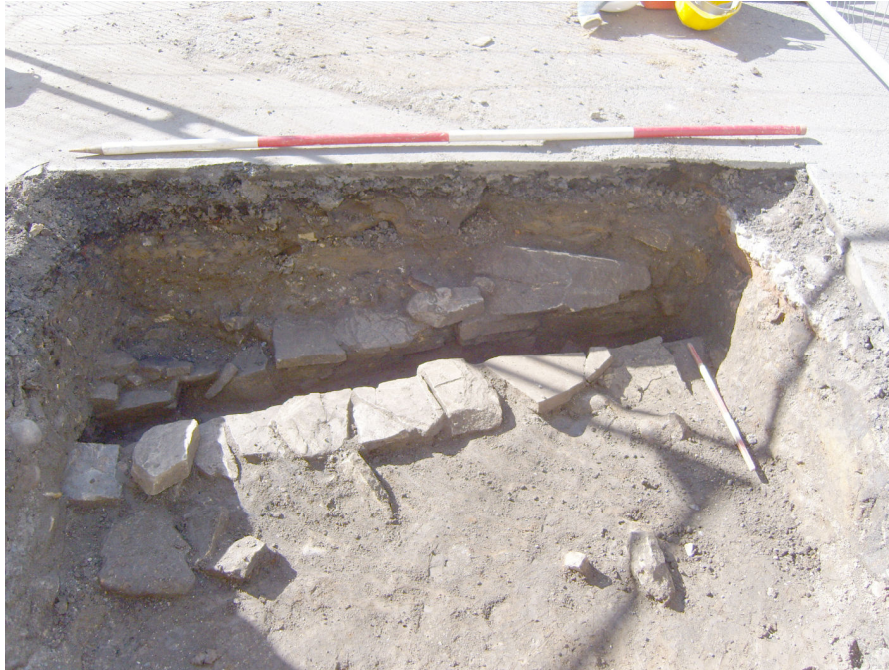
Plate 3: Trench 2, facing west

- 4.3.1 Trench 2 was 2m long by 2m wide, and was positioned in the northern corner of the garage forecourt (Figure 2). The maximum depth of the trench was over 0.70m.

- 4.3.2 Initial machining removed a approximately 0.10m tarmac, forming the main hardstanding of the car park. Beneath the tarmac, a modern lead pipe (205) was uncovered, running north-south across the eastern edge of the testpit. The pipe was set in a near-vertically sided cut with a rounded base [206], and the fill consisted of mixed brownish orange sandy silt. On the western side of the testpit, the machining uncovered a post-medieval culvert [204], built of randomly coursed sandstone blocks and capped with disturbed sandstone flags. The culvert was of drystone construction, with no obvious bonding material. Within the culvert, a dark brownish grey loose silty sand (203) was uncovered, being the final silting phase of the culvert. Within the fill, a number of sherds of 19<sup>th</sup> century pottery, clay tobacco pipe stems and fragments of glass were uncovered.

- 4.3.3 Both the modern pipe cut and culvert had been excavated through a deposit of mid greyish brown clayey silt (202), which was excavated to 0.15m depth. This deposit yielded two sherds of medieval pottery, and has been tentatively identified as a medieval soil horizon. No further archaeological features were noted, and the deposit lay directly on the natural drift geology, a compacted pale grey mottled clay (200).

5.2.5 *Sample <1> (203):* a post-medieval culvert [204], built of randomly coursed sandstone blocks and capped with disturbed sandstone flags was uncovered. The culvert was of drystone construction, with no obvious bonding material. Within the culvert, a dark brownish grey loose silty sand (203) was deposited, being the final silting phase of the culvert from which sample 1 was taken.
