Client Report No. 321/06

**For
HGBP LTD
NGR NY 406 555
Planning Application No.
1/03/1305**

F Giocco BA, Dip Arch, AIFA
North Pennines Archaeology Ltd
Nenthead Mines Heritage Centre
Nenthead
Alston
Cumbria CA9 3PD
Tel: (01434) 382045
Fax: (01434) 382294
Email: info@nparchaeology.co.uk

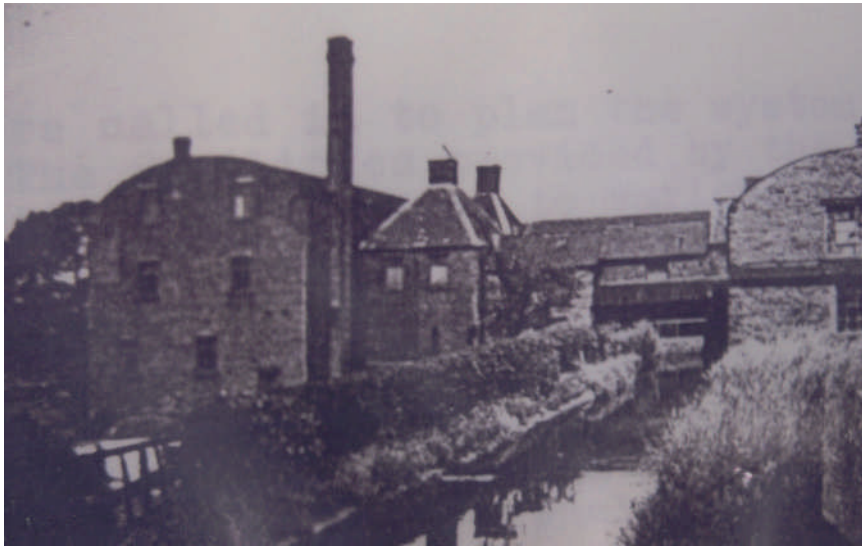
Plate 1: The Harraby Mill Complex in its final phase (circa 1950).

mill (see figure 23). The final wall foundation to be recorded within this building comprised Wall (199) a narrow 0.44m wide wall running east-west across the alignment of the mill and unbonded into the main exterior wall (198). A large chimney is illustrated on plate 1, just off the south east corner of the building, no evidence survived on site for this chimney.

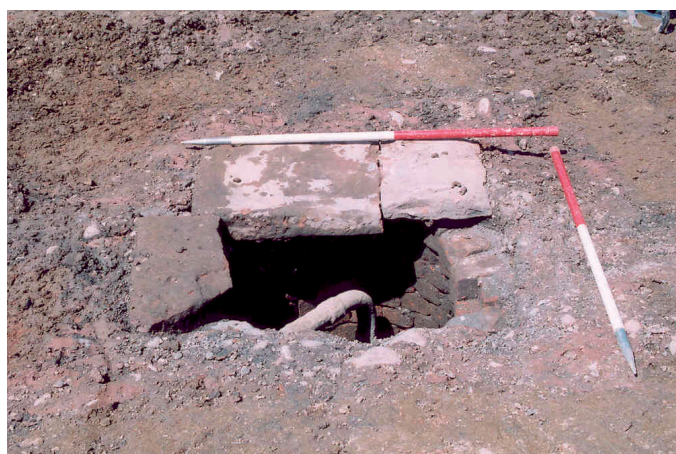
Plate 3: *Post excavation view of well (123)*

6.3.3 A well, of post-medieval date, was uncovered in the northern extent of the excavation area. The well was cut into the natural subsoil (101), the cut itself [122] measuring 1.5m in diameter and filled with (128), an orange-brown compact clay lining which butted up to the brick construction of the well itself (123). The well was

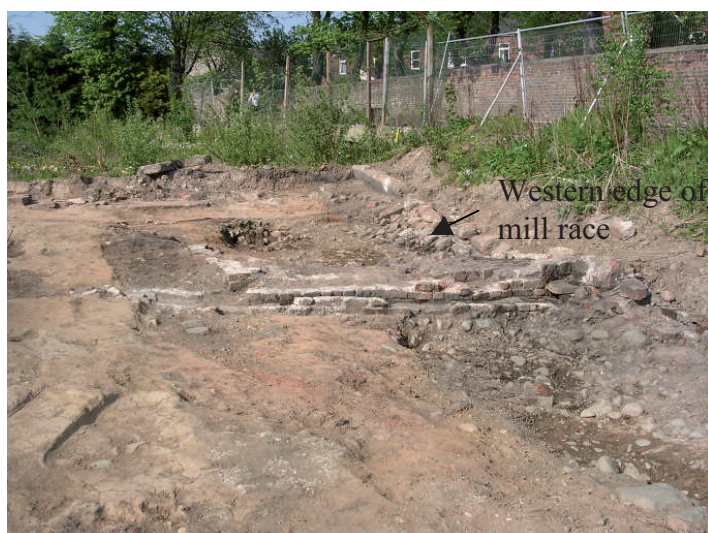
6.3.3.1 Along the eastern edge of the area at its northern extent, a sandstone wall (169) was recorded (see figure 18). This was identified as the western wall of the Mill Race, and comprised of mortared roughly dressed rectangular sandstone blocks (see plate 4). The wall was running on a north-south alignment and was highly truncated with a few standing courses surviving in a few sections.

Plate 4: North east corner of site.

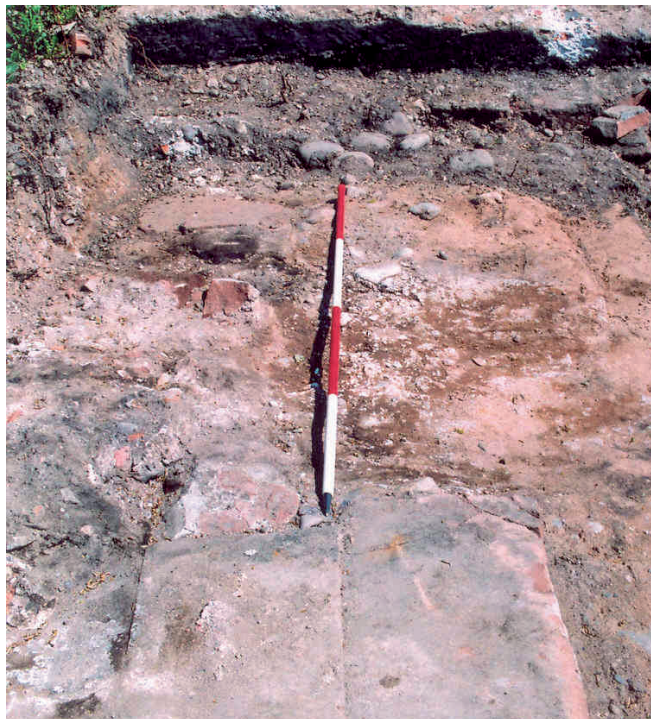
Plate 5: Remains of wall (170) and flagged entrance (171) looking east.

6.3.5.1 At the northern edge of the site the remnants of a sandstone wall foundation (170) were recorded (see plate 3), sitting directly on top of the natural subsoil (101) with no discernable cut (see figure 18). These remains have been identified as the southern property boundary wall of a cottage present in that location from the at least the mid 19th century when it appears on the 1842 Tithe map, the first useful map of the area (see figure 5). The building is listed in the tithe index as a cottage and garden. This structure ceases to exist by the time of the first edition ordnance survey of 1861 when it was replaced by a new cottage constructed slightly to the north of the original and beyond the limits of the excavation.

6.3.5.2 The wall extended for approximately 12m, measuring 0.46m in width and was aligned east-west (see figure 18). There was no obvious construction trench with the surviving foundations resting directly on the natural subsoil (**101**). A group of three sandstone flags (**171**), were recorded in a break in the foundation and are likely to represent an entranceway into this property.

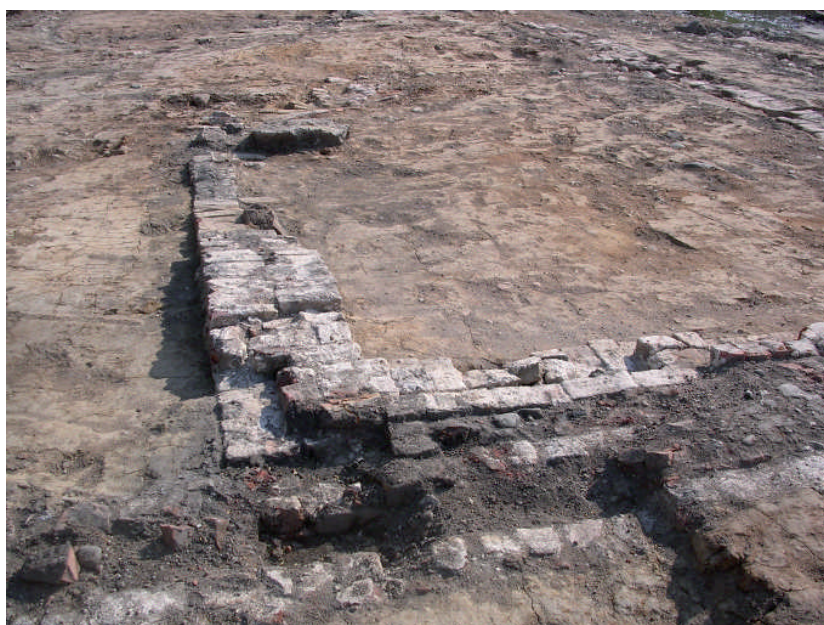
Plate 6: Northern end of cottage 2.

6.3.6.1 The remains of this building, again referred to as a cottage on the 1842 tithe map were positioned approximately 8m to the south of wall (**171**). The remains were highly truncated and fragmentary with the eastern and southern sides of the building having been totally destroyed by later activity (see figure 18). The surviving remains comprised the northern gable (see plate 4) and length of the western side (**175**), the foundation were of sandstone construction and measured approximately 0.78m in width (see figure 18). The foundations were found to lie within a shallow foundation cut [**174**], which was cut into natural subsoil (**101**). The original structure would have been rectangular in plan and measured approximately 5m in width and 12m in length. No floor surfaces survived within this structure.

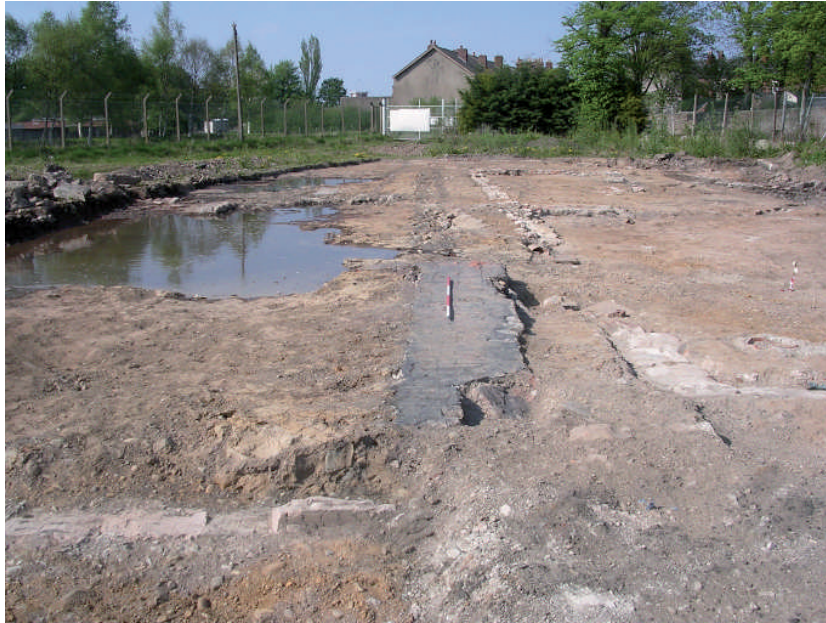
Plate 7: Foundation remains of the northern rolling mill extension

6.3.7.2 Context (**154**), consisted of a brick wall running in an east-west alignment, indicates the southern wall of the north-westernmost section of the extension, with an alley lying between that and wall (**155**), visible in the south western corner of *Area A* (see Figure 23). The foundations of this northern extension were far less substantial to those of the main block, measuring 0.90m in width with the brick footing set on a thin bed of concrete measuring 0.16m in depth (see plate 5). The shallow foundations

of this extension were cut into the natural subsoil (101), due to the high levels of later truncation no floor surfaces or internal features survived within this structure.

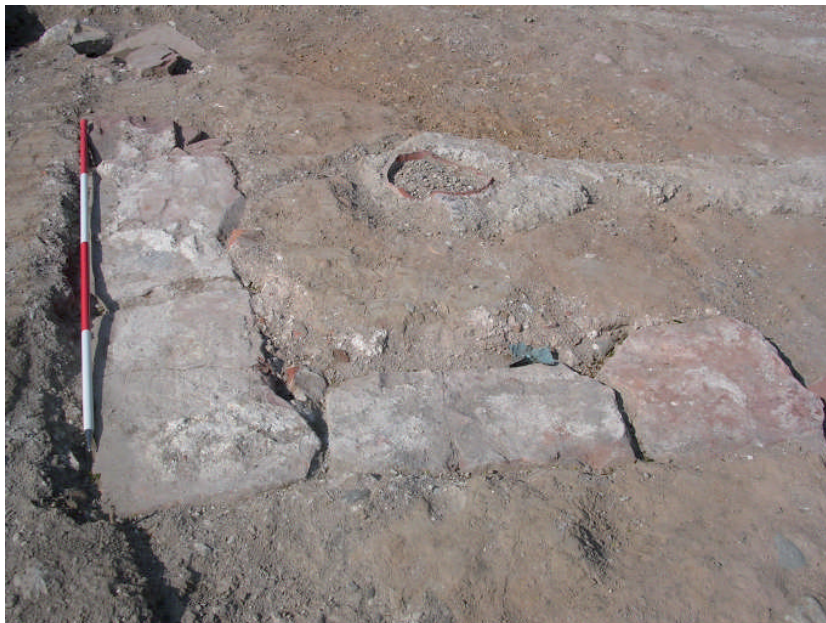
Plate 8: south western corner of bag store

6.3.8.1 The remains of the structure that had been described as a cart shed, bag store and cottage during its existence consisted of context (150)/(153) a north-south aligned wall constructed of small blocks of sandstone forming the south-western corner of the building (see figure 18). The wall remains were 0.6m wide and ran for approximately 3m in length, and appear to represent the lower foundation course of wall (175), a brick building with two surviving courses that make up the western wall of the cart shed. Wall foundation fragment (174) made up the surviving elements of the eastern wall of this structure.

- 6.3.8.2 The surviving remains of this structure were slight compared to the cart shed's original dimensions of 17.5m x 4.8m, with the southern and south-eastern portion of the building totally destroyed during the later development of the site

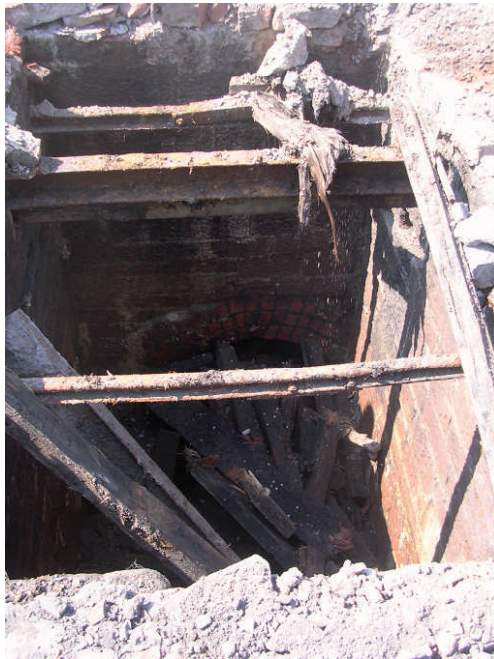
Plate 9: The condenser chamber

place, constructed out of dressed St Bees red sandstone blocks. The chamber walls (214) were braced with four cast iron supports which was recorded to a depth of over 2.7m beneath the current ground surface.

- 6.4.2.3 The condenser wall also butted up to wall (129), a rough undressed red sandstone wall (see plate 8), aligned north-south over the culvert between the wheel pit east wall of the main wheel and the condenser room. This section of substantial crude walling measuring 1.7m in width and 4.45m in length was undoubtedly of the same phase as the whole condenser chamber build and possible associated with a date stone in the main wheel pit dated to 1899 which would relate to the rebuilding of sections of the wheel pit to incorporate the water supply to the condenser chamber. Above ground, both the sandstone condenser chamber walls and the crude sandstone wall (129) were sealed by a red brick wall (212) measuring 0.60m, built directly on top of 214. Within the condenser chamber an outlet pipe was still present as was the water feed to the wheel pit and the steam feed from the engine. The condenser chamber was supplied with water by a brick arched culvert which was not recorded due to health and safety concerns. The culvert survived complete and could be seen to curve towards the back wall of the main wheel pit which provided the water supply for the condenser.

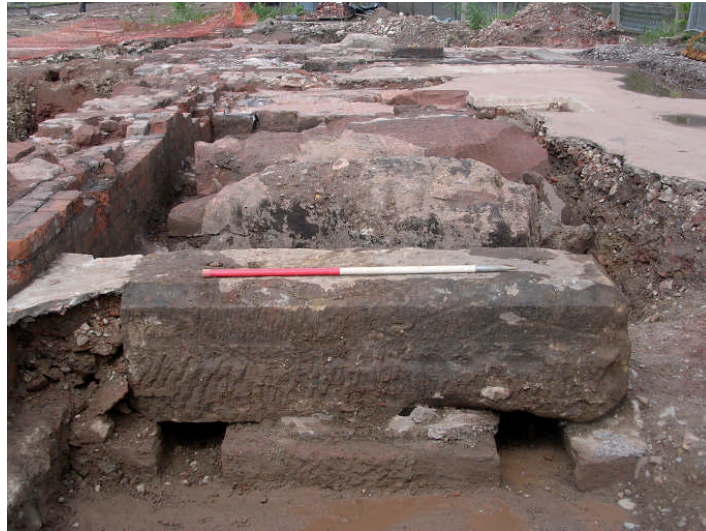
Plate 11: Engine mounting block in situ within remains of engine house

- 6.4.2.6 On the southern extent of the remaining engine room building a section of the concrete floor did still remain in situ (**137**) and butted up to a neatly tooled sandstone block (**134**) measuring 4m in length and c.1m wide, which would have been another mounting block for a steam engine, with two mounting bolts remaining in situ (see plate 10). The remains of a small brick drain (**135/136**) lay beyond that block running off in a southerly direction beyond the limits of excavation. An internal ceramic drain (**141**) was also recorded running on an east-west alignment (see plate 10).

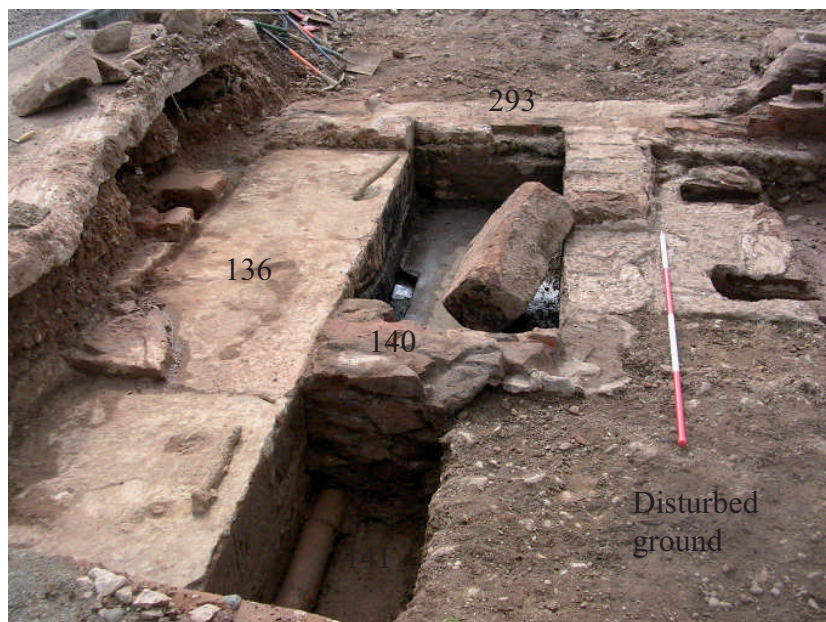
Plate 12: Detail of southern limit of engine house

6.4.2.7 The fragmentary remains of a internal sandstone wall (**140**) were also recorded running parallel to wall 293 approximately 2.4m to the east (see figure 22) and butting up to mounting block 136. This section of wall foundation measured 0.75m in width and survived to a height of 0.56m. The function of this wall is unclear and it is entirely possible that this stub of wall supported machinery and acted as base rather than a internal wall as such (see plate 10).

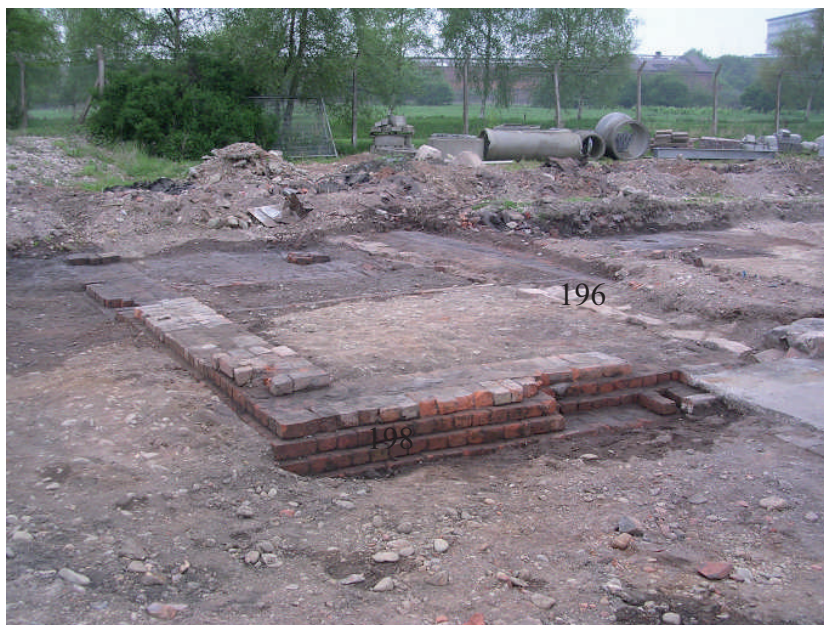
Plate 13: The south east corner of the Rolling mill

- 6.4.3.2 The western and southern extent of the Rolling Mill was uncovered during the excavation (see plate 11), revealing substantial brick walls (198) measuring 0.75m in thickness (three courses end to end thick), although badly disturbed it was possible to trace the full footprint of this north-south aligned building with overall dimensions of 11.5m by 25m for the original structure with the later addition increasing its length by 11.4m (see figure 23). Unfortunately none of the bricks were stamped which could have shed some light on the exact date of construction.

- 6.4.3.3 The excavated area of the Rolling Mill revealed the remains of a number of other wall foundations within the main building although no traces of an floor surfaces did survive. The most significant of these internal walls (196) measured 0.45m in width and was of course sandstone construction. The wall ran on an east/west alignment with a northward return on the same alignment as the eastern wall of the rolling plant. This wall was truncated by the western wall of the rolling mill (198) and sealed beneath the same wall on the eastern side as is likely to be the remains of a field boundary wall illustrated on the second edition Ordnance Survey of 1901 (see figure 23).

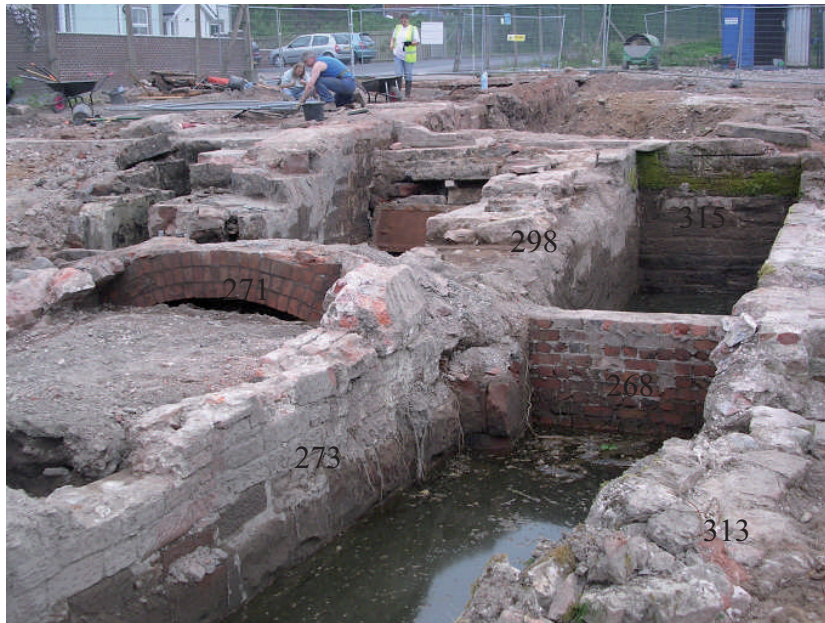
Plate 14: Wheel pit A, facing south east

- 6.4.4.3 **Wheel Pit A** measured c.12m in length by c.1.9m in width and was constructed primarily of dressed sandstone, with wall (313) forming the western side of wheel pit (see figure 24) and continuing northwards where it forms the western side of the tailrace (see plate 12). Wall 313 measured between 0.45m and 0.70m in width and was subject to numerous repairs over its working life. The eastern wall of the wheel pit (298) formed the common wall between the two wheel pits and was again constructed out of well dressed St Bees sandstone blocks measuring 1.2m in width.

- 6.4.4.4 The substantial width of this wall was the result of it having to secure the axles for both water wheels on what was largely a free standing wall. Only one of two sides of the wheel pit were keyed into wall southern wall of the wheel pit (315), which the eastern wall (298) butting up to wall (315). This clearly indicates that wall 298 although constructed out of a similar same type of dressed sandstone as the rest of the wheel pit; was constructed at a later date to walls (313) and (315). It is possible that the southern and western sides of the wheel pit are remnants of the mid 19th century mill. The most likely date for the major rebuilding of the eastern wall (298) would be during the early 1860s when the site was redeveloped from a gypsum crushing mill into a new corn mill with two water wheels (see 3.1.17).

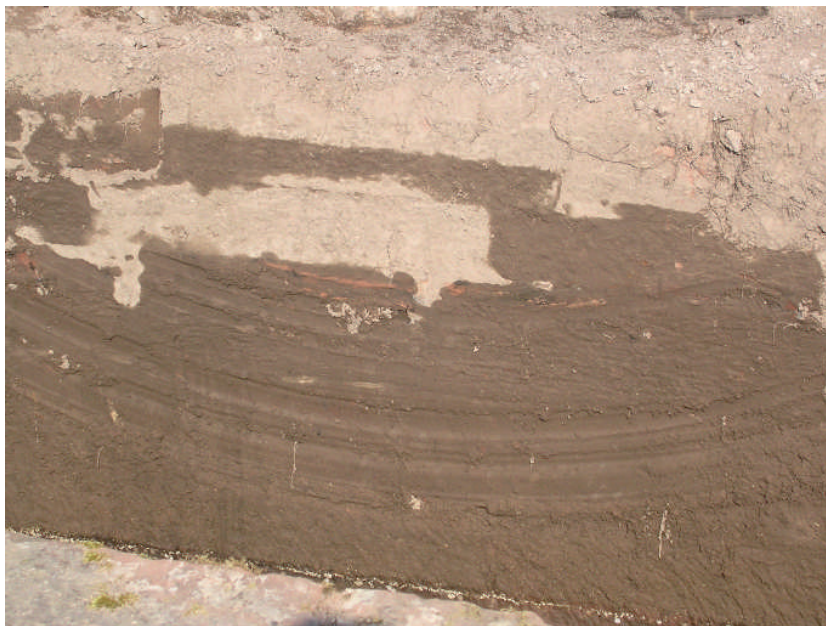
Plate 15: Scarring on the west side of wall 298

6.4.4.5 Scarring on both sides of the wheel pit caused by the water wheel becoming unbalanced during use resulting in grinding along the edges of the wheel rim and sides of the wheel pit. This scarring is useful in the analysis of the site as it gives a fair indication of the size of wheel (or wheels) used, which in this case would be approximately 4.2m in diameter; which corresponds well with a 14 foot wheel with 5 foot width documented in use at the site during the 1840s.

- 6.4.4.6 The probable reuse of this 1840s wheel in the 1860s rebuild is hinted at by the fact that the width of the new wheel pit was kept at 5 feet, (the width of the water wheel and wheel pit are always very close to each other with only minimal clearance required to allow for a efficient wheel to function) during its rebuilding. The wheel pit was aligned north-south upon the same axis as the millrace and measured approximately 1.8m in depth and 1.6m in width with the massive central wall running for 6.5m before it changed to a far narrower wall which merely separated the two channels of the tail race prior to the two channels merging. The base of the wheel pit was flagged in sandstone and sloped slightly from south to north. The wheel pit at some point in the 20th century went out of use with the mill reverting back to one operating wheel, with a small brick wall constructed across the wheel pit (268), blocking it off from the rest of the tailrace.

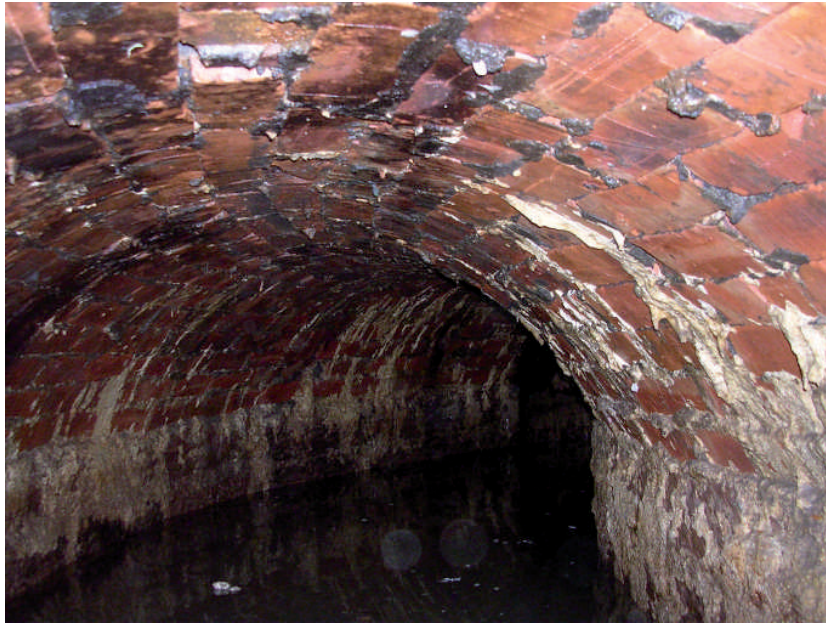
Plate 16: The brick arched tunnel leading from Wheel Pit B to condenser chamber

- 6.4.4.9 It is clear that this wheel pit post dated wheel pit A and was probably originally constructed in the 1860s but substantially altered or at least partially refaced in 1899 as a date stone remains in situ in the eastern face of wall (298). This rebuilding is likely to relate to the conversion to steam with the construction of the nearby condenser chamber and water supply culvert requiring a total rebuild of the south wall (219) of the wheel pit to include a brick arched tunnel and leading from its southern extent into the condenser chamber.

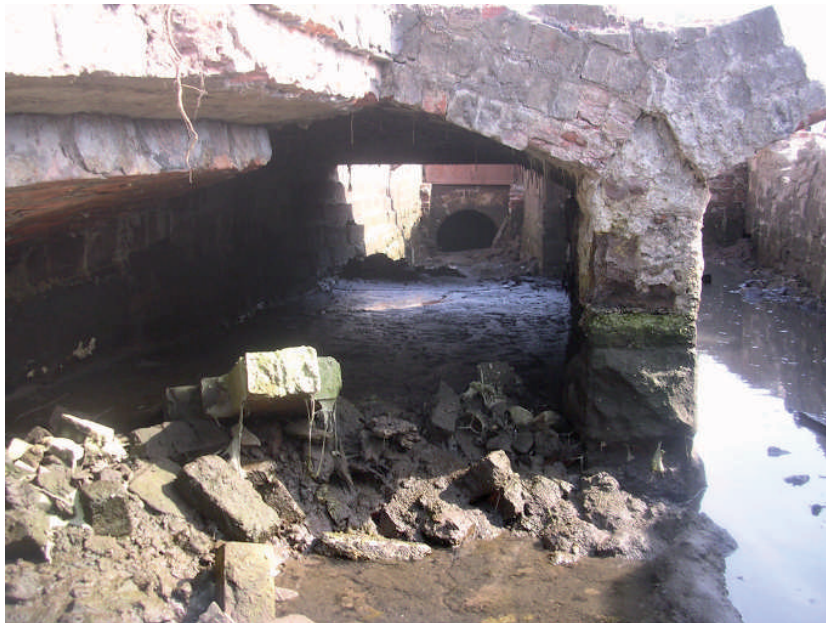
Plate 17: Brick archway 265 with fragment of later extension in foreground

6.4.4.14 To the north of the concrete slab (275) the tail race reverted to being covered by a low brick arch (265) which extended for a length of 4.5m (although only surviving on the eastern side) at which point it originally terminated. The capped millrace was later extended to the north with a new section of brick arching (264) added which again only survived on the eastern side and continued beyond the limits of excavation (see plate 15). This later section of arching appears to have covered the width of the millrace in a single span as there was no associated central wall extending beyond the northern limit of wall (273). This whole area was badly disturbed by the insertion later plastic sewer pipes into the course of the millrace.

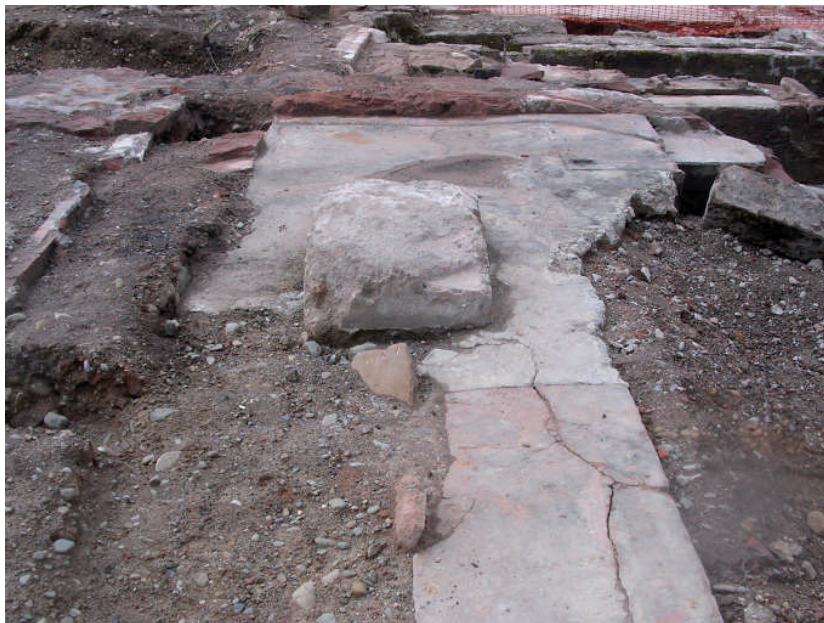
Plate 18: View of floor surface 104 and 113 and mounting block 105

- 6.4.4.16 A large rectangular concrete block (105) still in situ and set on top of concrete floor (103) measuring 1.2m by 0.60m appears to be a mounting block for a large piece of machinery. No metal fixings or fittings were present on this block to give any clues as to its original function. Floor surface 103 was the only substantial area of surviving floor surface relating to the mill itself and extended by approximately 3m by 1.5. This floor surface (103) partially overlay a late red sandstone flagged floor surface (104) within the mill extending to the east for over 3.4m and continued beyond the limits of excavation. The floor was composed of rectangular flags, measuring 1m by 0.60m which were laid directly onto the natural subsoil (101), no earlier features were recorded beneath surfaces (113) and (104).

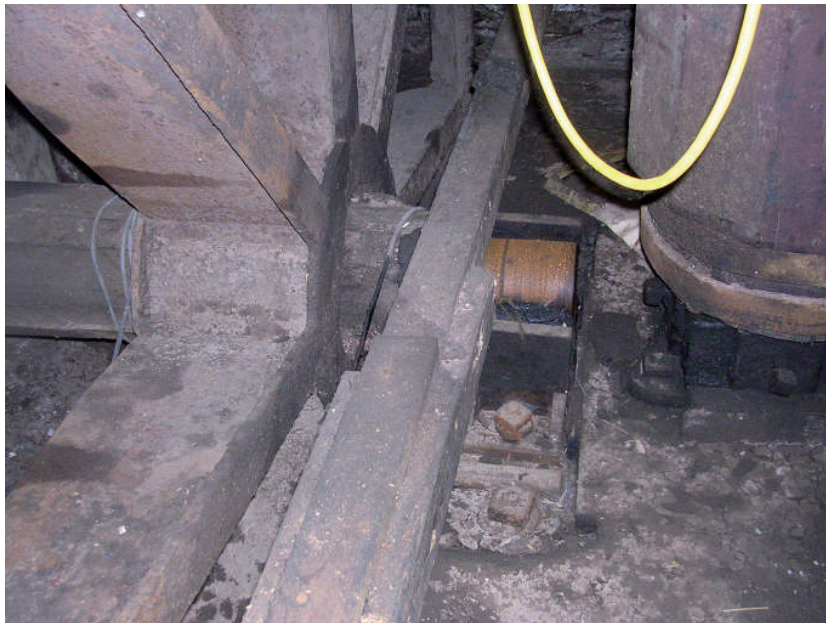
Plate 19: Detail of pit wheel and mounting arrangement at Warwick Mill

workings of a corn mill, kindly produced by Michael Davies-Shiel can be found on Figure 21. The mounting blocks measured approximately 1m in length and 0.26m in width and were made out of quarter inch steel plate holding two sets of half inch bolts that would have secured the water wheel to the wheel pit walls (see plate 19). A similar mounting arrangement for the wheel axle was recorded still in situ at the surviving 19th century water mill at Warwick bridge (see plate 18).

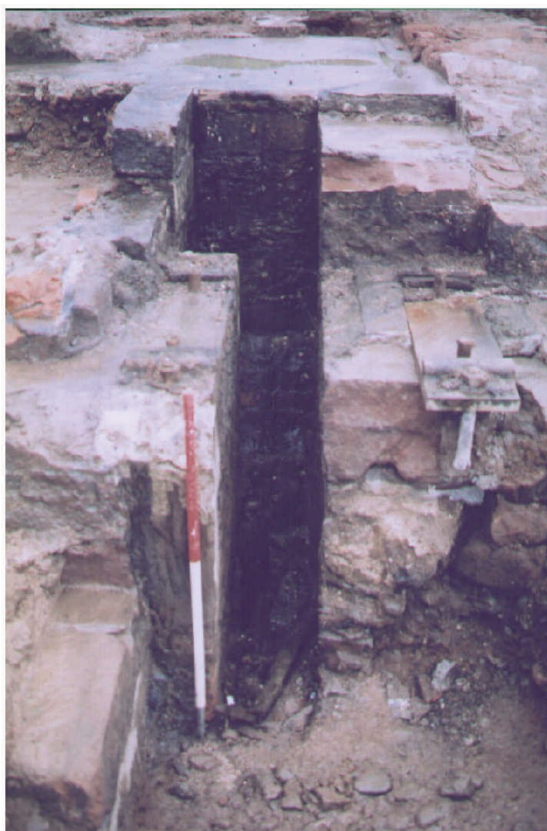
Plate 20: Drive pit showing detail of both mounting plates

- 6.4.4.20 The drive chamber, which housed the pit wheel was well preserved (see figure 20 and plate 19) and defined by two substantial walls and butted up to the eastern wall of Wheel Pit B (106). Context 112 formed the eastern side of the drive chamber pit, a substantial sandstone wall running north-south measuring 2.4m in length, 0.60m in width and 1.5m in depth. The western wall of the drive pit (115), was again well preserved and measured 2m in length by 0.52m in width and had a maximum depth of 1.5m, a large sandstone block measuring 1.2m by 0.60m forming the southern end of wall 115 extended to wall 112 to form the southern side of the drive pit.

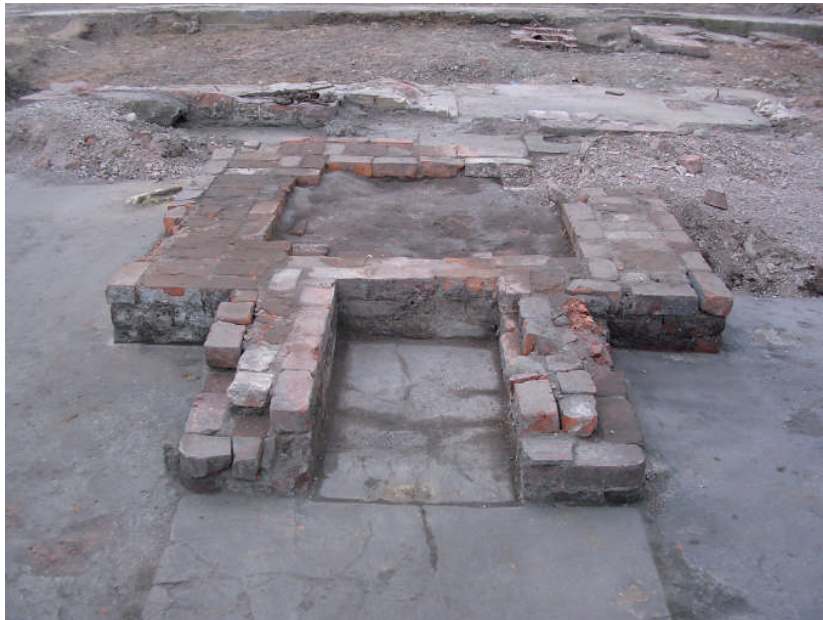
Plate 21: Detailed view of kiln base, context 190

- 6.4.5.2 The north-half of the structure was originally excavated during the site evaluation in 2002, described as such: “Structure (**313ev**) and consisted of a sandstone wall foundation measuring 0.70m in width, bonded by black ‘pug’ lime mortar. Measuring approximately 8.0 m x 7m in total, this structure forms the corner of a substantial building. This structure had a concrete floor (**312ev**) within it that was different in character, and likely to be older, than the modern reinforced concrete, consisting of large pieces of river gravel cemented into the base of the concrete acting as a reinforcing agent. Kiln base (**314ev**) consisted of a square, brick built structure cut to the north by a narrow band of modern reinforced concrete. Measuring 1.80 m x 2.0 m and constructed from engineering bricks, the floor of this structure was heavily stained by a black ashen deposit.”

- 6.4.5.3 The elements described in the evaluation were the furnace and wall foundation remains of the original corn drying kiln building. This building was likely to have been constructed in the late 1870s when the site appears to have been redeveloped (see 3.1.19). The southern wall and southern edge of kiln (**314ev**) were recorded during the excavation with the surviving concrete floor (**312ev**) found to extend up the southern wall (**287**) of the original structure (see figure 19). The only side of the building that had been totally truncated was the eastern side of which nothing survived.

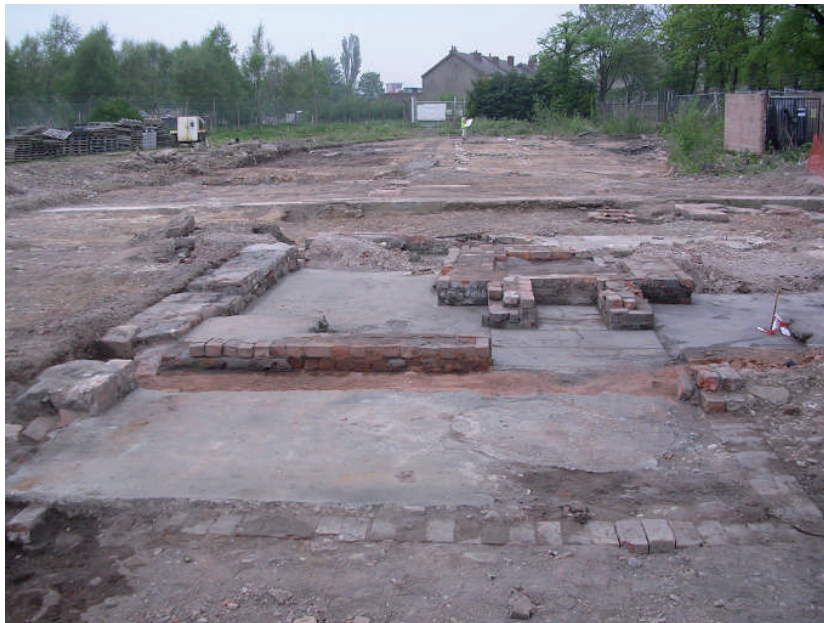
Plate 22: View of southern kiln and small “coal store”

- 6.4.5.4 The southern half and later extension measured 7m by 7m and was basically a mirror image of the original corn drying building, with a much better level of preservation. This building constructed circa 1905 had a variety of foundation styles with the western wall utilising a sandstone foundation which could possibly relate to an earlier garden wall foundation reused for this extension (see figure 29) and the southern wall using a narrow brick foundation. The brick wall (**195**) measured 0.33m in width and survived for a length of 6m and was clearly butting up to wall 196. Again as with the earlier kiln building nothing survived of the eastern wall.

- 6.4.5.5 Internally the room was floored in concrete (**193**) which covered approximately two thirds of the interior, the northern limits of the room were floored with sandstone flags (**191**) and had a small drain remaining in situ. This had the appearance of an external flagged surface, which was contemporary with the earlier building and later incorporated into the new internal concrete floor.

- 6.4.5.6 The kiln base (**190**) was slightly larger than the primary kiln but still of approximately the same design with a square fire box measuring approximately 1.3m by 1.3m and constructed out of engineering bricks which survived to three courses in height. The interior showed signs of intense heat with the inside course of bricks in a very poor state of preservation, indicating that the kiln was well overdue a relining by the end of its working life hinting at little investment on the

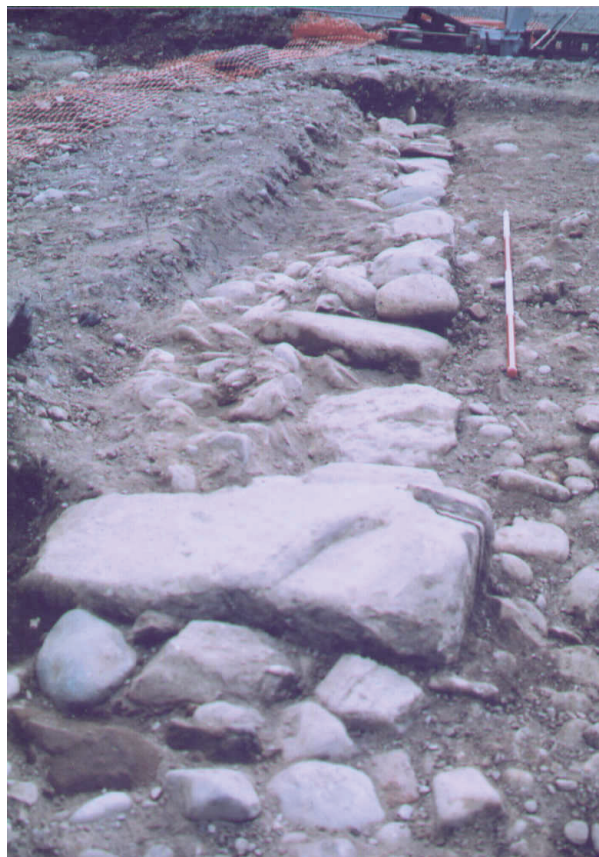
Plate 23: View of probable 18th century wall foundation

- 6.5.6 *Early Drain, pits and Wall [162], (163), [164], (165), [306], (307), (308), [309], (310), (311)*
- 6.5.6.1 At the southernmost extent of the site lay a stone drain and a substantial sandstone wall, tentatively dated to pre-1842, (and quite possibly much earlier) lying on a totally different structural alignment to the rest of the site (see figure 19a). The function of this earlier wall foundation is unknown as it does not appear on any of the cartographic representations of the area.
