Project Designs and Client Reports No. CP/474/07

**REPORT ON AN
ARCHAEOLOGICAL
BUILDING RECORDING
PROJECT AT
KIRK HOUSE
OVER KELLET
LANCASHIRE**

**FOR
WALLING UK
PROPERTIES**

26 April 2007

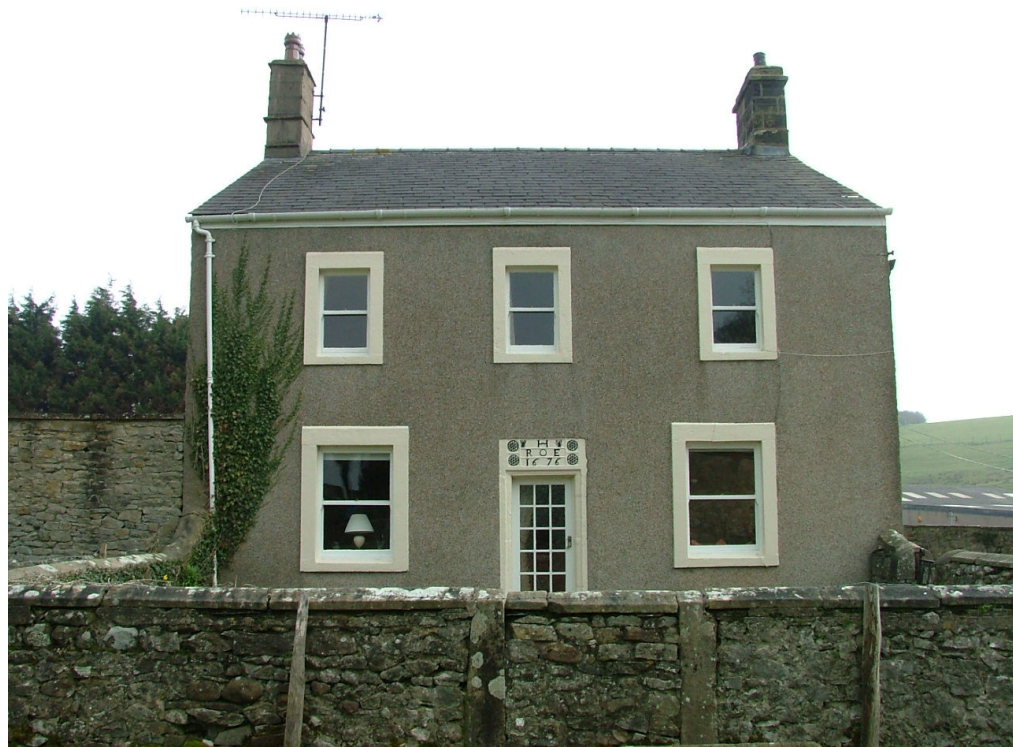
Plate 2 – West elevation of farmhouse at Kirk House with initials and date ‘R E H 1676’. Note the blocked gateway which originally provided access from the house to the church (See Figure 8 which shows the footpath)

- 4.3 Hennem's map of 1829 is interesting as it labels Kirk House as 'Crickland House'; Birkland Barrow and Swarthdale are also shown (Figure 6).
- 4.4 According to the Over Kellet village website, Birkland Barrow is the oldest dated building in the parish, having been rebuilt in 1663³. The farmhouse at Kirk House may also have been rebuilt soon afterwards, as it has a date stone of 1676, although this date stone could, of course, be reused (Plate 2).

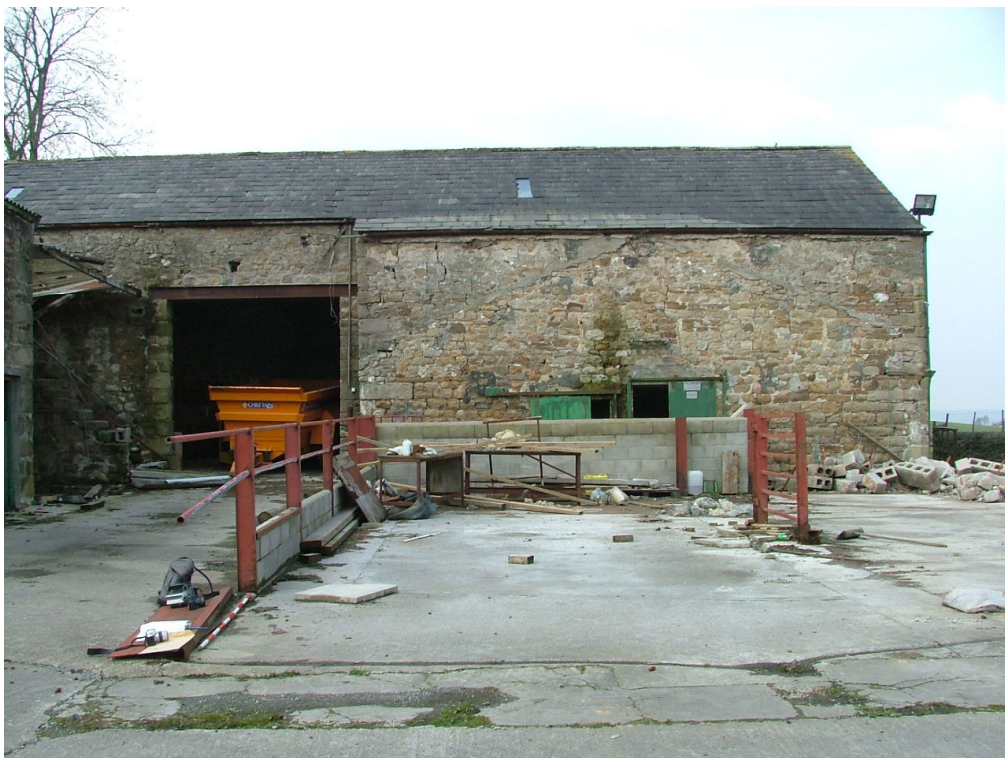
- 5.2.1 Range A is a two-storey gabled building constructed of roughly coursed rubble masonry, with large alternating blocks of squared masonry making up the quoins (Plate 3 and Figures 11 and 12). The roof is laid in Welsh slate with inserted skylights. The building measures approximately 24.30 metres in length, however the building is wider at its north-eastern end, measuring *c.*8.30 metres compared to *c.*7.20 metres at the south-western end. This is typical of, what Brunskill describes as, a ‘Lancashire Barn’; a structure which was constructed to house not only the processing of arable crops, but also a cow house with hay loft above. Although buildings were constructed throughout the country to house a number of functions, the type of plan form as seen at Kirk House is common throughout Lancashire, the county in which it was first identified⁸, although examples are known in the south of Cumbria such as at Chapel House, Casterton⁹.

Plate 3 – South-east facing elevation of Range A

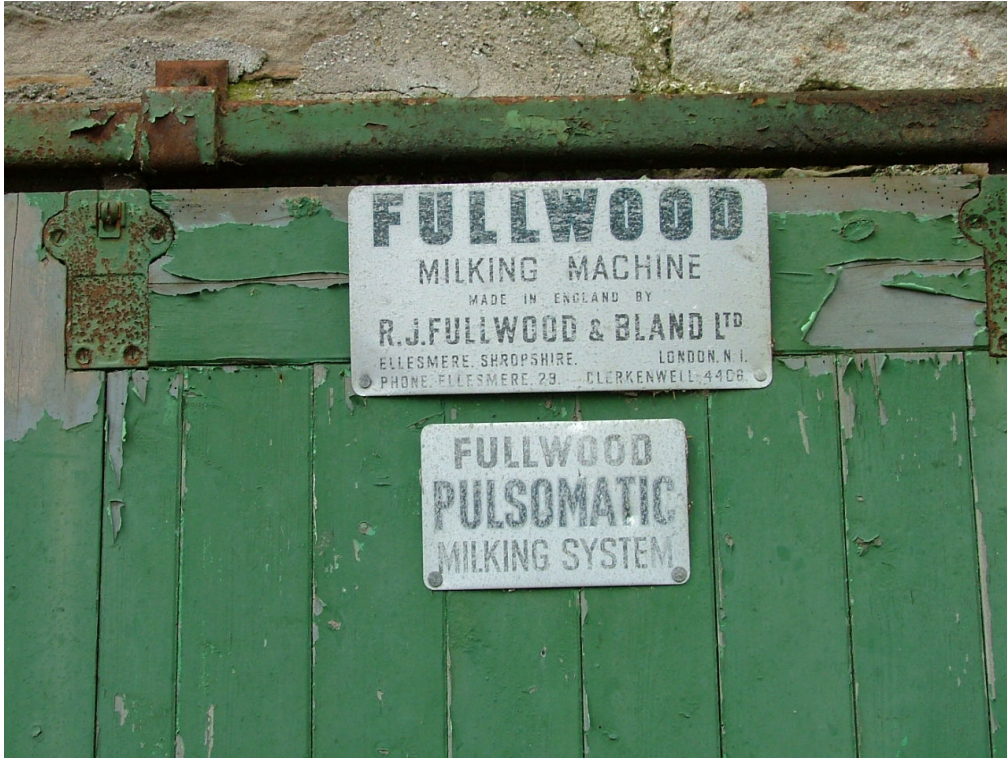
Plate 4 – Plaque on door to former cow house or shippon, south-east elevation of Range A

- 6.8 Despite the farm more latterly being beef and arable, the plaque on the south-east elevation of Range A indicates that dairying was also undertaken in the recent past (Plate 4).

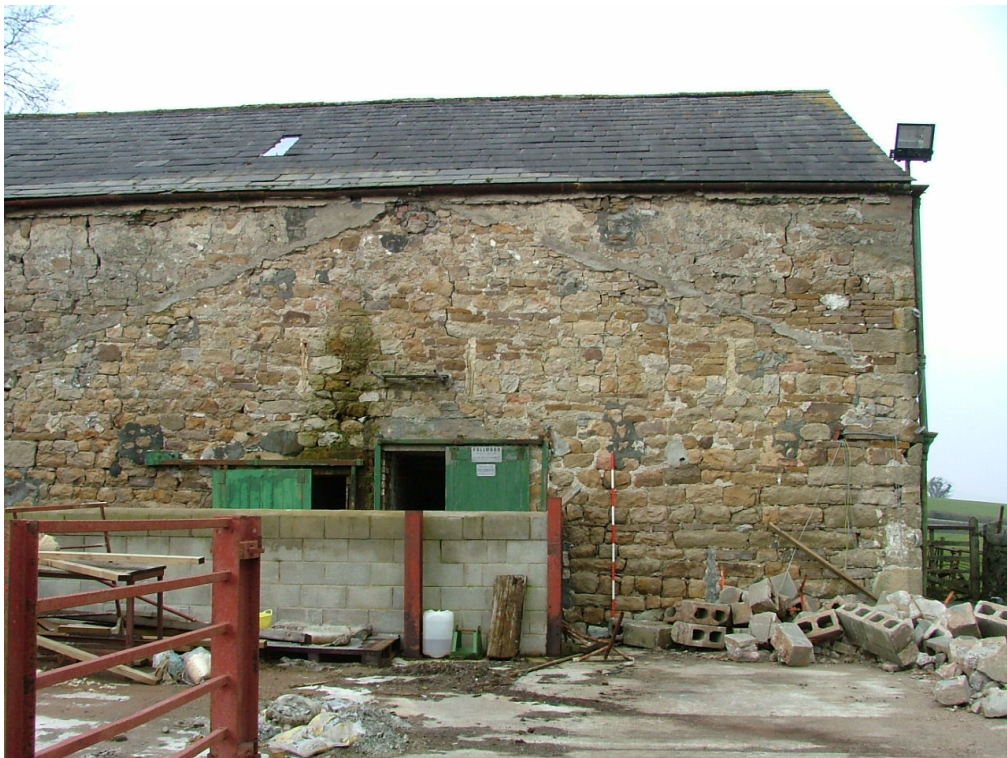
- 5.2.3 Several blocked-up ventilation slits were observed along this elevation both at ground and upper level (Plate 5). To the left-hand side of the large doorway in this elevation, one of the ventilation slits is partly obscured by the stone stairs in Range B which suggests that Range A was in existence prior to the construction of at least part of Range B (See 5.4.2). Ventilation slits are common in stone-built traditional farm buildings where corn (generic term for cereals) were processed and stored; hay

Plate 5 – South-east elevation of Range A showing blocked-up ventilation slits
(Scale = two metres)

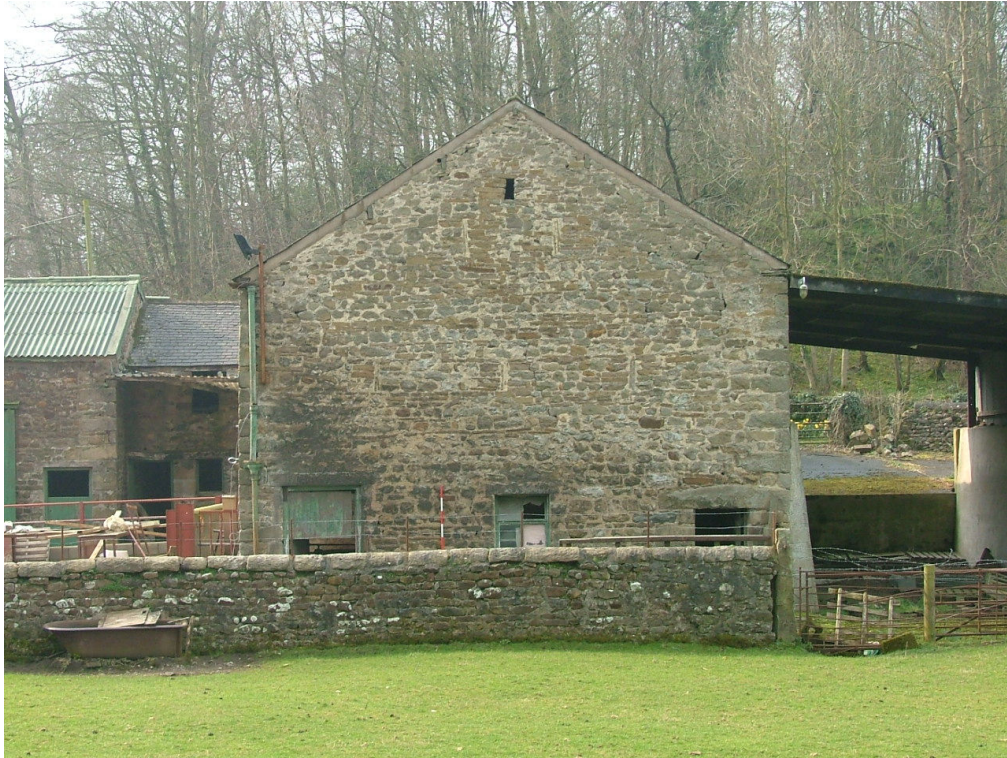
- 5.2.4 The north-east elevation of Range A has at ground level, a standard-sized doorway, a window and a much smaller doorway (Figure 13 and Plate 6). Both of the doorways had surrounds consisting of alternating dressed blocks of masonry which had chamfered edges which provides a hint of architectural detail, although of course this could also have been a practical feature to prevent animals from injuring themselves. The lintel over the smaller doorway consists of a large piece of masonry (Plate 7). Blocked ventilation slits were also observed on this elevation as well as an owl hole located close to the apex of the roof; a common feature in barns which allowed owls in to control vermin. There was the possible scarring for an earlier roofline visible on this elevation, suggesting that the building had been heightened at some point, but this was not discernable on any of the other elevations (Plate 6).

Plate 6 – North-east elevation of Range A

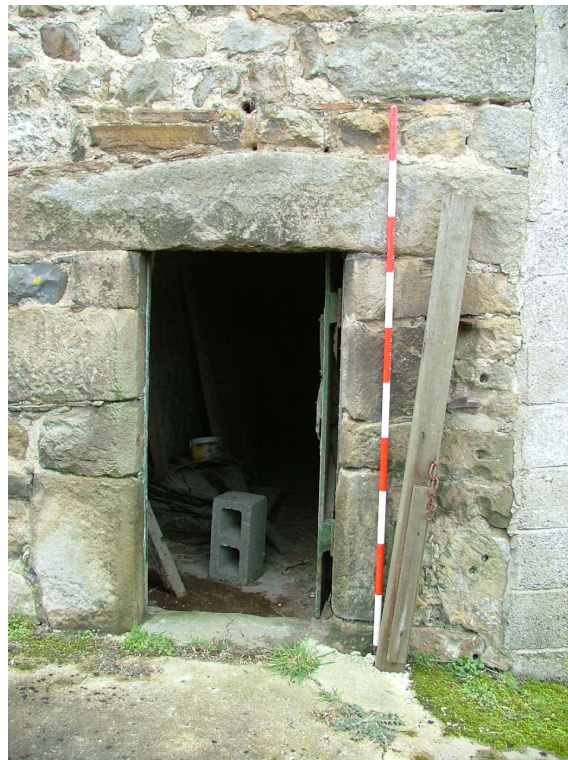
Plate 7 – Doorway to possible root store, NE elevation of Range A

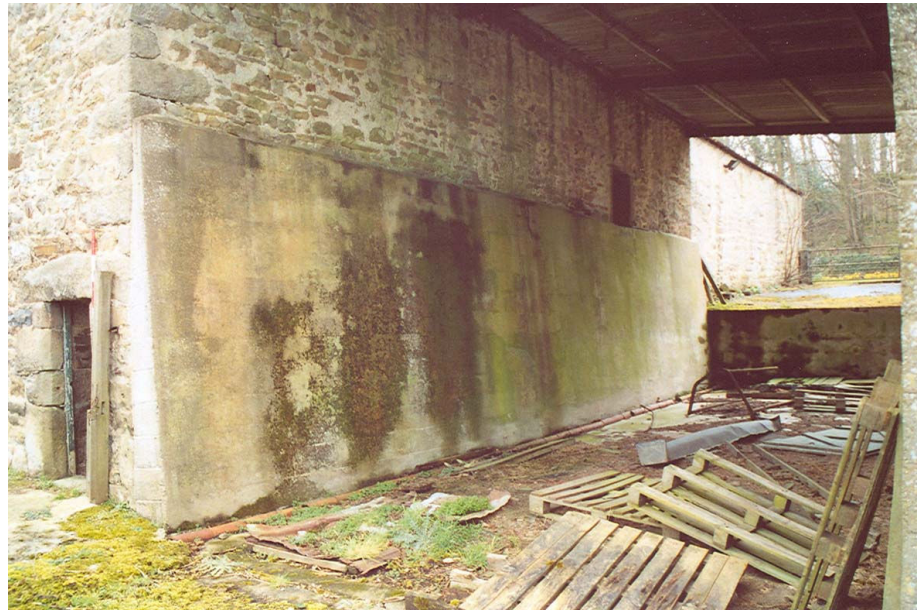
Plate 8 – Part of the north-west elevation obscured by the silage clamp, note the pitching hole to the right of photograph

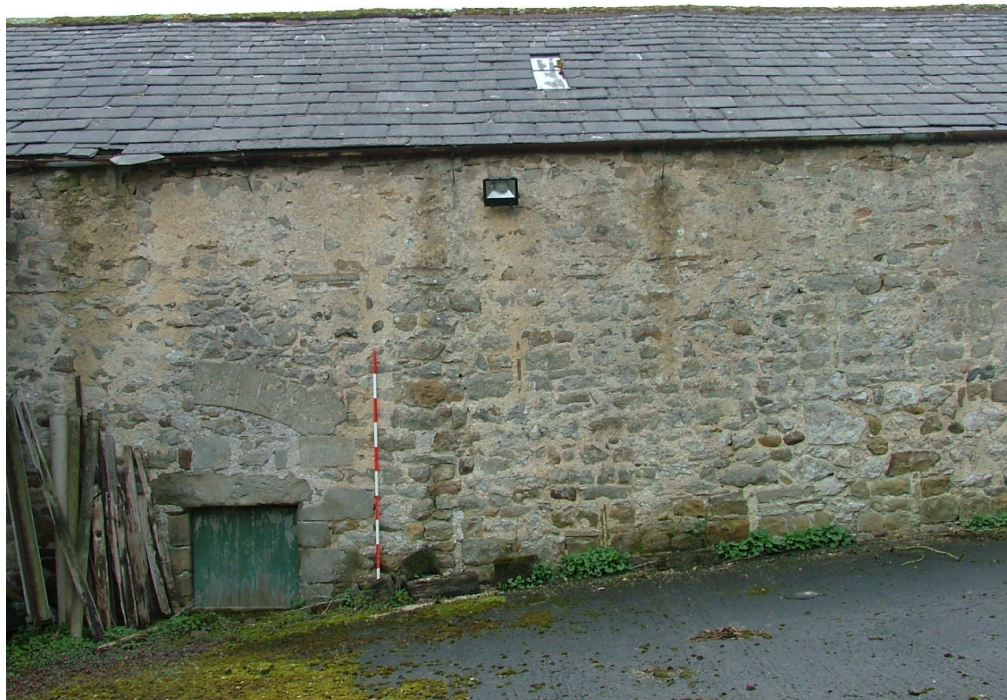
Plate 9 – Part of the north-west elevation showing the remains of a segmental arch and the blocked ventilation slits

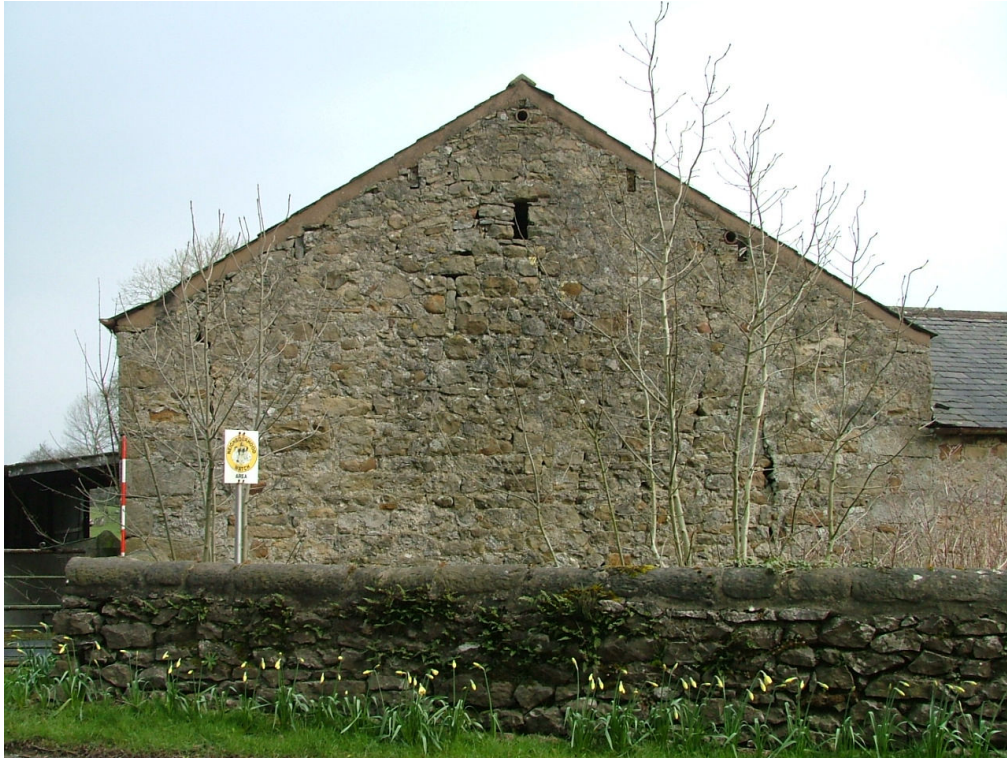
- 5.2.6 The south-west elevation of Range A faces the road and is relatively featureless apart from an owl hole and blocked ventilation slits (Plate 10).

Plate 10 – South-west elevation of Range A as seen from the road

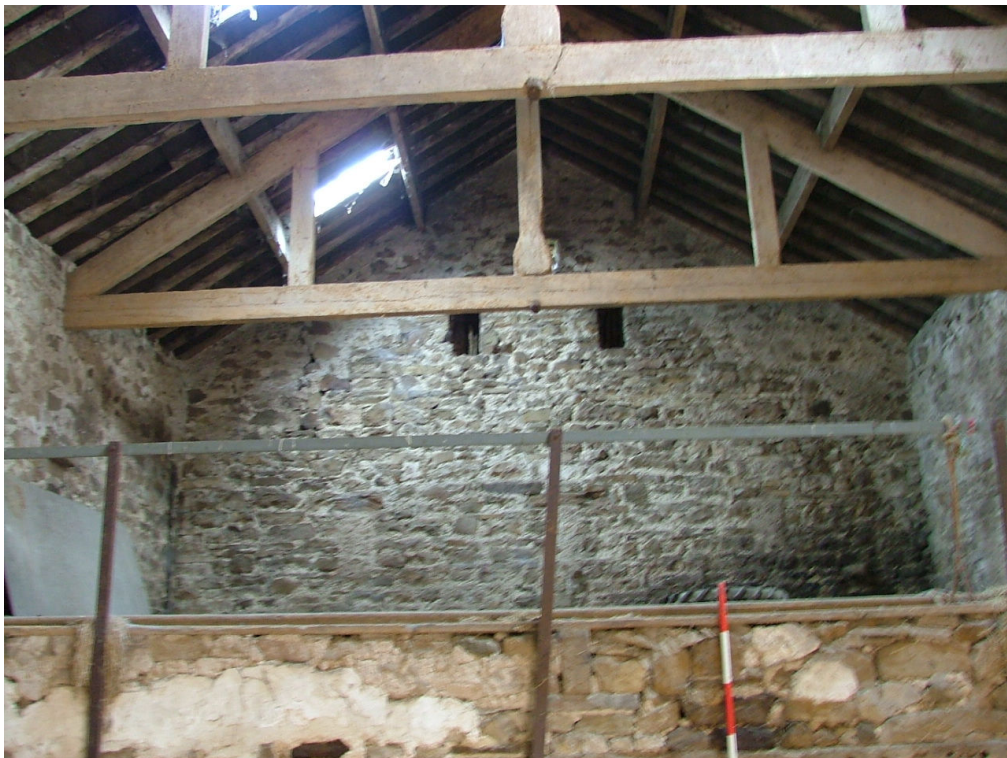
Plate 11 – Northern end of Range A showing the cross wall which creates a hayloft over the cow shed and root store

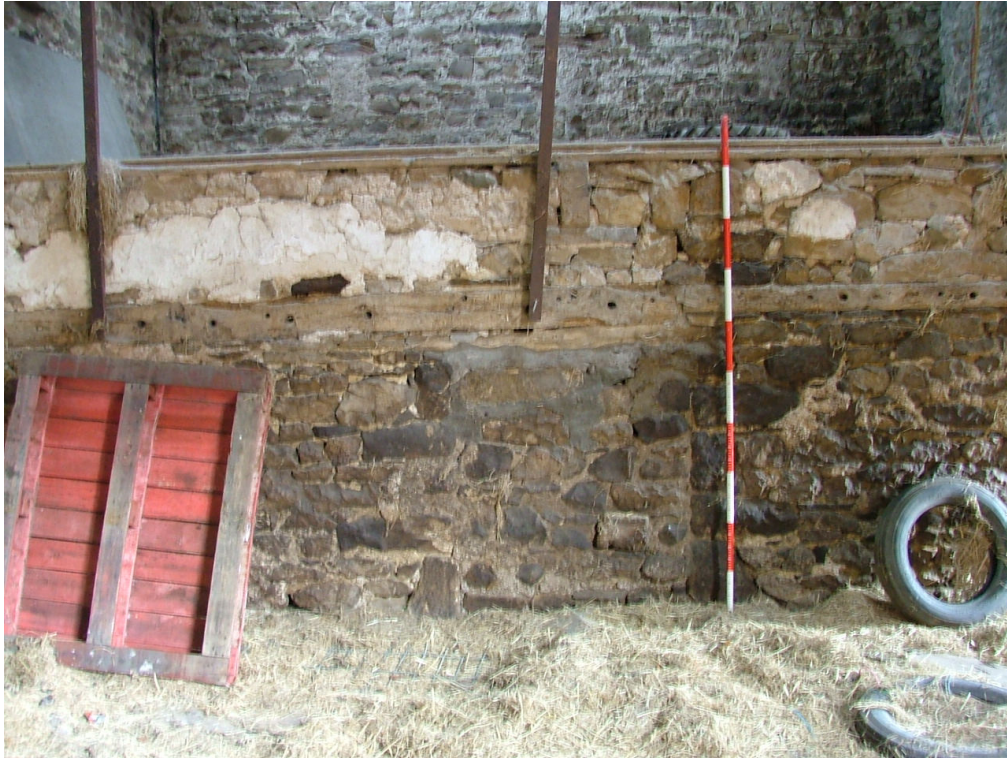
- 5.3.1 Access to the main body of the barn was possible through either the large doorway or the smaller doorway on the south-eastern elevation (Figure 11). Internally, the barn was open to the roof all along its length, the only internal division being ground level at the northern end where a cross wall creates a loft with cow shed and possible root store below (Plate 11). A blocked aperture was observed in this wall measuring *c.*1.10 metres which may have been used to transfer hay, straw or feed from the barn and loft to the cow house (Plate 12).

Plate 12 – Blocked hole in cross wall, north end of Range A (Scale = two metres)

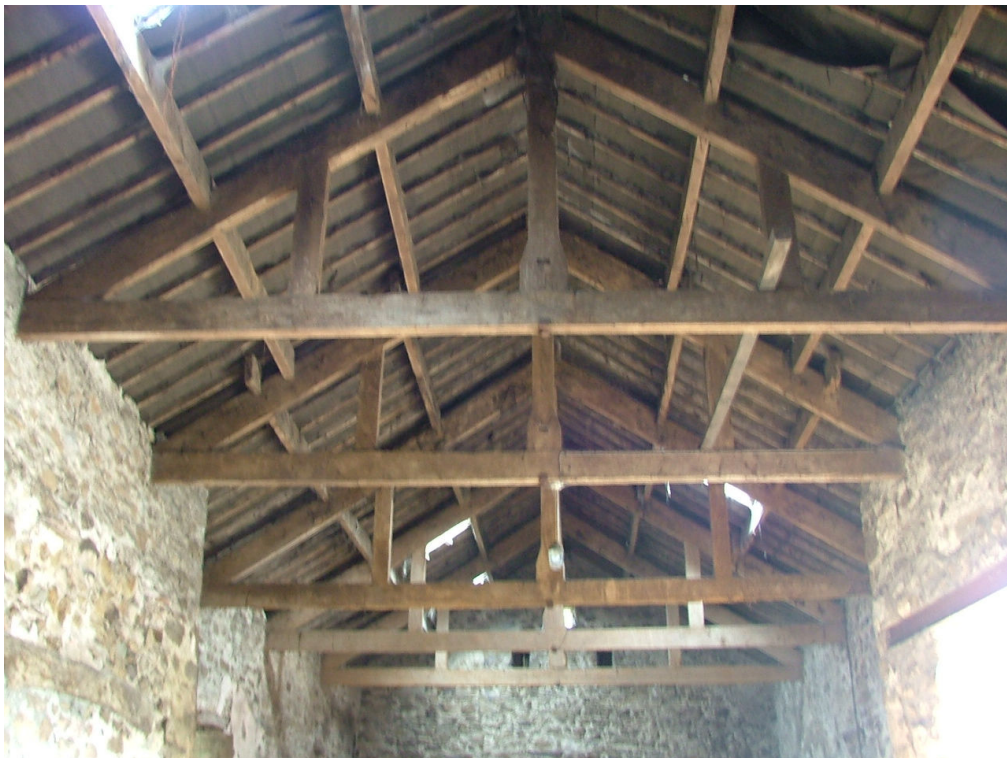
Plate 13 – Roof structure, Range A, looking northwards

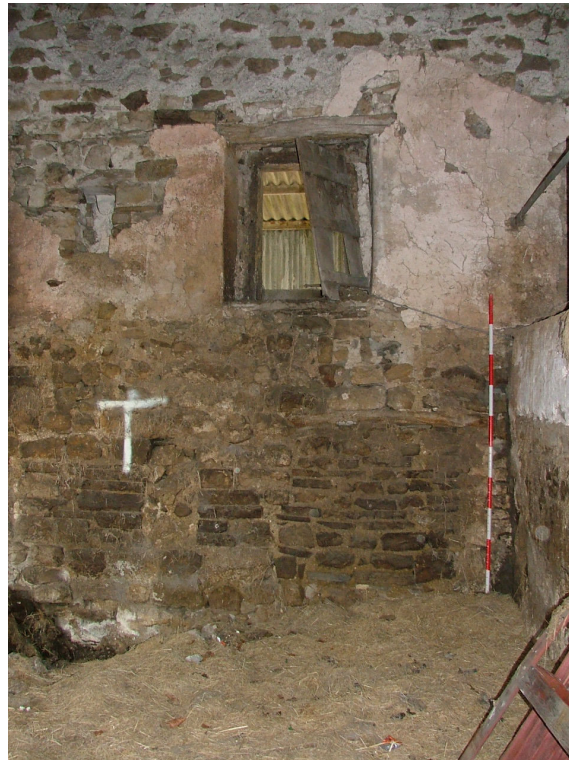
- 5.3.3 In the north-west elevation a blocked doorway measuring *c.*1.14 metres in width was observed beneath the pitching hole (Plate 14). Externally, this blocked doorway was hidden behind the concrete side of the silage clamp. The lintel of the former cart shed doorway observed on the north-west elevation (See 5.2.5) remained *in-situ* internally (Plate 15).

Plate 14 – Blocked doorway and pitching hole, north-west elevation of Range A

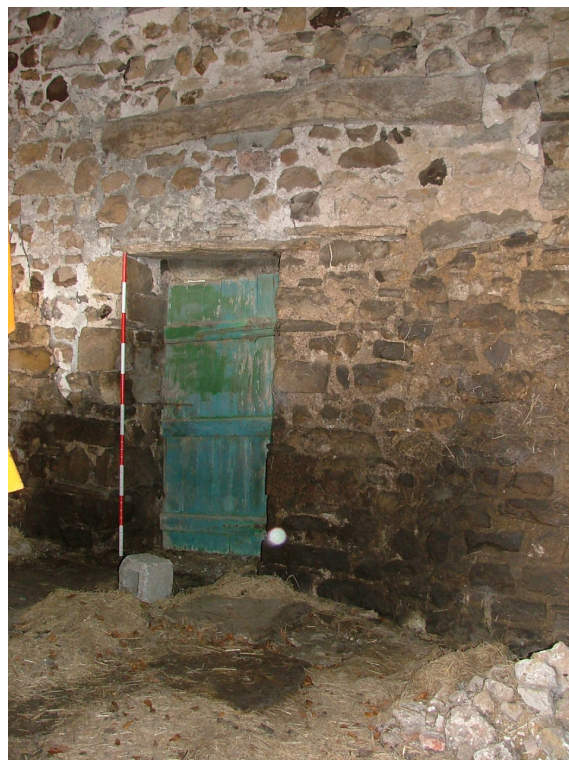
Plate 15 – Timber lintel of former cart doorway, north-west elevation of Range A

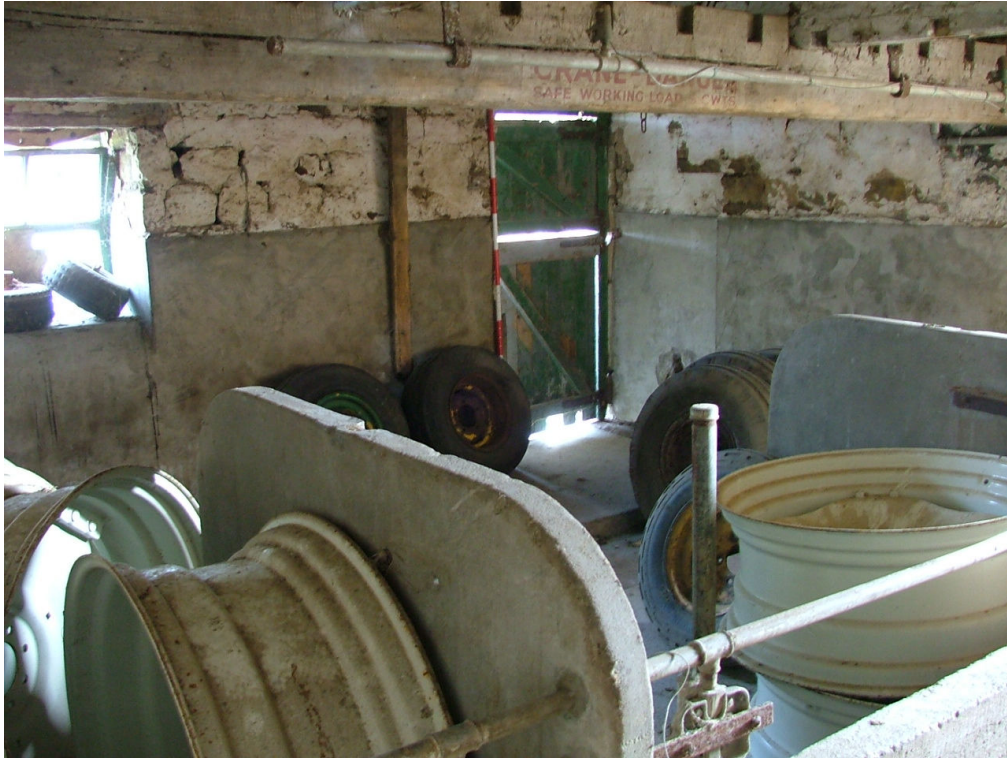
- 5.3.6 At the northern end of Range A, beneath the hayloft, was what may originally have been either a stable or cowhouse (most recently used as a cowhouse), and a possible root store. The cowhouse could be accessed by either the door on the north-east elevation or the door on the south-east elevation (Figure 11). The floor of this room is of concrete with a manure passage at the northern side, there are three double stalls separated by concrete dividers, and a feeding passage at the southern side (Plate 16). The remains of limewash, a common traditional wall coating and disinfectant, was visible above the plastered sections of wall.

Plate 16 – Interior of cow house, northern end of Range A

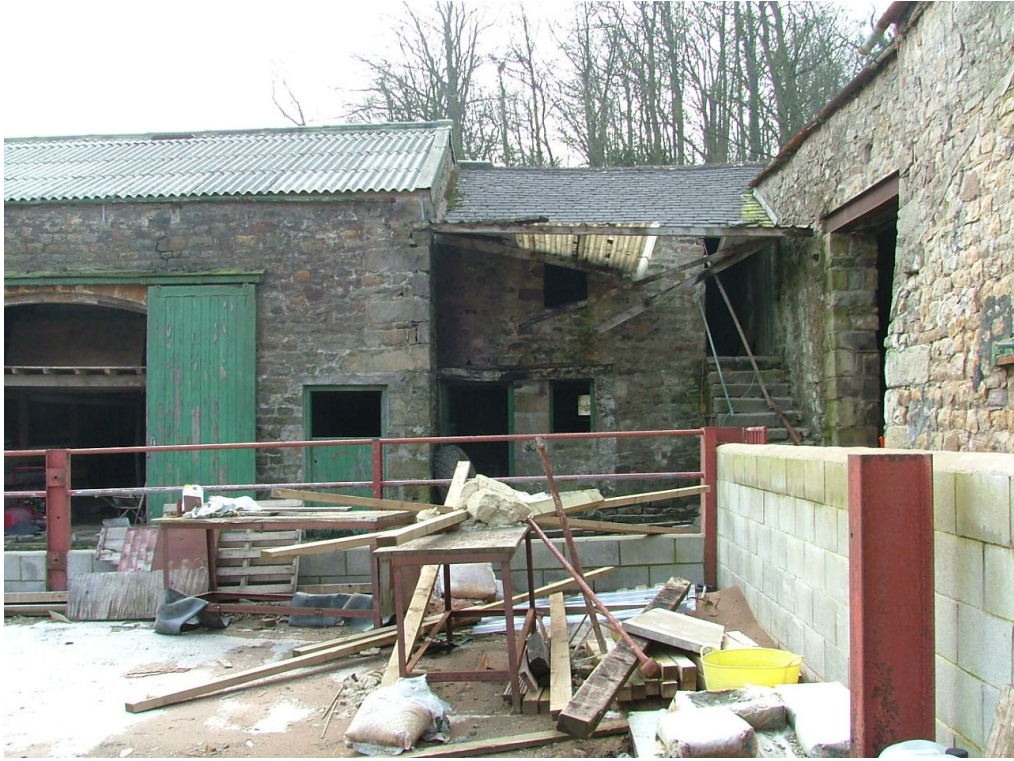
Plate 18 – North-east elevation of the granary/cowhouse, Range B

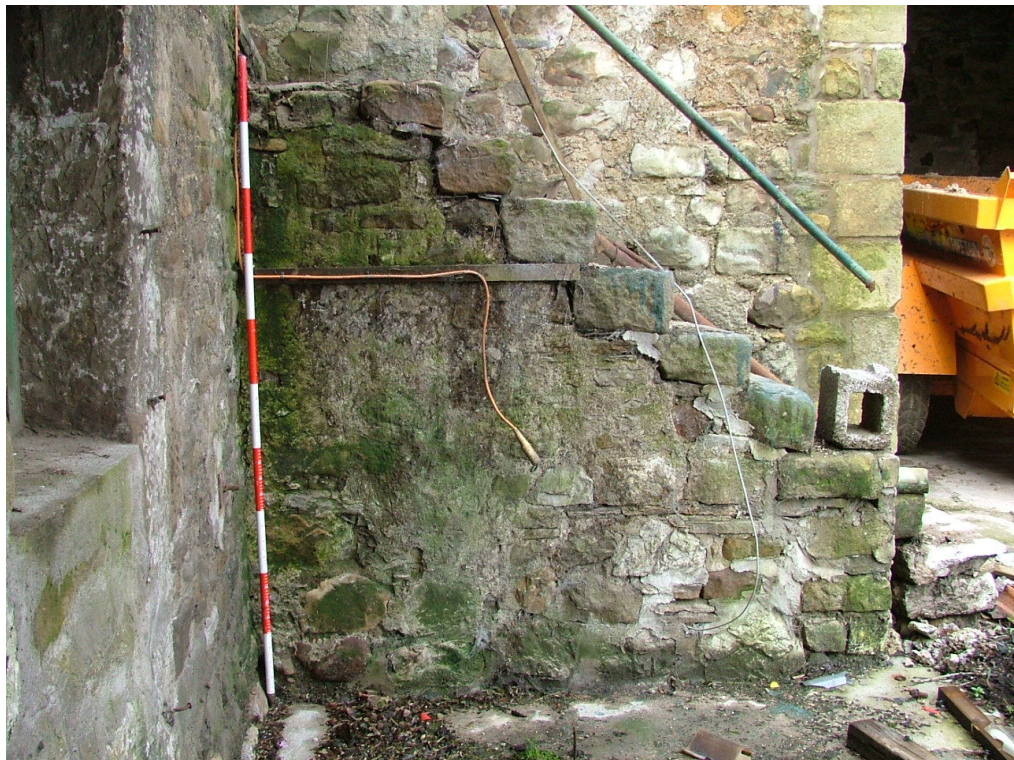
Plate 19 – Stone staircase to possible granary, Range B (built against the south-east elevation of Range A) (Scale = two metres)

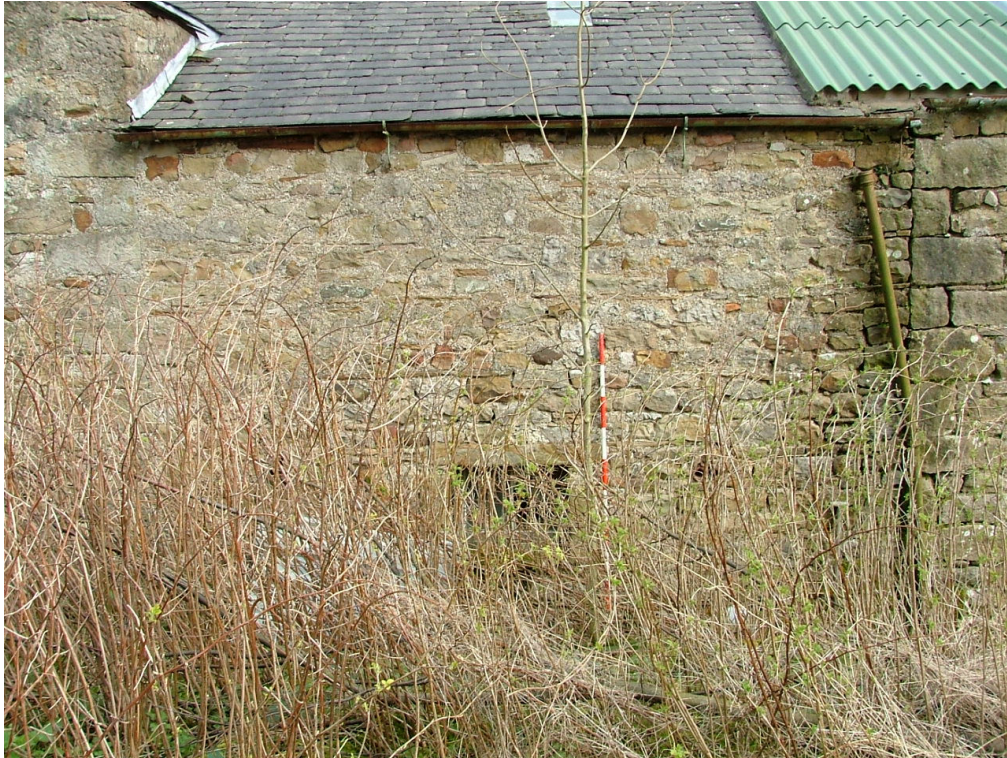
Plate 20 – South-west elevation of former granary/cowhouse showing two vertical construction breaks; one between Range A (left of photograph) and the other between the remainder of Range B (right of photograph)

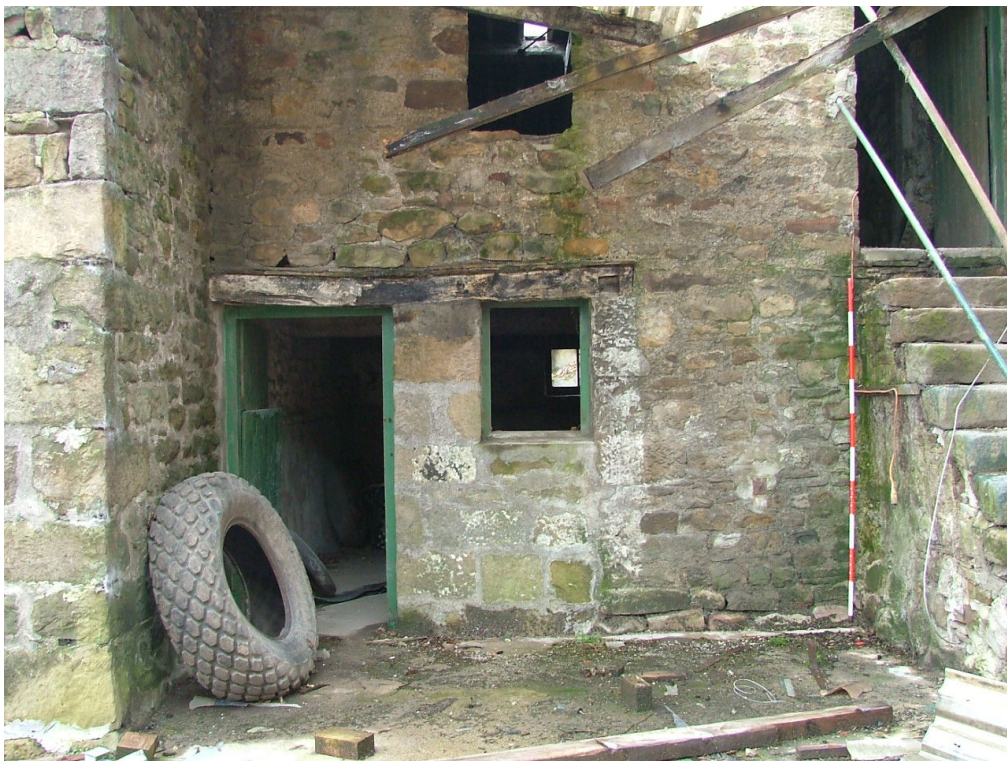
- 5.4.2 The building built butting up to the south-east elevation of Range A measures *c.*5.50 metres in width by *c.*6.50 metres deep (Figure 11); is of two storeys and has a Welsh slate roof with inserted skylights. On the north-east elevation is a doorway and window at ground level, a stone staircase and a doorway and window at first floor level (Plate 18). As part of the staircase (Plate 19) conceals one of the ventilation slits in Range A, then it appears that this building was constructed after Range A. This is also suggested by the vertical construction break observed on the south-west elevation (Plate 20). The only feature of note on the south-west elevation was a window (Figure 11). On the north-west elevation a wooden lintel over the door and window, and a possible vertical construction break may suggest that there was a larger doorway in this elevation at some point; although there has obviously been a lean-to or similar against this elevation until fairly recently due to the clean masonry, and consequently the vertical construction break may not be real (it could not be observed internally due to the cement walls) (Plate 21).

Plate 21 – North-east elevation of cowhouse/granary, Range B

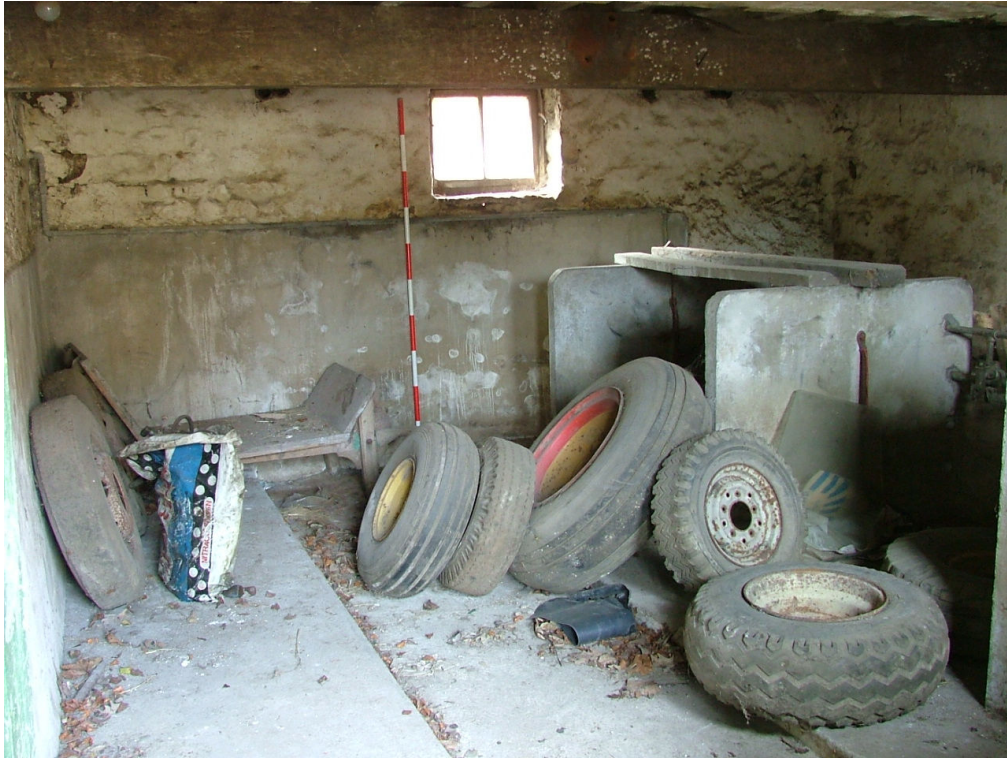
Plate 22 – Interior of cowhouse, Range B, showing concrete stall dividers, concrete floor and window in south-west elevation

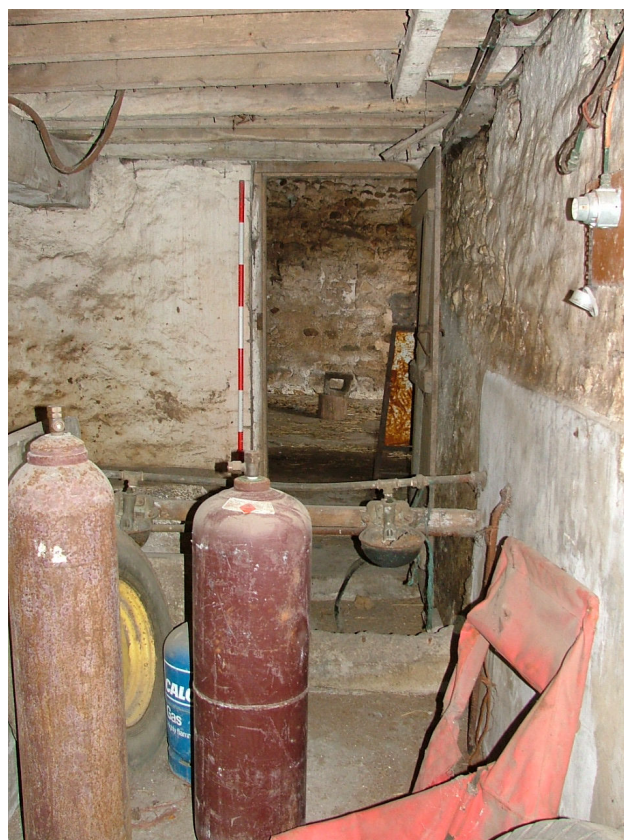
Plate 23 – Interior of cowhouse, Range B, showing doorway to Range A

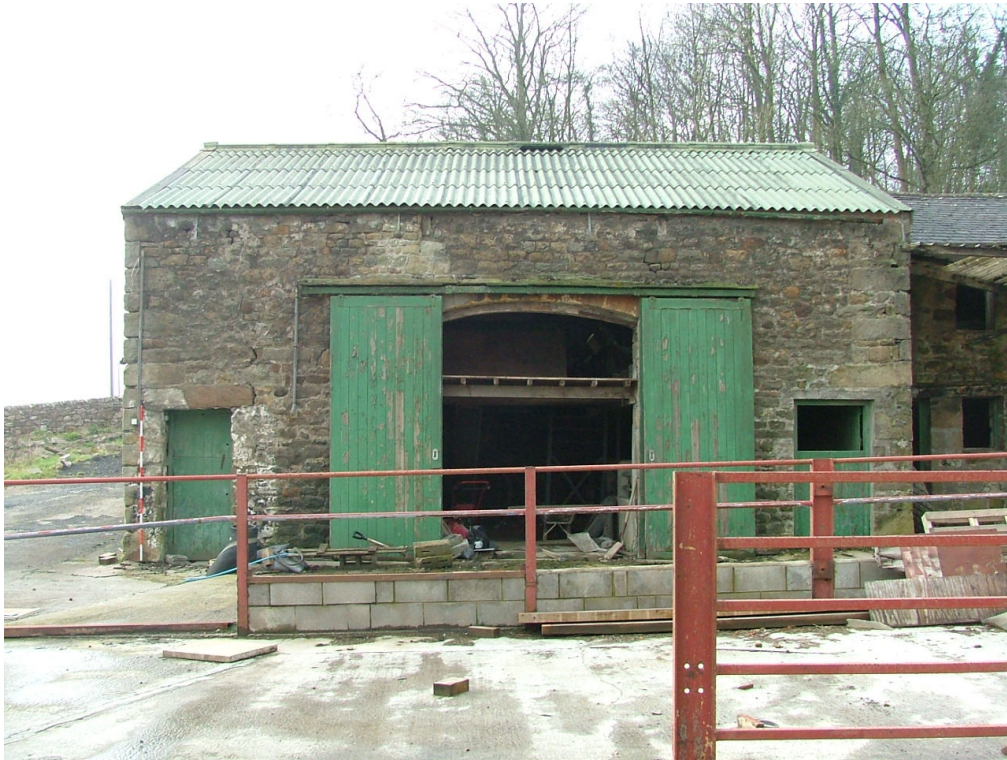
- 5.4.5 To the south of the cowhouse/granary is a larger building measuring *c.* 10.50 metres long by *c.* 8.50 metres wide (Figure 11 and Plate 24). Unlike the cowhouse/granary, the roof of this building is of modern corrugated sheeting: corrugated iron sheeting, to be replaced in the 1930s by asbestos corrugated sheeting¹⁵, became used increasingly on the farmstead from the late 19th century replacing tiles, slates or thatch as it was cheaper and allowed greater spans and lower pitches for the roof. Along the north-east elevation of this building is a large doorway with an arched head of 13 nicely dressed voussoirs¹⁶, complete with a curved wooden support (Plate 25). Either side of this large doorway are standard sized doorways, although it is not known if these are original features (Plate 24).

Plate 24 – North-east elevation of barn, Range B

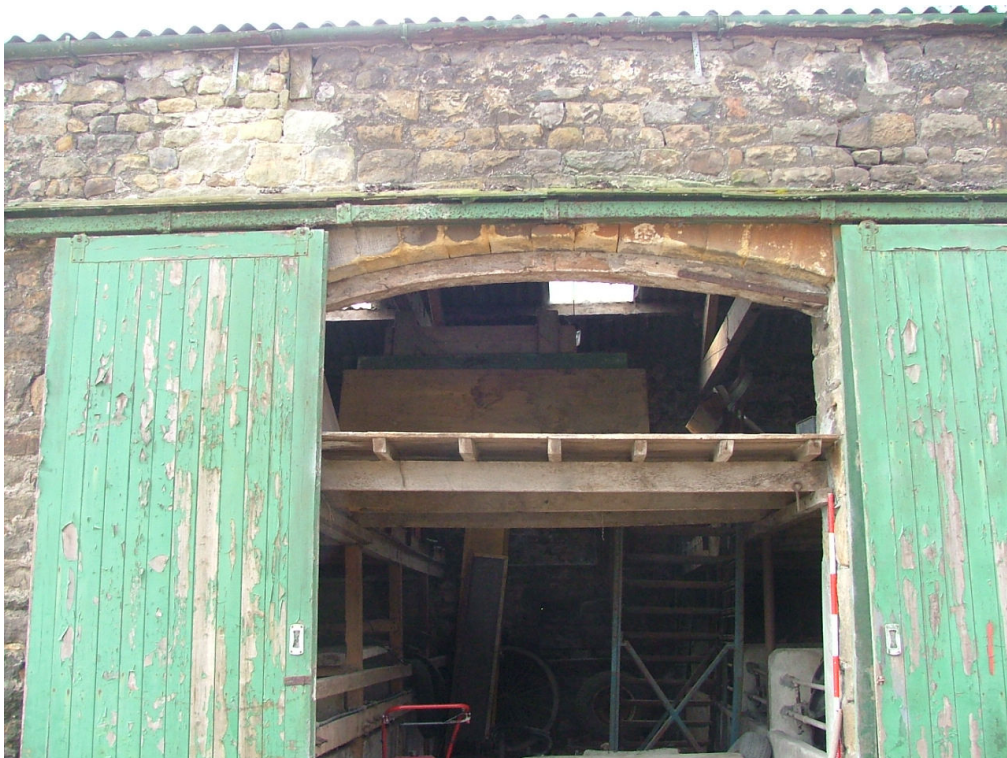
Plate 25 – Detail of arched doorway, north-east elevation of Range B

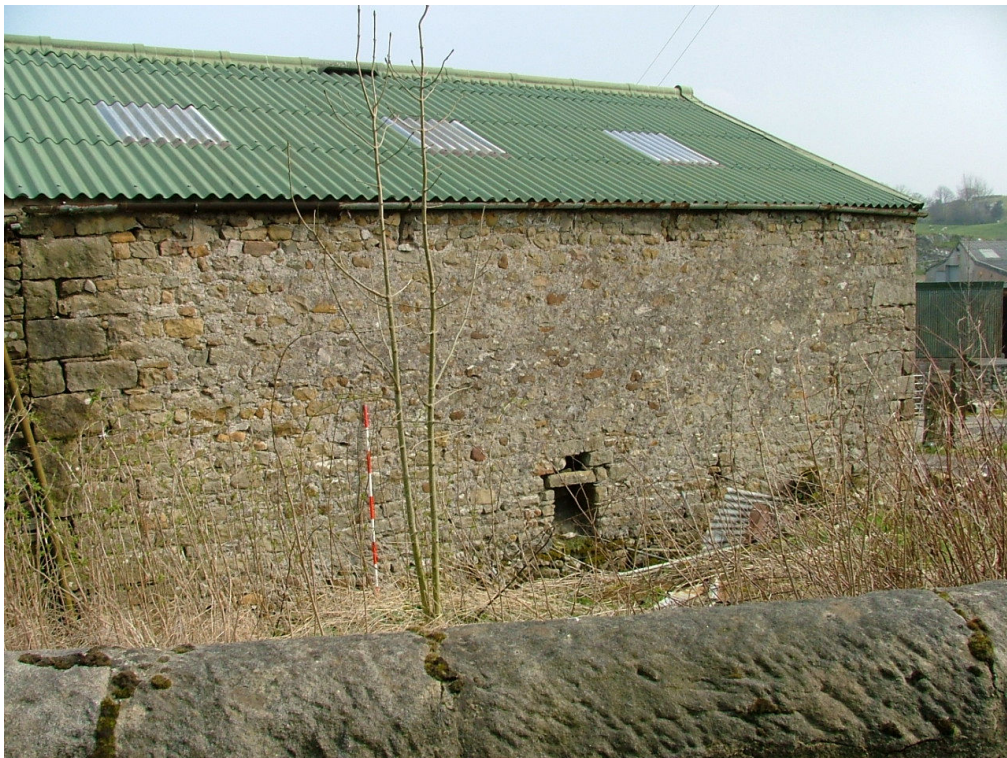
Plate 27 – South-west elevation of Range B, showing aperture mid-way along elevation

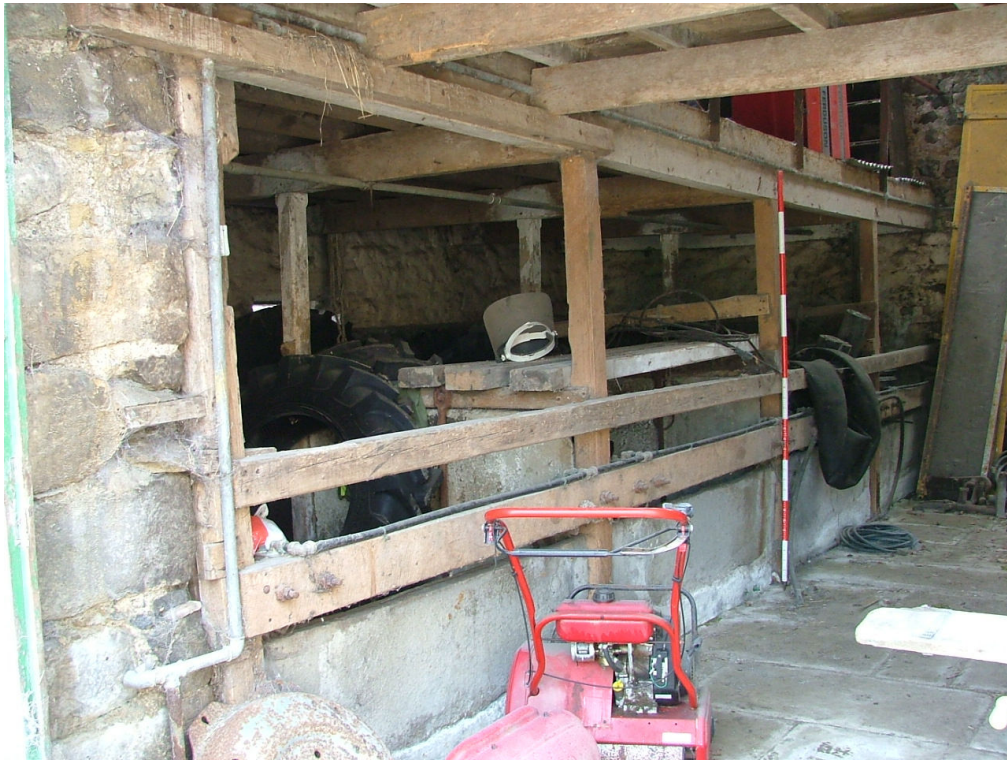
Plate 28 – Interior of large building, Range B showing stone and timber stall divisions and stone flagged floor of central section

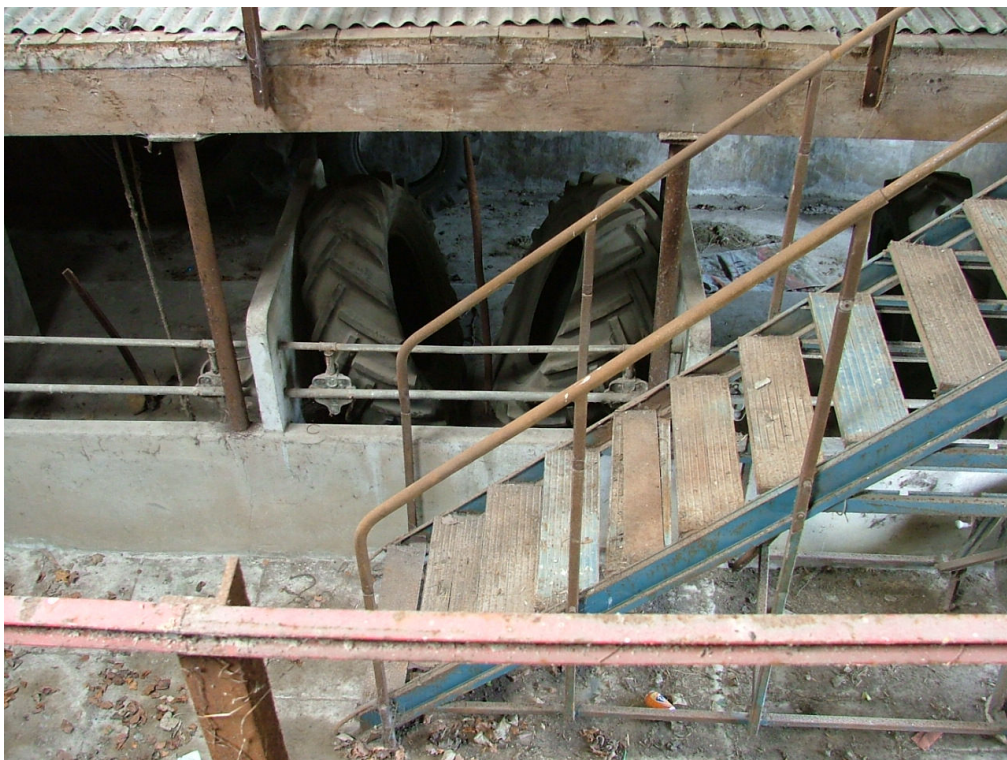
Plate 29 – Concrete stalls, right-hand side of main doorway, Range B, as seen from floor above

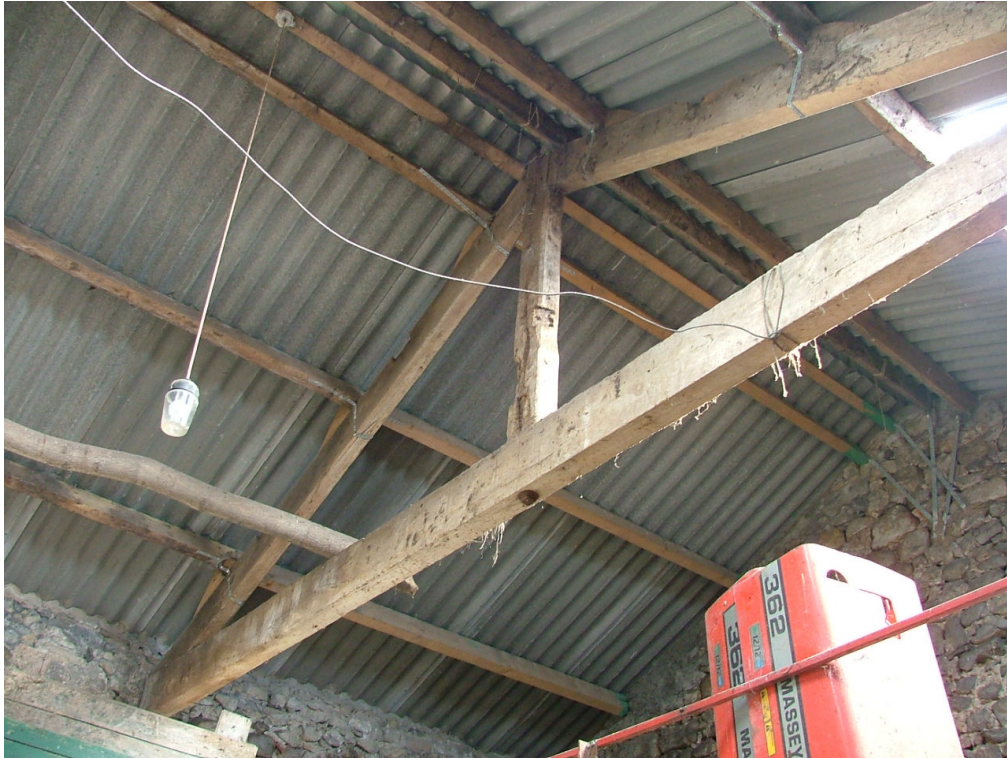
Plate 30 – Detail of roof truss, large building, Range B

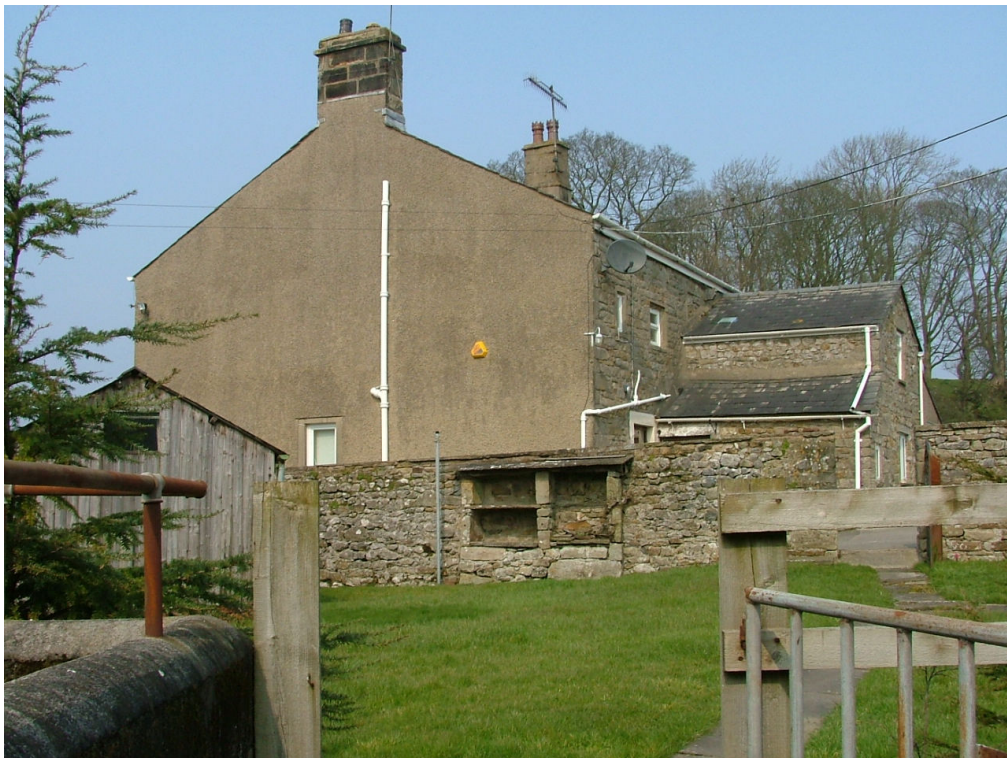
Plate 35 – The farmhouse as seen from the south, note the possible bee-boles in the garden wall

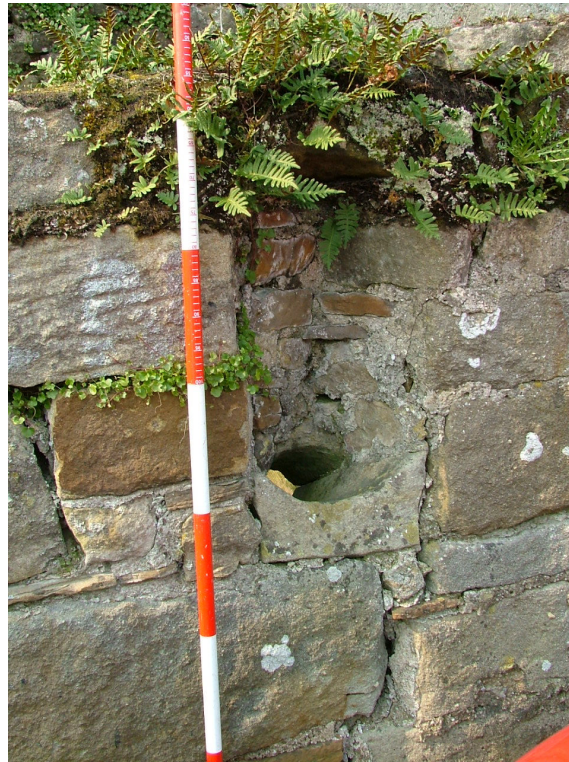
Plate 38 – Detail of feeding chute to pig sty
