Project Designs and Client Reports No. CP/474/07

**REPORT ON AN
ARCHAEOLOGICAL
BUILDING RECORDING
PROJECT AT
KIRK HOUSE
OVER KELLET
LANCASHIRE**

**FOR
WALLING UK
PROPERTIES**

26 April 2007

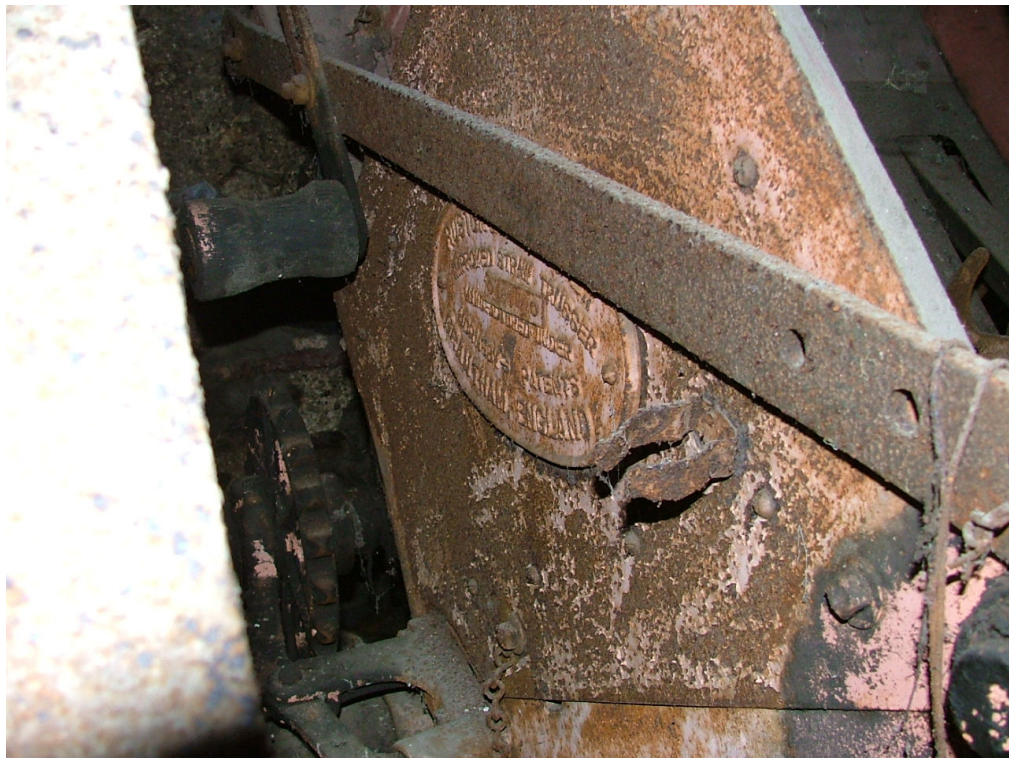
Plate 41 – Makers stamp on the side of the ‘Improved Straw Trusser’, manufactured in Grantham
