NORTH PENNINES ARCHAEOLOGY LTD

Project Designs and Client Report No. CP/525/07

**ARCHAEOLOGICAL
EVALUATION
AT THE
ANCHOR GARAGE
(PHASE II),
JOHN MARTIN STREET,
HAYDON BRIDGE,
NORTHUMBERLAND**

**FOR
PROPERTY DESIGN
MATTERS LTD.**

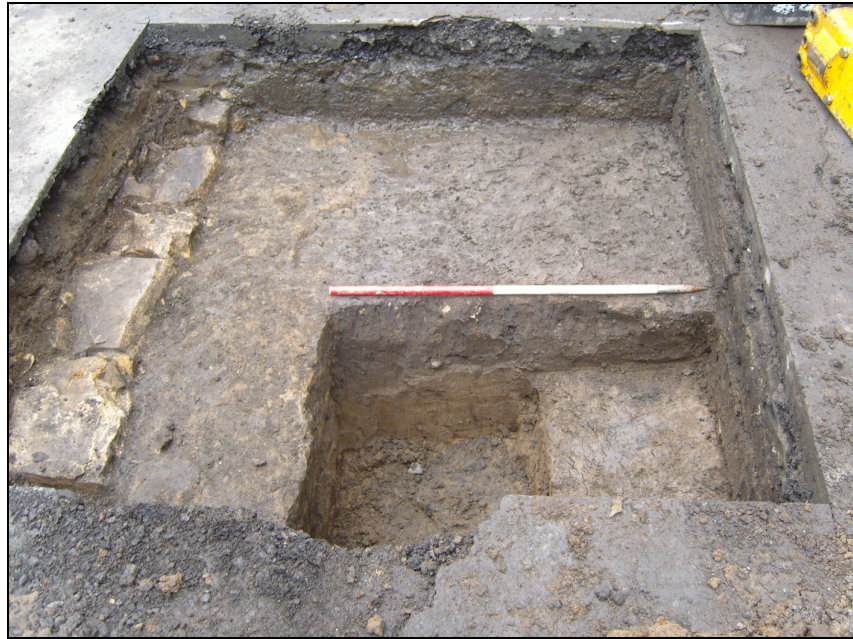
Plate1: Evaluation trench, facing south-east

- 4.2.3 Beneath the layer of building rubble and adjacent to the sandstone wall was a deposit of orange, silty, clay **(307)**. This had a rectangular-shaped feature cut through it **[308]** (Plate 1). The cut **(308)** contained a 0.26m thick layer of dark brown grey silt **(309)**, which contained several pieces of clay pipe stem and some pieces of post medieval pottery. The deposit may tentively be associated with the wall construction or other earlier building on site. A *sondage* measuring 1.10m by 0.90m was cut through this layer and down into a lower deposit of dark brown, grey silt **(301)** (Plates 1 and 3). It was undetermined as to whether or not this was the natural drift geology. No further evidence of archaeological deposits or features was uncovered.

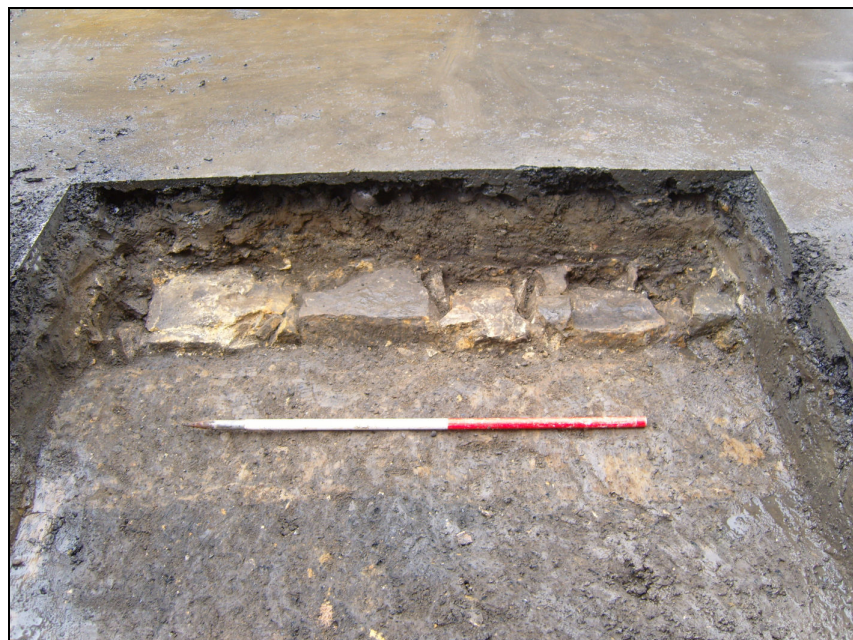
Plate 2: Evaluation trench showing wall [306], facing north-east

- 4.2.2 Initial machining removed approximately 0.08m of tarmac, forming the main hardstanding of the garage forecourt. Beneath the tarmac **(300)**, evident in the northern corner and down the north-east edge of the trench, was a surface of grey, river rounded cobbles, measuring 0.40m wide **(302)**. The cobbles lay on a 0.06m thick layer of brown, sand blinding **(303)**. On the north-east edge of the trench the sand blinding sealed a layer of small, compacted pieces of sandstone rubble in a sandy silt matrix **(304)** (Plate 2). This layer contained 2 sherds of post medieval pottery and one piece of post medieval bottle glass. Beneath this layer, running in a north-east to south-west direction was a substantial wall constructed of yellow sandstone blocks (Plates 1,2 and 3). **[306]**. A yellow, orange clay may have been used to bond the stonework. Only the south-west course and face of the wall was uncovered. Adjacent to contexts **(302)**, **(303)**, **(304)** and **(306)**, for a width of 1.60m under the tarmac **(300)**, was a 0.18m thick layer of made up ground consisting of mixed building rubble **(310)** (Plate 3, Figureure 3).

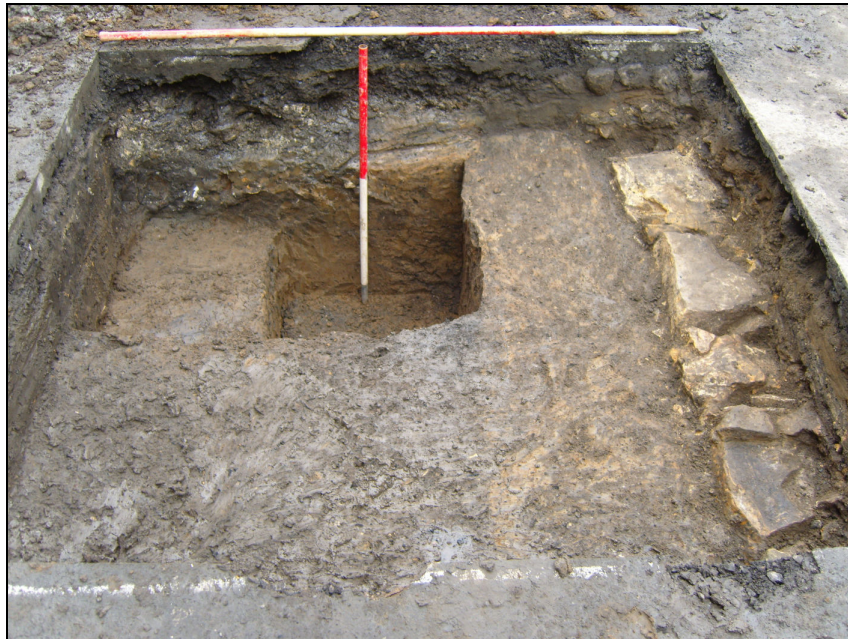
Plate 3: Trench section showing *sondage*, facing north-west

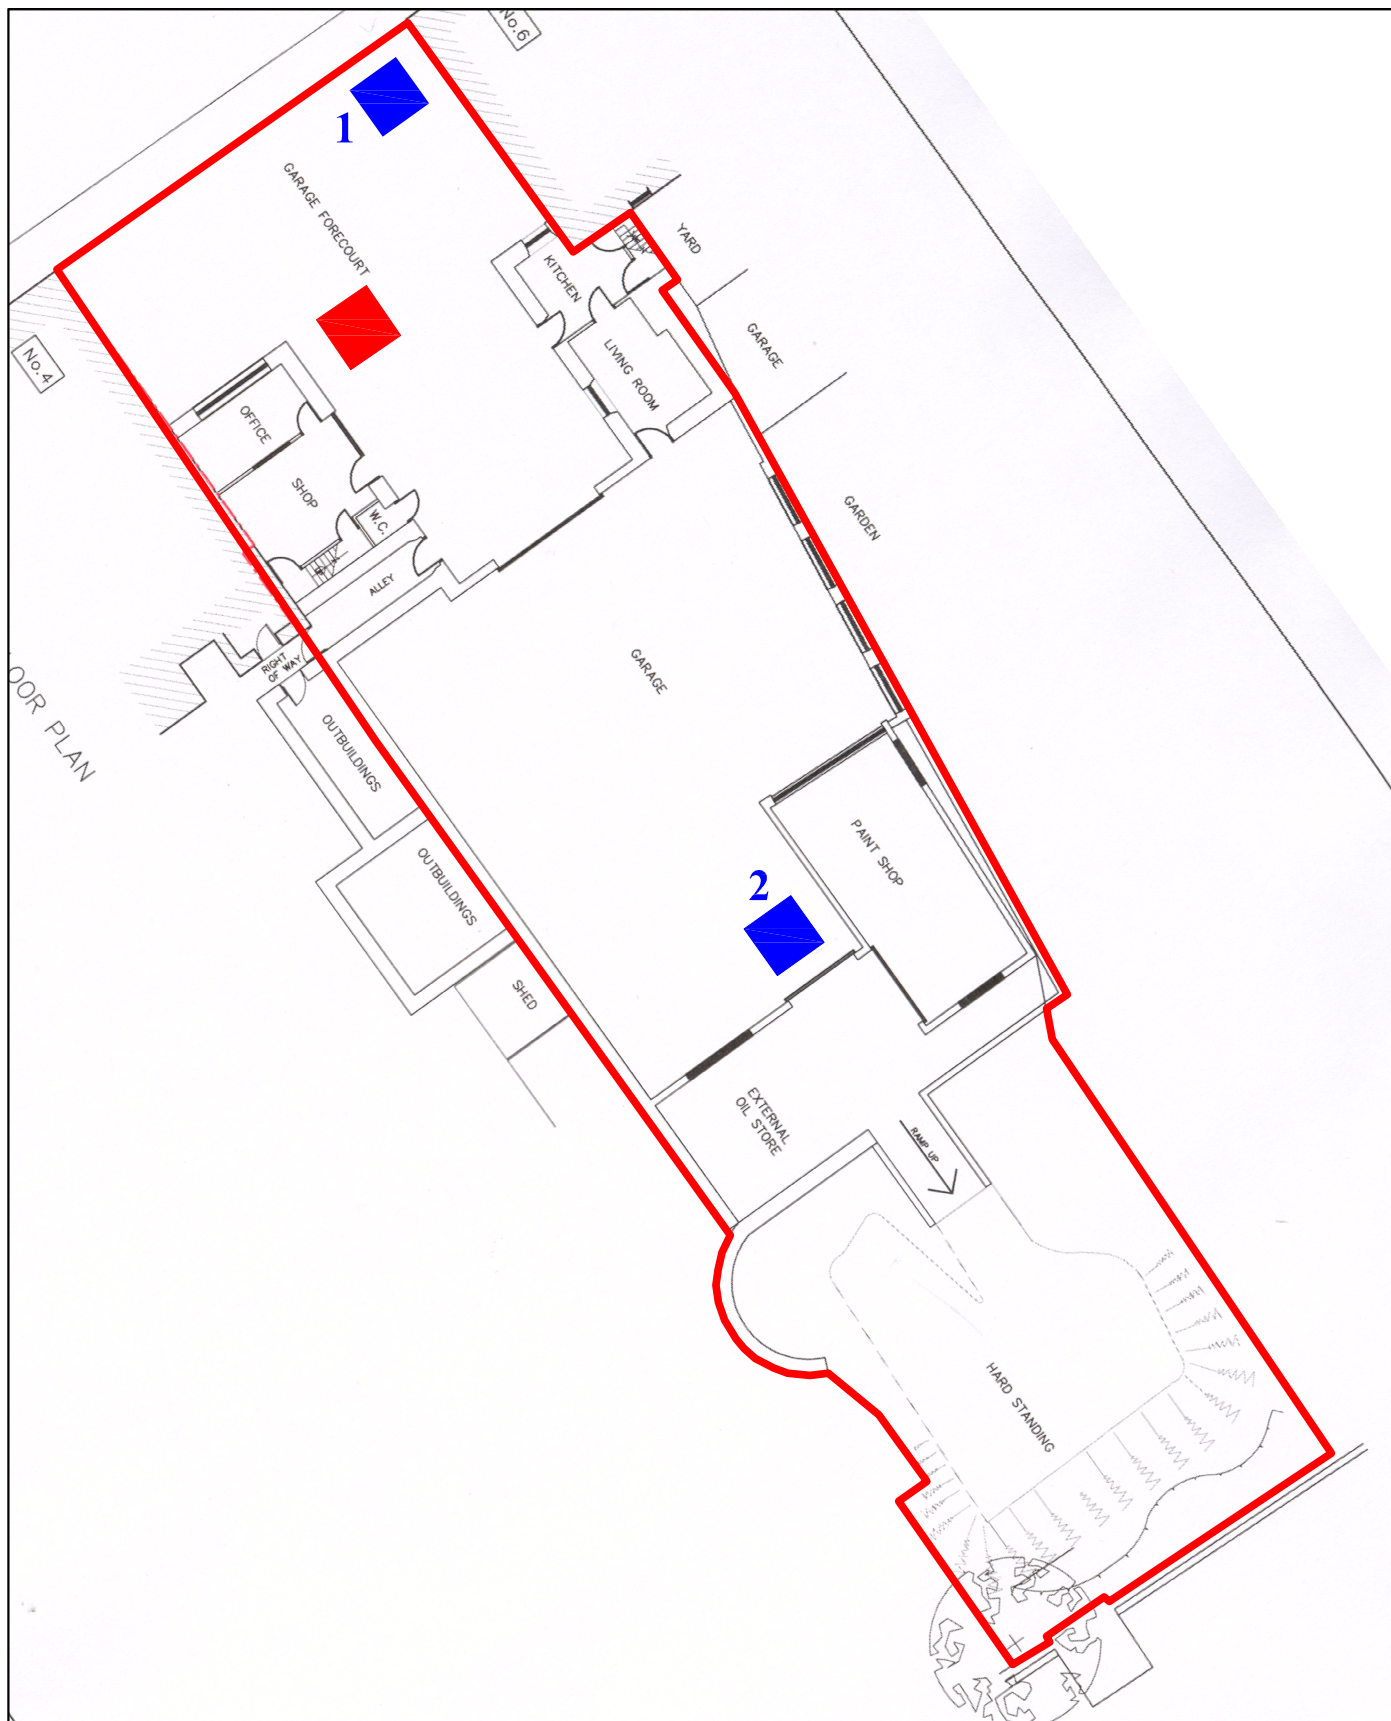
Figure 2 : Trench location

- 1.1.3 Trench 1, excavated towards the rear of the garage, succeeded in only uncovering building rubble and soils contaminated with diesel and oil, to a depth of 1m, overlying the natural, a pale grey glacial clay. No evidence of archaeological features was uncovered. In contrast, Trench 2, excavated towards the front of the garage forecourt, uncovered some archaeological remains. Above the natural drift geology a layer of probable medieval soil was uncovered, to a depth of 0.15m; the deposit yielded two sherds of medieval pottery (North Pennines Archaeology 2007). Cutting the deposit was a post-medieval stone culvert, which was silted up, but produced post-medieval pottery, glass and clay pipe from the fill. These trenches are marked in blue on Figure 2.

- 4.2.1 The trench was 2.0m long by 2.0m wide, and was positioned 1.20m centrally in the forecourt, to the east of the garage main office (Figureure 2). The trench was located using a CAT scan to avoid existing services, which were known to cross the site. It was excavated to a maximum depth of 1.05m.
