NORTH PENNINES ARCHAEOLOGY LTD

Project Designs and Client Reports No. CP/548/07

**FOR
MANDALE COMMERCIAL
LTD**

**NGR NZ 3591 6766
PLANNING REF: ST/1537/04/DM
OASIS REF: northpen3-30266**

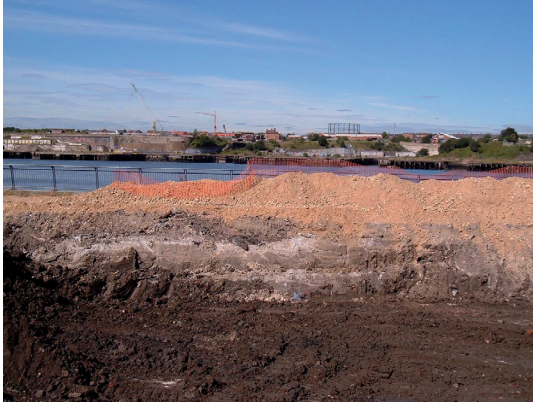
Plate 1: Eastern Concrete Structure from north-west

- 4.1.3 The earliest deposit encountered within Plot 'C', was of a mid to dark brown loose loam with up to 40% inclusions of ceramic building material, timber, rubble and concrete and the bottom of this deposit was not reached. Above this was a thin band of grey hardcore of 0.3m thickness which underlay a light yellowy sandy deposit of 0.2m depth. Overlying this was a light to mid grey-brown loose deposit with occasional inclusions of brick and ceramic building material infill. This deposit survived to a thickness of 1m, over which lay 0.5m of yellow or light brown deposit of sandy material consisting of at least 50% gravel and stone of the same colour. These deposits were observed surviving between two concrete structures; one, the westernmost, ran on a north-west to south-east alignment across the south western part of Plot 'C', and the other, the easternmost, ran on a similar alignment within the extreme north-eastern corner of Plot 'C', located about 20m to the north-east of the first. The western concrete structure had two metal rings attached to its north-eastern face, 2m apart towards the top of the structure (Plates 1 and 2). The deposits located to the west of the western concrete structure consisted of the same mid to dark brown loose loam with up to 40% inclusions of ceramic building material, timber, rubble and concrete as was located as the lowest deposit between the concrete structures, overlain by a light to mid grey-brown loose deposit with occasional inclusions of brick and ceramic building material infill. This deposit survived to a thickness of 1m. A coin from the reign of King George V was found within this early deposit, between the two structures towards the south of Plot 'C' (Plate 3). Post-excavation analysis showed that it was a one-penny piece, dated 1915.

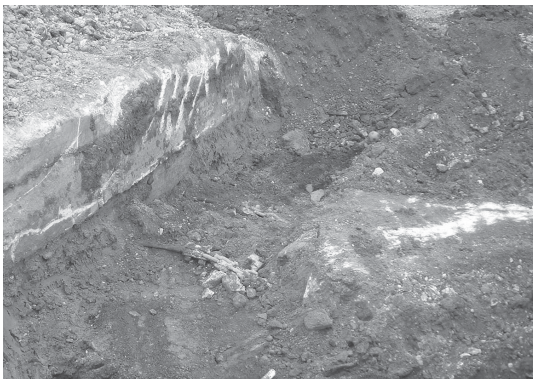
Plate 4: Concrete Footing and Chains from north-west

- 4.1.5 The earliest deposit recorded from Plot 'B' was a mid to dark brown loose loam with up to 40% inclusions of ceramic building material, timber, rubble and concrete, identical to that located in Plot 'C'. This deposit was consistent across the eastern part of the site below a light to mid grey-brown loose deposit with occasional inclusions of brick and ceramic building material infill, of a 1m thickness. A concrete structure was encountered 0.9m in thickness, on a north-west to south-east alignment, running from the centre of the northern extreme of the excavation in Plot 'B', to the south-eastern corner of the plot. It was better preserved at the northern end, where a concrete footing and associated chains was attached to it (Plates 4 and 5). Towards the south-east corner of the excavation in Plot 'B', and just at the western extreme of the excavation was a series of three steel girders, two of which remained vertical, with the central one leaning eastwards (Plates 6 and 7). The two upright structures were 2m apart, and they appeared to represent a discrete structure rather than circumstantial backfill.

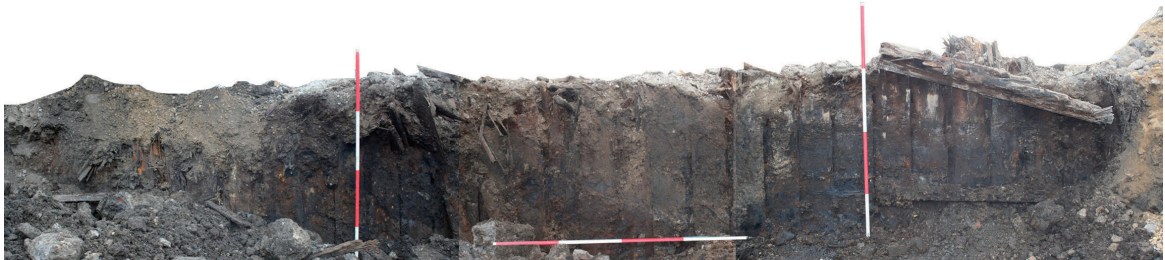
Plate 8: Western part of North Facing Section of Timber Structure

- 4.1.7 The earliest feature encountered appeared to be a timber structure, which was located within the southern half of Plot 'A' on the western side, on a west to east alignment. It was 0.7m thick and survived a distance of 14m in to a height of between 1.2m and 2m above the foundation level of the excavation (Fig 7). A second timber structure ran from the end of the first, heading north for 6m. This was only visible at the very base of the excavated area, so a true account of its form and function was not possible. Halfway along the first timber structure, a timber feature ran southwards for 1.5m and east for 4m. The timber structure was constructed from a series of timber uprights varying in width from 0.25m to 0.4m. A metal bolt was observed in the western part of the north face of the structure, perhaps indicative of repairs, as no others were observed. Horizontal timbers were also located at this edge, suggesting additional support was needed at this side. Adjoining the timber structure, to the south, was a concrete structure, running the width of Plot 'A' on a west to east alignment, of varying widths between 2.5m and 2m, the thicker part nearest the river. The soil deposits in Plot 'A' consisted of a mixed stony backfill, with ash and sand inclusions observed to formation level.

- 5.1.3 The deposits encountered within Plot 'A', namely the timber structure and adjoining concrete structure, may relate to activity in the development site prior to Brigham and Cowan's purchasing of the site in 1900. The First and Second Editions of the Ordnance Survey Mapping (Figs 3 and 4), dating to 1855 and 1898, show a 'Low Dock' in this area of the site. The Desk Based Assessment undertaken of the site (Peters 2007) revealed documentary evidence for a dock in this area in 1754, and the subsequent evaluation (Liddell and Peters 2007) revealed similar timber features, thought to have

been part of this timber dock. The 13m west to east stretch of the timber structure does relate to the site of the dock, seen in Figs 3 and 4. The presence of a bolt and horizontal structures at the western end (Fig 7) could be evidence for repairs, or greater support for the part of the dock adjoining the River Tyne. The presence of concrete to the south of the timber structure could also relate to the need for repairs or strengthening over time. Documentary evidence (Peters 2007) suggests that the 'Low Dock' remained in use at least until 1887, and probably until Brigham and Cowan bought the site in 1900. The deposit of mixed stony backfill, with ash and sand inclusions observed to formation level, must be an early 20th century deposit (c. 1900), dumped by Brigham and Cowan upon ownership of the area, to level the site prior to their construction of Dockyard Buildings within this area of the development site (Fig 5).

- 5.2.2 The survival of potentially mid-18th century timber deposits within the site is of interest. It shows the potential for early deposits, deep enough not to be affected by later development, to survive in good condition, sub-surface, in this part of South Shields. In addition, as the base of the timber struts were not exposed by the observed groundworks on-site, which incidentally meant that environmental sampling was not worthwhile, these will survive below the depths reached on the development site, and any future developments on-site should take this into account.
