**REPORT ON AN
ARCHAEOLOGICAL
BUILDING RECORDING
PROJECT AT
THE GARAGE ADJACENT
TO 18 DOOMGATE,
APPLEBY-IN-
WESTMORLAND
CUMBRIA**

**FOR
JULIE STEPHENSON**

**NY 68300 20265
Planning Application Ref:
3/07/0328**

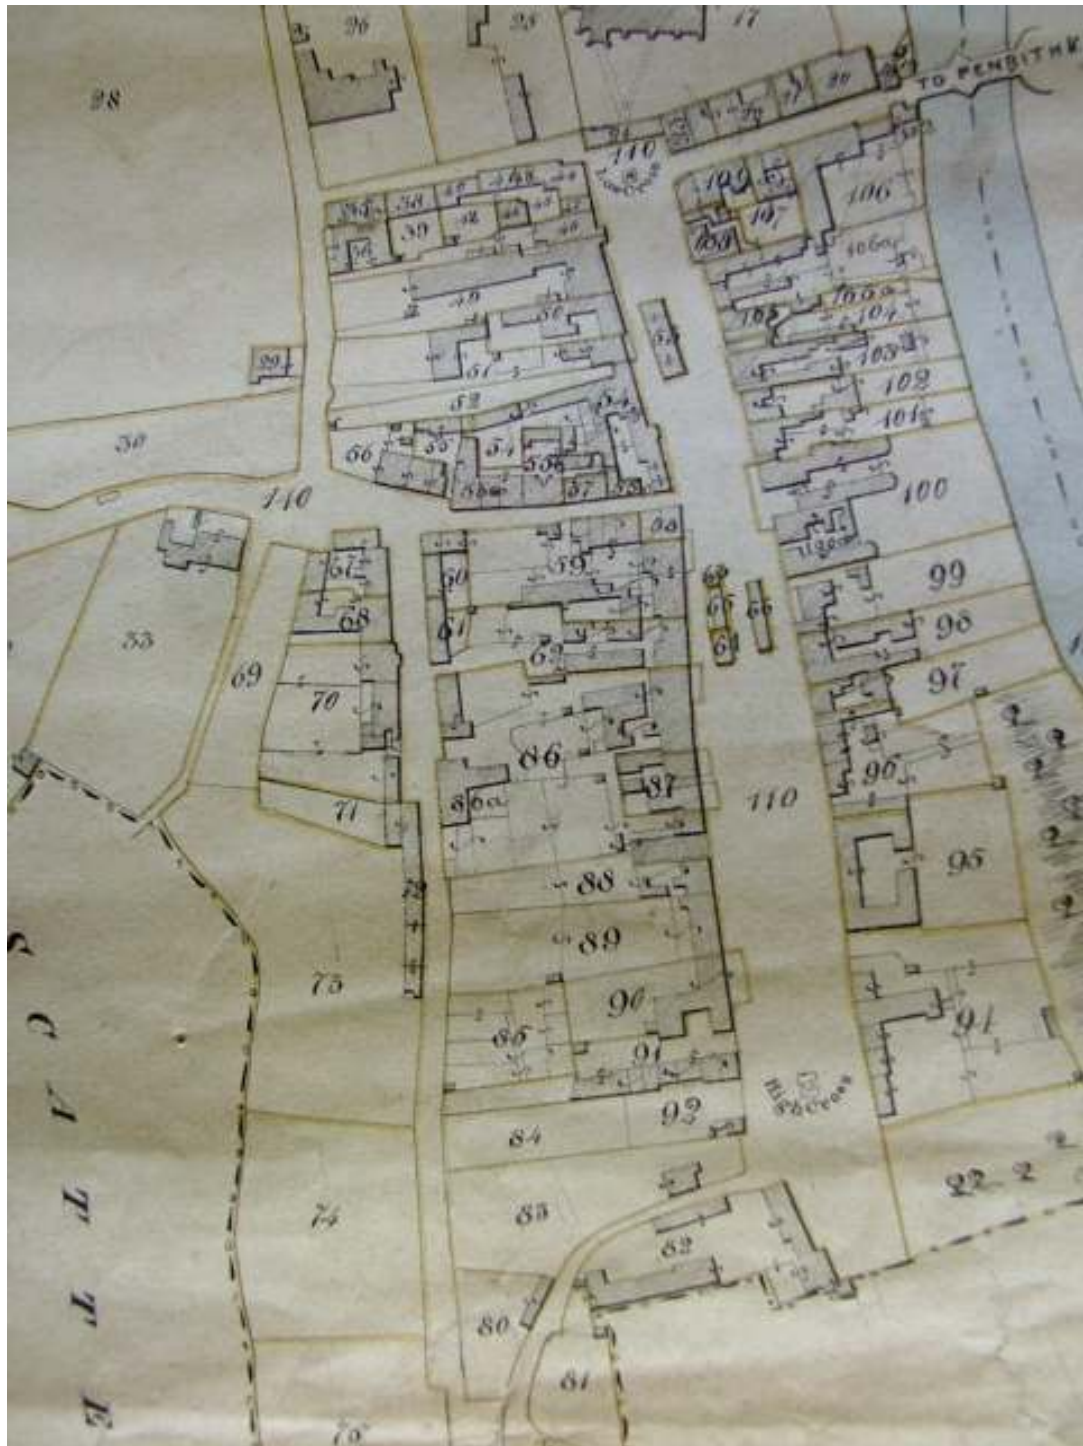
Figure 5 – Sketch plan of the Red House estate (1766) and extract from 1754 Election Map showing burgage plots that made up the Red House and White House properties (Source TCWAAS 1985)

- 6.1 From documentary evidence it appears that there has been a building on the site of the garage since at least 1754, as a structure is shown on Hill's map of Appleby of that date (Figure 3). The sketch plan of the Red Houses estate dated 1766 (Figure 5) provides some evidence as to the functions of the buildings on the site at this date: '*Mr Wilson's house, stabell, granary, barne, garding and cow house*'. The number of separate elements listed at this date suggests that buildings that formerly stood to the north of the garage are also included (Figures 5, 6 and 9). This documentary evidence ties in with the listed building description which suggests an 18th century date for the house and barn.

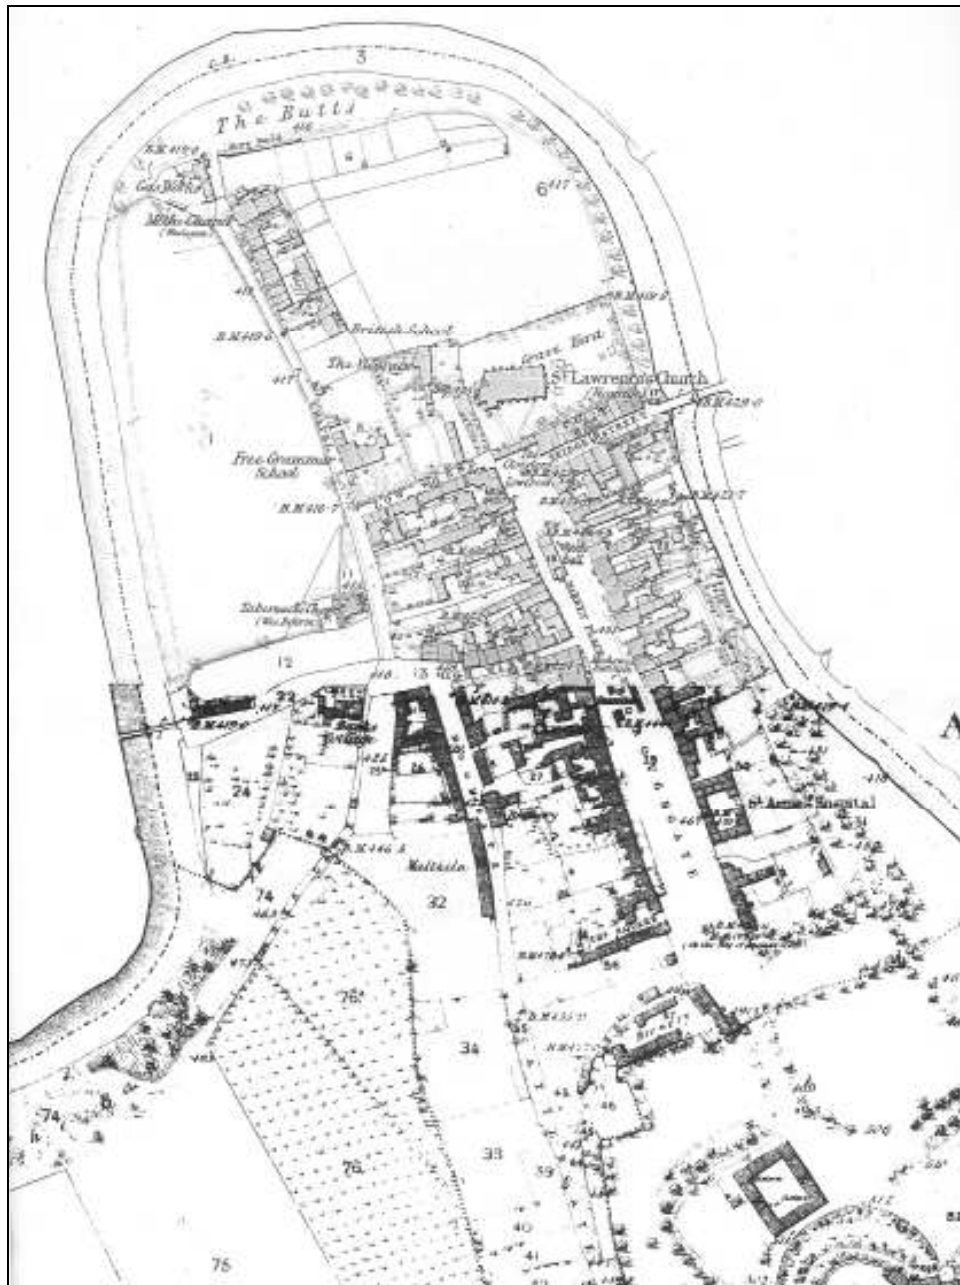
Figure 6 – Extract from the 1843 Tithe Map for the Parish of St Lawrence (KRO Ref: WDRC/8/26)

- 6.2 The Tithe map of 1843 indicates that the owner of the property at that date was the Earl of Lonsdale with the occupier being Thomas Lawson, and is described as 'house and yard' (Figure 6). The large-scale Ordnance Survey map of c.1865 clearly shows the buildings on the site at this date, and annotations suggest that the garage building was being used as a stable by a Mr Crosby, although the house (No.18) is noted to also be a stable with the name D Steadman (Figure 9). This map also clearly shows the buildings to the north with an external staircase on its north elevation, which is characteristic of a granary.

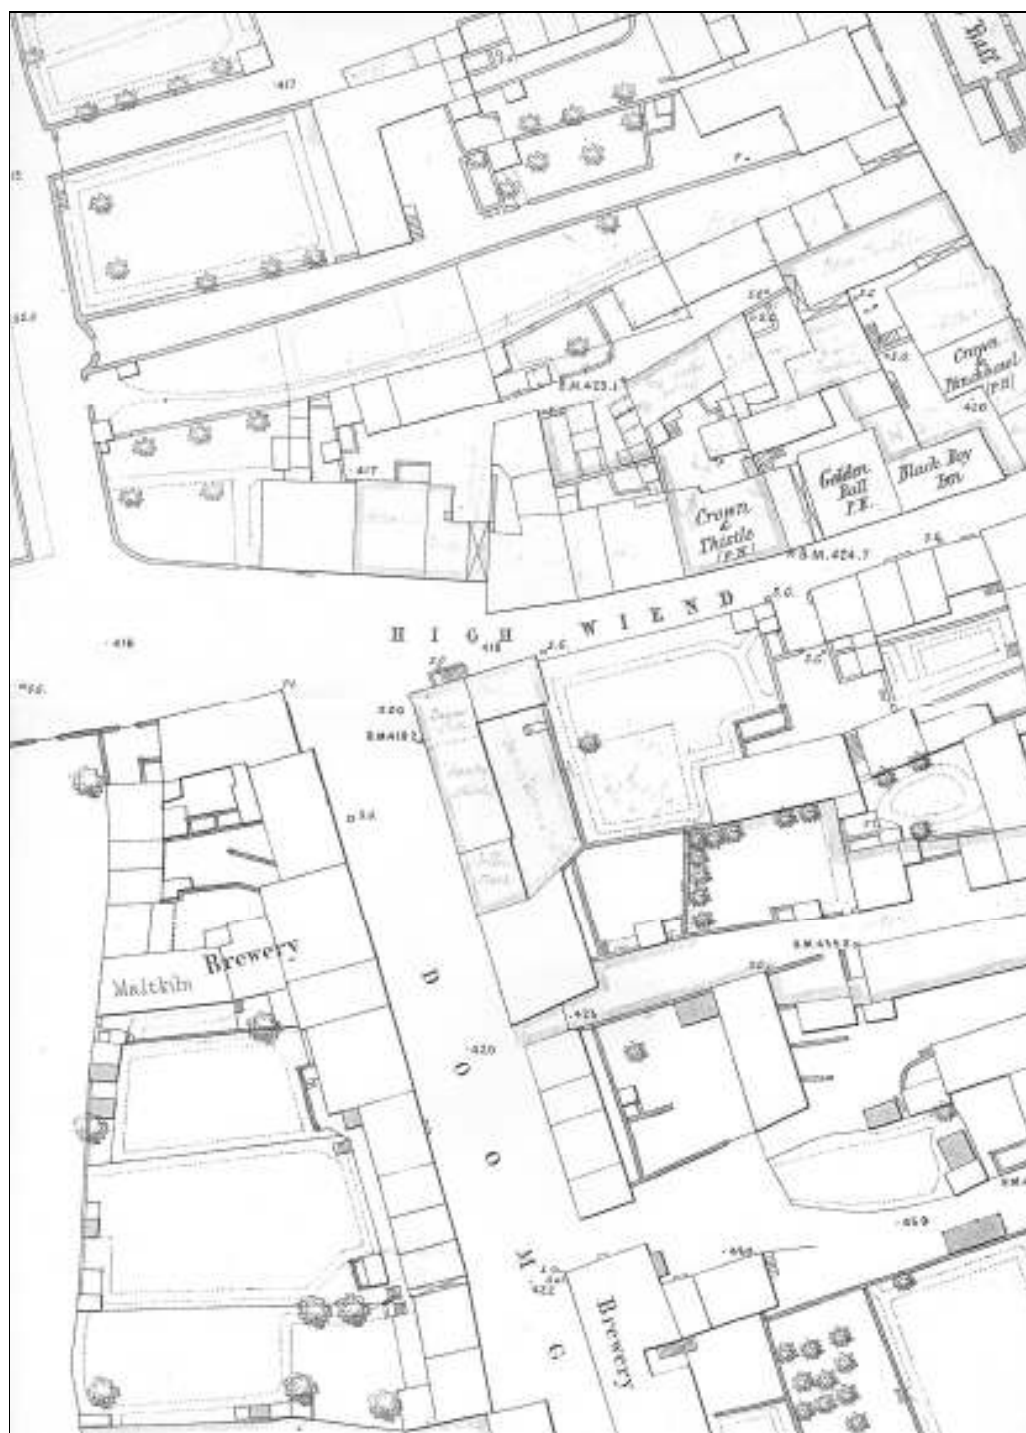
Figure 8 – First Edition Ordnance Survey Map of Appleby c.1858 (Scale = 25" to 1 mile) (the buildings on the east side of the River Eden are not shown on these maps)

- 5.3.2 Although no longer extant, consideration should be given to the building (or buildings) which were historically located to the north of the garage, orientated east-west, as they may have been part of the property. The large-scale First Edition Ordnance Survey map does suggest that these were two separate cottages (Figure 9) that may have been under the ownership of the Earl of Lonsdale, as it would appear was No.18 and the garage. A possible blocked doorway was noted in the northern boundary wall of the garden, which may relate to these buildings (Plate 23).

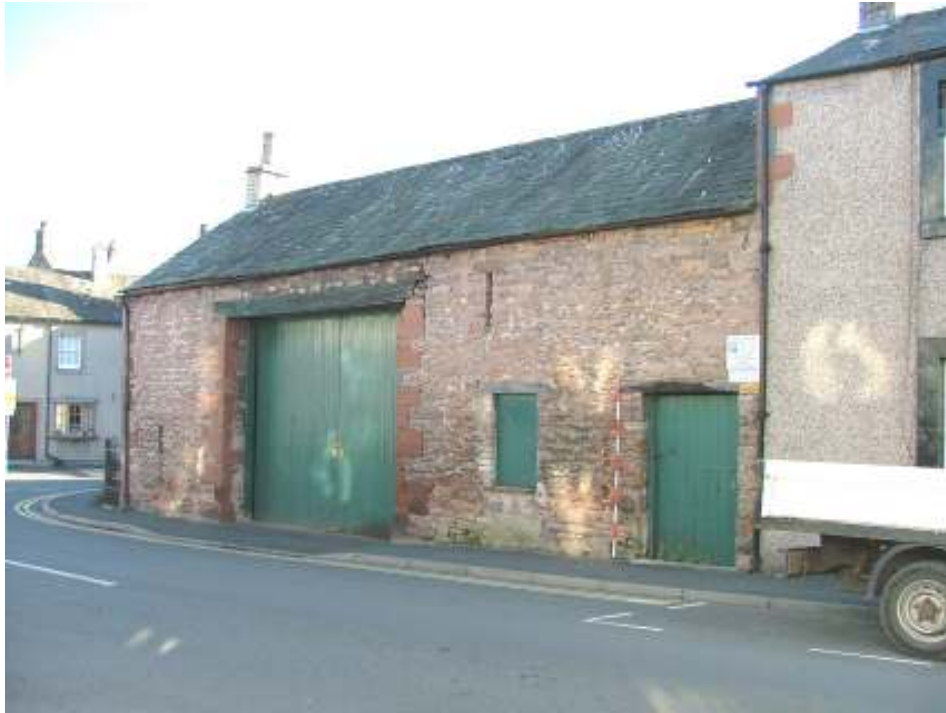
- 5.1.1 The garage is constructed of rubble sandstone masonry and measures *c.*12.70m in length, *c.*5.90m in width and is *c.*4.00m in height. Alternating long and short, squared blocks of masonry making up the quoins at the north-west corner of the building (Plates 1 and 2). The roof on the western side is laid in Welsh slate, whilst the eastern side is laid in stone flags with inserted skylights. There is a brick-built chimney at the northern end, which has a ceramic chimney pot (Plate 1).

Plate 1 – West elevation of the garage, with No.18 Doomgate right of photograph (Scale = 2m)

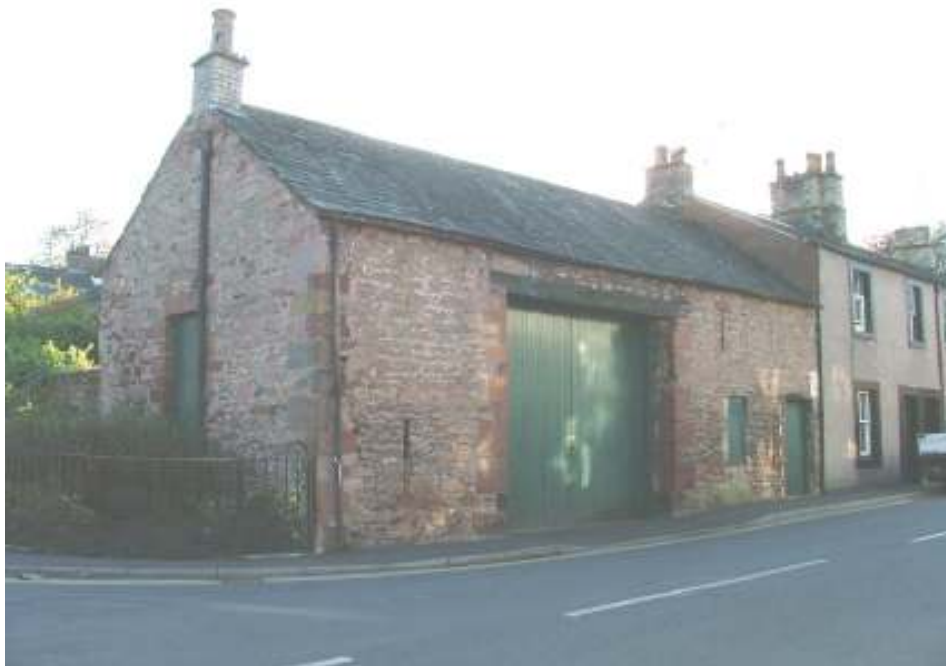
Plate 2 – North and west elevations of garage as seen from the north-west

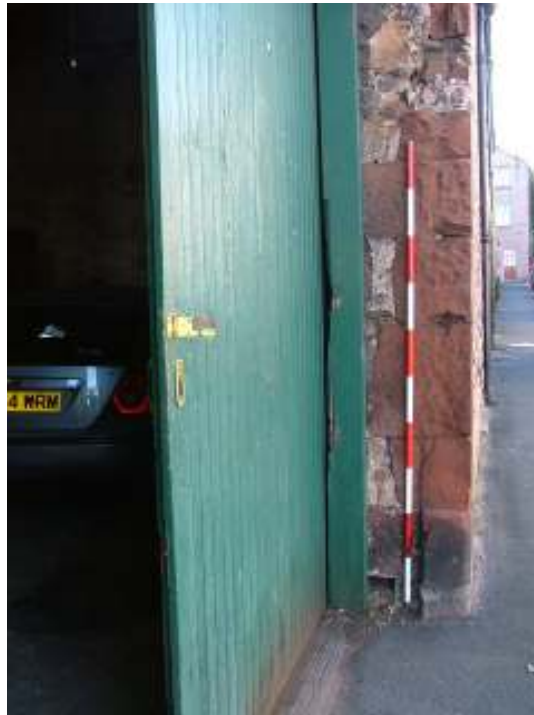
- 5.1.2 On the west elevation there is a large doorway with a modern sliding doorway. The jambs of this doorway consist of alternating long and short squared blocks of red sandstone, however it would appear that the jambs have been cut back, presumably to allow vehicular access to the garage. At the base of one of the jambs is a single block, which retains its internal rebate and hinge for a door; this suggests that the original large doors opened inwards (Plate 3).

Plate 3 – Base of door jamb, west elevation, showing blocks which have been cutback, the block at the bottom of the jamb still retains its internal rebate and door hinge (Scale = 2m)

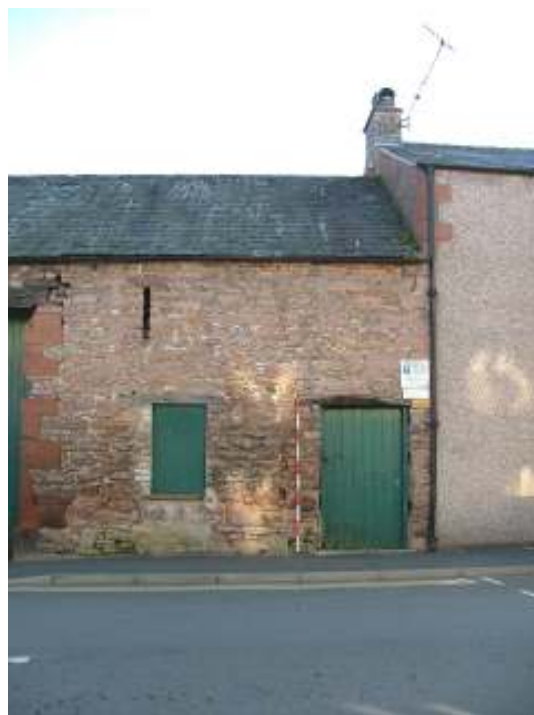
- 5.1.4 Either side of the large doorway on the west elevation are ventilation slits, some of which have been blocked-up with brick; at the upper level there is one open and two blocked ventilation slits, and at ground floor level there is one open and one blocked (Plates 1 and 4). If the window in this elevation is not an original feature, then it may have obliterated another ventilation slit, which would have given a total of six along this elevation. Ventilation slits are characteristic of a building used for the processing and storage of cereals and the housing of cattle, and ventilation slits such as these are commonly found in stone-built barns with the external width being smaller than the internal width to prevent too much wind entering the building (these ventilation slits measure 10cm externally compared to *c.*40cm internally).

Plate 4 – Doorway, window and ventilation slits, west elevation

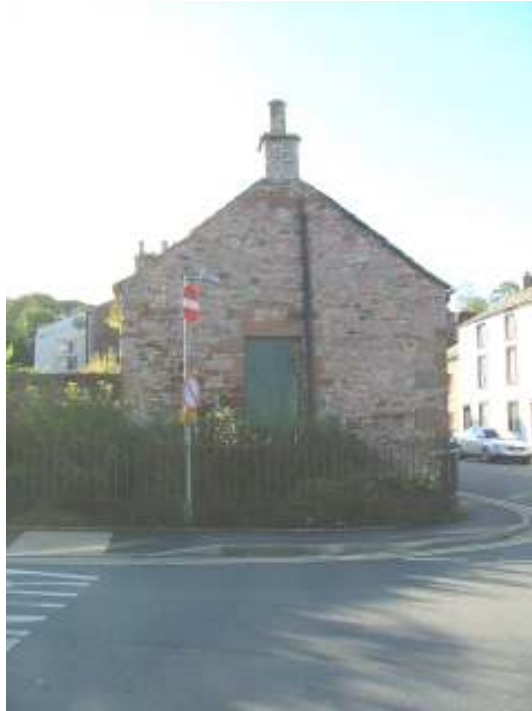
Plate 5 – North elevation showing possible former doorway with remains of blocked window above?

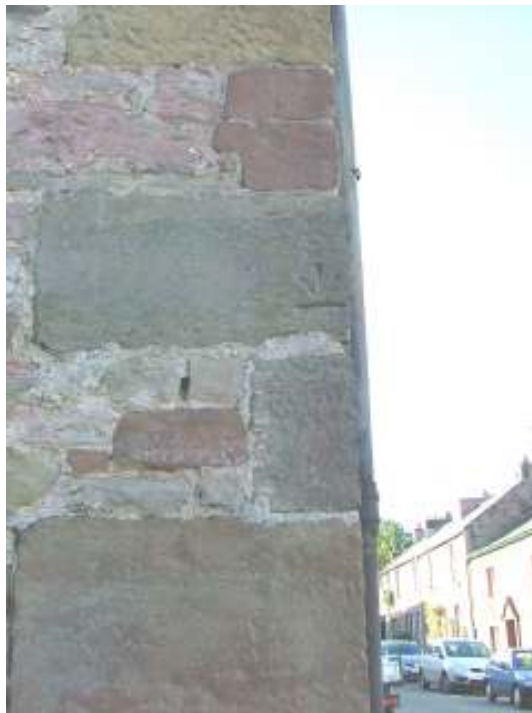
Plate 6 – Bench mark, north-west corner of garage. The bench mark is upside down.

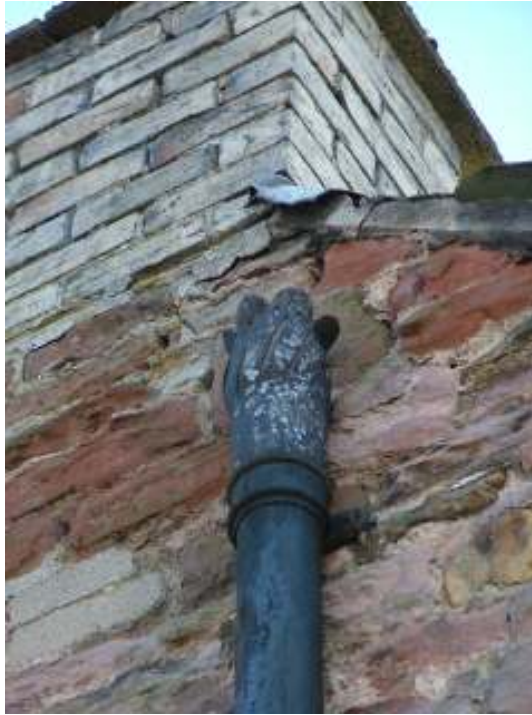
- 5.1.5 The north elevation of the garage faces High Wiend and has an area fenced-off along its frontage containing foliage; consequently it was not possible to easily observe the base of the wall (Plate 5). This elevation contains what is now a boarded-up window, but its height may suggest that it was once a doorway. It has sandstone blocks making up the jambs and a sandstone lintel. There are three longer blocks of sandstone above this lintel, which appear to be the remains of a former window (Plate 5). On one of the quoins that make up the north-west corner of the building is an upside-down bench mark, the location of which is shown on the early editions of the Ordnance Survey maps (Figure 9 and Plate 6). To the right of the window on this elevation is, what appears to be a metal down pipe, which has a decorative top (Plate 7). The base of the pipe enters the ground, yet there is no guttering or other pipe work at the top from

which water can flow. Therefore, either some guttering is missing, or the down pipe had another function.

Plate 7 – Detail of top of down pipe, north elevation

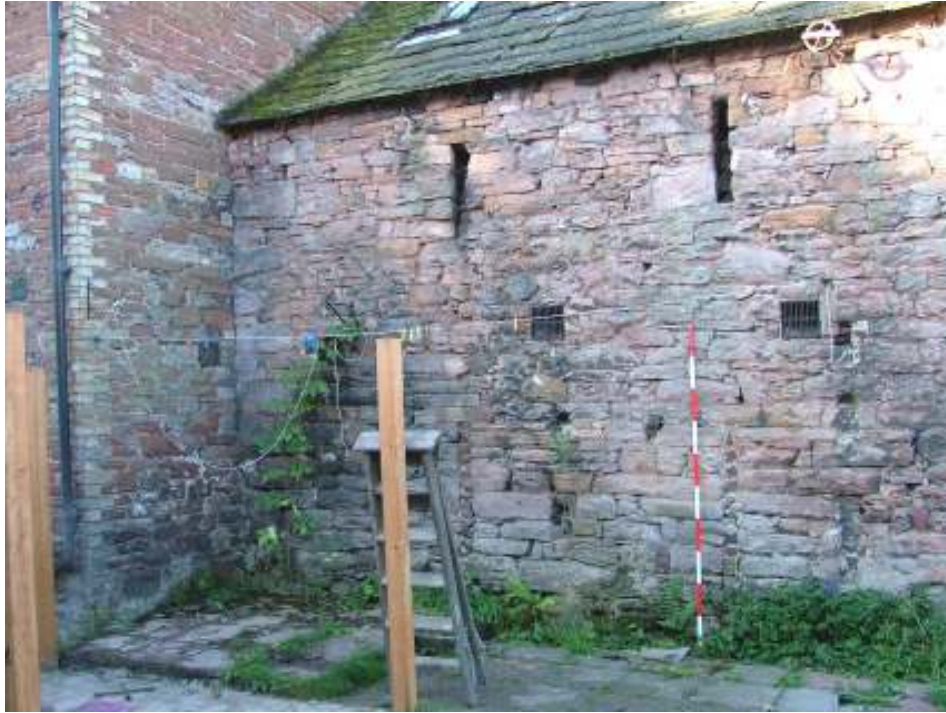
- 5.1.6 The east elevation faces into the garden at the rear of the property and could only be accessed through the garage interior (Figure 12). The southern end of this elevation contains two open ventilation slits at the upper level with two corresponding blocked-up ventilation slits below (Plate 8 and Figure 13). Between these two sets of ventilation slits are three square, iron ventilators. Below these ventilators there are two vertical scars in the masonry, measuring approximately 2m in height from ground level (Plate 8). These may indicate the former presence of a lean-to or ephemeral structure.

- 5.1.8 Located at the base of the roof, above the outshut is a small brick-built chimney (Figure 13). Just below the eaves to the left of the doorway in this elevation, is an iron pulley, which may have been used to hoist heavy metal objects when the building was used as a smithy (Plate 9). There is a single iron tie plate in this elevation, visible just to the left of the ranging pole on Plate 8; this does not appear to be large enough to

provide structural support, however similar tie plates have been observed in farm buildings where internal stall divisions, generally concrete, have been fixed into the wall.

Plate 8 – South end of east elevation showing ventilation slits, square iron ventilators and vertical scarring from former lean-to? (Scale = 2m)

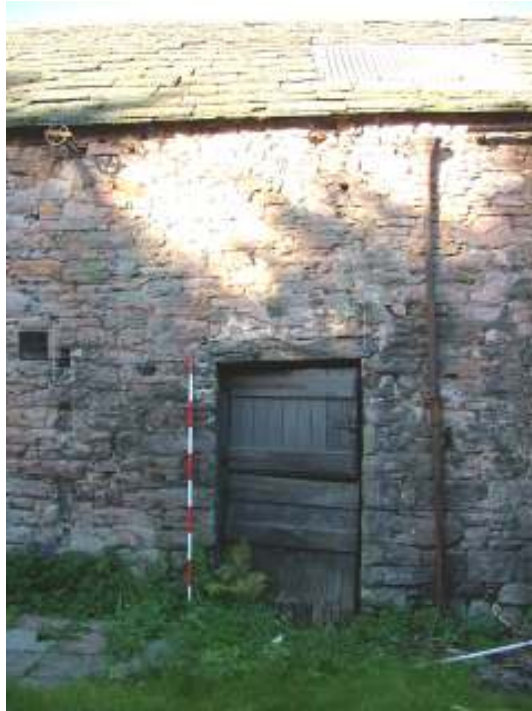
- 5.1.7 Also along this elevation is a standard doorway with timber lintel and split door which opens outwards (Plate 9). There are two ventilation slits at the upper level above a small stone-built outshut with pitched roof laid in Westmorland slate (Figure 13 and Plate 10). The only entrance into this outshut, or lean-to, is from the interior of the building. A length of stone wall projects from the east elevation of this outshut eastwards measuring c.2.93 long and c.0.40m in width (Plate 11). As this wall is built up against the outshut then it must be a later addition. This stone wall appears to have been constructed to provide some kind of protection to a possible external brick-built forge which is located to the north of the outshut against the east elevation (Plate 12 and Figure 12).

Plate 9 – Doorway in east elevation, note the iron pulley under the eaves left of photograph
(Scale = 2m)

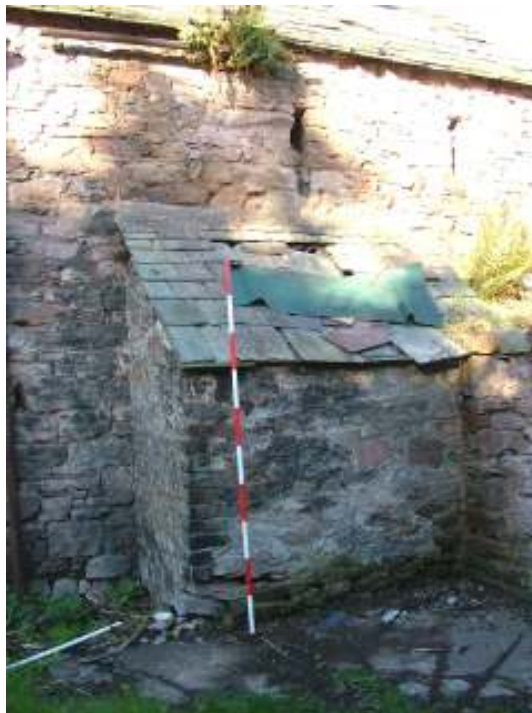
Plate 10 – Stone-built outshut against east elevation

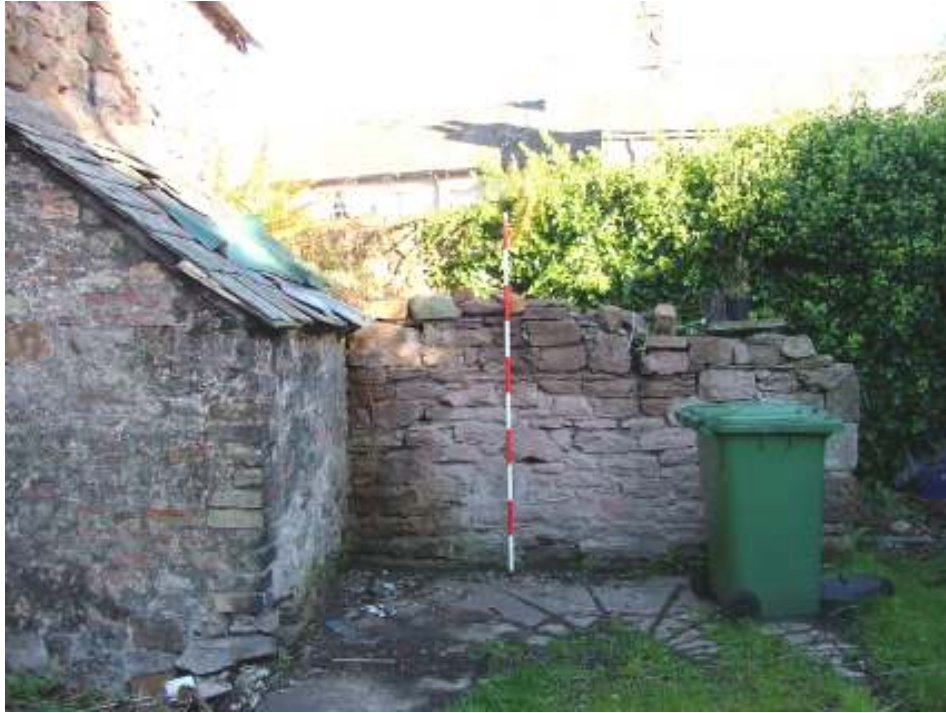
Plate 11 – Stone wall projecting eastwards from the outshut, east side of garage (view looking north) (Scale = 2m)

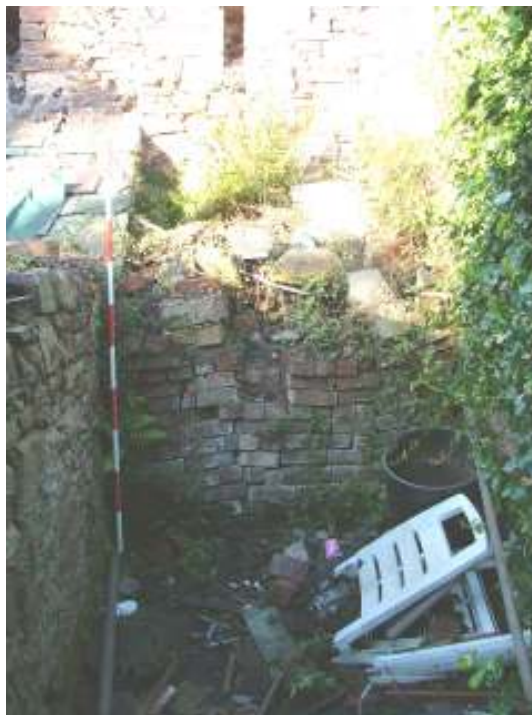
Plate 12 – Brick-built feature, against east elevation of garage

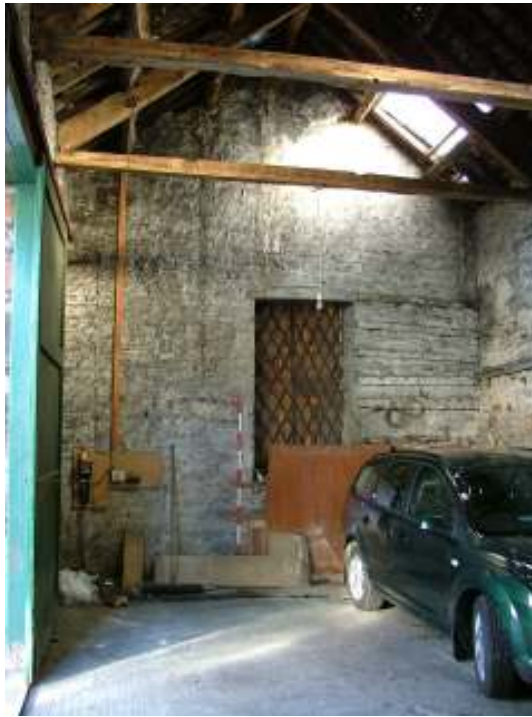
Plate 13 – Interior of garage, view looking north of window with iron framework (Scale = 2m)

- 5.2.2 In the northern gable end of the building is a large window which retains its decorative iron framework (Plates 13 and 16). This window, which appears on first observation to be a doorway, may be a later insertion to provide light to the smithy. The historical maps for the buildings on Doomgate show that there was a building to the north of the garage, in which case this window would have been blocked-up by the wall of the other structure. It is of course possible that this was a doorway from the garage (or former barn) into the adjoining property but its height from the floor seem too low to access a first floor. To the right of this window are several wooden battens fixed onto the walls with projecting nails, which may have been used to hang tools or small metal objects from the smithy.

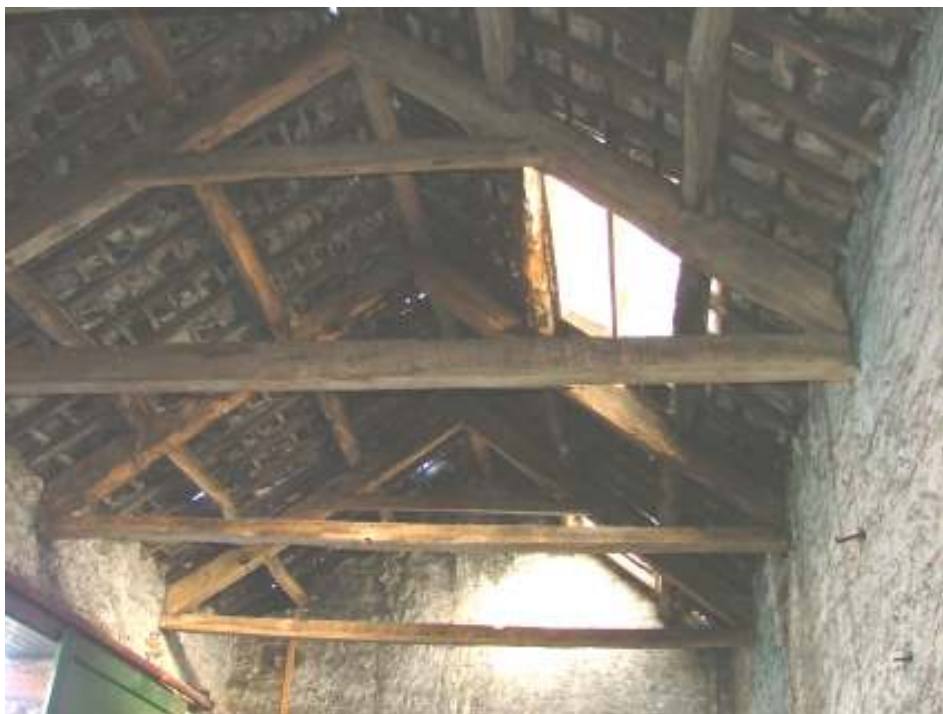
- 5.2.1 At the time of survey the building contained two parked cars, however the rest of the building was unobstructed. The interior of the garage could be accessed through the large doorway on the west elevation. The floor of the building is of concrete and the walls have been whitewashed (Plate 13). In some places the walls have been plastered which has hidden any evidence for former upper floors or other features. The building was open to the roof, which consists of five hand-cut roof trusses with collars that are held together with wooden pegs. Assembly marks were visible on at least two of the trusses (Plates 14 and 15), these are generally marks such as 'I' 'II' 'III' which inform the builders which rafter goes with which tie beam, and in some roof structures, the king post or collar. In some buildings the assembly marks may be out of sequence if the roof trusses have been reused from elsewhere.

Plate 14 – Detail of roof structure, view looking north

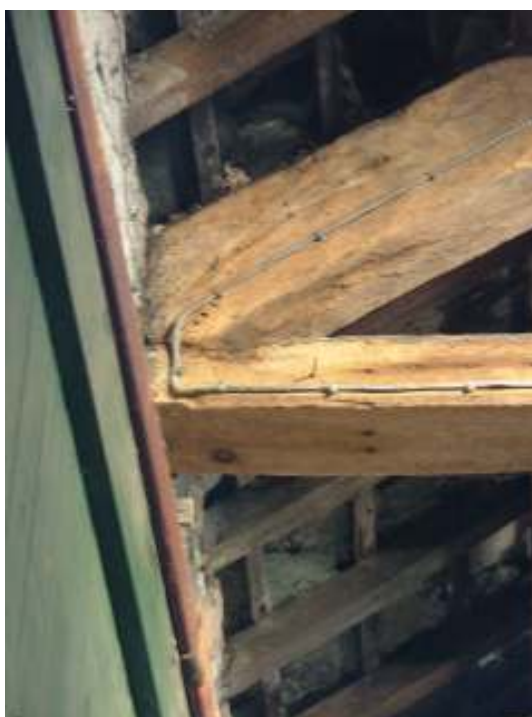
Plate 15 – Detail of assembly mark 'III'

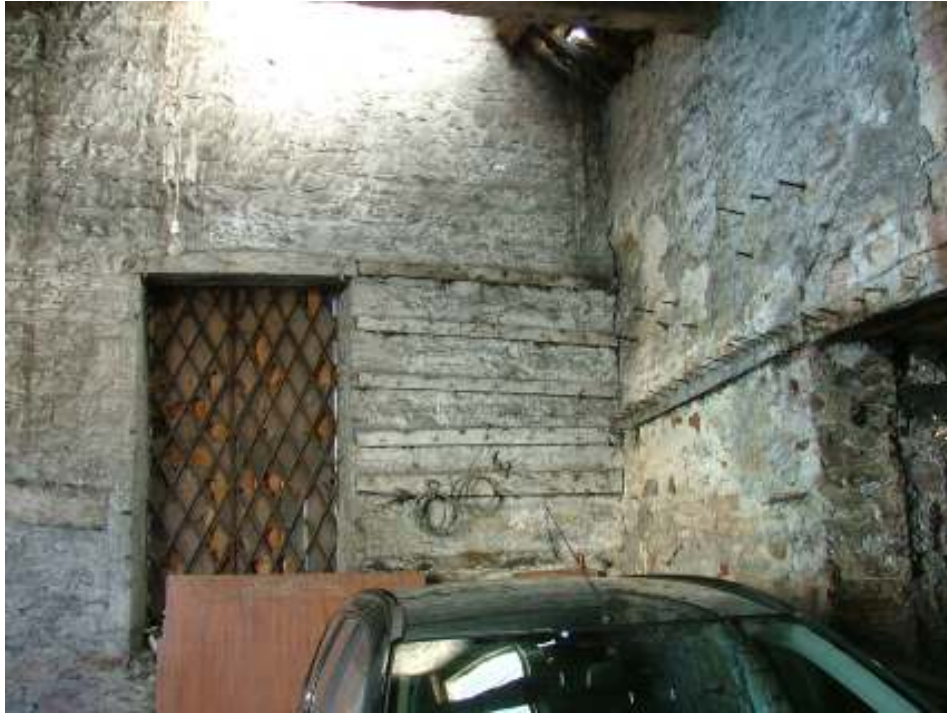
Plate 16 – Detail of iron framework in window (north elevation) and wooden battens fixed to wall

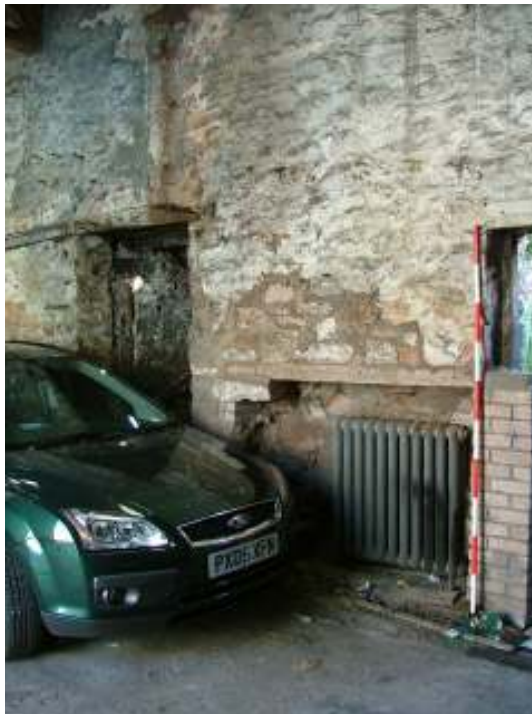
- 5.2.3 The interior of the outshut could not be closely observed due to one of the parked cars within the garage interior. The function of this outshut is unclear, however the location of the small brick-built chimney on the eastern side of the roof (Figure 13) corresponds with the internal door to the outshut and it may be tentatively suggested that the outshut was used to house an oil heater or wood burner and the flue went up the wall to the chimney above, as there was no evidence for a fireplace in line with the chimney. To the right of the outshut is a recess containing a modern radiator (Plate 17).

Plate 17 – Radiator inserted into wall in east elevation, to the left of this recess is the entrance to the outshut, above which a brown stain shows the location of the chimney above

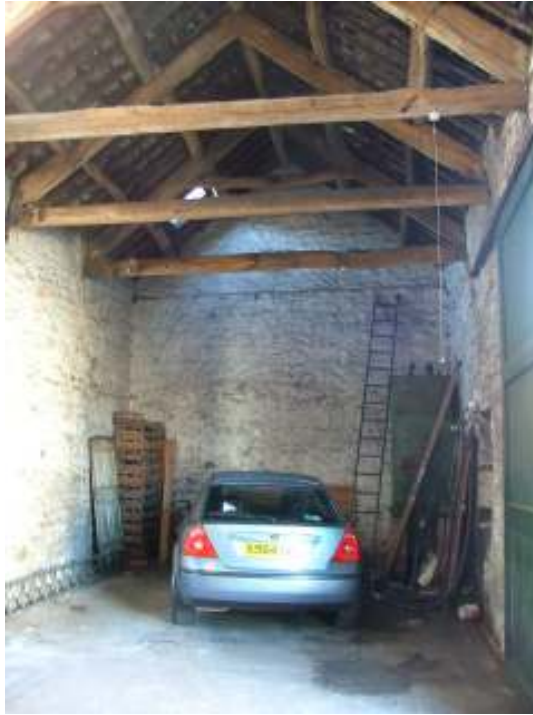
- 5.2.4 The southern end of the garage contained no evidence for former animal stalls, or rafter holes for a first floor hayloft, beneath which would have been the byre or stable accessed from the standard doorway on the west elevation, but as already mentioned the walls have been plastered so any evidence for such features is hidden (Plate 18).

Plate 18 – View looking south of garage interior

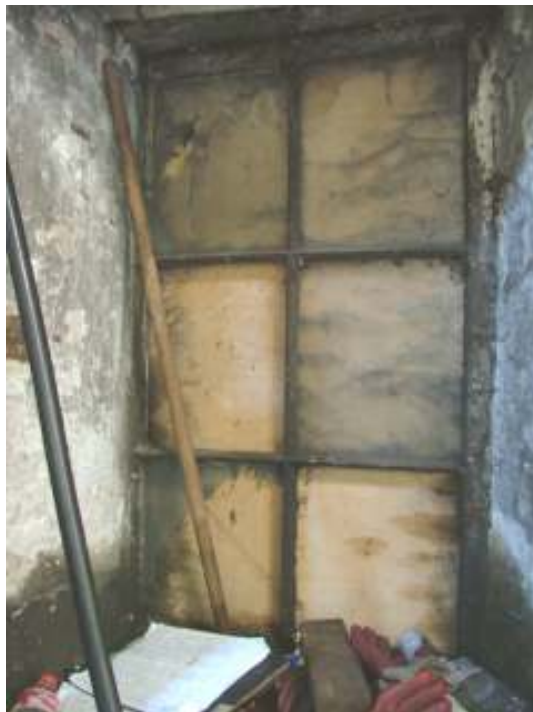
- 5.2.5 The window in the west elevation was observed internally to have a wooden frame containing six panes (Plate 19). The inside of the door in the east elevation has the initials 'T E' carved into it twice (Plate 20).

Plate 19 – Interior view of window in west elevation

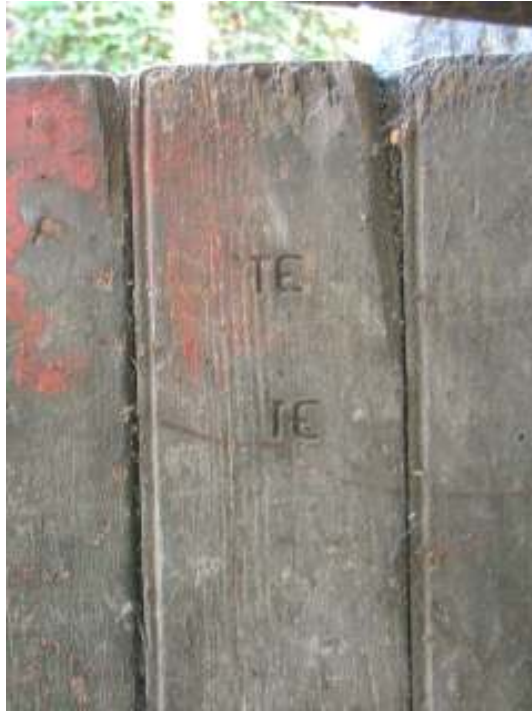
Plate 20 – Interior of door in east elevation, initials ‘T E’

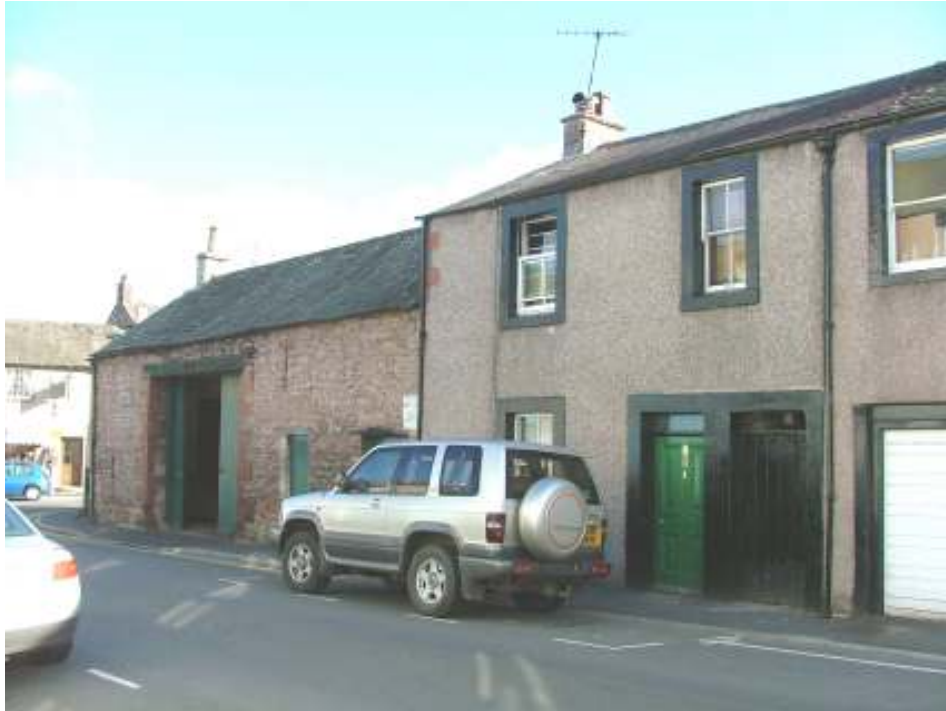
Figure 21 – West elevation of No.18 Doomgate and garage

- 5.3.1 In the listed building record, the garage is associated with No.18 Doomgate (Ref: 27244). No.18 is a two-storey house with a single sash window at ground floor level, and two at first floor level, all with four panes and in stone surrounds. The doorway is to the right of the elevation next to the doorway to the alleyway between No.18 and The Old Hall (Plate 21). The Old Hall is also a listed building and is believed to be 18th century in date.

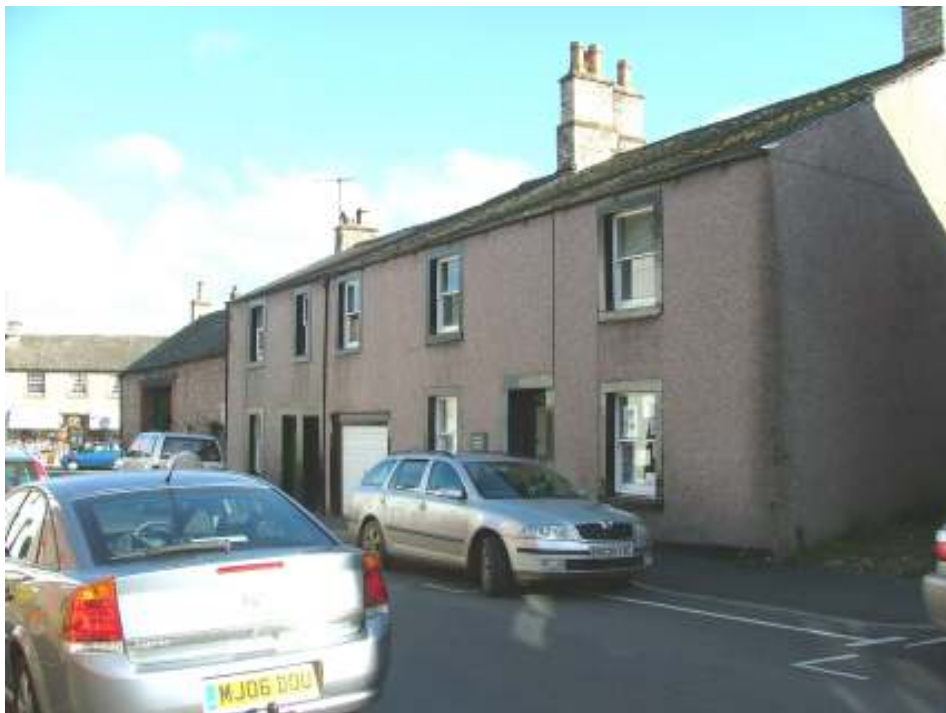
Figure 22 – West elevation of the Old Hall, No.18 and garage looking northwards to High Wiend

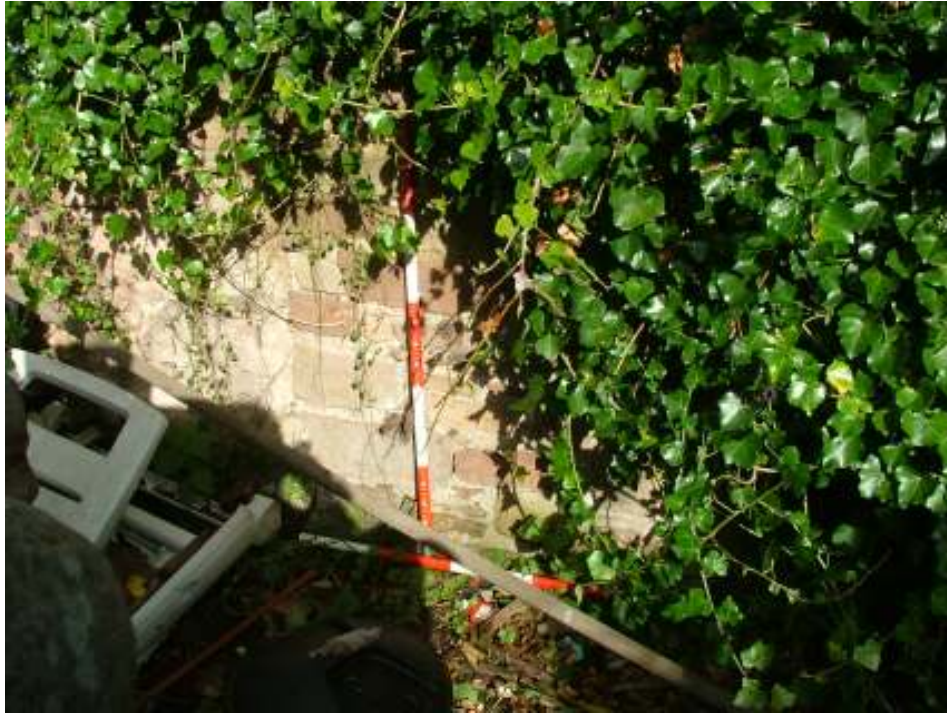
Figure 23 – Vertical construction break (left of ranging pole) possible blocked door in northern boundary wall of garden (Scales = 1m each)
