NORTH PENNINES ARCHAEOLOGY LTD

Client Report No. CP/106/05

DESK BASED ASSESMENT
AND REPORT ON
AN ARCHAEOLOGICAL
WATCHING BRIEF ON
LAND AT ASKHAM,
LAKE DISTRICT
NATIONAL PARK,
CUMBRIA

FOR UNITED UTILITIES

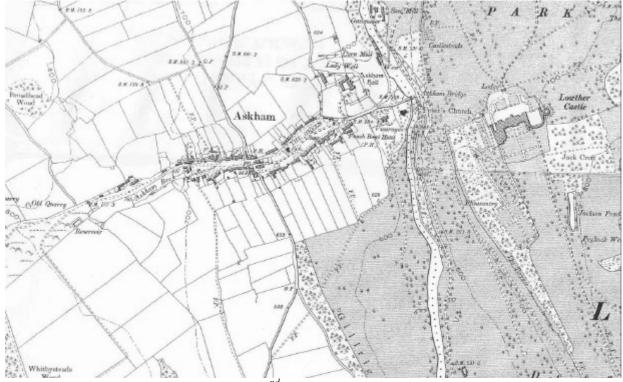
Figure 3: Ordnance Survey 1st Edition (1860) Scale 12 inches to 1 mile.

Figure 4: Ordnance Survey 2nd Edition (1899) Scale 12 inches to 1 mile.

5.1.16 The Ordnance Survey maps of the 19th century (figures 3 and 4) not only show the location of such industrial features, they also show the layout of the field

systems. When compared with the Tithe map (WDRC/8/195) of 1838, it is evident that the field systems within the study area to the south of the village have changed very little. Even at the present time many of the larger north south boundaries are still in use, although now fenced rather than walled.

- 5.1.17 Currently the biggest change has been the removal of most of the smaller east west boundaries which formed small paddocks close to the back of the village buildings. The long strips present on the 19th century mapping and still in use today are the fossilised remains of later medieval strip fields, land which would mimic the burgage plots of the buildings along the edge of the settlement.
- 5.1.18 **UNKNOWN** A number of features are recorded in the SMR as being of unknown date. To sets of earthworks observed from aerial photography (13533 and 14533), in addition to Askham Cross (15476) of which fragments still survive are noted on the 1st edition Ordnance Survey map (Figure 3).

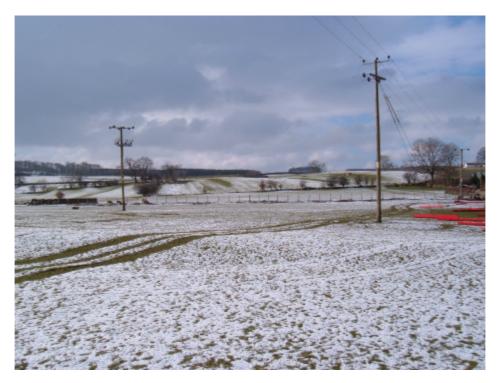
Plate 1: View from Area D to west showing the ridge and furrow in area B highlighted by light snow

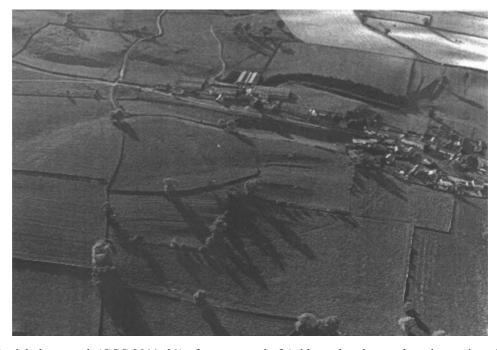
Plate 2: Aerial photograph (CCC 3011, 31) of western end of Askham showing earthwork remains of ridge and furrow and former field boundaries

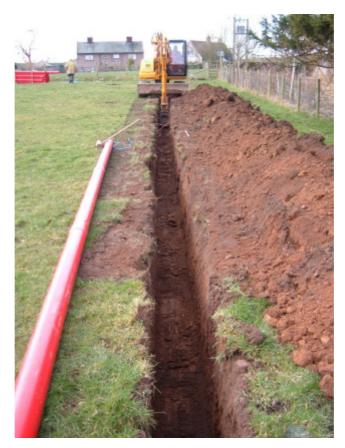
Plate 3: Excavation of the cable trench

- 5.3.3 The cable trench maintained an average depth of 1.20 metres across the entire route and varied between 0.40 and 0.60 metres in width. It was excavated by a 360° tracked excavator using a toothed bucket.

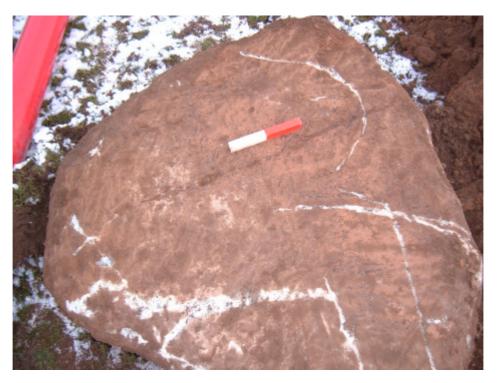
Plate 4: View of stone from context 105 showing tool marks where attempt has been made to cut in half
