# **NORTH PENNINES ARCHAEOLOGY LTD**

**Client Report No. CP/571/07**

In September 2007, North Pennines Archaeology Limited were commissioned by Mr Peter Whitehead to undertake an archaeological building survey of a derelict farmhouse at Scalegill Foot, Dentdale, Cumbria.

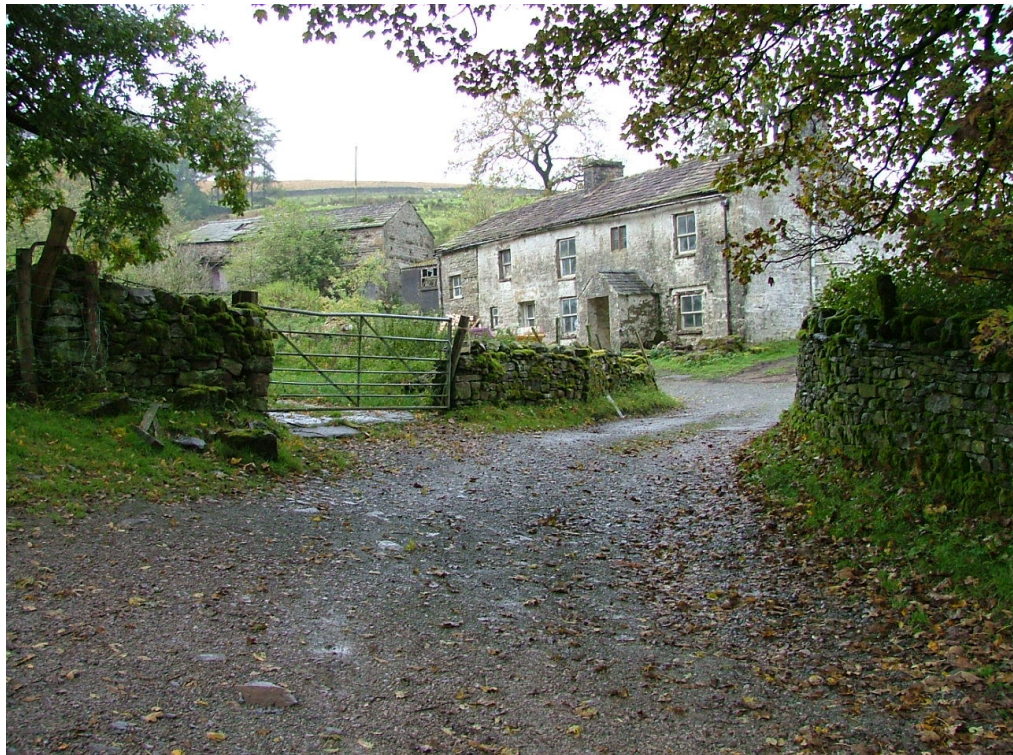
**Plate 1** – Scalegill Foot as seen from the east

- 1.1.2 Scalegill Foot is a listed Grade II building, which is referred to in the Listed Building Record as ‘Dee Side Farmhouse’, and is believed to be early 18<sup>th</sup> century in date (Plate 1).

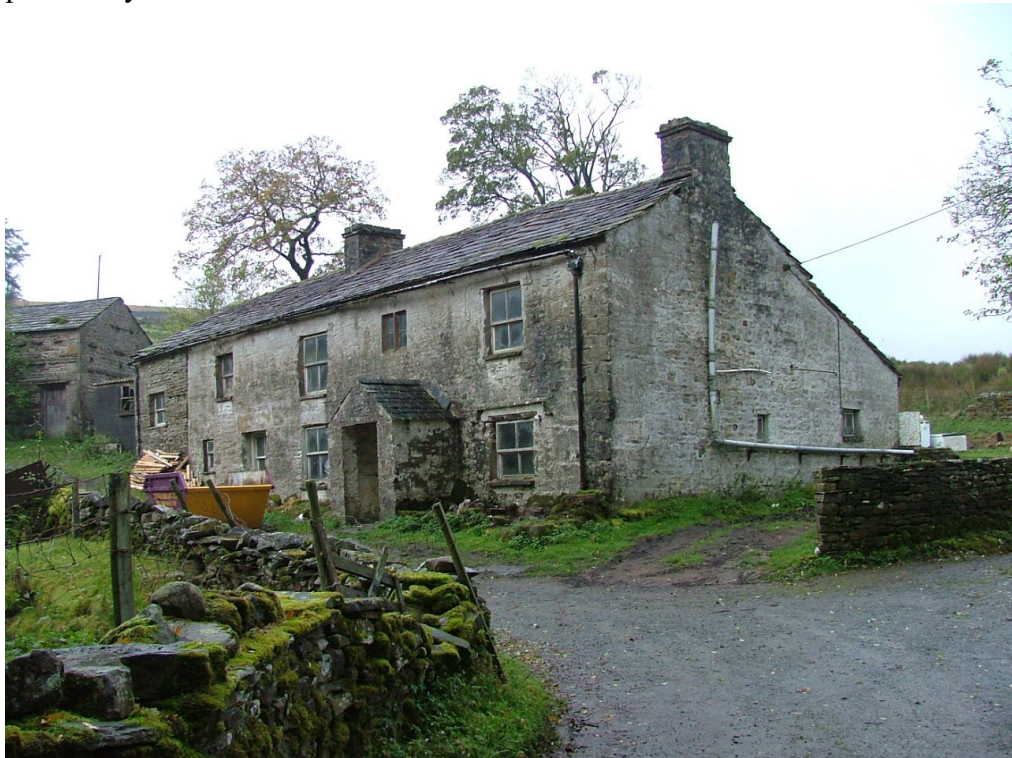
**Plate 4** – South and east elevations of Scalegill Foot

- 5.1.1 Scalegill Foot is a former farmhouse constructed of solid rubble masonry from locally quarried stone in the traditional manner. It is of two storeys to the main elevation (south) with an outshut to the rear (Plate 4). The whole roof, apart from over the porch on the south elevation, which is of Welsh slate, is laid in large sandstone slates, also quarried locally. The south and east elevations have been rendered and white-washed, interestingly these are the elevations which can be seen from the road, whilst the north elevation which faces away from the road, is mainly exposed masonry (Plate 3). There are two masonry chimneys, one on the eastern gable end and the other located approximately mid-way along the ridge line (Plate 4).

- 5.1.2 The main south elevation has a gabled porch also constructed of rubble masonry (Plate 4). Either side of this porch are two ground floor windows, presently 4-pane top-hung casements, which have been inserted into two earlier mullioned windows with lintels, jambs and hoodmoulds (Plates 5 and 6). Mullioned windows such as these originated in the medieval period but they continued at vernacular levels until the 18<sup>th</sup> century, after which square windows became popular<sup>7</sup>. The stone mullions at Scalegill Foot were diamond-shaped, however only the tops of the mullions survive. Hoodmoulds (sometimes referred to as drip stones) were used to throw water away from the windows; to be purely functional they only really needed to be a horizontal band of stone above the lintel; however they were often used to provide architectural detail to a building, as is the case with the right-hand window at Scalegill Foot (Plate 5). Glazing became common in small houses around the late 17<sup>th</sup> century; to accommodate wrought iron lattices and casements, the mullions and jambs were rebated<sup>8</sup>. Due to the presence of the later windows it was not possible to observe if the mullions and jambs at Scalegill Foot contained these rebates.

- 5.1.3 Also along the south elevation of the farmhouse are a further two 4-pane windows, and a small 2-pane window at ground level (Plate 4). The third window to the left of the porch may have been a doorway at some point (although it may not be original) as vertical breaks below the window indicated the base has been blocked-up (Plate 7). At first floor level, there are four windows, two of which are 4-pane similar to those at ground floor level, a small 2-light chamfered mullioned window above the porch which is flush with the main wall (Plate 8), and a 2-light window at the western end (Plate 4).

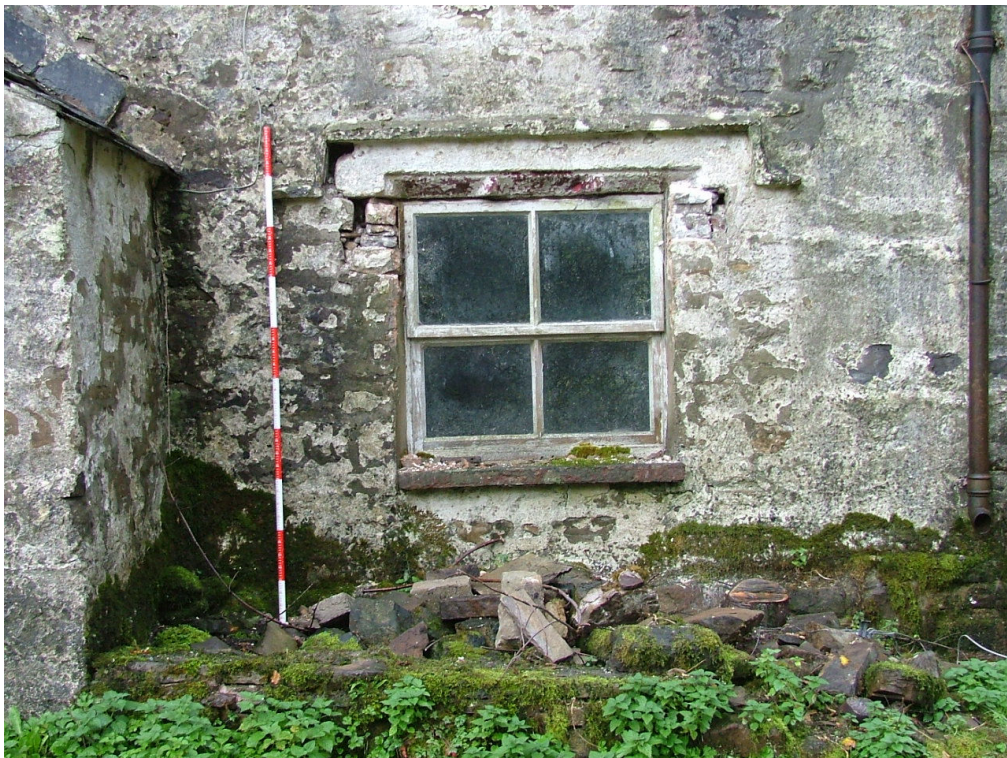
**Plate 5** – Ground floor window to right of porch on south elevation, showing earlier 3-light mullioned window and hoodmould (Scale = 2m)

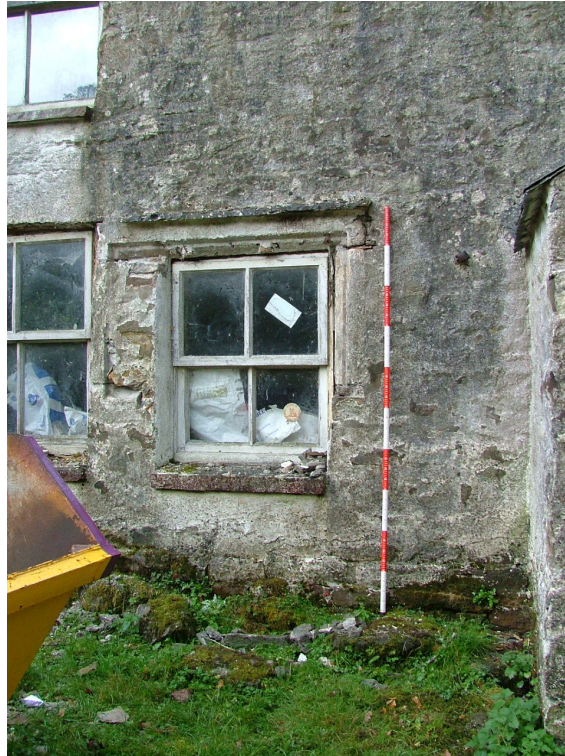
**Plate 6** – Ground floor window to left of porch on south elevation showing earlier 3-light mullioned window and hoodmould (Scale = 2m)

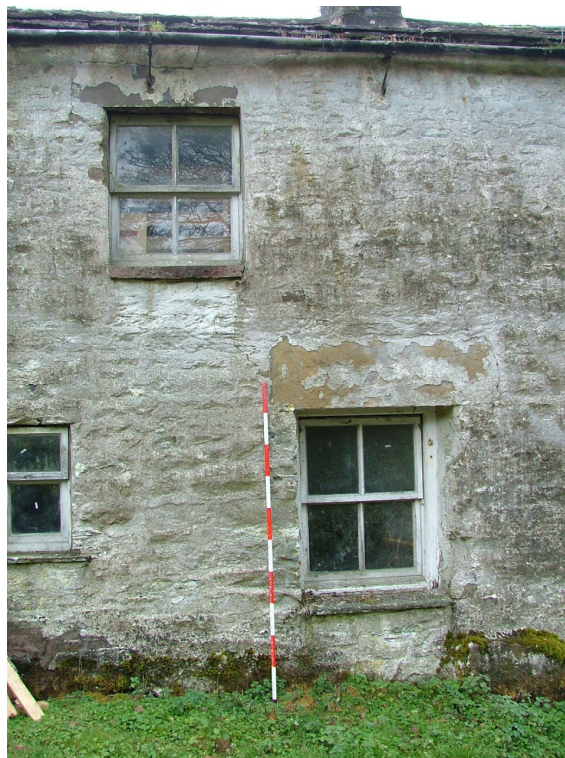
**Plate 7** – Window, south elevation, was possible former doorway (Scale = 2m)

- 5.2.5 A doorway to the left of the fireplace provides access to another room with two windows (Room 4). One of these windows is that noted on the south elevation which may have been a doorway at some point (See 5.1.3 and Plate 7). It is possible that this room formed part of the original house as no vertical construction break was observed externally to suggest that this part of the building was constructed before or after the main body of the house. It may have been the original byre or stable with no access from the main house, but from the former doorway in the south elevation.

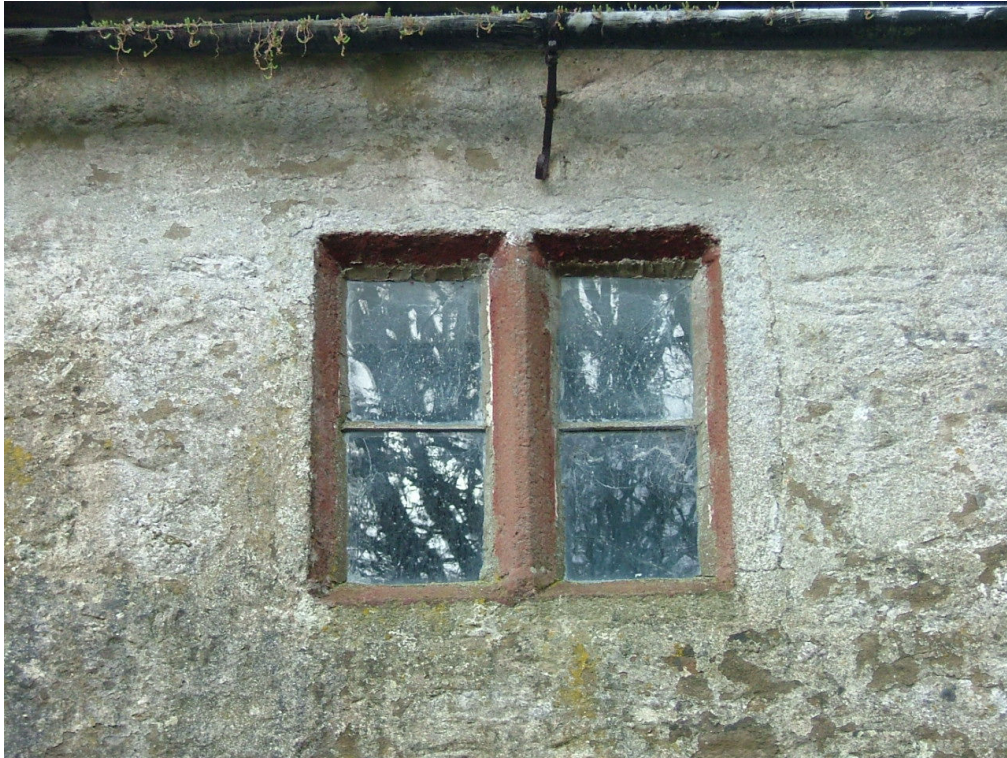
**Plate 8** – Two-light, chamfered mullion window, first floor, south elevation

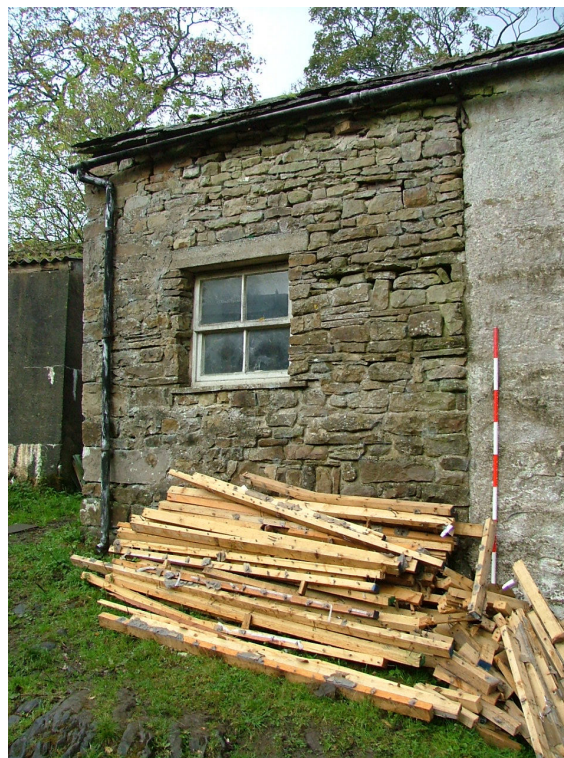
- 5.1.4 The western end of the house is an addition which has clearly been constructed after the rest of the property as shown by a vertical construction break (Plate 9). It is interesting to note that this part of the house has not been rendered or white-washed; this was not uncommon, certainly in the Lake District, where the outside walls of attached farm buildings such as a small byre with loft above, were not treated in the same way as the house<sup>9</sup>, suggesting the need to distinguish the two to visitors or

**Plate 9** – West end of house, south elevation

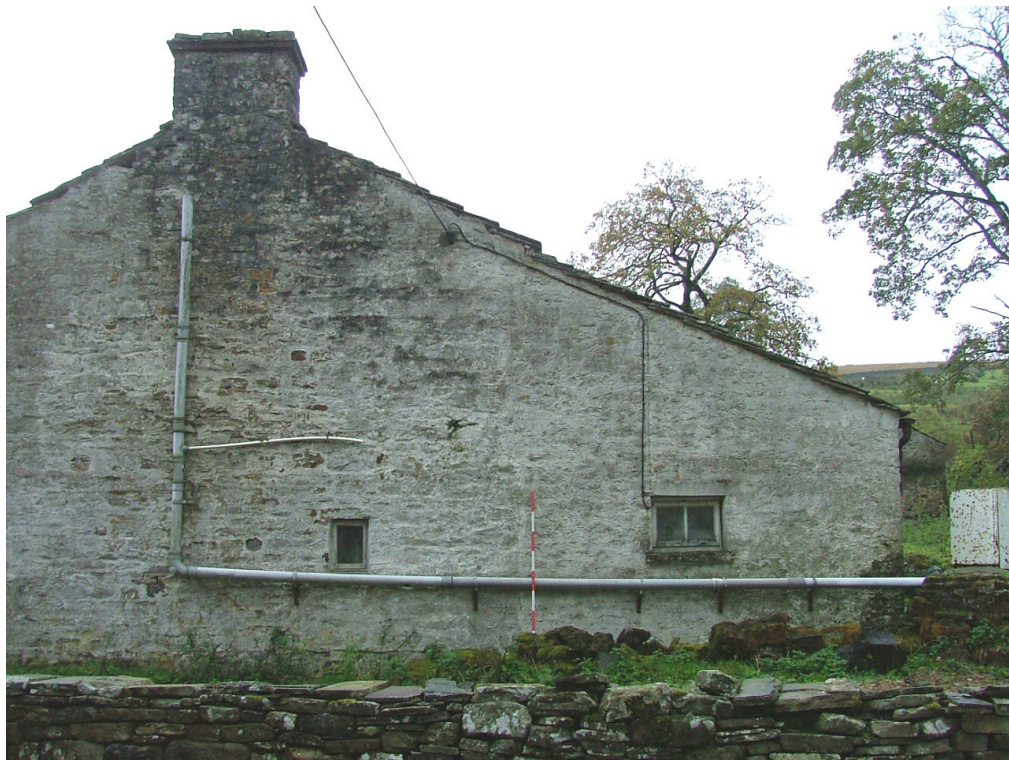
- 5.1.5 The east elevation of the property provides evidence for the addition of the outshut to the rear, as a vertical construction break could be observed between the main body of the house and the outshut. A slight change in the roof at this point also suggests that the outshut is a later addition (Plate 10). There is a small window in this elevation, which may be a modern insertion and relate to the use of the property as an outward bound centre, and in the outshut is a further small window (Plate 10).

**Plate 10** – East elevation showing main body of house to left, and addition of outshut to right. The vertical construction break between the two is just to the left of the ranging pole

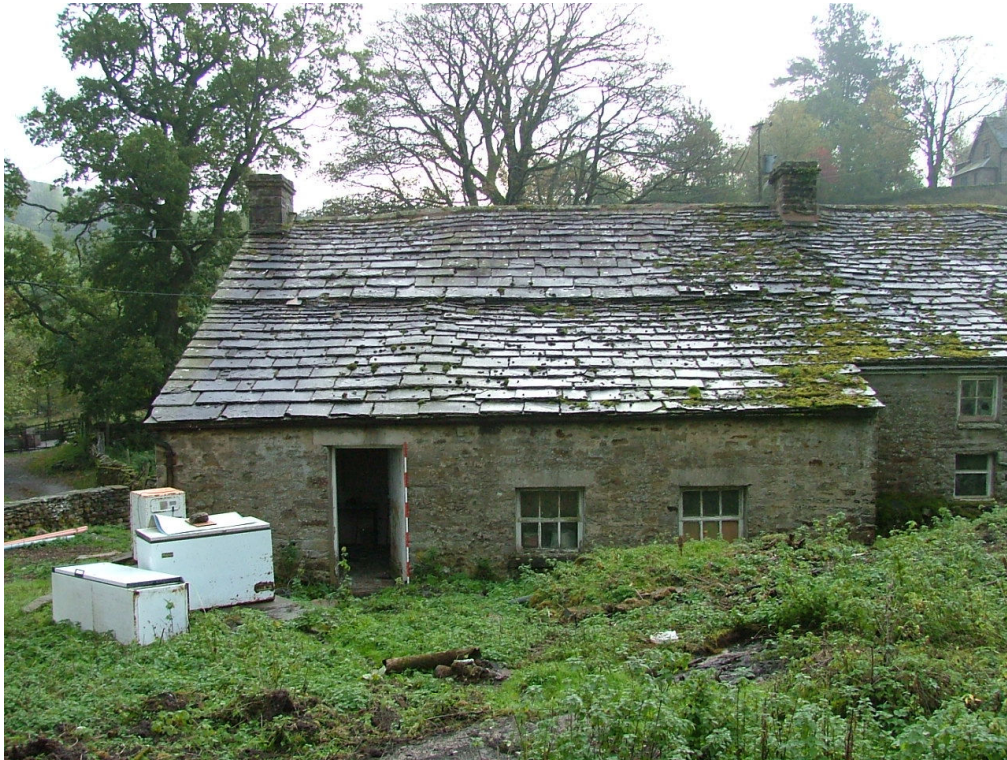
**Plate 11** – North elevation of outshut

- 5.1.6 The north elevation consists largely of the outshut which has been added to the main body of the house (Figure 3), a further small outshut to the west of that (shown as No.6 on Figure 3), and the addition at the western end which may originally have been for agricultural use or storage (Figure 3 and Plate 14). Changes in the roof could easily be observed from the north, which may provide further evidence for the outshut being a later addition (Plate 11). Along the north elevation of the outshut is a doorway and two 6-pane windows. Outshuts were generally added to earlier houses, or were included on new builds, between 1730 and 1820 (this is based on dated houses in Cumbria<sup>10</sup>). In many cases the addition of the outshut to the rear of the house was to accommodate a dog-leg staircase to replace a ladder or narrow flight of steps located beside one of the fireplaces to the first floor, or indeed an external staircase. The space either side of the new staircase was used to accommodate a dairy and scullery and over time, in some cases, first floors were inserted over the dairy and scullery to create small upper rooms within the roof space.

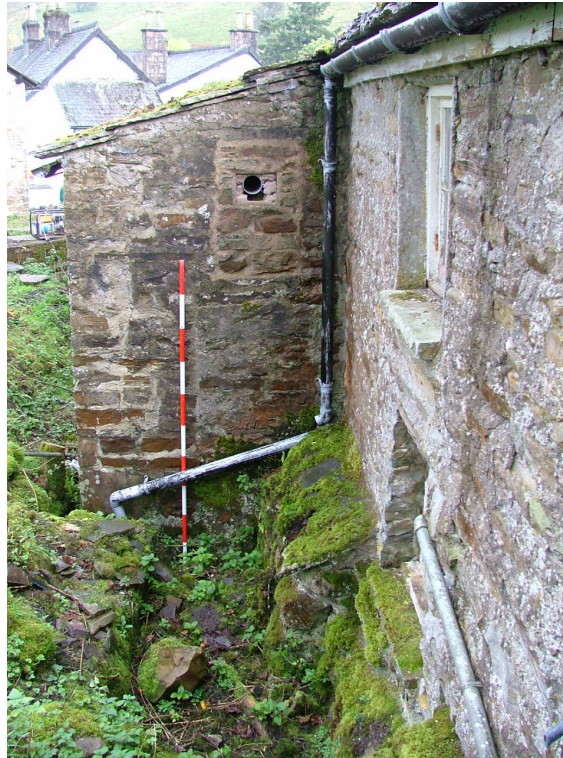
- 5.1.7 In the west facing elevation of the outshut, two blocked apertures were observed; one of these may be a former ground floor window, whilst the higher feature may be modern, possibly relating to the central heating system (Plate 12).

**Plate 12** – Possible blocked window and modern blocked feature? West elevation of outshut to the rear of the house

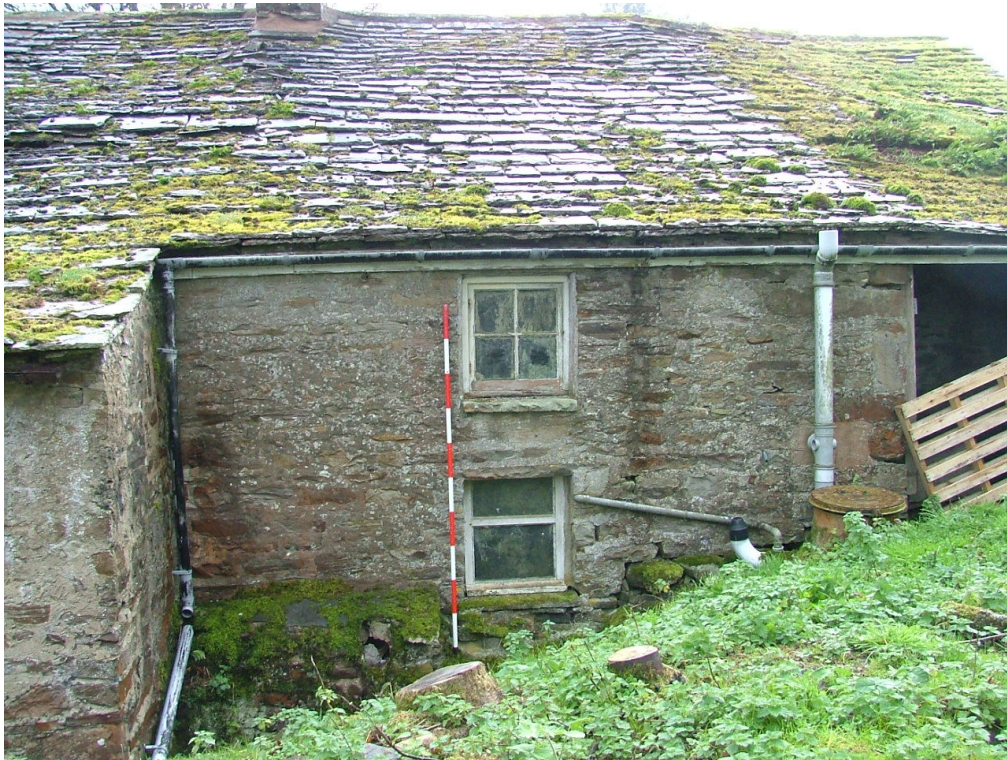
- 5.1.8 To the west of the main outshut is another addition that has a window at ground and first floor level (Plate 13). At the western end of the north elevation is a doorway into a small room (Plate 14 and shown as No.8 on Figure 3). This room still has the remains of limewash on its interior walls which may suggest it has been used to house animal, as limewash was a common traditional wall covering and disinfectant; it is also possible that this room may have been used to house fuel, and may have been the turf house referred to in 1824 (See 4.4 above).

**Plate 13** – North elevation of small outshut, rear of house (Scale = 2m)

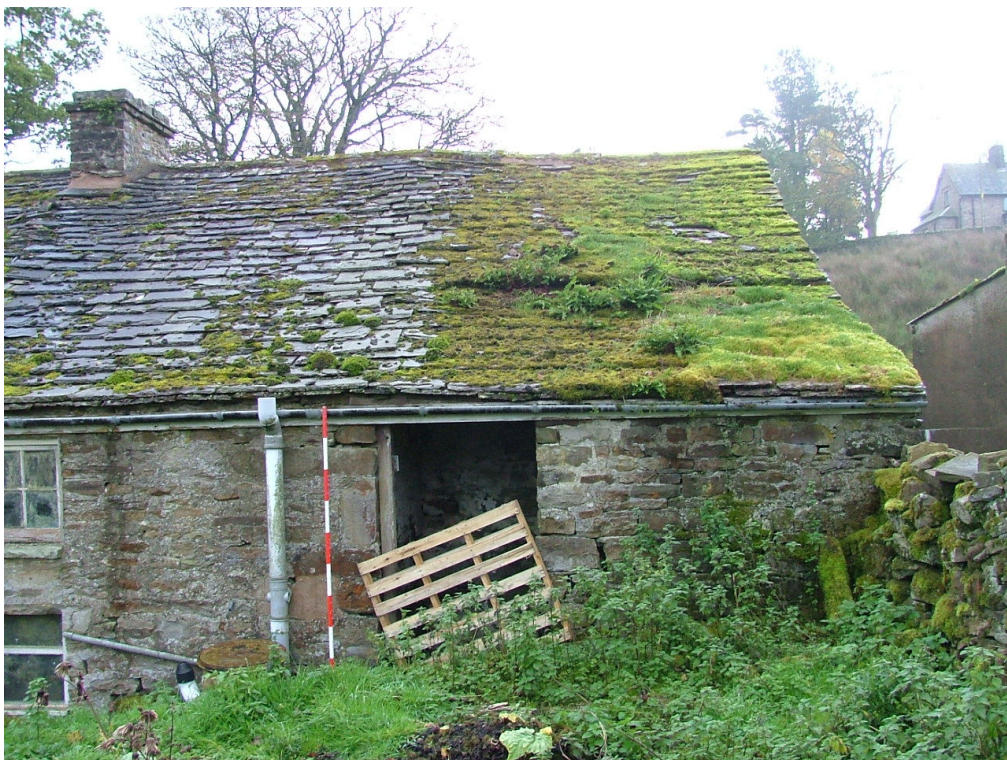
**Plate 14** – North elevation, western end showing door to possible turf house?

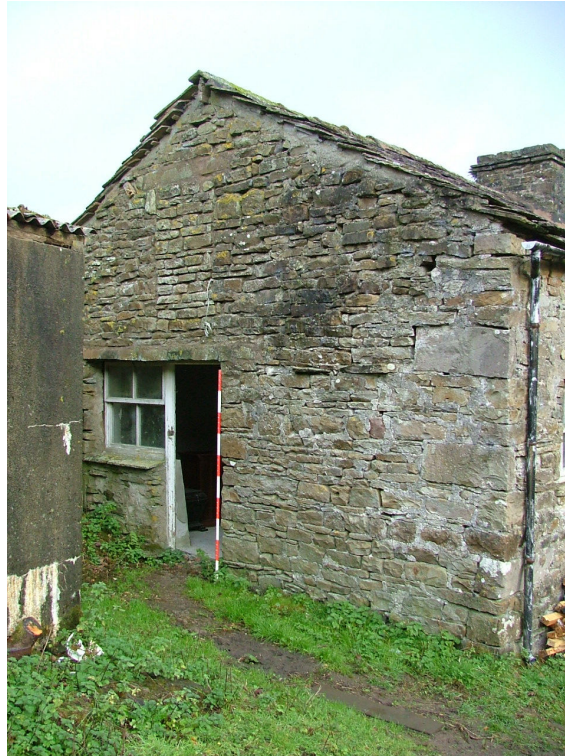
- 5.1.9 In the western gable end of the property there is a doorway with adjoining window, above which is a blocked-up first floor window (Plate 15). It is possible that this addition to the western end of the property was to house animals, with a hayloft above (the blocked upper window may have been a pitching door for transferring hay, straw etc into the loft). According to Denyer some houses within the Lake District have small byres (cowhouses) attached to one end with a loft over, and that their entrances are quite separate from that of the main house<sup>11</sup>.

**Plate 15** – West elevation showing doorway, window and first floor window now blocked  
(Scale = 2m)

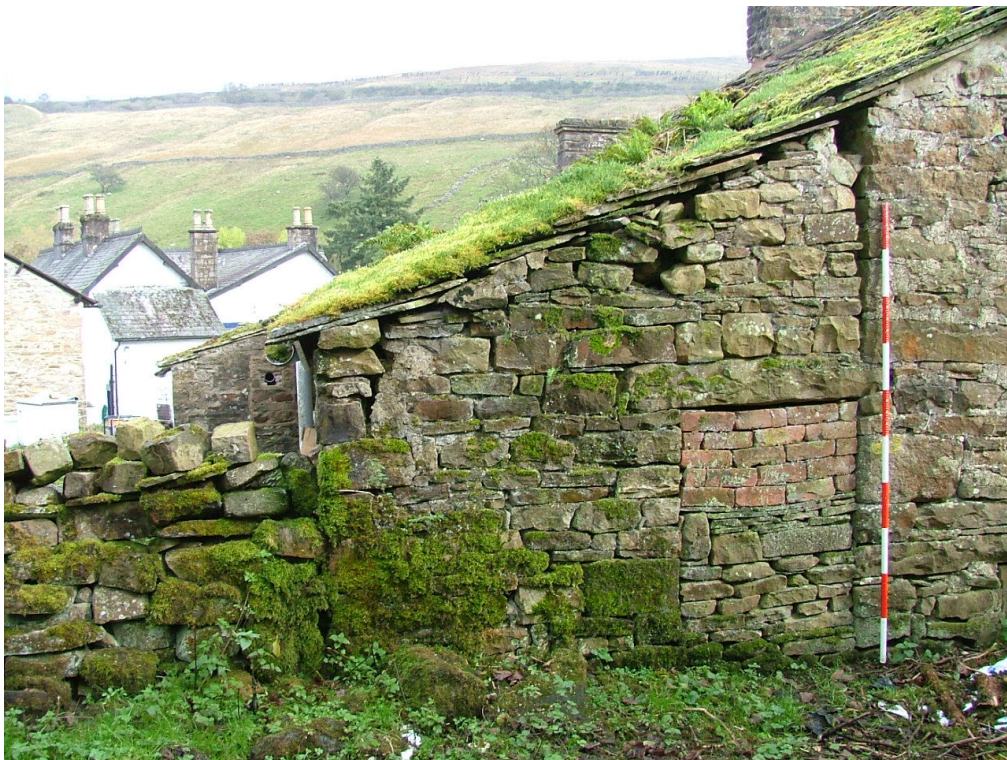
**Plate 16** – West elevation, blocked aperture in outshut (Scale =2m)

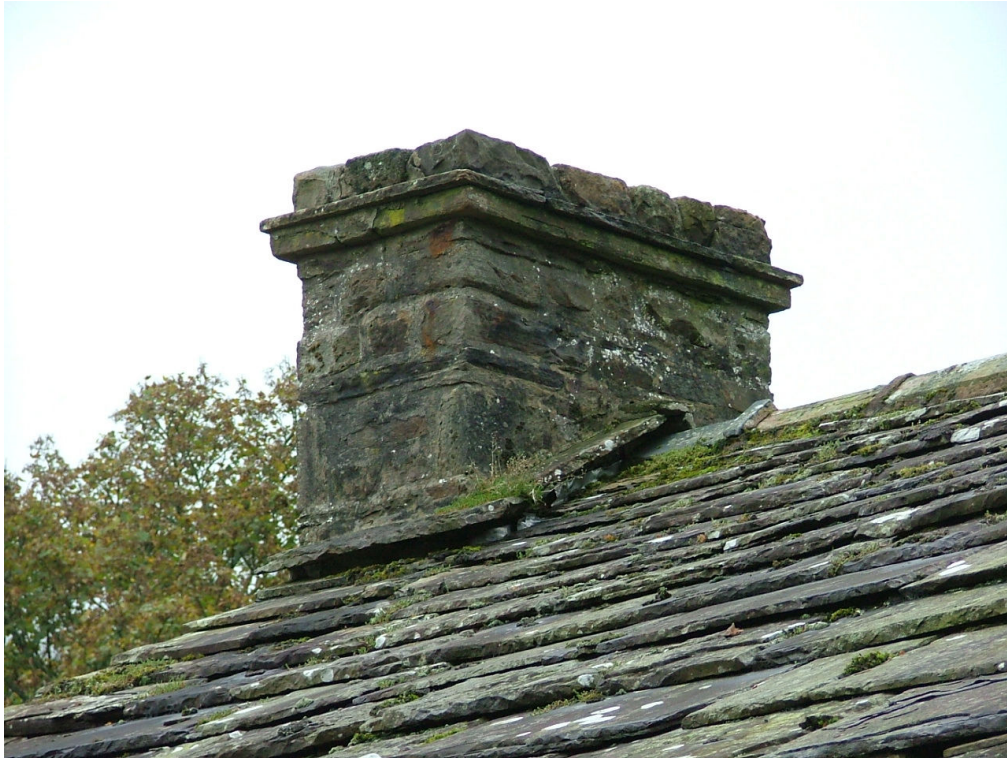
**Plate 17** – Detail of chimney on eastern gable end

- 5.1.10 As already noted above, there are two chimney stacks constructed of rubble masonry, one on the eastern gable end and the other approximately mid-way along the ridge. This second chimney half way along the ridge may be the location for the original western wall of the earliest house on the site; this will be discussed further in the

Conclusion. The chimney stacks have a degree of architectural detail as there is a projection of stone around their outer edges, close to the tops, and on the eastern-most, there is a raised section at the base which is not flush with the roof proper (Plates 17 and 18). This feature presumably was intended to keep water away from the bottom of the chimney and prevent it penetrating the roof.

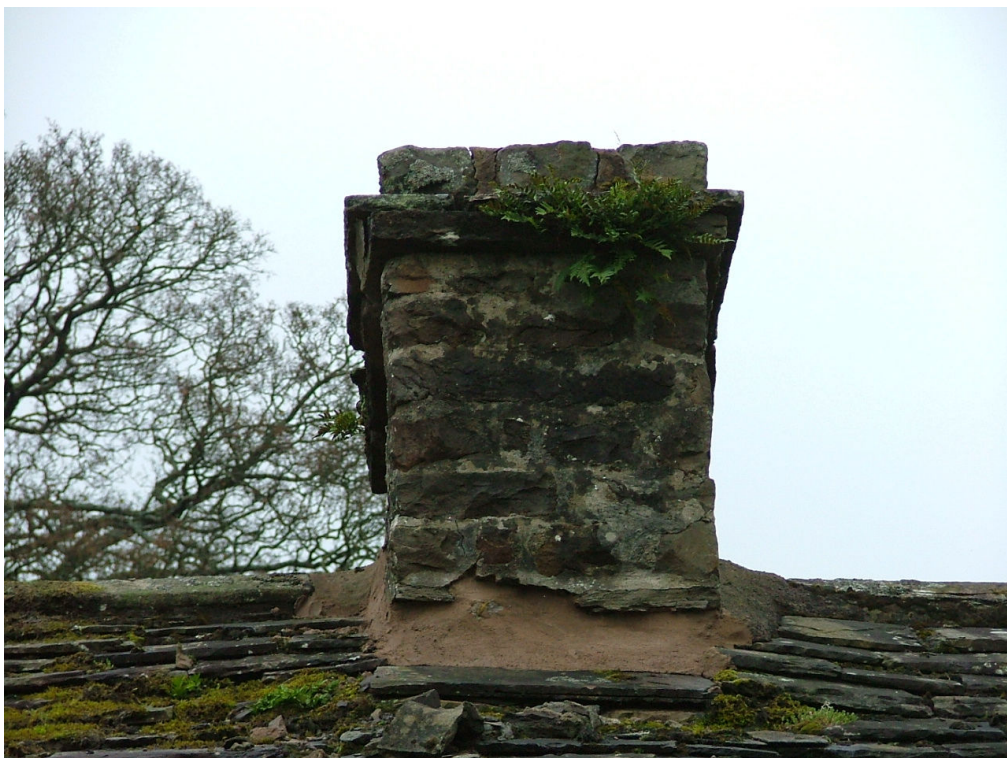
**Plate 18** – Detail of chimney stack, mid-way along ridge showing modern mortar at base

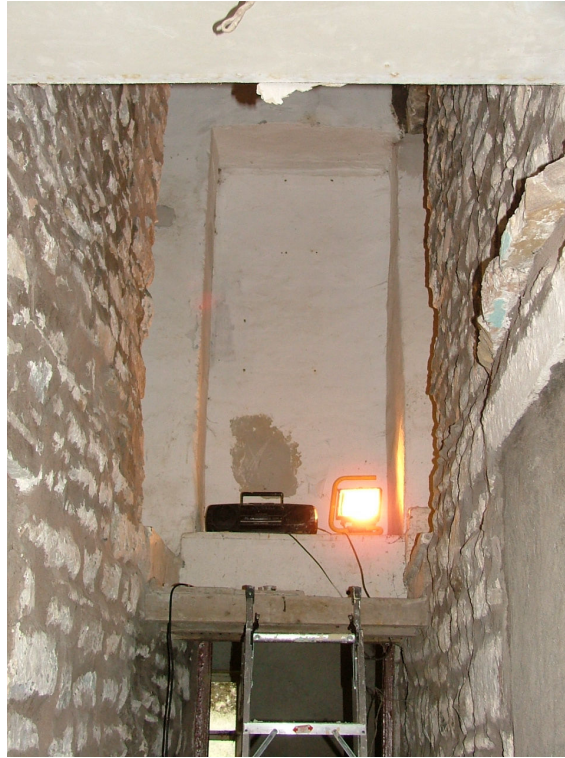
- 5.2.3 From the hallway looking up to first floor level, where the landing for the staircase would have been, it was possible to observe a blocked doorway (Plate 19). This doorway obviously provided access to the first floor at one time, although there are a number of different periods when it could have been inserted. It is possible that the earliest part of the house was a two-unit dwelling, one room deep, with two separate rooms at ground level, divided by either a stone or timber partition. In the earlier examples a steep ladder-type staircase provided access to the first floor, or a stone spiral staircase could have been located beside one of the fireplaces. In later examples a staircase was housed in a projection at the rear of the property, where it did not intrude on any internal space<sup>12</sup>. It is equally possible that this first floor doorway was inserted when the outshut was added to the north wall, as outshuts were generally constructed to house a staircase and provide extra space for service rooms such as the scullery and dairy (or buttery/pantry).

**Plate 19** – Blocked-up first floor doorway as seen from bottom of stairwell looking north

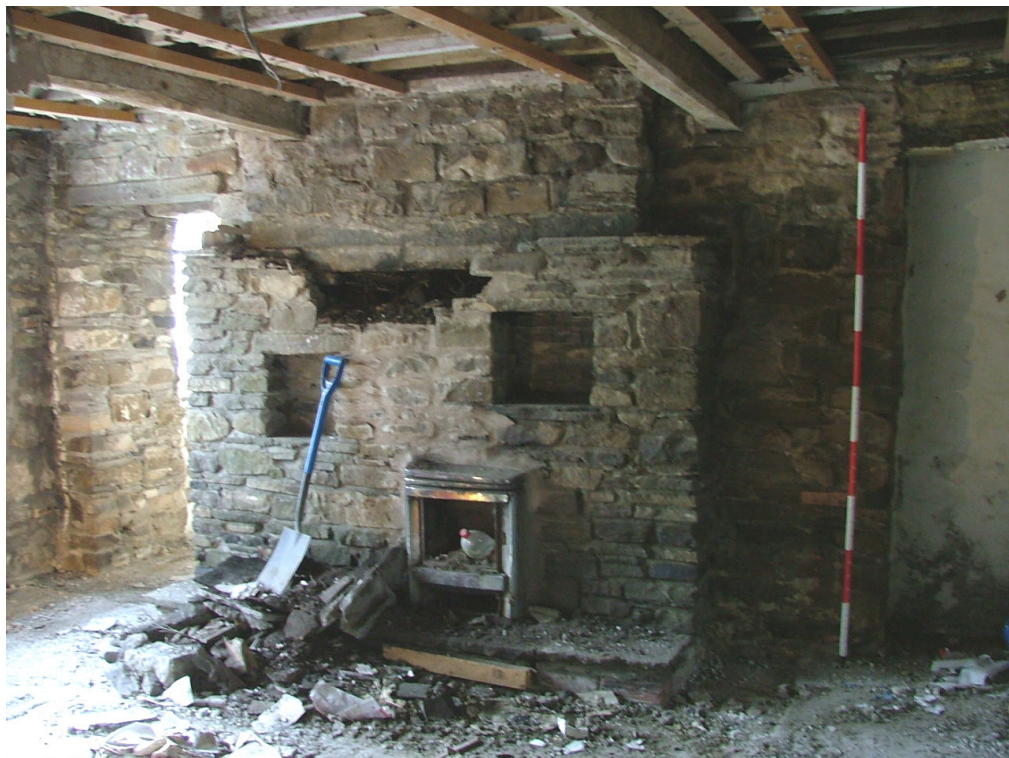
- 5.2.4 The room to the left of the main entrance (Room 3) contains a modern stone-built fireplace with niches (Plates 20 and 21). To the right of this fireplace is a blocked doorway (Figure 3), which, if this was the earliest western gable would have provided access from the house to outside, possibly towards farm buildings and the privy which would have been hidden from view behind the house.

**Plate 20** – Modern fireplace, Room 3, ground floor, with blocked doorway to right of ranging pole

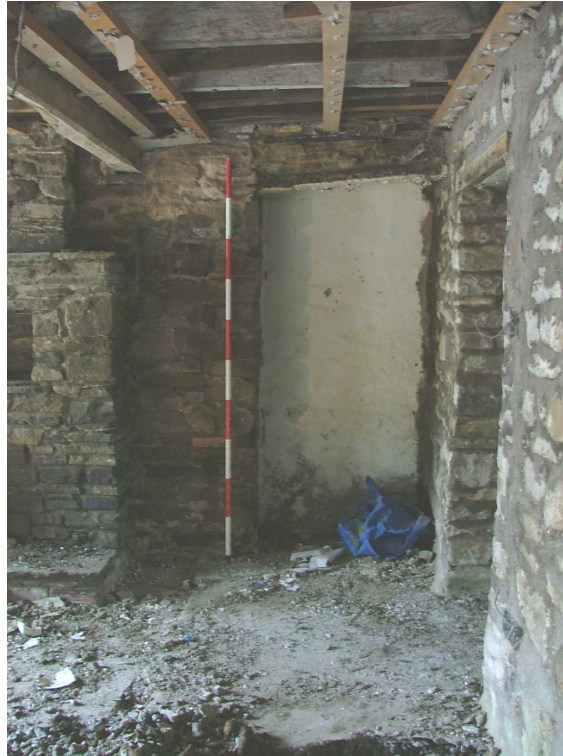
**Plate 21** – Blocked doorway, beside fireplace in ground floor room (3) (Scale = 2m)

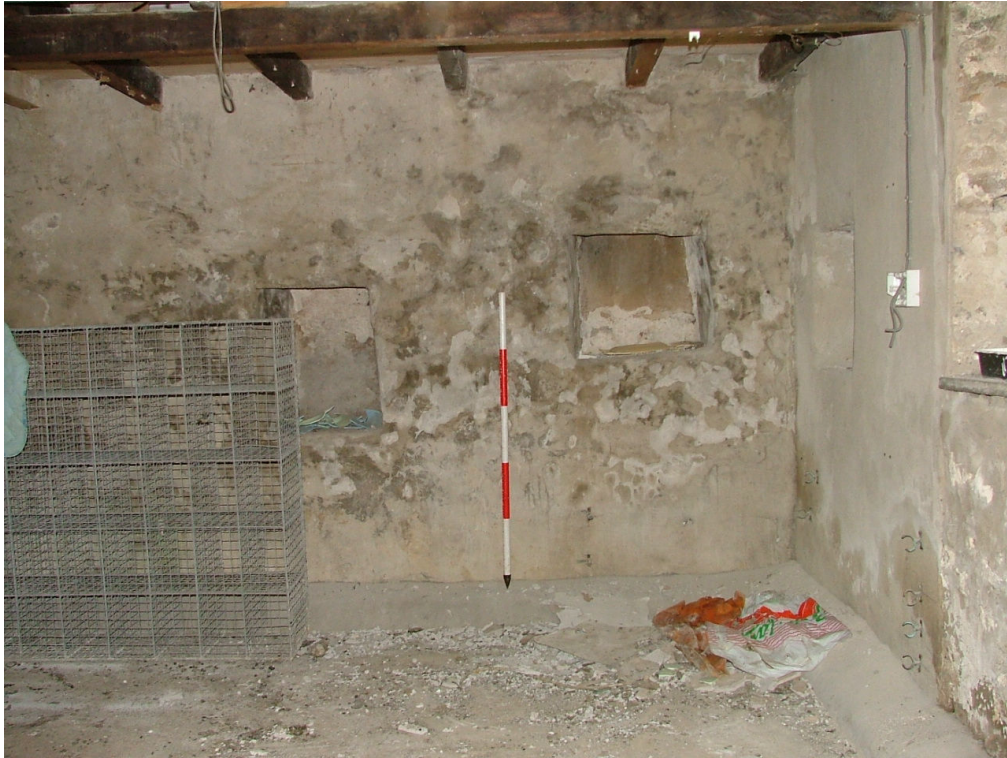
- 5.2.7 To the west of the outshut is a room accessed from Room 5 which is reminiscent of a pantry or larder. Pantries (sometimes referred to as a dairy or buttery, although these could be separate rooms) were used for storing foodstuffs and generally had low small windows to prevent too much sunlight entering the room and spoiling the milk, meat etc (windows are often in north wall, as is the case here). Stone shelves supported on brick or stone piers is also a common feature of pantries but if this particular room has been used as such then there was no evidence for these shelves at the time of survey. What was unusual about this room was the number of large niches in the walls (Plate 22), although it is not known what period in the house's history these belong to. This room has more latterly been used to house the boiler for the outward bound centre.

**Plate 22** – Interior of former pantry(?) (Scale = 1m)

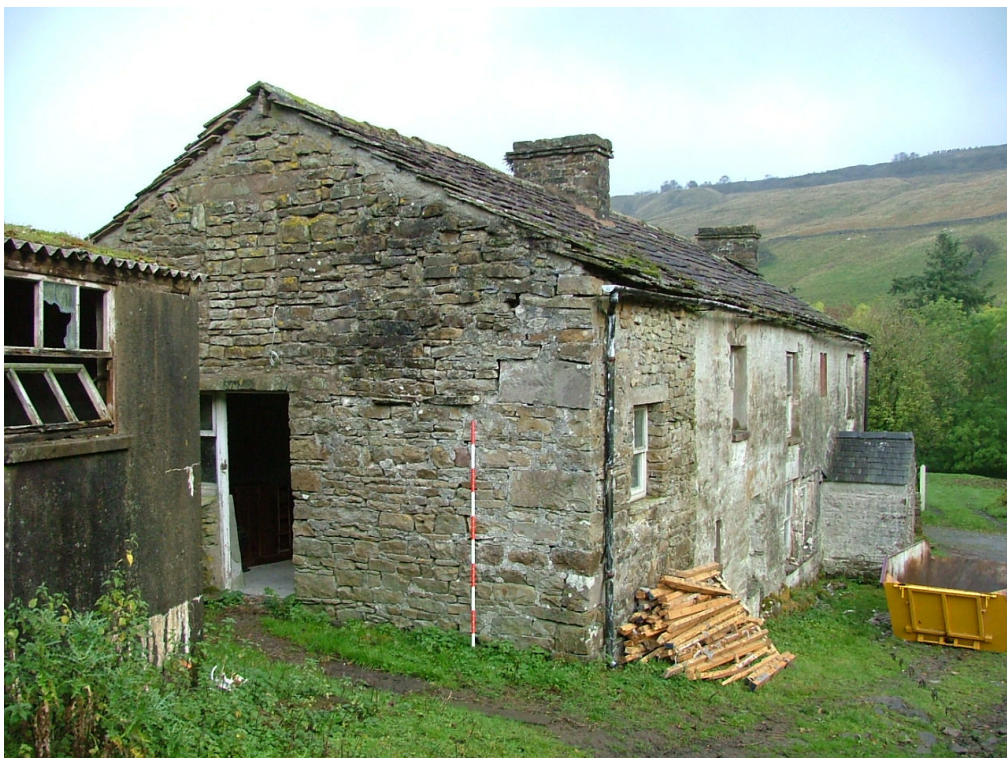
**Plate 23** – West and south elevations, view showing the increased height of the western end of the property compared to the rest (Scale = 2m)

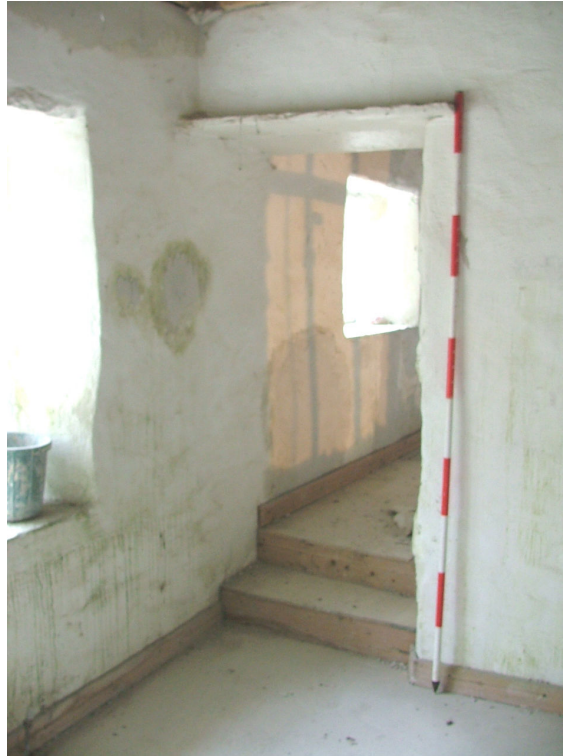
**Plate 24** – Doorway between rooms over (2) and (3), first floor

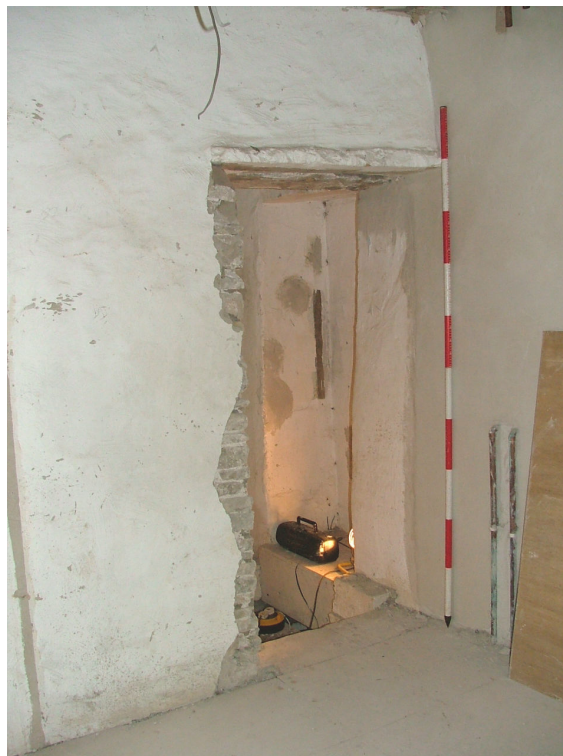
**Plate 25** – Doorway between room over (2) and top of stairwell (1) (Scale = 2m)

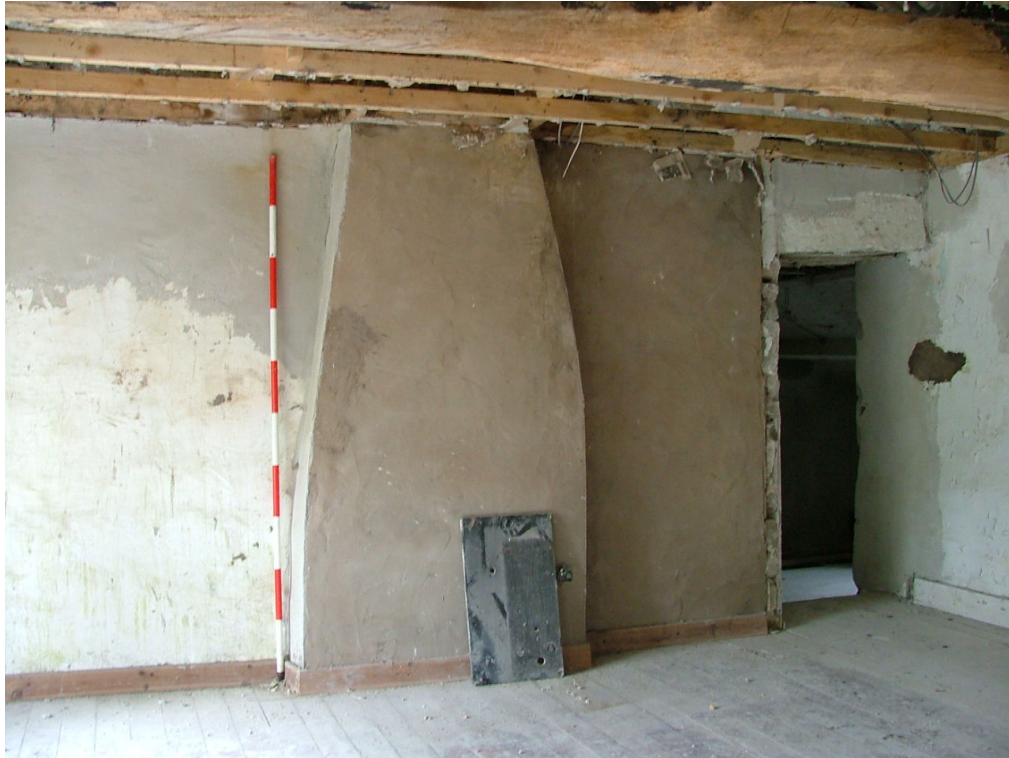
**Plate 26** – Chimney breast, first floor over Room (3), view looking west

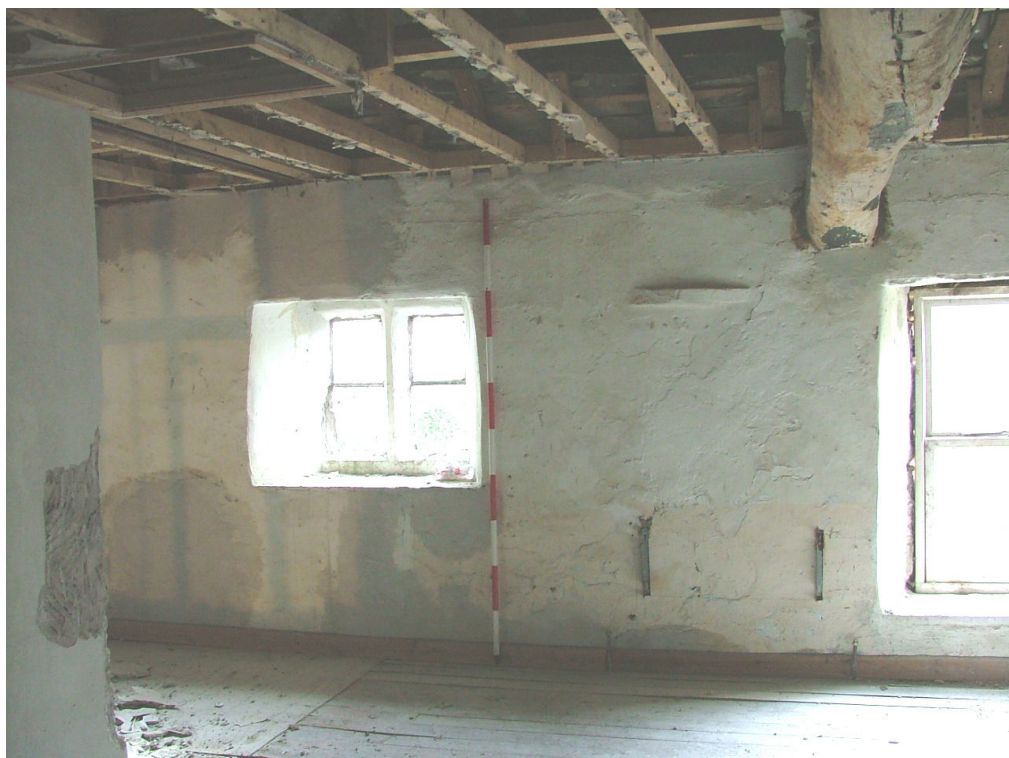
**Plate 27** – Windows and through-stone in south elevation, first floor

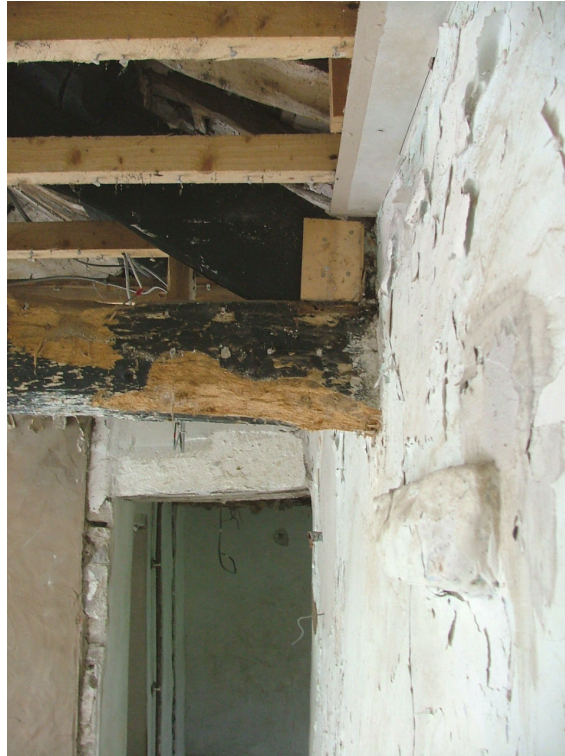
**Plate 28** – First floor, view of through-stone and end of roof truss, north wall

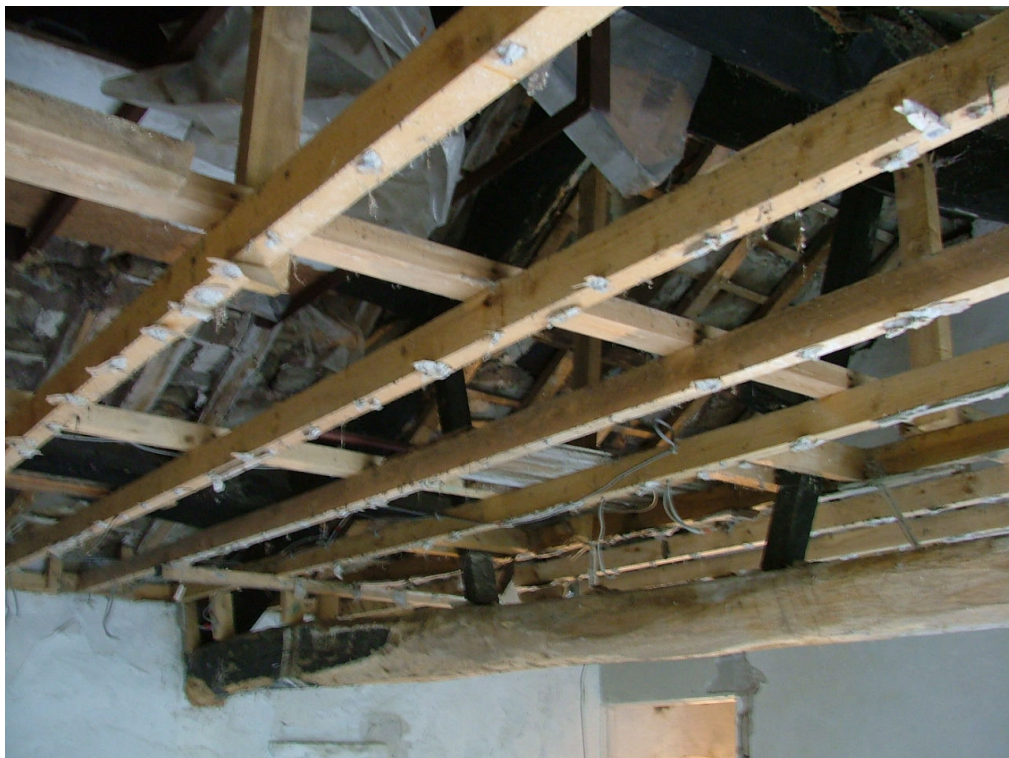
**Plate 29** – Roof truss, first floor room over (3)

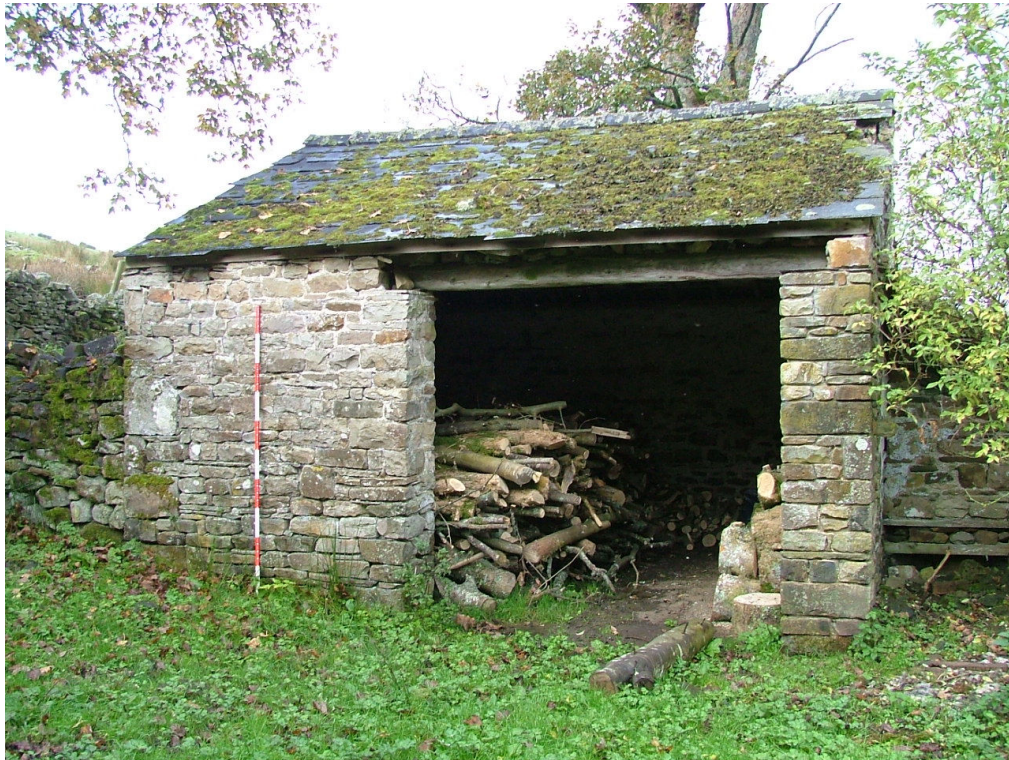
**Plate 30** – South facing elevation of cart shed/store with privy to right of photograph (Scale = 2m)

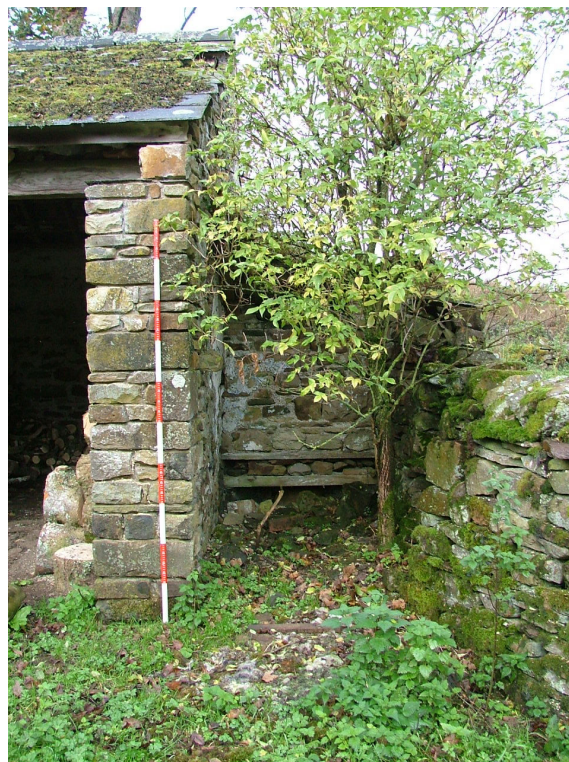
**Plate 31** – Remains of privy to right of cart shed/store

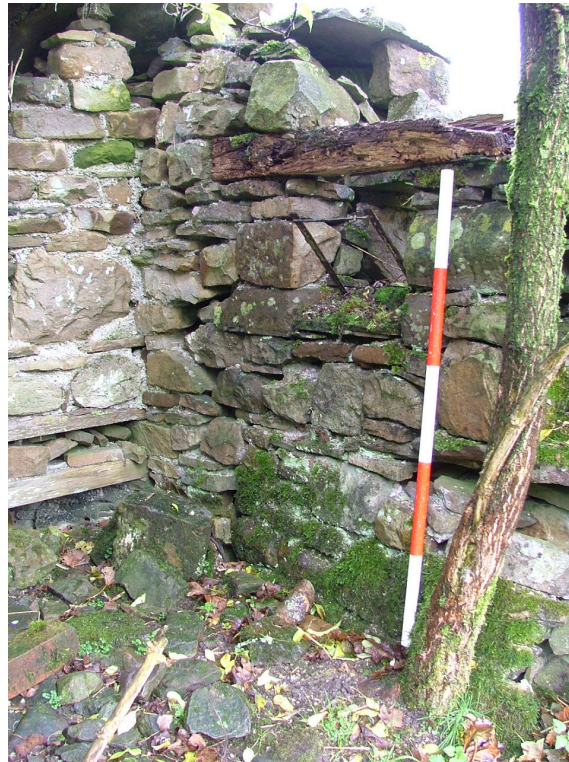
**Plate 32** – Eastern wall of privy showing iron window frame and timber lintel (Scale = 1m)
