# **NORTH PENNINES ARCHAEOLOGY LTD**

**Client Report No. CP/571/07**

In September 2007, North Pennines Archaeology Limited were commissioned by Mr Peter Whitehead to undertake an archaeological building survey of a derelict farmhouse at Scalegill Foot, Dentdale, Cumbria.

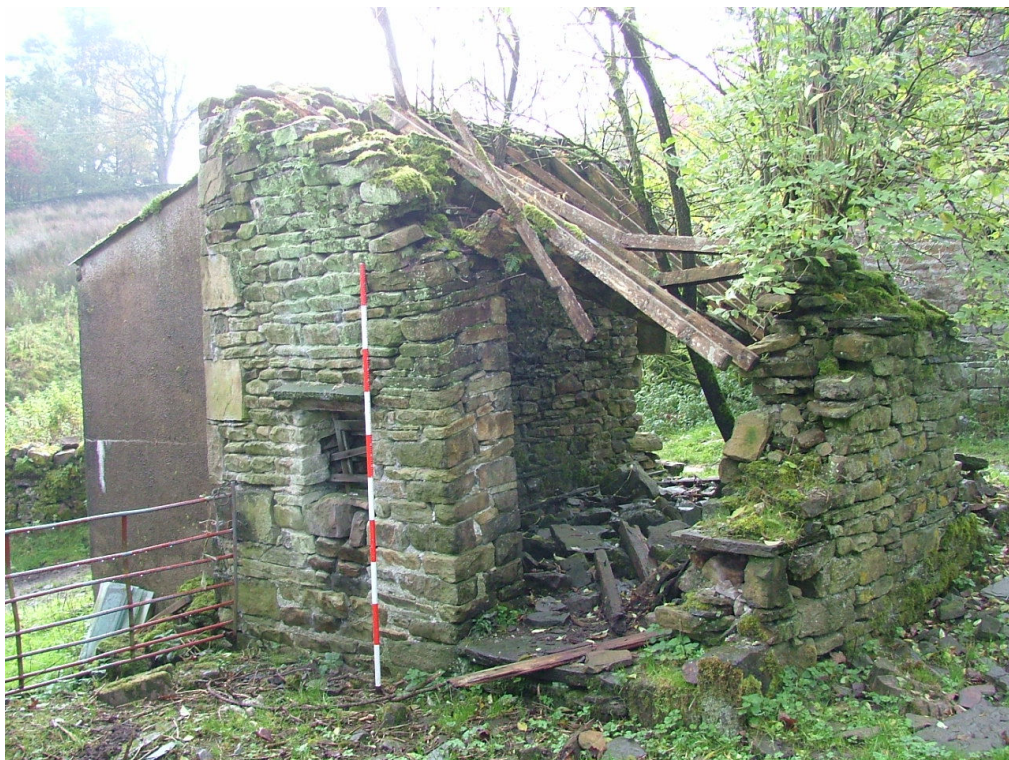
**Plate 33** – Building to west of house, east and north elevations

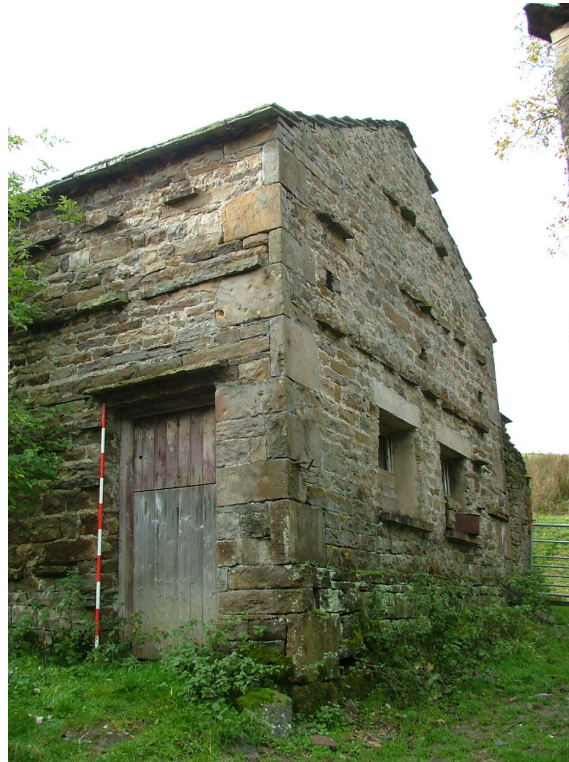
**Plate 34** – Northern end of farm building to south-west of house

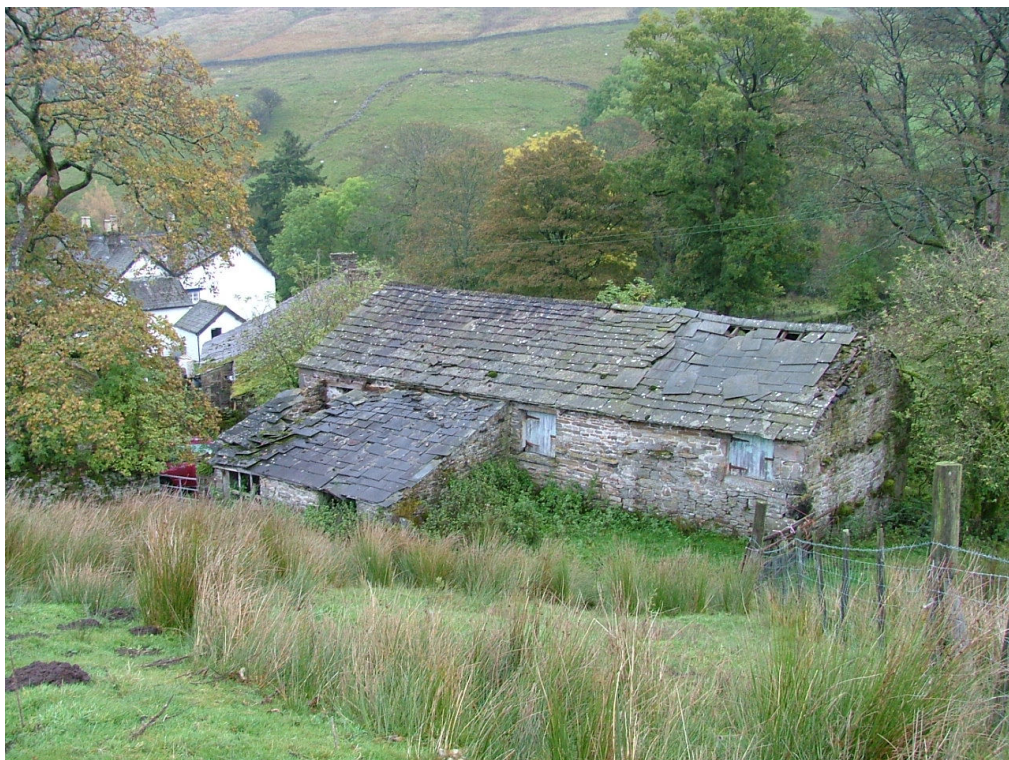
**Plate 35** – Farm buildings to the south-west of the farmhouse as seen from the higher ground to the west
