Client Report No. CP/594/07

**REPORT ON A
PHOTOGRAPHIC SURVEY
OF THE
GLENROYAL BUILDINGS,
SHIPLEY,
WEST YORKSHIRE**

**FOR
Mandale Developments**

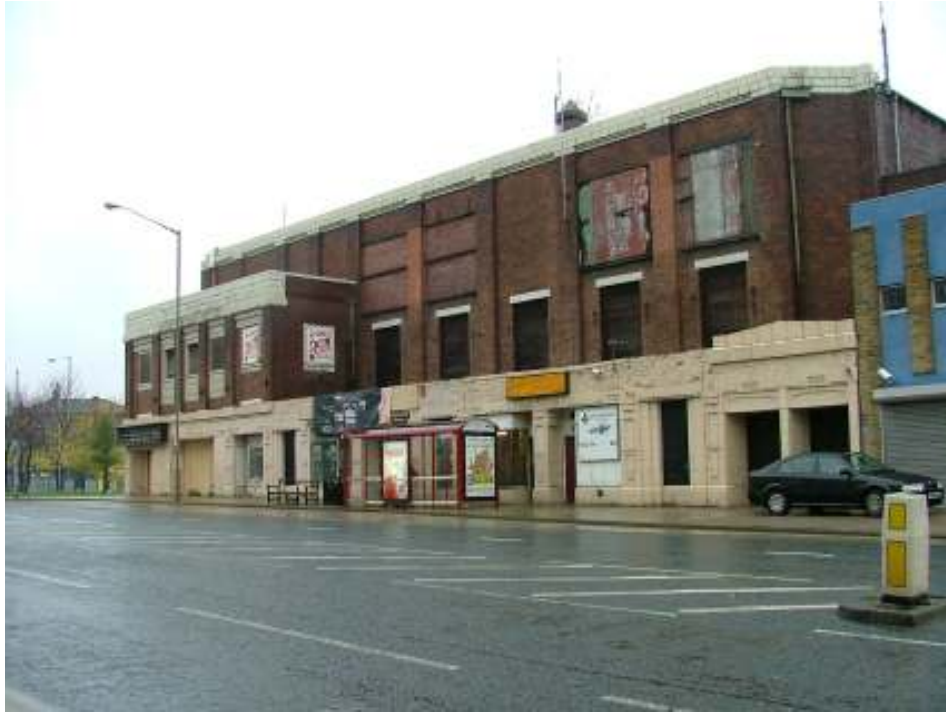
Plate 1 – South elevation facing Briggate

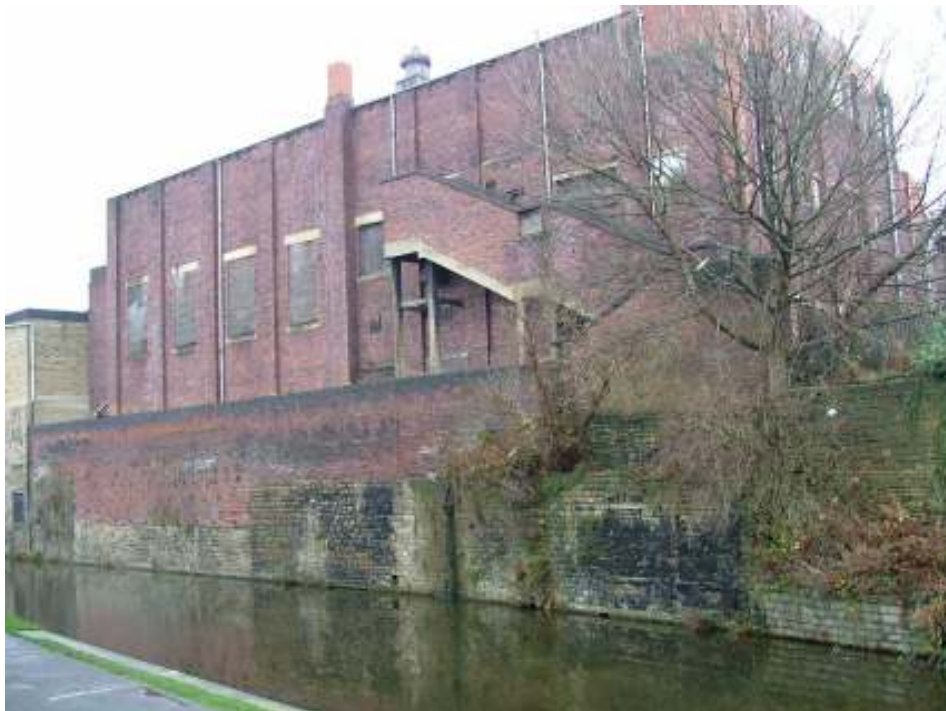
Plate 2 – North elevation facing the Leeds-Liverpool Canal

- 5.1.3 Like the west elevation, the north side of the building contains little in the way of architectural detail (Plate 2). There are four large boarded-up windows which also presumably lit the auditorium like those on the south elevation. A chimney stack is located approximately mid-way along the elevation, this would appear to have served the boiler which was located in the basement. The external staircase, which is also constructed of brick, is held up by concrete supports and is roofed in Welsh slate (Plate 11). This staircase presumably served as an emergency exit for those on the first floor balcony, and is evidence for the features incorporated within new builds to conform to legislation laid out in the Cinematographic Act of 1909. Located on the north side of the roof, and visible in Plate 2 is a projecting metal flue which presumably related to the heating and ventilation system.

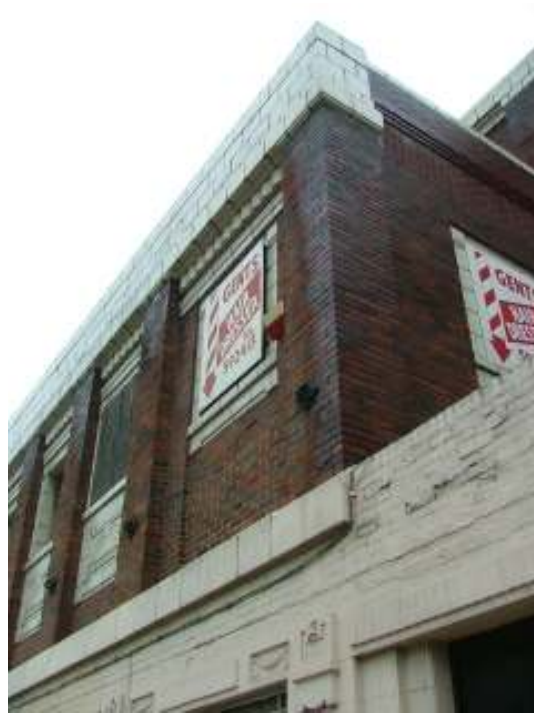
Plate 3 – South elevation, first floor projection which houses the stairs to the balcony

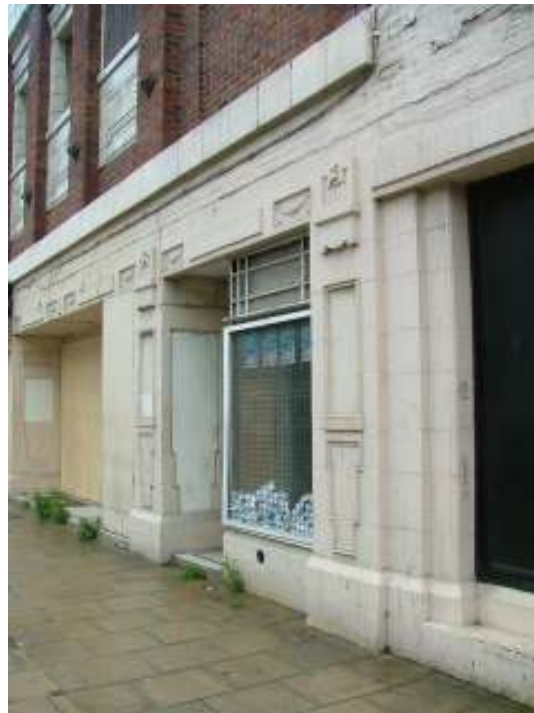
Plate 4 – South elevation, view of the cream, faience tiling and architectural detail such as the 'swags' over the windows and doors

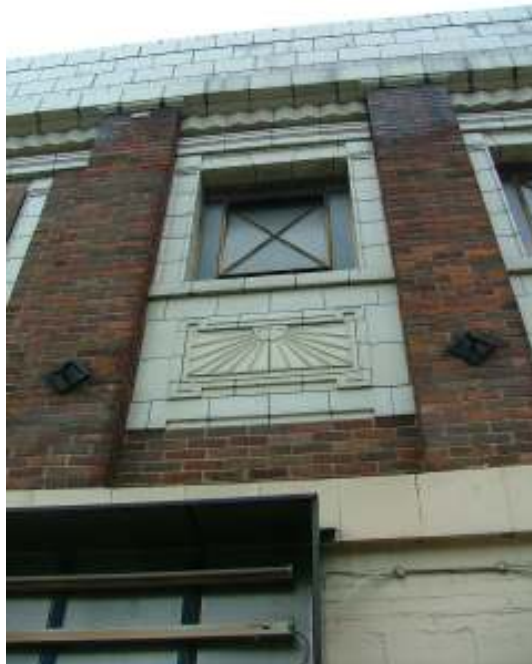
Plate 6 – Detail of first floor window, south elevation, which lights the foyer for the balcony

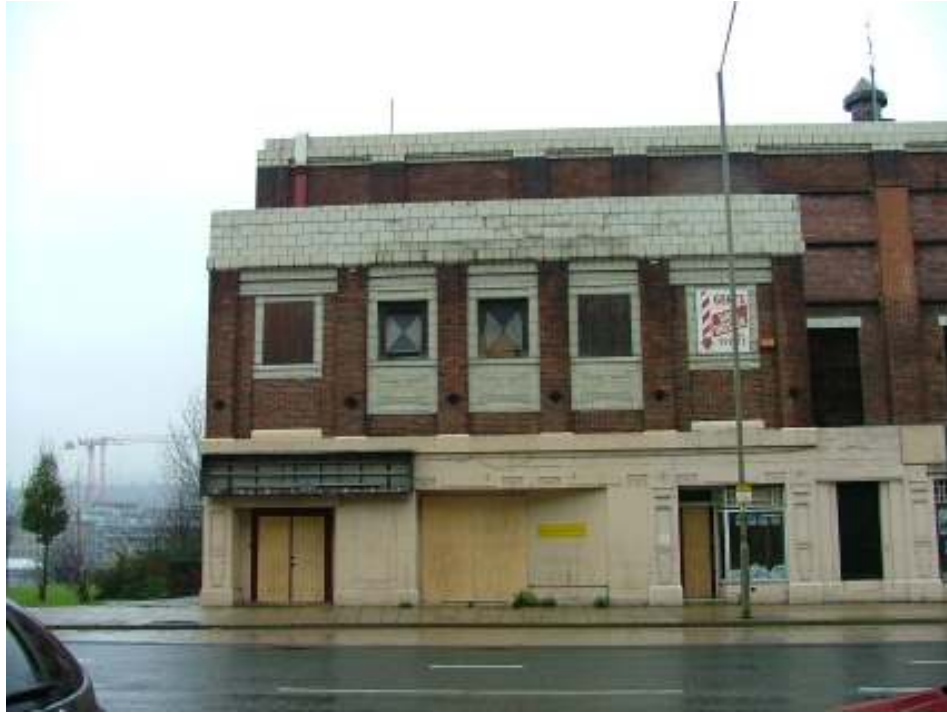
Plate 7 – South elevation showing coloured glass within the first floor windows

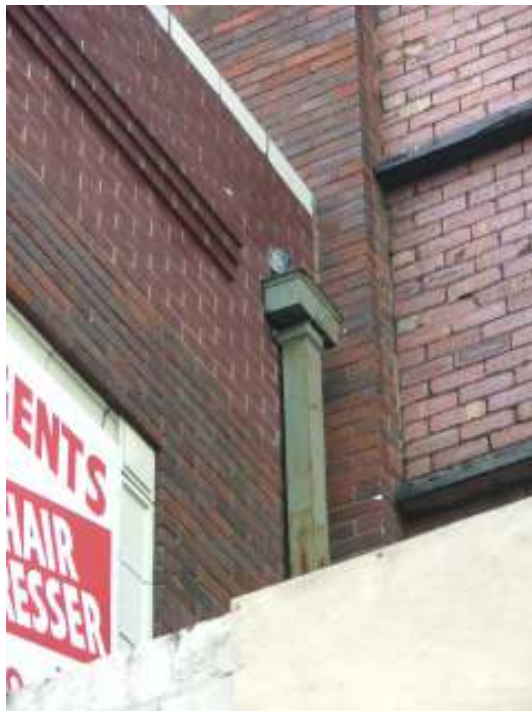
Plate 8 – Rainwater hopper and downpipe, east wall of first floor projection which houses the foyer for the balcony area of the cinema

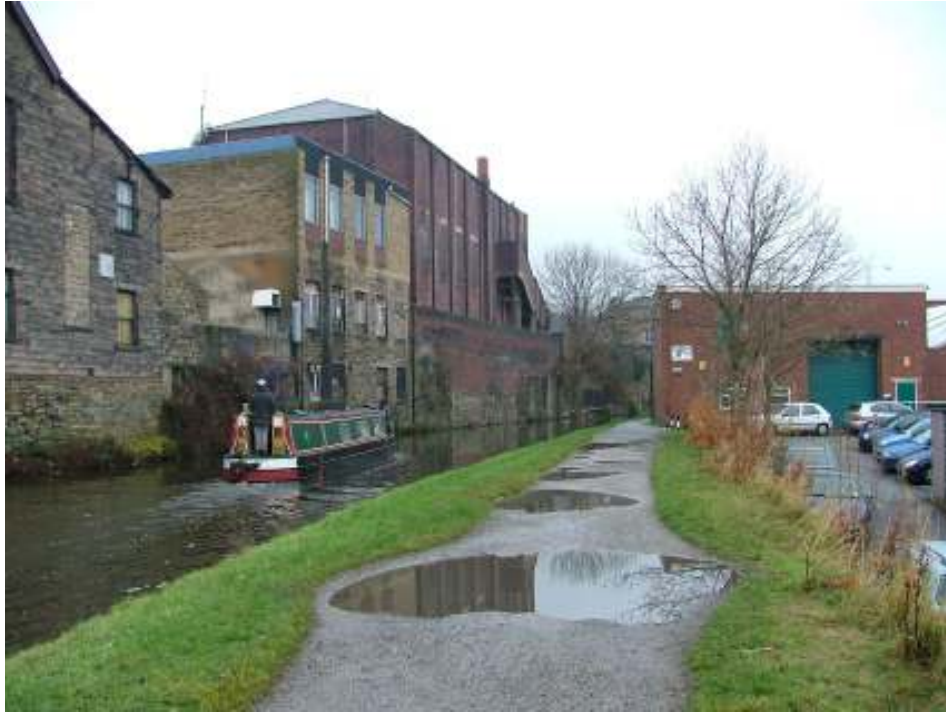
Plate 9 – The Glenroyal Buildings as viewed from the north-east showing the just visible hipped roof

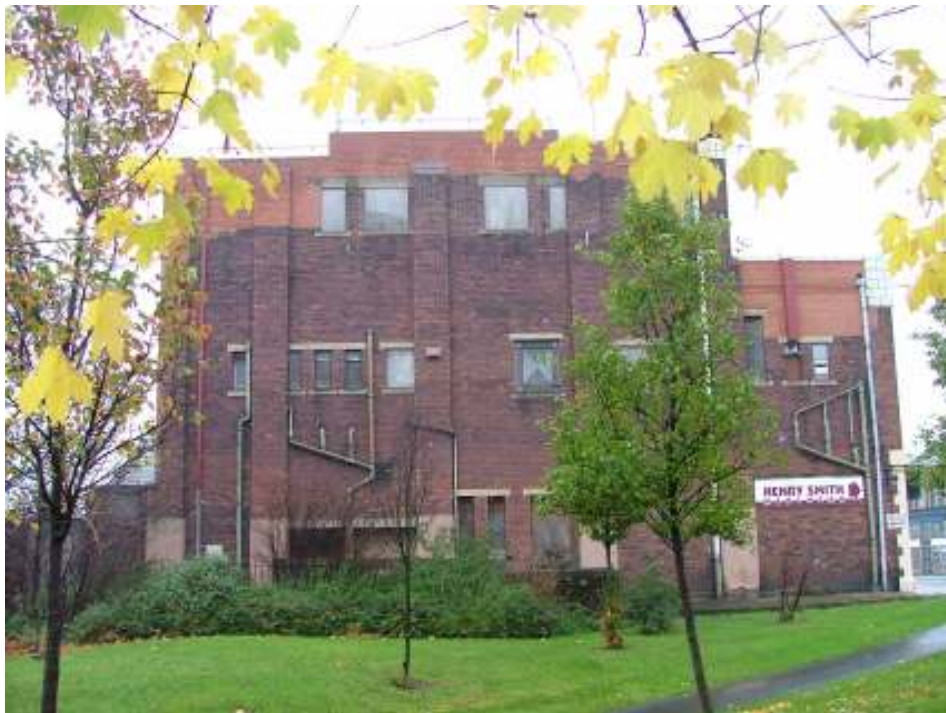
Plate 10 – West elevation of the Glenroyal Buildings showing the lack of architectural detail and areas of different coloured brick

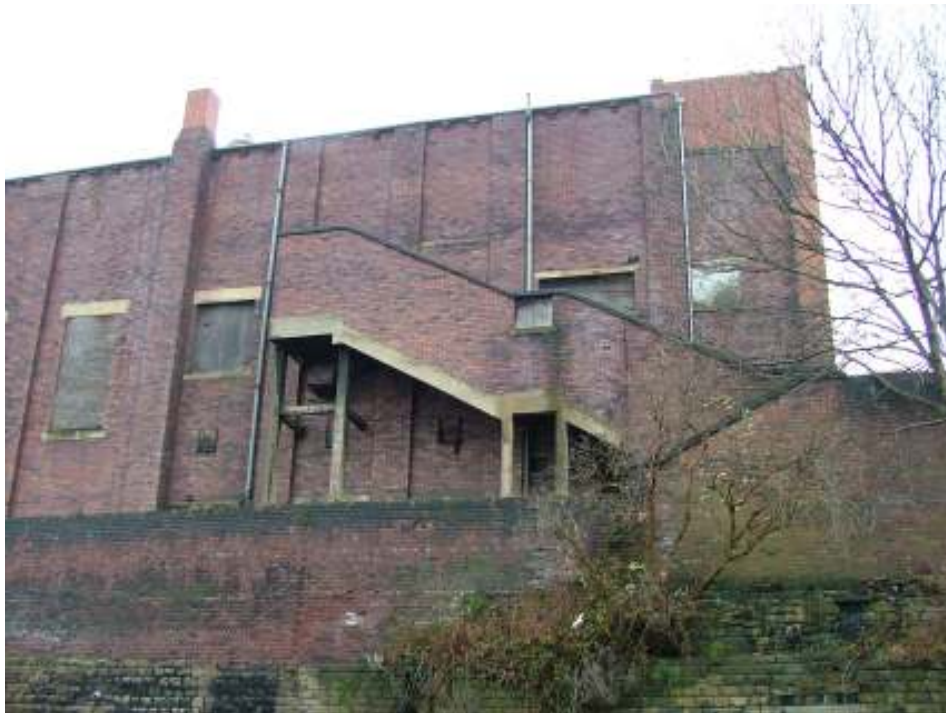
Plate 11 – External staircase, north elevation

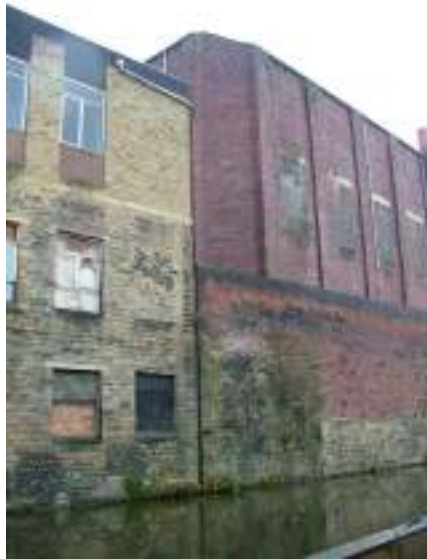
Plate 12 – View from the opposite side of the Leeds-Liverpool Canal, showing the north-east corner of the building, also note the brickwork making up the boundary wall constructed on earlier masonry walls

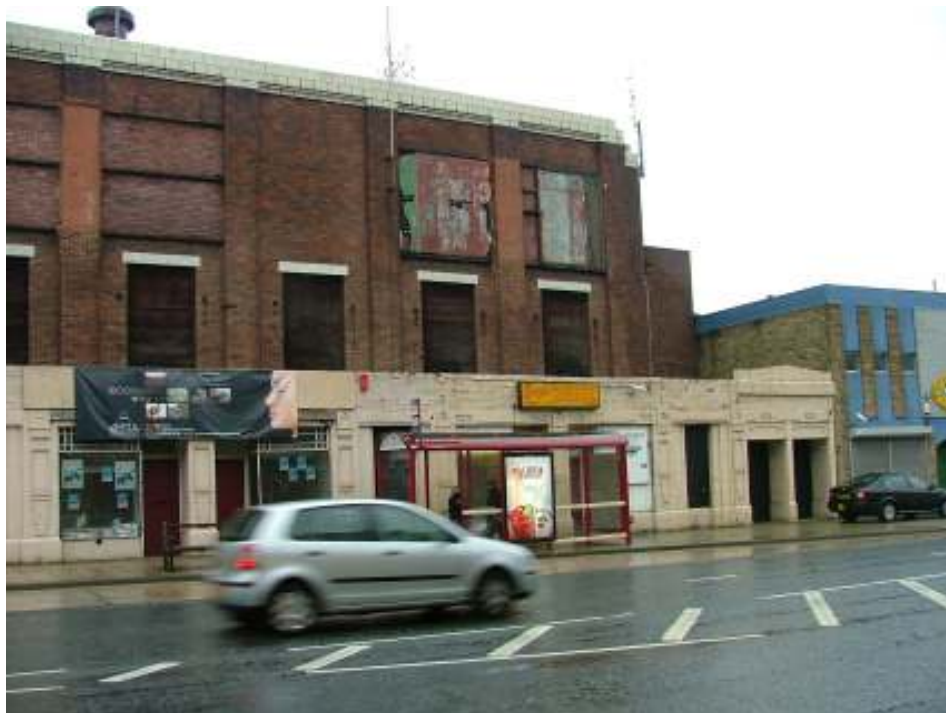
- 5.1.4 The east elevation of the Glenroyal Buildings was largely obscured by the building next door; however, it was possible to note from the opposite side of the Leeds-Liverpool Canal that the corners of this elevation were not square and instead where at a 45° to the main walls (Plate 12). Located at the base of these angled corners are fire exits which provided access to a back lane between the cinema and the building next door. There is a two-storey projection from the main body of the cinema on this elevation, which houses the stage area (Plate 13).

Plate 13 – View looking north-east showing the east end of the south elevation and the two-storey projection from the east elevation

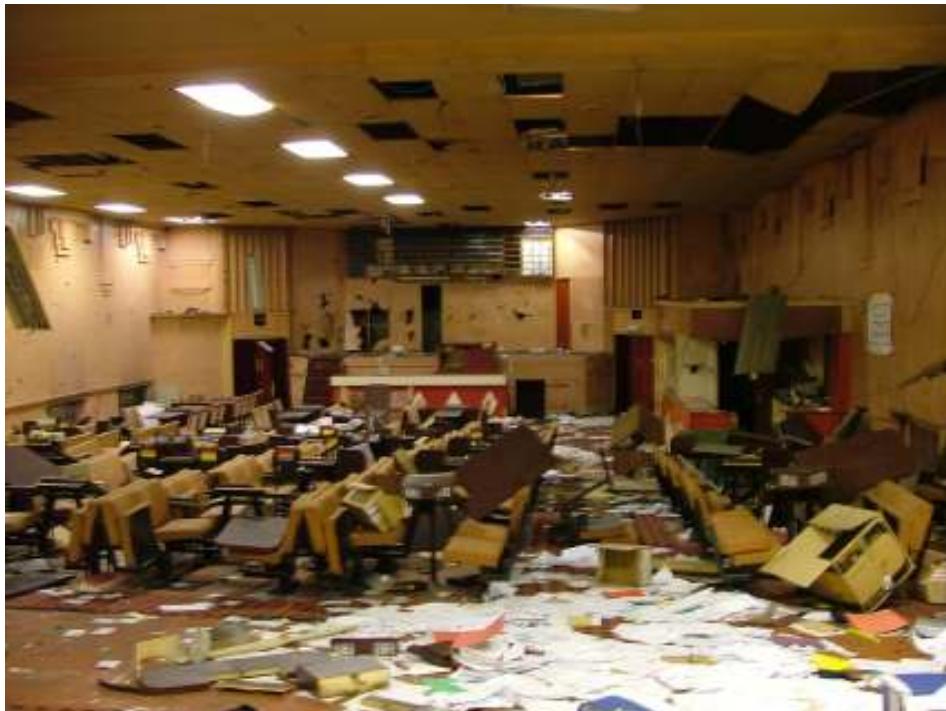
Plate 19 – View looking east towards the stage of the main auditorium showing the remaining seating for the bingo hall and the suspended ceiling

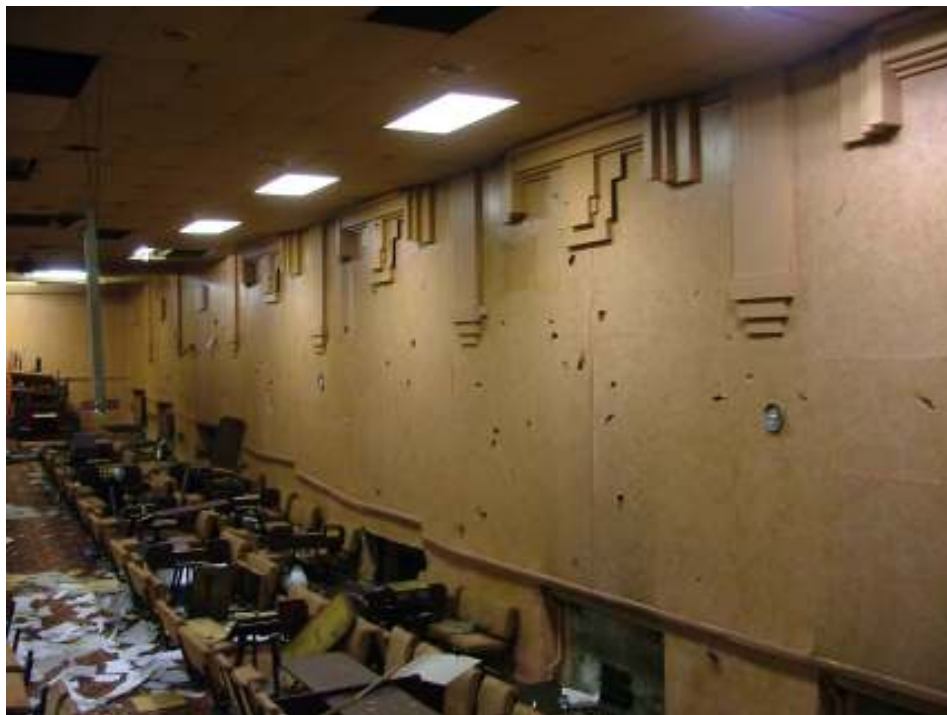
Plate 23 – North wall of the auditorium showing the base of the architectural detail, the rest of which is hidden by the suspended ceiling

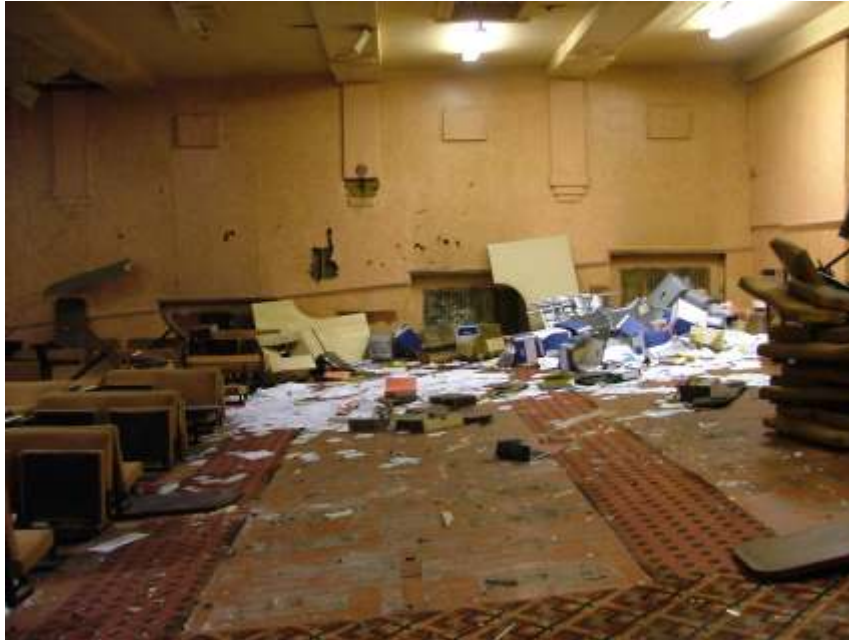
Plate 24 – View looking south of main auditorium showing the location of some of the radiators, and the scarring in the floor boards where the former seating were located

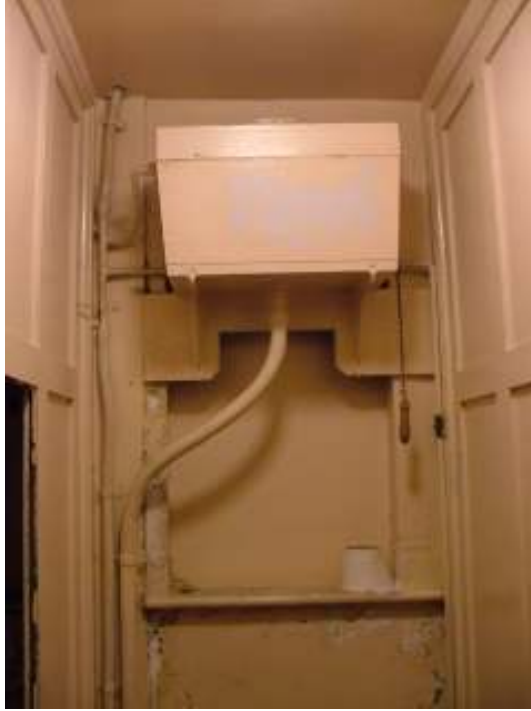
- 5.2.4 At the back of the auditorium (the western end) is a doorway which provided access to a door to the basement, and a fire escape. There also appeared to be some toilets situated beside the fire door however it was not possible to confirm this at the time of survey due to stacks of chairs preventing access. To the right of the doorway shown in Plate 25 were some ladies toilets which may be original, although it was noticeable that the cisterns prevented the windows behind being opened (Plate 26). This was also observed in the ladies toilets on the first floor.

Plate 26 – Detail of cistern, ladies toilets, ground floor

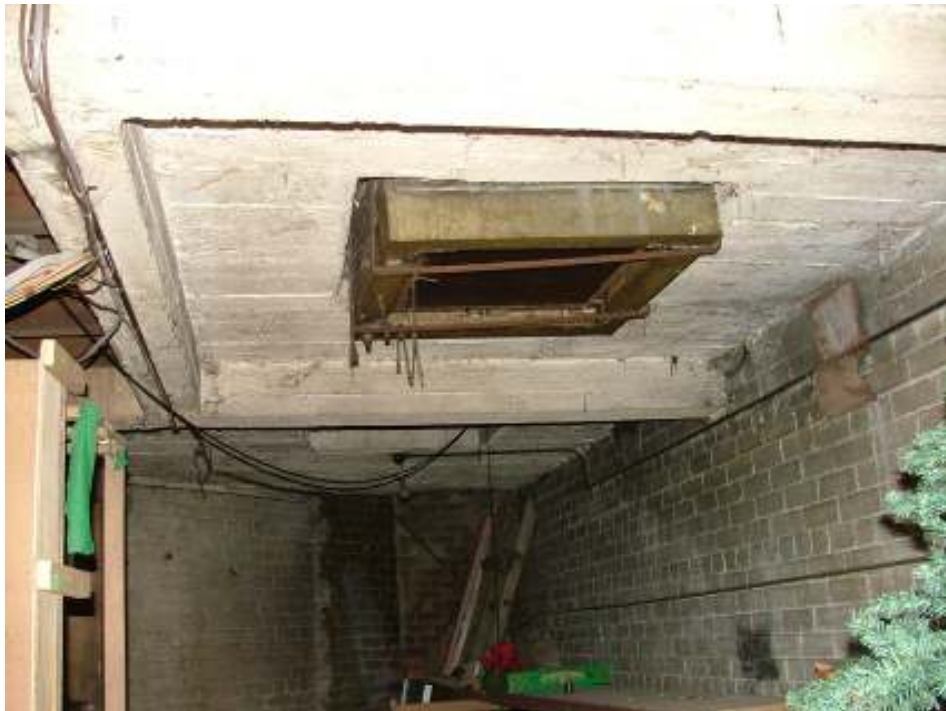
Plate 27 – View of the underside of the stage showing the concrete supported on brick walls and a metal duct?

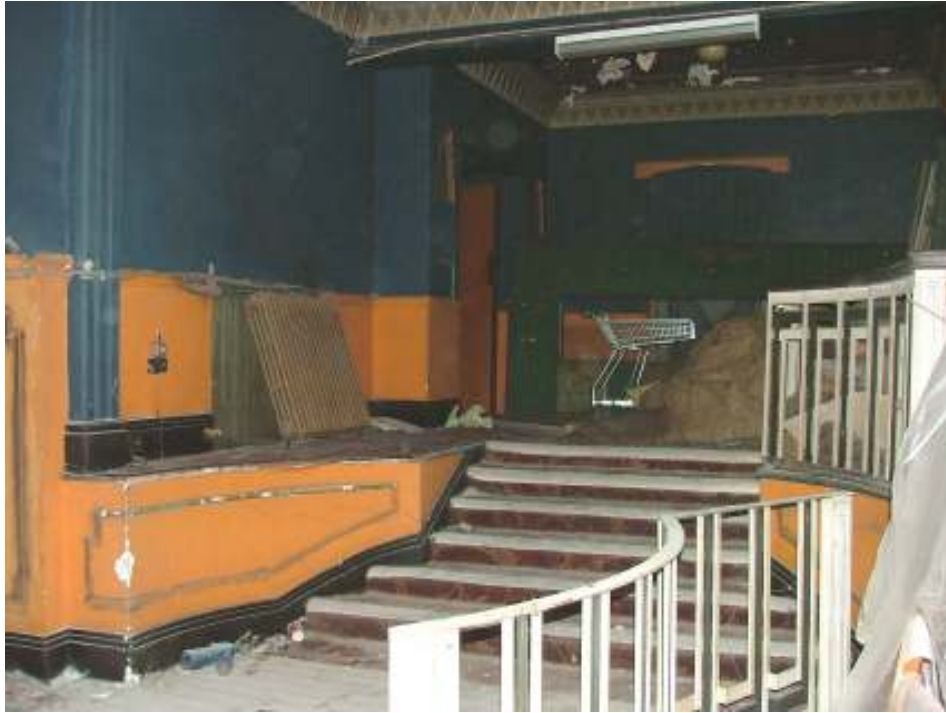
Plate 30 – Stairs to balcony from the first floor foyer, showing blue and gold décor, decorative ceiling and black and white iron balustrades

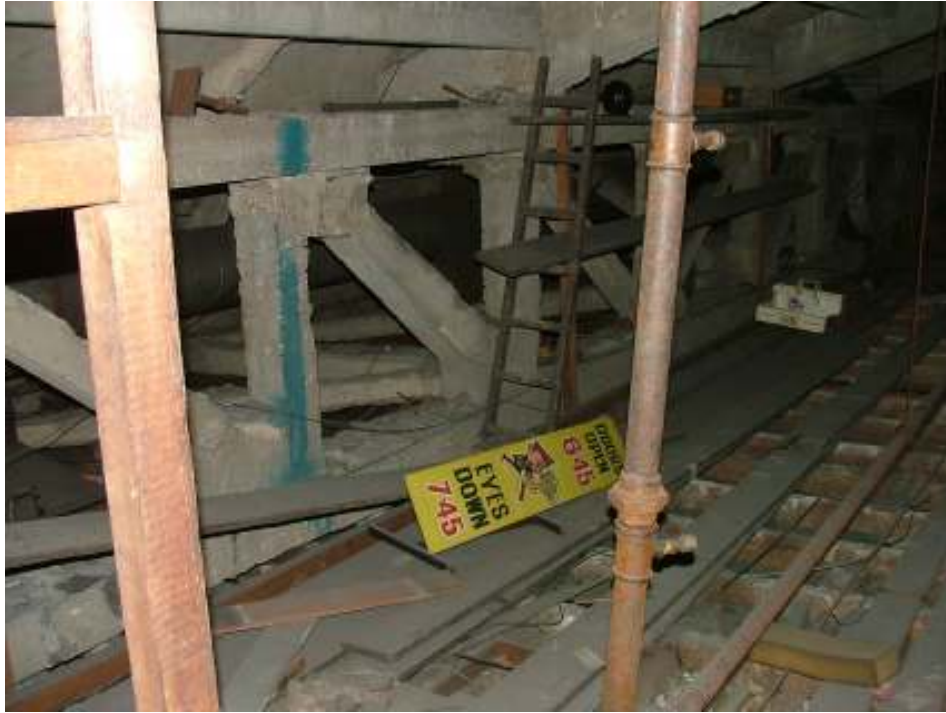
Plate 40 – View of the underneath of the balcony area showing the concrete construction. Note the sign for the bingo

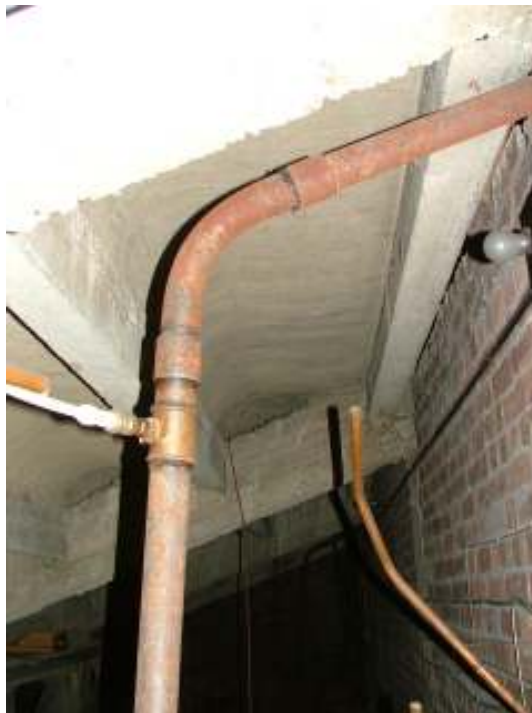
Plate 41 – View of the underneath of the balcony showing the curved concrete

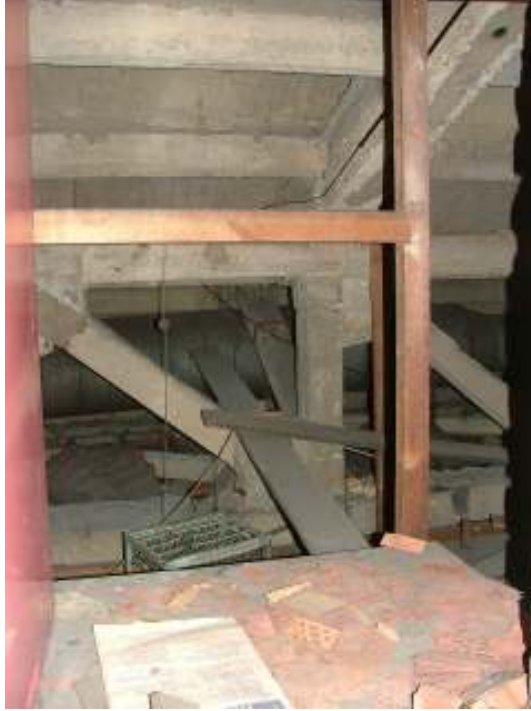
Plate 42 – View of the underneath of the balcony with large pipe visible in background

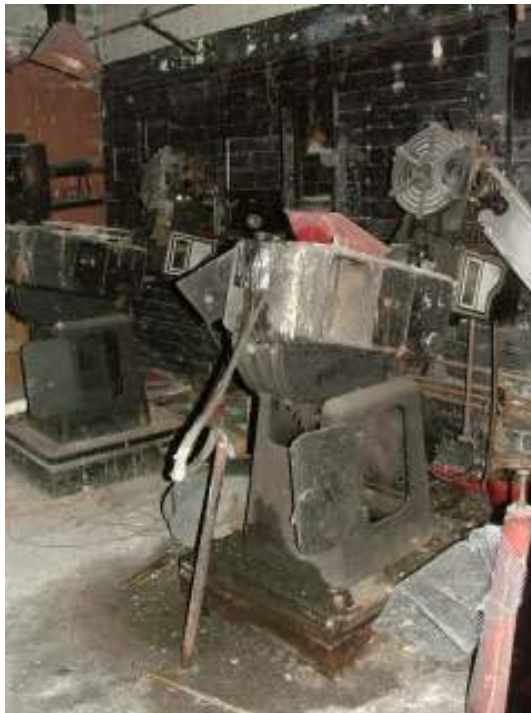
Plate 43 – Two of the projectors which remain *in-situ*

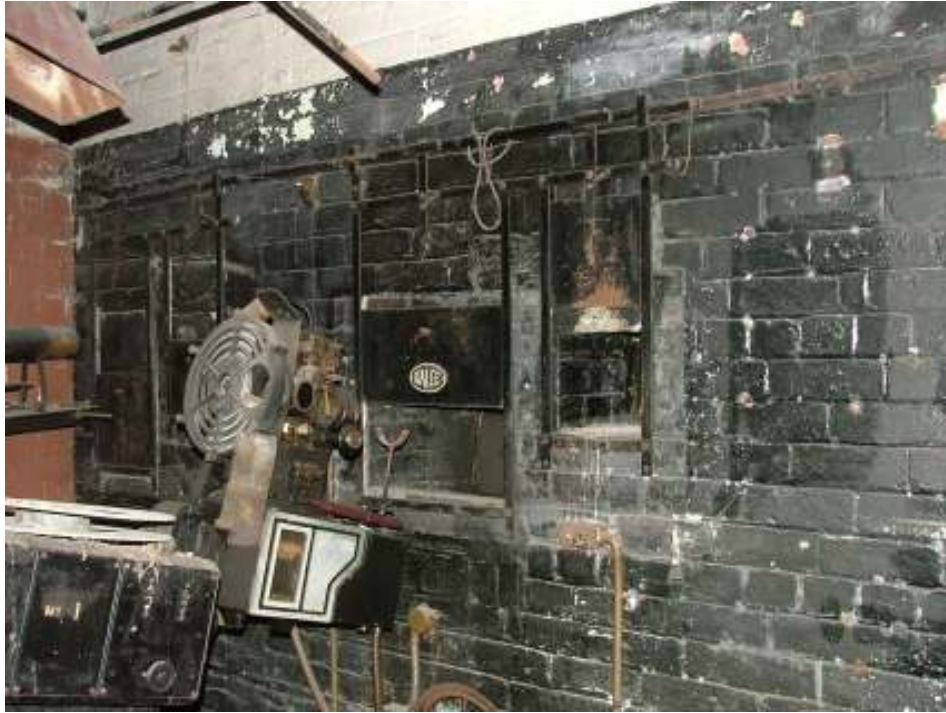
the films could be projected and observation holes, which presumably allowed the projectionist to keep an eye on the audience (Plate 44).

Plate 44 – Holes with shutters within the brick wall for projecting the films and observing the audience

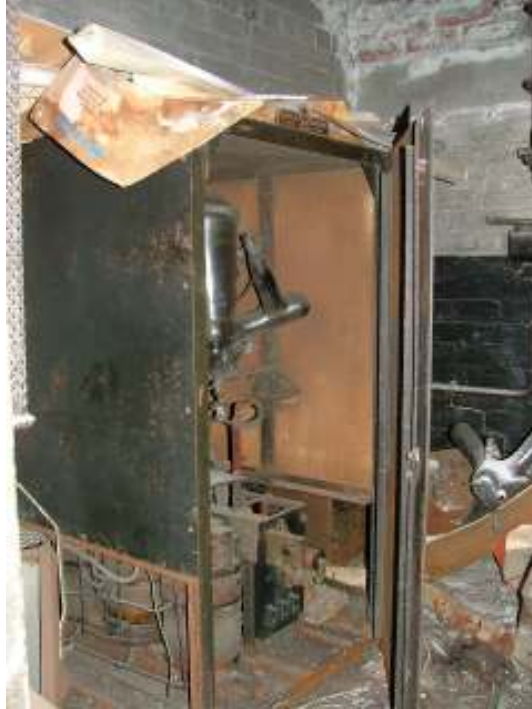
- 5.2.11 In a room to the south of where the projectors were located is some machinery. The function of this machinery is unclear, though it may be related to the ventilation system (Plate 45). On one of the walls of this room were two mesh ‘boxes’ with the metal tags showing the name ‘Kalee’ and the supplier as ‘A Kershaw & Son, Leeds’ (Plate 46).
- 5.2.12 Beneath the building was a basement which could be accessed via a doorway and staircase at the rear of the main auditorium. The basement would presumably have housed the boiler, and some machinery remains *in-situ* (Plate 47).

Plate 45 – Machinery in room to south of the projection room

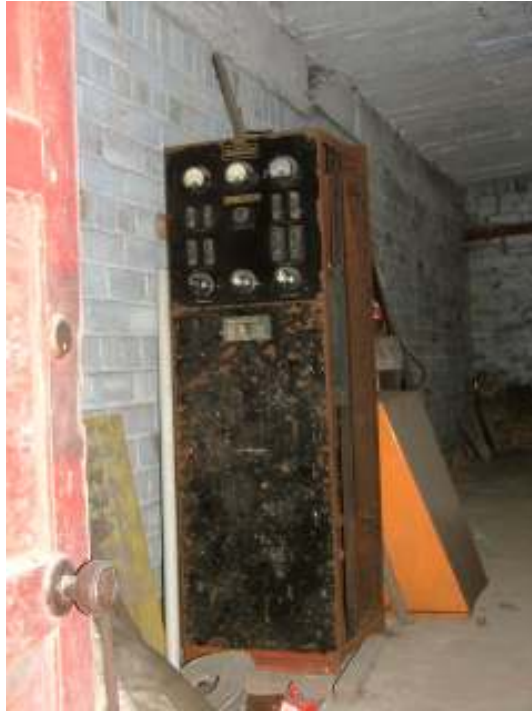
Plate 47 – Machinery remaining *in-situ* in the basement, note the concrete ceiling
